Appendices

**REPORT
ON
GEOLOGICAL SURVEY
FOR
PREPARATORY SURVEY FOR THE EAST-WEST ECONOMIC
CORRIDOR IMPROVEMENT PROJECT (PHASE 2)
(DATA COLLECTION SURVEY FOR THUWUNNA CTC)
IN
THE REPUBLIC OF THE UNION OF MYANMAR
THINGANGYUN TOWNSHIP, YANGON REGION
ORIENTAL CONSULTANT GLOBAL CO., LTD.**

PROJECT Preparatory Survey for the East-West Economic Corridor Highway Development Project (New Bago-Kyaikto Highway Section) Upgrading of the Thuvunna Research Laboratory and Training Center	CONSULTANT ORIENTAL CONSULTANTS GLOBAL CO., LTD. TOKYO OPERA CITY TOWER 9F 20-2, NISHISHINJUKU 3-CHOME, SHINJUKU-KU, TOKYO 163-1409, JAPAN	* NOT FOR CONSTRUCTION		REV. A XXXXX	REVISION	DATE #### ## ##	DRAWN BY: OCG	TITLE PLAN MOC TRAINING	DRAWING NO. A-001
				APPROVED BY: XXXXX	DATE: DEC. 10, 2019	SHEET SIZE A3	SCALE 1:600

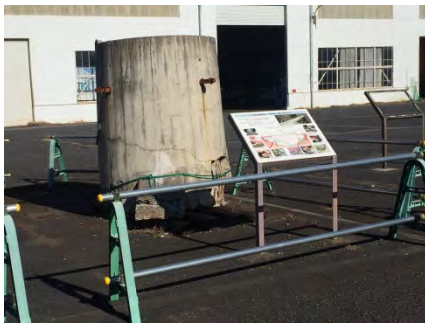
7) Outdoor exhibition area (Sample of the bridge column)

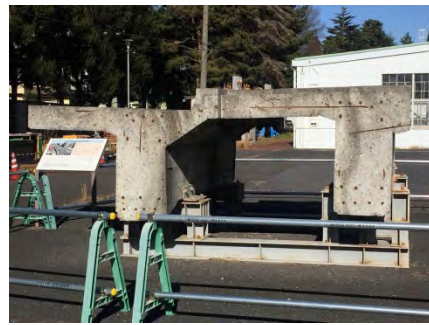
7) Outdoor exhibition area (Sample of RCT beam section)

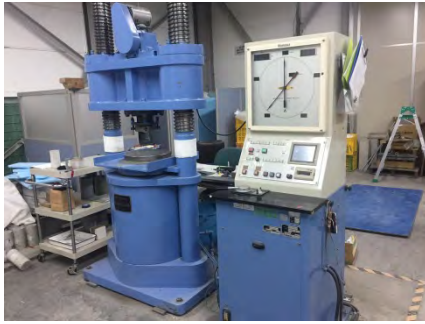
13) Material Testing Building (Universal Testing Machine (500kN))

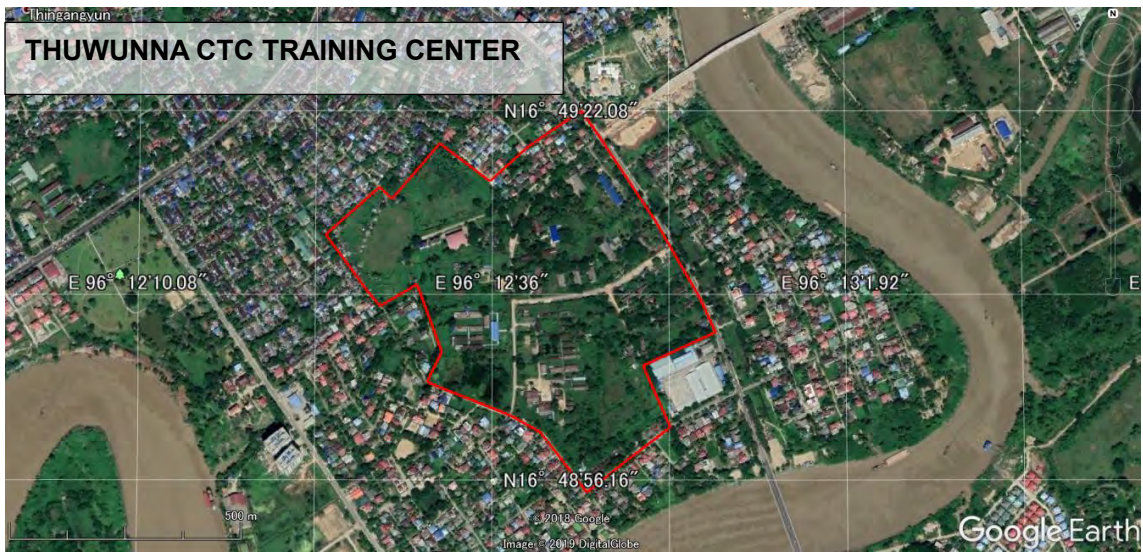
Figure-1 Project Location

The work area of this project is about 0.37 km² (a range marked in red) shown in Figure-1.

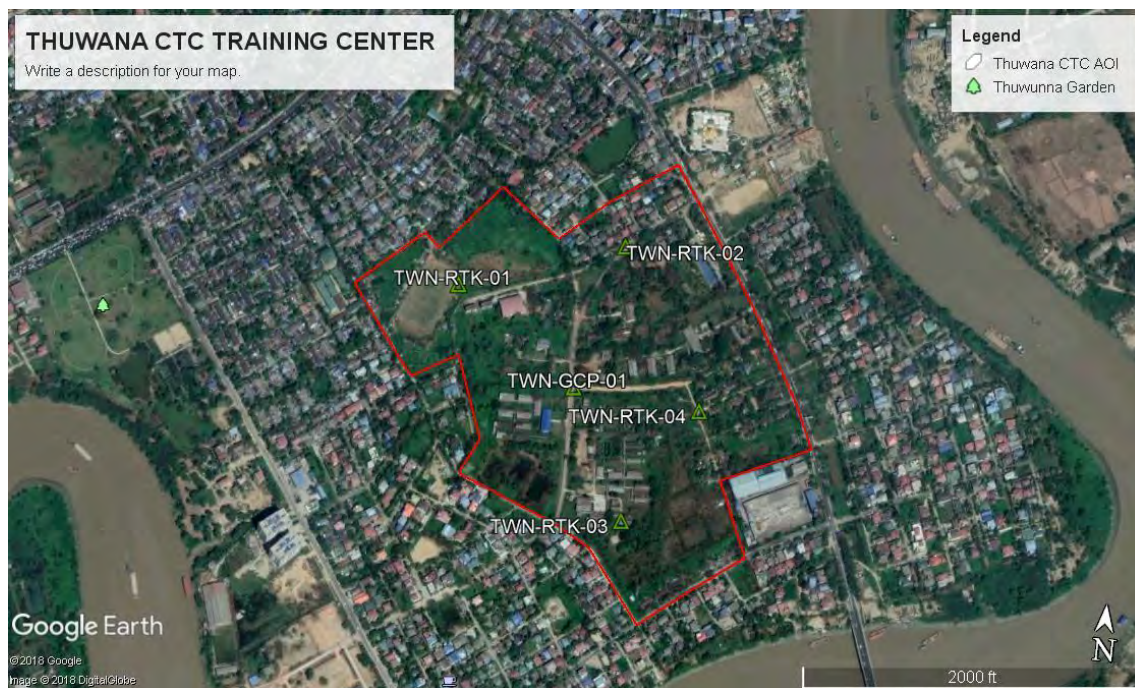
Figure-3 Target Plan

Targets for aerial triangulation were installed at the locations shown in the Figure-3 before taking aerial photography with UAV. Coordinate of these 5 targets was observed by GPS.

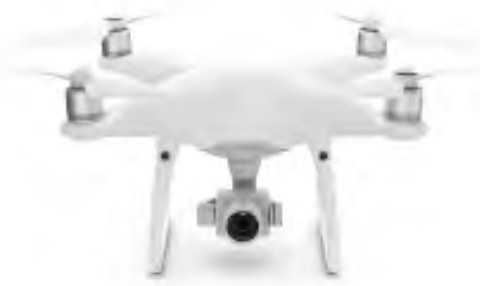
Figure-5 UAV used in this project (Phantom4 Pro)

- Total area: about 0.37km²
- Flight Height: 50m
- Overlap: 80%±5%
- Side-lap: 40%±5%
- UAV & Camera: DJI Phantom4 & Pro (Model – FC-6310) (Figure-5)
- Number of flight line: See Figure-6

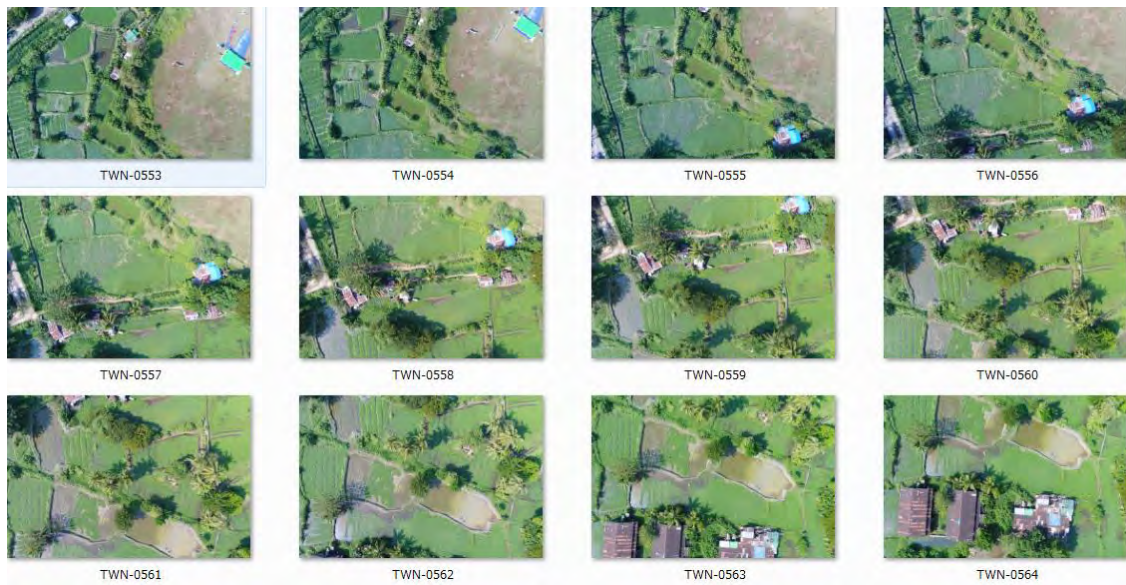
Figure-7 Sample of photos taken by UAV
(No.553-564 of Strip-10)

The shooting information of aerial photos taken by UAV is shown in the table-4. Figure-7 shows the sample of photos taken by UAV

Date	January 13, 2019
Strip and Number of Photos	Strip-1 to Strip-23 1,373 Photos (1,356 adjusted photos and 17 eliminated photos)
Ground sampling Distance	GSD is 0.0189 m
Evaluation	Overlap: OK, Cloudy: OK, Shadow: OK, Smoke: OK

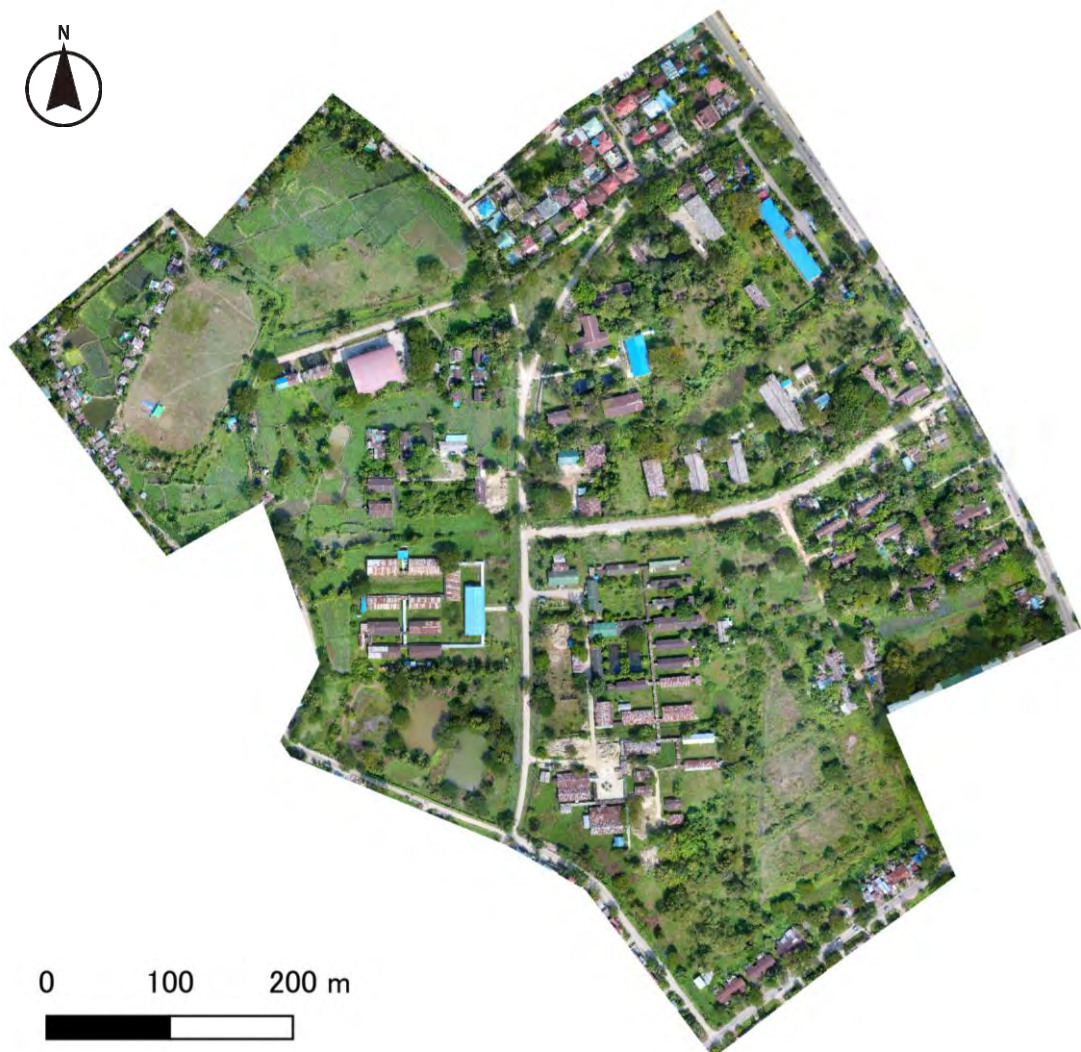
Figure-9 Mosaicked Aerial Photographs

Effective of the Clouds, Shadow and Smoke could not be seen over the principle point of any Photograph.

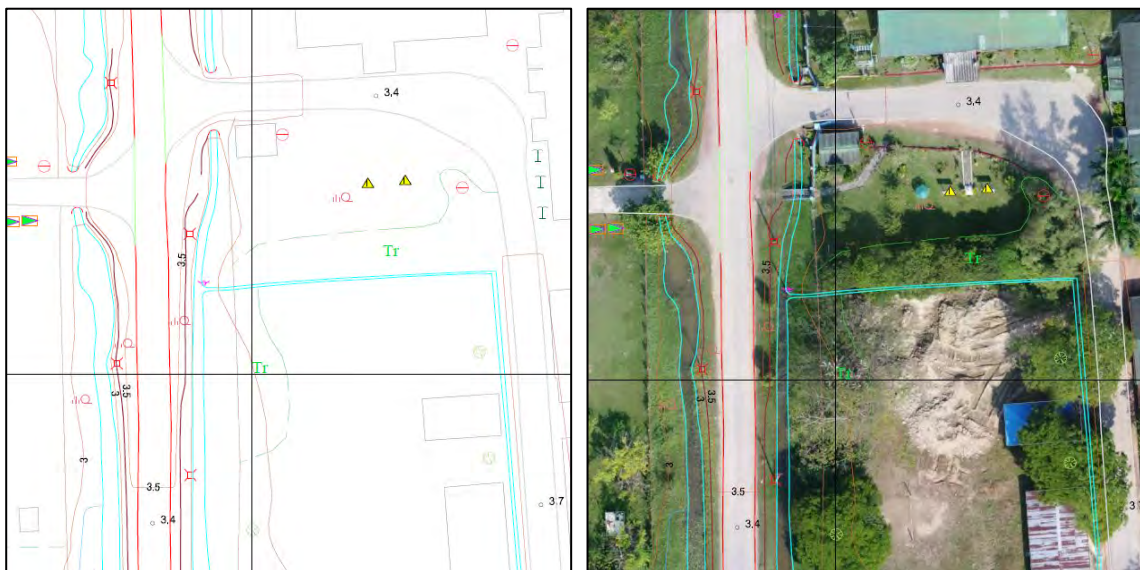
Figure-11 Part of Topographic Map (right: overlay Orthophoto)

All natural and artificial terrain features such as rivers, forests, monumental trees (together with the name of trees); paddy field, farms, plantation, roads, paths, houses, schools, public buildings, cemeteries, etc. interpreted and plotted by the stereo model after aerial triangulation. The drawn features are classified into layers in AUTOCAD file according to the map symbol specification. The topographic map of each area printed out the PDFs of A0 size. Figure-10 shows topographic map symbol specification adopted in this project. And a part of the topographic map is shown in Figure-11.

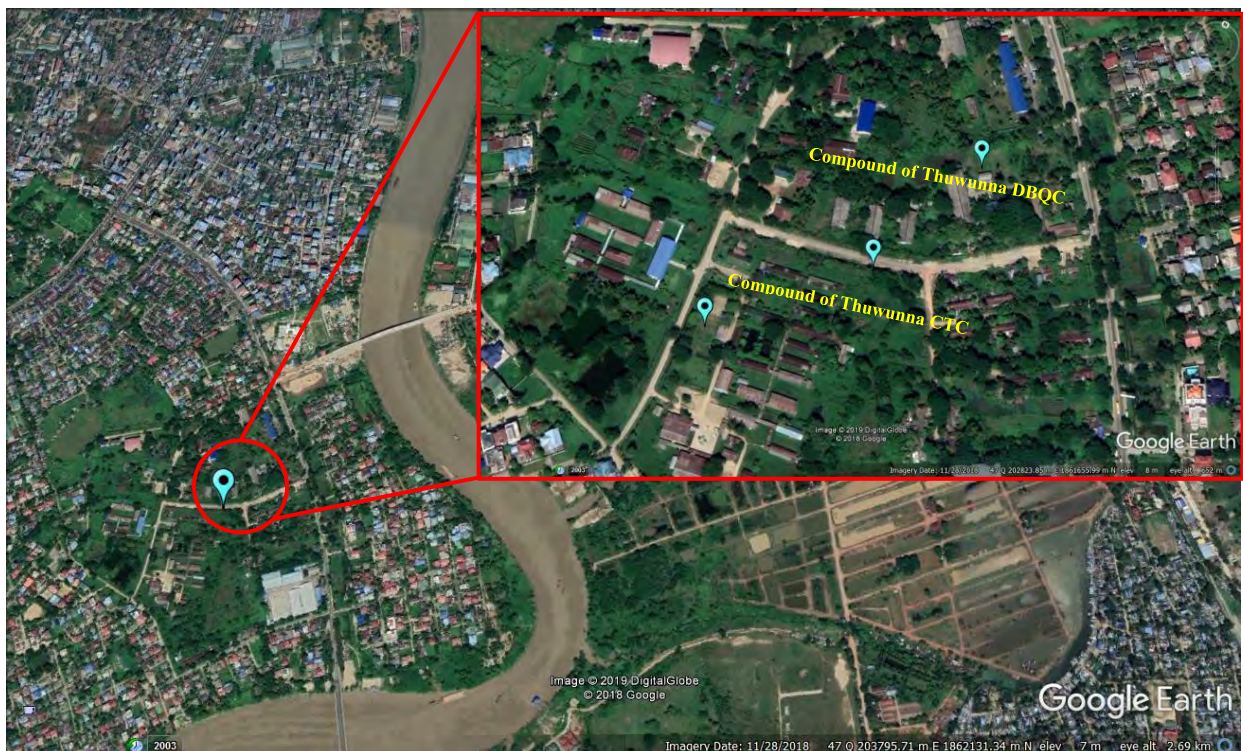
Figure - 1.1 Google map of project area

Project area is located at compound of Thuwunna CTC and Thuwunna department of bridge and quality control, Thingangyun Township, Yangon Region. The detailed location of project area is indicated as a google map in Figure-1.

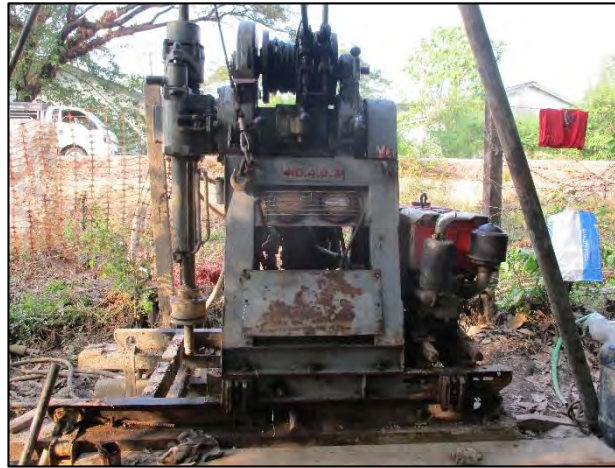
Photo - 1.5 TOHO-D1 Drilling Machine

The boring equipment, TOHO-D2 was applied in the soil investigation work of project area, to study general condition of soil layers under planned area for future construction. The specification and the types of boring equipment were presented in Table-1.2.

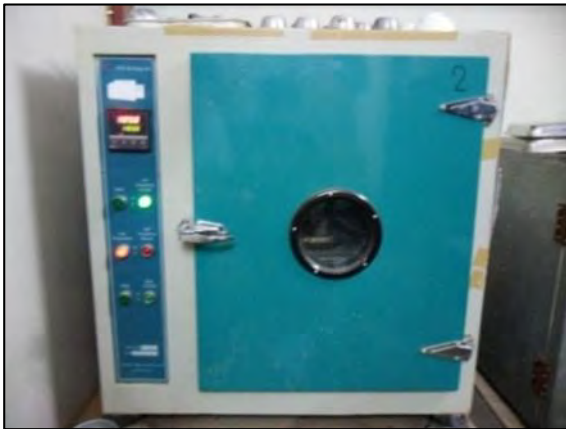
Photo - 1.6 Drying Oven

Instrument Name	Manufacturer and Type
Drying Oven	YF-STHX-3A
Electrical Balance	SARTORIUS 1404B (MP8-1)
Atterberg's Limit Test Apparatus	MARUI 1115013
Sieve Test Equipment	TOKYO SAITAMA (JIS Z 8801)
Unconfined Compression Test Machine	MARUI 19047
Consolidation Test Apparatus YF-WG-1B	YF-WG-1B

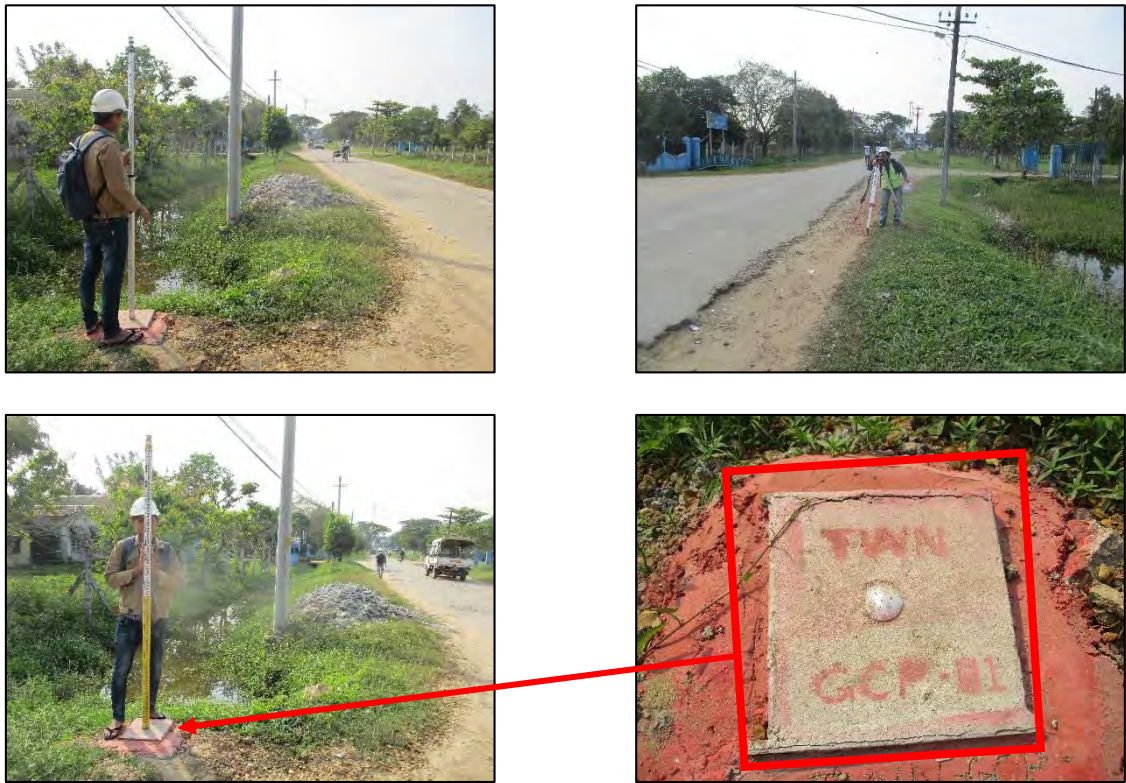
Photo - 3.1 Leveling Process and Control Point (GCP-01)

The locations of investigated points were designated by client. The plan map showing geotechnical investigated points are indicated in Figure-3.1. The coordinate and elevation of all borehole points are shown in Table-3.2. The coordinate of all investigated points were measured by Hand GPS, and the elevations of all investigated points were measured by Auto level from Control Point (CP-03) which is locating at near the site compound. Photo-3.1 is shown the leveling process and Control Point (CP-03).

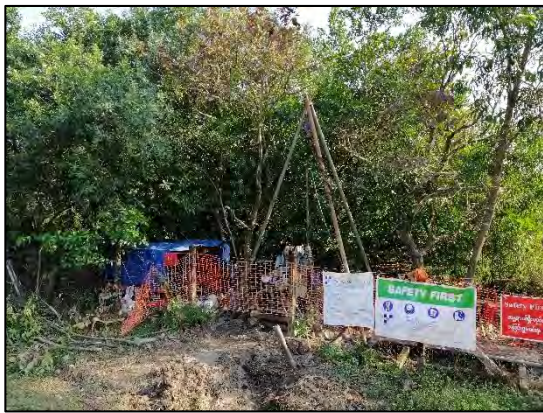
Photo - 3.2 View of BH-01

No.	BH No.	Easting (E)	Northing (N)	Elevation EL: (m)
1	BH-01	202843.000	1861640.000	+2.91
2	BH-02	202906.000	1861773.000	+3.38
3	BH-03	202713.000	1861526.000	+3.27
4	GCP-01	202690.944	1861629.590	+3.75

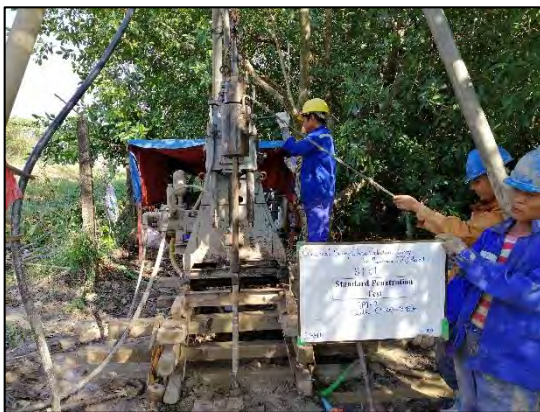
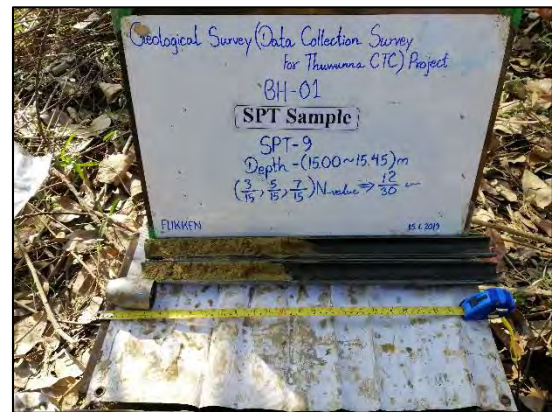
Photo - 3.5 View of Standard Penetration Test and SPT Sample

The standard penetration test was done in accordance with the ASTM Standard (American Society for Testing and Materials; D 1586-99). The test was performed using a spilt barrel sampler (50mm diameter) connected to the end of boring rods. The sampler was driven into the soil by means of a 63.5kg (140lb) hammer falling freely through the height of 76cm onto the anvil attached to the rod. The sampler is driven 450mm into the soil. SPT N-value is recorded for each 150mm penetration of the sampling tube. In this case, seating drive of 150mm is first reached and the blow count for the seating drive is not applied because the bottom of the hole may be apart from natural condition at a certain extent. The resistance, N-value, is taken as number of blow for the penetration of test drive of next 300mm. When 50 blows are reached before the full penetration 300mm, no other blows are applied but final penetration is recorded. At the conclusion of the test, the retained soil sample is extracted and stored in plastic bag for further analysis. In which, Figure-3.3 indicates the procedure and apparatus of standard penetration test. The distribution of N-value for each stratum is summarized in Figure-3.4.

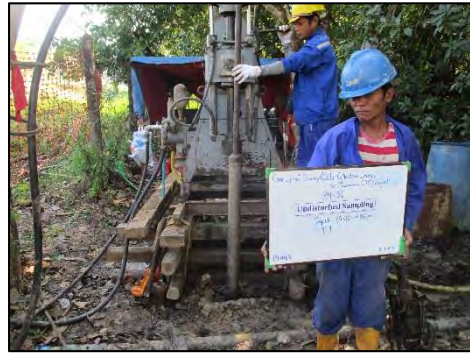
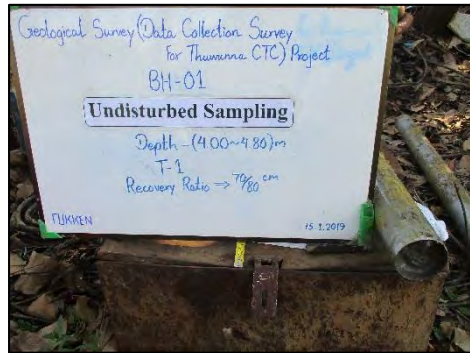
During the course of SPT testing, when SPT value was as low as N-value of 1 to 4 due to existence of fine soil. Piston Thin Wall samplers (Figure-3.5) are used to take as undisturbed sample in the layer of N-value below 5 and Denison samplers (Figure-3.6) are used in the layer of N-value between 5 and 12 in accordance with ASTM Standard for site investigation; by applying piston samplers by water pressure type, properly designed not to disturb in-situ condition of soil.

Photo - 3.6 Taking Undisturbed Sampling

Photo - 3.7 After taking Undisturbed Sample

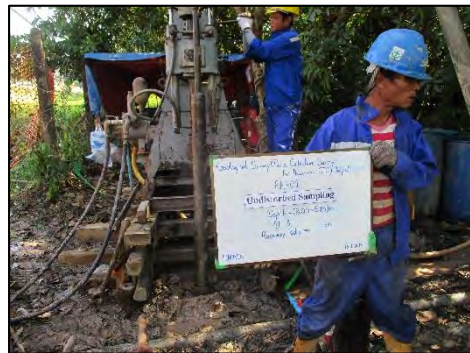
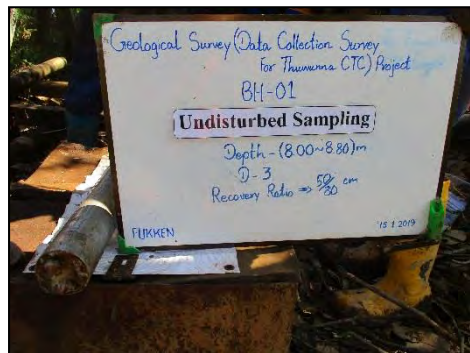
Photo - 3.8 Taking Undisturbed Sampling

Photo - 3.9 After taking Undisturbed Sample

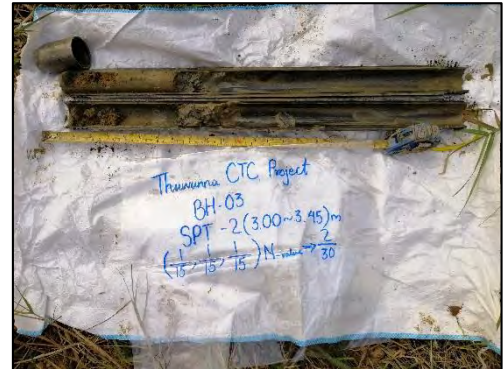
According to the investigation results, the upper most layer is CLAY-I layer. This layer is well observed in all investigated holes. The thickness of this layer is about 3.0m. The color of this layer is brownish gray color. The plasticity of this layer is medium to high plasticity and the water content is moist. SPT N-value range of this layer is 5/30 to 6/30 blows, and it can be described as firm in consistency.

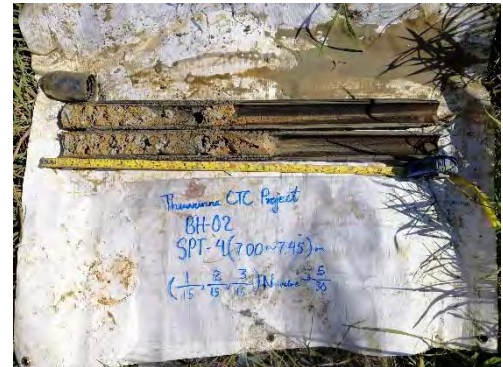
This layer is observed only at BH-01 and BH-02. The thickness of it is a minimum 4.0m and a maximum 6.0m. The color of it is mottled gray and yellowish brown, and the water content is moist. The plasticity of clay is low plasticity and the grained size of sand is fine grained. SPT N-value range is varying from 3/30 to 8/30 blows, and it can be described as loose in relative density.

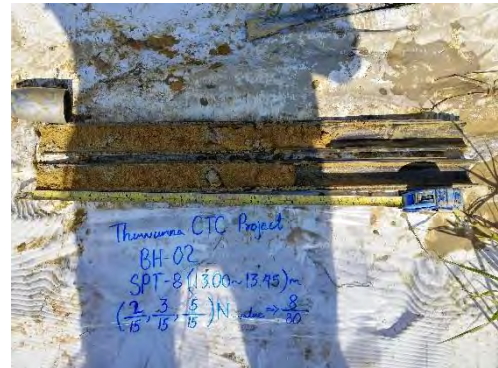
The fourth sub-soil layer is Silty SAND-I. This layer is observed only at BH-02. The thickness of this layer is 7.0m. The color of it is yellowish brown and the water content is moist. The grained size of sand is fine grained. SPT N-value range is varying from 5/30 to 10/30 blows, and it can be described as loose to medium dense in relative density.

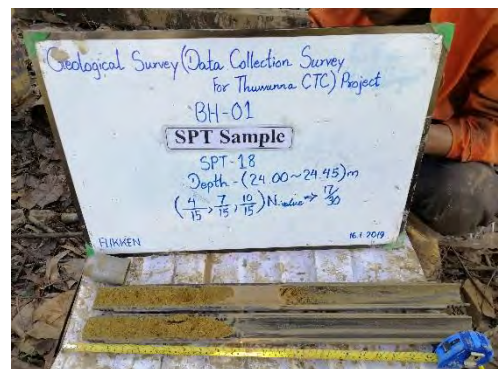
This layer is also well observed in all investigated holes. The thickness of it is a minimum 10.0m and a maximum 13.0m. The color of it is yellowish brown and the water content is moist. The grained size of sand is fine grained. Moreover, trace of fine gravel is including in some depth in this layer. SPT N-value range is varying from 11/30 to 34/30 blows, and it can be described as medium dense to dense in relative density.

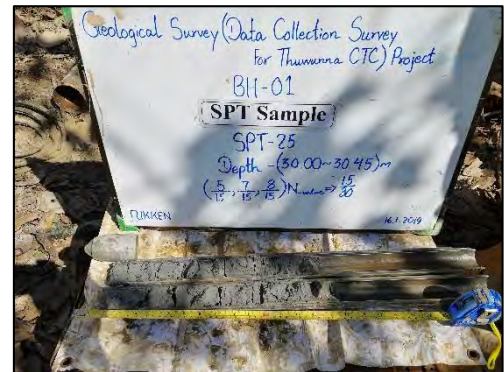
The sixth sub-soil layer is CLAY-III layer. This layer is also well observed in all investigated holes. The thickness of this layer is a minimum 7.0m and a maximum 12.0m. The color of this layer is gray color. The plasticity of this layer is medium to high plasticity and the water content is moist. SPT N-value range of this layer is 8/30 to 33/30 blows, and it can be described as firm to hard in consistency.

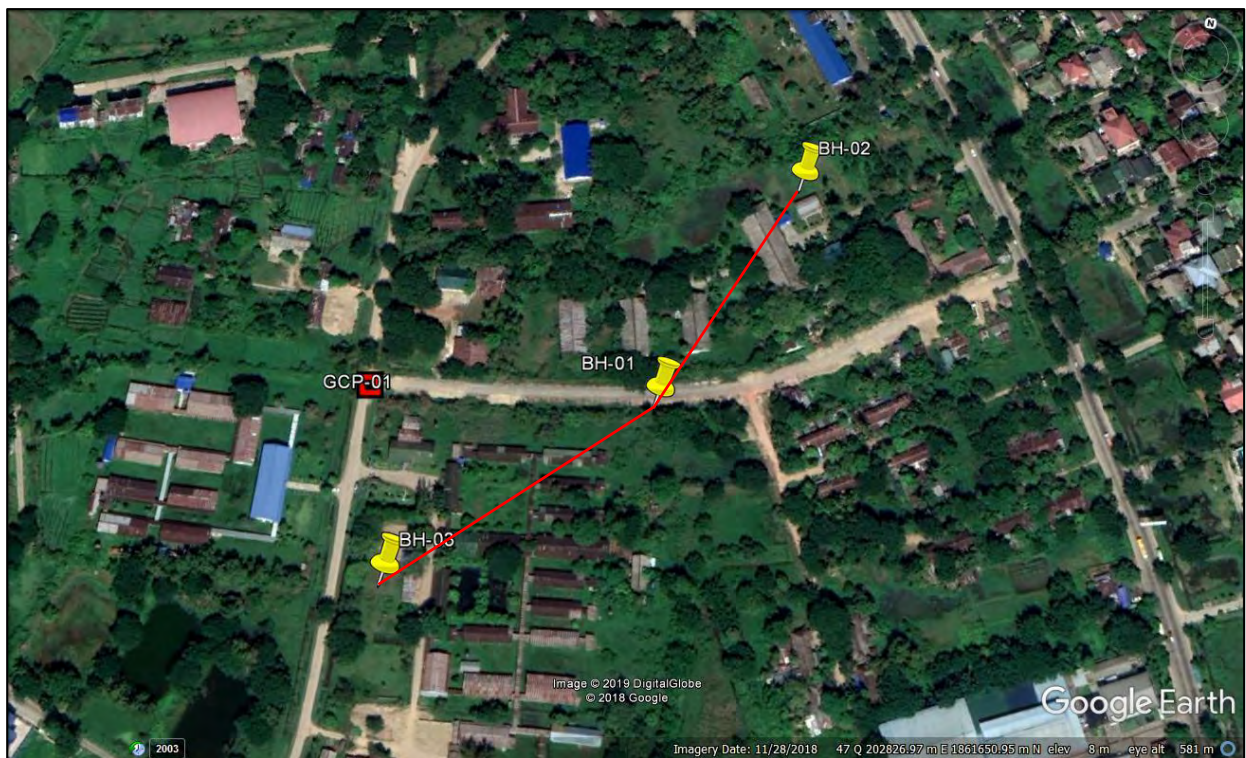
Figure - 3.7 Borehole Location and Soil Profile on Google Map

According to the investigation results, soil profiles were drawn based on not only visual check of soil samples at site and SPT results of the boreholes but also laboratory test results to determine the cross section throughout project area. Figure-3.8 shows the soil profile through the project area.

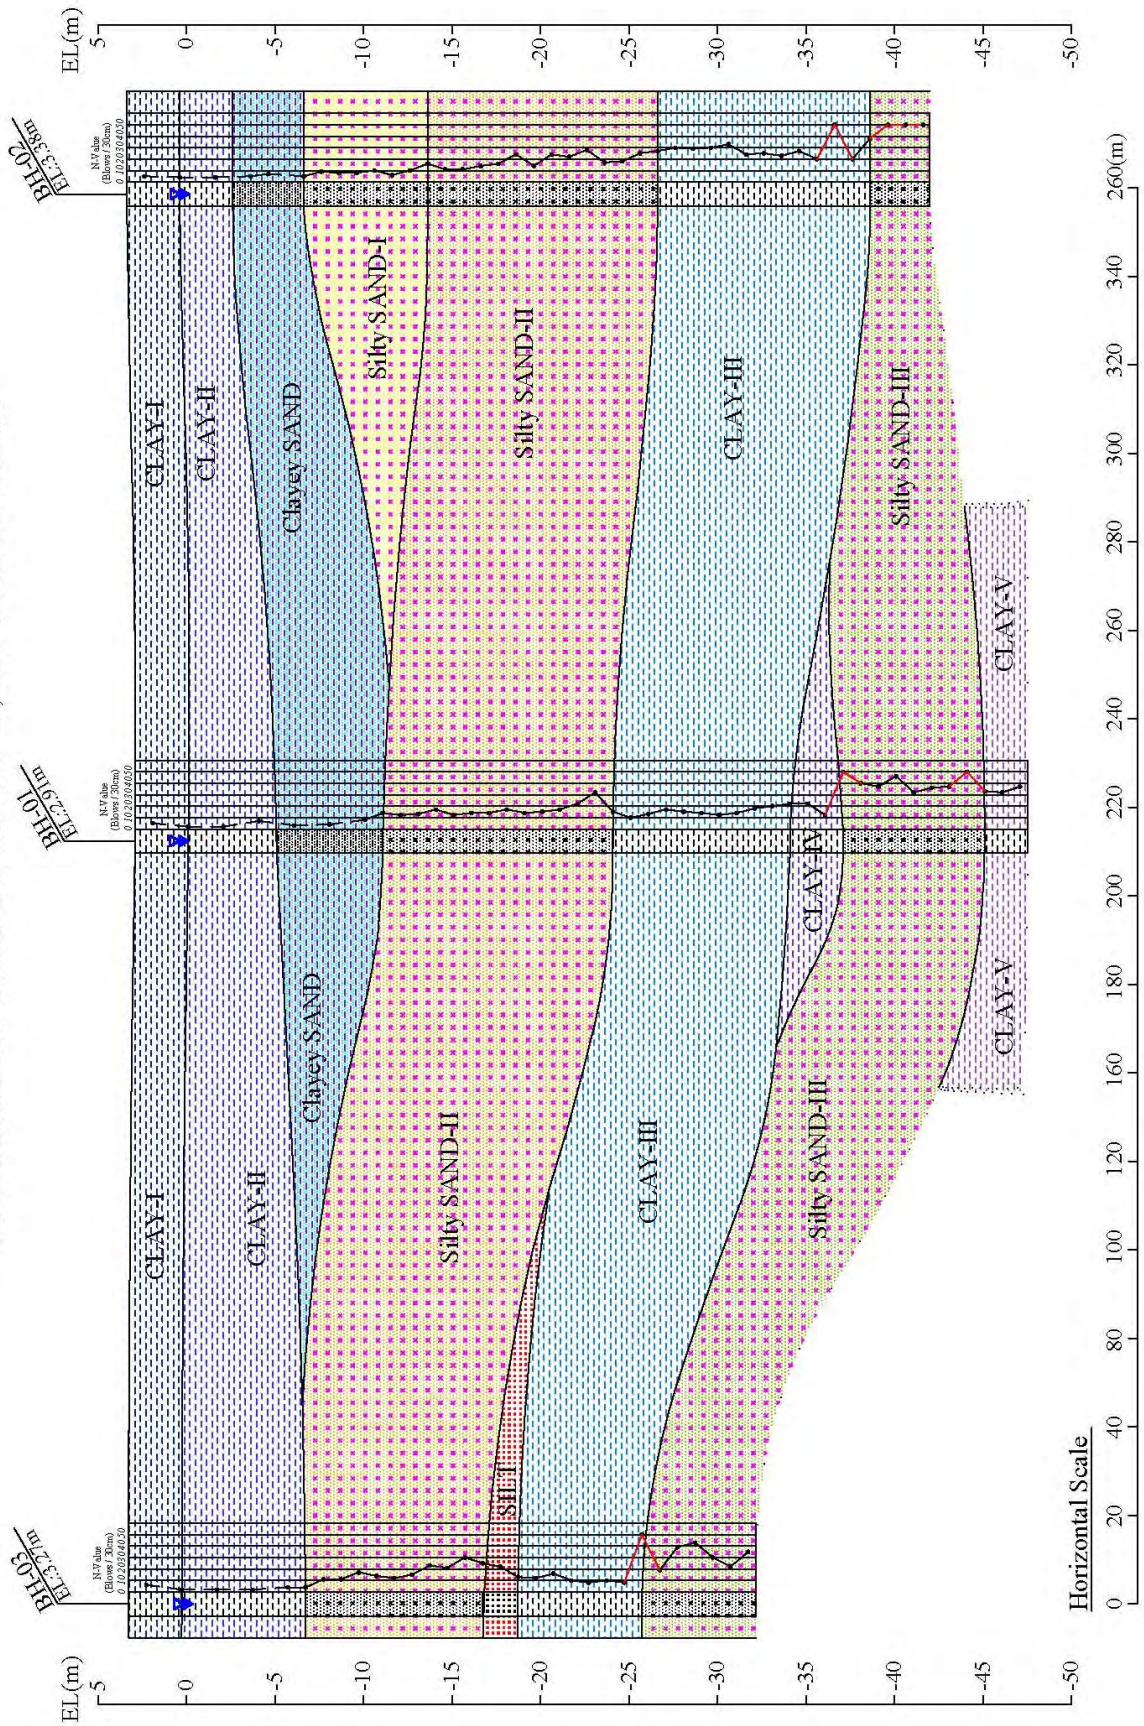
Figure - 3.8 Soil profile through the project area

SOIL PROFILE THROUGH BH-03, BH-01 AND BH-02
