### 3 Findings and recommendations

**GEOTECHNICAL INVESTIGATIONS AT GALAPITAGALAYAYA  
DISPOSAL SITE IN KATARAGAMA PRADESHIYA SABHA**

**3 PRB SYSTEM DESIGN**

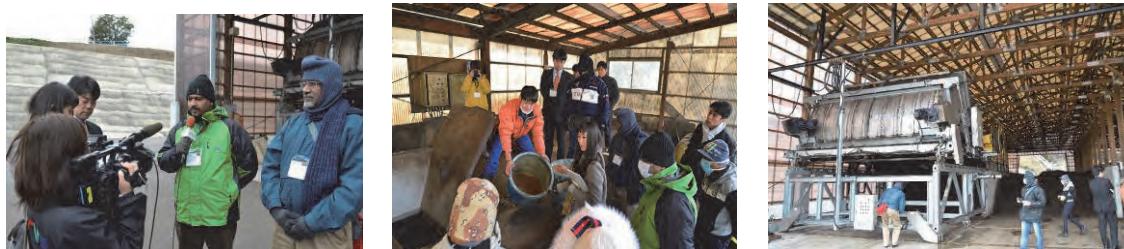
- Process: receiving bio-degradable waste->chopping->composting->packing
- Weight ratio between kitchen waste and garden waste = 1:1, volume = 1:3~4 mixing after chopping both
- Temperature 80C during decomposition period
- Turning of compost pile starts after 4-5 days after receiving waste. Mechanical aeration operates for 24hrs
- Purpose of adding Lactic acid bacteria is to deodorize

Observation of compost plant

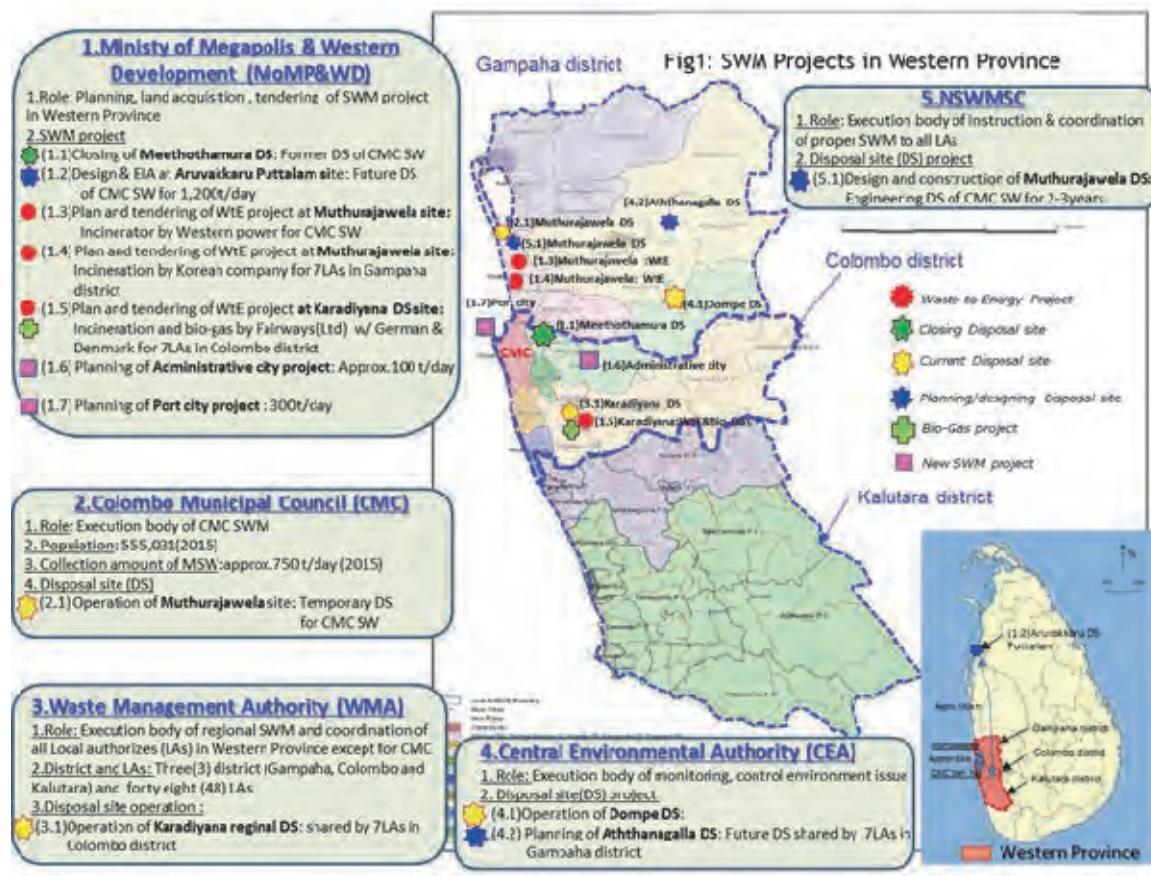
Figure 5-1: Current condition of incinerator plan and final disposal sites in Western province including Colombo Municipal Council

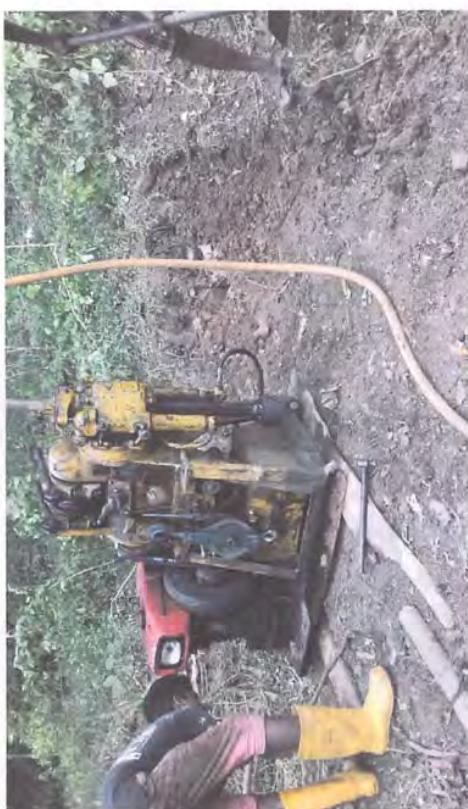
Location No.1

Fig. 1 - Machine setup for drilling at BH-01

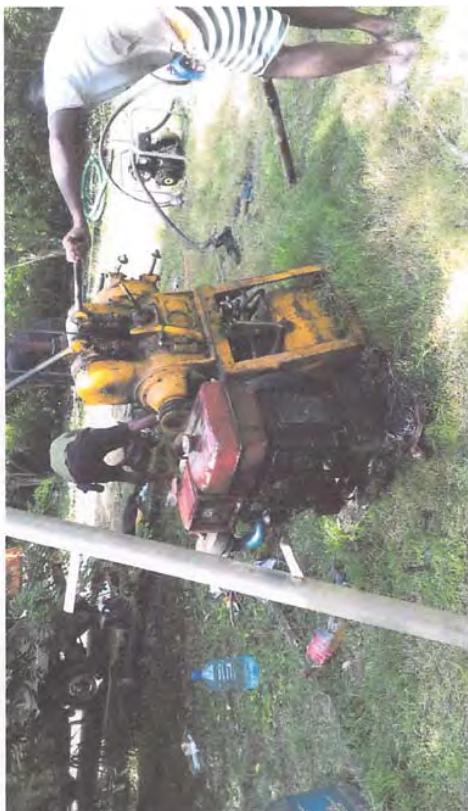
Fig. 4 - Machine setup for drilling at BH-02

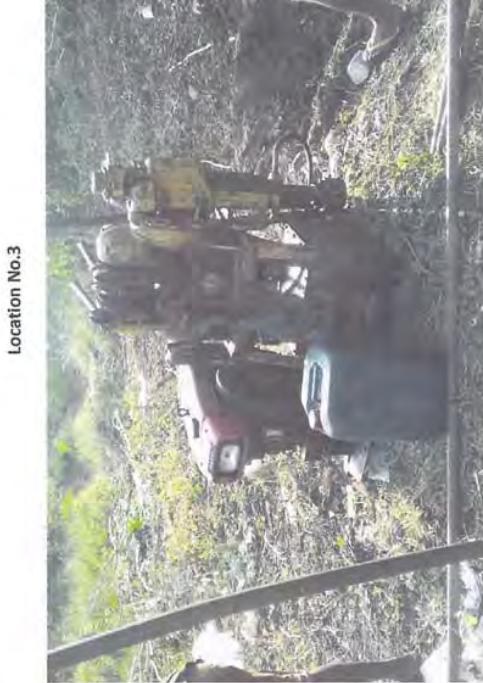
Location No.3

Fig. 7 - Machine setup for drilling at BH-03

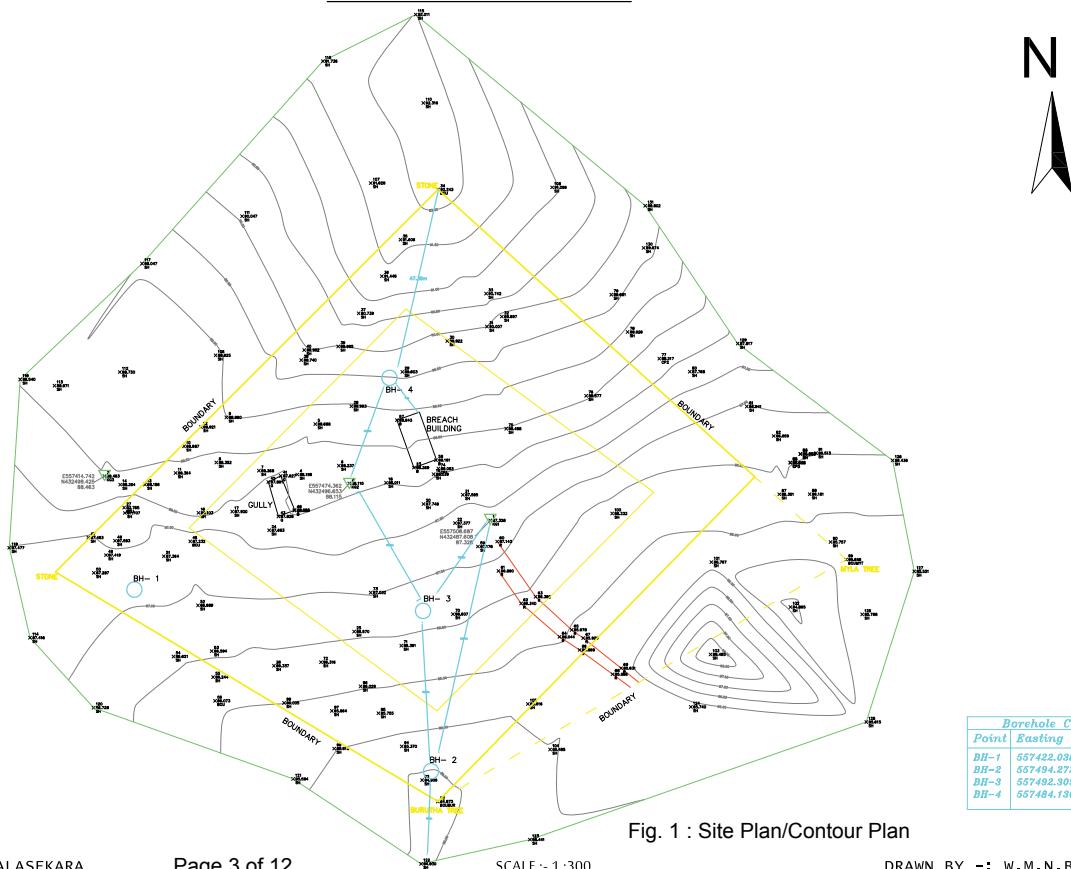
Fig. 1 : Site Plan/Contour Plan

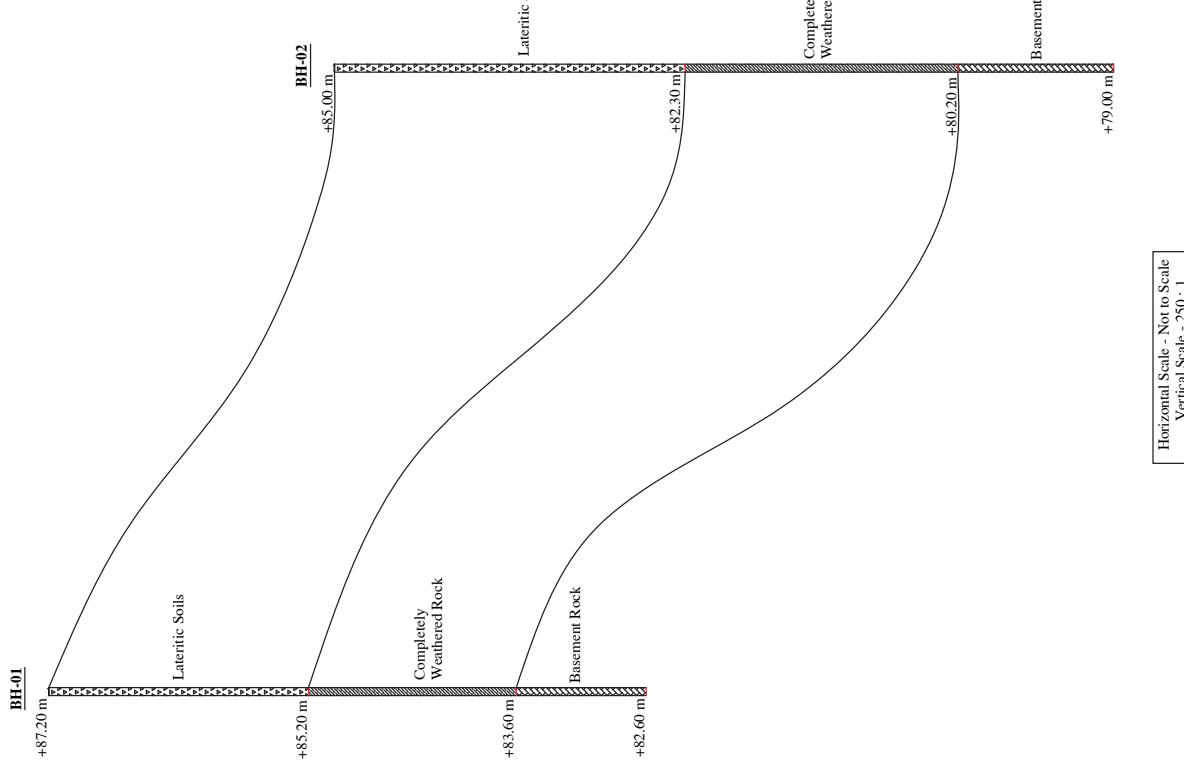
- **Fig. 2a :** Sub-Soil Profile across BH-01 and BH-02; and
- **Fig. 2b :** Sub-Soil Profile across BH-02, BH-03 and BH-04.

The summary of borehole data is given in the form of a generalized Sub-Soil Profile which interpolates conditions between boreholes. Profile of sub-surface layering across boreholes was prepared based on the above model as shown in Fig. 2a and 2b below.

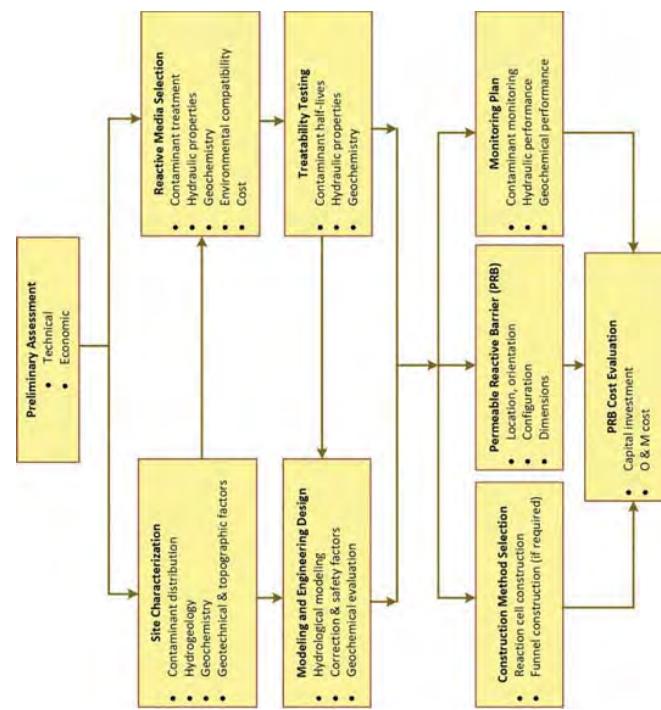
Figure 2-1 PRB Design criteria

The preliminary assessment is conducted to evaluate the technical and economic suitability of a given site for PRB application. Once a site is determined to be suitable, additional design steps are initiated.

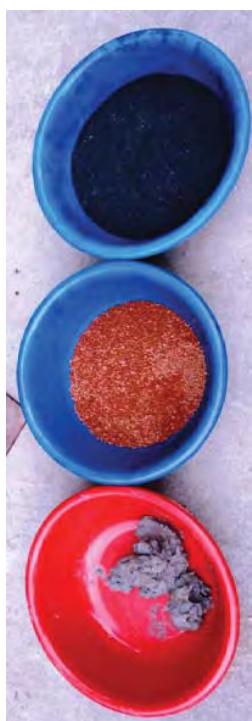
Figure 2-4 Picture of proposed PRB materials

Saito et al., [2016] and Kawamoto et al., [2016] have shown that a mixture of soil, biochar and brick in the ratio of 12.5%: 12.5%: 75% showed the highest hydraulic conductivity at degree of compaction with around 75%, showing more than 10<sup>-3</sup> cm/s and the value was 5 times greater than that of entisols from Bangadeniya. Therefore, following mixture of materials are proposed to be used in the PRB system.

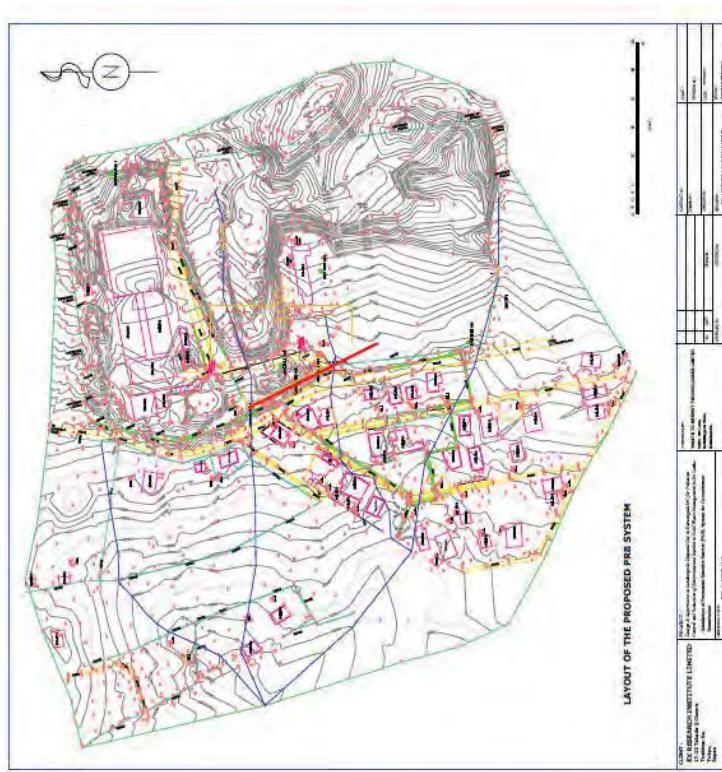
Following figure shows the proposed configuration of the PRB system (Refer "PRB layout map.pdf" for high resolution image).

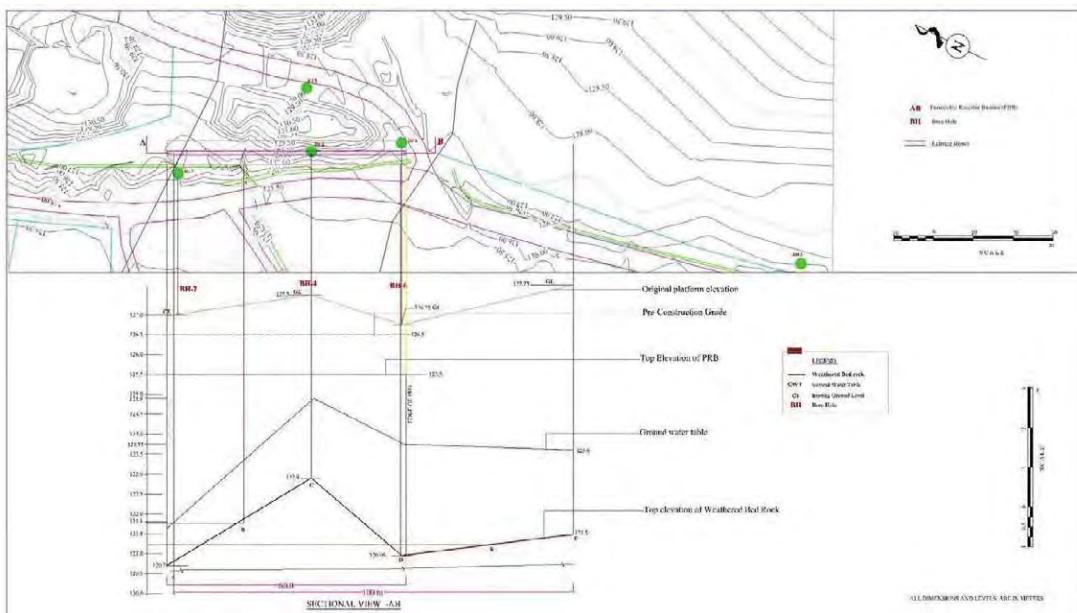
Figure 3-1 Cross Sectional Views of proposed PRB system

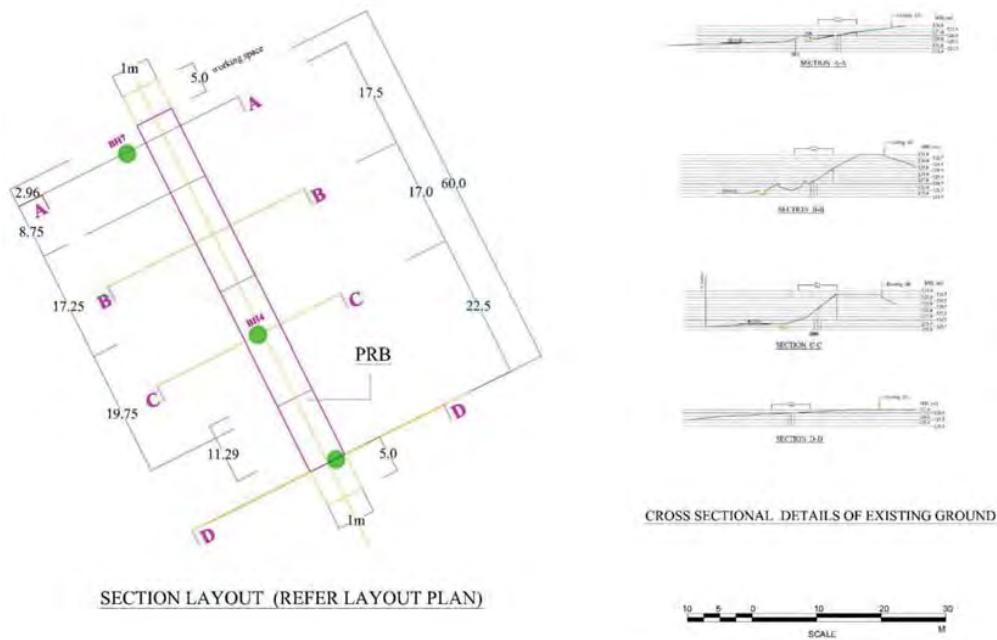
**Figure 3-3 Layout of the PRB system**

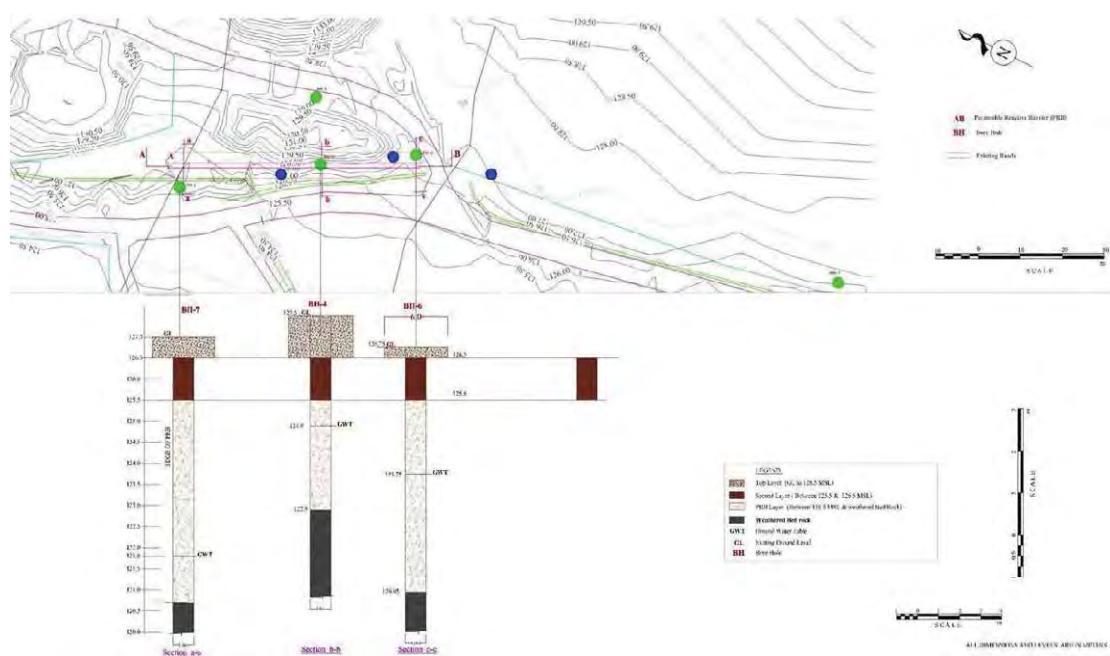
**Figure 3-2 Proposed heights and location of PRB system**

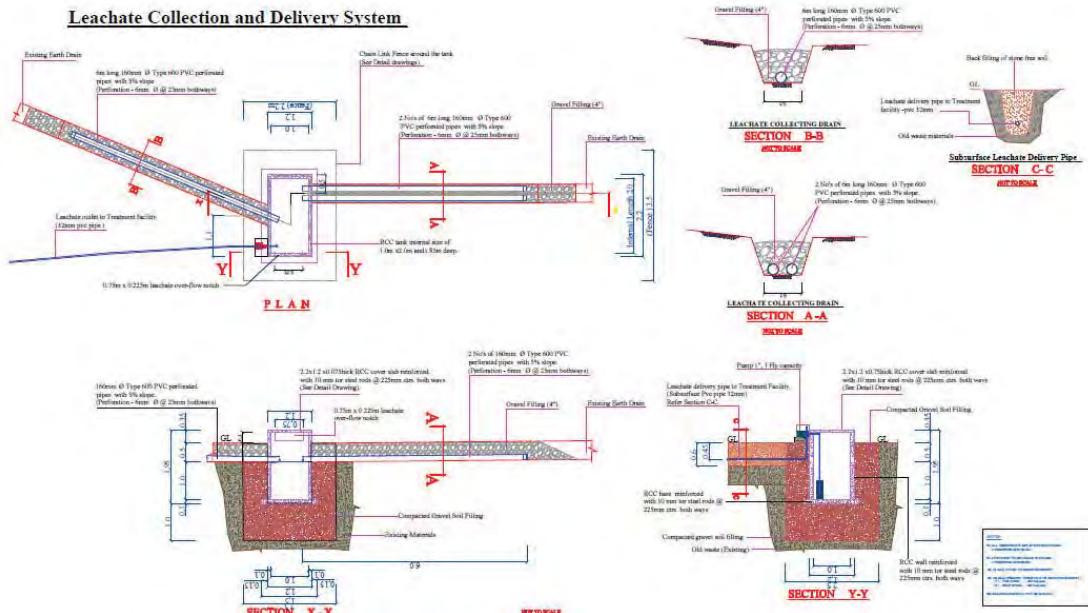
Figure 5-1 Leachate collection tank and piping system

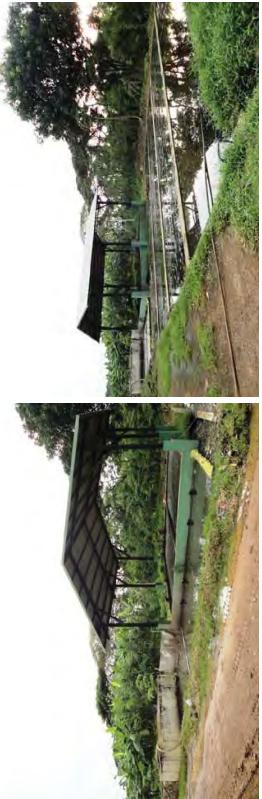
The existing gully suck waste treatment system needs immediate rehabilitation, especially replacement of coir-brushes. Moreover, the system will be used as a means of leachate and gully waste co-treatment.

Figure 5-2 Existing condition of gully suck waste treatment facility

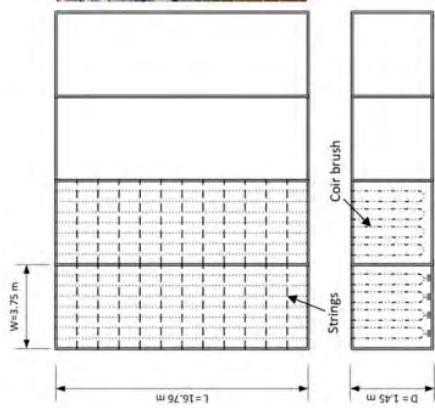
The system consists of four large concrete tanks having approximate sizes of  $L=16.76\text{m}$ ,  $W=3.75\text{ m}$  and  $D=1.45\text{m}$ . First, the debris in first two tanks shall be cleaned before installation of coir fibers. Then, tensioned plastic string with minimum diameter of 3.0mm shall be installed as shown in the figure. The coconut coir fiber strings shall be installed with a raw spacing of 300 mm across the length of the tank as shown in the figure. The coconut coir fiber loop shall be suspended in the tank using pre-fabricated concrete blocks.

Figure 5-3 Installation of suspended coir-brush system on treatment tanks

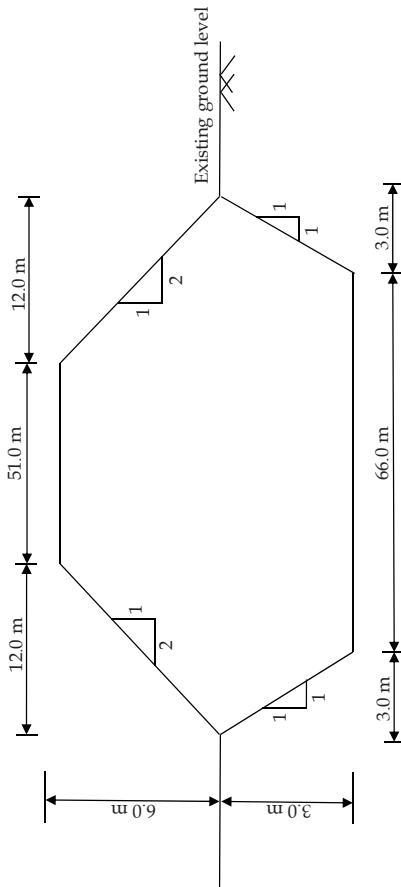
Figure 1 – Cross section of proposed landfill

Top/bottom areas and capacity estimation were designed considering planned landfill height and safe slope angle. The proposed total height of the landfill is 9 m where the landfill will have a height of 6 m is above the ground level and 3 m below the ground level. By considering width of the landfill as 75.0 m, the total cross-sectional area is as shown in Figure 1. Typical cross section of a sanitary landfill is shown in Figure 3.

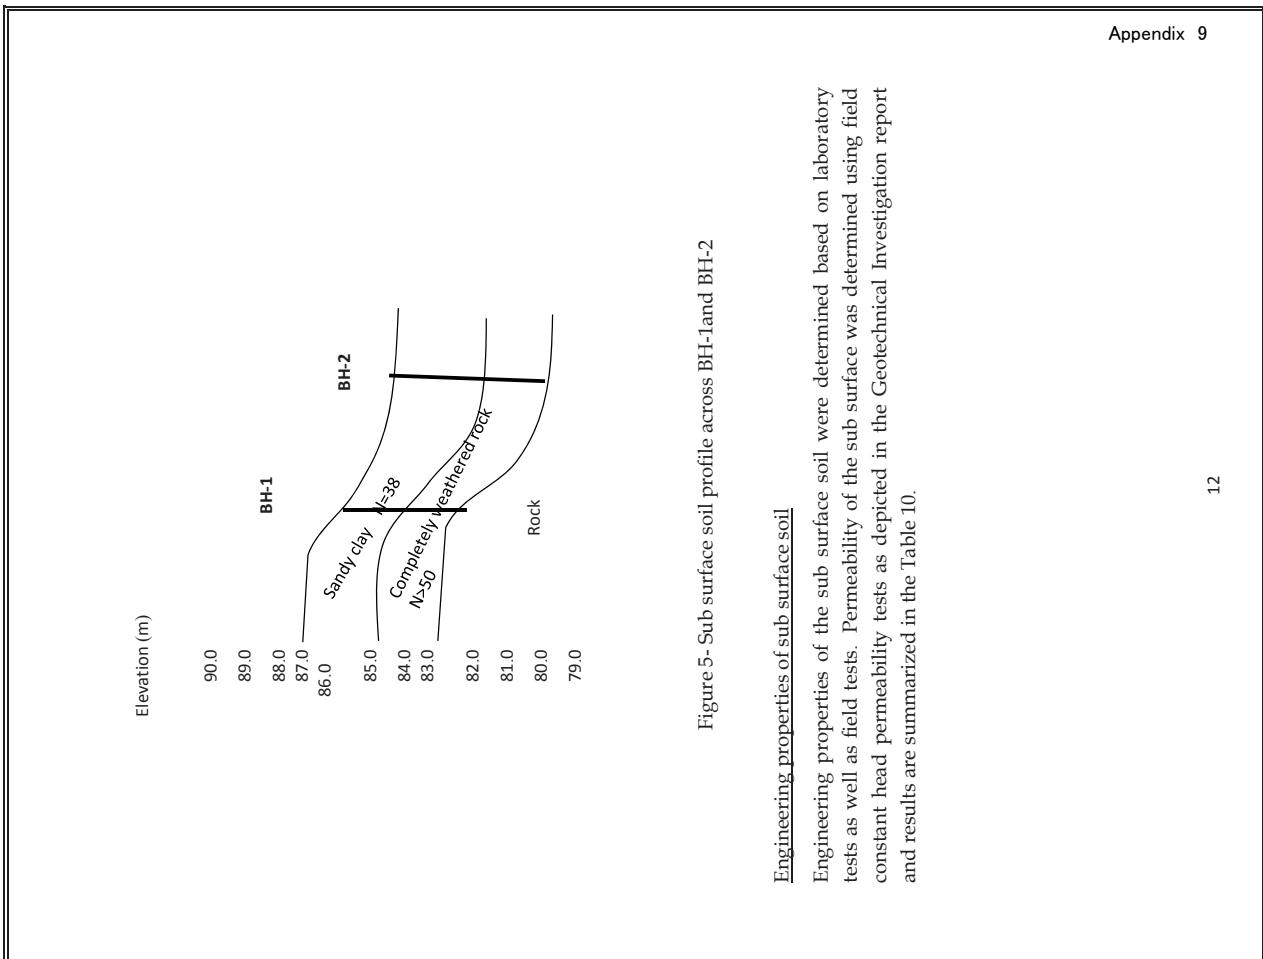
Figure 5- Sub surface soil profile across BH-1and BH-2

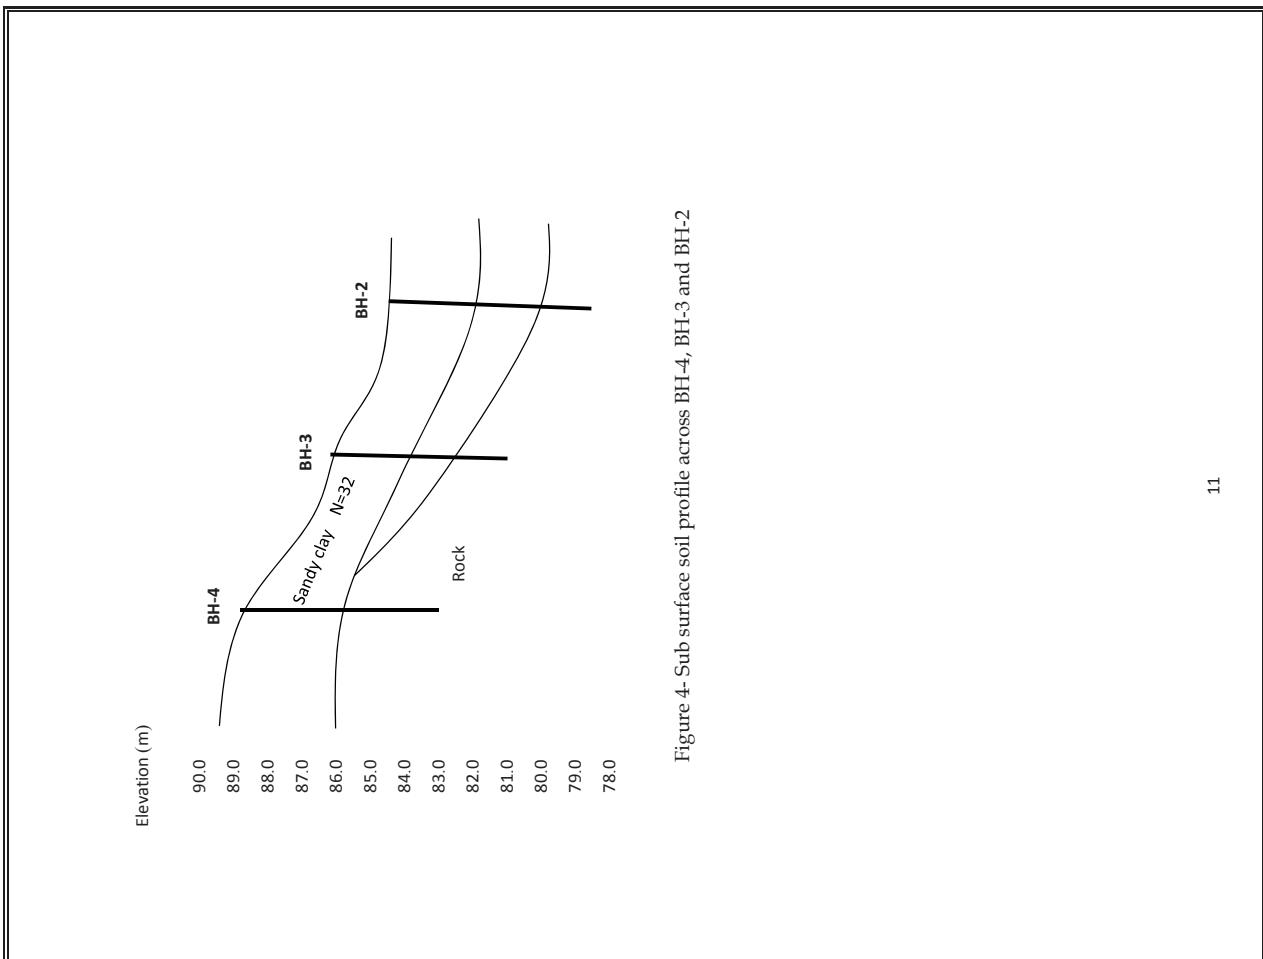
Figure 4- Sub surface soil profile across BH-4, BH-3 and BH-2

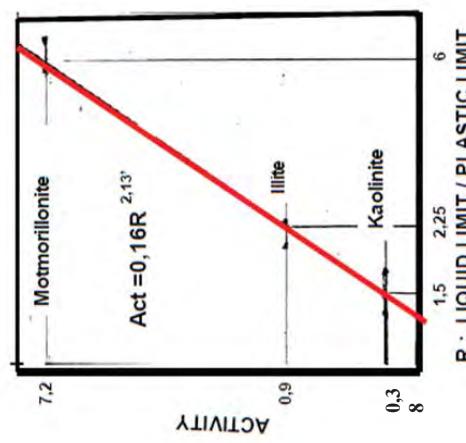
Figure 6 – relationship between Activity and ratio of Liquid limit/Plastic limit

Hence, based on the Figure 6, mineral type presents in the sandy clay can be identified as Illite.

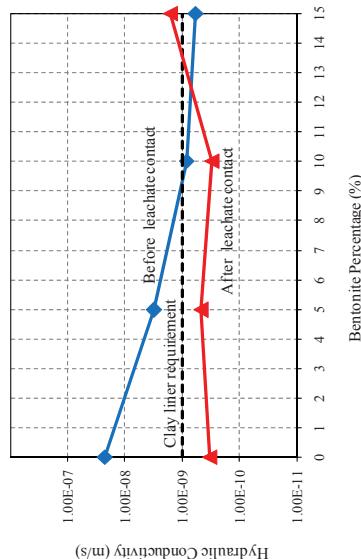
Since physical properties of the original soil at Galapitagalayaya is very similar to the Buttala soil, it is recommended to mix the sandy clay soil at with 10% of bentonite on weight basis and compacted at its optimum moisture content in order to achieve clay liner requirement with respect to hydraulic conductivity, i.e.  $1 \times 10^{-9} \text{ m/s}$ .

Figure 7 – Variation of hydraulic conductivity with percentages of bentonite

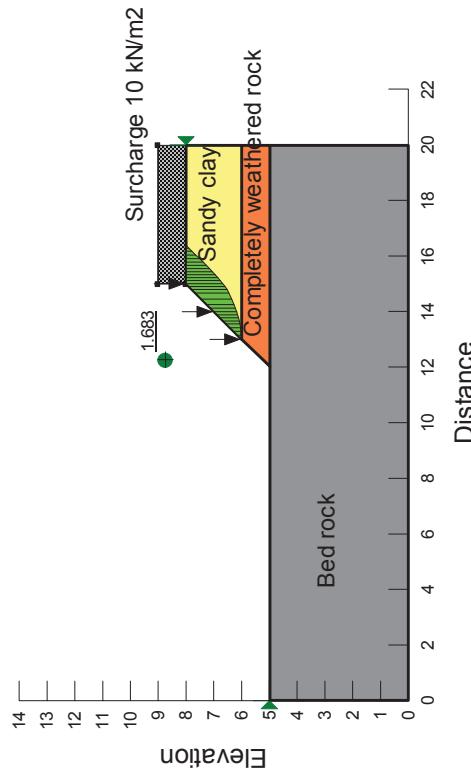
Figure 9 – Slope stability of landfill during cutting under dry condition

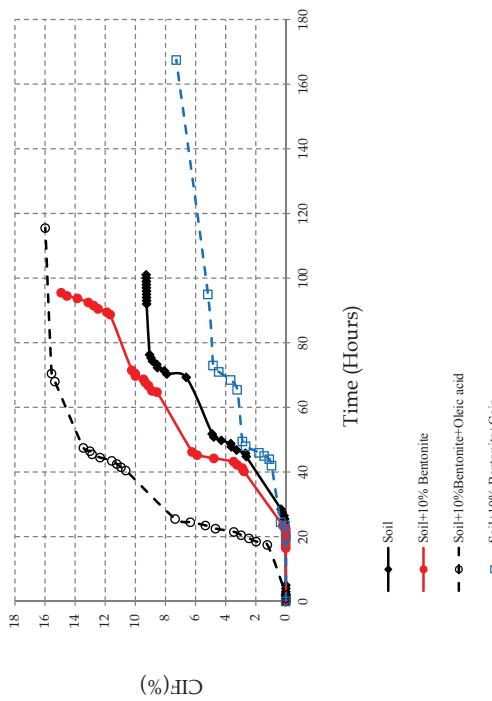
Figure 8 – Effect of coir on CIE

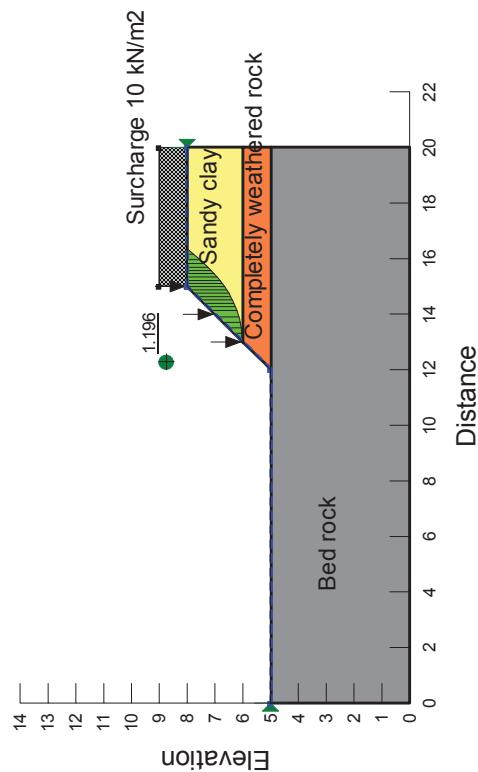
Figure 10 – Slope stability of landfill during cutting under saturated condition

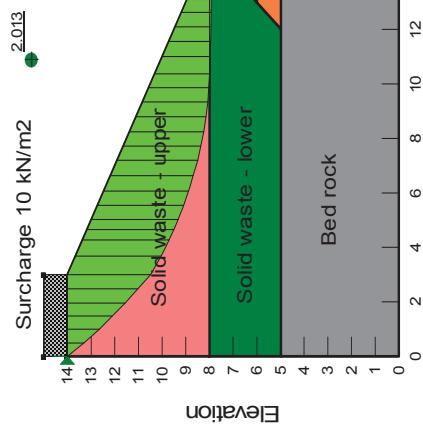
Figure 11 – Slope stability of landfill after closure under dry condition

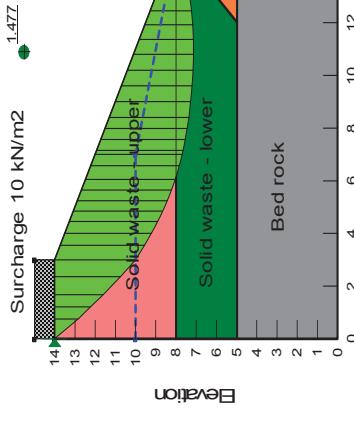
Figure 12 – Slope stability of landfill after closure under saturated condition

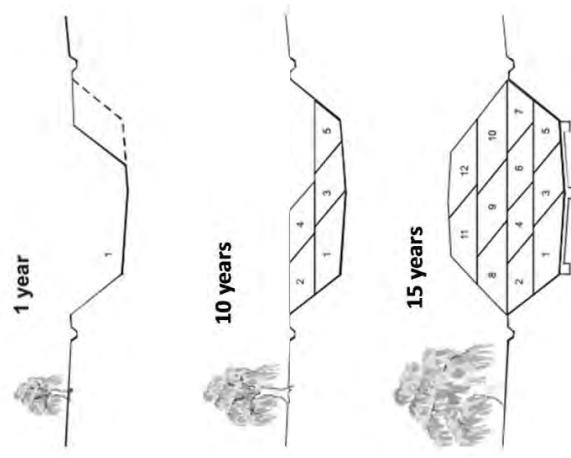
Figure 14 - Sequence of the construction of embankments for filling the site

- Unload the waste at the working face, in such a way that a single, small area remains uncovered during the day, and the waste will not need to be moved over long distances.
- Spread the waste in thin layers of 0.20 to 0.30 m and compact it to obtain a cell height of 1 to 1.5 m, forming a gentle gradient in the external slopes.
- Cover the compacted waste completely with a layer of earth 150 cm thick once the cell has reached maximum height.
- Compact the cell until a uniform surface is obtained at the end of the working day.
- Once the first cell has been completed, the second can be constructed immediately beside or on top of it, always following the landfill construction plan.
