## 添付資料 5 : Presentations of Kick-off and JCC Meetings

*Agenda of Kick-off Meeting on  
The Project for  
the Capacity Development of Road Services  
in the Democratic Republic of Timor-Leste*

**The Project for  
the Capacity Development of Road Services  
in the Democratic Republic of Timor-Leste**

***Work Plan***

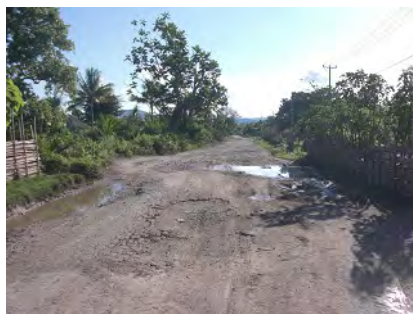
Pavement collapse on A05 due to the lack of roadside ditch

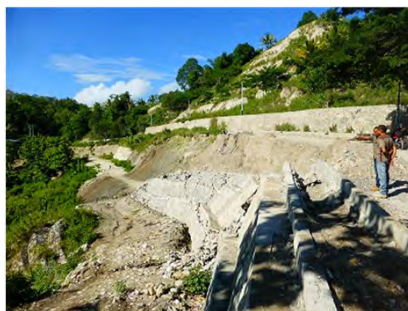
Collapse of embankment slope on A07 due to the unsuitable foundation material and lack of compaction

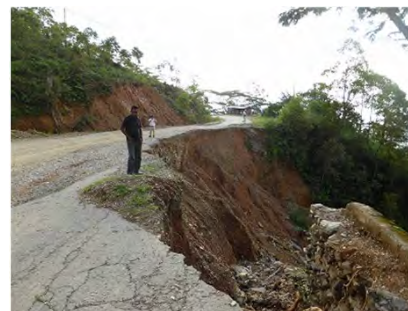
Collapse of cut slope on A02 due to the heavy rain and lack of slope protection

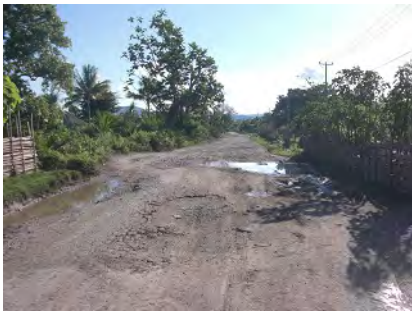
Pavement failure on A05 due to the lack of roadside ditch

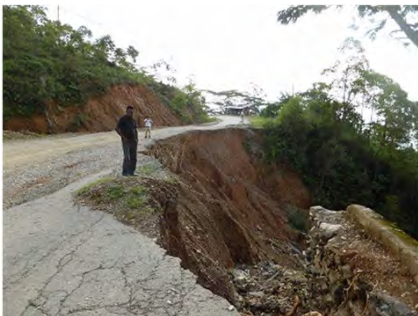
Cut slope failure on A02 due to the heavy rain and lack of slope protection

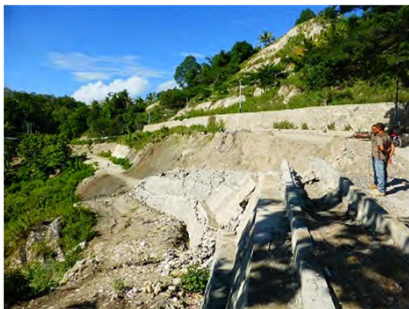
Embankment slope failure on A07 due to the unsuitable foundation material and lack of compaction

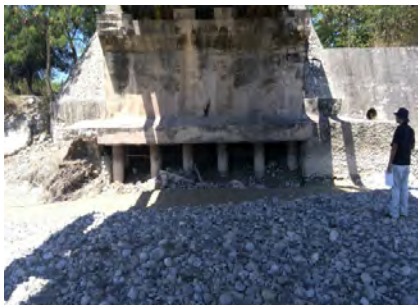
Scouring of bridge substructure on A14 due to severe river flow and lack of protection

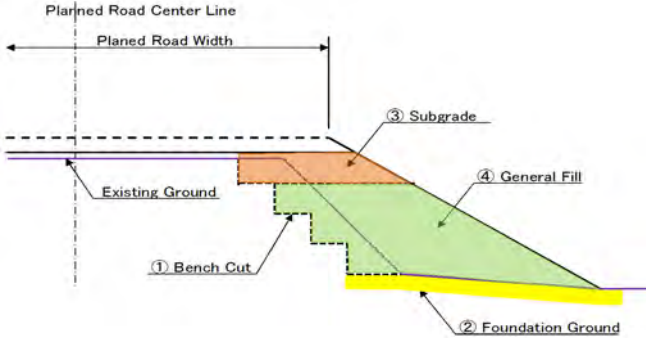
Checklist(Draft)

Check item of under construction for Widening of Embankments

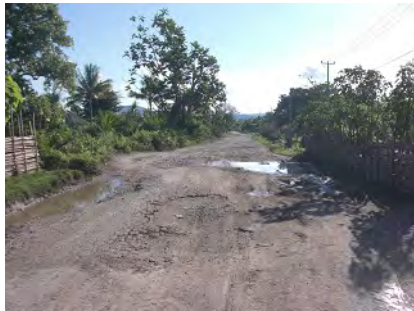
Pavement failure on A05 due to the lack of roadside ditch

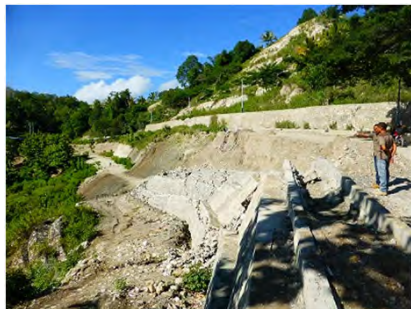
Embankment slope failure on A07 due to the unsuitable foundation material and lack of compaction

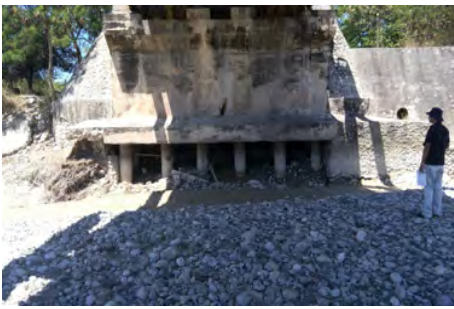
Scouring of bridge substructure on A14 due to severe river flow and lack of protection

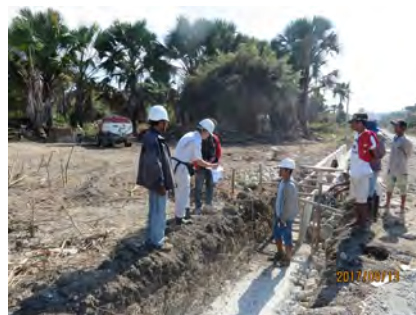
No.4\_9 Packages, Betano Pipe Culvert installation, Foundation ground condition must be checked @2017.08.16

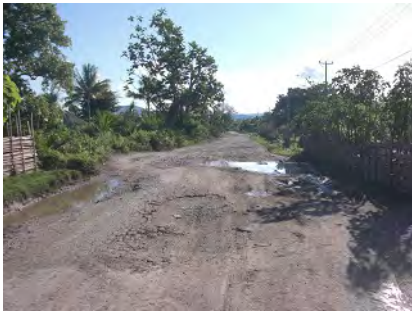
Pavement failure on A05 due to the lack of roadside ditch

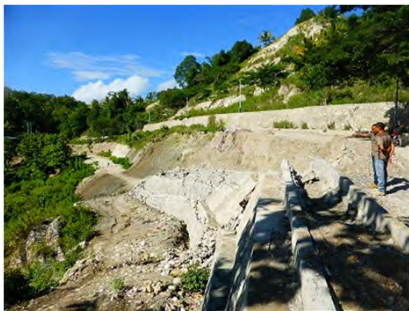
Embankment slope failure on A07 due to the unsuitable foundation material and lack of compaction

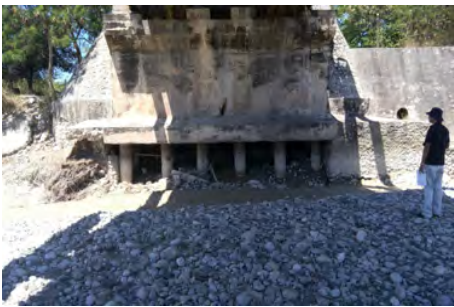
Scouring of bridge substructure on A14 due to severe river flow and lack of protection

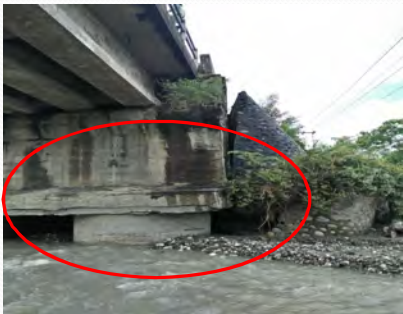
Figure 3. Mola bridge abutment

❖ Figures 3 and 4 show the scouring damage of Mola Bridges Pier & abutment. Due to scouring damage, the caving of the footing can be seen

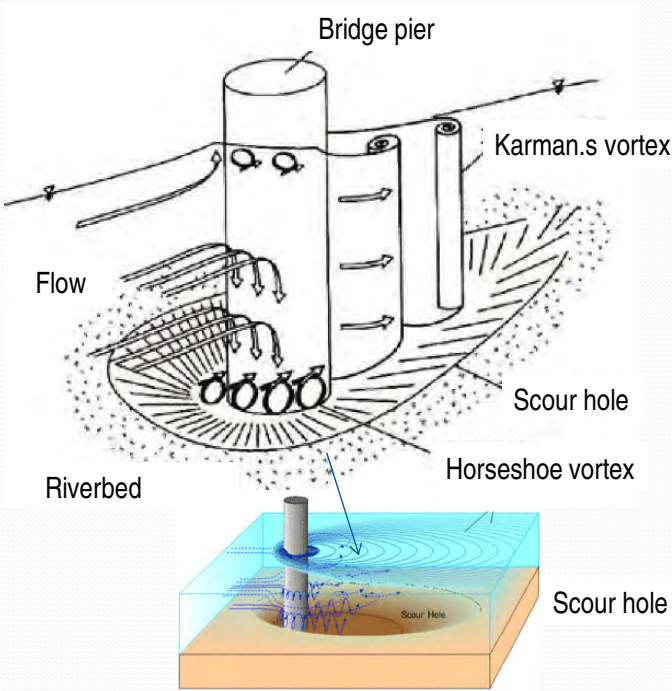
- The figure shows the hydraulic phenomenon that occurs around bridge piers during flood.
- Bridge piers located in a river cause complex vortices and waves that disturb the flow and water surface during flood; as a result, an increase in water level and riverbed scouring occur

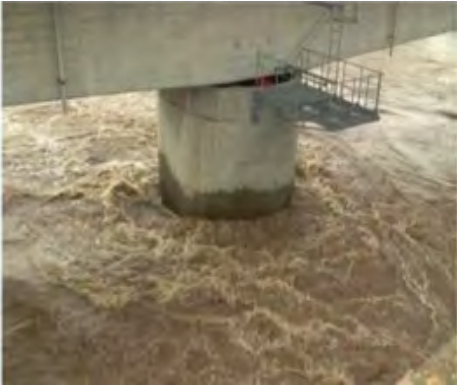
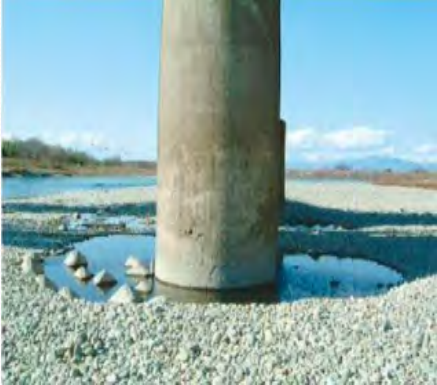
### Hydraulic Phenomenal around bridge pier (Japan Example)

The figure show the state of scour on bridge pier after a flood in Japan.The flood caused a scour hole to form around the bridge pier

The figure show the actual phenomenon around a bridge pier during floods.the occurrences of complex flow around the bridges pier apparent.

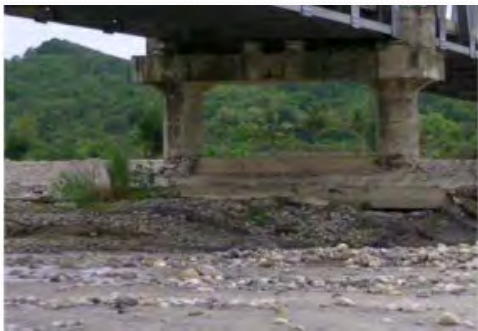
Gabion damaged situation  
Mola 2011

There are two types of protection work: Gabion and foot protection block. However, due to issues with the durability ( due to deterioration, etc.) of the metal wire use for gabion, it is recommended to that Timor Leste take the same approach as Japan and use “Foot Protection”

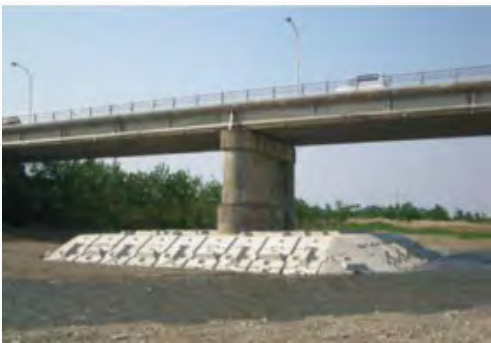
Foot Protection Blocks  
in Japan

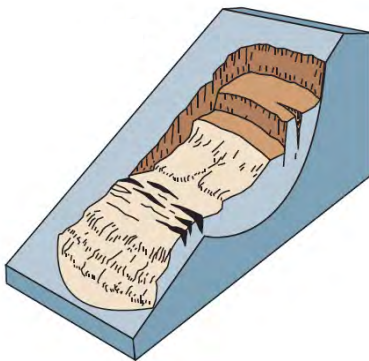
This is a slide in which the surface of rupture is curved concavely upward and the slide movement is roughly rotational about an axis that is parallel to the ground surface and transverse across the slide.

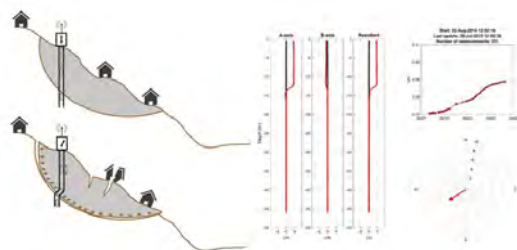
To detect displacement of the sliding mass, monitoring with the inclinometer is the useful tool. Measurement the inclination of casings with the inclinometer should be performed periodically, and the cumulative displacement of the casing should be analyzed to detect the depth of the surface of rupture.

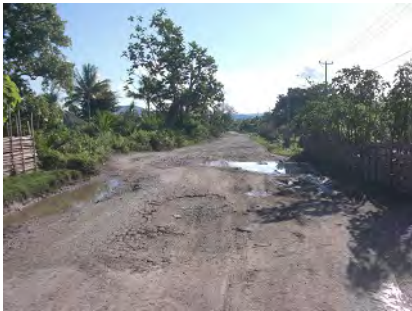
Pavement failure on A05 due to the lack of roadside ditch

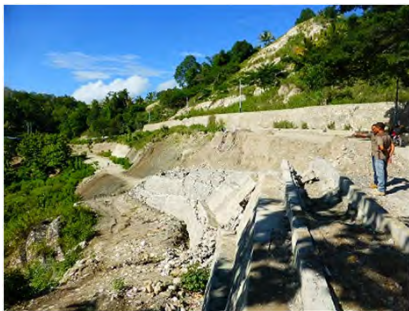
Embankment slope failure on A07 due to the unsuitable foundation material and lack of compaction

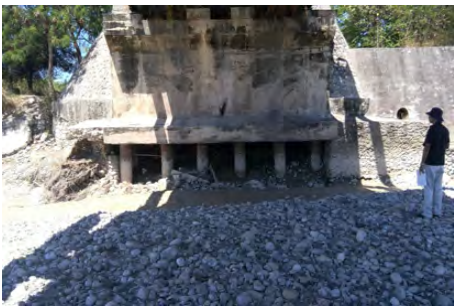
Scouring of bridge substructure on A14 due to severe river flow and lack of protection
