**Democratic Republic of Timor-Leste  
Ministry of Public Works**

**Project for Capacity Development of  
Road Services in the Democratic  
Republic of Timor-Leste  
Final Report**

**December 2019**

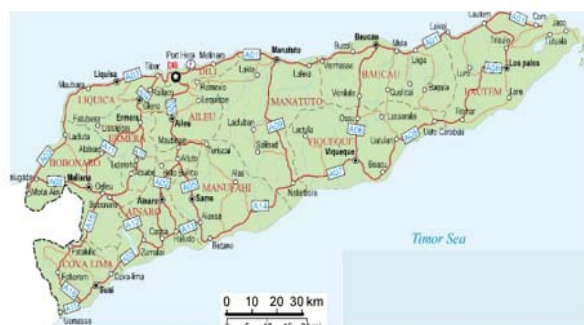
Figure 1.1 National road network in Timor-Leste

The target area of this project is the national roads in Timor-Leste (19 routes from A01 to A19). The technology transfer to the DRBFC will be carried out with the aim of improving the national roads in Timor-Leste to a ‘better passable’ state for several years. On the other hand, the maintenance of newly constructed and maintained roads by donor assistance is not covered by this project.

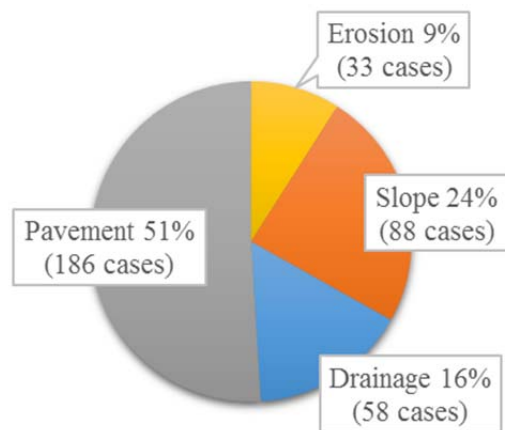
Figure 2.1 Types of road damage in Timor-Leste

In addition to reviewing the contents of the 9 road maintenance projects approved in the fiscal year 2016 budget, the JICA Expert Team also visited the target roads, examined improvement measures for inspection surveys, and confirmed database issues and improvements. Specifically, the JICA Expert Team confirmed the contents of the 9 road maintenance projects that were fully introduced in the 2016 budget. These infrastructure development projects are not for single-year projects, but for multi-year and expensive infrastructure projects that use infrastructure funds over several years. This project targeted periodic inspections and partial repairs on sections where the DRBFC had completed rehabilitation work for asphalt or gravel pavement. The current condition of road damage in Timor-Leste was analysed while confirming the actual situation. The road damage data analysed was collected from sources such as the road database that was prepared previously by Project for the Capacity Development of Road Works (CDRW), from the current road damage data compiled by the Department of Projects, and from information on road damage compiled by the Chief of the Department of Maintenance. The results are shown in Figure 2.1. The proportion of damages to the pavement was the largest at 51%, followed by slope failure at 24%, drainage damage at 16%, and road shoulder erosion at 9%.

Pavement damage is mostly due to the weakness of the pavement structure, lack of cross grade due to vehicle traffic, stagnation of rainwater due to depressions, and expansion due to insufficient maintenance. In recent years, it is thought that the technology related to pavement repair is becoming established, because the progress of fundamental pavement reconstruction work by donors is progressing and the number of repairs to pavements has increased.

As shown in Figure 2.18, the main causes of road damage in Timor-Leste are pavement damage, slope collapse, drainage damage and shoulder erosion. Of these, slope failure and damage to cross drainage have occurred repeatedly because countermeasures have been implemented without sufficient analysis of the cause of the damage. For this reason, there is a need for technical support for specific research, analysis and design. In Timor-Leste, 42% of all bridges are damaged. This damage is mainly caused by insufficient protection of the revetments and bridge substructures, because amongst the damaged bridges, 60% of the damage is caused by scouring. Furthermore, the scouring has repeatedly damaged bridge substructures and only coping techniques for countermeasures have been taken, so there is a considerable need for technical support for specific investigation, analysis and design, because bridge damage is directly linked to road traffic safety.

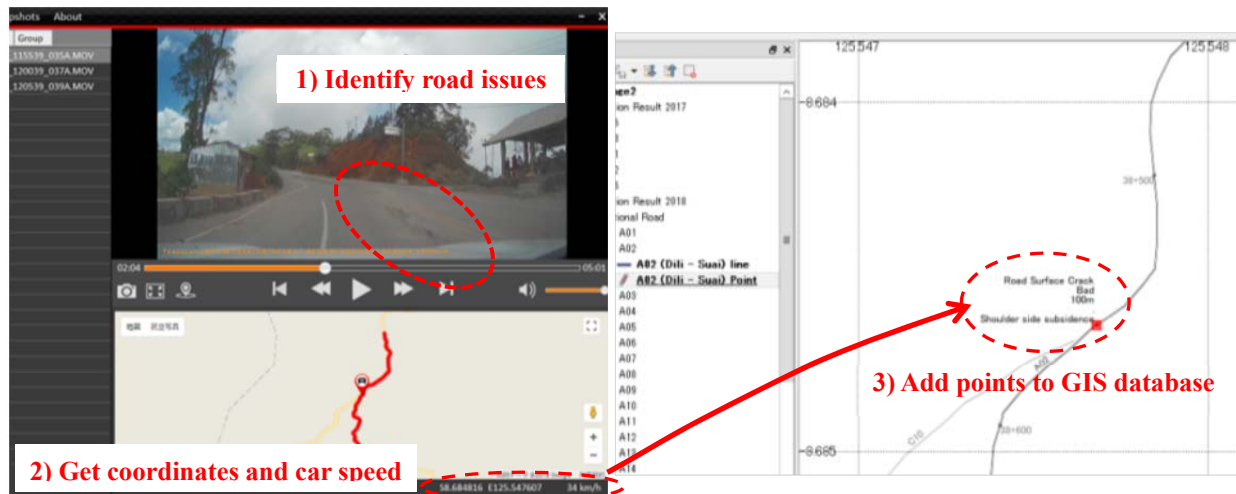
An example of the data input procedure is shown in Figure 2.5.

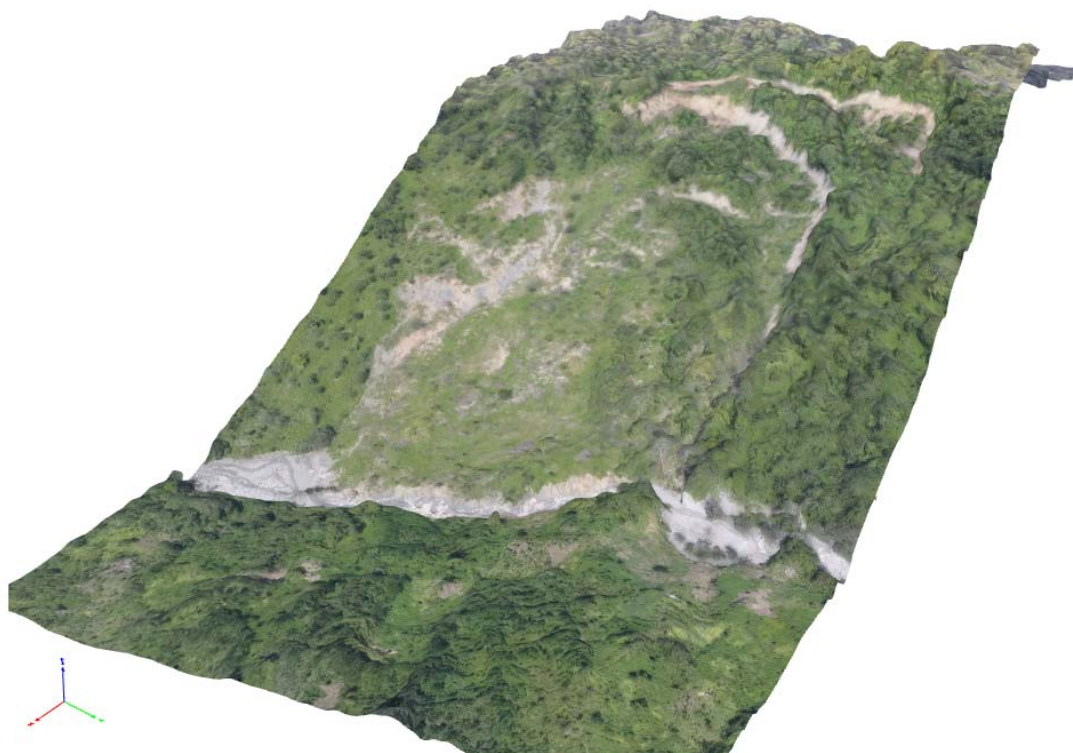
A landslide occurred during the rainy season on national road A02 (about 25 km south of Ainaru). Before the survey, the road had collapsed over a width of about 100m and the form of disaster was unknown. At the request of the DRBFC, a topographic survey was conducted by unmanned aerial vehicle (UAV) and the disaster turned out to be a large-scale landslide. The topographic survey produced orthophotos and detailed topographic maps, which were used for surveying and design of countermeasures. A 3D topographic model produced during this activity is shown in Figure 2.17.

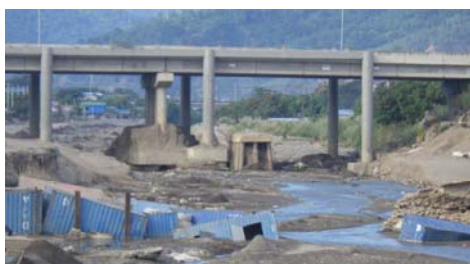
Damage of existing bridge substructure

The recent disaster on the Comoros River involved the collapse of the groundsill (a structure in middle of the river to reduce the speed of the river flow during the rainy season), which was downstream of the exiting bridge, and exposure of the bridge foundation due to scouring.

Repair of the groundsill is necessary for protection of the substructure of the existing bridge. The DRBFC have not collected basic data around the disaster area, such as topographical data, despite the changes to the river bed due to the heavy rains in March 2019 and the collapse of the groundsill. Therefore, a site survey from the Hinode Bridge (upstream, completed in 2018) to the existing bridge and the collapsed groundsill

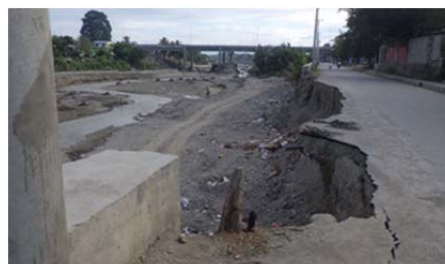
Retaining wall damage

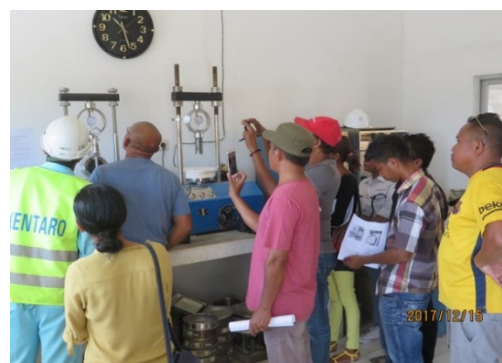
Marshall test during asphalt pavement workshop 2 (15 December, 2017)

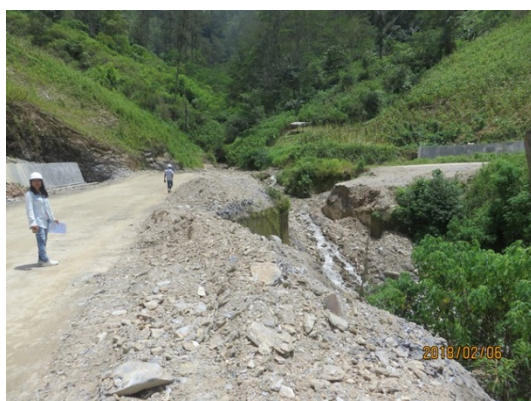
Condition of the proposed site for cross drainage on Ex-Japan Road

The JICA Expert Team used the cross drainage planned for the Ex-Japan Road as a case study and conducted a series of surveys, planning, design and construction supervision in collaboration with the working group that prepared the Culvert Design Guideline. A basic survey was conducted by the working group for culvert design, including a preliminary survey and calculation of the estimated flow rate. The results of the case study were announced by the working group at the 4th JCC meeting held on 26 September, 2018.

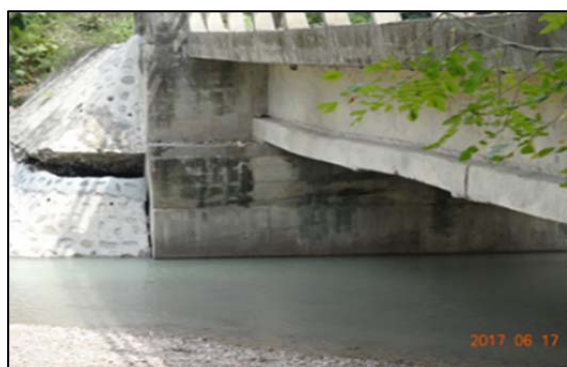
The damage to bridge substructures in Timor-Leste is due to the lack of foot protection works, such as concrete blocks, which would protect bridges from scouring damage. Without this protection, scour holes have been developing around and under the footings. In the case of Kelan Bridge, in southern Timor-Leste, scouring at the bottom of the abutment has resulted in the development of a large crack in the abutment. Emergency measures are necessary. Also in southern Timor-Leste, Sarai Bridge is also in dangerous condition as it has scour damage at the bottom of the bridge pier, and the bottom of the footing has become exposed.

Scouring under abutment (Kelan Bridge)

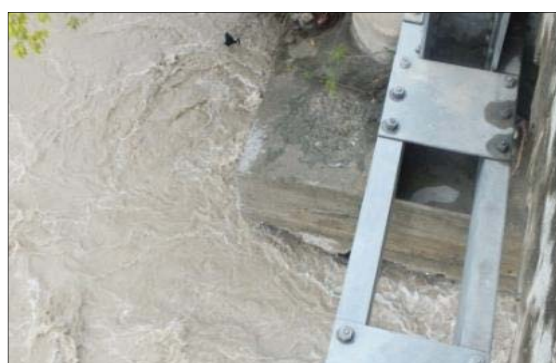
Scouring under pier (Sarai Bridge)

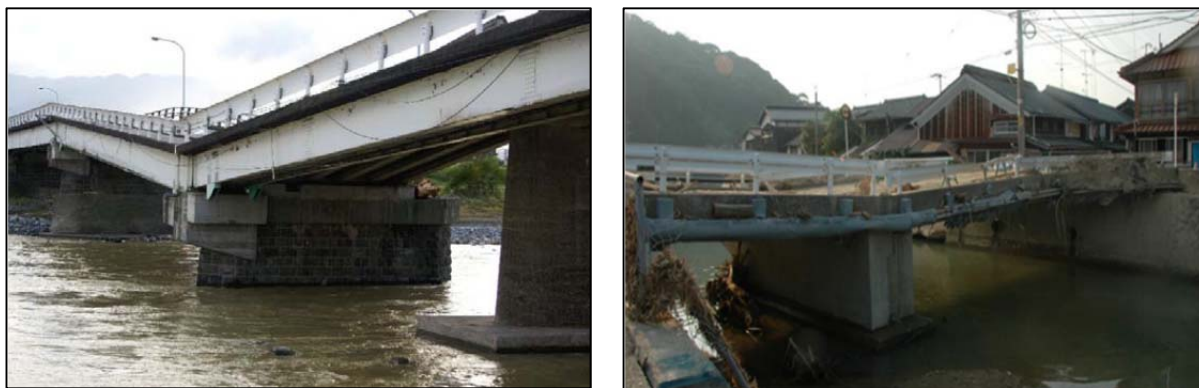
Figure 2.25 Example of damage due to scouring (Japan)

Figure 2.25 shows an example from Japan, are examples of the potential danger of allowing scouring to continue. In these cases, the large amount of settlement damage required the restriction of vehicle traffic on the bridge due to safety concerns.

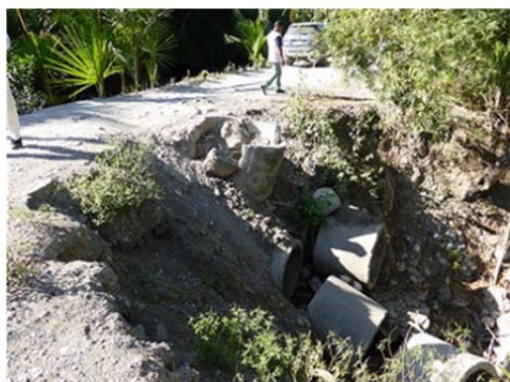
The damage due to drainage issues is prevalent where roads cross watercourses and thus where culverts are necessary. Cases of road structure damage in Timor-Leste are shown below.

A05 Road structure damage (Sesurai)

A common failure mechanism of the road structure for these cases is overtopping with free fall on the downstream side, as shown in Figure 2.26. The causes of overtopping include insufficient culvert capacity for probable rainfall events (inadequate design), reduced culvert capacity due to sedimentation (inadequate design and/or maintenance), and extreme or improbable rainfall events (beyond design basis). The appropriate design of discharge for cross drainage can mitigate the hydrological risk of overtopping onto roads.

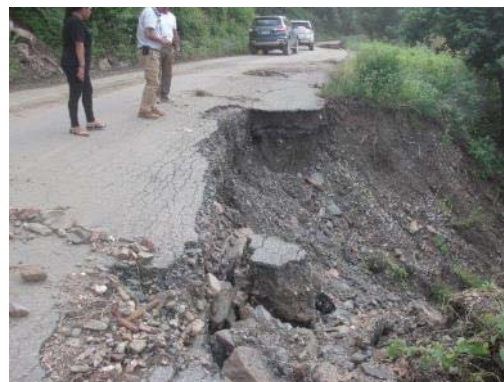
A03 Road structure damage (Likisá)

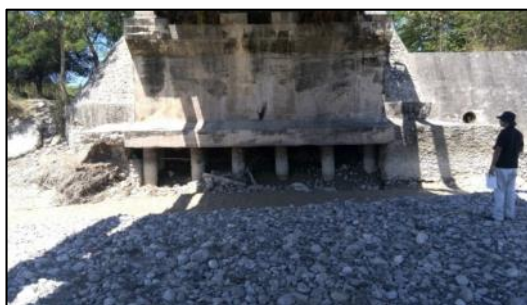
The conditions at the case study site (Sahen Bridge) are as follows. There is scouring damage in front of the abutment and below the bridge pier footing, both on the right bank side. Urgent measures are necessary.

Abutment scouring damage (Sahen Bridge)

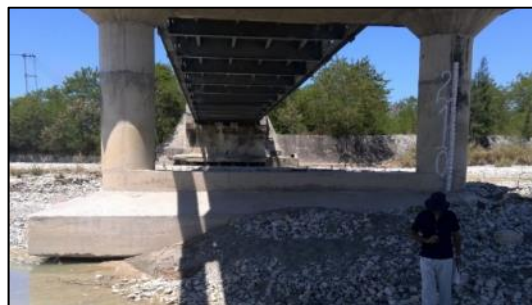
Bridge pier scouring damage (Sahen Bridge)

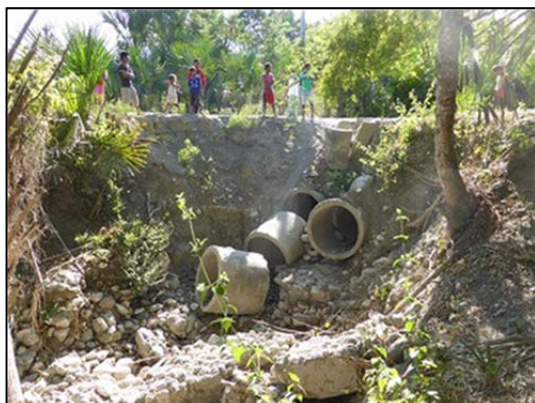
Damaged road and culvert (Sesurai culvert)

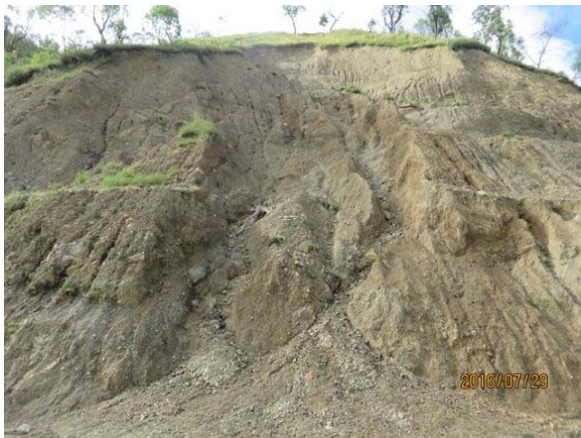
The JICA Expert Team observed repeatedly damaged sites along A02 and A05 with guidance by the staff of the Department of Maintenance from 27 to 29 July, 2016. Existing countermeasures against slope disaster by DRBFC were re-cutting of slopes using heavy equipment and many installations of gabion walls for structural countermeasures. Currently, the slope protection works are only implemented by planting vegetation, and protection structures are not being constructed. The site investigation found that there was a problem that could not be controlled by these existing measures and that it was estimated to be a surface layer collapse or landslide of about 2 m in depth.

Surface layer collapse

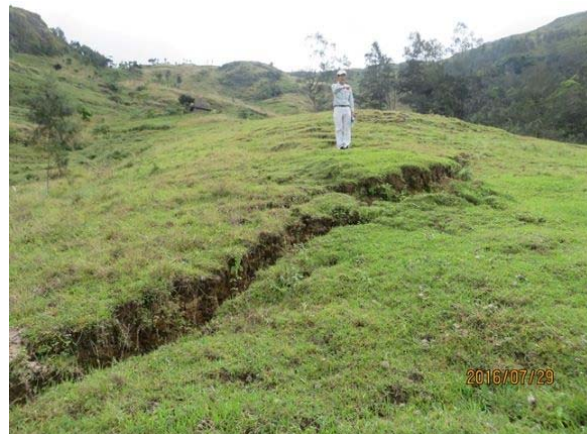
Scarp (long, steep slope) suspected of landslide

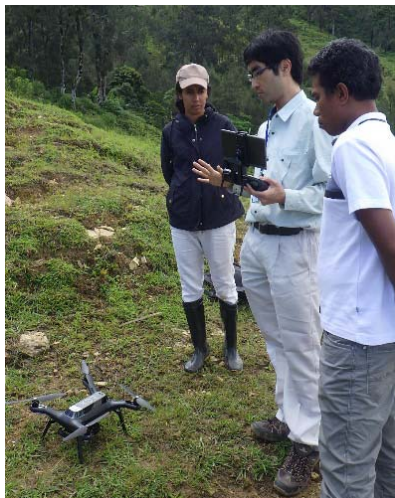
Site OJT for UAV Survey

In Timor-Leste, there are no accurate topographic maps that can be used for extracting landslide topography, so orthophotos and detailed topographic maps were prepared using a UAV. The target areas of the survey were the Aitutu landslide, which was the case study site for a landslide survey and observation, and the Jakarta II landslide, which was a large-scale landslide that occurred during the rainy season. The JICA Expert Team conducted activities on site and seminars to introduce the DRBFC to the way of processing data and the results that can be achieved with UAV surveying. This activity did not aim for complete technology transfer to allow the C/P to conduct surveys by themselves; instead, it introduced the concept of UAV surveying and provided the DRBFC with the necessary information to consider whether C/P could conduct these surveys in the future.

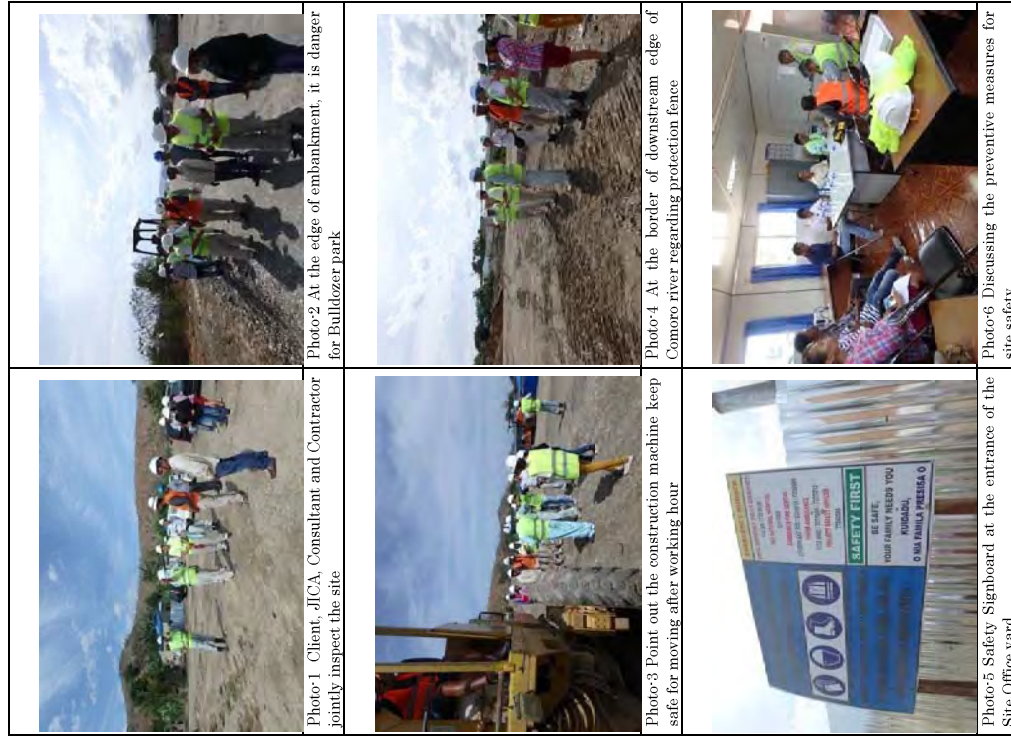
Photo-1 Client, JICA, Consultant and Contractor jointly inspect the site

Photo-2 At the edge of embankment, it is danger for Bulldozer park

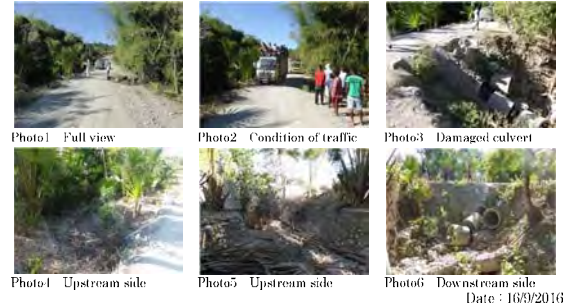
Current situation of the site is shown as following pictures. Width of the road is about 2.5m and passage vehicle has to reduce its speed with careful attention.

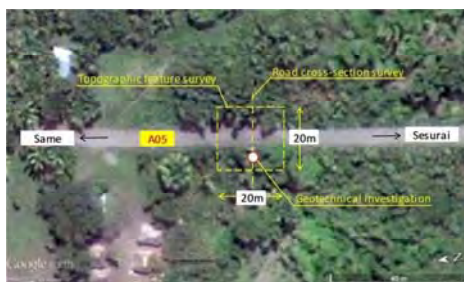
Figure 3.2 Location of Geotechnical and Topographic Survey
