CTI ENGINEERING INTERNATIONAL CO., LTD. Designed by: _____ Date: _____ Checked by: _____ Date: _____	TITLE: PREPARATORY SURVEY ON THE PROJECT FOR UPGRADING OF THE KUKUM HIGHWAY PHASE 2		Drawing No. 070
		LAYOUT PLAN OF ROAD MARKINGS (1)		SCALE 1:1,000

LUNGGA BRIDGE  
REPAIR GENERAL DRAWING

ソロモン国  
第二次ククム幹線道路改善計画  
ルンガ橋点検調書

本事業の対象区間にあるルンガ橋は、我が国の無償資金協力による建設から25年以上が経過している中で、本事業の成果を将来に亘って発現させるために必須となる橋梁である。

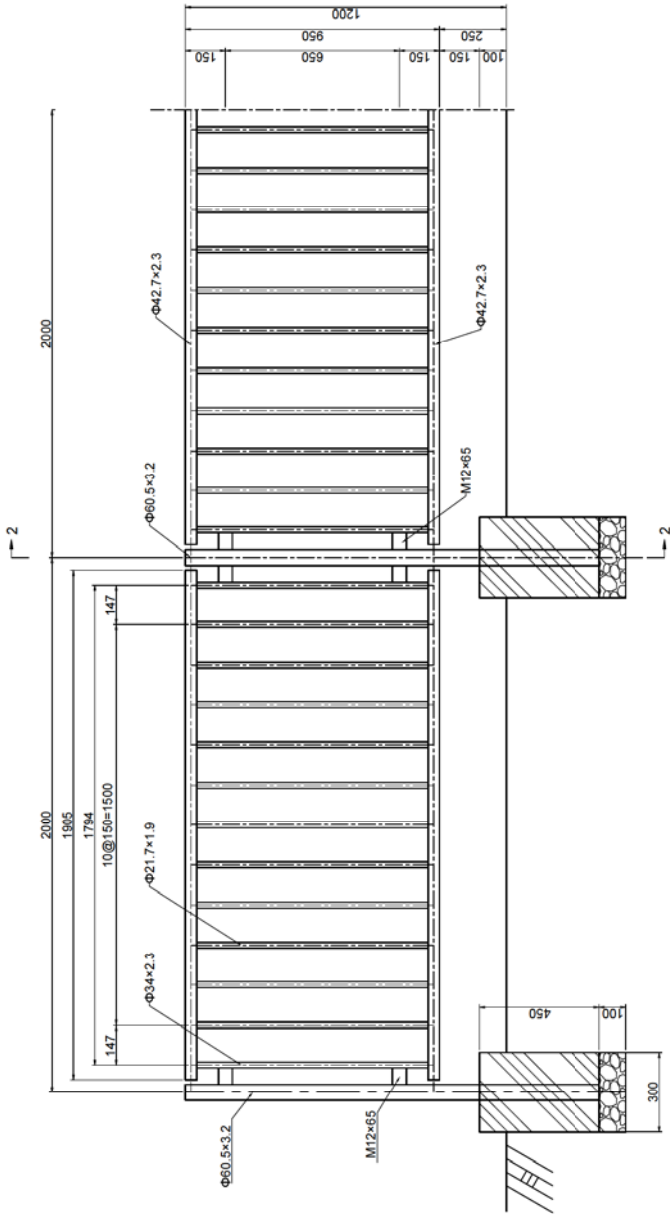
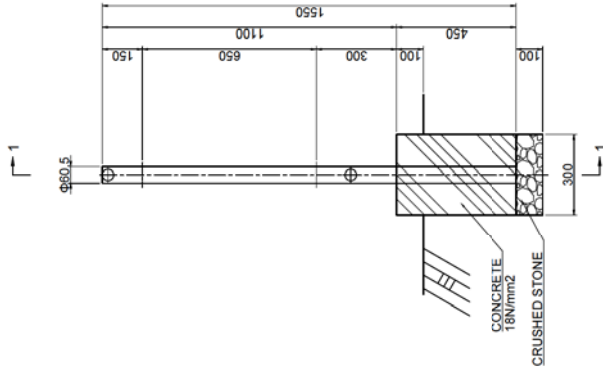
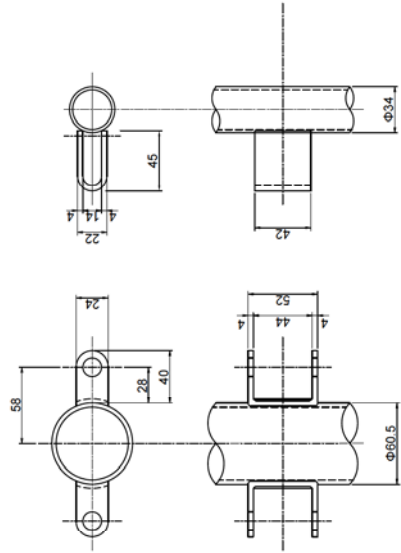
# HANDRAILS GENERAL DRAWINGS

SECTION 1 - 1 S=1:10

SECTION 2 - 2 S=1:10

## DETAIL OF FITTING PARTS S=1:2

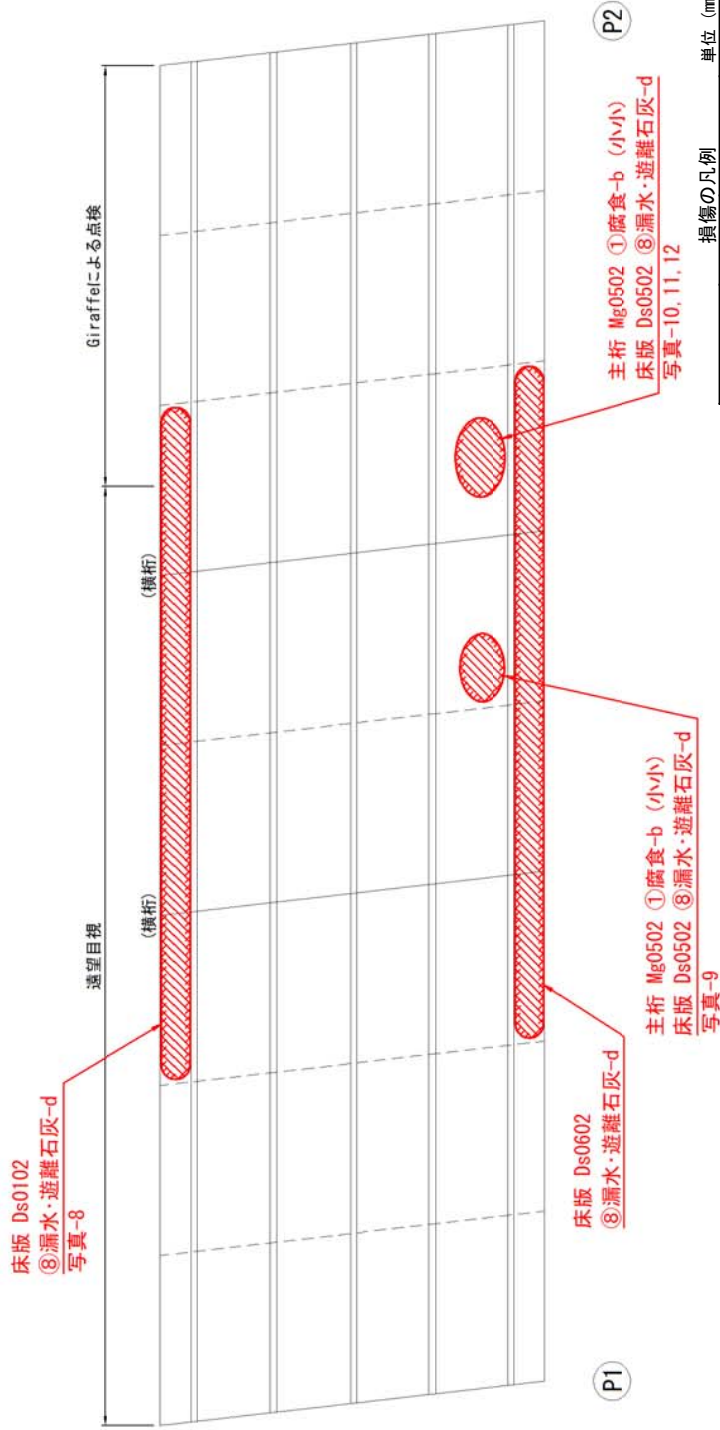
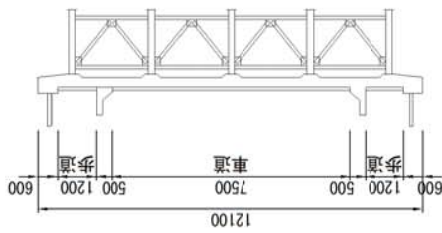
ルンガ橋 上部工下面  
第2径間

※上記以外の損傷は以下の通り  
主桁・横桁・下横構・対傾構：⑤防食機能の劣化

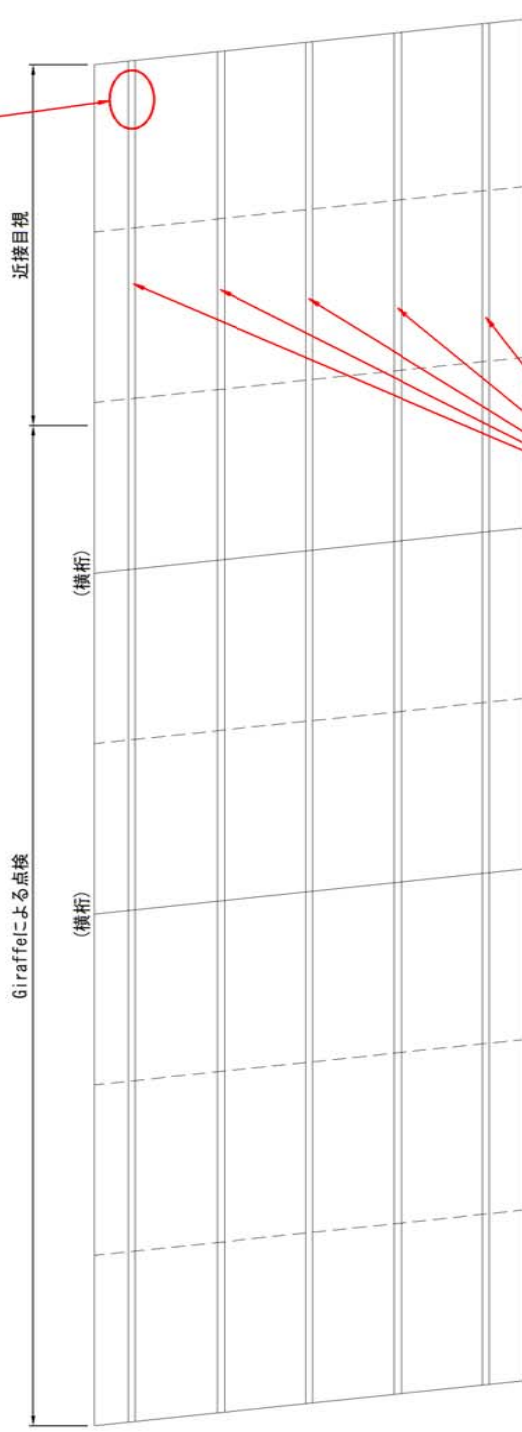
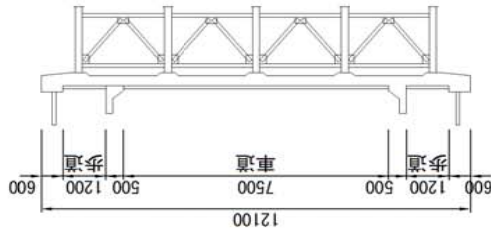
ルンガ橋 上部工下面  
第3径間

主桁 Mg0103 ①⑦その他-e  
写真-13, 14

主桁 Mg0103, 0203, 0303, 0403, 0503  
⑤防食機能の劣化-d~e  
写真-15

※上記以外の損傷は以下の通り  
主桁・横桁・下横構・対傾構：⑤防食機能の劣化

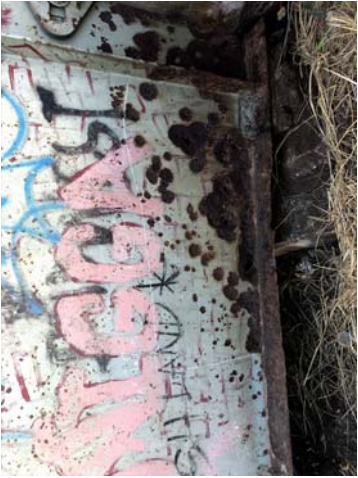
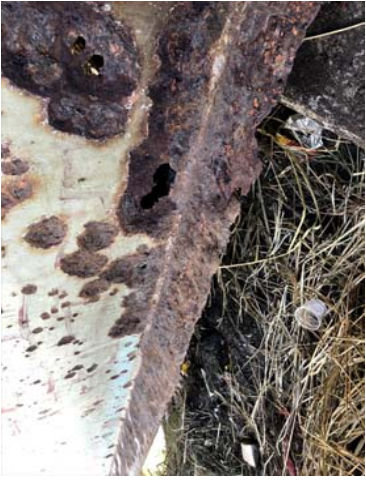
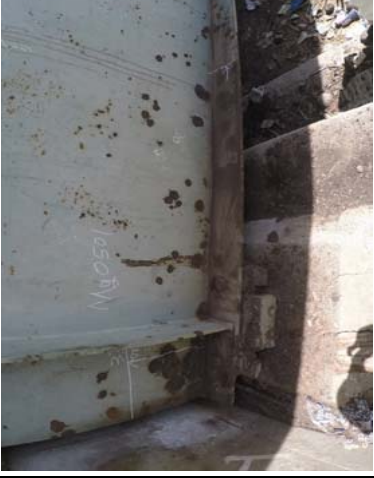
フリガナ		路 線 名		Kukumu Highway		MID		橋梁コード		-	
橋梁名		ルンガ		ルンガ橋		管理者		橋梁コード		-	
備考											
写真番号	1	径間番号	1	写真番号	2	径間番号	1	写真番号	3	径間番号	1
部材名	主桁	要素番号	0101	部材名	主桁	要素番号	0101	部材名	主桁	要素番号	0501
損傷の種類	腐食	損傷程度	d(大小)	損傷の種類	腐食	損傷程度	d(大小)	損傷の種類	腐食	損傷程度	d(大小)

前回損傷程度	
		-				-					
		メモ				メモ					
		損傷範囲: ウエブ 1.7 x 0.6m 下フランジ 2.2m 断面欠損 を確認				写真番号1 の下フランジ 近方の 拡大写真		損傷範囲: ウエブ 0.3 x 0.3m 減肉を確認			
写真番号	4	径間番号	1	写真番号	5	径間番号	1	写真番号	6	径間番号	1
部材名	主桁	要素番号	0501	部材名	主桁	要素番号	0101	部材名	床版	要素番号	0201
損傷の種類	腐食	損傷程度	d(大小)	損傷の種類	腐食	損傷程度	d(大小)	損傷の種類	漏水・遊離石灰	損傷程度	d

フリガナ 橋梁名		ルンガ ルンガ橋		路線名	管轄	Ministry of Infrastructure Development (MID)	現地確認年月日	2019年11月27日～ 2019年12月6日			
供用開始日	1991年	橋長	126m	活荷重・等級	等橋	適用 示方書	道路橋示方書(日本道路協会) 橋梁設計基準(オーストラリア道路協会) 道路橋設計基準(ニュージーランド標準規格協会)	調査年	2019年		
上部構造形式	3径間連続鋼桁 (5主桁)	幅員		全幅員	12.1m	車道幅・車線	車道幅 1.2m 歩道幅 0.6m	交通量	12,501台 昼間12時間		
下部構造形式	RC逆T型橋台 RC張出付き壁式橋脚	幅員		有効幅員	10.9m	車道幅・車線	車道幅 3.75m 歩道幅 1.2m	大型混入率	2.0%		
基礎形式	打込式鋼管杭	備考				車道幅・車線	車道幅 3.75m 歩道幅 1.0m	荷重制限	40 t		
一般図・写真											
総合検査結果	<table border="1" style="width: 100%;"> <tr> <td>健全度 (橋単位)</td> <td style="text-align: center;">Ⅲ</td> </tr> </table> <p>A1の主桁端部に断面欠損を伴う腐食が発生している。損傷原因として、本橋の周辺には、ごみや排泄物が散見されることから、排泄等の人為的な行為によるものと推定する。なお、伸縮装置や橋梁側面等からの漏水跡が本損傷の周辺で確認されなかった。また、A2の主桁端部に、塗装の焼失やウェーブの変形・変色が発生している。損傷原因として、周辺に山積みされたごみの焼却処分によるものと推定する。 主桁の耐力低下が懸念され、橋梁構造の安全性の観点から、5年以内に補修される必要があると判断する。</p>									健全度 (橋単位)	Ⅲ
健全度 (橋単位)	Ⅲ

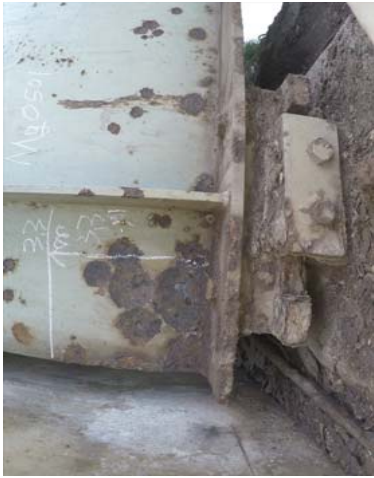
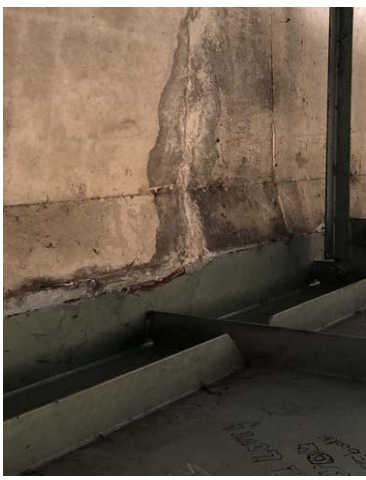
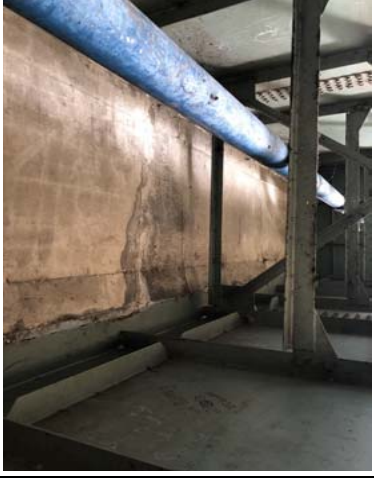
前回損傷程度	
		-				-					
		メモ				メモ					
		写真番号3 の拡大写 真				橋面から の漏水に より上フラ ンジの一 部が腐食		橋面から 漏水で遊 離石灰が 発生 錆汁の跡 は無し

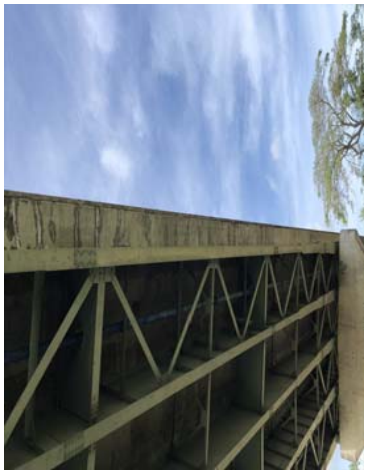
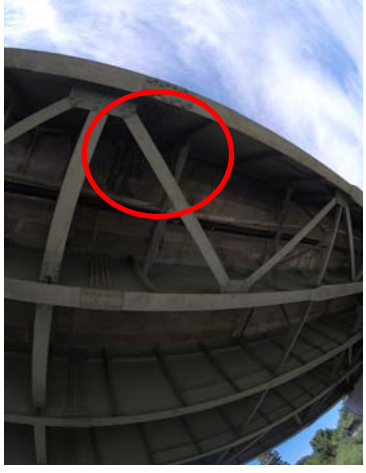
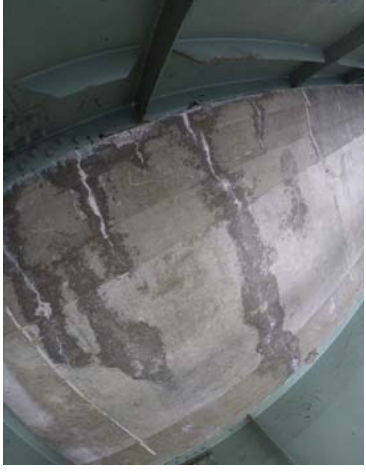
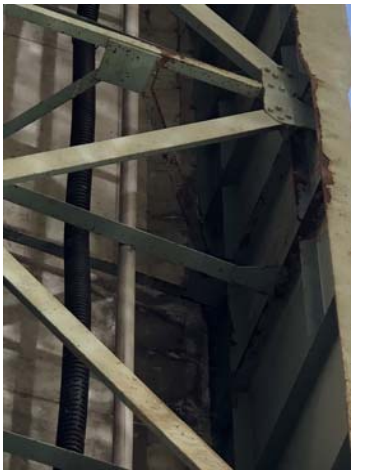
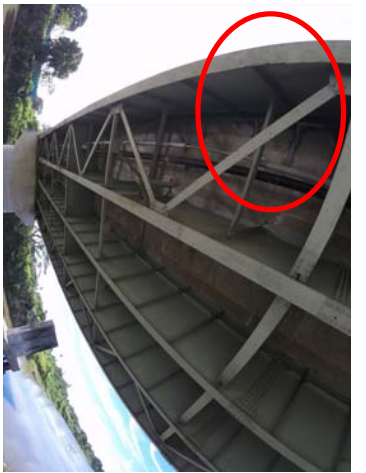
フリガナ 橋梁名		ルンガ ルンガ橋		路線名		Kukum Highway		MID		橋梁コード		-	
備考													
写真番号	7	径間番号	1	写真番号	8	径間番号	2	写真番号	9	径間番号	2	前回損傷程度	
部材名	主桁	要素番号	0101.0201.0301, 0401.0501	部材名	床版	要素番号	0102	部材名	主桁 床版	要素番号	0502 0502	損傷の種類	腐食 漏水・遊離石灰
損傷の種類	防食機能の劣化	損傷程度	d~e	損傷の種類	漏水・遊離石灰	損傷程度	d	損傷の種類	漏水・遊離石灰	損傷程度	b(小)小 d	写真

床版から の漏水に より主桁に 腐食が発 生	
前回損傷程度	-	前回損傷程度	-	前回損傷程度	-	前回損傷程度	-	前回損傷程度	-	前回損傷程度	-	写真番号	10の漏水・ 遊離石灰 の拡大写 真
	メモ		メモ		メモ		メモ		メモ		メモ		
			防食機能 の劣化 一部で点 錆が発生				床版張り 出し部に 漏水・遊 離石灰が 発生						
写真番号	10	径間番号	2	写真番号	11	径間番号	2	写真番号	12	径間番号	2	写真番号	10の漏水・ 遊離石灰 の拡大写 真
部材名	主桁	要素番号	0502	部材名	主桁	要素番号	0502	部材名	床版	要素番号	0502	部材名	10の腐食 部の拡大 写真
損傷の種類	腐食	損傷程度	b(小)小	損傷の種類	腐食	損傷程度	b(小)小	損傷の種類	漏水・遊離石灰	損傷程度	d	損傷の種類	腐食 漏水・遊離石灰

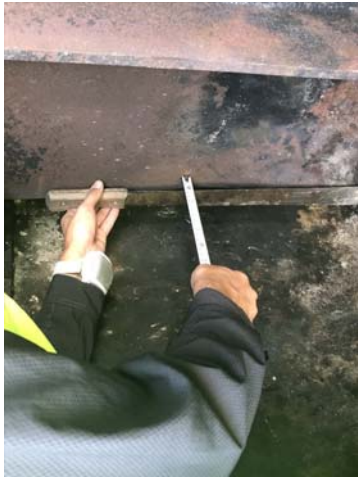
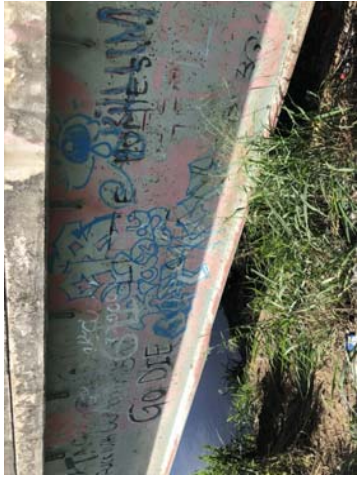
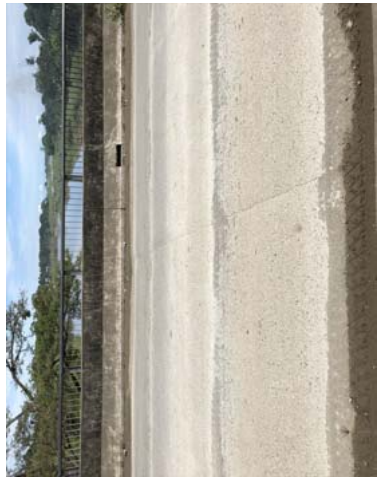
フリガナ 橋梁名		ルンガ ルンガ橋		路線名		Kukumu Highway		管理者		MID		橋梁コード		-													
備考																											
写真番号	13	径間番号	3	写真番号	14	径間番号	3	写真番号	15	径間番号	3	写真番号	0103,0203,0303, 0403,0503	主桁	要素番号	0103,0203,0303, 0403,0503	損傷の種類	防食機能の劣化	損傷程度	d~e	前回損傷程度	-	メモ	点錆が発生			
部材名	主桁	要素番号	0103	部材名	その他	要素番号	0103	部材名		要素番号		部材名															
損傷の種類	その他	損傷程度	e	損傷の種類		損傷程度		損傷の種類		損傷程度		損傷の種類															
写真		写真		写真		写真		写真		写真		写真		写真		写真		写真		写真		写真		写真

前回損傷程度	-	前回損傷程度	-	前回損傷程度	メモ	前回損傷程度	メモ	前回損傷程度	メモ	前回損傷程度	メモ	前回損傷程度	メモ	前回損傷程度	メモ	前回損傷程度	メモ	前回損傷程度	メモ	前回損傷程度	メモ	前回損傷程度	メモ	前回損傷程度	メモ		
塗装の焼失: 桁端部から2.0m程度		橋軸直角方向に最大で3cmの歪みの長さは12cm程度																									
支承本体の腐食		舗装の異常		舗装の打ち継ぎ目
