添付資料-2: ケニア道路状況調査報告書(現地再委託
業務)

**BASIC RESEARCH ON TECHNICAL COOPERATION OF
PERFORMANCE BASED ROAD MAINTENANCE
CONTRACT**

FINAL COMPLETION REPORT

CONTRACT REF. NO: JKL.2021/11

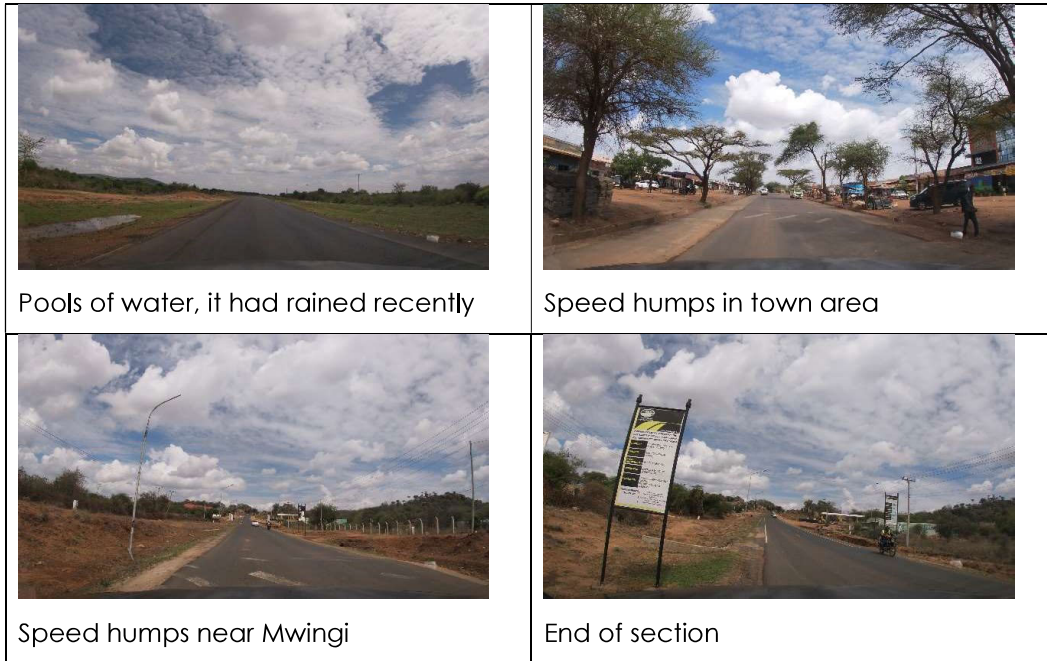
Pools of water, it had rained recently

Speed humps in town area

Condition at the time of measurement	The sky was cloudy and it was evident that it had recently rained. The pavement was dry though due to the recent rains, there was muddy tire marks in areas where traffic was joining from earth roads.
Reason for peak points of IRI	The reason of the peak points of IRI can be attributed to the speed humps in the town areas and also potholes at the starting section near Kanyonyo.
IRI characteristics	The IRI values range from 2.37 to 6.87 mm/m with an average of 3.62 hence majorly fair condition.
Other findings and considerations	During the condition survey to ask on the history/age of the road as the recent overlay does not seem to have helped in improvement of the IRI.

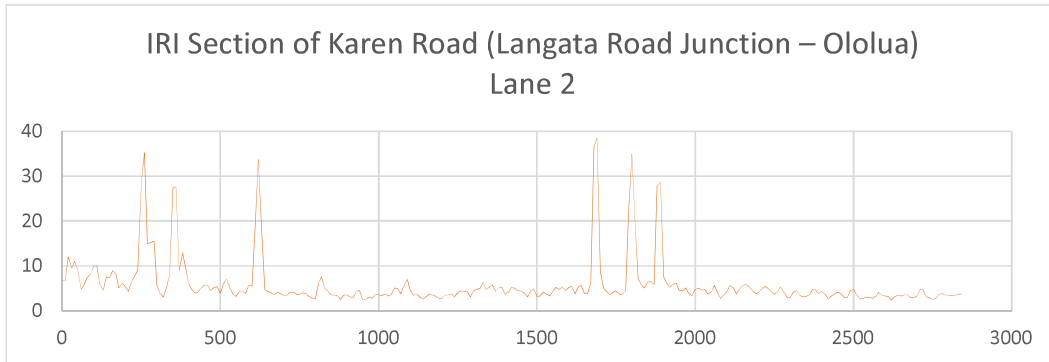
Lane 2 IRI Image Map

Condition at the time of measurement	The sky was sunny with a bit clouds
Reason for peak points of IRI	The reason of the peak points of IRI can be attributed to the speed humps.
IRI characteristics	The IRI values range from 4.79 to 7.48 mm/m with an average of 5.95 hence majorly poor condition.
Other findings and considerations	During the condition survey to ask on the history/age of the road.

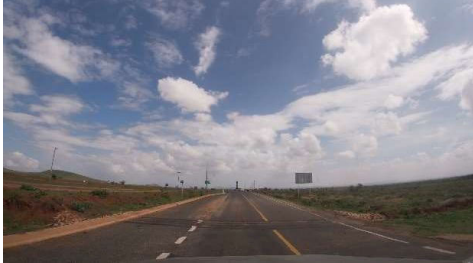
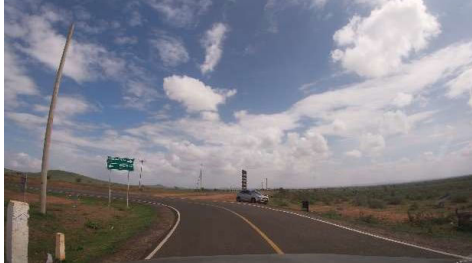
Cut pothole areas yet to be filled	Cloudy skies

Rumble strips	End section

Condition at the time of measurement	The sky was cloudy and the pavement itself was majorly dry and clean.
Reason for peak points of IRI	The reason of the peak point of IRI can be attributed to cut potholes not yet to be filled and rumble strips.
IRI characteristics	The IRI values range from 2.69 to 4.48 mm/m with an average of 3.32 mm/m hence majorly fair condition.
Other findings and considerations	During the condition survey to investigate why the IRI is not good while the road is fairly new.

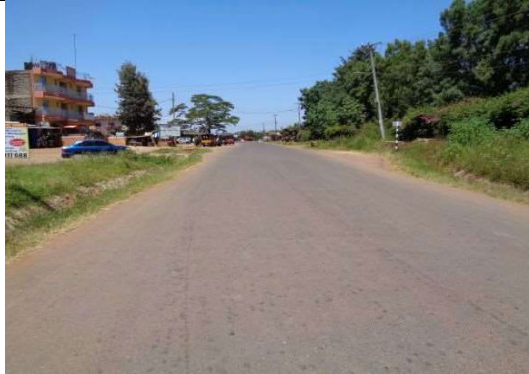
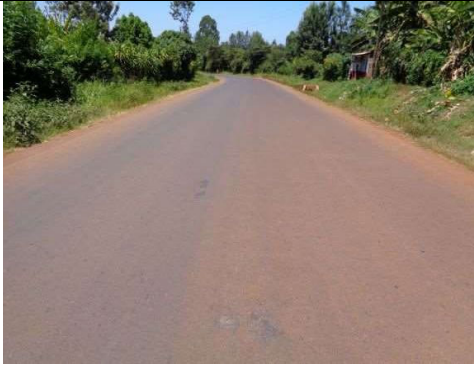
Start of survey .Clear sunny skies	Typical road section

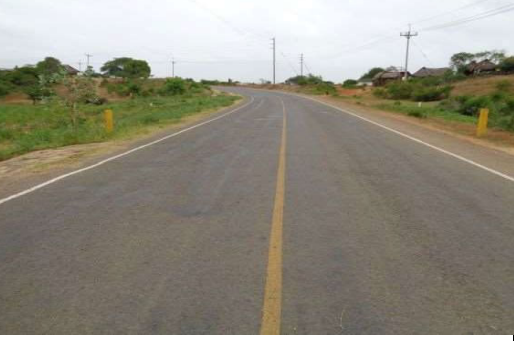
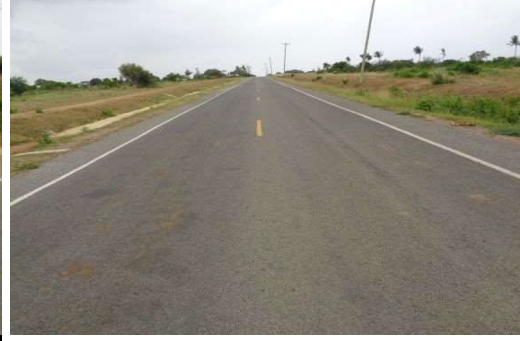
Fair section of highway	Fair section of highway

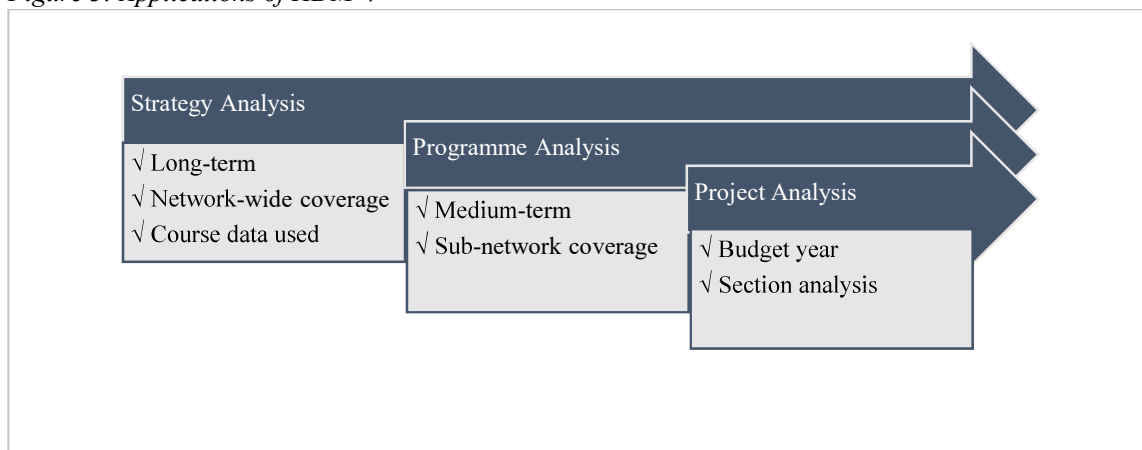
Figure 3: Applications of HDM-4

The analysis was undertaken using the Highway Development & Management model (HDM-4), a tool for appraisal and assessment of road management investment decisions (Kerali and Odoki 2009)². HDM-4's analysis framework is based on the concept of pavement life cycle analysis which is used to predict road deterioration; road works effects; road user effects; and, socio-economic and environmental impacts. The uses of HDM-4 mainly include strategy analysis, programme analysis and project analysis as represented in Figure 3 (Kerali and Odoki 2009).
