ケニア共和国
水資源庁（WRA）

ケニア共和国
水資源管理アドバイザー業務

業務完了報告書

独立行政法人
国際協力機構（JICA）

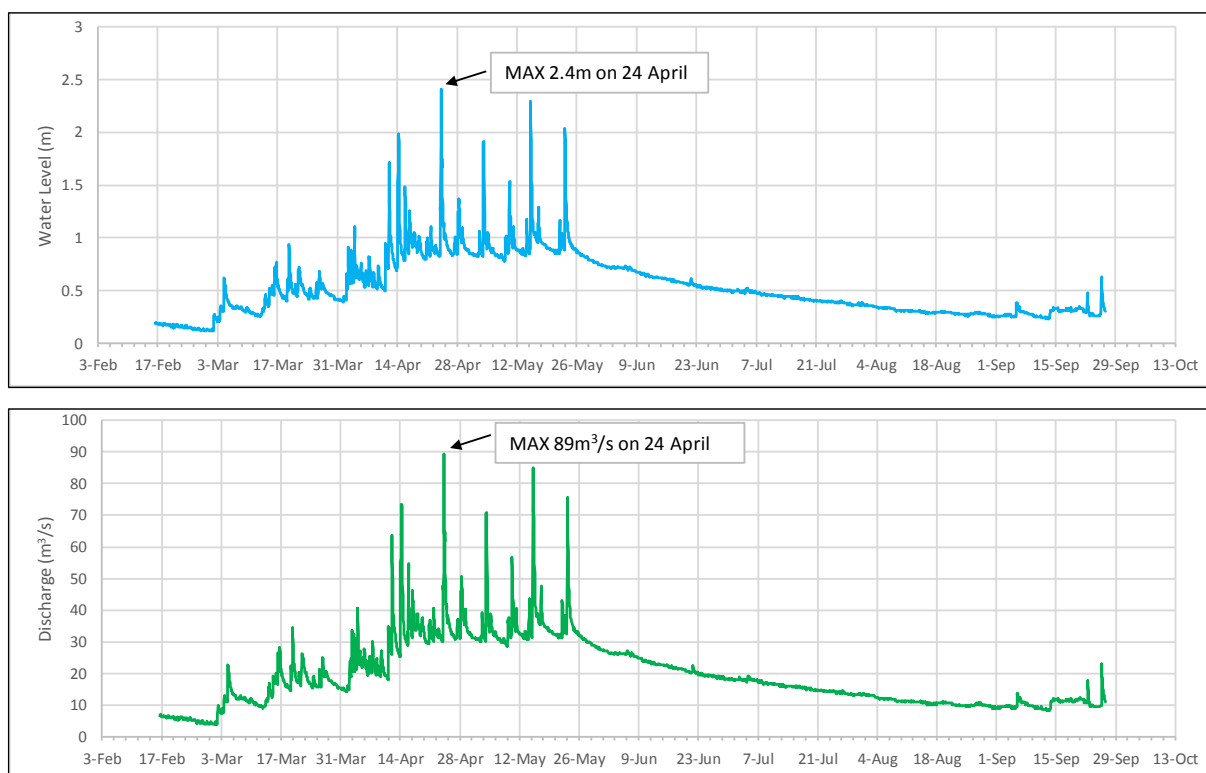
図 2.4 水位及び流量観測結果 (4F10 観測所)

表中の「(1)水位」は流量観測の開始時(開始)と終了時(終了)観測水位の平均値を示す。

対象とする水位観測所を選定するにあたり、継続的に活動ができることを考慮すると、アクセスの良さは重要な必要条件である。また、今回新規観測所として位置づけた 4F10 は、過去水位観測を実施していたが、洪水により水位標や水位計が破損し、観測が途絶えていた箇所である。下流に堰があるが、集落から近いいため候補地として適切と判断した。

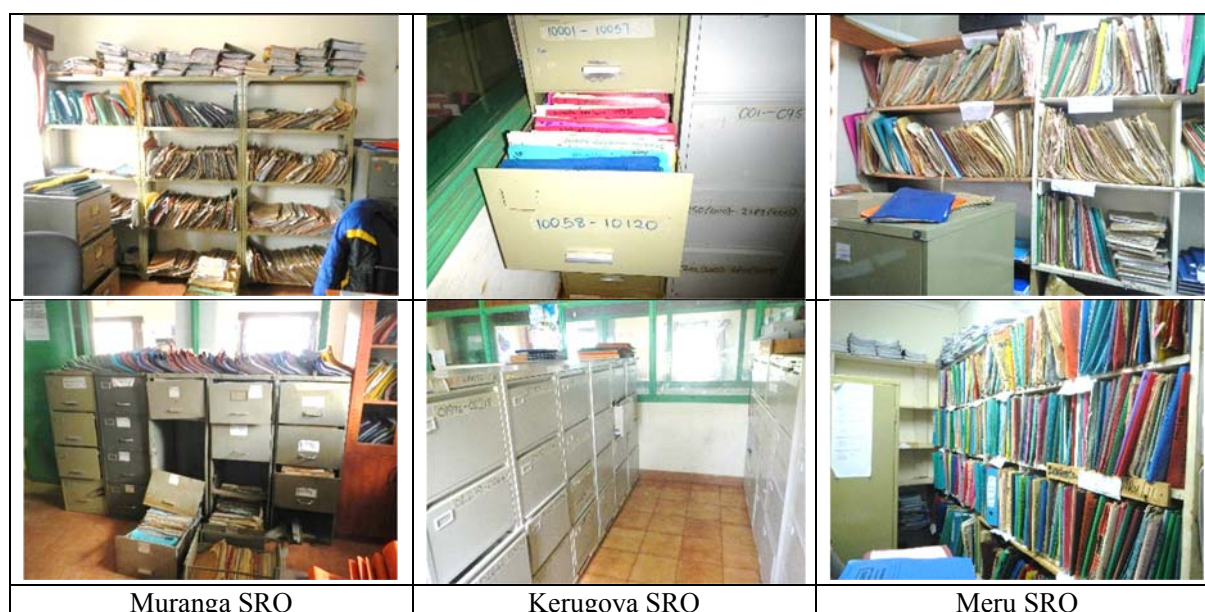
図 2.13 観測月報の保管状況

観測月報は下図に示すとおり、紙ベースで棚に保管されている。事務所によっては棚の引出しが壊れており、また、オープン型の棚に保管されていることから記録紙の劣化が激しい状況も確認された。各 SRO のデータ管理担当者は1名でデータの品質検査や月報の保管、データ入力、データの送信等を実施している。SRO から RO へのデータ送信は月1回を基本としているが、RO の担当者によると SRO によってはデータ提供が滞ることもあるとのことであった。SRO は、原則として各観測所に1名の観測担当者を配置して観測データの記録を委託しており、定期的に委託作業の謝礼として手当を支給している。SRO への聞き取り調査の結果、予算が無い場合は支給が滞る場合があり、データ記録作業が中断することがあるとのことであった。これが、RO へのデータ送信が滞る主要因の一つであると考えられる。また、SRO の担当者はデータ管理専属ではないことから、時期的には他業務の影響でデータ入力等の作業が停滞する点も原因の一つとして考えられる。

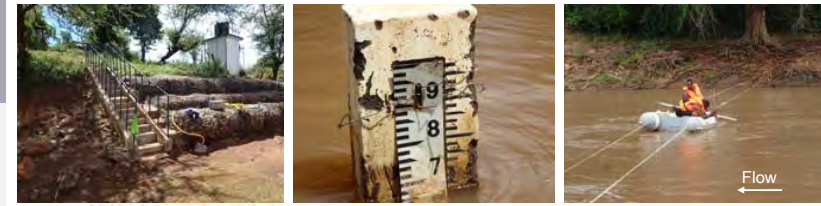
DM works at RGS 4F10 (Kathita)

- ◆ H= 0.65m at 12:40 on Jun.12, 2018 Tuesday (by current meter method)
- ◆ No damage to the staff gauge, gauge house, steps and gabion mattress
- ◆ Bolt and nut for fixing gauge plate (1st: 0.0m – 1.0m) were taken away.
- ◆ WL of flood mark might be 1.5-2.0m at maximum by debris remained on gabion.

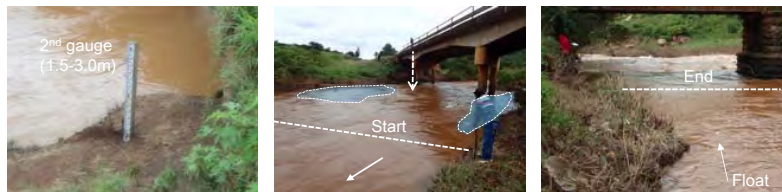
DM works at RGS 4BE01 (Maragua)

- ◆ H= 1.20m at 10:30 on Jun.11, 2018 Monday (by float method)
- ◆ 1st gauge (0.0-1.5m) has been washed away and 2nd gauge (1.5-3.0m) is tilted.
- ◆ Due to stable flow condition and straight stretches, the river section between two bridges is appropriate for both current meter and float methods.
- ◆ However, careful measurement is necessary because dead flow areas exist by influence of bridge piers.

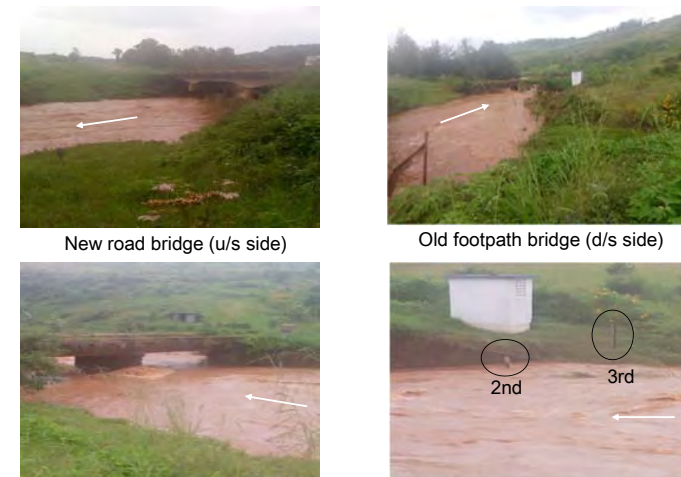
River Condition at 4BE01 on 22nd May 2018

Note: The 2nd gauge (1.5m-3.0m) was almost submerged under water (around H=2.7m).

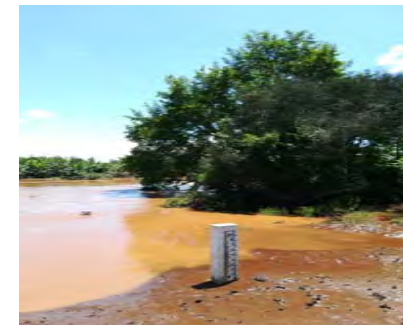
4BE10 -2ND Gauge plate damaged.

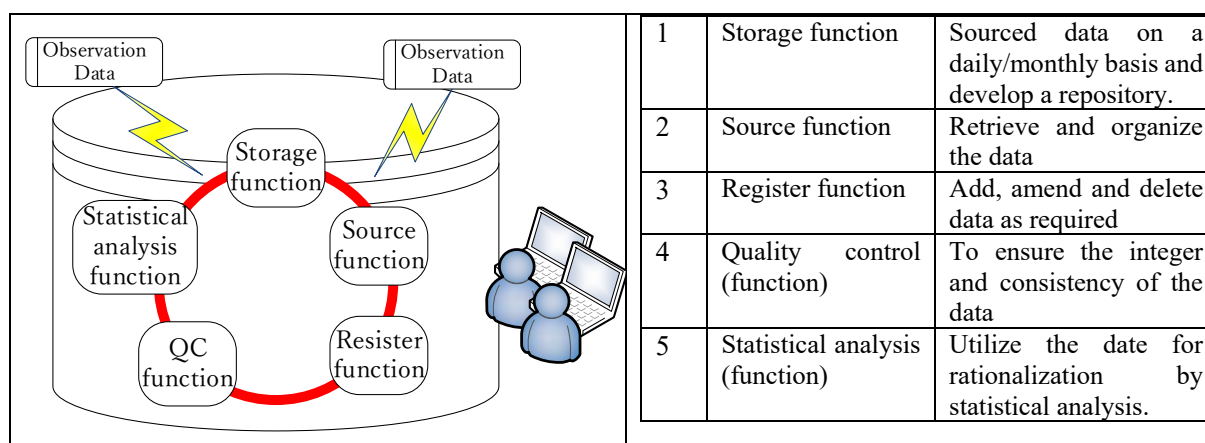
Figure 2 Functions of Database

The functions of database are divided into five categories as shown in the figure below. The roll of task of each function is indicated in the table below;

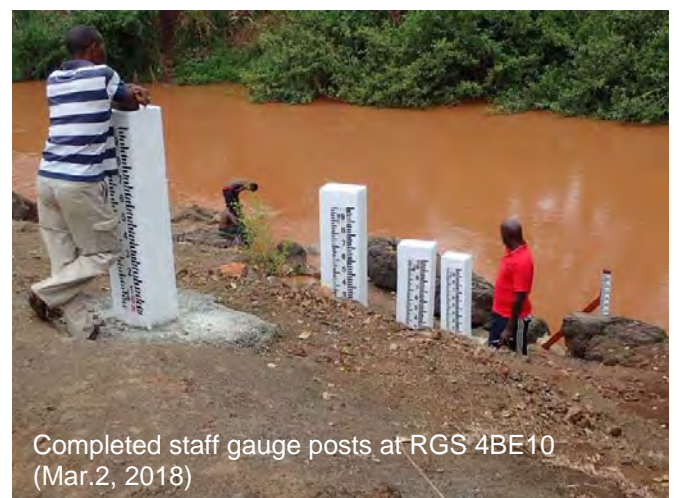
Completed staff gauge posts at RGS 4BE10 (Mar.2, 2018)

Rehabilitation of existing G/S and installation of a new G/S has been completed at RGS 4BE10 (Tana Rukanga), 4DD02 (Thiba) and 4F10 (Kathita) through a sub-contract in March. New water level sensor was installed at 4F10 and new staff gauges and signboard were installed at all three stations. Beside the staff gauge installation, river bank protection works by gabion mattress and construction of small drain canal were also completed at 4F10 and 4BE10 respectively.

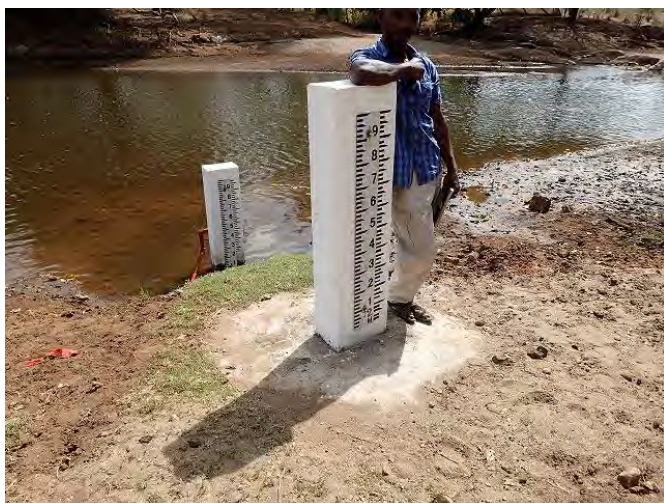
水位標の設置：4F10（2019/03/01）

階段工および護岸工の設置：4F10（2019/03/01）
