REPUBLIC OF KENYA WATER RESOURCES MANAGEMENT EXPERT

COMPLETION REPORT

MAY 2019

JAPAN INTERNATIONAL COOPERATION AGENCY

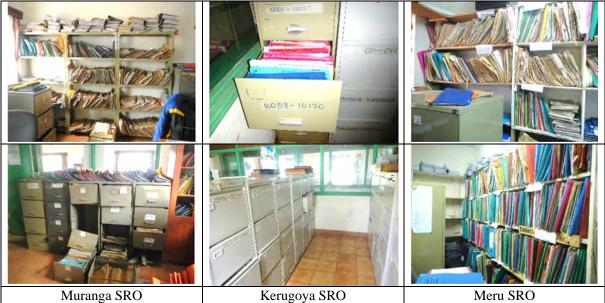
The paper-based monthly reports of observed data are stored in shelves as shown in Figure 2.13 below. It was found that the drawer of shelves had been broken in some offices and confirmed degradation of the monthly report due to storage in the open-type shelves. The number of officials in-charge of database management is one staff at each SRO, and the person in-charge engages in inspection of quality, storage of monthly report, data entry, data transmission, and so on. The data transmission has been basically implemented on a monthly basis; however, according to the RO staff, some SROs sometimes miss the data transmission. SROs basically allocate one gauging reader at each station for entrusting recording of the observed data and provide them with an allowance periodically. As result of the interview with SRO staffs, they sometimes could not give the gauge readers an allowance due to budget constraint; therefore, the activities of data recording by gauge readers had been stacked up for some time. This is probably the reason why some SROs have sometimes been stacked up with the data transmission. In addition, the person in-charge of database management has a full schedule for other works depending on the season since the person is not an exclusive official for the database management. It is assumed that it is also one of the reasons for the interruption of data transmission.

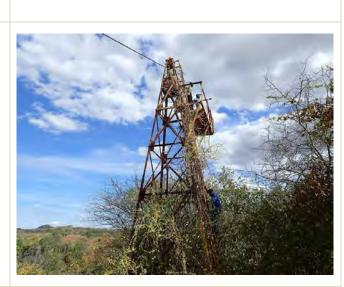
A tower to stay cables for discharge measurement (4F13, 2017/06/14)

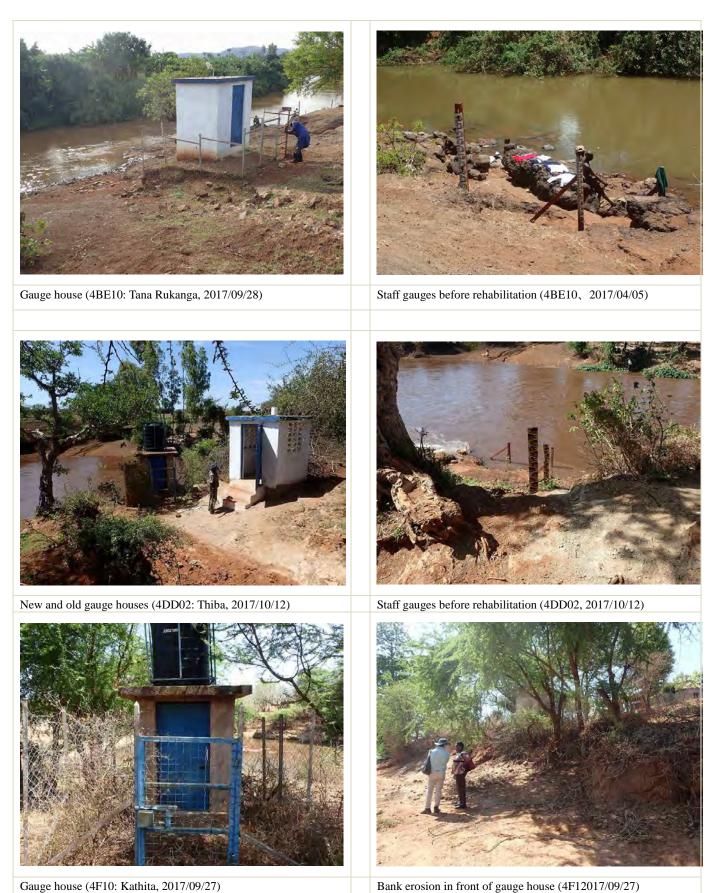
Bank erosion in front of gauge house (4F12017/09/27)

not show channel erosion and aggressive variation of river channel sections. However, through discussions with CP, bank slope protection by gabion mattress was provided at 4F10 (Kathita) to protect from further bank erosion in front of the existing gauge house. At 4BE10 (Tana Rukanga), since the risk of erosion at the foundation of the existing gauge house by surface flow on the slope due to rainwater was confirmed, a small drainage canal (length: 15 m) was constructed by stone masonry at the back of the gauge house. This new canal can catch the rainwater on the ground surface and lead it safely to a creek nearby through the canal.
