CHAPTER 4 DATA COLLECTION AND STUDY ON NEW KARUMA BRIDGE

4.1 Current Condition of the Study Area

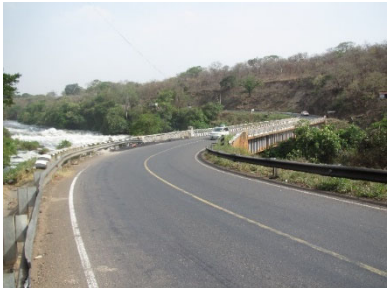
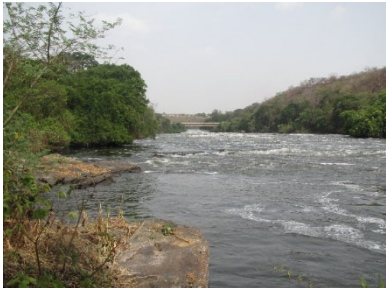
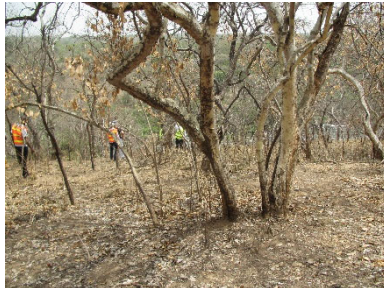
Figure 4.1.1 The Geographical Condition of New Karuma Bridge

【Karuma Bridge (existing)】	【The River Nile】	【Route of Current Design】
The existing bridge is constructed at a valley between hills on both sides.	The river width is narrow at the existing crossing and the river is meandering.	New route passes through the forest within the Murchison Falls Nation Park.

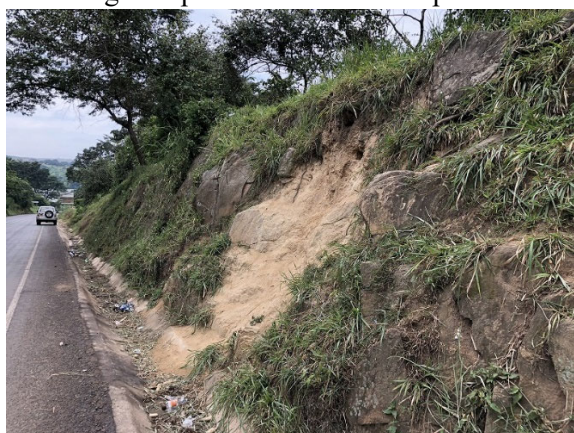
Figure 4.1.2 Rock Outcrops Observed at New Karuma Bridge Site

It was also reported that the rock support layer at the site is found after the depth of 0.02 – 1.0m. The followings are photos of rock outcrops observed at the project site.

Rock cut on Gulu side approach road
(the right bank)

Rock cut on Kampala side approach road
(the left bank)

Rock outcrops were observed at both riverbanks and existing approach roads. According to the Final Detailed Design Report for the Project prepared by AIC Progetti, laboratory tests were conducted for the rock sampled from surface of the outcrops. According to the test results, allowable rock bearing pressure could vary from 2.6 to 8.6 MPa. However, the strength of the rock is expected to be better for deeper rock.

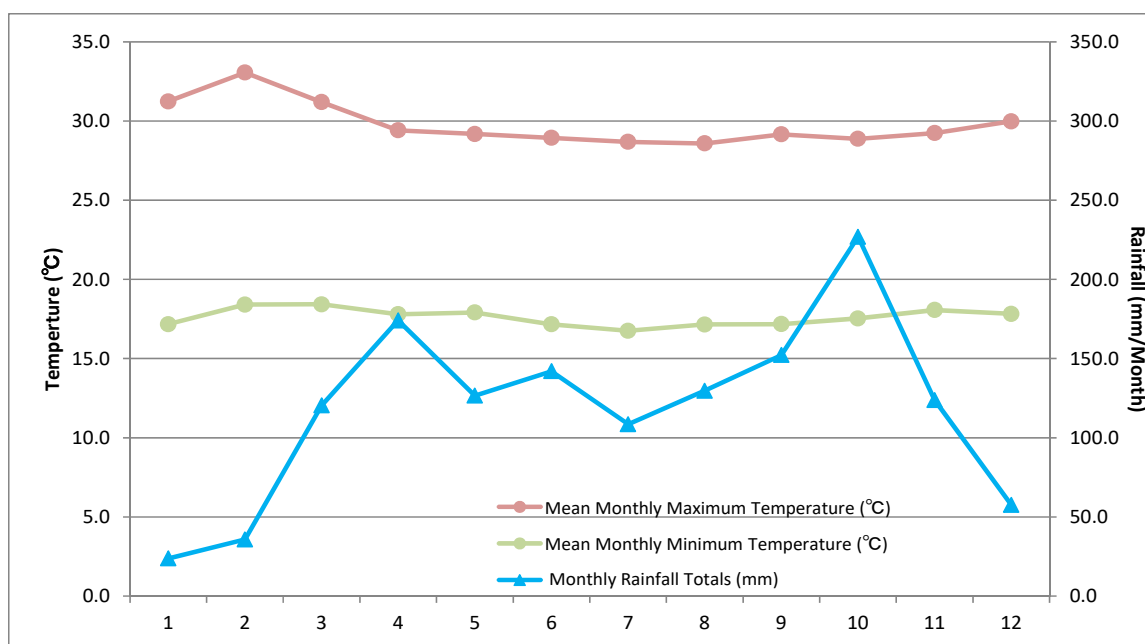
Figure 4.1.3 Average Temperature and Rainfall in Karuma

The Karuma Bridge is located in a tropical area and at 1,000m elevation characterized by predominantly torrential rains and high humidity. The temperature in Karuma is within a range between 17°C and 33C across the year, as shown in Table 4.1.1.

The monthly rainfall in Karuma is shown in Table 4.1.2. The Karuma has two tropical rainy seasons in a year, i.e., light rain season from March to May, and heavy rain season from August to October.

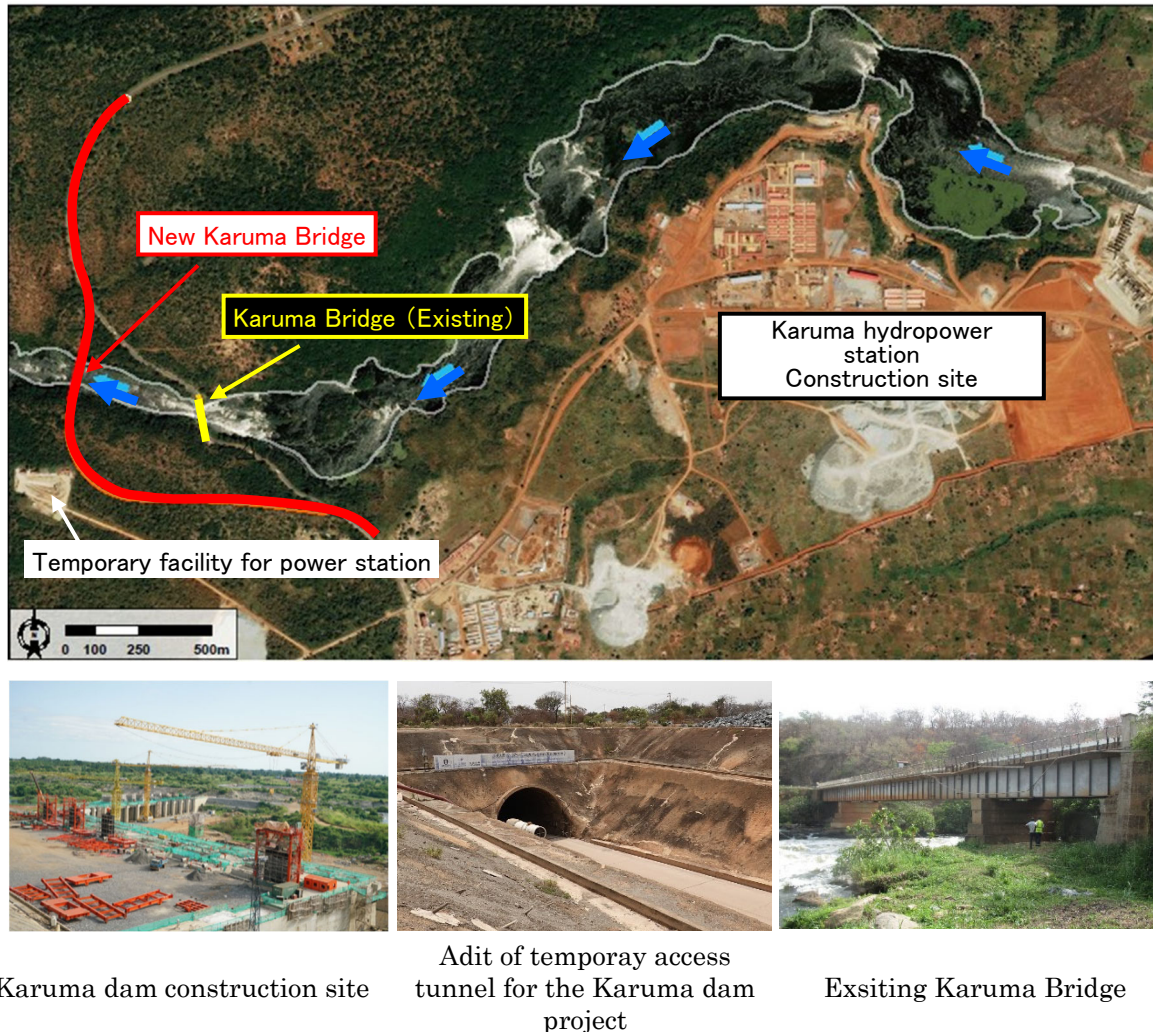
Figure 4.2.1 Facilities in Karuma Bridge Site

The ongoing Karuma hydropower dam is located approximately 4km upstream of the existing bridge. The new Karuma Bridge was planned at approximately 500m downstream from the existing bridge. Major facilities around the Karuma Bridge are shown in Figure 4.2.1.

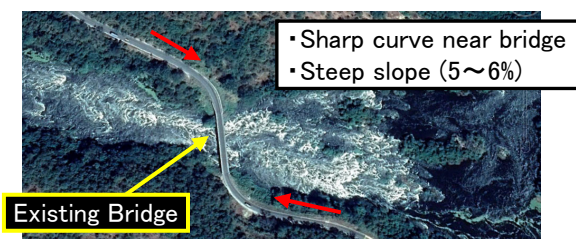
Figure 4.2.6 Road Condition Near the Bridge

Approach roads to the existing Karuma Bridge on both sides have a sharp curve with a steep slope of 5 % to 6% and its road width is not sufficient. Because of this unfavourable road geometrics, many accidents have occurred at the bridge. In addition, “Feasibility and Preliminary Design Study Report – New Karuma Bridge, August 2018, UNRA (referred to as “FS-NKB”)” reported some recent accidents as extracted below:

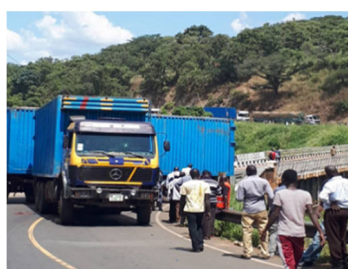
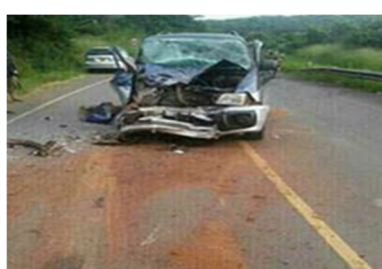
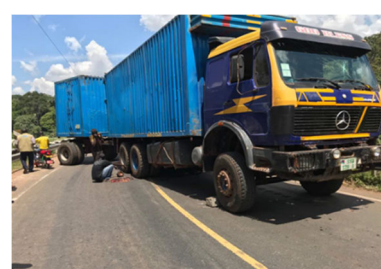
(i)	On 5th June 2018, a Fuso truck loaded with timber travelling from Lira District to Bweyale lost control and crashed into the guide rails & masonry parapet on the left hand side of the approach road and the bridge guard rails damaging approximately 16m length of approach road guide rails and 23.5m portion of the bridge guard rails. Apportion of 17m length of the masonry wall was also damaged. The lorry has plunged into the river and disappeared into the water, occupants feared dead except one behind the lorry who managed to jump off but sustained injuries.
(ii)	On 30th May 2018, Erute North County Member of Parliament Hon. Charles Angiro Gutomoi was involved in an accident on the Karuma Bridge in Kiryandongo District. The MP was driving himself in a Toyota Noah UAV 089G when he collided with a Fuso truck registration number UAJ 730U near Karuma Bridge at about 3am.
(iii)	<p>On 07th July 2017, an identified truck carrying cows, 9 people and chicken lost control at night and knocked a boda cyclist with two passengers dead. The over speeding Truck lost control at the Karuma Bridge and knocked guard rails and plunged into the River Nile water. The truck was headed for Kampala having left a food market in Northern Uganda. Rescue Marine police managed to recover only 3 bodies and with 6 dead cows.</p> <p>On 10th January 2018, Two foreign nationals were killed and one critically injured in a road accident in Ayuda village Diima parish near Karuma Bridge in Kiryandongo District on the Kampala –Gulu highway. The accident took place at around 10:15am when a driver of the vehicle, registration number UAB 042B, in which the foreign nationals were travelling knocked Truck registration UAU 366 loaded with sand. The lorry was coming from the Kampala direction, headed to Lira, while the other vehicle was coming from the opposite direction.</p> <p>In May 2018 a Gaaga Bus registration number UAK 562L from Lira to Kampala was involved in an accident with a tractor registration number UAU 872M and a trailer loaded with crates of beer near the Karuma Bridge. The bus reportedly hit the tractor before it rolled and collided with the oncoming lorry. The accident claimed the lives of 22 people and happened near Karuma Bridge at Nanda village, in Nyamasha parish, Mutunda sub-county, Kiryandongo district.</p>

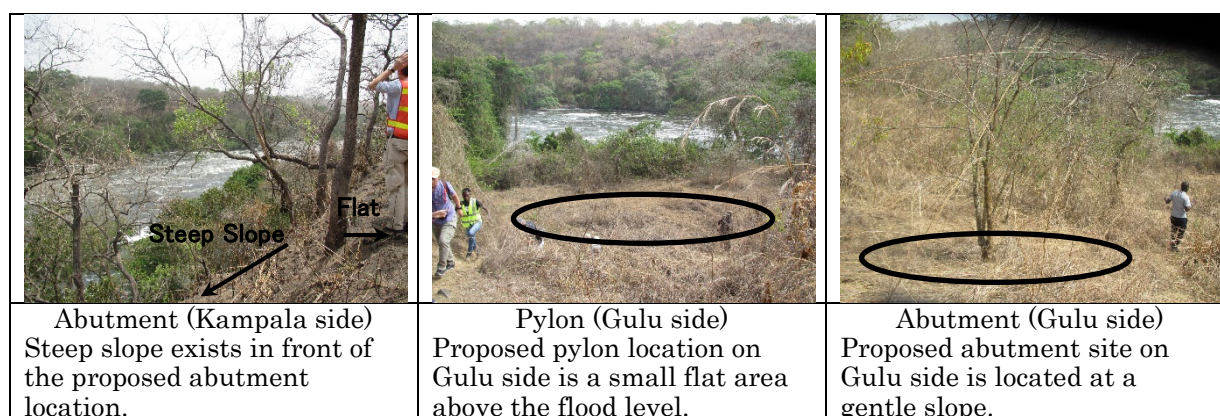
Figure 4.2.8 Location of New Karuma Bridge**5) Cost of new Karuma bridge in current design**

During the field survey carried out by the JST, locations of substructures proposed for the new bridge was investigated as shown in the photos below. The proposed locations were considered to be suitable for planning the substructures.

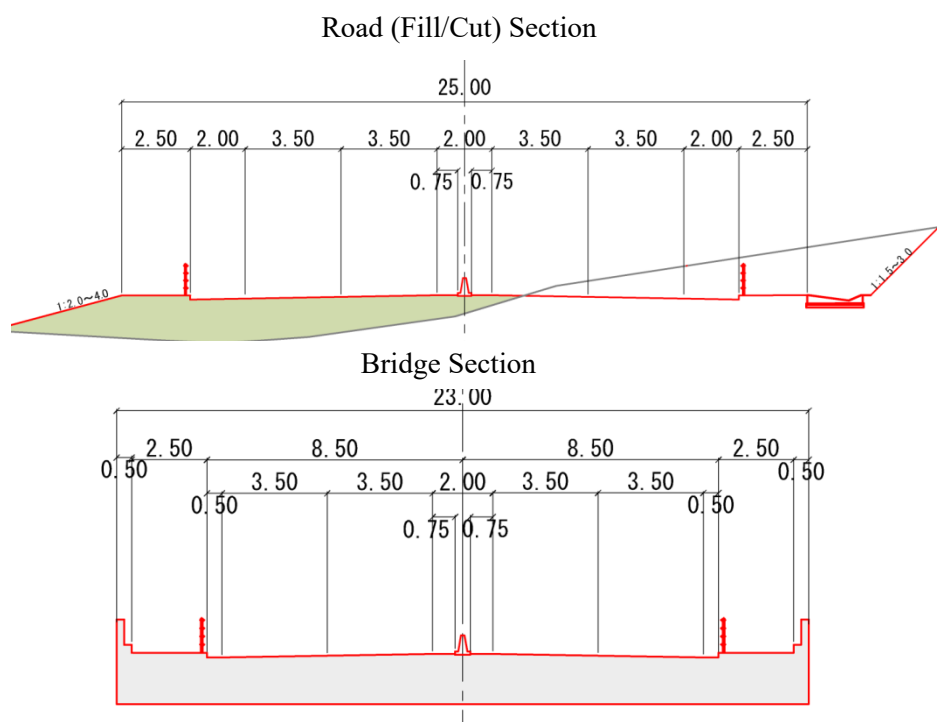
Figure 4.3.1 Proposed Typical Cross Section

Typical lane width of 3.50m which is the same as II paved class of Road Design manual is recommended. Typical Cross Sections for the Road section and Bridge section of the project are shown in the Figures below.

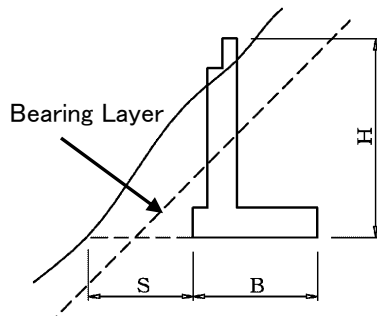
- ✓ The height of the abutment (assuming common inversed T-shaped abutment) shall not be more than 12m according to Japanese standard.
- ✓ Position of the abutment which will be located on slope are determined based on the rule shown in Figure 4.4.2 below:

Type of Bearing Layer	Recommendable S value
Soil	$S \geq B$
Soft Rock	$S \geq 1/2 B$
Rock	$S \geq 1.0 \text{ m}$

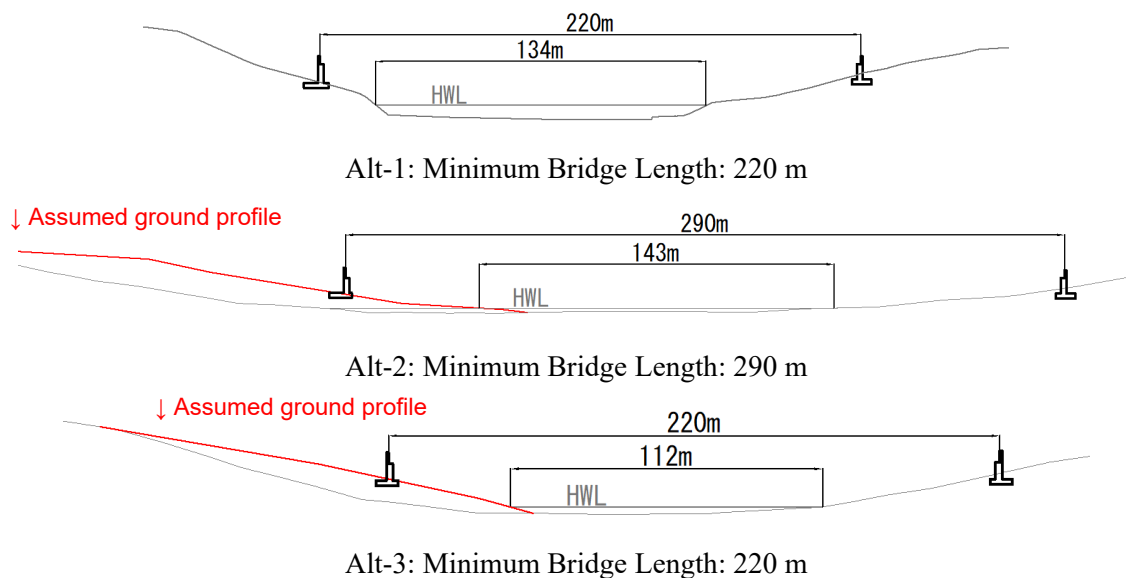
Based on the above rule for abutment position, estimated bridge length from the abutment positions and vertical alignments are shown in Figure 4.4.3. The bridge lengths were established rounded by 10m. River widths for each option, i.e. 134m and 143m and 112m for Alt-1 and Alt-2 and Alt-3 respectively, were determined based on the design of 100-year flood level analysed by the current detailed design study.

Note: HWL: High Water Level

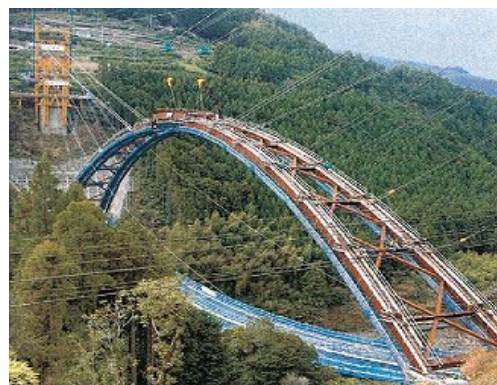
**Construction of Steel Arch using
Temporary Cable Crane**

Side views of the options and remarks are presented below. Both the concrete box girder and the extradosed will require longer total bridge length for the same main span length due to its structural characteristics. However, drivability will be improved by raising the road profile. There are no significant differences in bridge structural aspects in arch and cable-stayed options. However, the arch options will be disadvantageous in constructability and cost due to necessity of a cable crane (see Photo) which shall be imported and exported after completion.

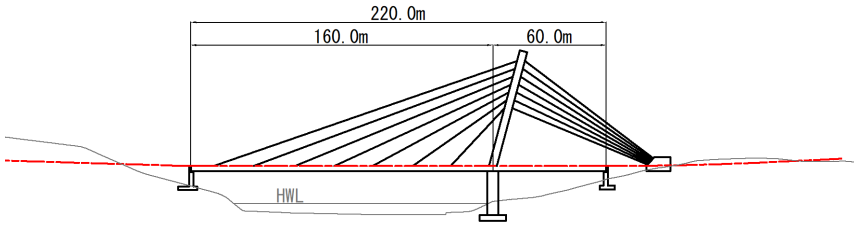
<p data-bbox="1153 591 1417 880">An alternative for the current design. The bridge length will become slightly longer than the original one due to the conditions for “Alt-1” route option. Piers are not placed inside the river course.</p>
<p data-bbox="188 900 496 929">【Alt-1 – Steel Arch Bridge】</p>

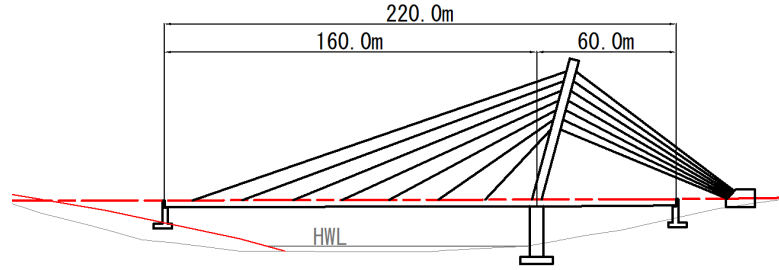
<p>An alternative for the current design. The bridge length will become slightly longer than the original one due to the conditions for “Alt-3” route option. Piers are not placed inside the river course.</p>
<p>【Alt-3 – Steel Arch Bridge】</p>

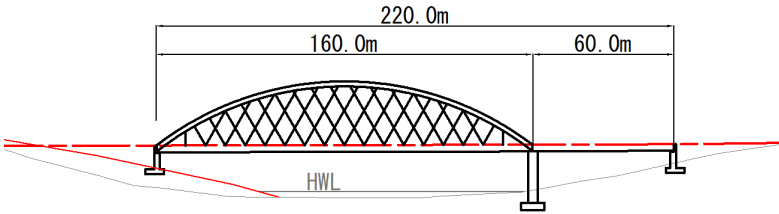
<p>An option with arch alternative to the above cable-stayed. Piers are not placed inside the river course.</p>
<p>【Alt-3 – Continuous Concrete Box Rigid Frame Bridge】</p>

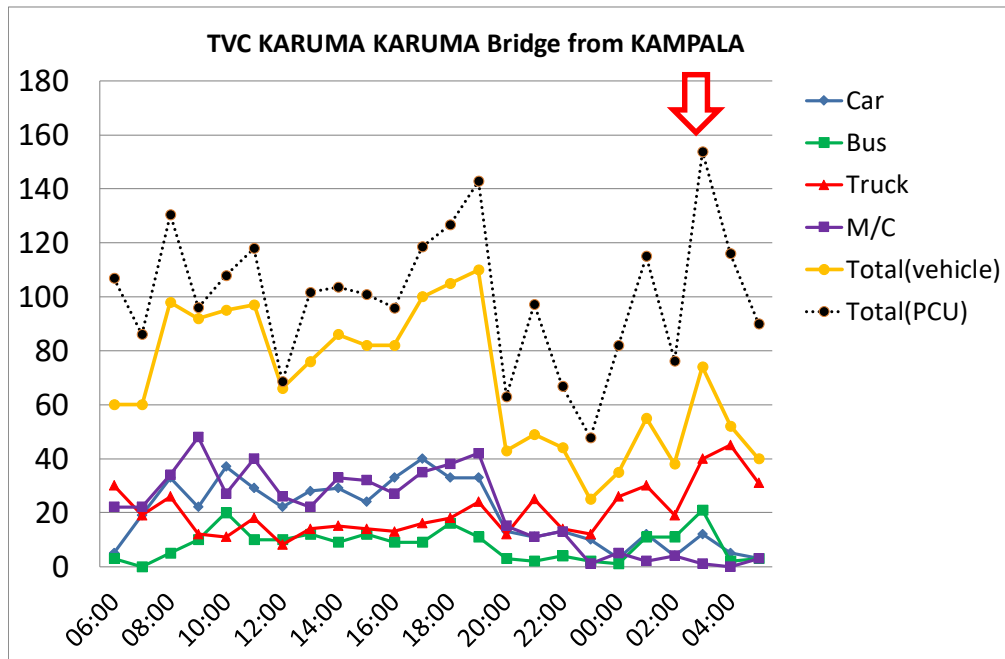
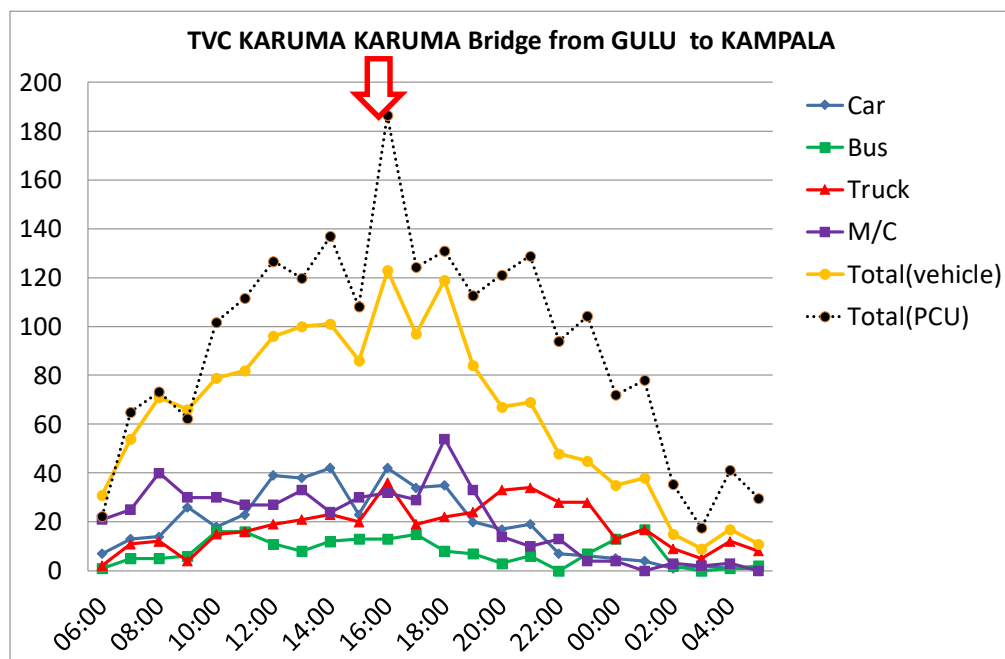
Peak time from Kampala to Gulu is 03:00. It means that most trucks pass the Karuma bridge under unsafe road conditions in order to arrive at the border between Uganda and South Sudan in the morning.

- ✓ [Peak Hour (pcu):Kampala→ Gulu] 03:00-04:00, 8.5% (186pcu/hour)
- ✓ [Peak Hour (pcu) Gulu→ Kampala] 16:00-17:00, 6.1% (154pcu/hour)

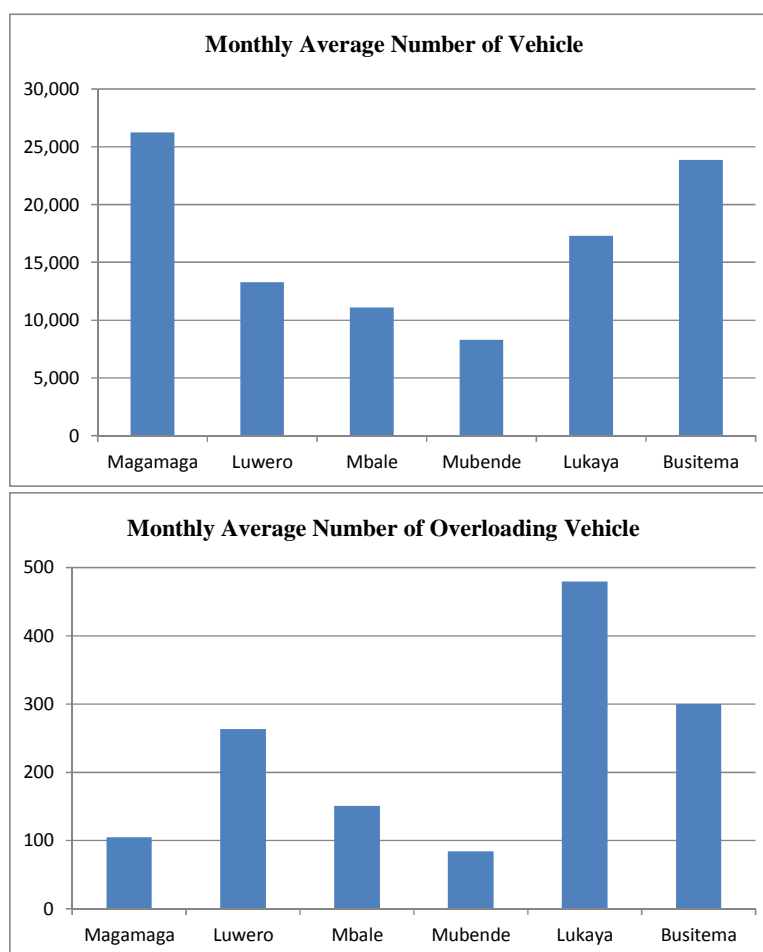
Figure 3.1 Summary of Axel Load Survey

Location		Average Weight (ton)									
		2 Axle	3 Axle	4 Axle	5 Axle	6 Axle	7 Axle	8 Axle	9 Axle	10 Axle	
1	Magamaga	14.0	22.0	23.0	28.0	34.0	36.0	43.0	51.0	52.0	
2	Luwero	15.0	21.0	23.0	29.0	33.0	36.0	44.0	46.0	53.0	
3	Mbale	16.0	24.0	24.0	29.0	36.0	37.0	46.0	50.0	54.0	
4	Mubende	15.0	23.0	22.0	28.0	33.0	38.0	45.0	49.0	52.0	
5	Lukaya	16.0	22.0	22.0	30.0	32.0	37.0	44.0	51.0	52.0	
6	Busitema	14.0	22.0	24.0	29.0	36.0	37.0	45.0	50.0	53.0
