DATA COLLECTION SURVEY
ON
THE MAINTENANCE OF POWER PLANTS
USING STATE-OF-THE-ART TECHNOLOGY SUCH AS
IoT AND AI
IN
THE REPUBLIC OF THE UNION OF MYANMAR

EXECUTIVE SUMMARY

September 2019

Japan International Cooperation Agency (JICA)

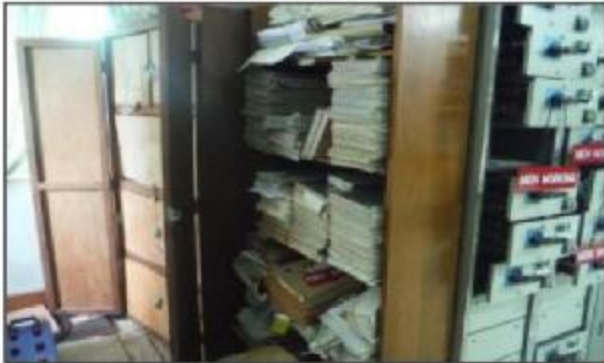
Critical operating records not managed with data

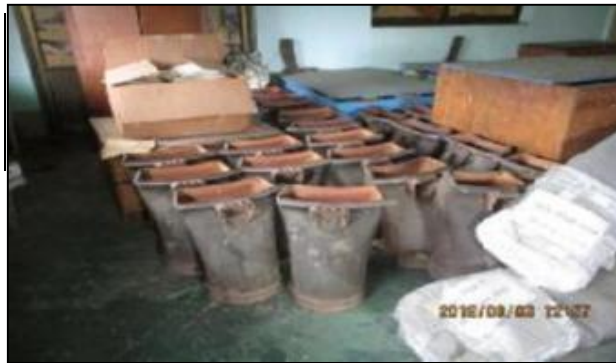
Unorganized parts management (Dead stock included)

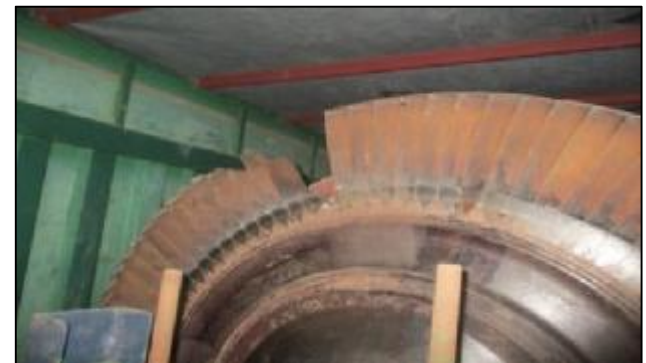
Gas turbine rotor left in damaged condition

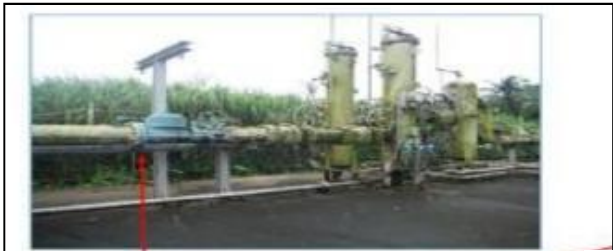
Dangerous operation in gas leakage condition

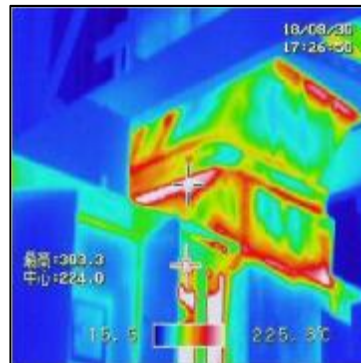
Detection of abnormal temp. exceeding design value

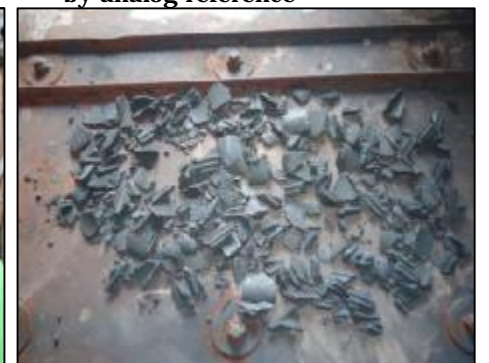
Damaged parts found in gas turbine

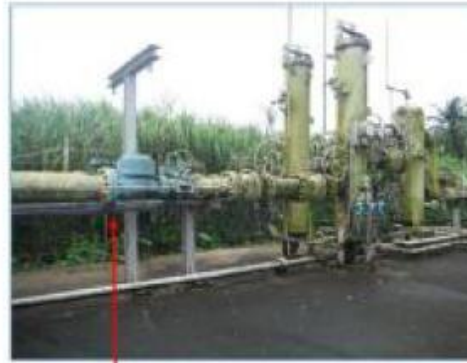
Gas leaks and Overheating

were found at some power Plants. (Dangerous situation)

Check valve flange (15%LEL)

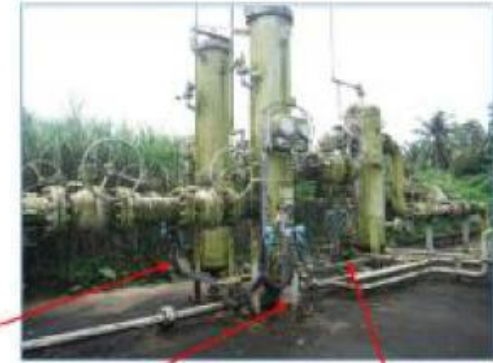
Cyclone separator level gauge lower side flange (32%LEL)

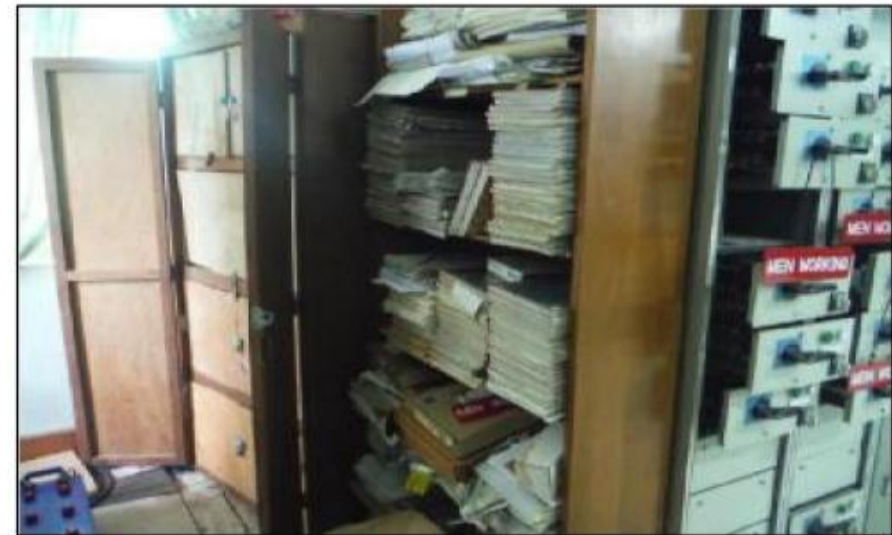
Control status of operation data

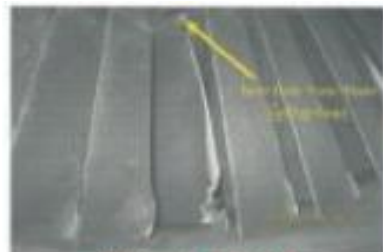
IGV was missed

Plant	Type	Plant Configuration	Original Capacity	Latest Capacity	Δ (delta)	Main Reason
Ywama	Fr5	2GT CHP	37MW	37MW	153MW	✓ H-25 1on1 was stopped due to heavy damages of Turbine buckets from 2014. ✓ 701D was stopped due to heavy damages of Compressor bucket from July, 2018.
	H-25	1on1 C/C	33MW	0MW		
	701D	2GT S/C	240MW	120MW		
Thaketa	Fr5	3GT S/C	57MW(GT) 35MW(ST)	38MW(GT) 0MW(ST)	54MW	✓ GT#2 was stopped from 2015 due to IGV damages. ✓ ST was stopped from 2013 due to High Vibration.
Hlawga	Fr6	3on1 C/C	100MW(GT) 54MW(ST)	67MW(GT) 36MW(ST)	51MW	✓ GT#3 was stopped from 2013 due to GEN grounding fault damage.
Ahlon	Fr6	3on1 C/C	100MW(GT) 54MW(ST)	100MW(GT) 0MW	54MW	✓ ST was stopped from Mar. 2018 due to HRSG tube leakage.
Thilawa	H-25	2GT S/C	50MW	50MW	0MW	✓ No issue
Total (Except Hydro)			760MW	448MW	312MW

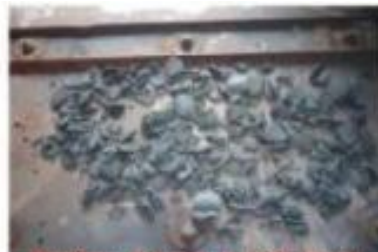
Broken pieces in Exh.Duct

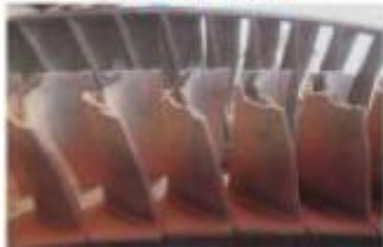
Blades were damaged

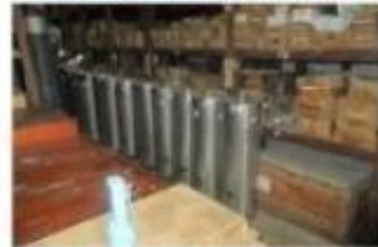
New materials not used

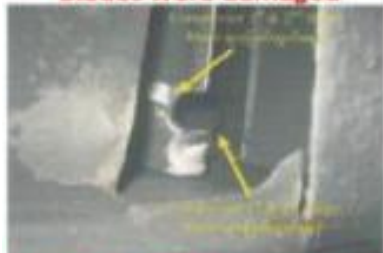
Comp. Blades were damaged

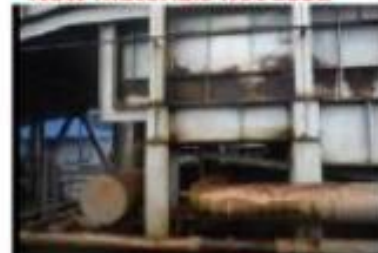
Casing over heated

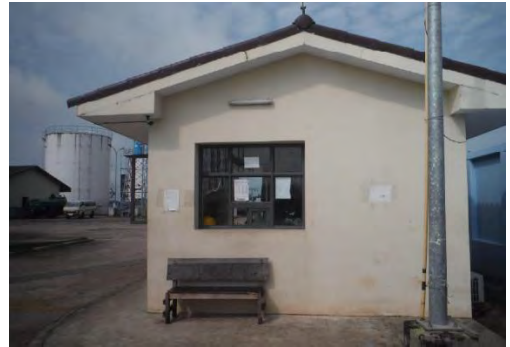
Fig. 3-18 Guardian Office (Thilawa P/S)

At some power plants such as the Thilawa power station, the keys are managed by using a control book, and access to the transformer and the gas compressor area is restricted.

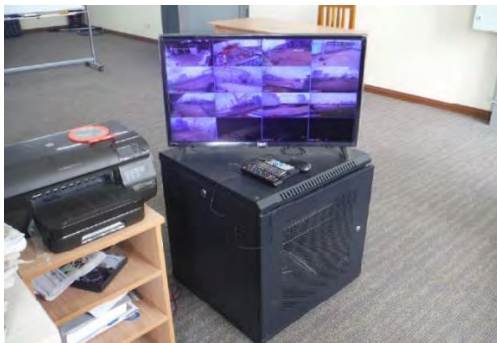
**Fig. 3-21 Surveillance Camera Monitoring Screen
(Thilawa P/S)**

In addition, security cameras are installed at the Thilawa power station, and it is possible to monitor the main gate and other places from the central control room.

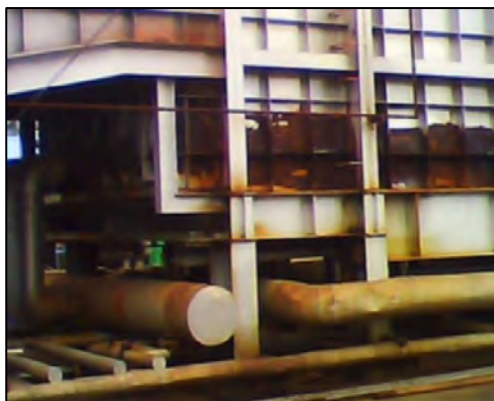
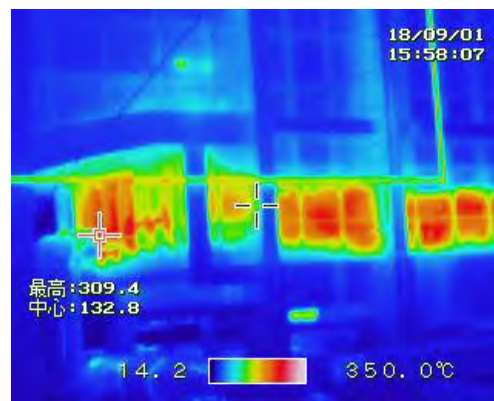
Fig. 3-31 HRSG Casing Overheating

It was confirmed that the maintenance condition of the thermal insulation coating of the HRSG casing was not sufficient and it overheated. At the time of the investigation, the bypass damper was closed and operated as a combined cycle, but it was confirmed that the bypass stack overheated. From this, it is considered that there is a leak in the bypass gas damper and the exhaust gas flows to the bypass stack side.

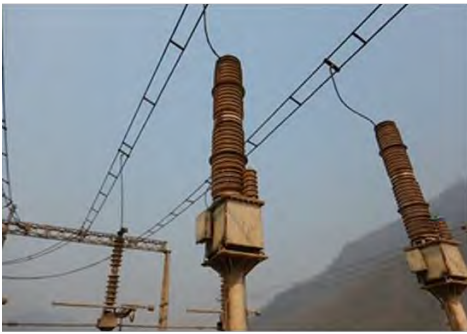
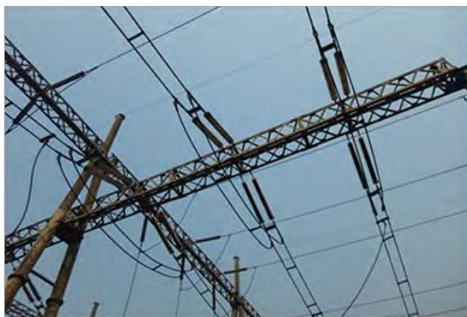
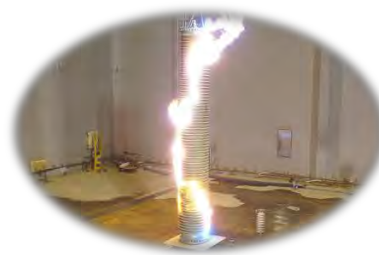
Fig. 3-35 Expected Risk of Occurrence of Grounding Fault

When the surface of the insulator is dirtied, the electrical current flows easily. When the voltage applied to the surface of the insulator exceeds the withstand voltage limit, it will lead to an insulation breakdown and grounding fault. The circuit breaker and disconnector are cleaned every year, so the insulation performance of the insulator is restored. However, insulation performance cannot be recovered because the insulators in high places have never been cleaned. It was found that river water and the algae cause electrical current to flow, and they lowered the withstand voltage of equipment. From these findings, it is evaluated that the adhesion of algae to the insulators is in a very dangerous situation, which may cause grounding faults in the near future. An example of the assumed situation should a grounding fault occur is shown in Fig. 3-38.

Insulator of circuit breaker and disconnector

Insulator of lattice steel structure of high place

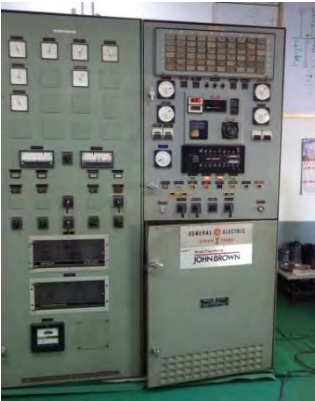
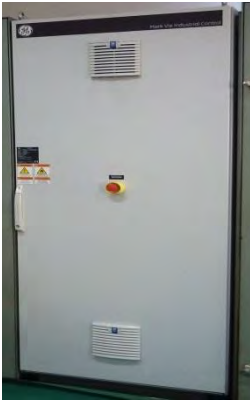
Analog control panel	Digital control panel (after updating)
Data sampling method	Reading the meter on the panel	Reading values on the maintenance tool
Data accumulation	Stored as paper (Not transferred to Excel, etc.)	Stored as paper (Not transferred to Excel, etc.)
Automatic data storage function	Not provided	Provided (Possible to be converted to Excel, etc.)
Control panel comparison

Even after the expensive control panel is updated, the data accumulating method is unchanged and the equipment is not effectively utilized.

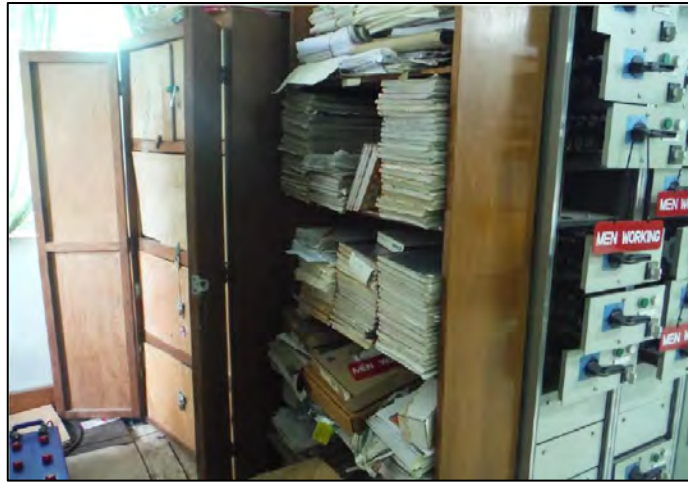
Fig. 3-41 Control Status of Operation Data, etc.

The paper-based records are stored in the book store room at the power plant. However, they are not filed or controlled on a time basis, but are simply stacked.

The logbooks are controlled in the same manner.

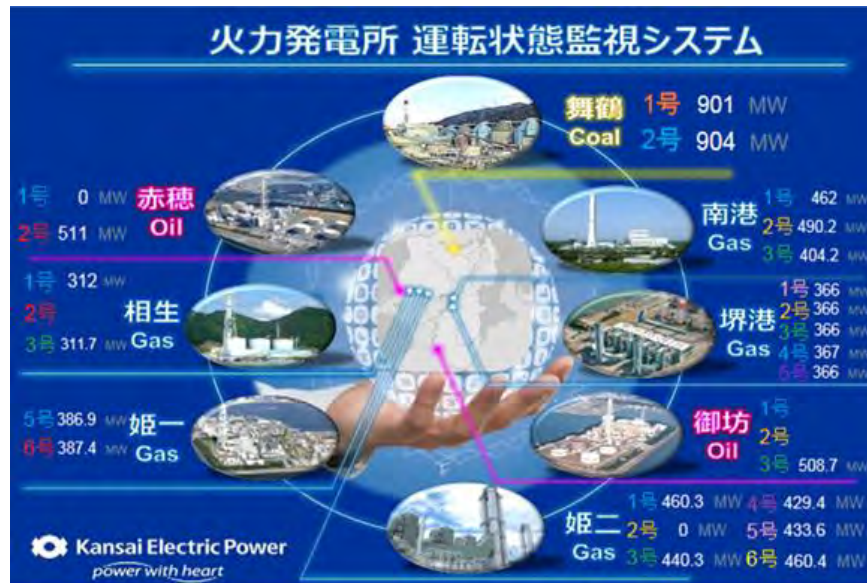
Fig. 4-1 Monitoring Screen (an example of KANSAI)

In response to the above recent trends, a Japanese electricity company introduced OSIsoft's PI System that has been widely adopted overseas and in other industries. Conventionally, monitoring of facilities for abnormalities depended heavily on the awareness and experience of on-site duty personnel and maintenance personnel, but the PI System makes it possible to uniformly predict and detect equipment trouble. In addition, it makes it possible to unify and manage the operation data in real-time between the head office

and all the thermal power plants, as well as to standardize monitoring (Fig. 4-1).

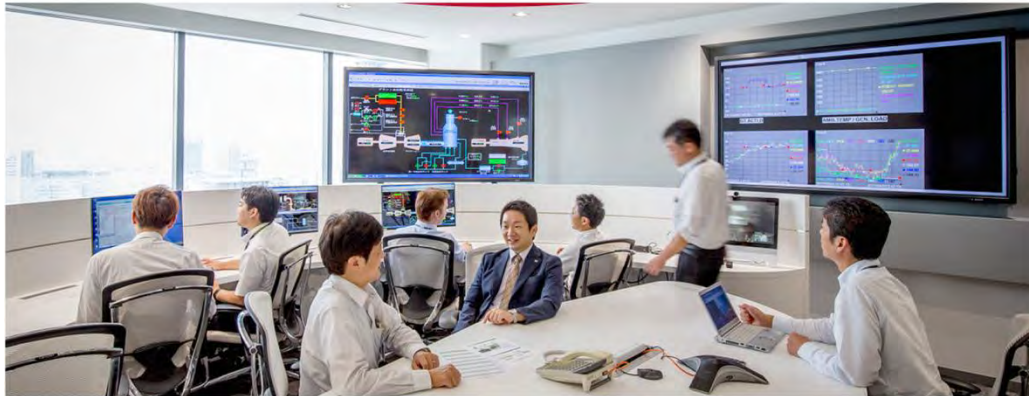
Fig. 4-2 A Pilot Equipment

The accuracy of detecting abnormal signs increases when a large volume of data is collected via remote monitoring that employs IoT and AI.

Therefore, we will introduce pilot equipment for data collection and remote monitoring in this survey, and verify the effectiveness of these digital solutions for the issues in Myanmar by actually operating the equipment.

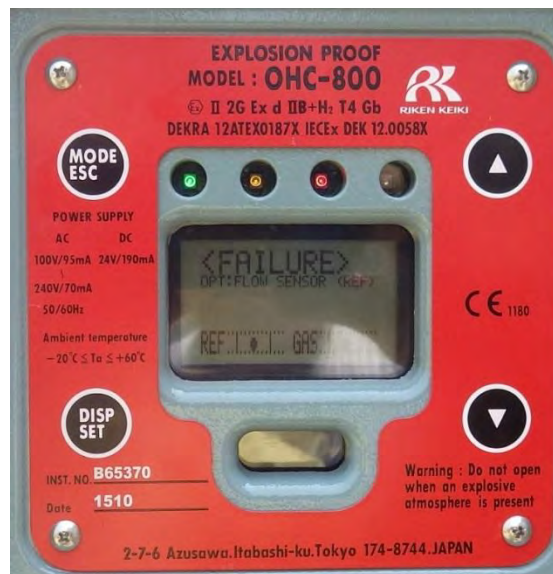
Fig. 4-8 Display of Calorimeter Showing "FAILURE"

After receiving the alert, the meter itself was manually checked and was found showing a "Failure" message.

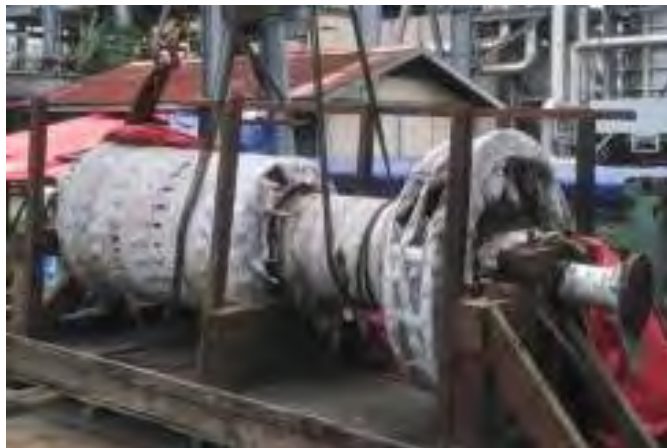
Fig. 5-16 Spare Rotor That Was Installed After Compressor Damage

The history of the replaced spare rotor is unclear. It was repaired by Corrttech, a company in India, and stored for more than 3 years. See Fig. 5-16.

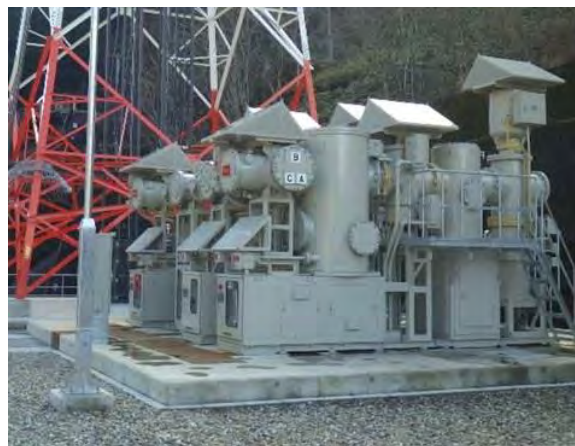
Fig. 5-21 GIS (Gas Insulated Switchgear)

A GIS (Gas Insulated Switchgear) is a gas-insulated switchgear housed in a cubicle. Circuit breakers, earthing switches, disconnectors, lightning arresters, and instrument transformers are integrated in a GIS. The appearance of a GIS is shown in Fig. 5-21.

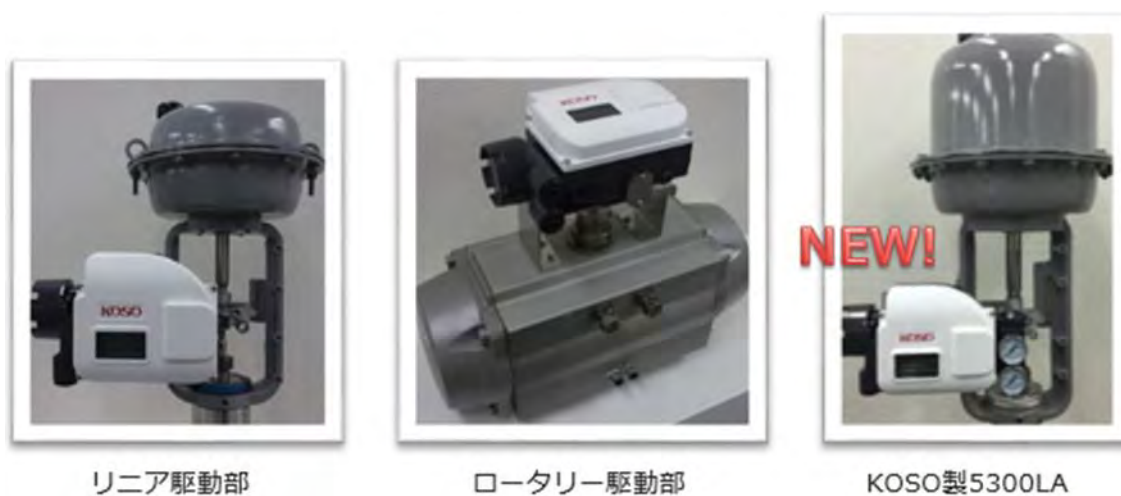
Fig. 6-4 Product Photos of Smart Valves

In general, a control valve (pneumatic type) used at a power plant has parts that wear and deteriorate over time in both of the valve main body and driving system. Also, it is necessary to overhaul the valve periodically in order to confirm the deterioration state. On the other hand, if the wear and deterioration of the control valve is understood by using the above-mentioned smart valve, it is possible to shift from time-based maintenance (TBM) to condition-based maintenance (CBM). Also, unlike a pneumatic positioner, an electric positioner has few parts that wear and deteriorate, and its accuracy is reliable because instrument error is less likely over time.

Installing the smart valve to the small power plants and simple cycle GTs with a small number of control valves will be low cost-performance because of high initial cost for renewing the positioner, building the system, etc. On the other hand, installing the smart valve to large power plants with a large number of control valves is feasible because of high cost-performance.

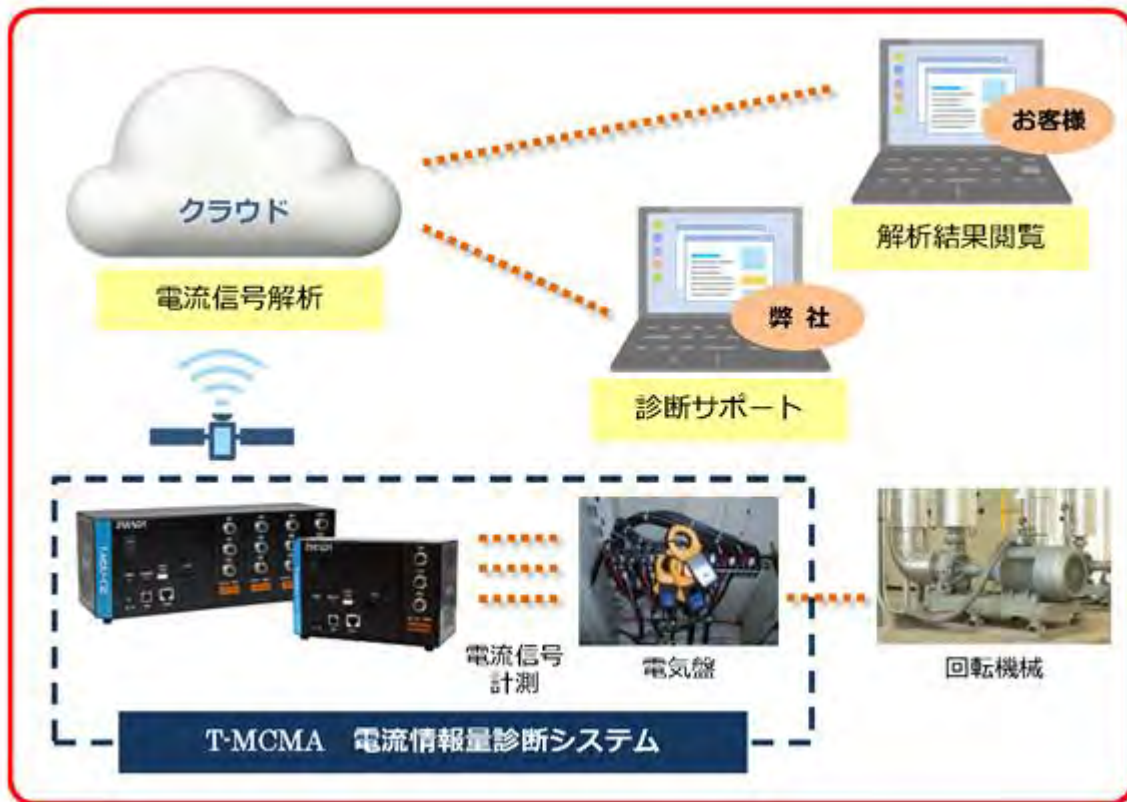
Fig. 6-6 Configuration Example of a Rotary Equipment Diagnostic System

A configuration example of a rotary equipment diagnostic system is described below.

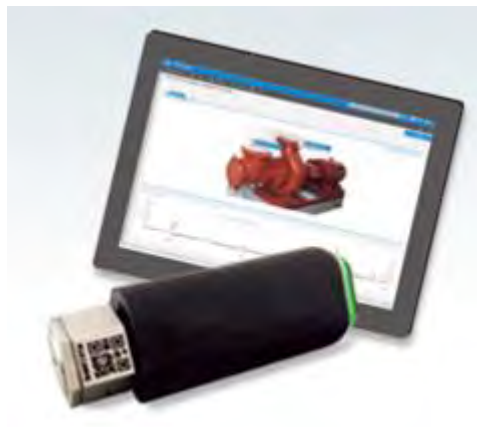
Fig. 6-7 Portable Vibration Sensor

However, in recent years, thanks to technological advances, compact, lightweight and easily retrofittable wireless vibration sensors with built-in batteries have been developed. Therefore, it is possible to prevent trouble by monitoring for abnormal symptoms and analyzing the vibrations when an abnormality occurs, by using this vibration sensor together with an analysis system.

Examples of a portable vibration sensor and vibration analysis system are shown below.

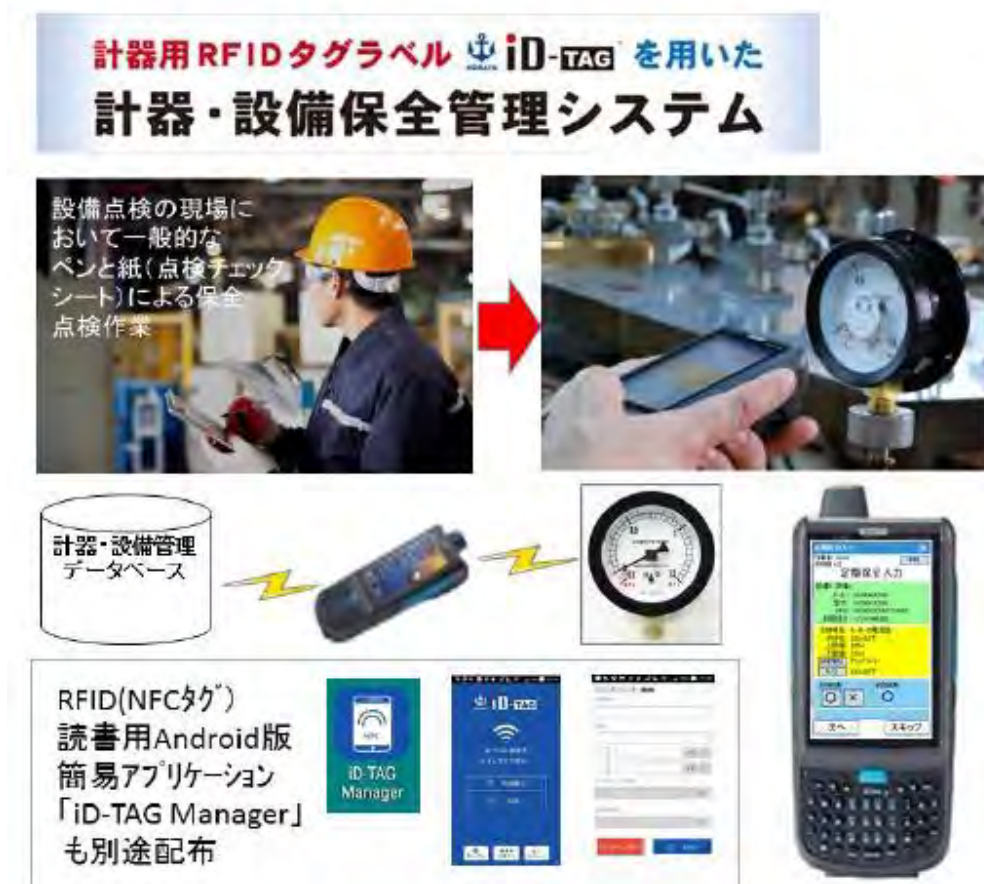
Fig. 6-9 Configuration Example of a Facility Maintenance Management System

As another IoT device undergoing field testing, there is a product that enables remote monitoring by linking the device with a monitoring system after installing a tag label on the glass surface of the indicator at the site. In addition, it is possible to link equipment specification documents, drawings and instruction manuals with information on the tag label. Therefore, improvement in work efficiency will be expected because workers can confirm the above information by using mobile devices in the field.

A configuration example of a facility maintenance management system using radio frequency identifier (RFID) labels is shown below.

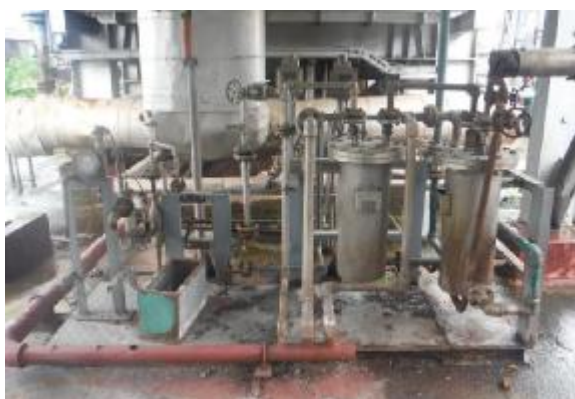
Installed Instrument Failure

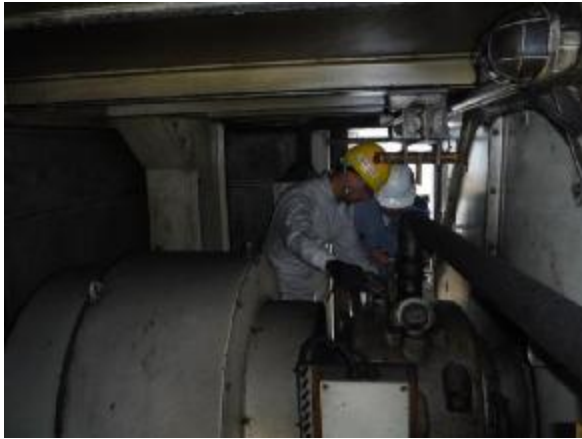
#2GT No.1

No.	#2GT Issues
1	Exciter side bearing high vibration (horizontal direction)
2	Diverter damper closing defect

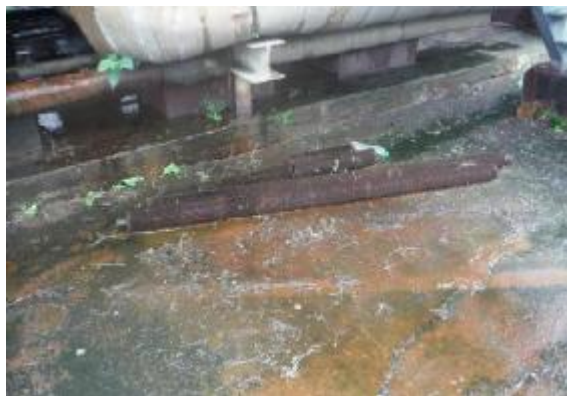
#1HRSG No.1

No.	#1HRSG Issues
1	Inappropriate storage of removed boiler tube
2	Control cable inappropriately laid around drum
3	Boiler top handrail damaged

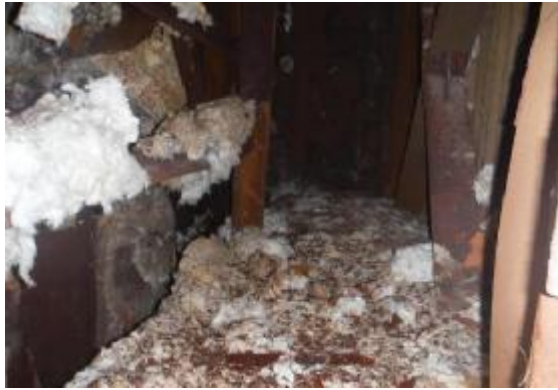
#3HRSG No.1

No.	#3HRSG Issues
1	Heat insulation material scattered around boiler

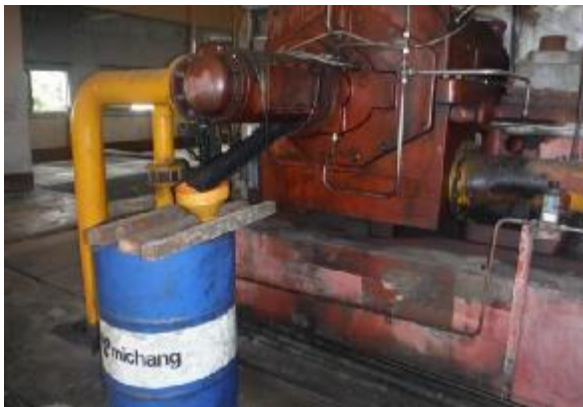
ST No.1

No.	Steam Turbine Issues
1	Turbine top oil leakage

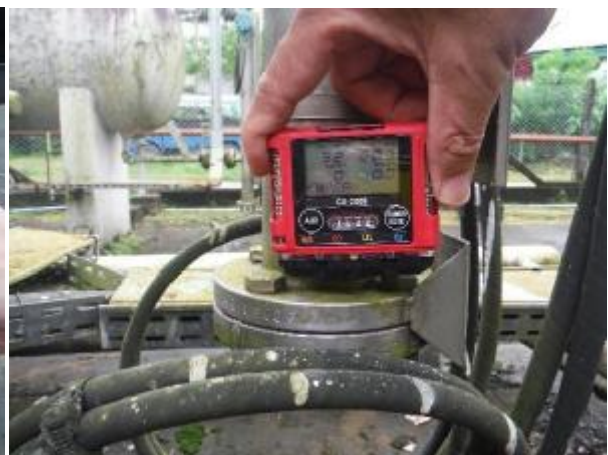
BOP No.2

No.	BOP Issues
1	Gas station strainer level gauge lower side flange gas leakage
2	Gas station cyclone separator level gauge lower side flange gas leakage
3	Gas station check valve outlet flange gas leakage

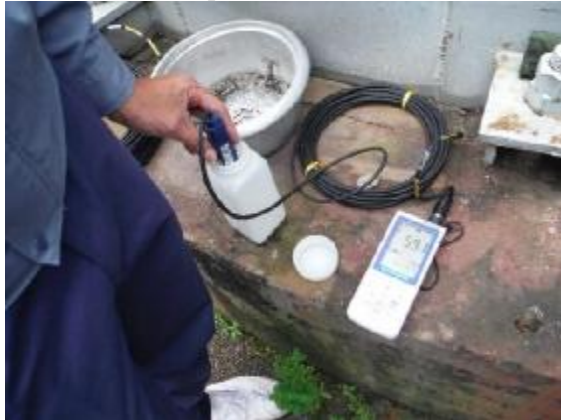
測定値	現地盤指示	装置仕様
1.793	1.19	-

Electric Conductivity (mS/m)

Water Quality Measurement

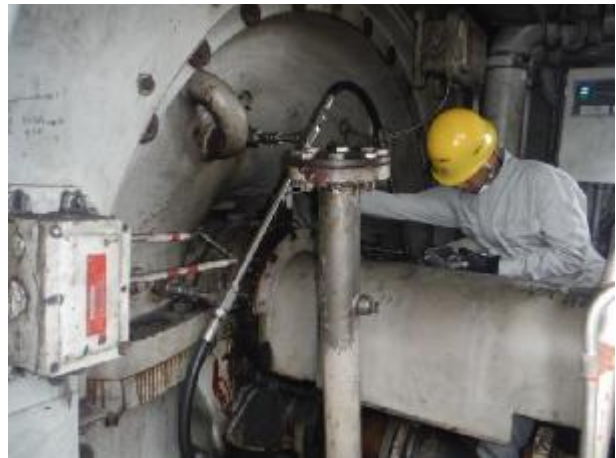
◆Vibration Measurement			
Title	Vibration Measurement		
Power Station	Ahlone		
Object	#2GT		
Measurer	Hiraoka (MHPS)		
Observer	Ozaki (Kansai)		
Equipment Specification			
Type	Frame6(GE) PG6541B	Capacity	38,340 kW (15°C)
Roating Speed	5100 rpm (GT) 3000 rpm (GEN)	COD	1995.4
Generation Type	T190-240 43MVA		
Measurement Result			
Measurement Date		9.5.2018	
Measurement Tool	Type	Portable Vibrometer	
	Serial Number	VA-10 00280204 Vibration Meter Rion Co., LTD	
#1 Bearing Stand	V	25 μm (6.71 mm/s)	
	H	30 μm (8.05 mm/s)	
	A	25 μm (6.71 mm/s)	
Exciter	V	90 μm (14.14 mm/s)	
	H	170 μm (26.70 mm/s)	
	A	52 μm (8.17 mm/s)

◆Vibration Measurement			
Title	Vibration Measurement		
Power Station	Ahlone		
Object	#3GT		
Measurer	Hiraoka (MHPS)		
Observer	Ozaki (Kansaï)		
Equipment Specification			
Type	Frame6(GE) PG6541B	Capacity	38,340 kW (15°C)
Roating Speed	5100 rpm (GT) 3000 rpm (GEN)	COD	1995.5
Generation Type	T190-240 43MVA		
Measurement Result			
Measurement Date		9.5.2018	
Measurement Tool	Type	Portable Vibrometer	
	Serial Number	VA-10 00280204 Vibration Meter Rion Co., LTD	
#1 Bearing Stand	V	35 μm (9.39 mm/s)	
	H	15 μm (4.03 mm/s)	
	A	27 μm (7.25 mm/s)	
Exciter	V	15 μm (2.36 mm/s)	
	H	40 μm (6.28 mm/s)	
	A	44 μm (6.91 mm/s)

Vibration Measurement

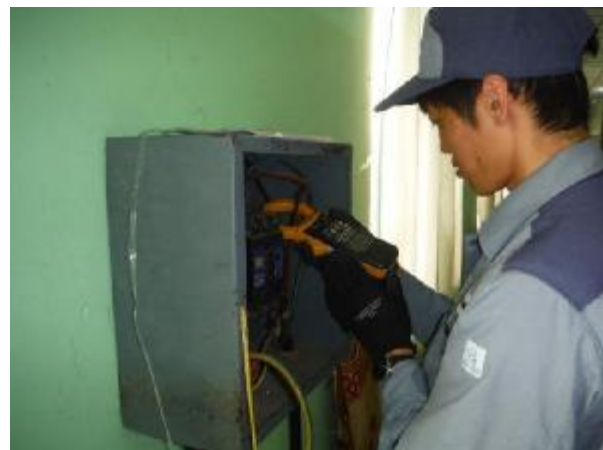
Current measurement was carried out with the No.2 exhaust flame cooling fan of the #3 GT.
No abnormality

◆Motor Current Measurement			
Title	Motor Current Measurement		
Power Station	Ahlone		
Object	#3 GT Exhaust Frame Cooling Fan		
Measurer	Sato (Kansaï)		
Observer	Ozaki (Kansaï)		
Motor Specification			
Type	-	Capacity	30 kW
Number of Poles	2	Serial Number	752163000002
Rotating Speed	2955 rpm	Voltage	400V
Current	52 A	Insulation Type	F
Manufacturer	LEROY SOMER	Made Date	-
Measurement Result			
Measurement Date		9.5.2018	
Measurement Tool	Type	HIOKI 3285	
	Serial Number	80523503	
	Calibration Date	2009.8	
Phase Current	A	19.0 A	
	B	20.5 A	
	C	20.6 A

Current Measurement

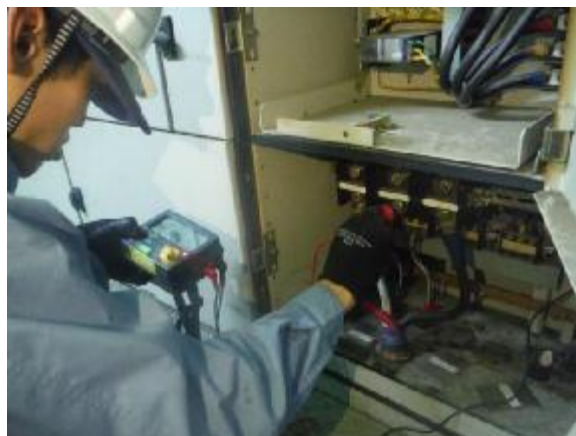
No abnormality

◆Motor Insulation Resistance Measurement			
Title	Insulation Resistance Measurement of Low Voltage Motor		
Power Station	Ahlone		
Object	B-Condensate Pump		
Measurer	Sato (Kansai)		
Observer	Ozaki (Kansai)		
Motor Specification			
Type	Totally-enclosed Fan-cooled	Capacity	110kW
Number of Poles	4	Serial Number	K11R315S4 TWS
Rotating Speed	1480 rpm	Voltage	400V
Current	195A	Insulation Type	-
Manufacturer	VEM motors	Made Date	1998.5
Measurement Result			
Measurement Date		9.5.2018	
Measurement Tool	Type	Insulation Resistance Measuring Device 500V Type	
	Serial Number (Model)	YOKOGAWA MY40-01	
	Calibration Date	2017.8	
Condition	Weather	Cloudy	
	Temperature (°C)	29.7°C	
	Humidity (%)	75%	
Insulation Resistance	MΩ	8.3 MΩ	
Reference Value: more than 1MΩ

Insulation Resistance Measurement

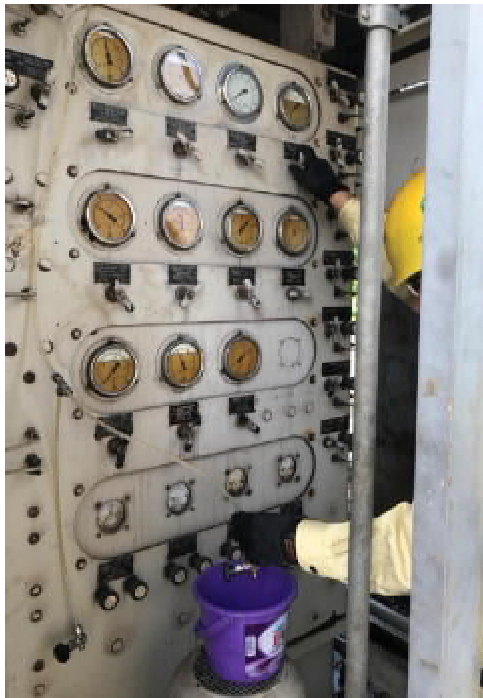
Item	Unit	Reference Value		Analysis Result	Evaluation
		Value	Exhibition		
Acid number	mgKOH/g	≦0.3	JIS K2213	0.07	ü
Kinematic viscosity	mm ² /s (40°C)	28.8~35.2	JIS K2213	31.94	ü
Moisture	%	≦0.1	ASTM 4378-01	0.003	ü
Sludge Content	Mg/100ml	≦10	General Reference Value	0.6 (mesh 0.80.8)	ü

ü : The analysis results met the reference values and no degradation was observed.

Lube Oil Sampling
Sampling Point : #3GT Pressure Gauge
Connect point

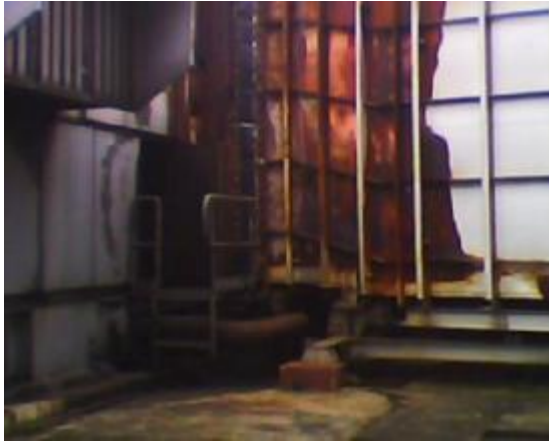
Overheating of the GT exhaust duct and gas leakage of the bypass damper, etc. were found.

GT Exhaust Duct Overheating (#1, 2, 3 GT)

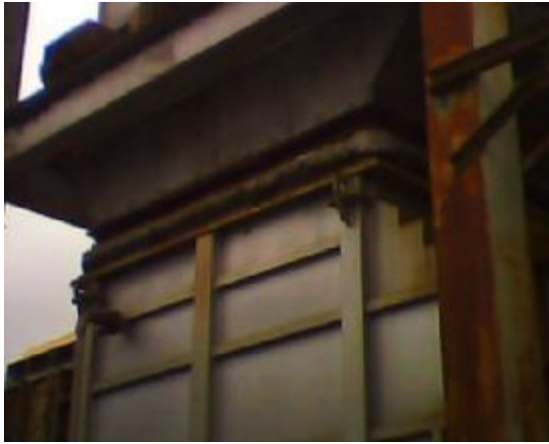
Bypass Stack Expansion Joint Gas Leakage (#1, 2, 3 HRSG)

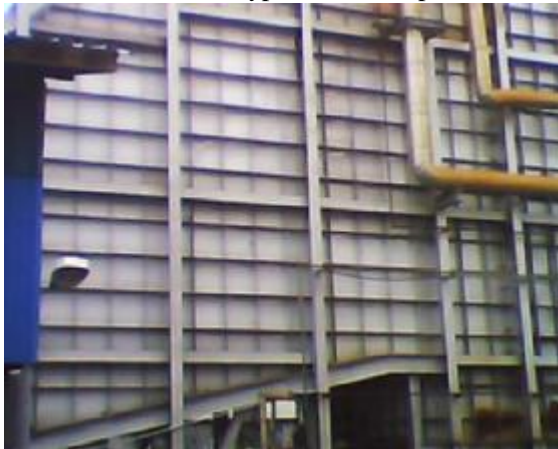
Bypass Damper Gas Leakage (#2, 3 HRSG)

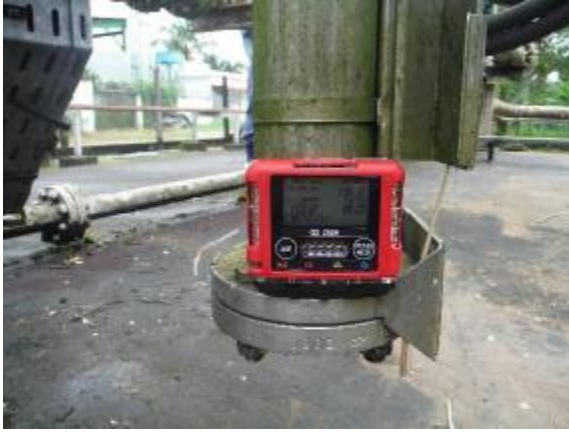
Gas leakage diagnosis of NG station was carried out using a portable gas detector.
Gas leakage at the strainer inlet/outlet flange was found.

Strainer Level Gauge Flange Gas Leakage

※Gas leakage concentration of the strainer level gauge flange exceeded the LEL (lower explosion limit).

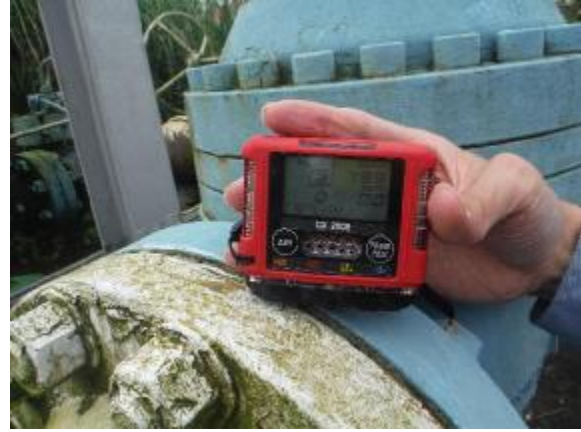
Check Valve Outlet Flange Gas Leakage

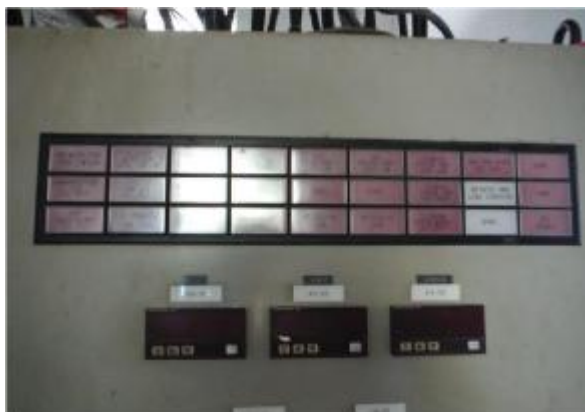
- There is no chemical analysis room at the power station to conduct water quality, lubricant, control oil, or fuel management.
- Lube oil is only checked at the tank level; exchange standards, replacement timing, etc. are not specified.
- For water quality control, water quality is checked by portable analyzer due to malfunction of installed instruments. (PH, electric conductivity)
- However, periodic calibration of instruments has not been implemented.

Instrument Malfunction

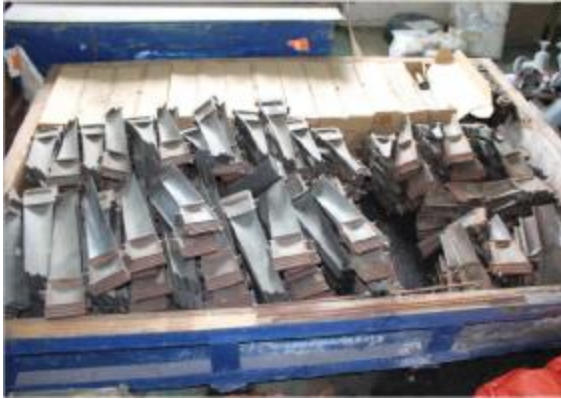
- Spare parts are kept in a warehouse and managed by spare parts list. Stocktaking is carried out once a year.
- Brand new and used (required for repair) parts exist together.
- Lifetime management by serial management has not been implemented for hot gas parts, and proper management has not been implemented.
- Interchange of spare parts between power stations is possible with the approval of EPGE.

Gas Turbine Rotor Blade (Used)

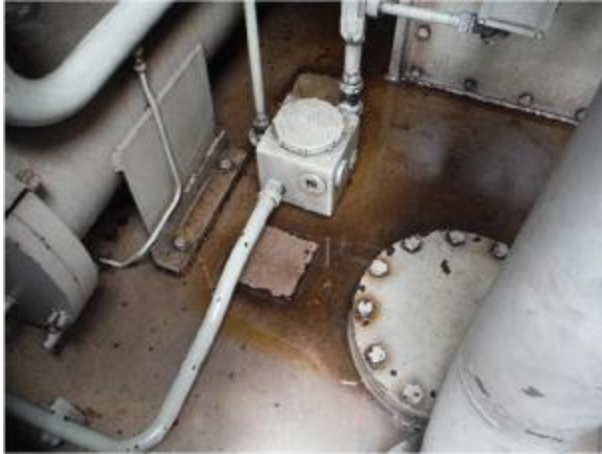
GT Common Issue No.1

No.	Gas Turbine Common Issues (#1GT, #2GT, #3GT)
7	GT local instrument malfunction
8	Main transformer local instrument malfunction
9	Main transformer silica gel degradation
10	GT enclosure deterioration

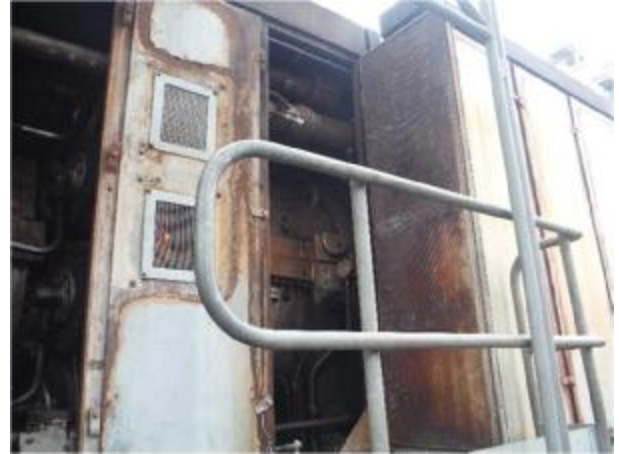
GT Common Issue No.2

No.	Gas Turbine Common Issues (#1GT, #2GT, #3GT)
1	Oil leakage around GT starter equipment
2	GT casing gas leakage
3	Cable trench top cover damage
4	CO2 fire extinguishing equipment deterioration
5	Intake air filter automatic cleaning equipment failure
6	Instrument malfunction of fuel system (gas flow, pressure)

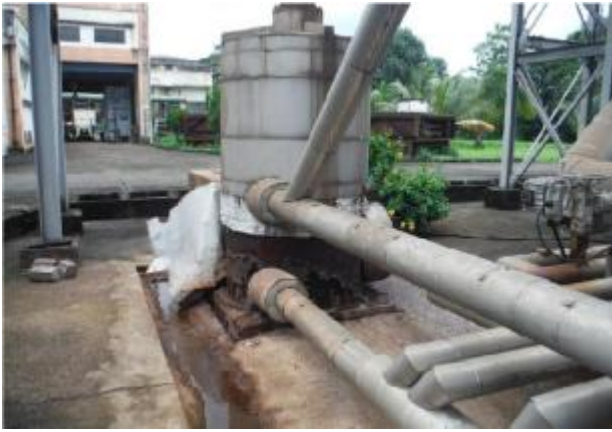
HRSG Common Issue No.1

No.	HRSG Common Issues (#1HRSG, #2HRSG, #3HRSG)
1	Blowdown tank corrosion damage
2	Casing overheating and external seizure (insulation deterioration)
3	Expansion joints deterioration
4	Bypass damper seal air fan failure
5	Sampling device and instrument malfunction
6	Drum level meter malfunction
7	Feed water control valve malfunction
8	Pipe and valve insulation deterioration
9	Local instrument, transmitter failure
10	Chemical injection pump leakage, injection pipe clogging

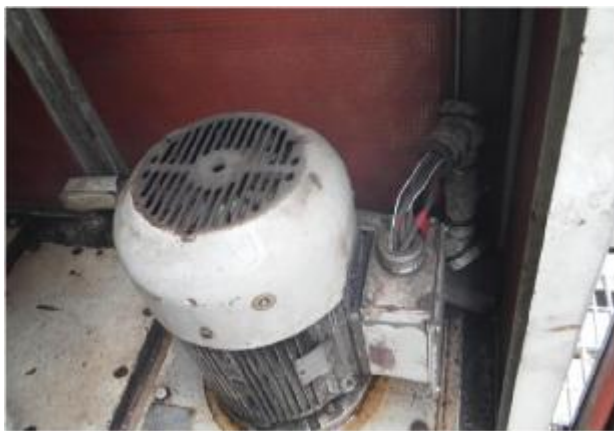
#1GT No.1

No.	#1GT Issues
1	Oil pump motor power cable terminal processing defects
2	Exhaust gas duct and expansion joints gas leakage
3	Starter unit and GT base oil leakage
4	Oil supply line around starter unit oil leakage
5	Turbine three-stage wheel space temperature rise
6	Exhaust frame cooling fan malfunction or two unit operation due to filter clogging (usually one unit operation)
7	High lube oil temperature
8	#1 and #2 bearing vibration meter malfunction
9	No.2 frame detector malfunction
10	Governor command problem
11	Other alarms <ul style="list-style-type: none"> · No. 1 exhaust frame cooling fan low outlet pressure · EOP startup command · Control hydraulic low pressure · Bleed valve position problem

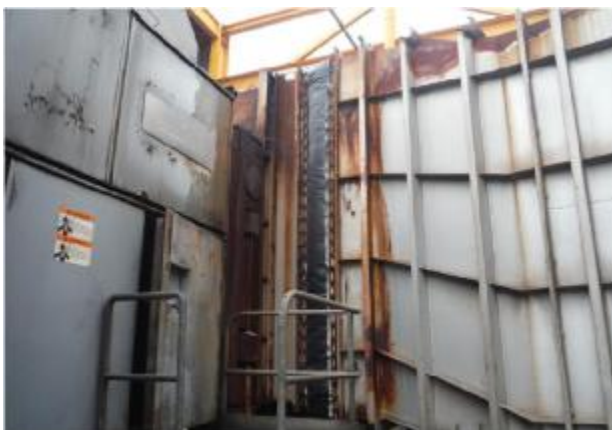
#2GT No.1

No.	#2GT Issues
1	Exhaust gas duct and expansion joints gas leakage
2	Starter unit and GT base oil leakage
3	Governor command problem
4	Other alarms <ul style="list-style-type: none"> · Inlet filter failure · IGV opening failure · Bleed valve forced open signal

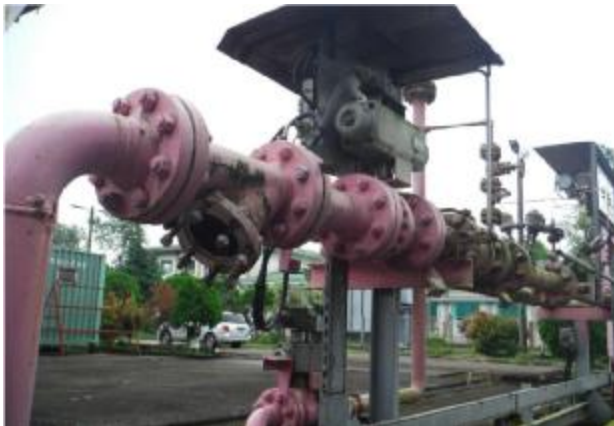
#3GT No.1

No.	#3GT Issues
1	Fuel gas strainer removed
2	Starter unit parts removed
3	Under inspection due to generator ground fault
4	Dirt around the starter unit due to long-term stoppage

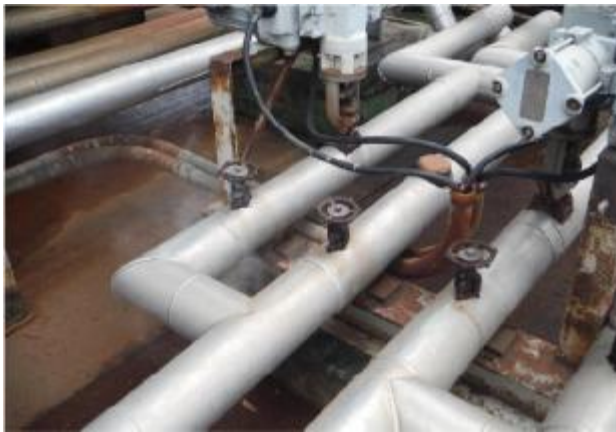
#2HRSG No.1

No.	#2HRSG Issues
1	Steam leakage from blow valve (manual valve) gland
2	SH spray control valve flange leakage
3	Insufficient number of manhole tightening bolts

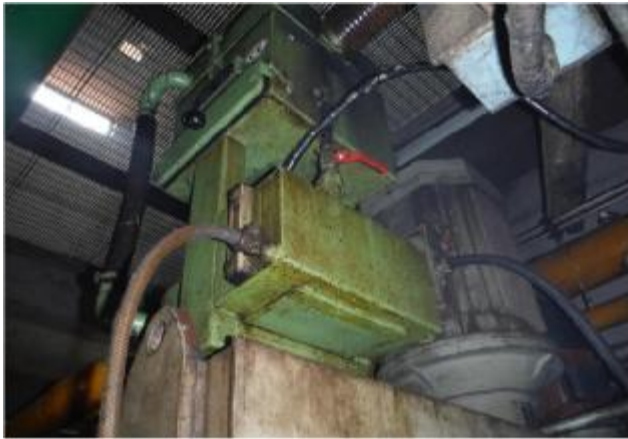
ST No.1

No.	Steam Turbine Issues
1	Main oil tank exhaust oil separator filter clogging and gas leakage
2	Oil leakage around main oil tank
3	Oil leakage around turbine base
4	Instruments malfunction
5	Oil leakage around generator base
6	Terminal block cover open

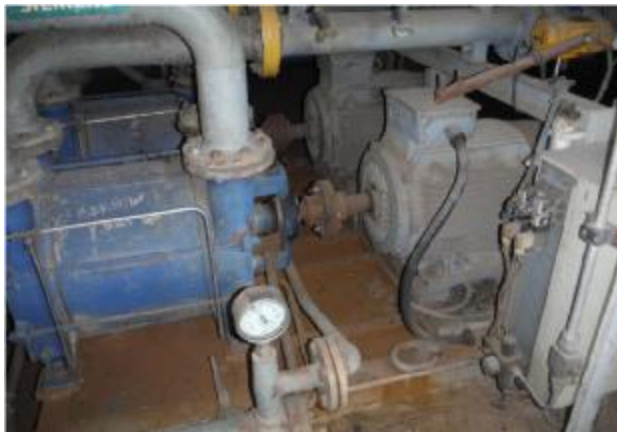
BOP No.1

No.	BOP Issues
1	A/B vacuum pump coupling cover removed
2	A/B vacuum pump inlet valve (solenoid valve) defect
3	Cooling tower concrete deterioration
4	B cooling tower fan removed due to damaged
5	Oil leakage around condensate pump
6	A/C feed water pump gland leakage
7	B feed water pump coupling disconnected
8	Control air compressor failure (both are stopped)
9	Control air dryer failure (stopped)
10	Chemical injection equipment degradation (NH ₃ , Na ₂ SO ₃)
11	Fresh water intake pump room submerged

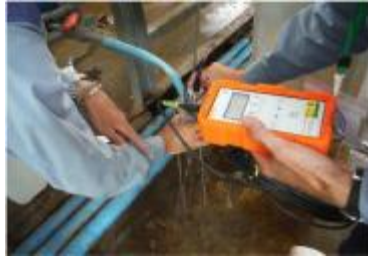
- Since the installed instruments on the pure water apparatus and the boiler water sampling equipment are broken, pH and conductivity are measured manually (portable analyzer).

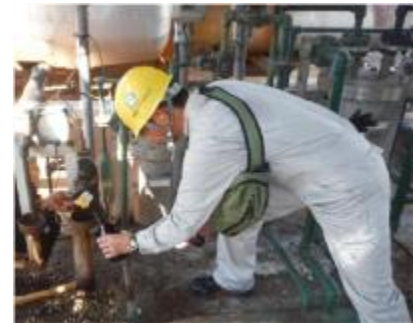
Sampling Point

- At present, there are many leaks at the gland of the chemical injection pump to the boiler water supply system, and it is operated limitedly.

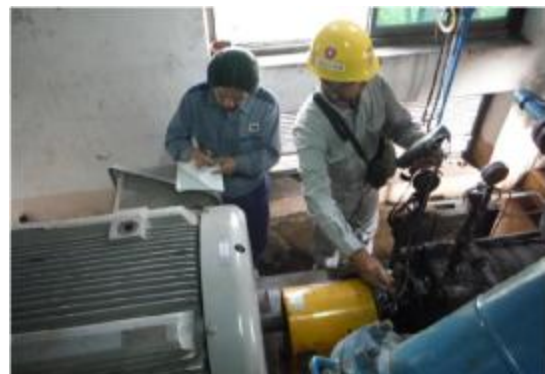
Title		Vibration Measurement	
Power Station	Hlawaga		
Object	F6 GTCC A-Feed Water Pump		
Measurer	Hiraoka (MHPS)		
Observer	Ozaki (Kansai)		
Equipment Specification			
Type	Centrifugal Pump	Capacity	48 kgf/cm2
Roating Speed	2980 rpm	Serial Number	RW08432-01 1/3
Current	24.3A	Voltage	6,600V
Manufacturer	EBARA	Made Date	2010
Measurement Result			
Measurement Date		9.1.2018	
Measurement Tool	Type	Portable Vibrometer	
	Serial Number	VA-10 00280204 Vibration Meter Rion Co., LTD	
Pump Bearing (Free Side)	V	20 μm	
	H	50 μm	
	A	37 μm	
Pump Bearing (Coupling Side)	V	35 μm	
	H	70 μm	
	A	20 μm	
Motor Bearing (Coupling Side)	V	15 μm	
	H	15 μm	
	A	14 μm	
Motor Bearing (Free Side)	V	20 μm	
	H	40 μm	
	A	35 μm	
Vibration Reference Value (JIS B 8301): 35μm

Title		Vibration Measurement	
Power Station	Hlawaga		
Object	F6 GTCC C-Feed Water Pump		
Measurer	Hiraoka (MHPS)		
Observer	Ozaki (Kansai)		
Equipment Specification			
Type	Centrifugal Pump	Capacity	48 kgf/cm2
Roating Speed	2980 rpm	Serial Number	RW08432-01 3/3
Current	24.3A	Voltage	6,600V
Manufacturer	EBARA	Made Date	2010
Measurement Result			
Measurement Date		9.1.2018	
Measurement Tool	Type	Portable Vibrometer	
	Serial Number	VA-10 00280204 Vibration Meter Rion Co., LTD	
Pump Bearing (Free Side)	V	15 μm	
	H	35 μm	
	A	25 μm	
Pump Bearing (Coupling Side)	V	25 μm	
	H	40 μm	
	A	30 μm	
Motor Bearing (Coupling Side)	V	30 μm	
	H	60 μm	
	A	20 μm	
Motor Bearing (Free Side)	V	18 μm	
	H	40 μm	
	A	50 μm	
Vibration Reference Value (JIS B 8301): 35μm

Title		Vibration Measurement	
Power Station	Hlawaga		
Object	F6 GTCC B-Condensate Pump		
Measurer	Hiraoka (MHPS)		
Observer	Ozaki (Kansai)		
Equipment Specification			
Type	Centrifugal Pump	Capacity	304 m3/h
Roating Speed	1,485 rpm	Serial Number	1238606/01-3
Current	195A	Voltage	400V
Manufacturer	APOLO	Made Date	1998
Measurement Result			
Measurement Date		9.1.2018	
Measurement Tool	Type	Portable Vibrometer	
	Serial Number	VA-10 00280204 Vibration Meter Rion Co., LTD	
Pump Bearing (Free Side)	V	35 μm	
	H	45 μm	
	A	35 μm	
Pump Bearing (Coupling Side)	V	35 μm	
	H	50 μm	
	A	-	
Motor Bearing (Coupling Side)	V	23 μm	
	H	40 μm	
	A	70 μm	
Motor Bearing (Free Side)	V	30 μm	
	H	60 μm	
	A	55 μm	
Vibration Reference Value (JIS B 8301): 54μm

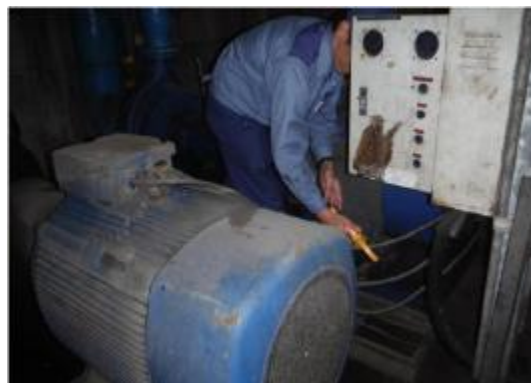
Current measurement was carried out with the B condensate pump. No abnormality

Title	Motor Current Measurement		
Power Station	Hlawaga		
Object	F6 GTCC B-Condensate Pump		
Measurer	Sato (Kansai)		
Observer	Fujihara (Kansai)		
Motor Specification			
Type	Totally-enclosed Fan-cooled	Capacity	110kW
Number of Poles	4	Serial Number	K11R315S4 TWS
Rotating Speed	1480 rpm	Voltage	400V
Current	195A	Insulation Type	-
Manufacturer	VEM motors	Made Date	1998.5
Measurement Result			
Measurement Date		9.1.2018	
Measurement Tool	Type	HIOKI 3285	
	Serial Number	80523503	
	Calibration Date	2009.8	
Phase Current	A	169.8 A	
	B	164.8 A	
	C	165.1 A

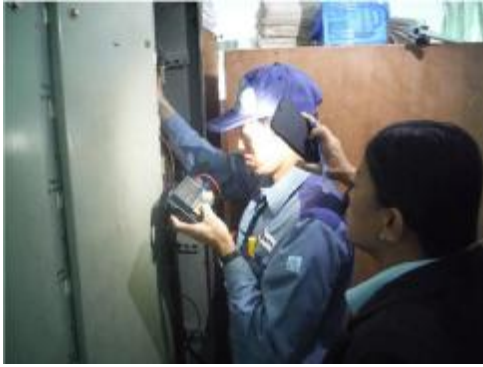
Insulation resistance measurement was carried out with the # 3 GT lubricating oil cooler fan (No. 2, No. 3). It was confirmed that the insulation of the No.3 fan was deteriorated.

Title	Insulation Resistance Measurement of Low Voltage Motor		
Power Station	Hlawaga		
Object	#3GT FIN FAN Cooler #3		
Measurer	Sato (Kansai)		
Observer	Fujihara (Kansai)		
Motor Specification			
Type	Totally-enclosed Fan-cooled	Capacity	7.5kW
Number of Poles	8	Serial Number	K11R315S4 TWS
Rotating Speed	720 rpm	Voltage	400V
Current	16.6A	Insulation Type	F
Manufacturer	ELECTROMO	Made Date	-
Measurement Result			
Measurement Date		9.3.2018	
Measurement Tool	Type	Insulation Resistance Measuring Device 500V Type	
	Serial Number (Model)	YOKOGAWA MY40-01	
	Calibration Date	2017.8	
Condition	Weather	Cloudy after Rain	
	Temperature (°C)	27.3°C	
	Humidity (%)	51%	
Insulation Resistance	MΩ	0.026 MΩ	
Reference Value: more than 1MΩ

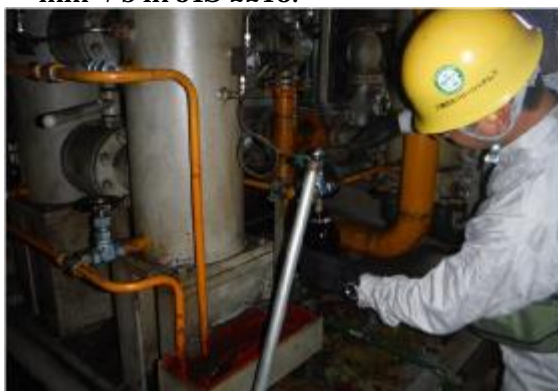
Lube Oil Sampling
Sampling Point : Lube oil strainer blow line

Item	Unit	Reference Value		Analysis Result	Evaluation
		Value	Exhibition		
Acid Number	mgKOH/g	≤0.3	JIS K2213	0.08	ü
RPVOT(RBOT)	min	100	General Reference Value	410	ü
Kinematic Viscosity	mm ² /s(40°C)	41.4~50.6	JIS K2213	47.22	ü
Moisture	%	≤0.1	ASTM 4378-01	0.0041	ü
Sludge Content	Mg/100ml	≤10	General Reference Value	0.3 (mesh0.8µm)	ü

ü : The analysis results met the reference values and no degradation was observed.

All other items were within the reference values, therefore it was considered that there was no decline in lubricating oil performance.
