DATA COLLECTION SURVEY
ON
THE MAINTENANCE OF POWER PLANTS
USING STATE-OF-THE-ART TECHNOLOGY SUCH AS
IoT AND AI
IN
THE REPUBLIC OF THE UNION OF MYANMAR

EXECUTIVE SUMMARY

September 2019

Japan International Cooperation Agency (JICA)

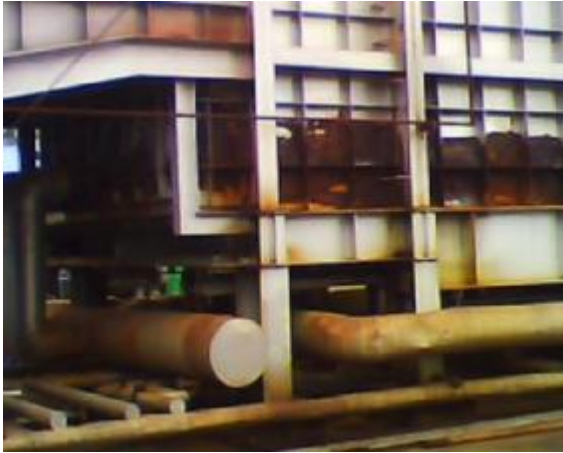
HRSG Casing Overheating (#1HRSG, #2HRSG)

Overheating of the HRSG casing and gas leakage of the bypass damper were found.

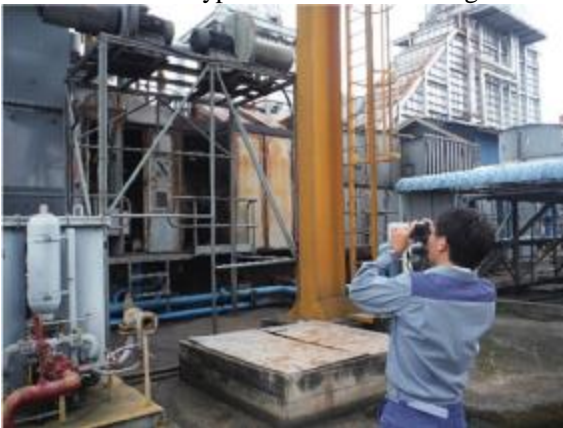
Leakage Diagnosis by Thermal Camera

Surveys such as gas leakage, steam leakage, overheating, etc. of equipment (GT, HRSG) during operation were conducted using a thermal camera.

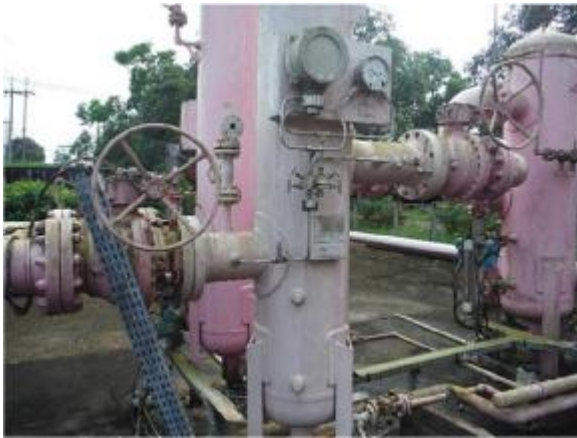
Strainer Inlet/Outlet Flange Gas Leakage

Gas leakage diagnosis of NG station was carried out using a portable gas detector.
Gas leakage at the strainer inlet/outlet flange was found.

※The flange was not tightened by bolts; it was isolated with front and rear valves.
(Sheet leakage of front valve or rear valve)

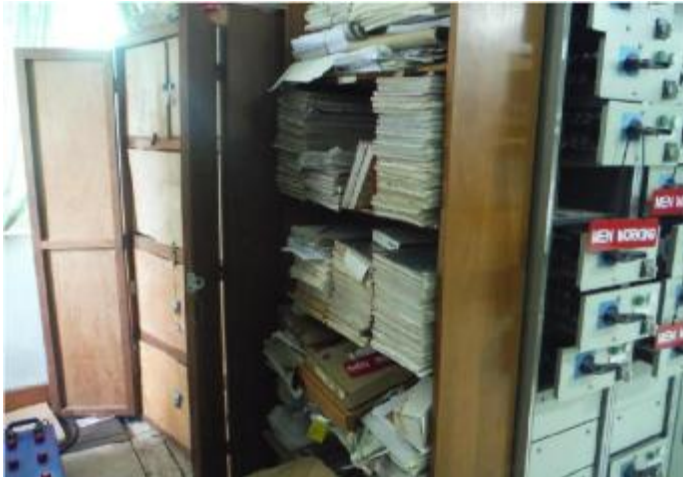
Storage Conditions of Recorded Data

- Operation data is compared with the reference values to check for problems, but data is not accumulated or analyzed.
- Operation data, various records, etc. are stored on a bookshelf, etc., but they do seem not to be utilized.

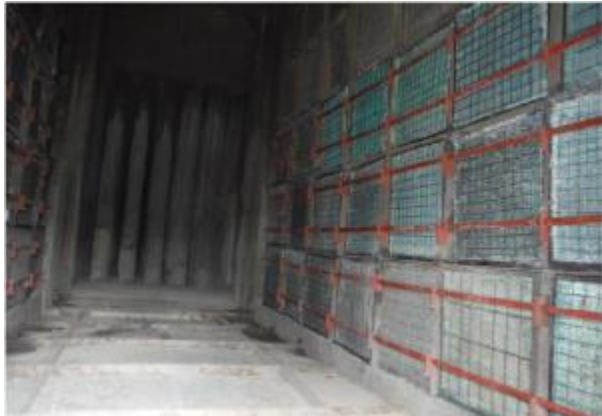
GT Common Issue No.1

No.	Gas Turbine Common Issues (#1GT, #2GT, #3GT)
1	Intake air filter deterioration
2	Instrument malfunction of fuel system (flow meter)
3	Oil leakage around GT starter equipment
4	Gas leakage at gas station

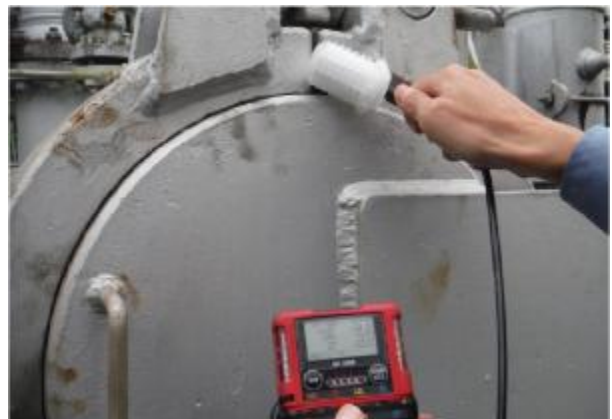
GT Common Issue No.4

- ž Since both the GT and ST were stopped during the first site survey, simple diagnosis was not carried out.
- ž Gas leakage inspection was carried out at the gas station, and there was a lot of gas leakage at the strainer lid, etc.

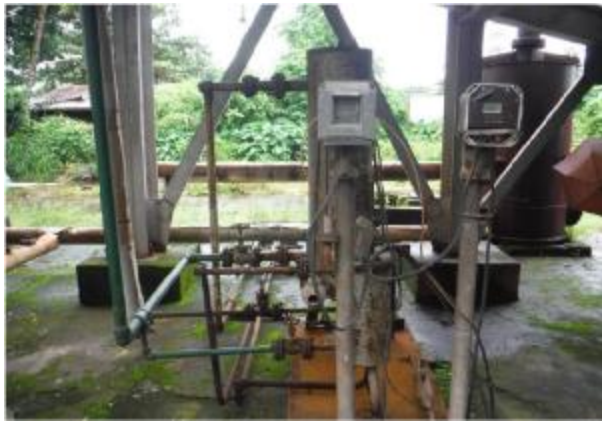
HRSG Common Issue No.1

No.	HRSG Common Issues (#1HRSG, #2HRSG, #3HRSG)
1	Sampling device malfunction
2	Instrument malfunction
3	Insufficient number of manhole tightening bolts
4	Pipe thermal insulation deterioration
5	Blowdown tank deterioration
6	Drum level meter malfunction
7	Feed water control and motor valve malfunction
8	Casing overheating and external seizure (insulation deterioration)

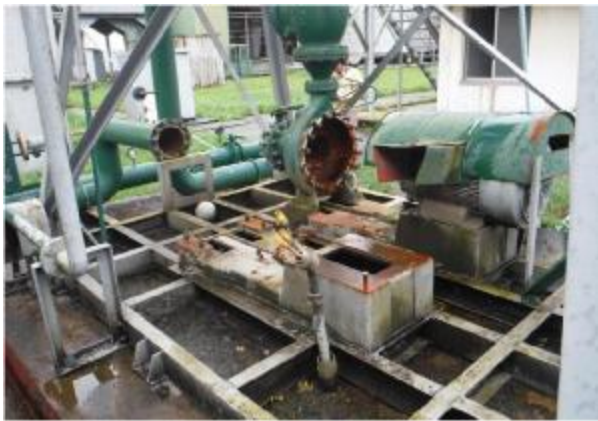
#2GT, HRSG No.1

No.	#2GT, HRSG
1	Cooling water pump removed
2	GT intake filter inlet door deterioration
3	Start-up motor removed

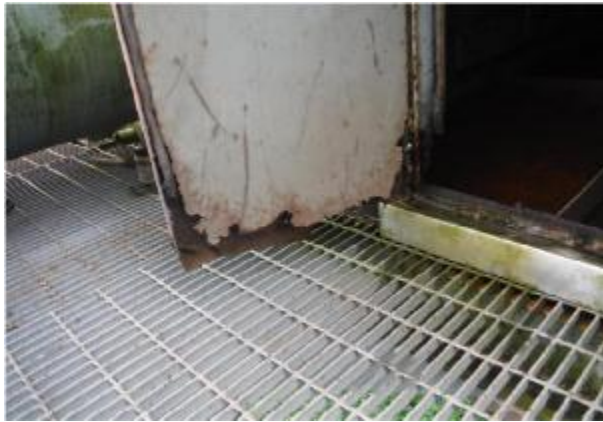
#3GT No.1

No.	#3GT
1	GT intake filter inlet door deterioration
2	Gas flow control valve gas leakage

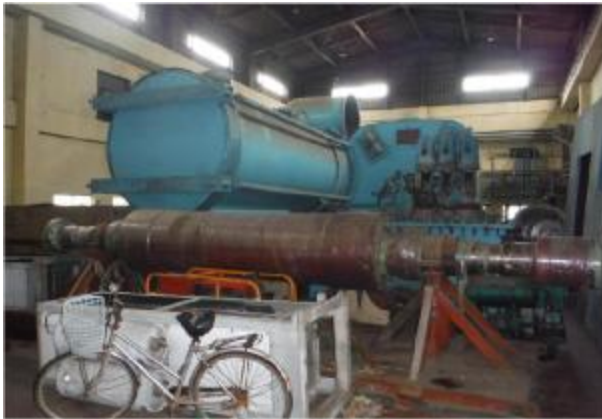
ST No.1

No.	ST
1	Inadequate storage condition after pulling out the generator rotor
2	Inadequate storage condition after pulling out the turbine rotor
3	Turbine shaft sealing part deterioration
4	Feed water instrument deterioration

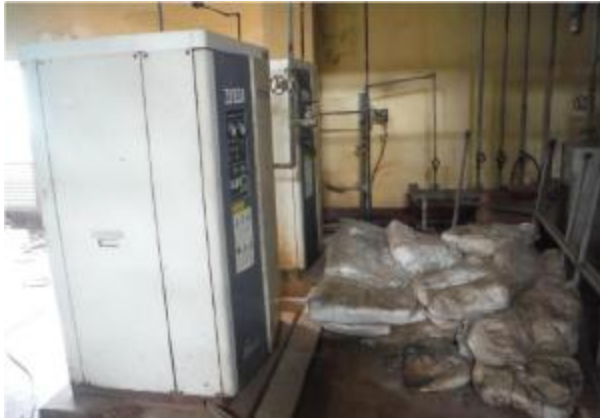
BOP No.1

No.	BOP
1	Control air compressor malfunction
2	Feed water pump deterioration
3	B cooling tower fan removed due to malfunction
4	Cooling tower deterioration
5	Demineralized water equipment control panel malfunction

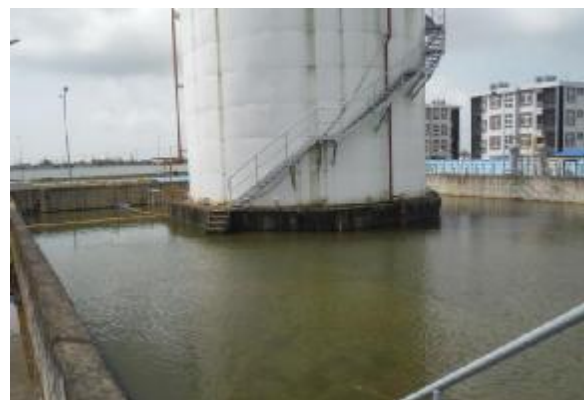
Fuel Tank Yard Storing Rain Water

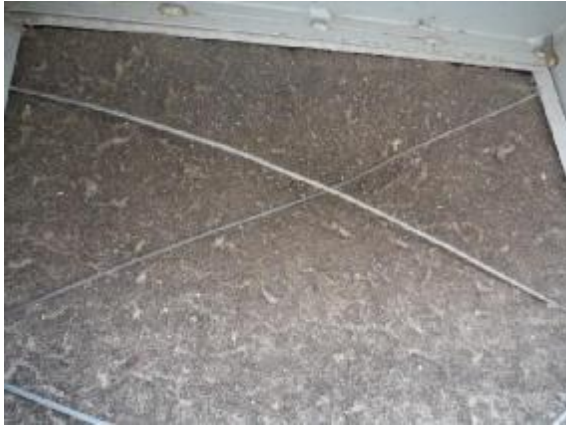
Gas Turbine Common Issue No.1

No.	Gas Turbine Common Issues (#1GT, #2GT)
1	#1,2 GT first bearing cooling fan intake filter dirt
2	#1,2 GT lube oil cooling system intake section fin dirt
3	#1,2 GT cable penetration water seal of control compartment deterioration
4	#1 GT submersion of cables in the pit

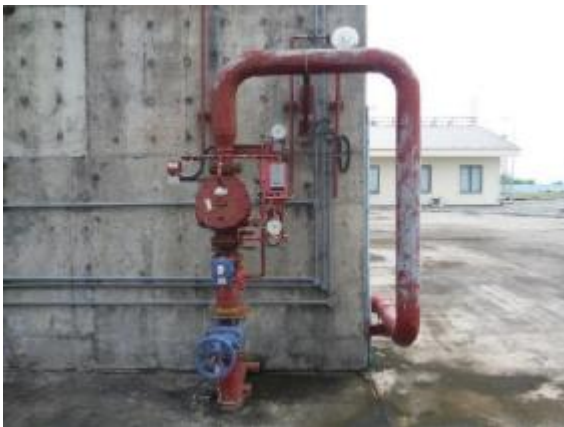
BOP No.1

No.	BOP Issues
1	Paint peeling off major transformers firefighting water piping
2	Gas station condenser tank manhole bolt corrosion
3	Outdoor storage of spare cable, etc.

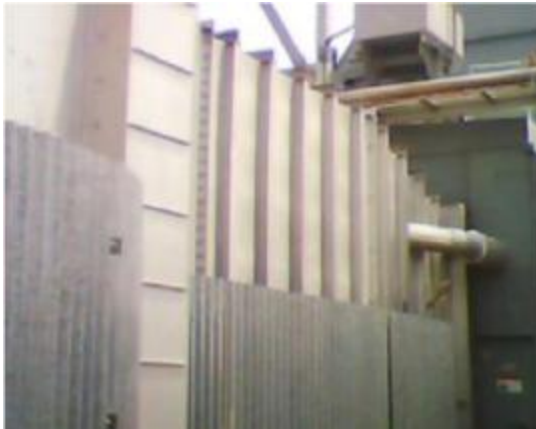
Ø Leakage Location Diagnosis
Surveys for gas leakage and equipment overheating (#2 GT which is under operation) were conducted by using a thermal camera. No abnormality

#2 GT Exhaust Gas Duct

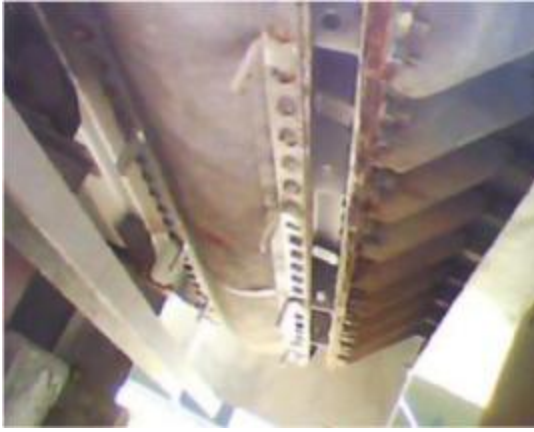
#2 GT Chimney Inlet Expansion

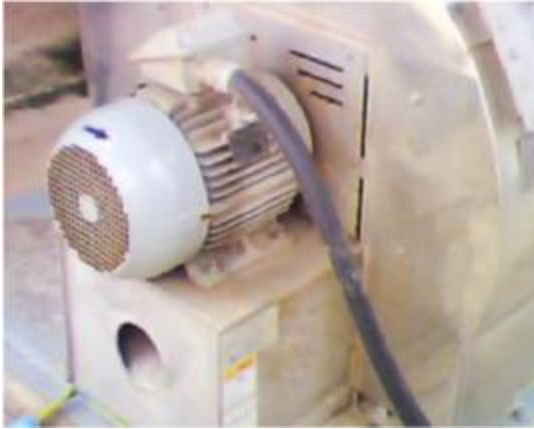
#2 GT Motor of Lube Oil Mist Separator Fan

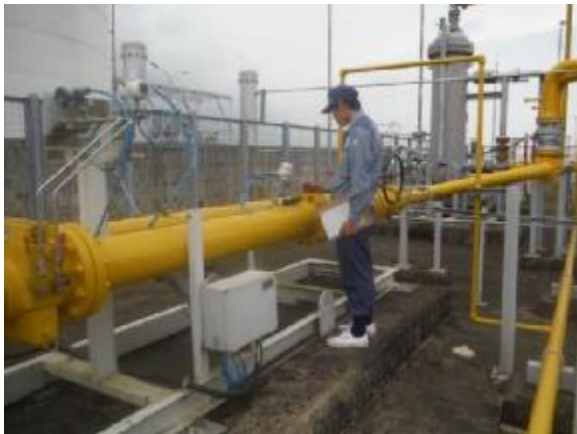
Gas leakage diagnosis of the NG station was carried out by portable gas detector.
No gas leakage

Gas Leakage Check

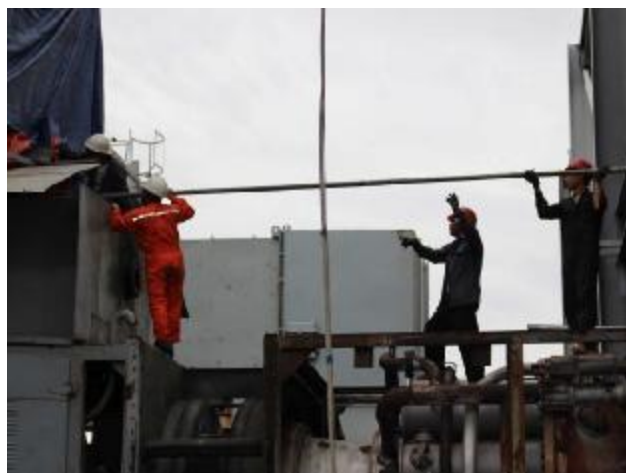
- ž At the time of the on-site survey, we confirmed the implementation status of the periodic inspection of the H-25. In regular inspections, size and clearance management and wear dimensional inspection of high temperature parts are not conducted, and any replacement of high temperature parts is determined by the director from the Hlawga power station. In addition, there is no safety management, and dangerous work can be seen.

Fig. Periodic Inspection Execution Scene

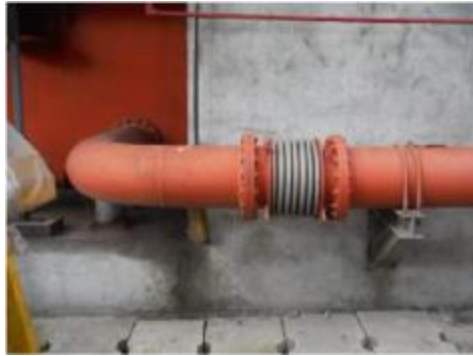
M701D Common Issue No.1

No.	M701D Common Issues
1	There is no bellows limit rod.
2	Lubricant cooler fin deformation
3	Start-up device burnt oil stain

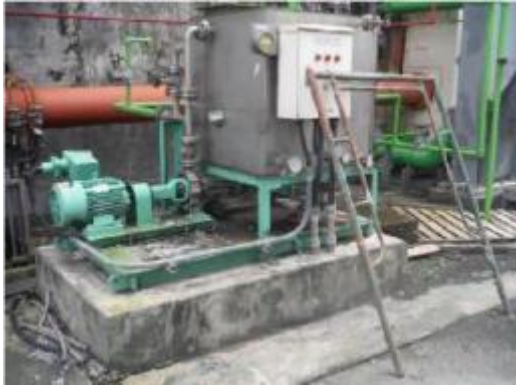
M701D #1GT No.1

No.	M701D #1GT Issues
1	Scaffolding leaned against local board
2	Cooler fan motor for generator cooling water removed
3	Stack exterior plate peeling
4	Lubricating oil storage cooler flange oil seepage
5	TCA (A rack) thermal insulation off
6	Intake filter element scattering
7	Compressor wing damage

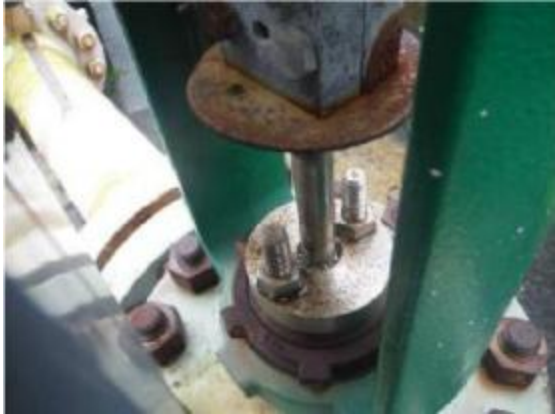
M701D #2GT No.1

No.	M701D #2GT Issues
1	Gas shutoff valve ground leak
2	GEN bearing temperature rise (load limit)

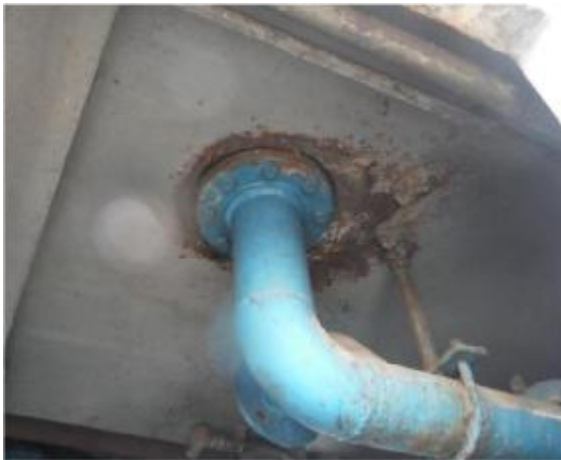
F5 Common Issue No.2

No.	F5 Common Issues
1	Gas detector damage at gas station
2	Widespread enclosure corrosion

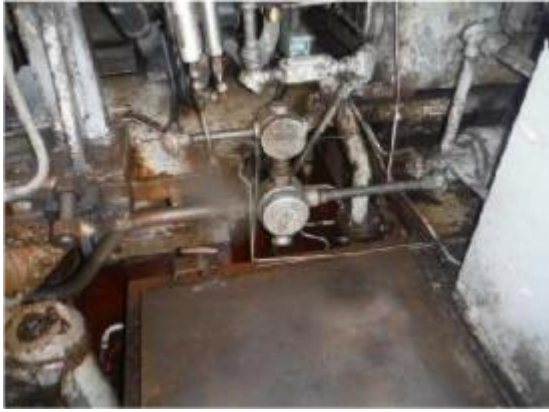
F5 #2 Issue No.1

No.	F5 #2GT Issues
1	Start-up device burnt oil stain
2	Oil is oozing

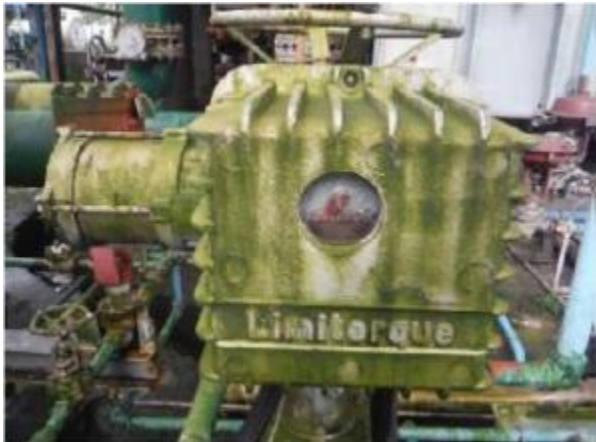
H25 common Issue No.1

No.	H25 common Issues
1	Condensate pump outlet valve drive flooded
2	Circulating water pump ground corrosion
3	Widespread cooling tower concrete deterioration
4	Widespread cable rack corrosion
5	Gas station gas detector damage
6	Instrument malfunction

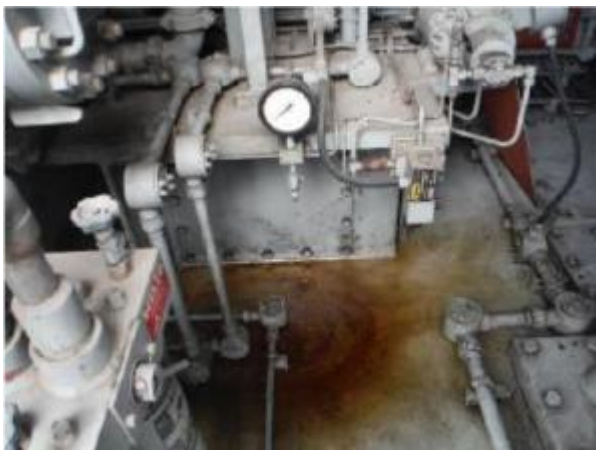
H25 GT No.1

No.	H25 GT Issues
1	Start-up device burnt oil stain
2	Partial removal of instruments

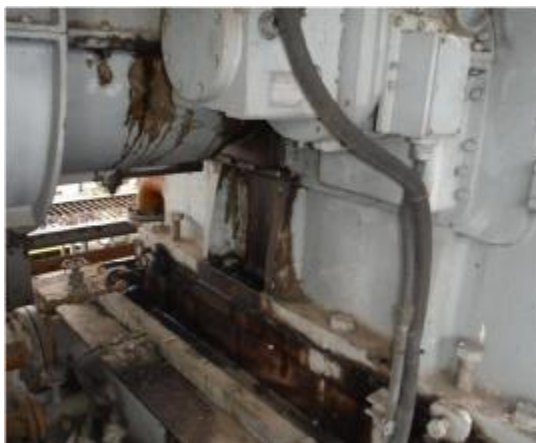
H25 ST No.1

No.	H25 ST Issues
1	Oil bleed from ST reduction gear bearing

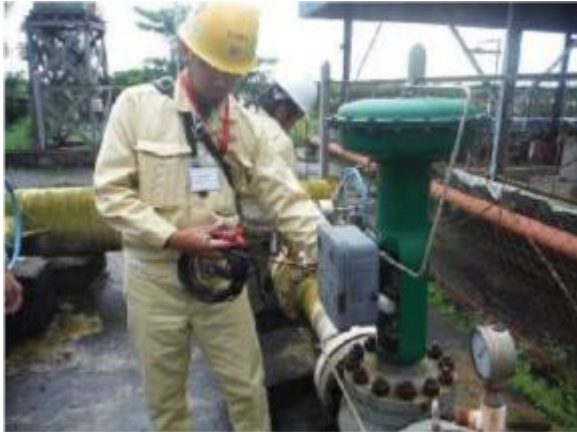
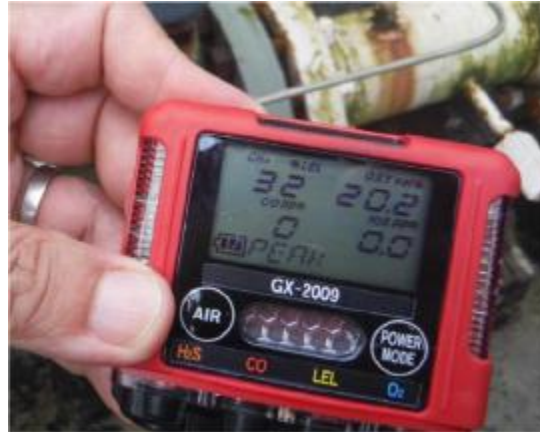
Gas Leakage Check

Gas leakage diagnosis of the NG station was carried out using a portable gas detector. There are gas leaks at the NG gas station.

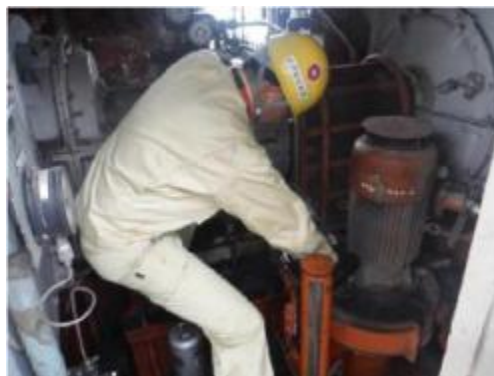
Vibration Measurement Scene

◆Vibration diagnosis measurement			
Record name	Vibration diagnosis measurement		
Power station	Ywama Power station		
Target equipment	M701D #2GT #2 bearing		
Measurer	MHPS Hiraoka Toshiyuki		
Confirmation (person)	Kansai Electric Power Ozaki Keisuke		
Equipment specification			
Model	M701D	Capacity	120MW
Rotation speed	3000rpm	Serial number	-
Motor rated current	-	Motor rated voltage	-
Manufacturer	MHPS	Date of measurement	August
Measurement result			
Date of measurement		30-Aug-18	
Measurement tool	Type	Portable Vibration Meter	
	Serial number	Rion Corporation Vibration Analyzer VA-10 00280204	
Measured value	V	65 μm	
	H	35 μm	
	A	30 μm	
Reference value(JEAC 3704) :130μm p-p

◆Vibration diagnosis measurement			
Record name	Vibration diagnosis measurement		
Power station	Ywama Power station		
Target equipment	M701D #2GT Main oil tank exhaust fan		
Measurer	MHPS Hiraoka Toshiyuki		
Confirmation (person)	Kansai Electric Power Ozaki Keisuke		
Equipment specification			
Model	Vertical fan	Capacity	-
Rotation speed	-	Serial number	-
Motor rated current	-	Motor rated voltage	-
Manufacturer	-	Date of measurement	August
Measurement result			
Date of measurement		30-Aug-18	
Measurement tool	Type	Portable Vibration Meter	
	Serial number	Rion Corporation Vibration Analyzer VA-10 00280204	
Motor upper bearing	V		40 μm
	H		52 μm
	A		15 μm
Motor lower bearing	V		40 μm
	H		29 μm
	A		36 μm
Reference value(JIS B 8330) : 100μm

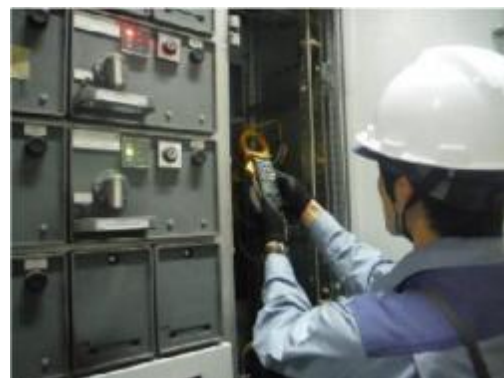
Current Measurement Scene

Current measurement was carried out with the M701D #2GT main oil tank exhaust fan. No abnormality.

◆Motor current measurement			
Record name	Motor current measurement		
Power station	Ywama Power station		
Target equipment	M701D #2GT Main oil tank exhaust fan		
Measurer	Kansai Electric Power Sato Ryo		
Confirmation (person)	Kansai Electric Power Ozaki Keisuke		
Equipment specification			
Model	-	Capacity	-
Number of poles	-	Serial number	-
Number of rotations	-	Rated voltage	-
Rated current	-	Insulation type	-
Manufacturer	-	Made date	-
Measurement result			
Date of measurement		30-Aug-18	
Measurement tool	Type	-	
	Serial number	-	
Measured value	Phase A		1.0 A
	Phase B		1.1 A
	Phase C		1.2 A

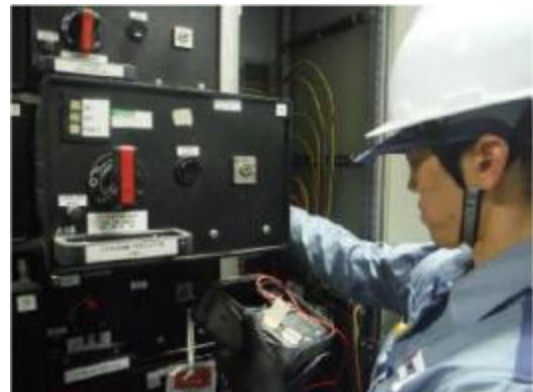
Resistance Diagnosis Scene

Insulation resistance measurement was carried out with the M701D #1GT c-package ventilation fan. No abnormality

◆Insulation Resistance Diagnosis			
Record name	Low voltage motor Insulation Resistance Diagnosis		
Power station	Ywama Power station		
Target equipment	M701D #1GT C-PACKAGE VENTILATION FAN		
Measurer	Kansai Electric Power Sato Ryo		
Confirmation (person)	Kansai Electric Power Ozaki Keisuke		
Equipment specification			
Model	-	Capacity	-
Number of poles	-	Serial number	-
Number of rotations	-	Rated voltage	-
Rated current	-	Insulation type	-
Manufacturer	-	Made date	-
Measurement result			
Date of measurement	30-Aug-18		
Measurement tool	Type	Insulation resistance measuring instrument 500V M	
	Serial number	-	
Environment	Weather	Cloudy	
	Temperature (°C)	-	
	Humidity (%)	-	
Measured value	MΩ	223 MΩ	
Reference value : over 1MΩ

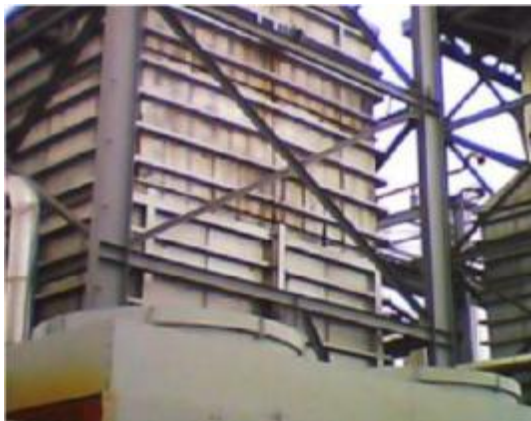
M701D #2GT Exhaust Gas Duct

Surveys for gas leakage and overheating of equipment (M701D #2GT and F5-#2GT which are under operation) were conducted by using a thermal camera. Some parts are hot.

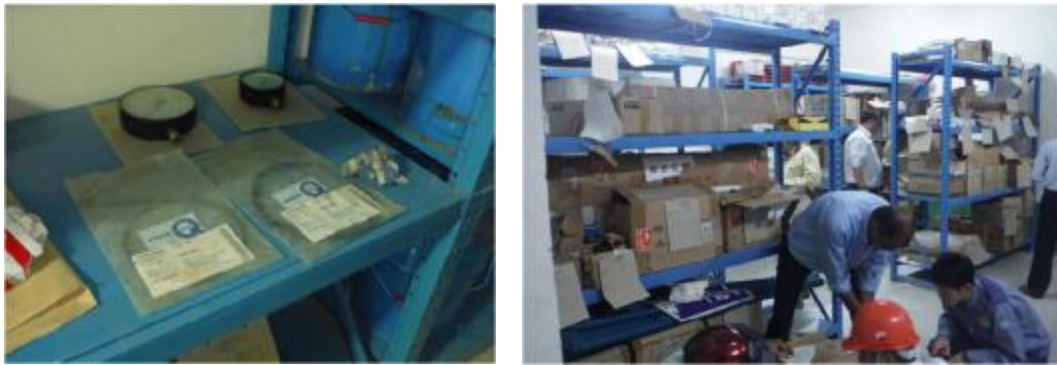
Fig. Spare Parts Storage Status

- Spare parts are organized in a warehouse with stock cards. In addition, they check and report inventory every six months to the EPGE headquarters.
- Spare parts include mechanical parts (such as bearings) and parts prepared during construction. It is confirmed every day by five people.
- No spare parts control system

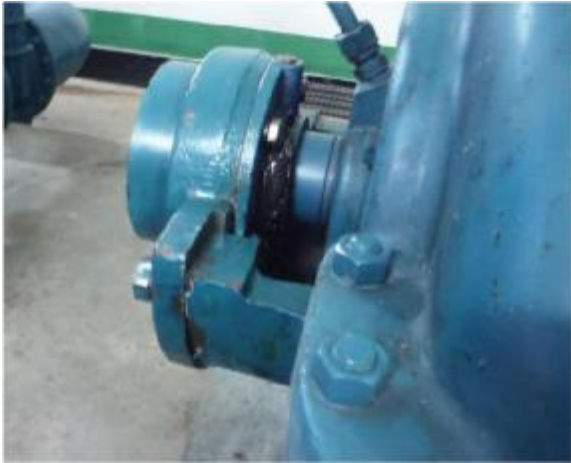
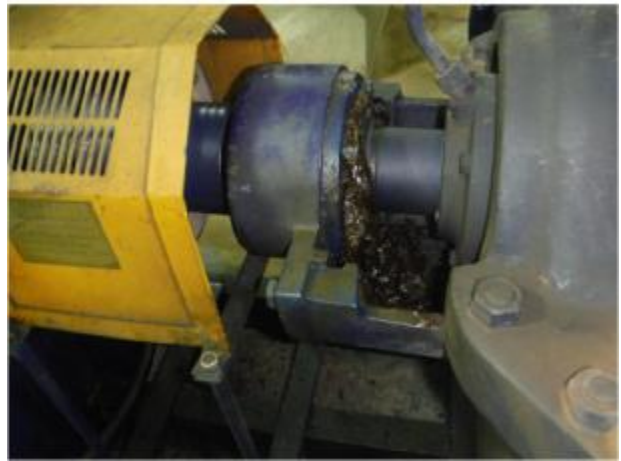
Unit #1 Issue No.1

No.	Issues at Unit #1
1	Cooling water pump bearing grease outflow (grease overflowing)
2	Cooling water pump (# 1 Unit B1) , motor overheated
3	Pressure gauge indication failure
4	Oil drips on generator floor, generator oil bleeds

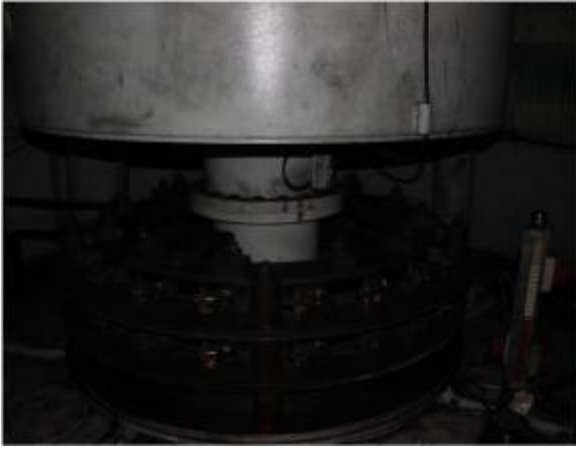
Unit #3 Issue No.1

No.	Issues at Unit #3
1	Failure due to damage to the # 3 unit generator thrust bearing due to equipment assembly failure during construction

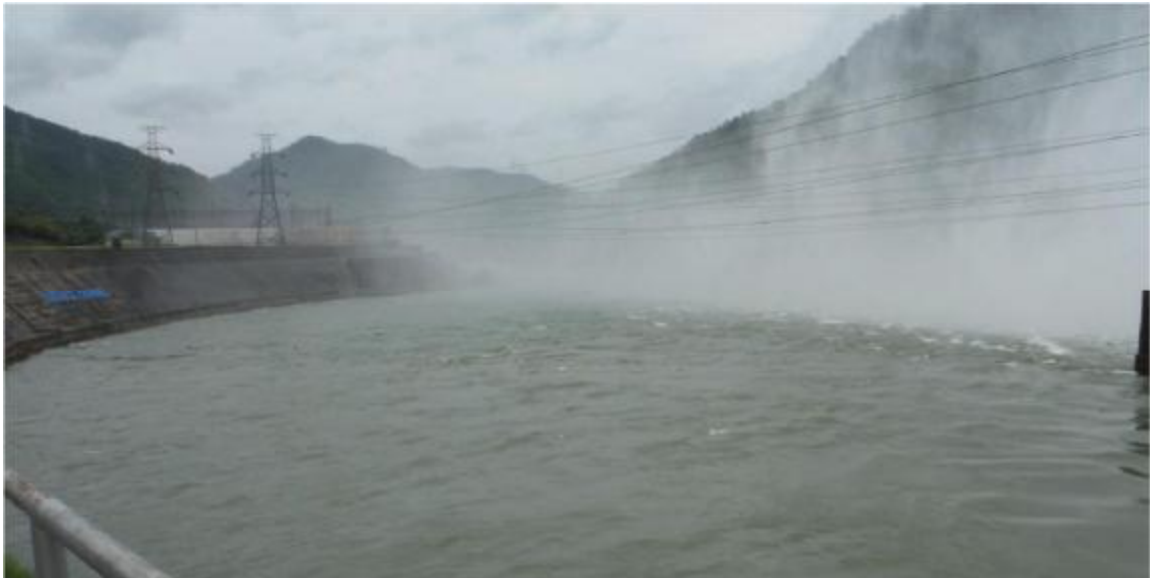
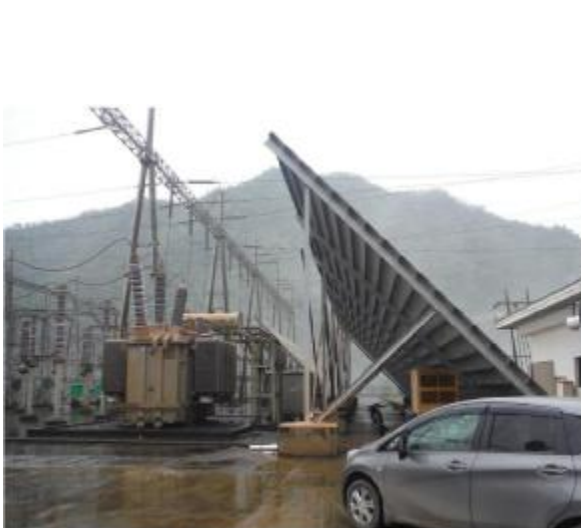
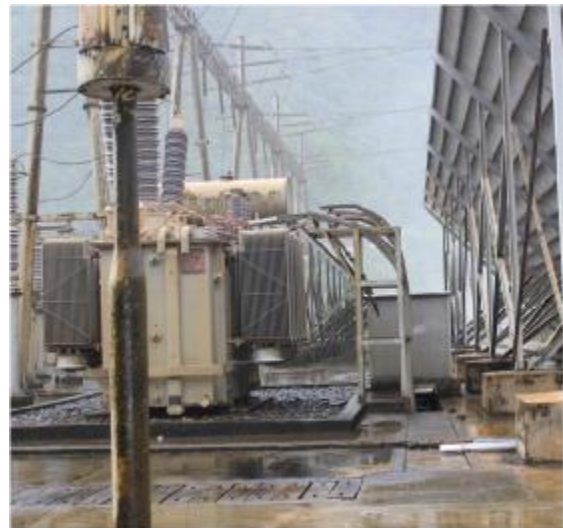
Other Common Issue No.1

No.	Other Common Issues
1	Switching station failure due to spillover water from dam
2	Air conditioning problems in the turbine building

- Ź There is no spare OPS. There is a demand for spare parts.
- Ź Regarding spillover water problems at substations, the EPGE's role is maintenance and repair, and operation commands (management) are conducted by the DPTSC. Therefore, power cannot be generated as the EPGE thinks. According to the design curve, the P/S would like to make effective use of water resources, but there are problems with the transmission system and IPP operation rate guarantee (Take or Pay), so the P/S cannot operate as the EPGE wishes.

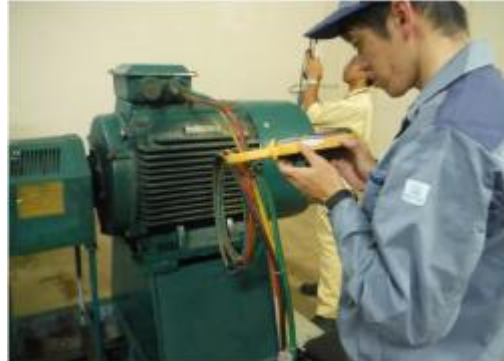
Drain Pump Motor Measurement Scene

We conducted measurements on the drainage pump motor. None of the control values were exceeded.

◆Motor current measurement			
Record name	Low voltage motor current measurement		
Power station	Yeywa Power station		
Target equipment	Drainage pump		
Measurer	Kansai Electric Power Sato Ryo		
Confirmation (person)	Kansai Electric Power Ozaki Keisuke		
Equipment specification			
Model	-	Capacity	132kW
Number of poles	4	Serial number	-
Number of rotations	-	Rated voltage	400V
Rated current	-	Insulation type	-
Manufacturer	-	Made date	2009
Measurement result			
Date of measurement		24-Aug-18	
Measurement tool	Type	Insulation resistance measuring instrument 500VM	
	Serial number	-	
Environment	Weather	Cloudy	
	Temperature (°C)	35.9	
	Humidity (%)	61.3	
Measured value	MΩ	1.2	
Reference value IMΩ over
