DATA COLLECTION SURVEY ON CURRENT SITUATION
OF
THE PROJECT FOR IMPROVEMENT OF COASTAL
FISHERIES DEVELOPMENT
IN SAINT LUCIA

FINAL REPORT

JAPAN INTERNATIONAL COOPERATION AGENCY (JICA)

ECOH CORPORATION

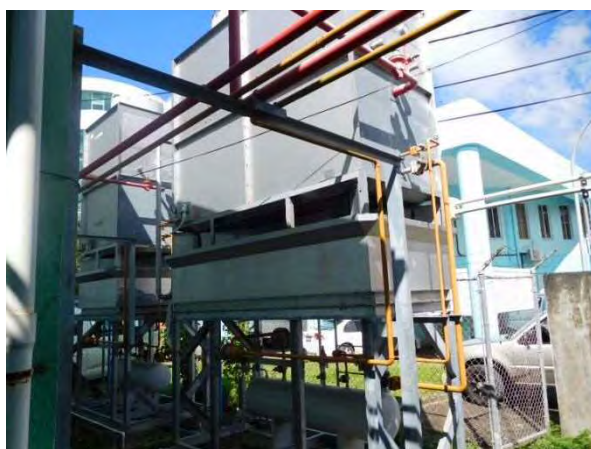
- There are no problems.
 - Equipment is well maintained by a resident refrigeration engineer of SFMC.
- (6) Utilization
 - It is a central core facility for fisheries distributions in Saint Lucia managed by SFMC.
 - It is well used and maintained.

Photo 2-5 Condenser for cold storage and freezing storage

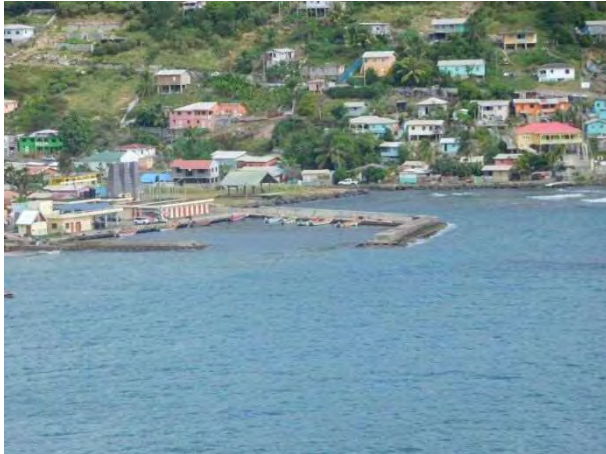
- There are no problems.
 - A pipe valve of condenser for ice machine on rooftop is damaged by salt.
(Confirmed after advice from a refrigeration engineer of SFMC)
- (6) Utilization
 - It is the only fishing port facing to the Atlantic Ocean in Saint Lucia, and accounts for 21% of fish landing volume, which is the second largest. Fishery center is managed by SFMC, and Fishermen's Co-operative is responsible for the management of fishing gear lockers and fuel facilities.
 - Facilities are well used and maintained.
 - Seaweed is carried into the basin of fishing port causing inconvenience for mooring fishing vessels.
 - Sedimentation of sand is found on a corner of the port, but it does not cause problems for wharf utilization. According to the manager of Fishermen's Co-operative, the sand is regularly removed.

Photo 2-7 Fishing port

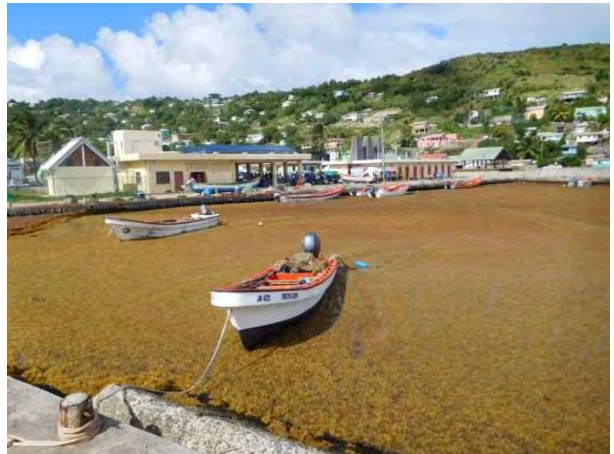
Photo 2-8 Seaweed carried into the port

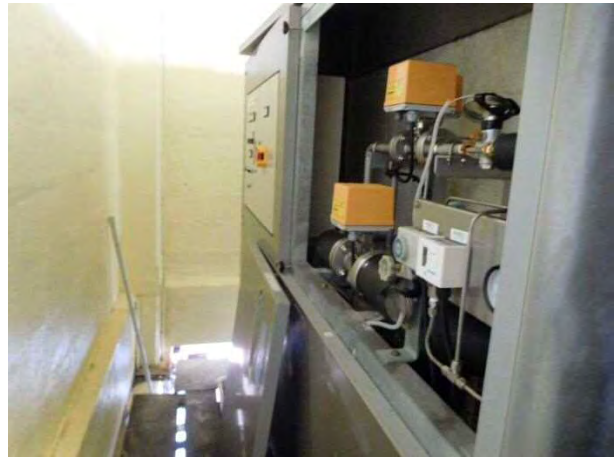
Photo 2-10 Ice machine

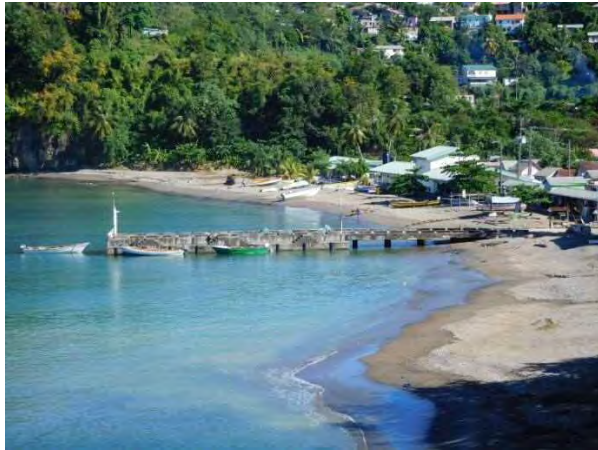
Photo 2-25 Fishing port and recovered beach

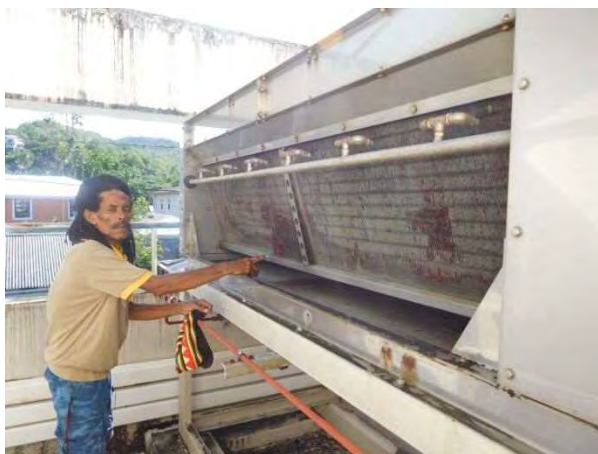
- Existing old condenser for ice machine was out of order in June, 2017, and the ice machine is not in operation now.
 - According to refrigeration engineer of SFMC who is in charge of the maintenance, Fishermen's Co-operative cannot replace the broken condenser into a new one because of its expense.
- (6) Utilization
 - It is a small fishery center occupying 4% of fish landing volume in Saint Lucia, managed by Fishermen's Co-operative.
 - It is well used and maintained except for the broken ice machine.
 - Since the beach was eroded in front of the fisheries facility in 2012, riprap work was executed as follow-up project by JICA in 2013. On November 2017, beach erosion has been solved.
 - An event called "Fish Friday" is held on every Friday, and many tourists are entertained.

Photo 2-29 Broken condenser

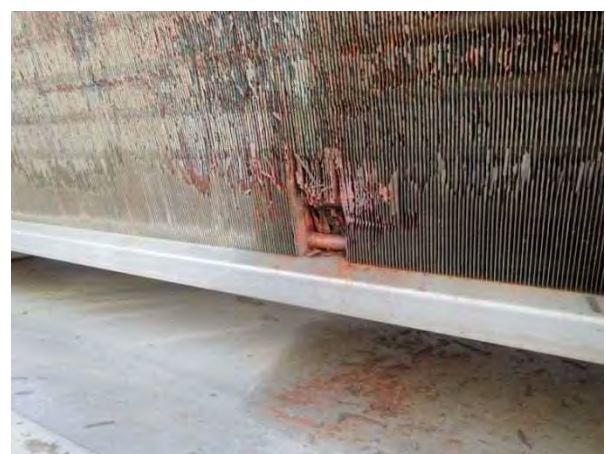
Photo 2-30 Broken part of condenser

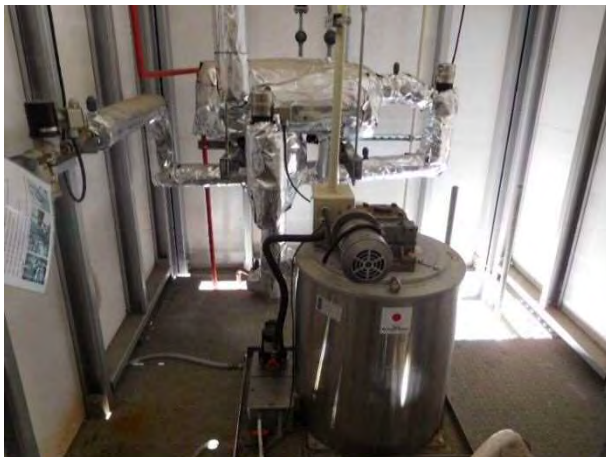
- According to a refrigeration engineer of SFMC who is in charge of the maintenance, a needle valve of ammonium pipe is broken and automatic operation of ice machine is impossible on November 2017. The engineer is now considering measures taking contacts to the Consultant and Contractor.

Photo 2-33 Ice machine

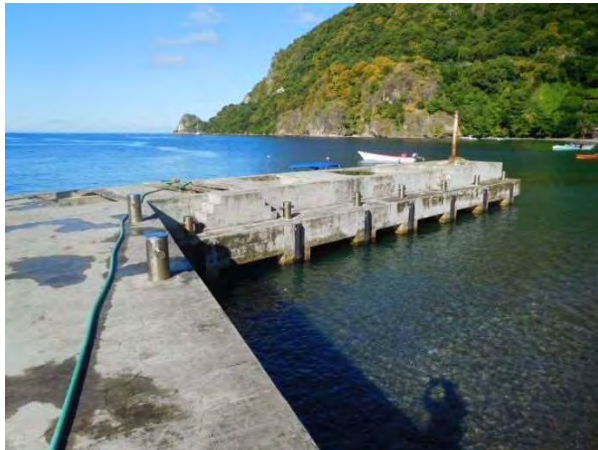
- It is well used and maintained.
 - Fishing gear sales area was constructed using a container by Fishermen's Co-operative in 2016.
 - The wooden plate on superstructure of the fish landing jetty was damaged by a hurricane in 2016, and left as it is. Appropriate repair work is needed.

Photo 2-37 Fish landing jetty

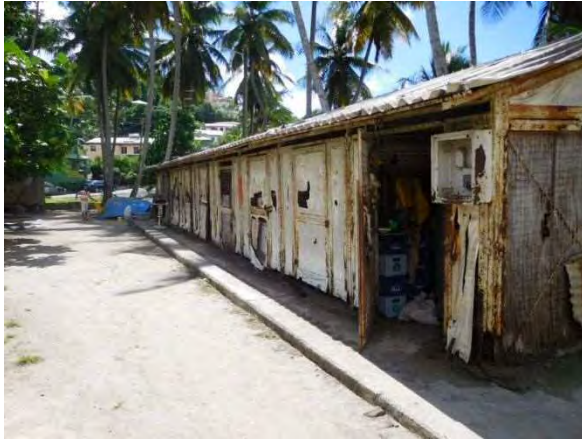
- The facilities are severely deteriorated because approximately 30 years have passed since the construction in 1989.
 - Ice machine and cold storage have been out of order and not been used for many years.

Photo 2-51 Fishing gear lockers (severely deteriorated)

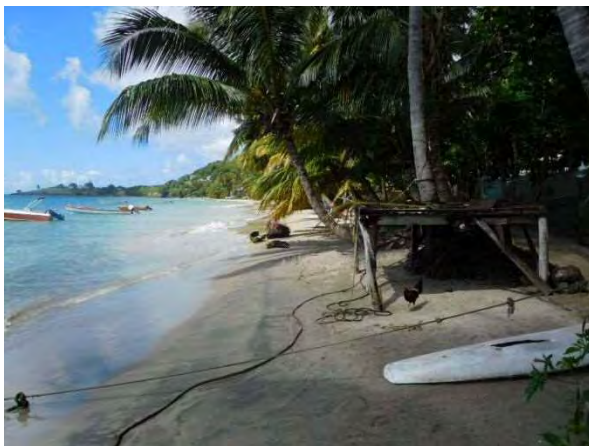
- Importance of fishery center has been decreasing after construction of Vieux Fort fishing port nearby.
 - The beach has been eroded in recent years.

Photo 2-53 Eroded beach (1)

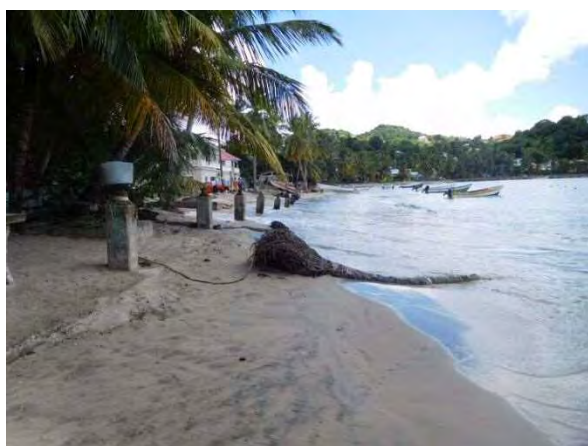
Photo 2-54 Eroded beach (2)

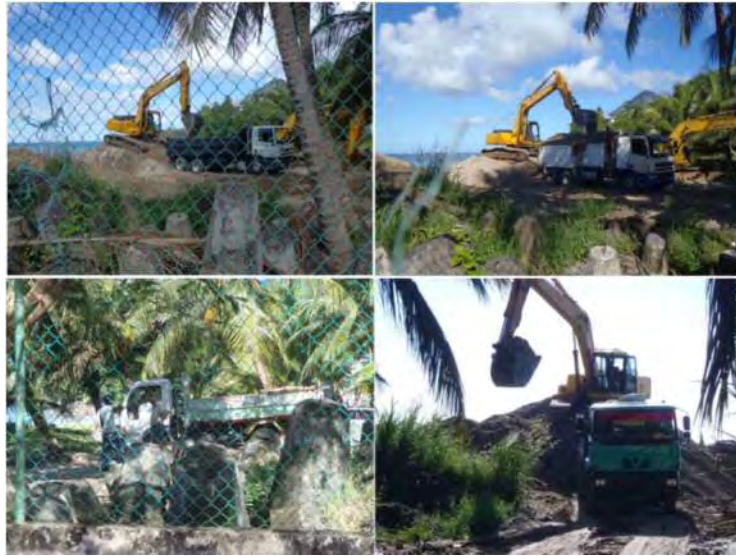
Photo 2-68 Transportation of dredged sand by truck (November 2017)

Sand removed from the port entrance by dredging work was temporarily piled on the beach located on the north of the groin, and then it was often taken out by trucks as seen in Photo 2-68.

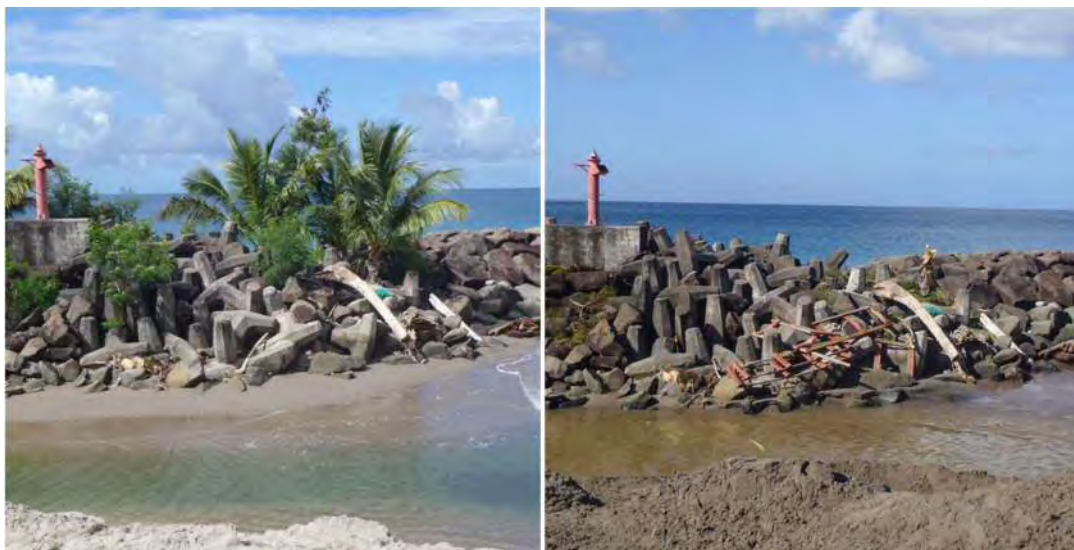
Photo 2-69 Port entrance, November 2017: Left 18th (Saturday), Right 21st (Tuesday)

Photo 2-69 is the conditions of the port entrance on Saturday, November 18, 2017 and Tuesday, November 21, 2017. Comparing 2 photos, the water on the left photo (day of 18) is clear, while the water on the right one (day of 21) is turbid. This is because dredging work by a backhoe was executed just before photo on the right was taken. The same reason can apply to the fact that the sand dredged and piled on the ground in front side of the right photo (day of 21) looks dark. In the photo on the right (day of 21), some ladders are left on the wave dissipating blocks. These ladders are used for pulling up fishing boats on a slipway or a sandy beach. The fact that such ladders are left there means that sand was deposited at the port entrance from 18 to 21 on Saturday to Tuesday and resultantly fishing boats could not sail themselves. In other words, although maintenance dredging work was executed at the port entrance with backhoe, it was not always enough and there were sometimes problems for fishing boats entering and leaving the fishing port.

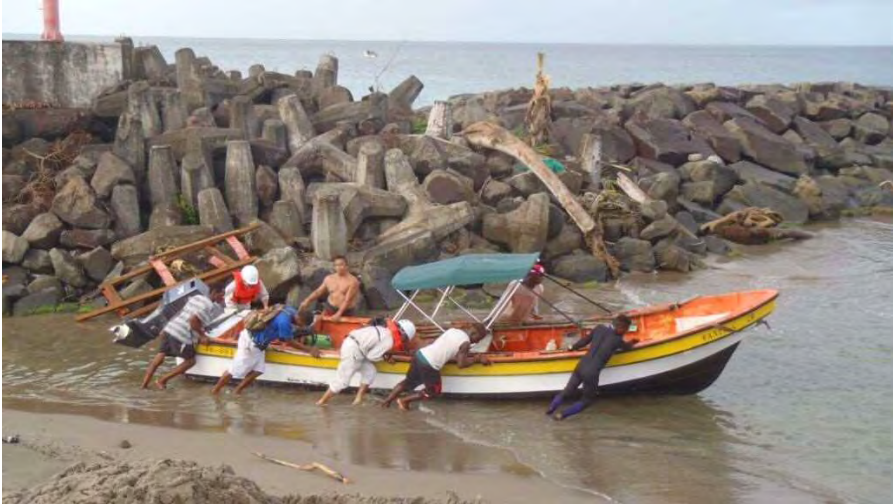
Photo 2-70 Port entrance when self-sailing becomes difficult on December 5, 2017

Photo 2-70 shows the conditions of the port entrance when the study team went out for regular inspection of the wave gauge on Tuesday, December 5, 2017. The study team could leave the port with the support of three young people who passed by. After regular inspections at offshore, the survey team could enter the port smoothly. It means dredging works at the port entrance by backhoe was completed. After all, sometimes it seems to be difficult for self-sailing.

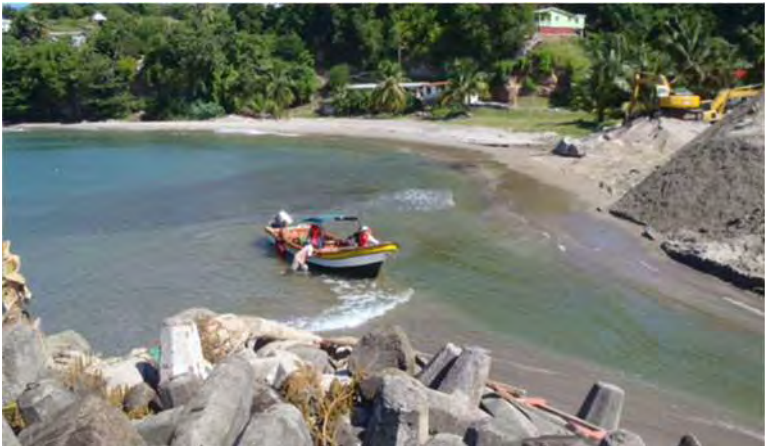
Photo 2-71 The remaining shallow area after dredging by backhoe on November 24, 2017

Another weakness of dredging work by backhoe is that the dredging area is limited to only the reach of the backhoe. As shallow area is left outside of the reach, fishing boats have to be pushed when passing through such area as shown in Photo 2-71.

The above is the conditions of the dredging work by backhoe confirmed at the time of the first site works. After that, it seems that significant improvements have been made to the dredging method by backhoe, which is explained later.

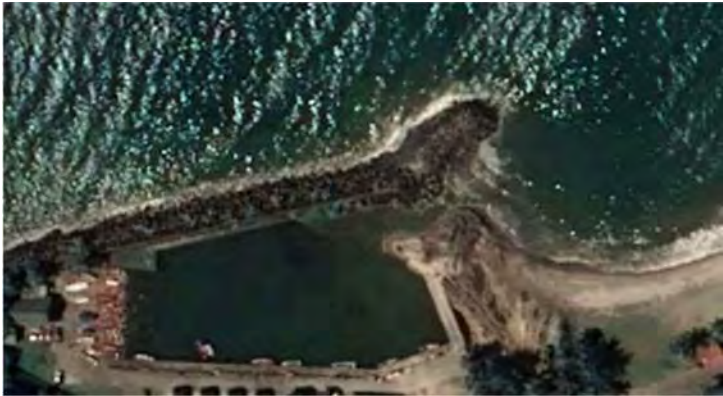
Photo 2-72 Choiseul fishing port (Google earth; January 4, 2018)

On January 4, 2018 as shown in Photo 2-72, the amount of deposition on the north side of the

Looking at the Photo 2-7 to 2-74 sequentially, it is clear that the amount of deposition on the north side of the groin gradually decreased and the width of the port entrance was widened. This is considered to be the result of a significant improvement of efficiency for the dredging work by backhoe.

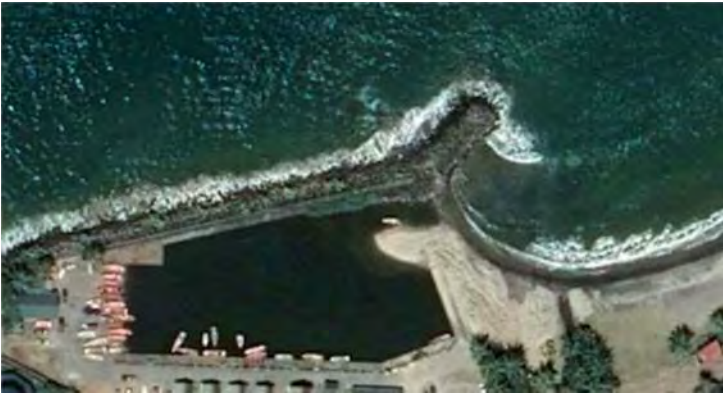
Photo 2-73 Choiseul fishing port (Google earth; March 24, 2018)

On March 24, 2018 as shown in Photo 2-73, the port entrance was blocked. The closure of the port entrance is considered as a temporary event because the dredging work was seemingly interrupted since backhoe is not in the photo, it was on Saturday, and fishing boats are not pulled up on the beach outside the port. It should be noted that, compared to Photo 2-72, the amount of deposition on the north side of the groin decreased and the port entrance width became wider.

The improved dredging work was commenced before March 24, 2018 (Photo 2-73). It is because, in the Photo 2-84, there is a concave dark area in the place surrounded by the red dashed line and this is considered to be a trace of sandy beach excavation.

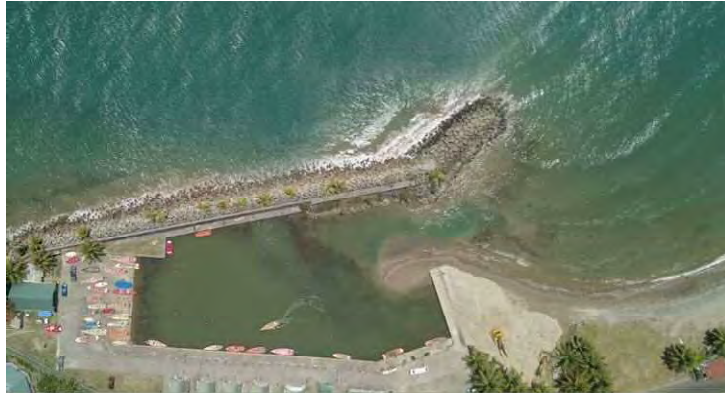
Photo 2-74 Choiseul fishing port (Drone photo; August 13, 2018)

On August 13, 2018 as shown in Photo 2-74, the amount of deposition on the north beach of the groin decreased, and the port entrance width became wider. Sand is transported around the tip of the groin and is deposited in the port. However, level of the deposition is not high because the deposition in the port looks dark and moist compared to Photo 2-73. The amount of deposition on the north side of the groin further decreased and the port entrance width further expanded.

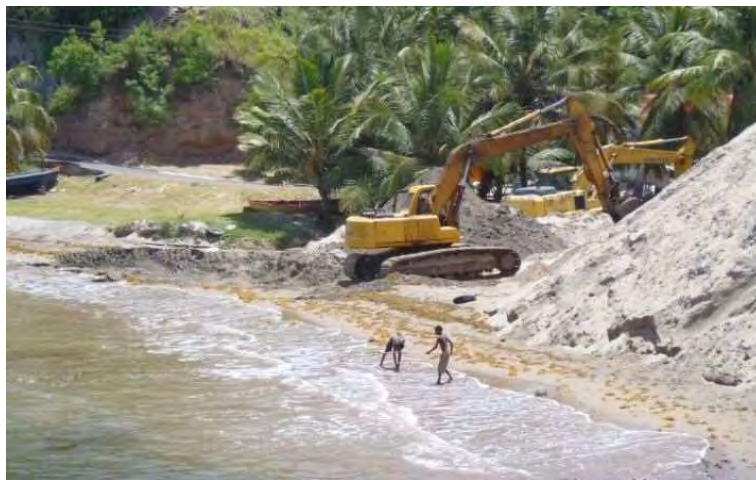
Photo 2-75 Excavation on the sandy beach on 11:17, August 14, 2018

The new method of dredging work is specifically explained below. As seen in Photo 2-75, the backhoe was used to excavate a sandy beach 30 m away to the north from the groin on August 14, 2018. At this time, the deposition occurred in the port as confirmed in Photo 2-76. In other words, the backhoe was operated for excavation on beach without dredging in the port.

Photo 2-77 was taken afternoon on August 16, after two days from Photo 2-75, showing excavation trace on sandy beach. The sand piled up just aside looks dark and moist, thus excavation seemed to be carried out in the morning.

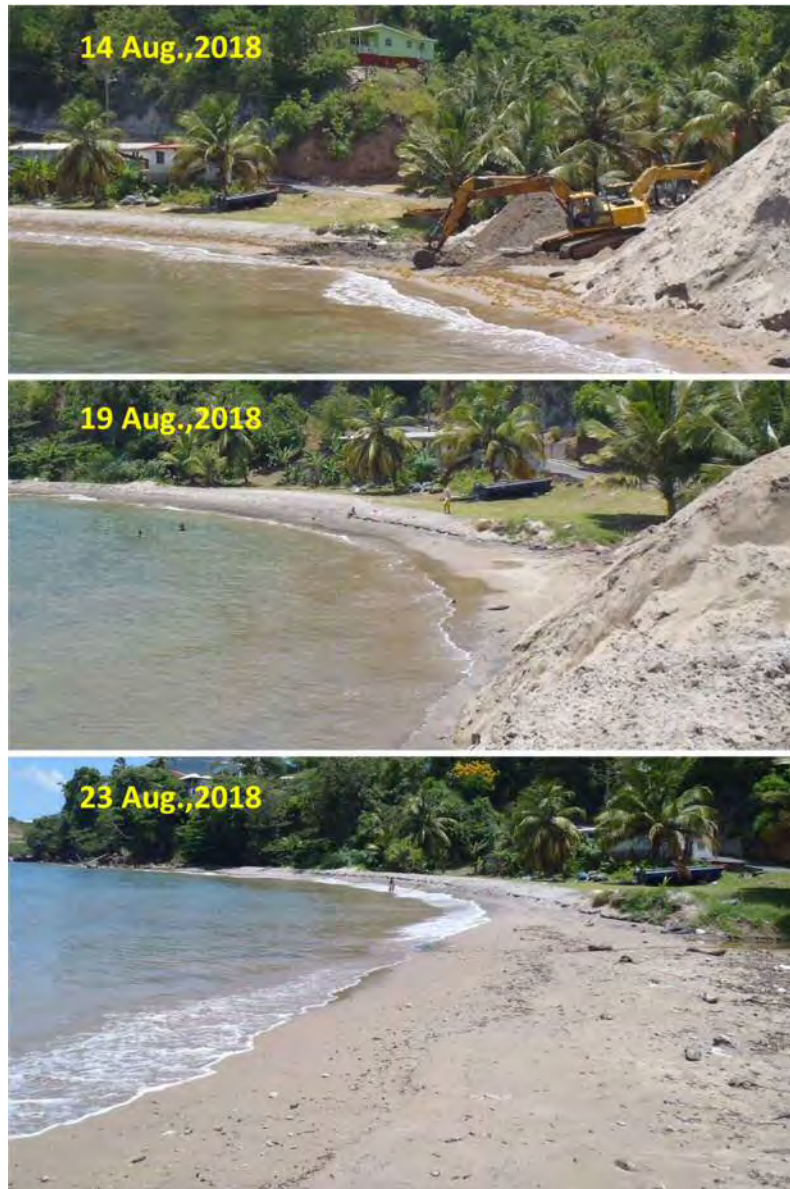
Photo 2-78 Recovery of excavation trace

Photo 2-78 shows the recovery condition of excavation trace. It was almost completely backfilled leaving only a slight depression on August 19. The excavation trace could not be found on August 23.

Sand for recovery was transported from the neighboring beach by waves. Photo 2-78 contains the evidence to support it. Photo 2-79 is an enlarged view of the sandy area where the trace was left. The upper Photo 2-79 shows excavation on the beach, and the topography of foreshore where the seaweed is washed up is a regular beach topography. On the other hand, in the middle photo, scarp is formed between the excavation site and the person sitting on the beach (see a further enlarged photo 2-80). And on August 23, it is recognized that the formation of the scarp extended all over the sandy beach. The scarp is a micro topography on sandy beach which is usually formed by sand transportation from foreshore to offshore in case of high waves. However, since the sea condition from August 14 to 23 was calm with a significant wave height of about 0.3 m, observed value, it is reasonable to consider that the scarp is formed by sand transportation in the longshore direction, from foreshore to the excavation site.

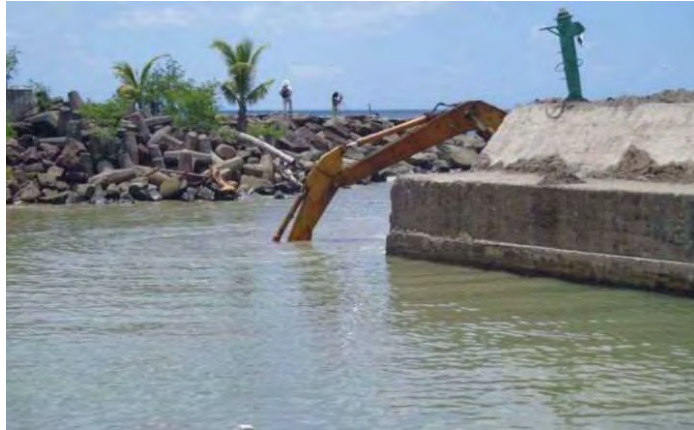
Photo 2-81 Dredging work by backhoe on August 21, 2018

Similarly, in the area between the excavation site and the groin of the Choiseul fishing port, sand should have moved in the direction from the groin to the excavation site, which is in the opposite direction of sand transport causing the deposition in the port. On August 21, 2018, when this temporary reverse excursion occurred, the sand deposited in the port was dredged by the backhoe as shown in Photo 2-81.

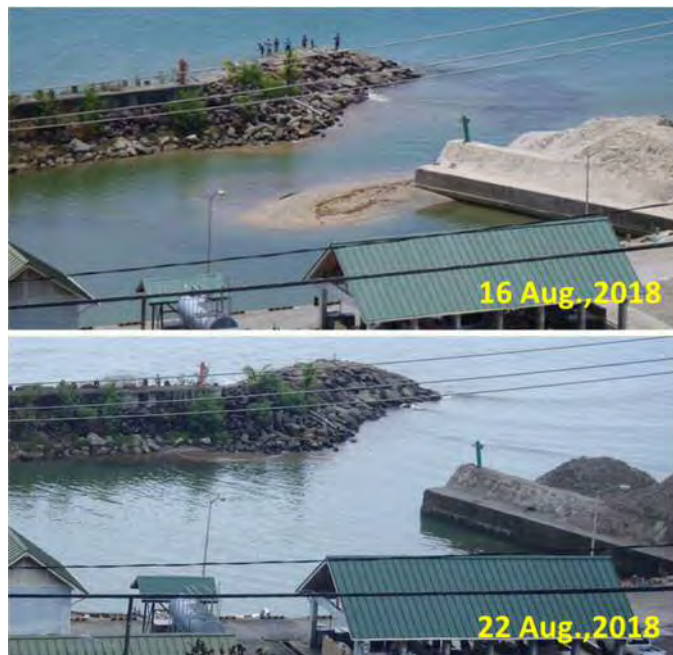
Photo 2-82 Comparison of before and after dredging work by backhoe

Photo 2-82 shows the condition before and after dredging work by the backhoe in the port. Upper photo, before dredging work, was taken on the day when the sandy beach was excavated, and deposition extended from the tip of the groin into the port was formed. The deposition partially appeared above the sea level. In lower photo, after dredging work, the deposition is completely removed, and it is seemingly the same condition as the dredging work was executed at the time of the construction of the additional breakwater as shown in Photo 2-83.

To summarize the dredging work by the backhoe implemented in August 2018, firstly, the beach about 30 m apart to the north from the groin was excavated to create a depression topography. Then, sand is transported from both sides to fill in the depression, which causes temporary sand excursion in the direction from the port entrance toward the excavation site. This sand excursion occurs in the opposite direction from the one that causes the deposition in the port. The sand is dredged by the backhoe while the sand excursion occurs in the reverse direction. Since sand is removed by excavation at sandy beach prior to the dredging work in the port, repetition of the excavation results in gradual decrease of the amount of deposition on the north side of the groin and widening of the port entrance.

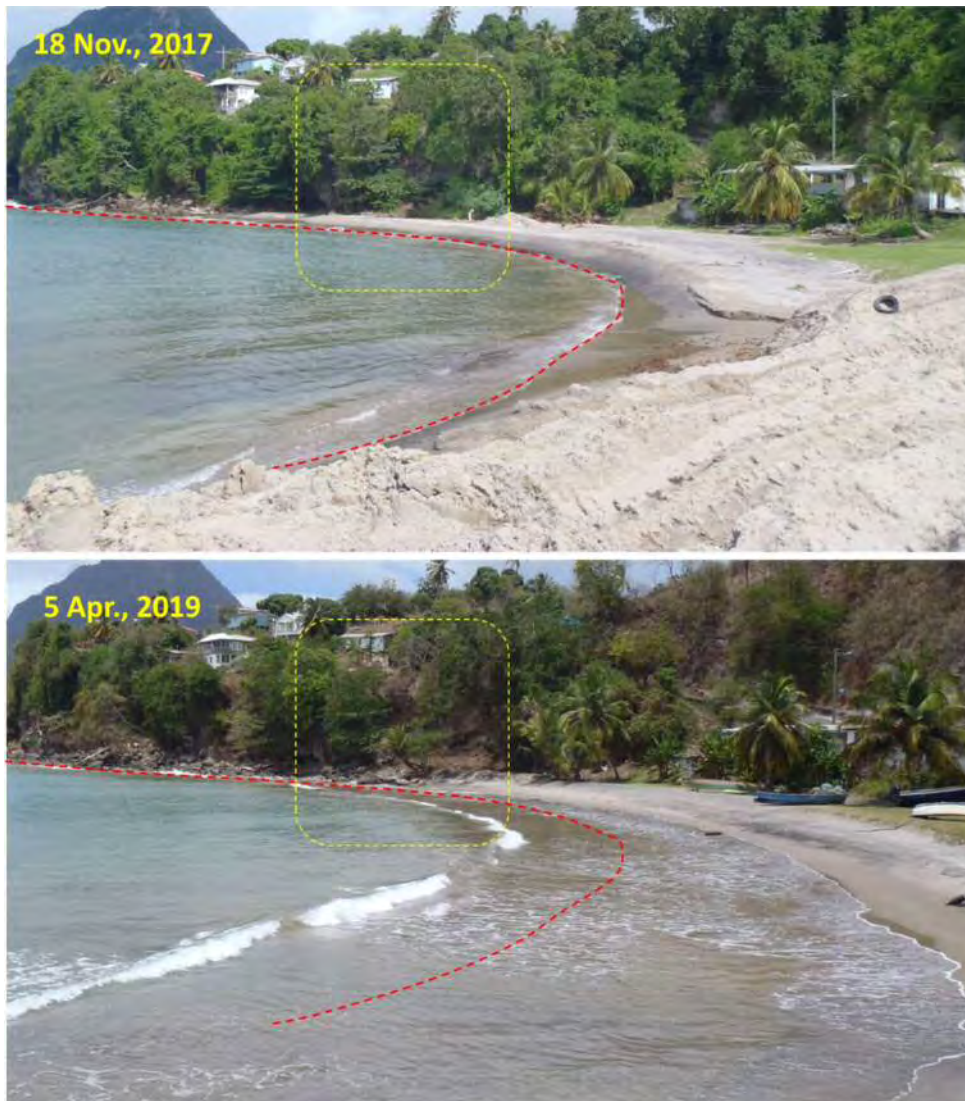
Photo 2-85 Comparison of whole north beach of Choiseul fishing port

On April 4, 2019, the project manager of the study team visited Saint Lucia to explain the surveyed result in Phase-1, and could have an opportunity of site reconnaissance though it was a limited time. Photo 2-85 compares the north beach of the Choiseul fishing port. The upper photo and lower photo were taken in November 18, 2017, and April 5, 2019 respectively. The same camera was used to take both photos from the location of the blue beacon installed at the tip of the groin. The red dashed line shown in the lower photo shows the shoreline of the upper photo. The erosion of the whole shoreline can be confirmed referring to the red dashed lines.

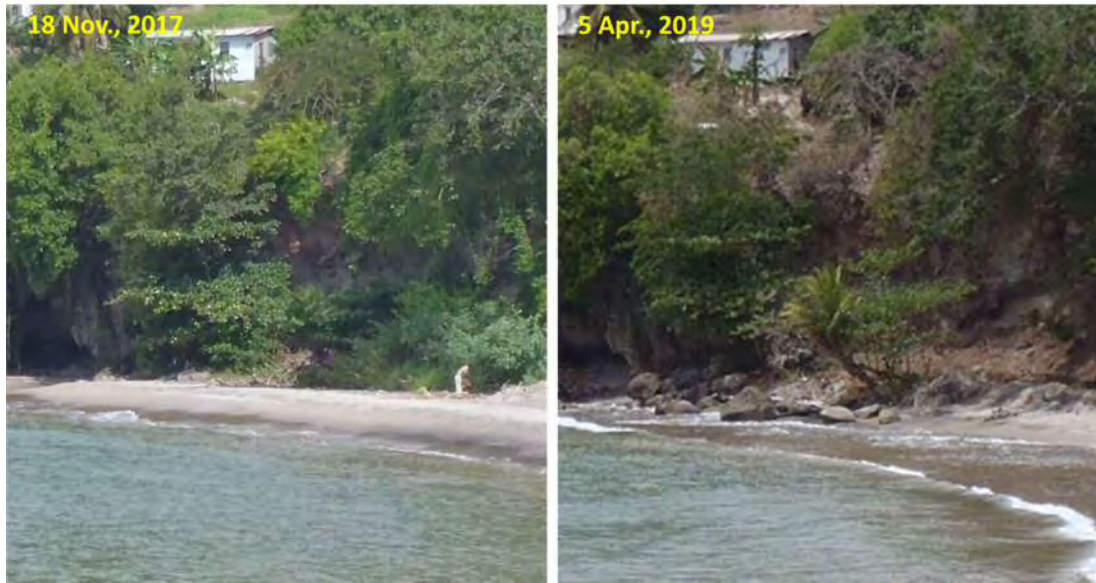
Photo 2-86 Comparison of north end of north beach of Choiseul fishing port

Photo 2-86 compares enlarged views of the part squared by a yellow dashed line in Photo 2-85. The beach existed in 2017, but it is completely eroded and rocks are found there. Referring to a person in the photo in 2017, size of the rock can be understood. Photo 2-87 is taken at the north end of the north beach. In 2017, these rocks were covered by sand. The erosion is a result of “beach excavation near the groin”.

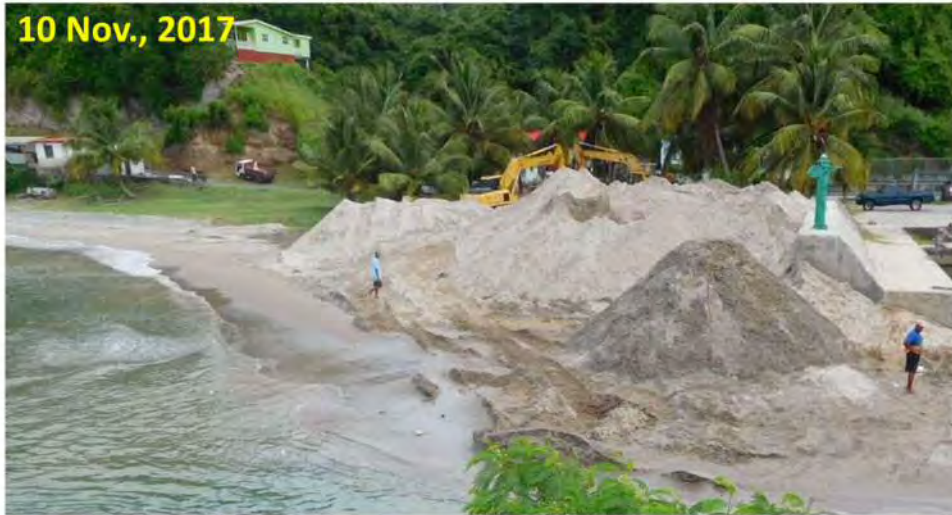
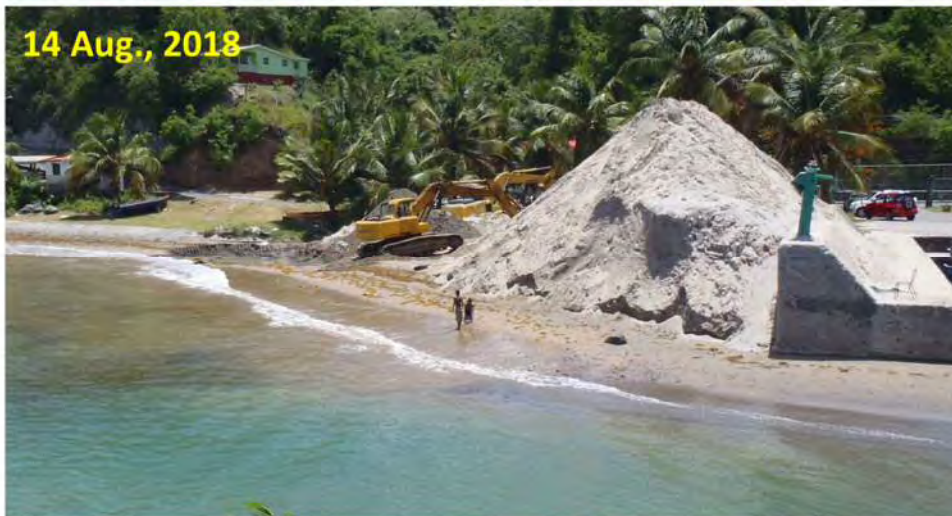
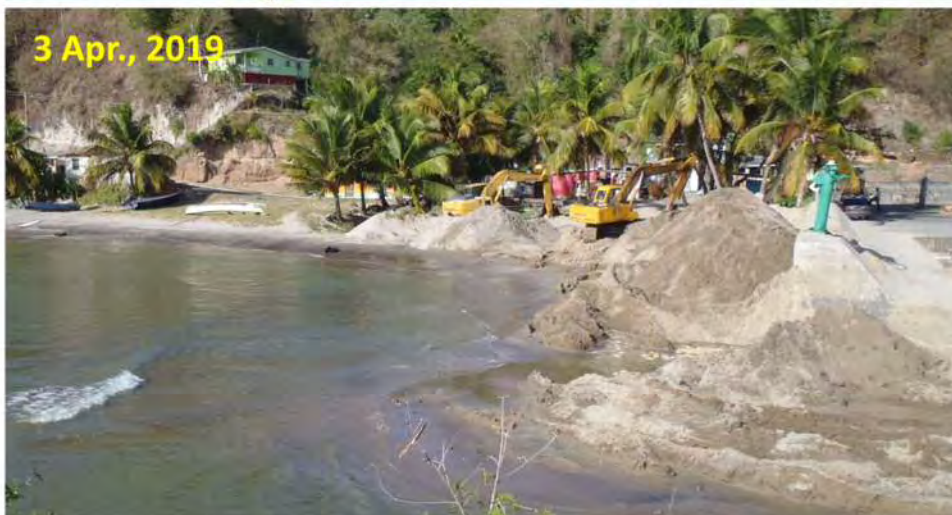
Photo 2-88 Comparison of beach near the sand groin

According to Photo 2-88, 2 backhoes seem to be used for the excavation. However, the backhoe on the left in the bottom photo was completely broken as of 2015 and was abandoned as of 2019.

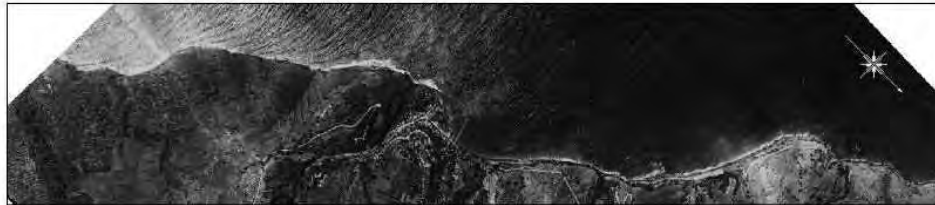
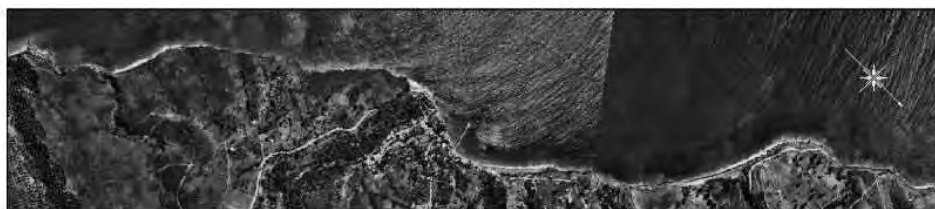
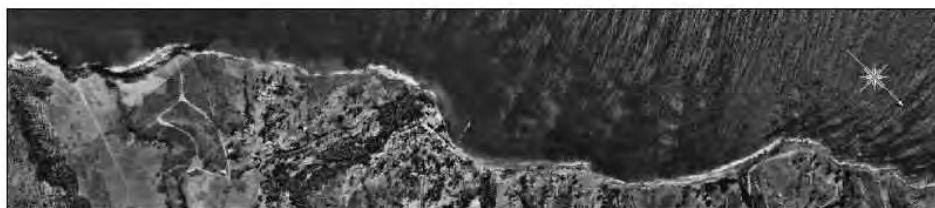
Photo 4-1 Aerial photos from 1941 to 2007

Collected photos were rather old like 2009 as the newest and since even shooting intervals becomes more than 10 years, Google Earth pictures are also collected and utilized to understand the coastline conditions. Photo 4-1 and 4-2 show the collected aerial photos and Google Earth pictures (1941 to 2018).

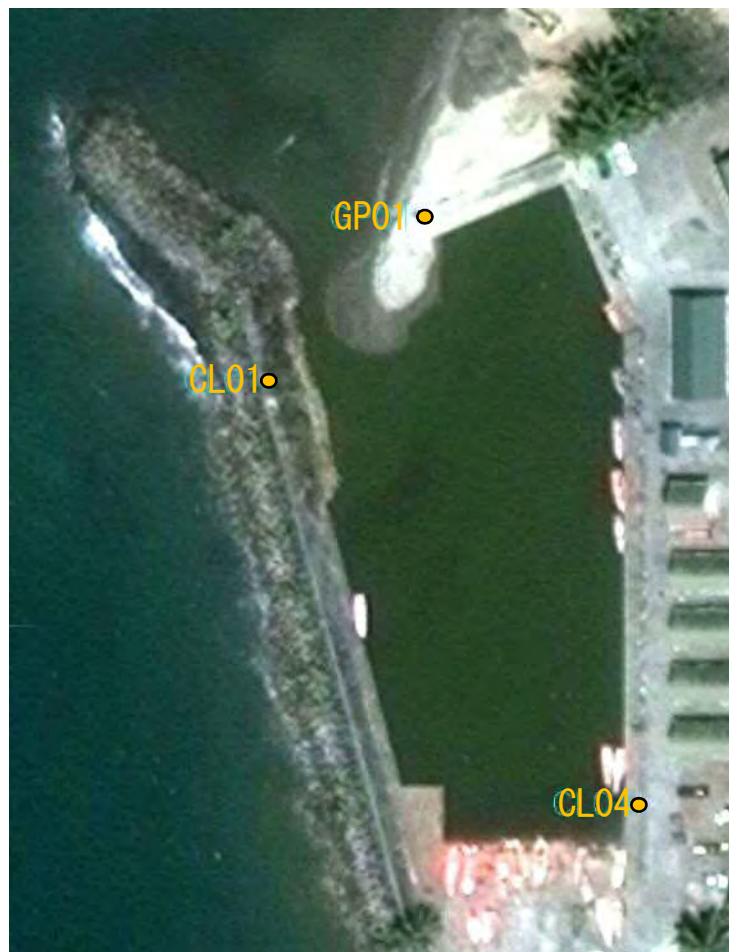
Figure 4-11 Location of each benchmark

Benchmark	Latitude	Longitude	Elevation
GP01	Lati. 13°46' 29.80016"	Longi. 61°03' 2.86970"	C.D.L +5.86m
CL01	Lati. 13°46' 28.92031"	Longi. 61°03' 3.69907"	C.D.L +4.26m
CL04	Lati. 13°46' 26.68071"	Longi. 61°03' 1.70921"	C.D.L +2.00m

The topographic survey was made from November 16 to December 1, 2016 by the local survey company (Hart, Hutchinson & Field) consigned. The shoreline surveys were made 3 times in November 14, 22 and 30, 2017 at the time of first site survey and also 3 times in August 10, 21 and September 25, 2018 at the time of second site survey. Table 4-3 shows the coordinate and elevation of each benchmark and Figure 4-11 shows each location of the benchmark.

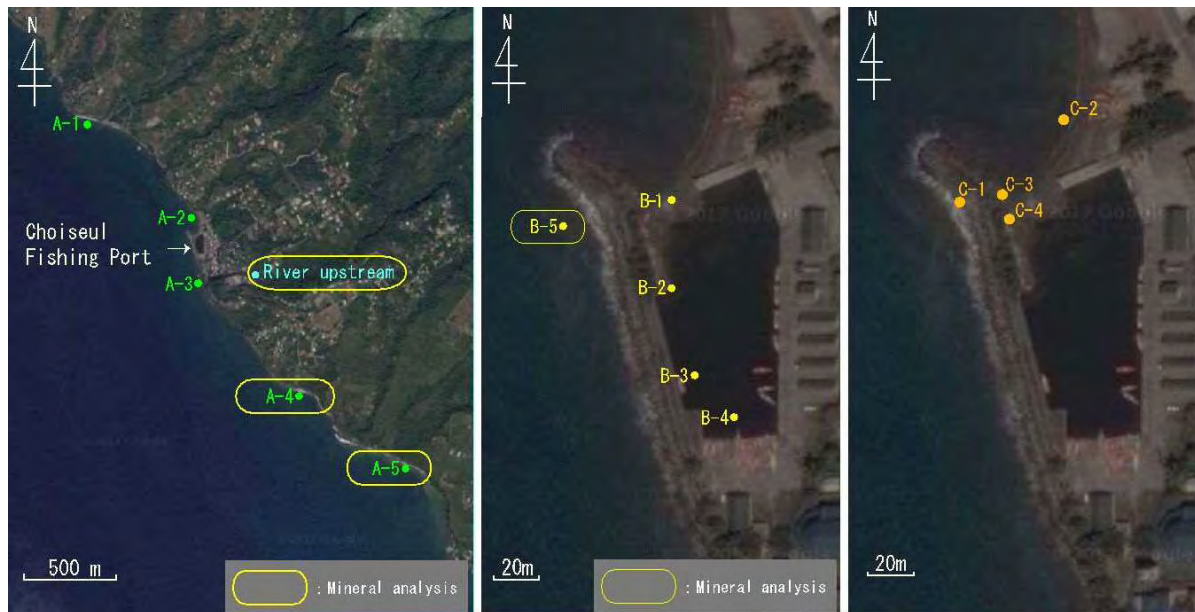
Figure 4-16 Sediment survey spot

For understanding the sand features settled in Choiseul fishing port, grain size test, density test, gravel confirming investigation and mineral analysis were conducted collecting sands from bottom and beach on November 2017. Table 4-4 shows the content of sediment survey, and Figure 4-16 shows survey points. Figure 4-17 shows the sand density in each collecting point, and Table 4-5 shows median grain size obtained by particle size distribution test.

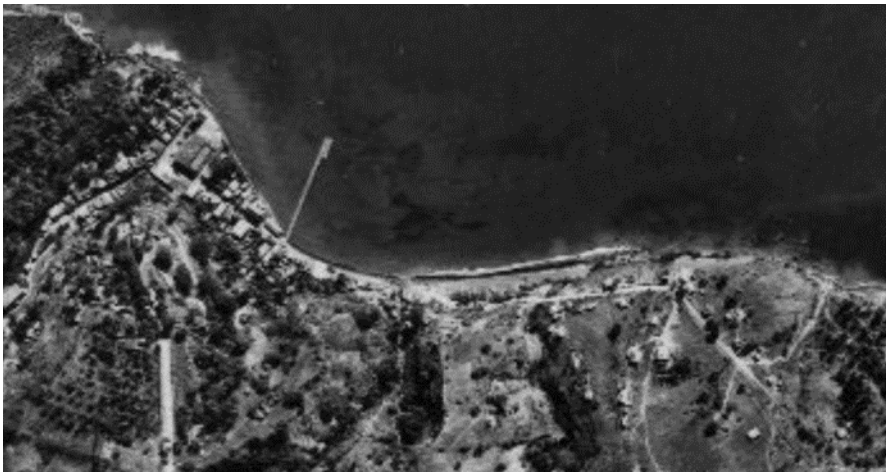
In 1966, there was an approximately 100 m long pier in Choiseul as shown in Photo 6-1. Although, the pier was not a fishery related facility, it was used as a maritime transport base for people and luggage. It was broken when the hurricane struck and has not been rebuilt since that time. It seems that the demands for maritime transport have been diminished as land transportation system has been developed.

Photo 6-1 The pier in Choiseul in April 18, 1966

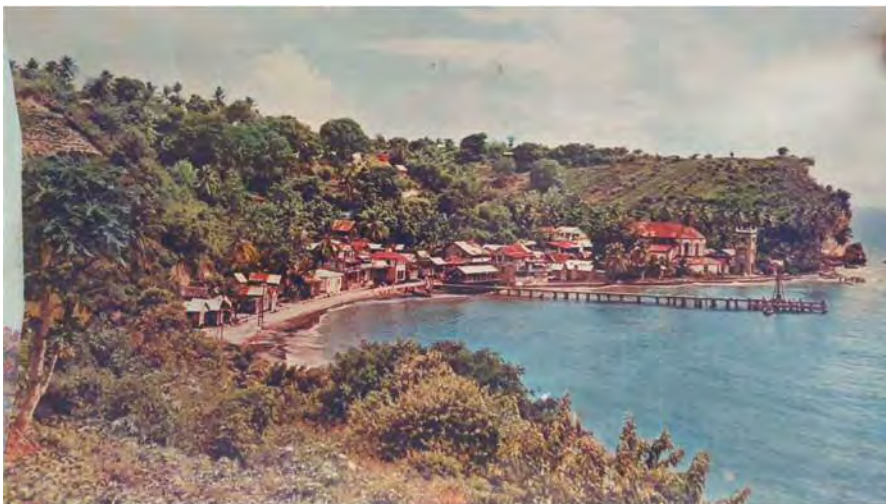
Referring to Photo 6-2, it is clear that the pier was a permeable structure supported by piles. This is one of the structural types that has the least impact on the surrounding terrain.

Photo 6-2 The pier in Choiseul (Unknown date)

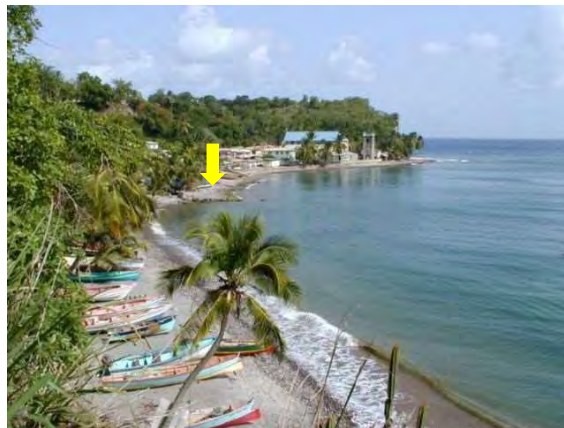
Photo 6-3 shows the coast before the construction of the Choiseul fishing port. It was taken in the same month as the bathymetric survey conducted in July 2000. The deposited topography near the center of the coast and the characteristic hook-like topography can be confirmed as shown by a yellow arrow in Photo 6-3. On the north coast (front coast in the Photo), it seems that the swash zone is composed of gravel, and the beach where boats are pulled up is composed of sand.

Photo 6-3 Coast in July 24, 2000, before the construction of the Choiseul fishing port

According to Photo 6-3 to 6-6 taken in July 2000, cobble stones are deposited in the swash zone of area from the near mouth of the Choiseul River to the hook-like topography. Because seaweed adheres to surface of the cobble stones near the sea surface, cobble stones are usually not rolled or transported. It seems that gravels are deposited on the northern coast of the hook-like topography and cobble stones are not deposited there.

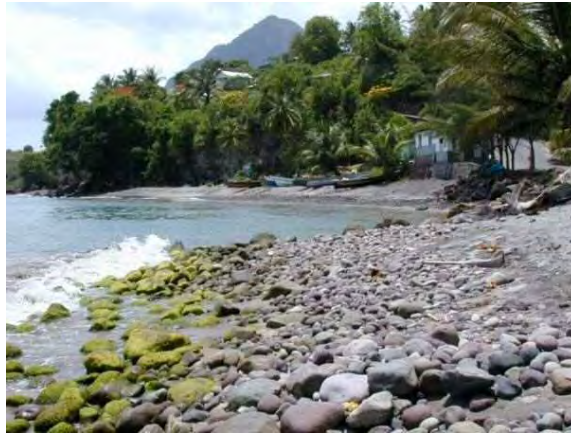
Direction (A)

In the foreground of Photo 6-4, which is taken in the direction of (A), the hook-like topography can be seen and clearly cobble stones are deposited. The cobbles on the swash zone are covered with green seaweed, so it is assumed that this photo was taken at the time of low tides and these cobbles would not be transported by usual waves.

Photo 6-4 The north coast taken from the vicinity of the hook-like topography in July 23, 2000

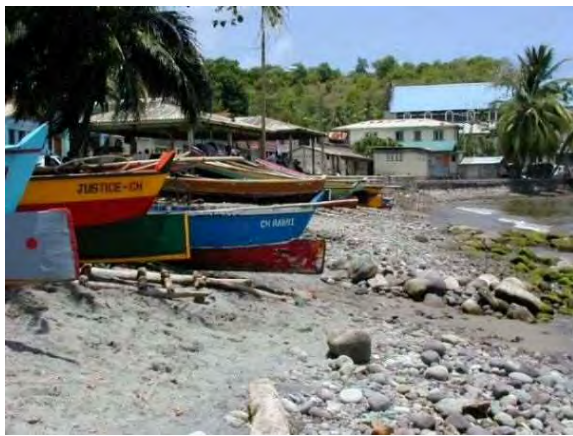
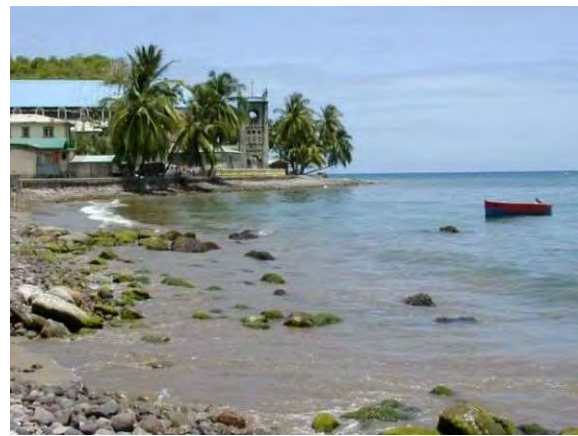
Photo 6-5 The south coast seen from around the hook-like topography in July 23, 2000

Photo 6-5 shows the conditions of the south coast seen from the location of the hook-like topography. Currently, the Choiseul fishing port has been constructed at this location. Many cobble stones are deposited at above the water surface. According to the picture in the shooting direction (C), it seems that seawater is turbid and sand is transported in suspension. In addition, the stones scattered underwater are large in size.

In the photographs taken in 2000 (e.g., Photo 6-5 shooting direction (C)), deposit of sand below the sea surface can be seen. Although the sea looks calm, the sea water near the shoreline is turbid and sand is transported in the state of beach drift. In other words, sand was expected to be always transported along the coast, but since depositional landform was mainly composed of is cobble stones, the landform was stable for a long time.

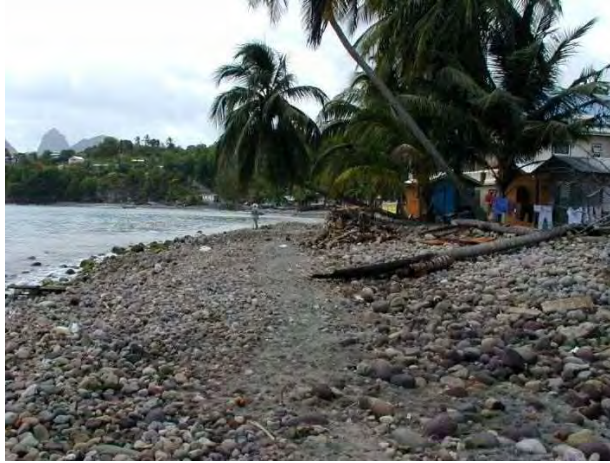
Photo 6-6 was taken in the Direction (D) seen from the right side of river mouth of the Choiseul River. The coast is mostly covered with gravel and cobble stones.

Photo 6-6 Direction (D) taken from the vicinity of the Choiseul River in July 23, 2000

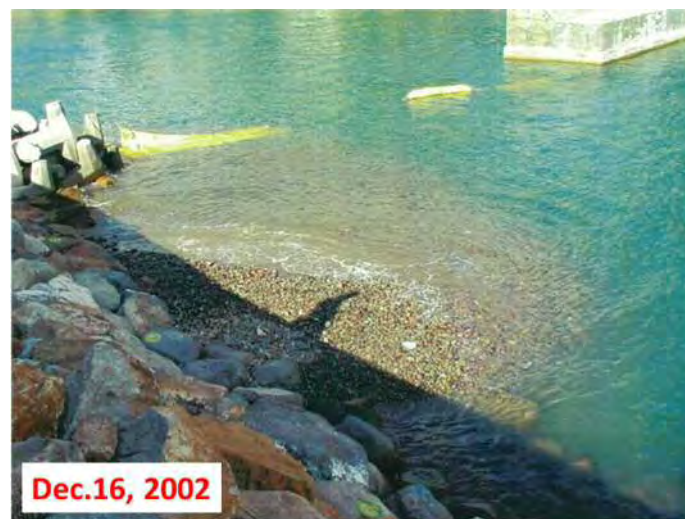
Photo 6-9 Deposition on December 16, 2002

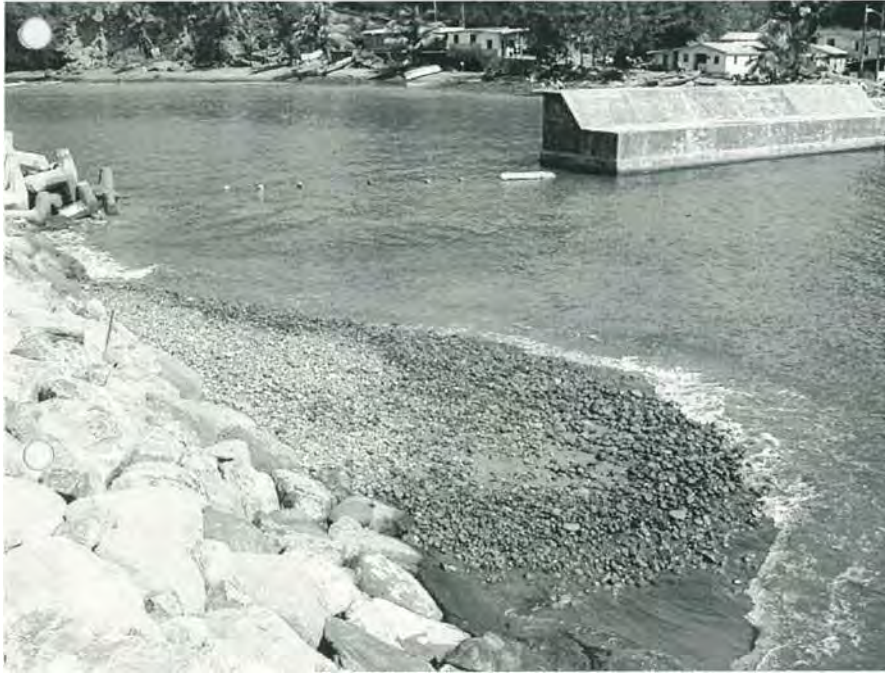
The close-up photos of the deposition were taken after 2 months, on February 6, 2003, shown in Photo 6-10 and Photo 6-11. Photo 6-10 shows the overall situation of the deposition. Photo 6-11 is the close-up photo of the deposition, and the white stick in the center is a triangular scale for 15 cm (actual length: 16.8 cm). As of February 6, 2003, the deposition had a wide range of particle sizes from fine sand to stones with a diameter of about 15 cm or more.

Photo 6-10 Deposition in the port on February 6, 2003

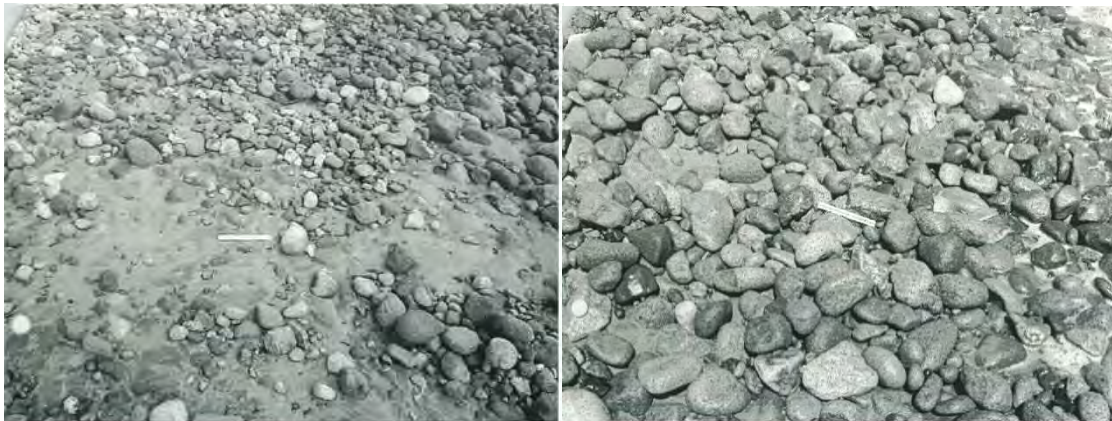
Photo 6-11 Close-up photo of the deposition on February 6, 2003; white stick is a triangle scale with a real length of 16.8 cm

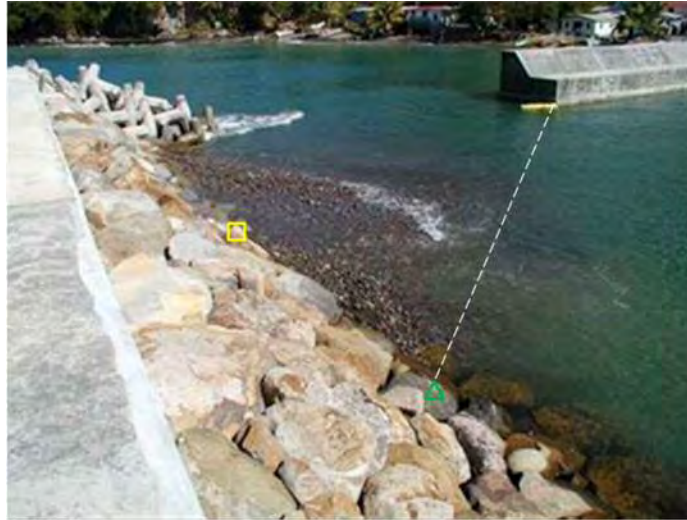
Photo 6-12 December 30, 2002

Photo 6-12 shows the condition on December 30, 2002. The deposition of cobble stones is located near the port entrance, outside of the dashed line, and the point marked □ is closely in the center of the deposition. Photo 6-13 shows the condition on January 6, 2003. Compared to photo 6-12 taken in 7 days ago, it seems that the deposition area on the water surface is extended. However, because the tide level in Photo 6-12 is high, it is judged that the amount and position of the deposition have not changed.
