DATA COLLECTION SURVEY ON CURRENT SITUATION
OF
THE PROJECT FOR IMPROVEMENT OF COASTAL
FISHERIES DEVELOPMENT
IN SAINT LUCIA

FINAL REPORT

JAPAN INTERNATIONAL COOPERATION AGENCY (JICA)

ECOH CORPORATION

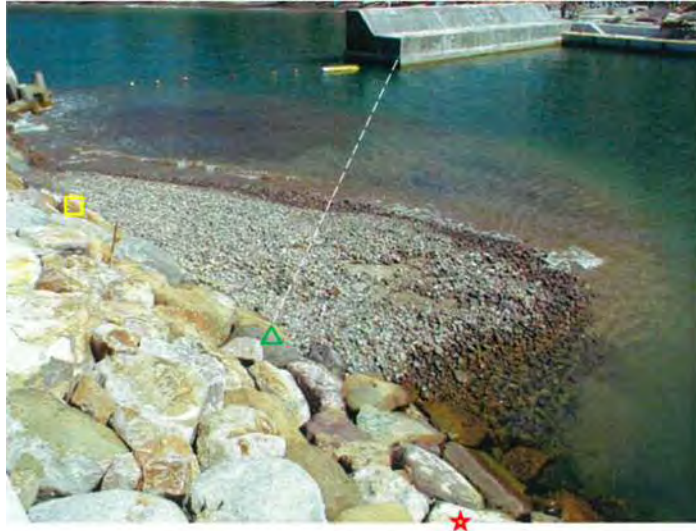
Photo 6-14 February 3, 2003

Furthermore, on February 3, 2003, the deposition clearly moved to the interior of the port, rightward in Photo 6-14. The edge of the moved deposition almost reaches the midpoint between the mark Δ and the mark \star . In comparison with Photo 6-13, port entrance side of the deposition approached the mark \square . It suggests that there was no (or just a little) supply of cobble stones from outside of the port in the process of the deposition of cobble stones being moved toward the interior of the port.

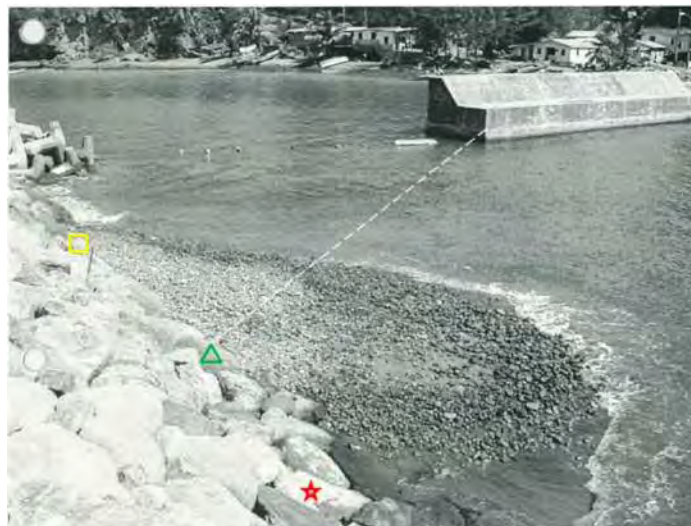
Photo 6-15, on February 6, 2003, was taken after 3 days from photo 6-14. Compared to Photo 6-14, the top of the deposition of cobble stones slightly developed over the mark \star to the interior of the port just in 3 days. It seems that developed area of the deposition is composed of sand, not cobble stones.

Photo 6-15 Deposition on February 6, 2003 (repost of photo 6-10)

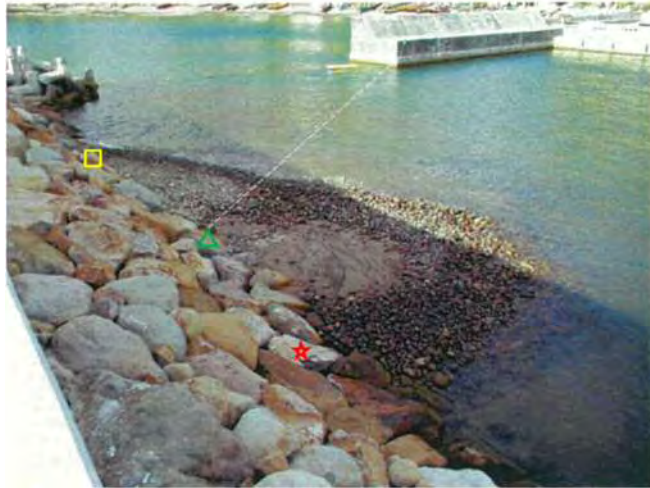
Photo 6-16 on February 17, 2003

The deposition that once developed beyond the mark ☆ to the interior of the port was eroded back to the mark ☆ and sand disappeared, and the surface of the tip was covered with cobble stones on February 17, 2003 as shown in Photo 6-16. A part of the disappeared sand seems to have been landed between the mark Δ and the mark ☆, but the amount is small, thus possibly most of the sand has been transported to further interior of the port.

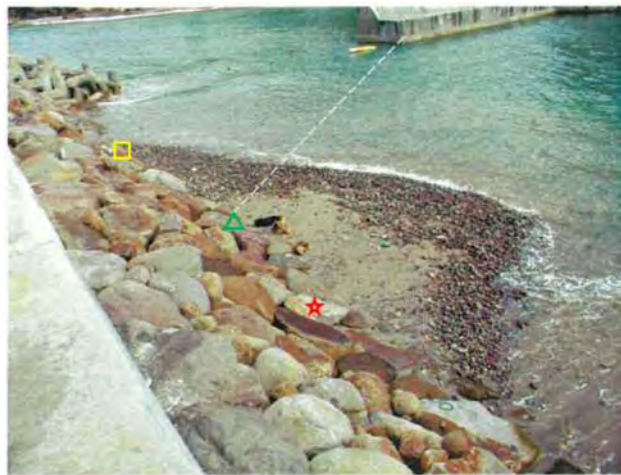
Photo 6-17 on February 24, 2003

Photo 6-17 was taken on February 24, a week later from Photo 6-16. The tip of the deposition developed again beyond the mark ☆ and further to the interior of the port. The edge of the deposition is covered with cobble stones. However, although cobble stones are scattered under water surface, it seems the sand deposits on the gentle slope. Sand has been landed beyond the area between mark Δ and mark ☆ in the central part of the deposition.

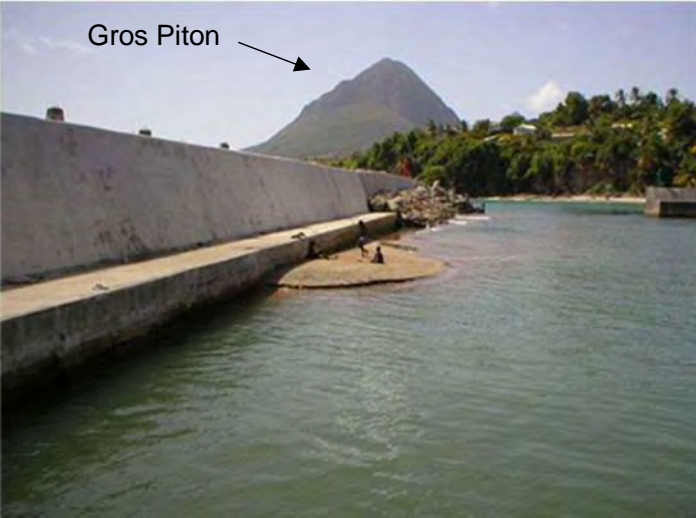
Photo 6-18 Deposition appearing on the sea surface in the fishing port taken on June 29, 2003

Photo 6-18 shows the deposition that appeared above the sea surface in the fishing port, which was photographed on June 29, 2003. The approximate location of deposition on the sea surface is shown in Figure 6-6 with a red hatch. The deposition was found further interior part of the port, not on the center of the foundation that was left. It is assumed that the sediments composing the foundation were carried further to the interior of the port by the waves intruding from the port entrance, and were deposited above the sea surface. Although it is difficult to specify the material from this photo, the material deposited above sea surface is probably sand. If so, the cobble stones were removed by dredging work and then new stones were not deposited after dredging work.

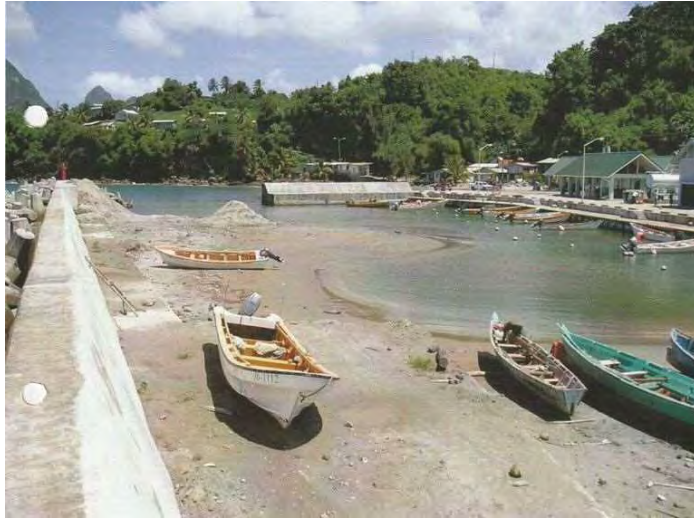
Photo 6-20 September 16, 2004

Photo 6-20 shows the deposition in the port after one year from Photo 6-19. Deposition extended to the interior of the port, and it spread to a wider area in the port. Cobble stones are not recognized in this photo. Shortly after this, a dredging work by a backhoe began as shown in Photo 6-21 and 6-22. According to Photo 6-22, the deposited material is apparently sand and does not contain cobble stones.

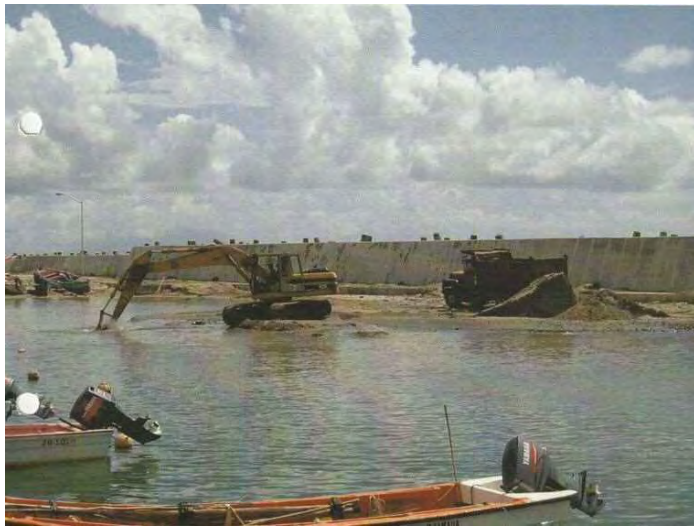
Photo 6-21 Dredging work by backhoe on September 21, 2004

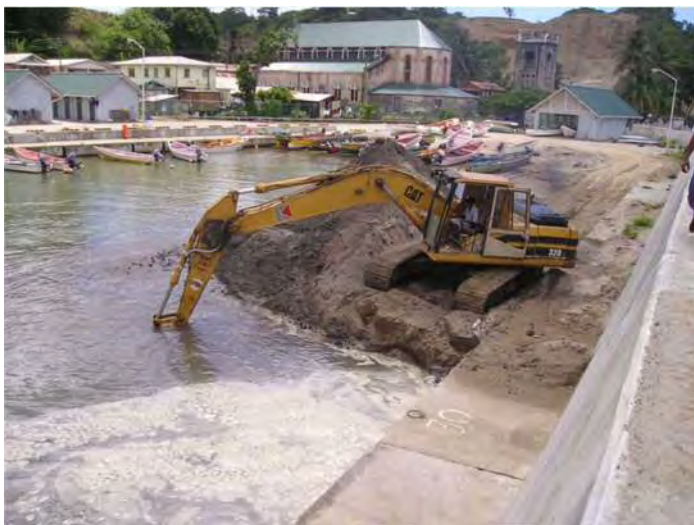
Photo 6-22 Dredging work by backhoe on October 19, 2004

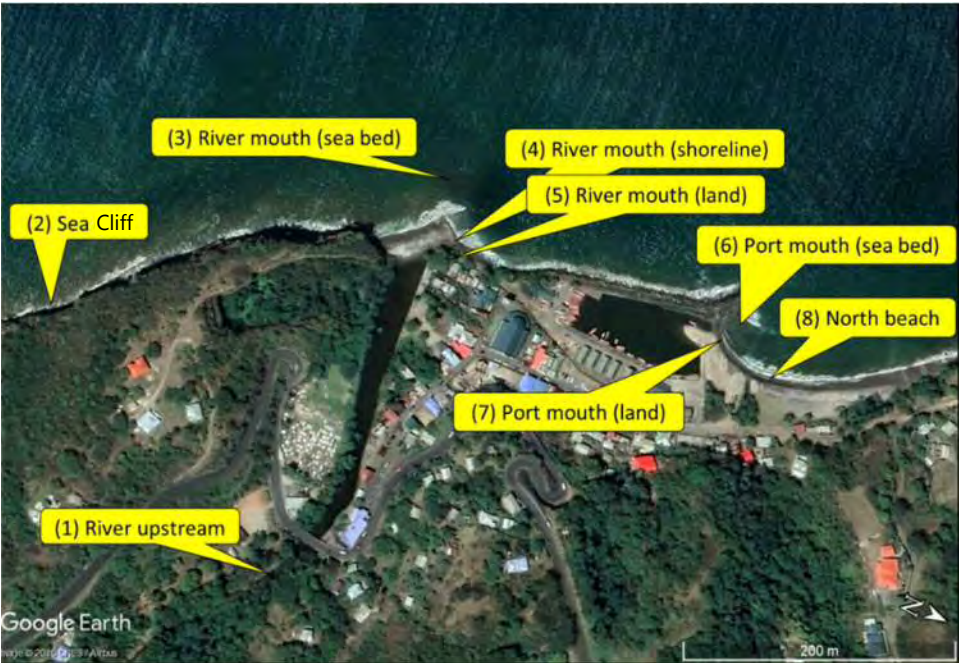
Figure 6-6 Places where cobble stones are accumulated or scattered
(Google Earth, taken on March 24, 2018)

When the area around the fishing port was examined, cobble stones were accumulated or scattered at the points shown in Figure 6-6. The features of points (1) to (8) are as follows.

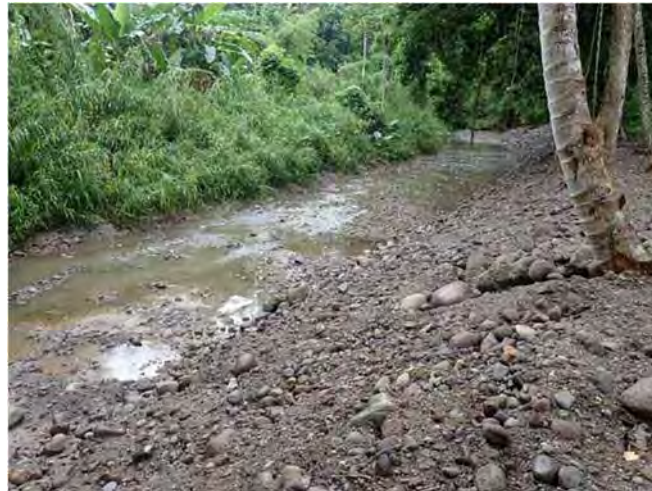
Photo 6-23 shows the river channel about 300 m upstream from the mouth of the Choiseul River. The bottom of the river is not the natural condition because dredging works by a bulldozer were conducted around here about 2 weeks before shooting, but there are cobble stones on the slope and the riverbed.

Photo 6-23 A point about 300 m from the mouth of the Choiseul River on December 6, 2017

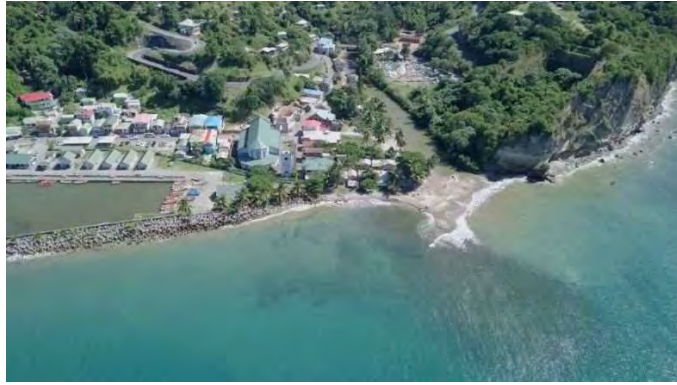
A photo 6-24 taken by a drone in November 2017 shows a black shadow linearly extending from seabed in front of the Choiseul river mouth to offshore. The bathymetric survey at the same time shows contour lines projecting to offshore directions from the river mouth (see Figure 6-7). There are cobble stones on the river as shown in Photo 6-23. From these facts, the black shadow in Photo 6-24 is considered to be the sediment that flowed out of the Choiseul River.

Photo 6-24 A black shadow of the sea bottom extending to offshore in the front of the river mouth
(Taken by drone on November 25, 2017)

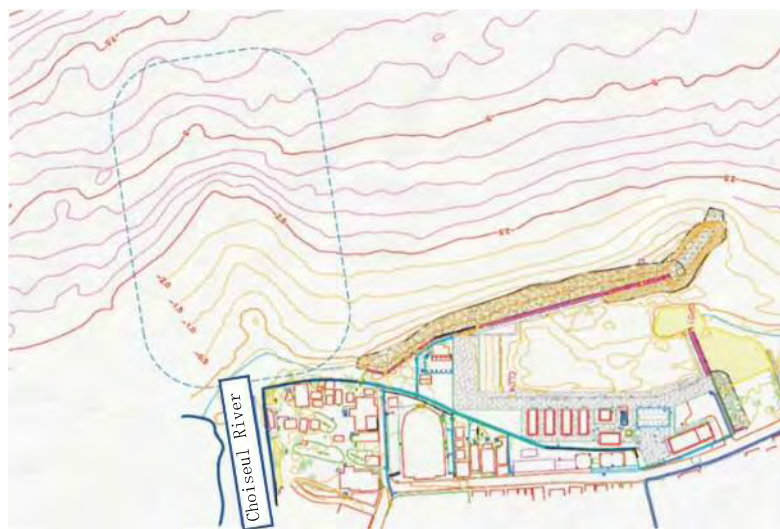
Figure 6-7 Depositional landform on the sea bottom in front of the Choiseul River mouth
(Survey on November 2017)

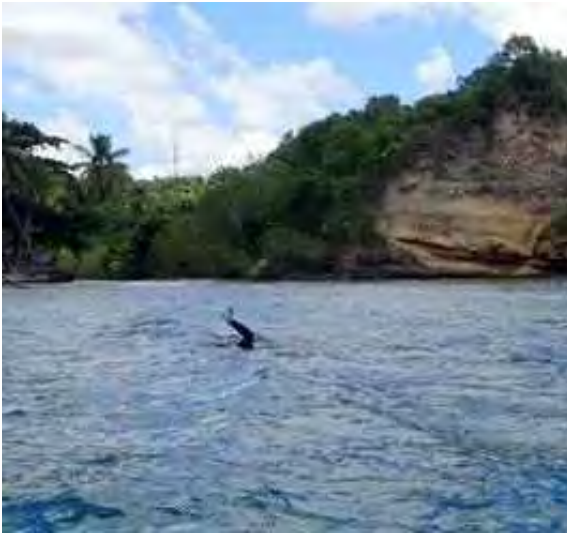
Photo 6-26 shows the diver measuring the accumulation area of cobble stones. The diver raised the GPS device above the sea surface and moved along the boundaries of the cobble stones. Also, the diver observed visually the condition of the seabed. Figure 6-9 shows the accumulation area of cobble stones comprehended by the survey.

Photo 6-26 Measuring of the accumulation area of cobble stones

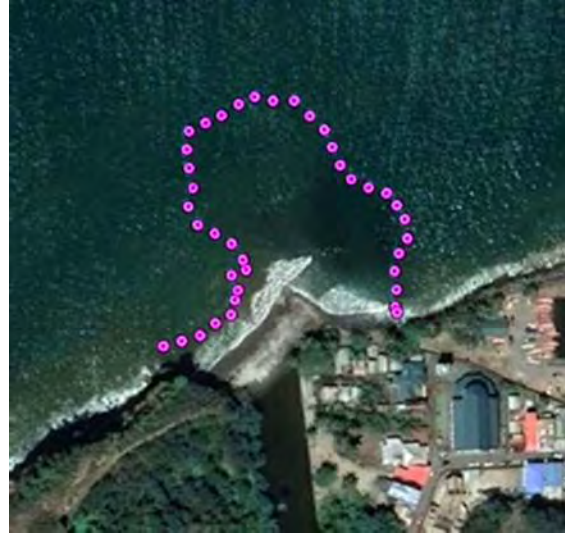
Figure 6-8 Accumulation area of cobble stones on September 3, 2018

It is considered that the cobble stones deposited in front of the river mouth are not constantly provided from the river every year, but such cobble stones are discharged altogether at the time of very large and rare floods.

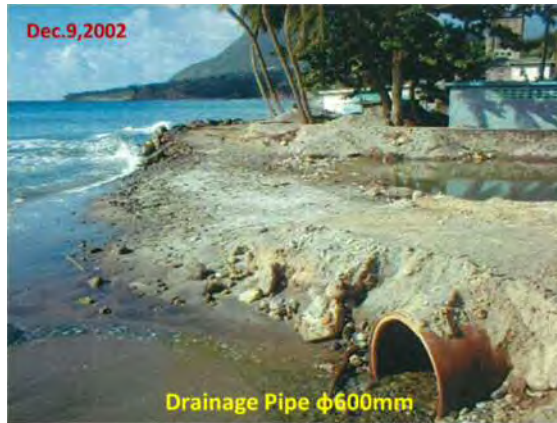
Photo 6-27 is a temporary road constructed at the mouth of the Choiseul river for the construction of the Choiseul fishing port. The temporary road completely blocks the Choiseul river mouth, so a pipe with a diameter of 600 mm is installed to discharge the river water. Since the diameter of pipe seems to be enough to drain the water from the river, it is inferred that sediment discharge including cobble stones from the Choiseul river is usually scarce. Sediment discharge occurs during a major flood. Considering the situation in Anse La Raye, the recent major flood from February 2009 was probably at the time of the hurricane Tomas attack on October 30, 2010. At that time, a large amount of sediment including cobble stones flowed out of the Choiseul river to the sea. Sand as well as cobble stones should have been included, but sand was unlikely to be deposited in front of the river mouth since the sand could be carried easier than cobble stones.

Photo 6-27 Temporary road and drainage pipe in the Choiseul river mouth

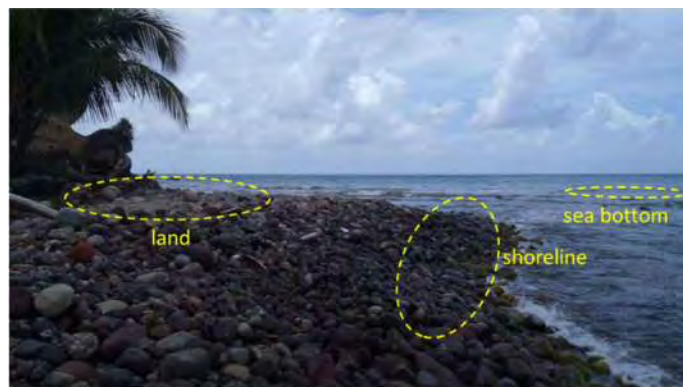
The cobble stones are also accumulated in the land area of the river mouth as seen in Photo 6-28. The cobble stones on the shoreline, indicated as "shoreline" in the photo, where the waves are affecting almost continuously are dark-colored.

Photo 6-28 Cobble stones at river mouth on August 18, 2018

Cobble stones are also deposited on the backshore of the land area in the river mouth, shown as "land" in Photo 6-28. Looking at the close-up photo of the backshore in Photo 6-29, it is recognized that the deposited cobble stones are whitish and sand is deposited among the cobble stones.

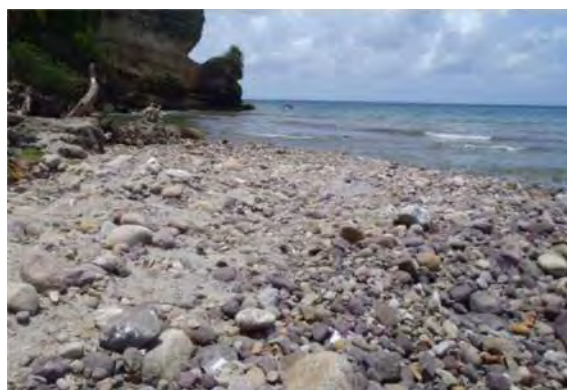
Photo 6-29 Close-up photo at backshore on August 18, 2018

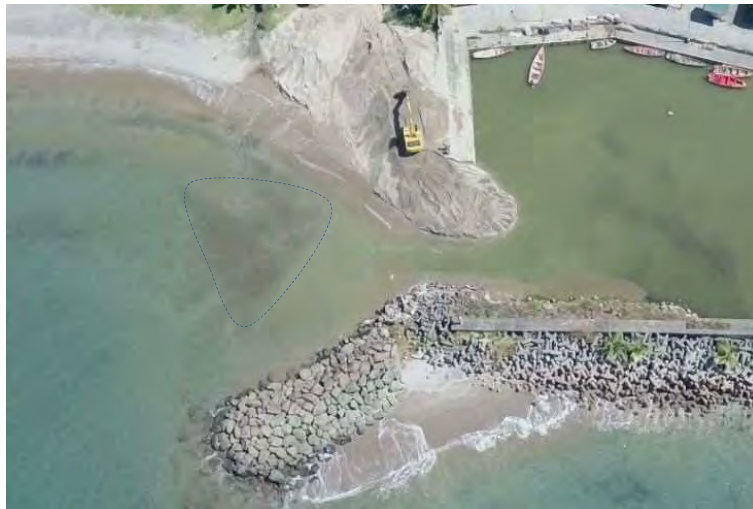
Photo 6-30 Black shadows of the seabed at the port entrance on November 25, 2017

Photo 6-30 is the entrance of the Choiseul fishing port taken by a drone. A black shadow, enclosed by dashed line in Photo 6-30, is observed on the seabed just outside of the port entrance. Actually, at the site, deposited cobble stones were confirmed as seen in Photo 6-31. The surface of stones covered by moss-like material. This means that these cobble stones do not roll on the seabed and stay the same place stably. Figure 6-9 shows the results of measuring the distribution area of cobble stones by walking along the boundary of accumulation area of the cobble stones and the sand with GPS. It roughly matches the area of the black shadow recognized in Photo 6-30.

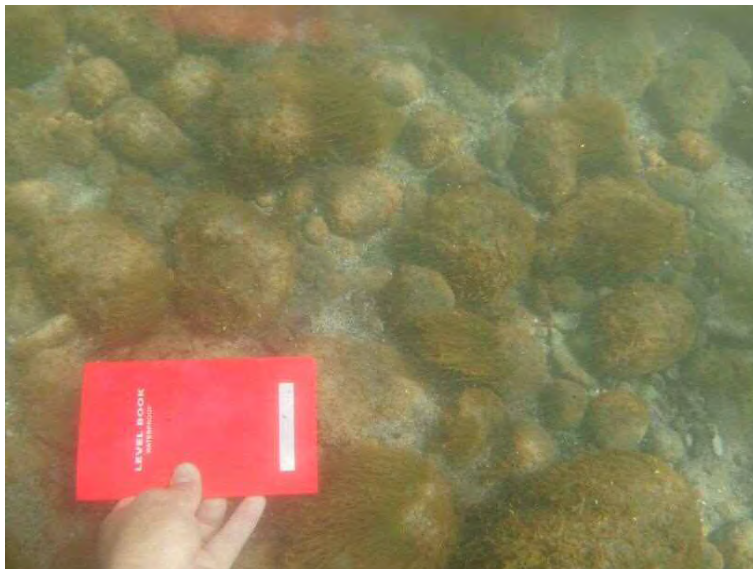
Photo 6-31 Cobble stones accumulated in the port entrance on November 29, 2017; the long side of the red Level book is 16.5 cm

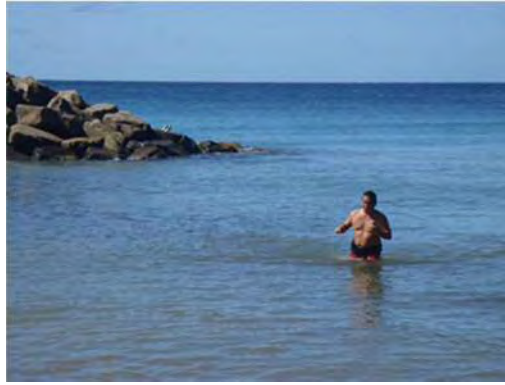
Photo 6-32 Measuring of accumulation area of cobble stones on November 29, 2017

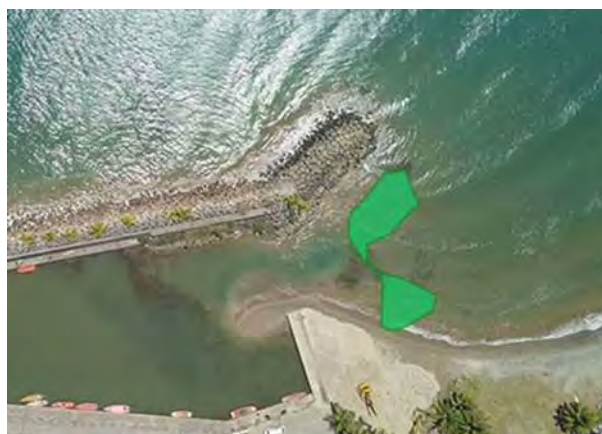
Figure 6-10 The cobble stone accumulation area in the port entrance on August 13, 2018

The same diver measured accumulated area of cobble stones on August 19, 2018, approximately 9 months later from first site works, Figure 6-10. The accumulations of cobble stones were confirmed at two places. Probably, the change of accumulation areas of cobble stones is not caused by waves, but by some effects of dredging work by a backhoe which is a yellow machine stayed at the lower side in Figure 6-10. For instance, sand deposited on cobble stones, and/or sand covering the cobble stones was removed.

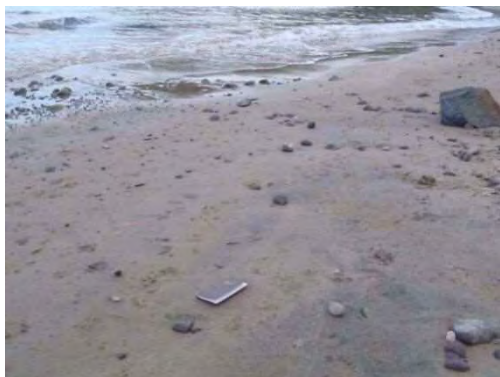
Photo 6-33 Cobble stones scattered in land area of port entrance on August 10, 2018

Photo 6-33 shows the conditions at the land area of port entrance. The cobble stones are not accumulated but scattered on the foreshore.

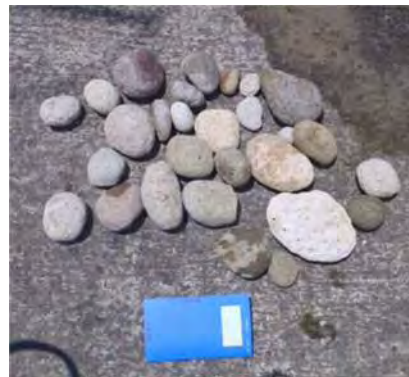
Photo 6-34 Cobble stones collected in north beach on August 10, 2018

Cobble stones are scattered on the backshore in the north beach, but sizes of the most cobble stones are small as seen in Photo 6-34.

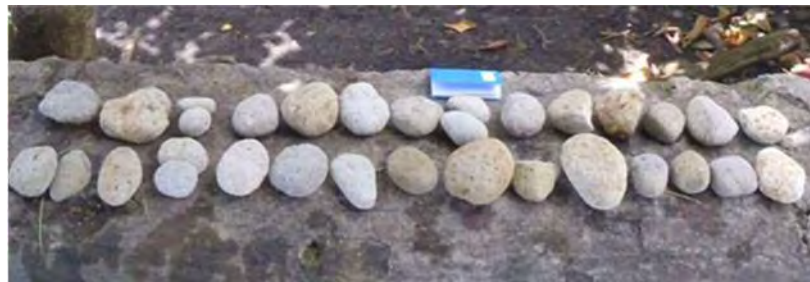
Photo 6-35 Cobble stones collected in (5) Land area at river mouth; the long side length of the field book is 16.5 cm

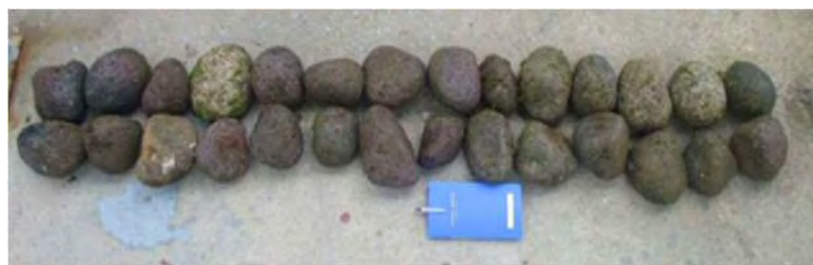
Photo 6-36 Cobble stones collected in (6) Seabed at port entrance the long side length of the field book is 16.5 cm

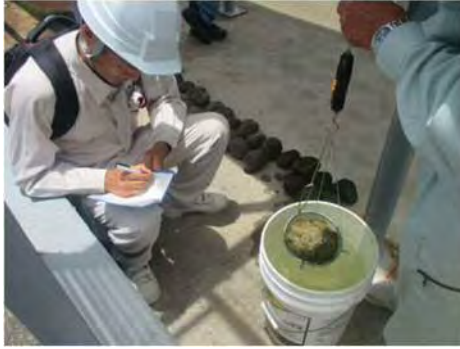
Photo 6-38 Measuring of weight in air

The weights of the cobble stones have been measured on site. The maximum weight of digital scale is 50 kg, and the sensitivity is 0.01 kg. The weights in the air and in seawater have been measured as shown in Photo 6-38 and Photo 6-39. The specific gravity of seawater is assumed to be 1.02, and the specific gravity of stone is calculated by equation (1). Regarding the sample of small size, several samples are put together and the total weight is measured as one sample.

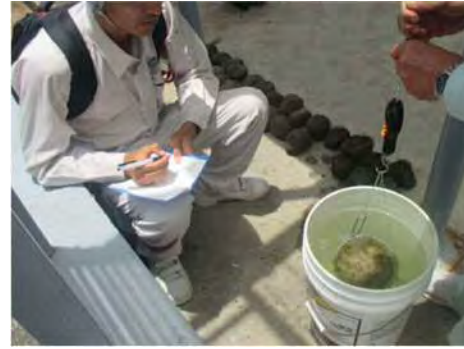
Photo 6-39 Measuring of weight in seawater

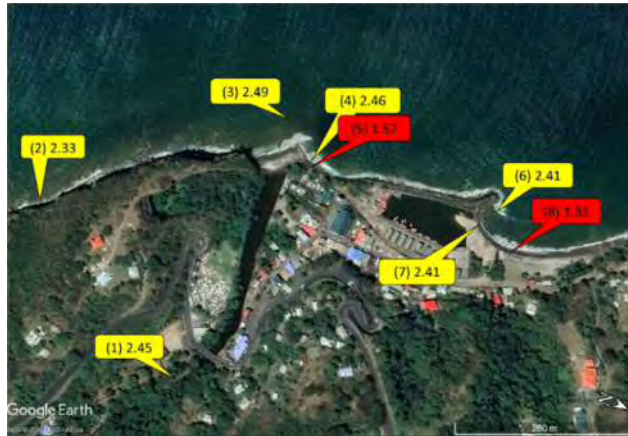
Figure 6-14 Average value of specific gravity of cobble stones

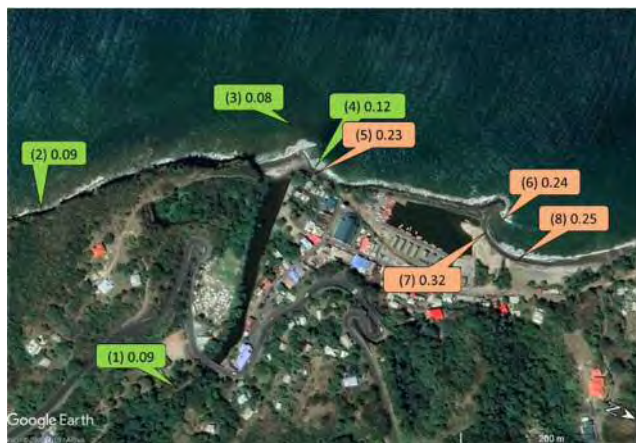
Figure 6-15 Standard deviations of specific gravity of cobble stones

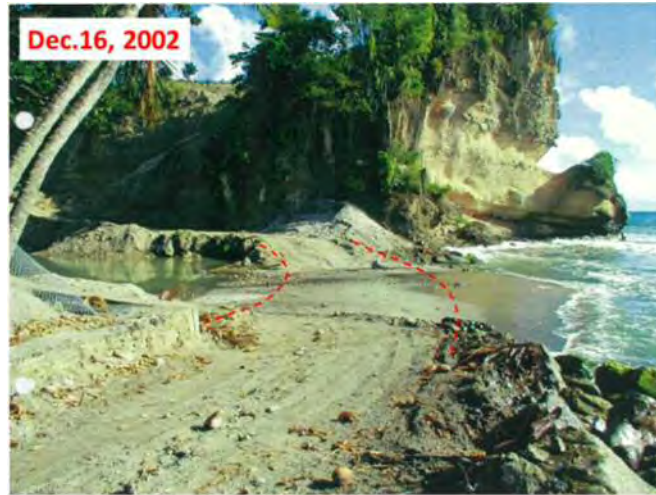
Photo 6-40 Temporary construction road at Choiseul river mouth

For the construction of the breakwater and transportation of wave dissipating blocks to be installed in front of the breakwater, the temporary road was constructed across the Choiseul river mouth (see Photo 6-40, Photo 6-41) up to the root of the breakwater (see Figure 6-22). The temporary road was still present as of December 2002. However, after the completion of the Choiseul fishing port on May 2003, the temporary road should have been removed.

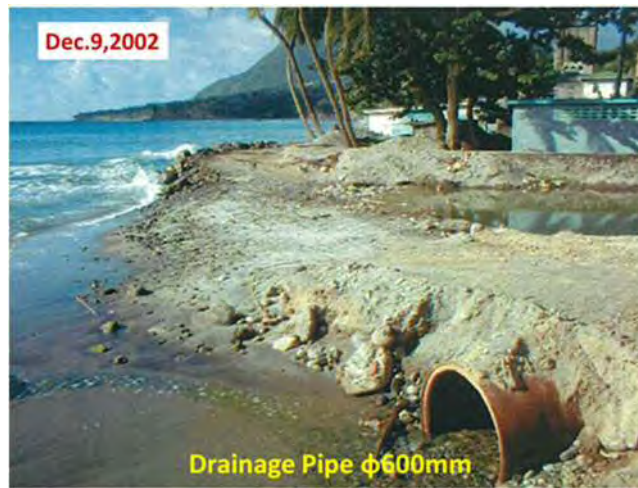
Photo 6-41 Temporary construction road and drainage

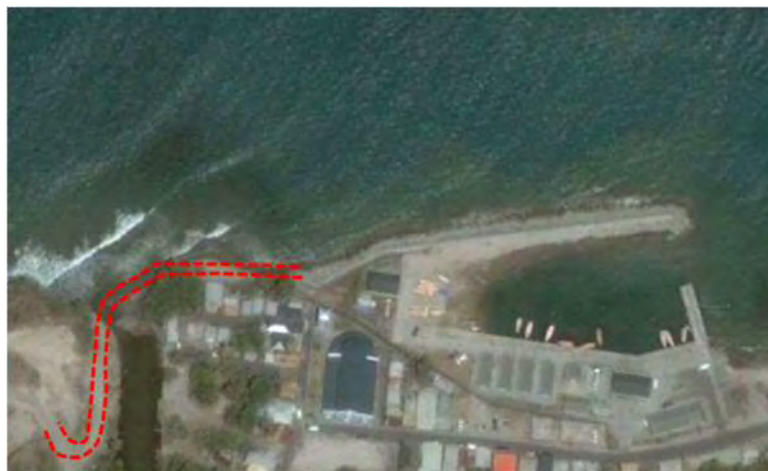
Figure 6-22 Estimated location of temporary construction road (Photo: Google Earth May 4, 2006)

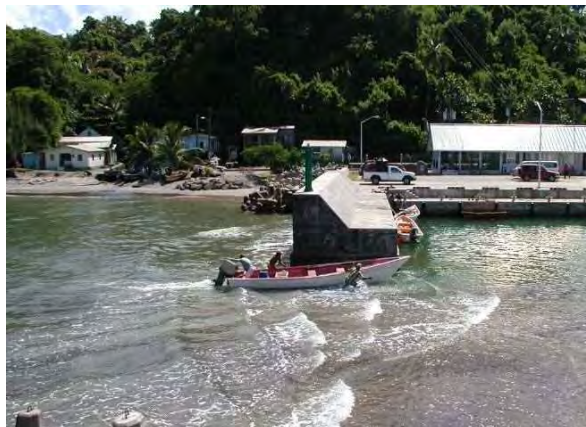
Photo 6-43 The fishing vessel returning to the port in August 28, 2004

In Photo 6-43, the fishermen are standing beside the fishing boat and pushing it, so it can be easily assumed that the port entrance is quite shallow. Two fishermen are outboard and another one is adjusting the angle of outboard motor with its propellers turning slowly. Looking at -1 m contour lines in Figure 6-23, it is clear that vicinity of the groin where the fishing boat is sailing, where the green beacon light is installed, is the deepest at the port entrance. At this time, the deposition occurred in the port as seen in Photo 6-44.

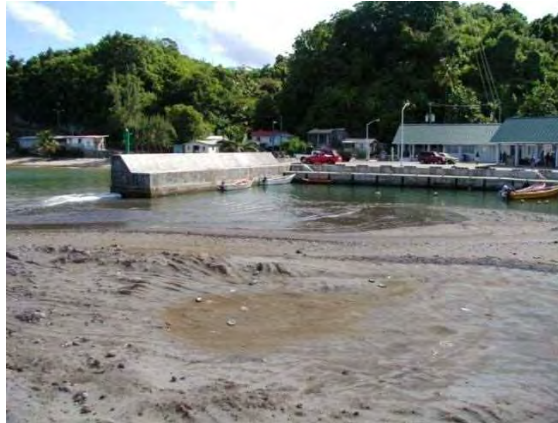
Photo 6-44 Deposition in the port in August 28, 2004

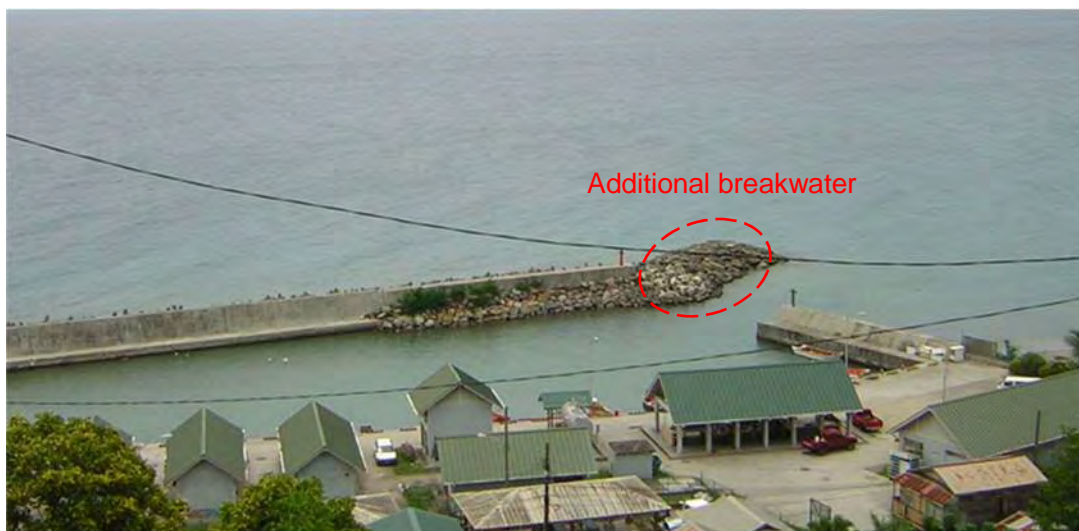
Photo 6-45 Choiseul fishing port on September 29, 2008

Photo 6-45 and 6-46 were taken just a month after the construction of the additional breakwater was completed. At the same time, the deposition in the pond was removed by dredging work. Looking at the air bubbles and ship waves generated by the propellers of the outboard motors attached on the fishing boat, it can be understood that the fishing boat is operated at a high speed. In other words, the port entrance was kept in good condition.

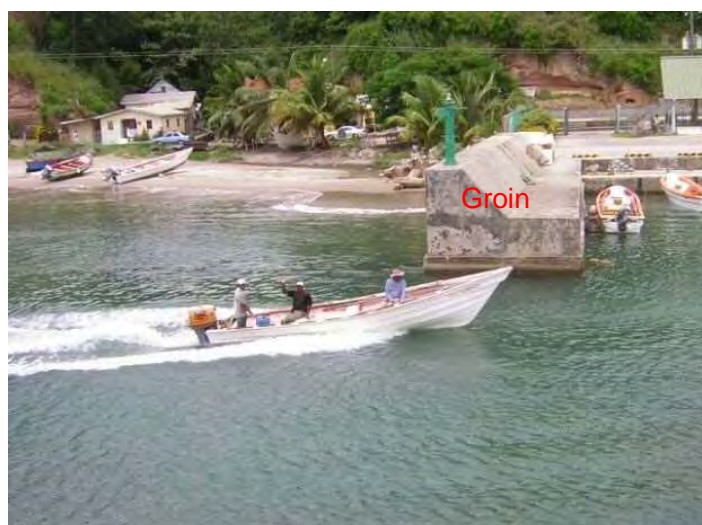
Photo 6-46 Port entrance on September 29, 2008

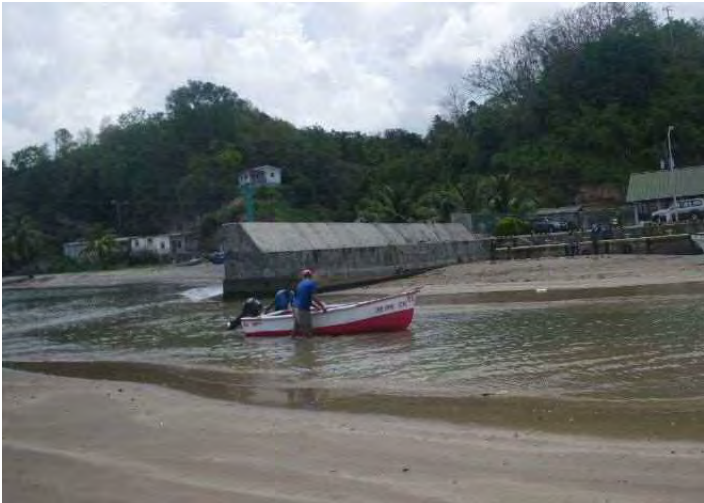
Photo 6-47 The fishing boat returning to the port (May 9, 2009)

However, the condition changes significantly after that. Photo 6-47 and 6-48 show the conditions approximately nine months after the construction of the additional breakwater. It is unclear whether a dredging work was executed or not during this time. In Photo 6-47, two fishermen are pushing the fishing boat to enter the port. The deposition seems to progress considerably. It should be noted that the fishermen are pushing the fishing boat and passing near the center of the port entrance. Before the construction of the additional breakwater, fishermen passed near the tip of the groin (see Photo 6-43). In other words, the relatively deep place where fishing boats can pass changed from the area close to the groin to the central area of the port entrance due to the construction of the additional breakwater. In Photo 6-48, the deposition occurs inside the groin. Deposition in this area was not found before the construction of the additional breakwater (see Photo 6-44). Furthermore, according to Photo 6-48, deposition also occurs on the outer side of the groin, and the shoreline advances forward. The advance of the deposition and shoreline outside the groin did not occur without the additional breakwater (Photo 6-43) and right after the construction of the additional breakwater (Photo 6-46).

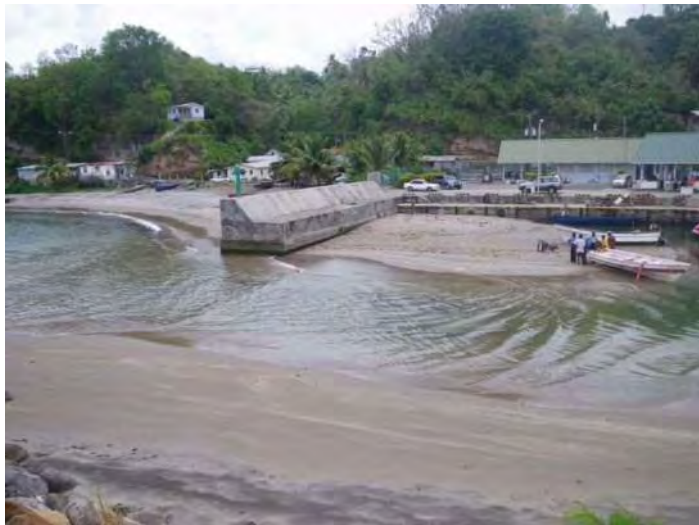
Photo 6-48 The port entrance (May 9, 2009)

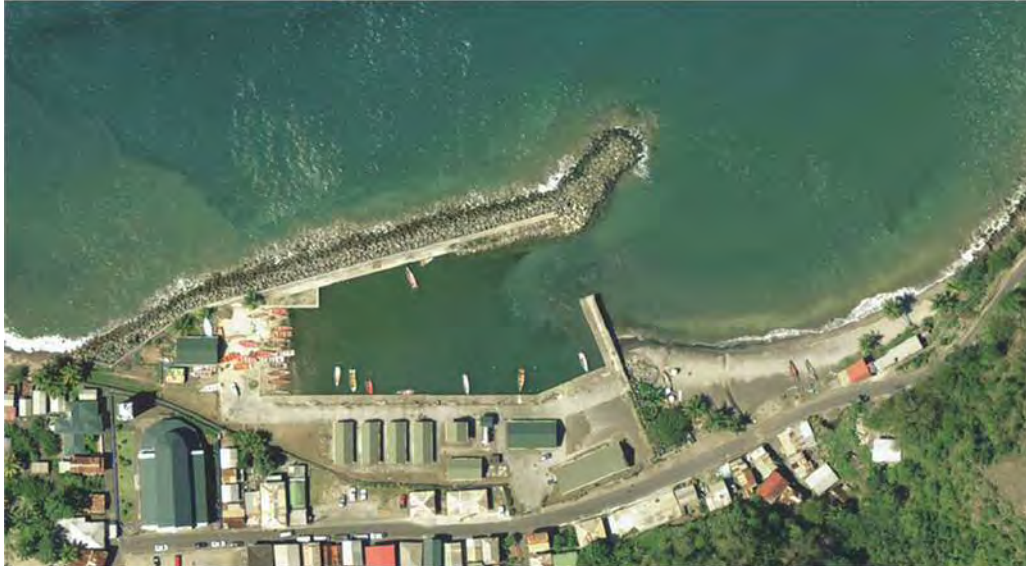
Photo 6-49 Choiseul fishing port on September 29, 2009

As of September 29, 2009, deposition in the pond disappears as seen in Photo 6-49. Probably, a large-scale dredging work was implemented between May 9 and September 29, 2009. About two months later as shown in Photo 6-50, although there is a slight deposition below the sea surface backside the breakwater, neither deposition at the port entrance nor advancement of the shoreline on the north beach is confirmed.

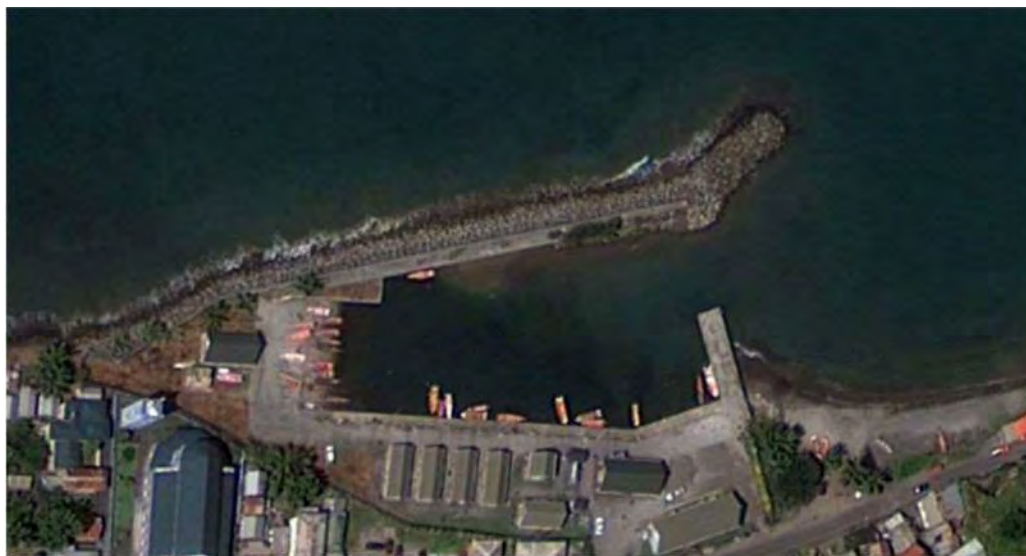
Photo 6-50 Choiseul fishing port (Google Earth; November 23, 2009)

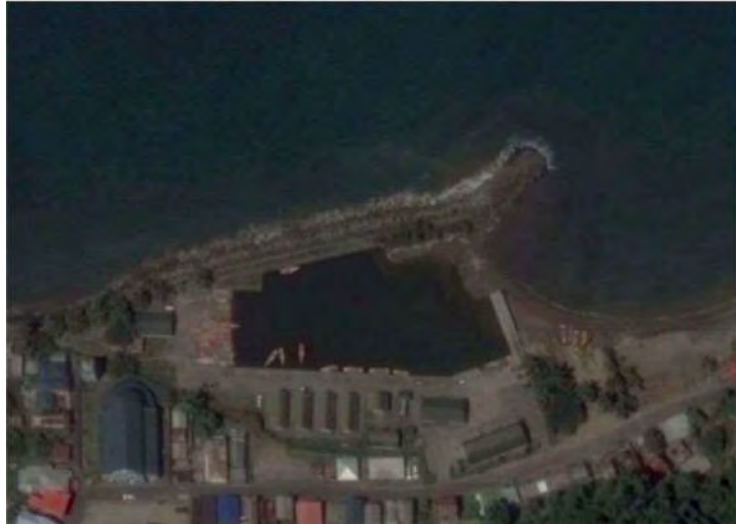
Photo 6-51 Choiseul fishing port (Google Earth; September 27, 2015)

Approximately 6 years later, on September 27, 2015 as shown in Photo 6-51 and November 4, 2015 as shown in Photo 6-52, the port entrance is completely closed and some fishing boats are pulled up on the beach outside of the port. The yellow backhoe seen in the Photo 6-52 had been provided by Japan to dredge the port entrance. However, at this time it has already been deteriorated and unusable.

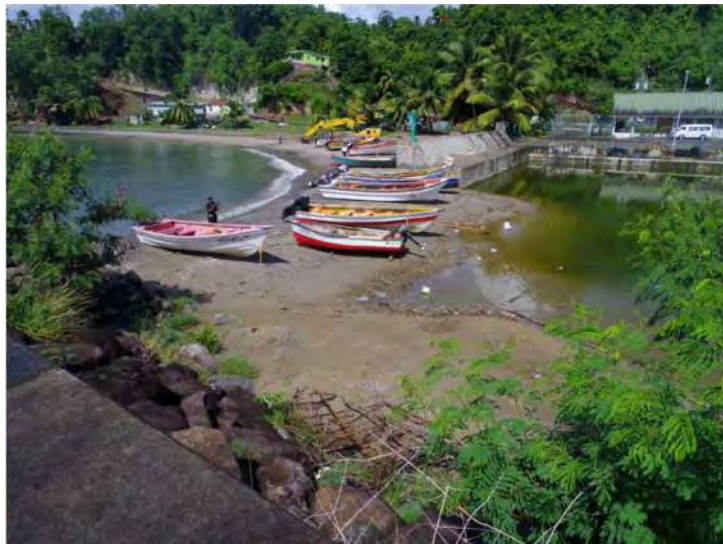
Photo 6-52 Port entrance completely blocked on November 4, 2015

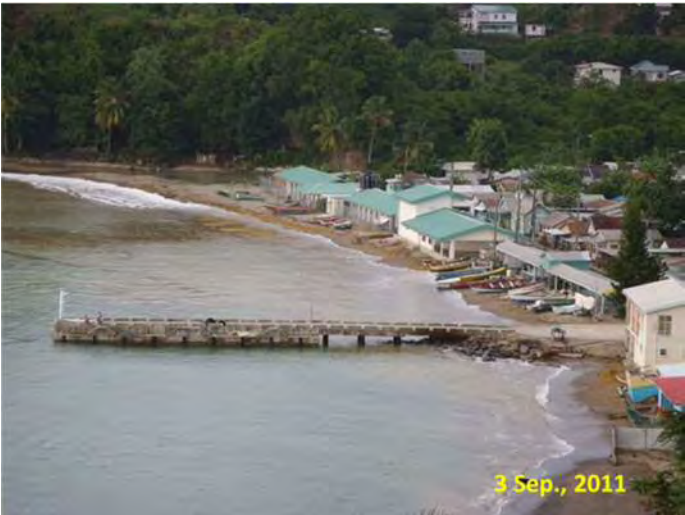
Photo 6-54 Anse La Raye Beach on September 3, 2011

Anse La Raye is located approximately 18.4km north of Choiseul fishing port in a direct distance as shown in Figure 6-34. The beach of Anse La Raye had its shoreline receding at a constant speed of 0.5m/year since 1966. As a result, waves acted directly on a part of the fishery complex (Photo 6-54, a green roof on a sandy beach) developed with the assistance of JICA as seen in Photo 6-54. Therefore, in September 2011, JICA conducted a survey for formulation of countermeasures against erosion and

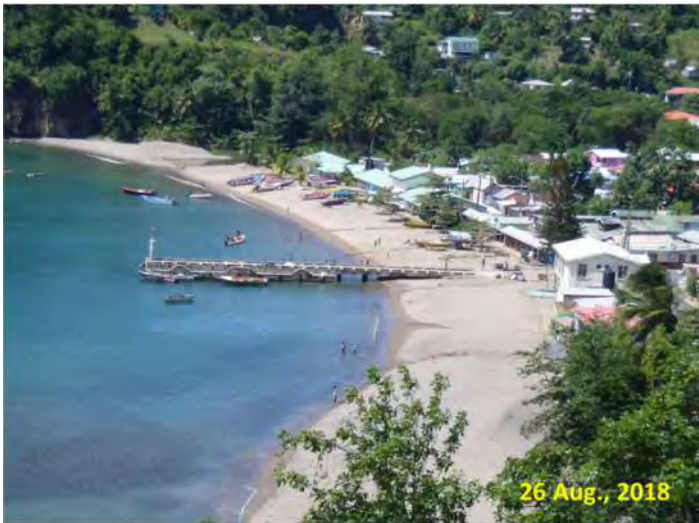
Photo 6-55 Recovered Anse La Raye Beach on August 26, 2018

Photo 6-55 is the condition of the beach of Anse La Raye about seven years later. No artificial treatment such as artificial beach nourishment has been added. As expected, sandy beaches have returned to nature on beaches where erosion has gradually progressed for several decades.

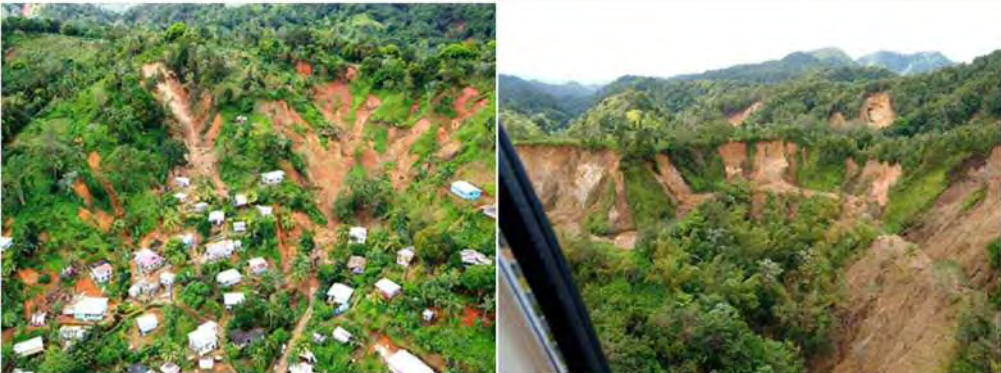
Photo 6-56 Massive hillside collapse due to hurricane Tomas

Figure 6-35 shows the daily rainfall observed at Hewanorra International Airport (see Figure 6-34). A record heavy rainfall of about 600mm has occurred on October 30, 2010, about a year before the JICA survey. This is due to the hurricane Tomas. The amount of rainfall is estimated to be once in 180 years. And large and small-scale landslides and hillside collapses occurred everywhere in St. Lucia (see Photo 6-56). Then, the sand that flowed out from the river flowing into the Anse La Raye bay deposited

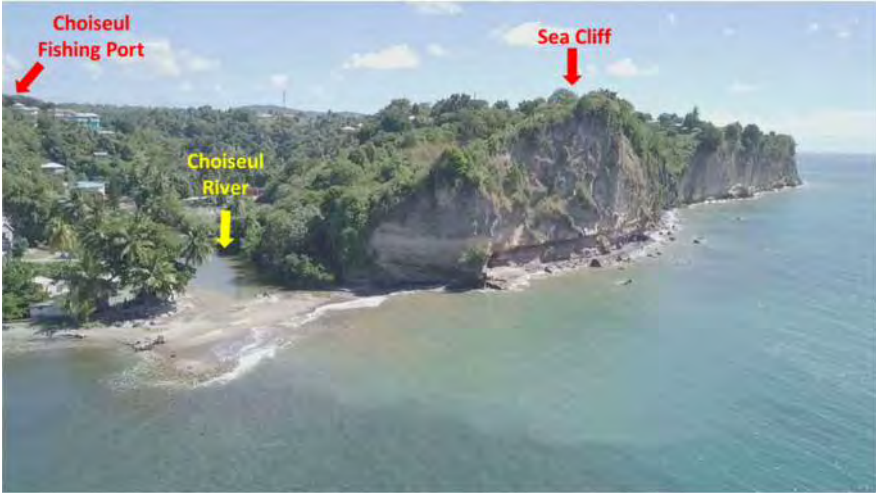
Photo 6-58 South Sea Cliff of the Choiseul fishing port
(Drone photo, 25 November 2017)

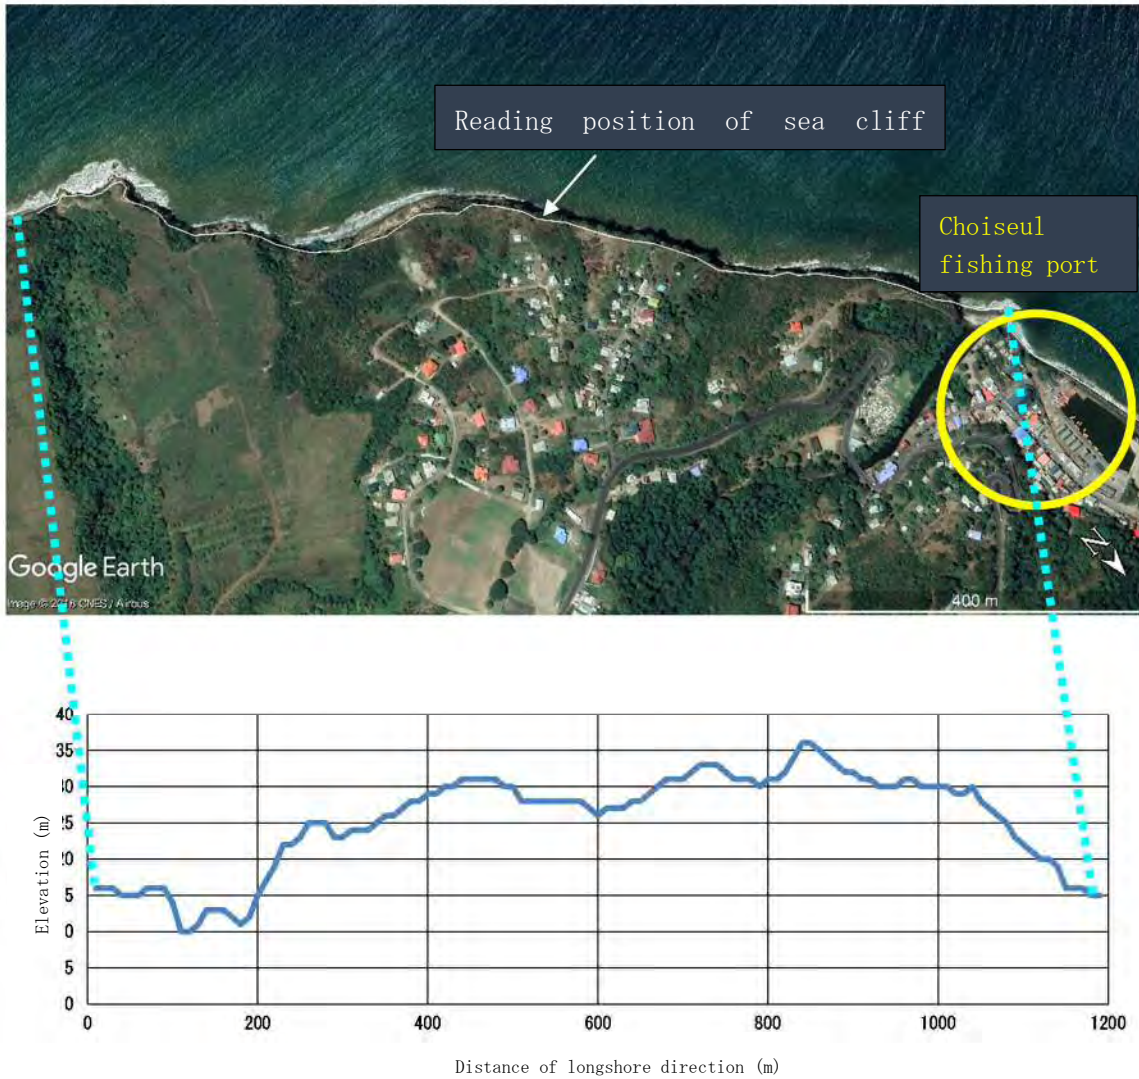
The elevation of the top of the sea cliff on the same survey lines with the interval of 10 m in the longshore direction has been read from a photograph of Google Earth, photographed on March 24, 2018. The upper part of Figure 6-42 is the reading point of the sea cliff elevation, and the lower part is the result.

Figure 6-42 Reading position of cliff topography (upper figure) and its elevation (lower figure)

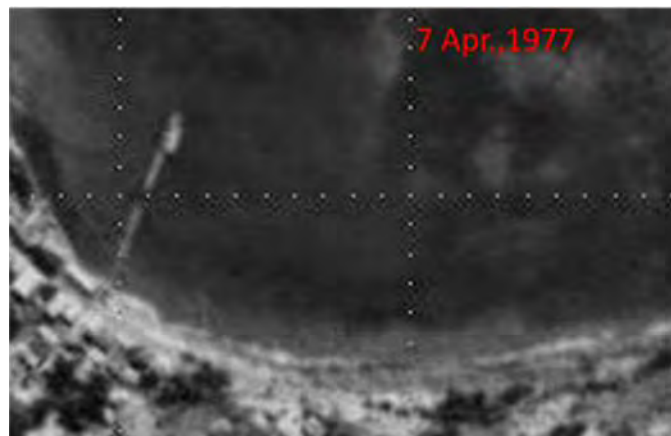
Photo 7-2 Initial shoreline at stage 1 (Taken on April 7, 1977)

In Stage 1, effects of the construction of the Choiseul fishing port occur, and the period of shoreline change reproduction covers from July 2002 to February 2007. It is confirmed that the construction of the breakwater and the installation of wave-dissipating blocks have been completed at the end of November 2007. However, since the data indicating the construction progress of the breakwater is not available, it is assumed for the reproduction that facilities had been already completed to a certain extent that affected sand transport as of July 2002, and this timing is set as an initial condition of the reproduction. Since there is no shoreline data in July 2002, the shoreline before the construction of the Choiseul fishing port is assumed to be stable. Shoreline shown in the aerial photograph as of April 7, 1977 (Photo 7-2) is set as initial shoreline for reproduction.

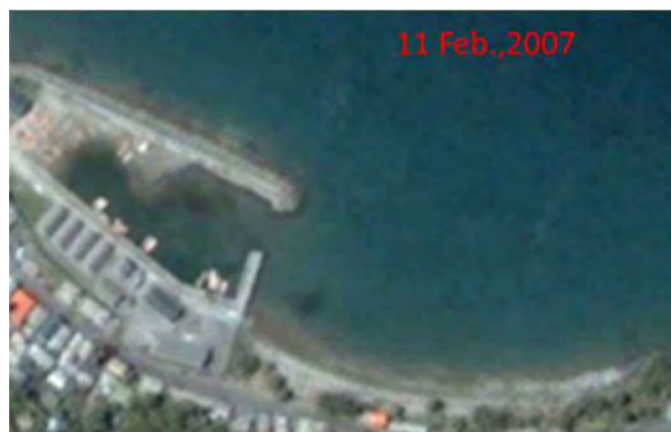
Photo 7-3 Reproduction target in Stage 1 and also initial shoreline in Stage 2  
(February 11, 2007, Google Earth)

Photo 7-3 was taken on February 11, 2007, and this shoreline is the reproduction target in Stage 1.

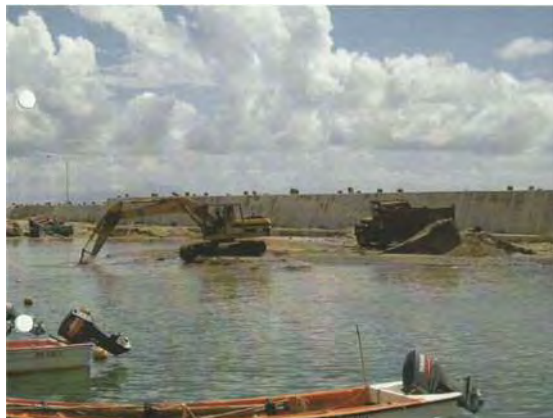
Photo 7-4 Dredging work in the port during Stage 1 on September 21, 2004

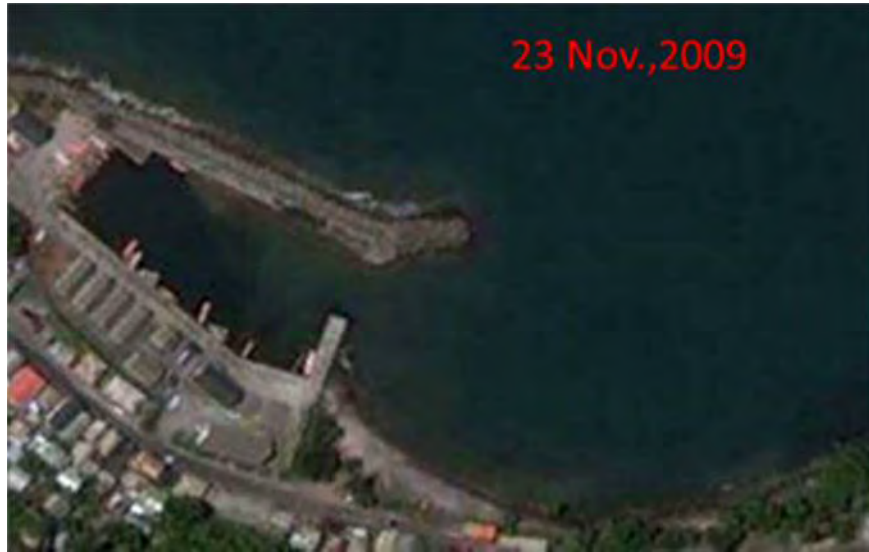
Photo 7-5 Initial shoreline in Stage 2 (November 23, 2009, Google Earth)
