DATA COLLECTION SURVEY ON CURRENT SITUATION
OF
THE PROJECT FOR IMPROVEMENT OF COASTAL
FISHERIES DEVELOPMENT
IN SAINT LUCIA

FINAL REPORT

JAPAN INTERNATIONAL COOPERATION AGENCY (JICA)

ECOH CORPORATION

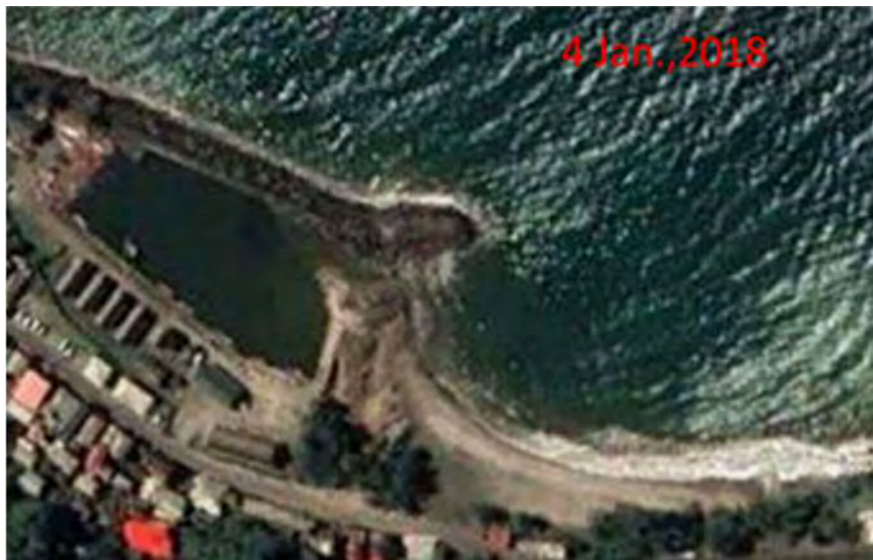
Photo 7-6 Target shoreline in Stage 2 (January 4, 20108 , Google Earth)

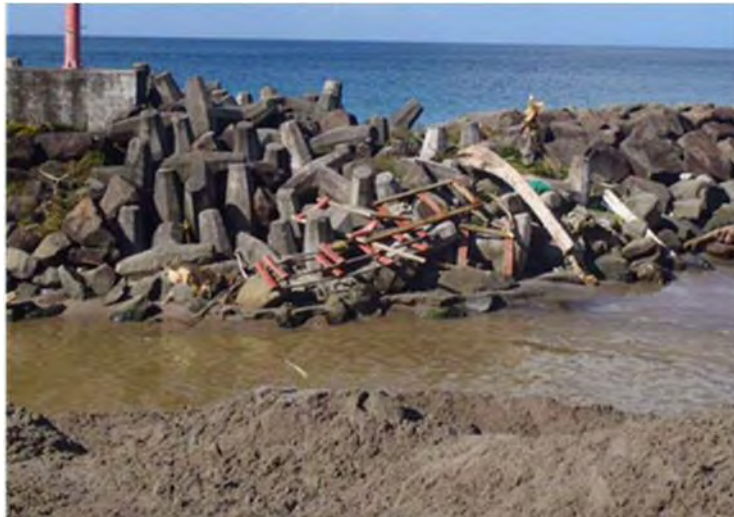
Photo 7-7 View of port entrance on November 21, 2017

In Stage 3, dredging work by backhoe is being implemented. Dredging work by backhoe began on December 23, 2016. The dredging work about in the first one year was small-scale. It seems that the work was for excavating a waterway for fishing boats, rather than maintaining a navigation channel. For example, in Photo 7-7, some tools which seem to be ladders are placed on the wave dissipating blocks. These are auxiliary tools which are used to slide and land fishing boats on the beach. Ladders being put such a place imply that port entrance is often closed and fishing boats cannot navigate. Photo 7-8 shows a scene that the study team is leaving the port for regular inspection of the offshore wave gauge. The port entrance is so shallow, water depth of ankle height, that the study team finally can pass the port entrance by pushing the boat with eight people. Photo 7-9 shows the view of the port entrance on January 4, 2018. There is only a narrow waterway that allows one fishing boat to pass at one time.

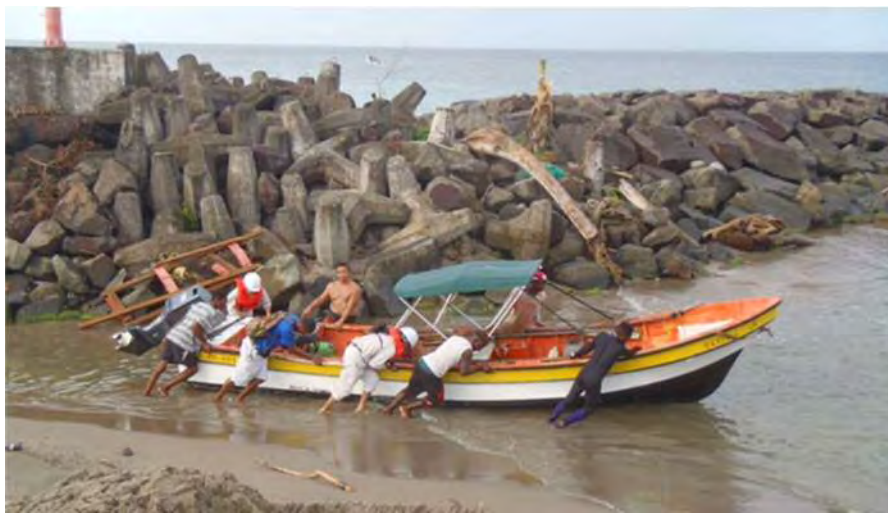
Photo 7-8 View of port entrance on December 5, 2017

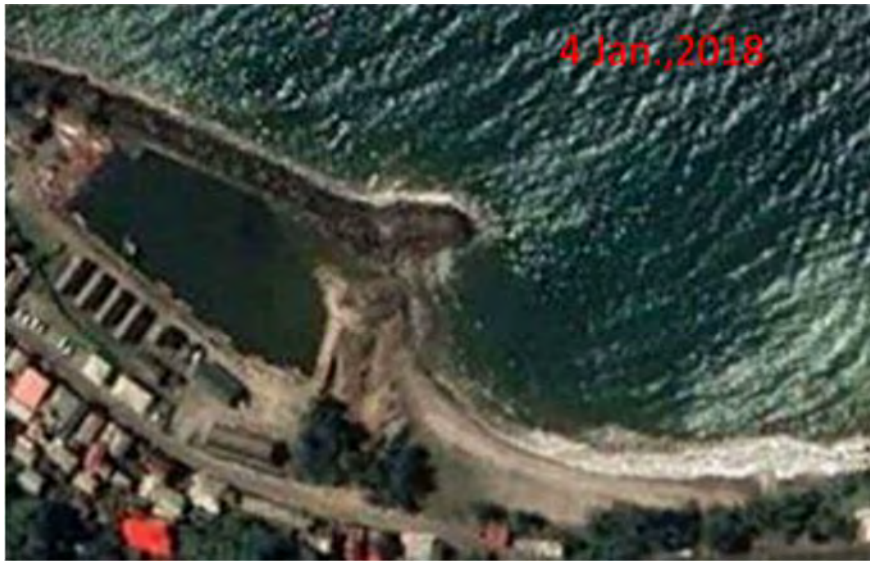
Photo 7-9 Initial shoreline in Stage 3 (Previously shown as Photo 7-6, January 4, 2018, Google Earth)

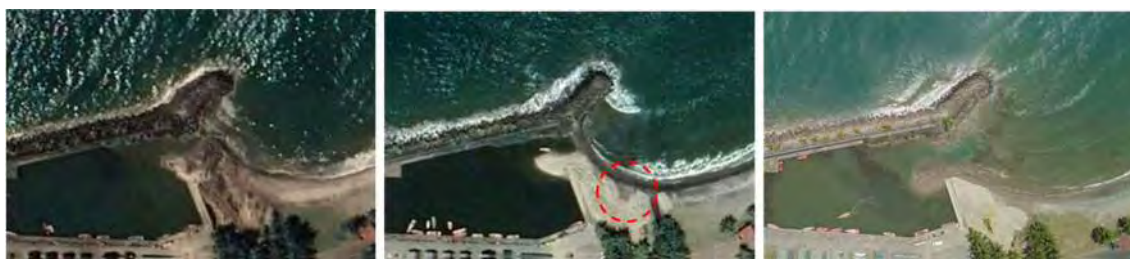
In stage 3, the amount of sand deposited around the port entrance gradually decreases as shown in Photo 7-10, which is explained in detail in **2.6 Record of dredging works by the government of Saint Lucia after construction completion in 2003**. It is because of the effect of the improved excavation method by backhoe. Although the timing of introduction of the improved method is unclear, it can be understood that the improved method was applied as of March 24, 2018, since the trace of excavation is recognized in the photo on the same day. For this reason, it is necessary to consider the amount of sand excavated from the beach in the reproduction in Stage 3. However, the amount of sand excavation is unknown. In order to evaluate its amount, two factors are taken into consideration; that is, the eroded amount of  $2,182\text{m}^3$  in an area surrounded by a blue line in Figure 7-20, which is estimated based on the results of bathymetric survey conducted on December 30, 2017 and on September 25, 2018, and an excavation period of 6 months. Referencing to Figure 7-21, the longshore sand transport rate of  $660\text{m}^3/\text{month}(= 8000 \text{ m}^3 / \text{year})$  is entered into the blue box, while the excavated volume of sand is  $360\text{m}^3/\text{month}(= 2183 \text{ m}^3 / 6 \text{ month}) + \alpha$  and the remaining amount of sand,  $660 \text{ m}^3 / \text{month} + \alpha$ , is transported to the north. After several trial calculations,  $\alpha$  is set as  $140 \text{ m}^3 / \text{month}$ .

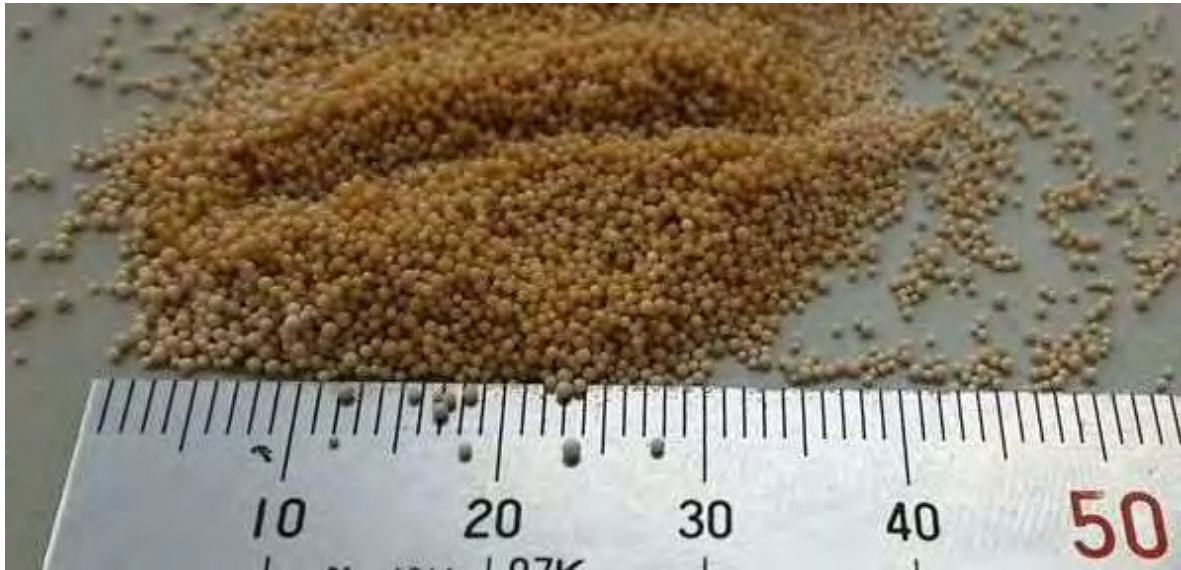
Photo 7-12 Particles of ion exchange resin utilized as tracers  
(Median grain size is 0.68 mm and specific gravity is 1.26)

Topography changes such as the deposition (sedimentation) and the erosion (scouring) cannot be reproduced by the fixed bed model experiment. Therefore, the methodology frequently used is that the injected tracers are tracked, and sediment transport at site and topographic changes such as deposition and erosion are inferred. Material which is almost same as sand in particle diameter, is smaller than that of sand (2.65) in the specific gravity, and is easy to obtain, is selected as the tracer in general. The particles of ion exchange resin are utilized as the tracers in the model experiment of Choiseul fishing port (Photo 7-12). The median grain size of this material is 0.68 mm and the specific gravity is 1.26. However, since there is no similarity law related to the movement of particles of ion exchange resin, it is required to testify that they are useful enough for understanding the sediment transport and the topographic change in the field. This is testified performing the experiment for reproduction of sand deposition in the port in 7.2.2.

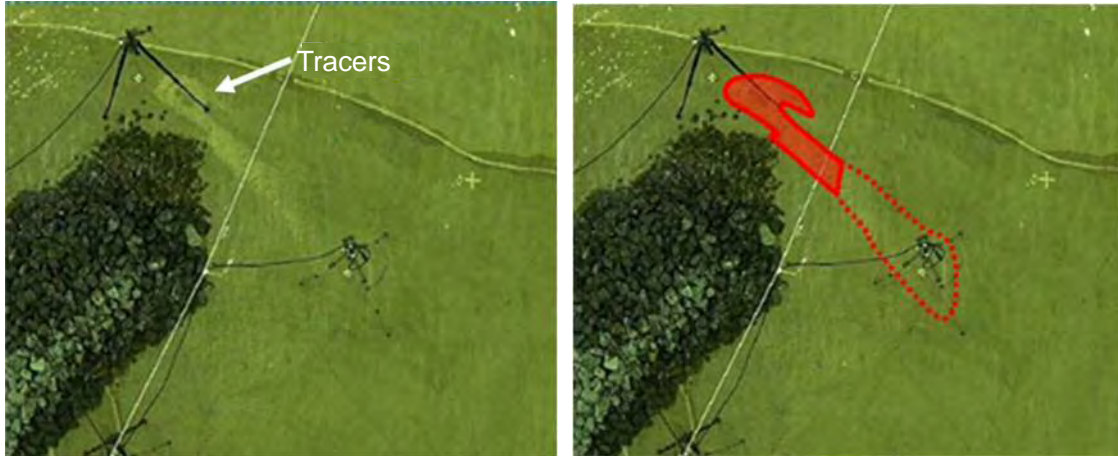
As seen in Figure 7-42, the distribution of tracers read from the still-pictures are superimposed so that the movement of tracers is easily understood. Tracer injection point is marked by white ☆ mark below.

(1) Picture of tracer distribution

(2) Sample expression of tracer distribution

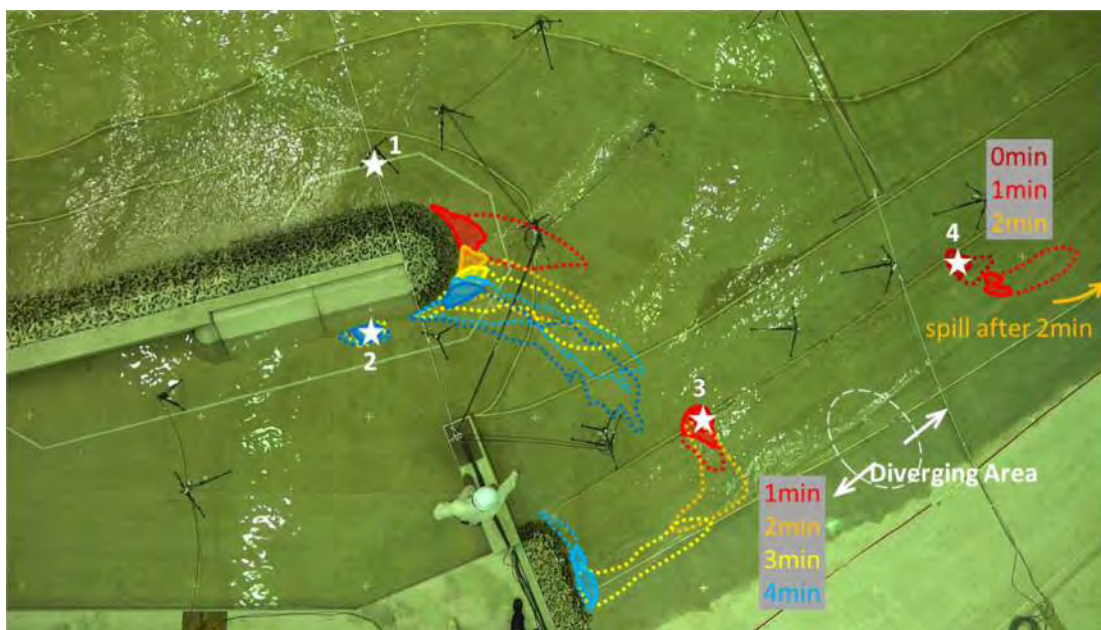
in the port, the movements of tracers injected at point 1 and 2 are specially focused. Main group of tracers injected at point 1 moves wrapping around the tip of breakwater drawing an arc. However, the tracers injected at point 2 remain the injection point without movement. In other words, although the sand transport wrapping around the tip of breakwater is reproduced, the sand transport toward the interior of the port along the breakwater is not reproduced. Therefore, it becomes important how to interpret and understand this result.

Figure 7-44 Movement situation of tracers injected at 4 points

Returning to Figure 7-44 again, the movement of tracers injected at point 3 and 4 are focused.

The tracers injected at point 3 are carried along the shoreline in the direction to the groin and accumulate near the base of the groin. The speed of tracers is fast: it is noted that an interval of tracking tracers is 1 minute. The shoreline is inferred to advance in the area adjacent to the base of groin. This shoreline change can be reproduced with the numerical simulation, see Figure 7-48. The tracers injected at point 4 are washed away to the north direction (to right) in 2 minutes after injection. This movement corresponds to the sand transportation through route B in Figure 7-43. Also, it is found by observing nearshore currents by means of dyed water that there was an area making current separated to the south and the north (left and right sides) around the area circled by dashed line between the injection points 3 and 4.

In addition, a circle by a dashed line in Figure 7-50 shows the diverging area of nearshore currents confirmed by the movement of dyed water. In comparison with the diverging area shown in Figure 7-44, it is shifted to the north (right) and the shifted length is almost the same as the length of additional breakwater. This location also well corresponds to the diverging area of the nearshore currents calculated by the numerical simulation, Figure 7-51.

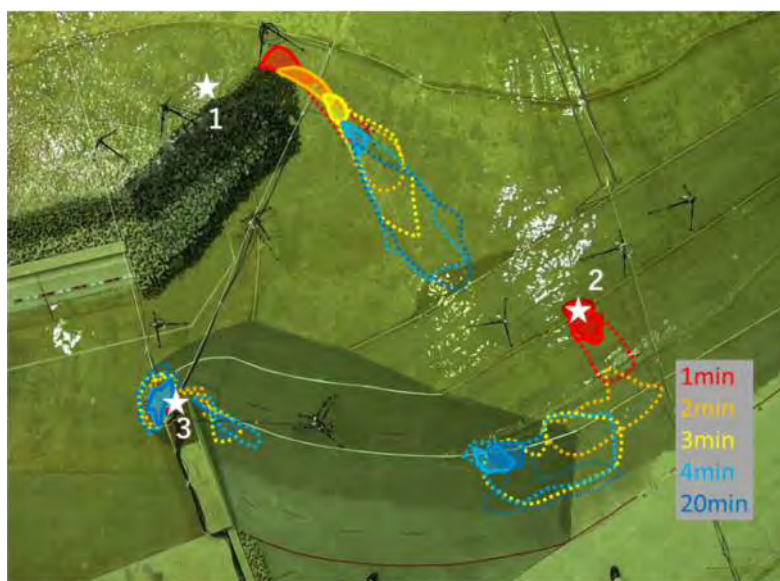
Figure 7-52 Tracer movement after advancement of shoreline due to construction of additional breakwater

Figure 7-52 shows the movement of tracers after advancement of shoreline at the north side of groin due to the construction of additional breakwater. The movement of tracers injected at point 1 is the same as the situation just after construction of additional breakwater, see Figure 7-50. The tracers injected at point 2 direct to the groin, however, the tracers do not reach the groin. It is considered that the connection part between depositional topography by mortar and original beach topography is sharp and the tracer movement stops at the acute angle part. It was unavoidable to have acute angle part due to the limitation of thickness for placing the mortar. However, since sand deposition occurs at the place where the tracers stop, it can be considered that the shoreline is advanced and this acute part becomes gentler, which enhances the tracer movement toward the tip of groin.

The depositional topography is made up to the tip of groin, and the tracers injected at point 3 are carried to the inside of the port beyond the groin as seen in Figure 7-52. This movement of tracers corresponds to the situation that the sand is getting in the portside of groin after the installation of additional breakwater shown in the Photo 7-13.

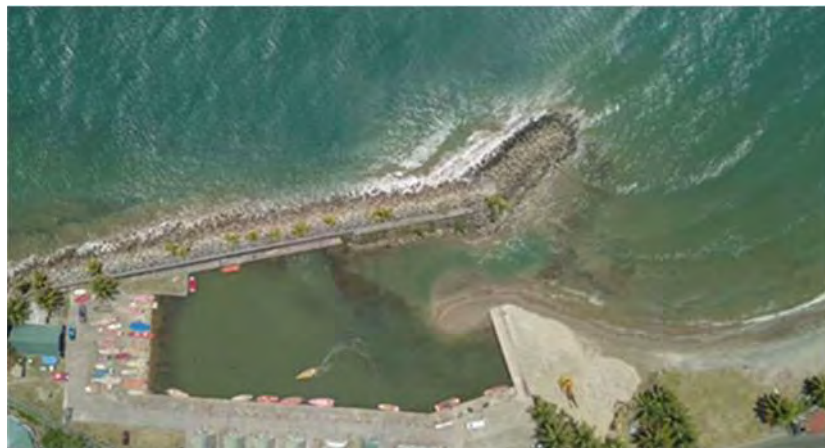
Photo 7-13 Situation that sand flows in and deposits passing through tip of groin (13 Aug., 2018)

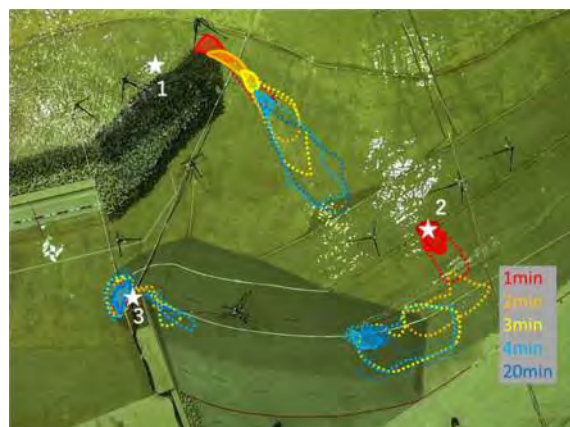
Figure 7-53 is the repost of Figure 7-52. Figure 7-54 shows the movement of tracers when the second sand groin in constructed. The location, length and other conditions of the second sand groin have been determined by the numerical simulation of shoreline change.

Figure 7-53 Movement of tracers after advancement of the shoreline due to the construction of additional breakwater (repost of Figure 7-52)

Comparing the movement of tracers before, Figure 7-53, and the just after, Figure 7-54, the construction of second groin, most of the tracers injected at point 1 have the same tendency of movements in the both cases. The movements of tracers injected at point 2 is almost the same each other, directing to south after being carried toward the shoreline. The movement of tracers just after the construction of second groin well corresponds to the pattern of nearshore currents calculated by the numerical simulation, Figure 7-55.

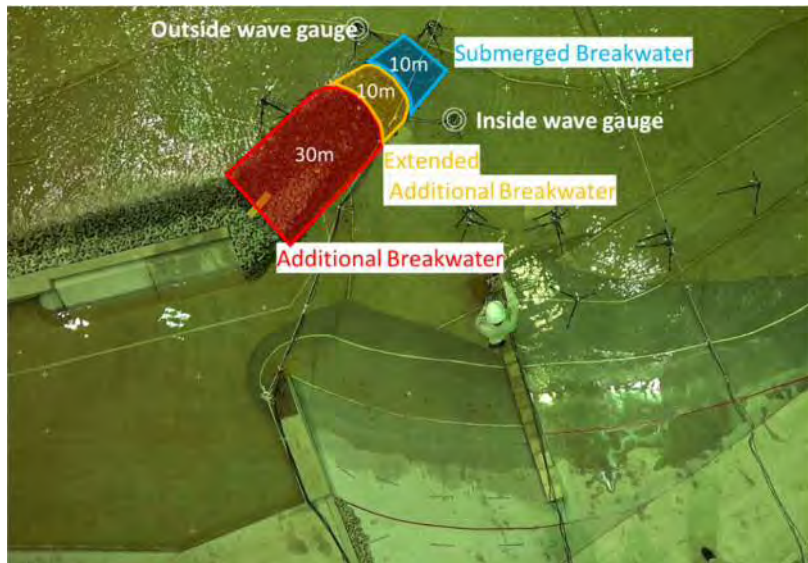
Figure 7-60 shows the plan-views of legend, which indicates the combination of additional breakwater and submerged breakwater, and wave measuring points. Wave transmission coefficient has been evaluated by the wave heights measured at the offshore side and landside of submerged breakwater.

Figure 7-60 Legend of combining additional breakwater and submerged breakwater, and wave measuring points

Figure 7-63 Inside and outside wave heights and transmission coefficient of structures (refer to Figure 7-60 for the wave measuring point)

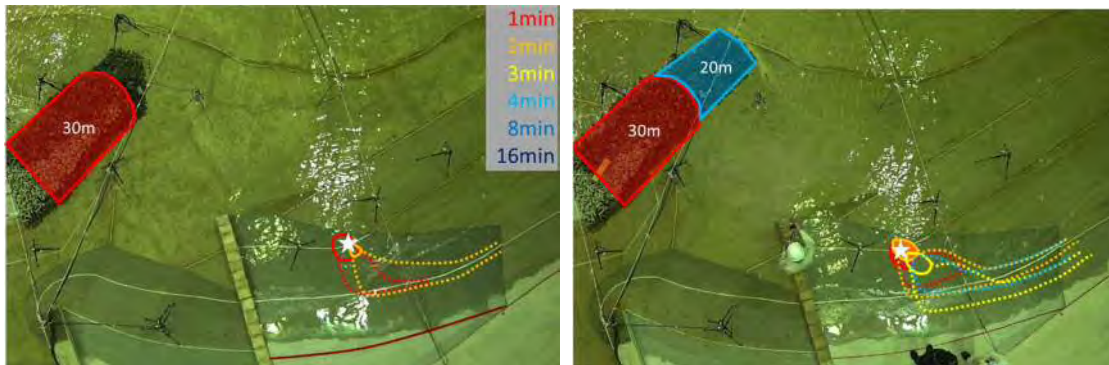
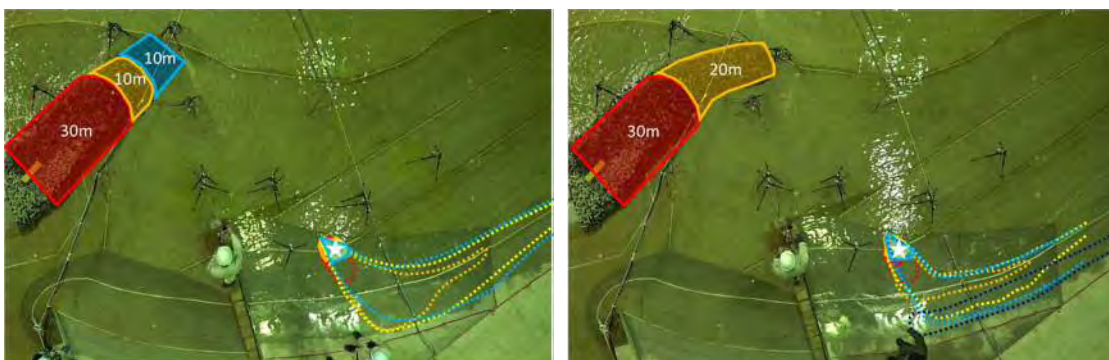
Figure 7-61 shows the results of tracer tracking by combination pattern. The tracer injection point is the front face of the north side beach of the second groin. Tracers injected in this point are rapidly transported to the north direction (to the right) and flow out to outside of the survey area.

(1) Add. BW 30m (existing)

(2) Add. BW 30m + Submerged BW 20 m

(3) Add. BW 30 m + Add. BW extension

(4) Add. BW 30 m + Add. BW 20 m extension

Figure 7-61 Patterns of submerged breakwater and movement of tracers

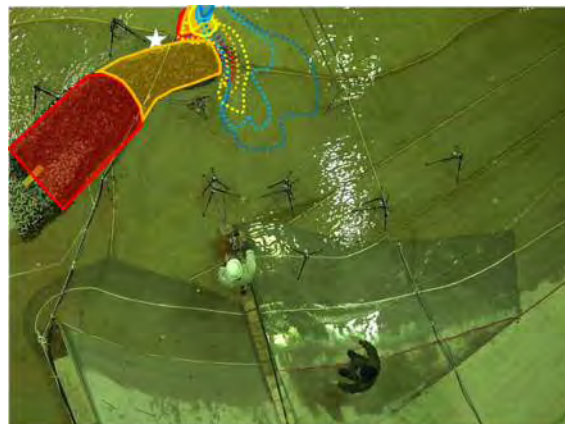
Figure 7-64 shows the movement of tracers by each pattern of combining the structures constructed at the tip of additional breakwater. Injection point of tracers, marked by ☆, is located outside of the port. The combination patterns (1) to (4) correspond to the ones in Figure 7-59 and Figure 7-61. The pattern (0) in Figure 7-64 is the situation before the construction of additional breakwater, which is the same as that at the time of construction completion in Choiseul fishing port.

(4) Add. BW 20 m

Figure 7-64 Combination pattern of structures at the tip of breakwater and the movement of tracers

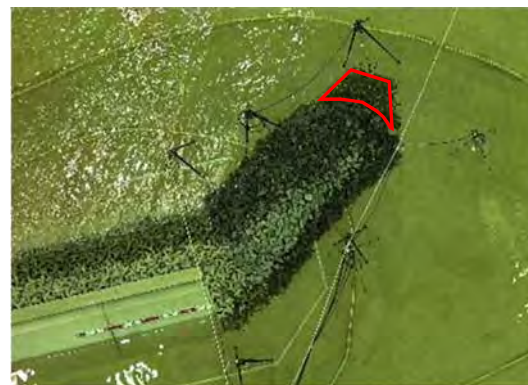
Additional breakwater in hydraulic model experiment

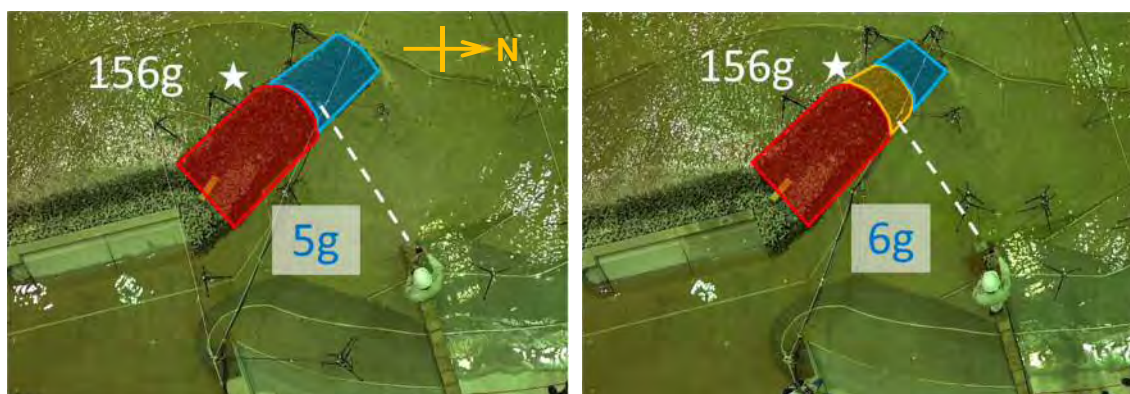
Figure 7-71 shows the weight of tracers which deposit inside the port and collected after the experiment. Here, the definition of “inside the port” is an area which is the northern side (left side) of a white dashed line connecting the existing additional breakwater and second groin. The weight of tracers injected outside of the port is 156g in each case. On the contrary, length of submerged breakwater is different: (1) submerged breakwater of 20m long, and (2) submerged breakwater of 10m long. If tracers are suspended and transported beyond the submerged breakwater, the weight of tracers deposited inside the port must be proportional to the length of submerged breakwater. However, 5 g and 6 g of tracers are collected respectively so the weight are almost the same. From this fact, it is judged that tracers are not transported beyond the submerged breakwater in suspension.

(1) Submerged breakwater of 20 m long

(2) Additional breakwater of 10 m long and submerged breakwater of 10 m long

Figure 7-71 Weight of tracers deposited inside the port

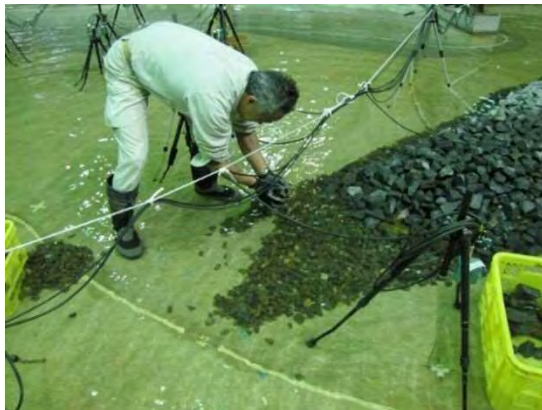
Photo 7-14 (1) shows the removal works of stones to confirm the conditions under the submerged breakwater after the execution of experiment with the tracers injected outside of the port. In Photo 7-14 (2), an existence of tracers is confirmed on the bed after removal of stones. From this fact, it is concluded that tracers have passed under the submerged breakwater in the previous experiment, and such tracers come out and are found inside the port in Figure 7-72.

(1) removal works of submerged breakwater

It is necessary to make the submerged breakwater having the structure that sand does not pass through.

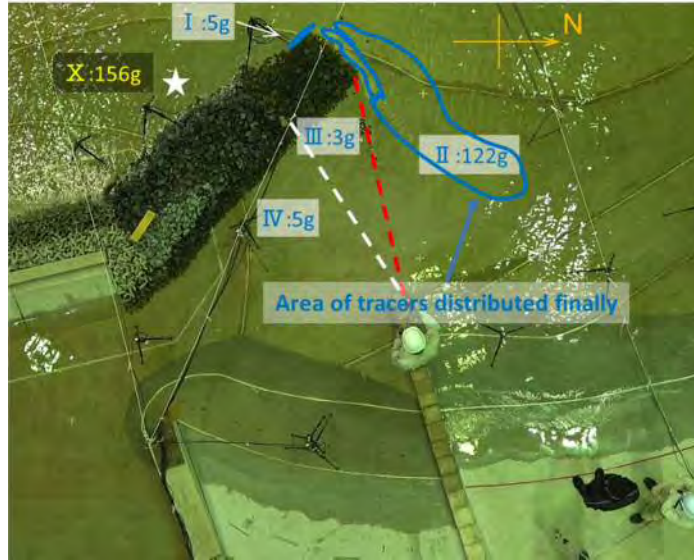
Figure 7-79 shows the results of experiments after construction of second groin and submerged breakwater of 20 m long. Both the upper (1) and lower (2) have the submerged breakwater of 20 m, but the shape on offshore side is slightly different (see [Reference] in 7.2.4.(3)). Tracers are collected from four areas divided as follows.

- Area I outside of submerged breakwater
- Area II north side of a red dashed line connecting the tips of submerged breakwater and second groin
- Area III between a white dashed line connecting the tips of additional breakwater and the red dashed line
- Area IV near side to the port from the white dashed line

(1) Submerged breakwater of 20 m, corresponding to Figure 7-64 (2)

Figure 7-79 Weight distribution of collected tracers (with second groin + submerged breakwater of 20 m)

Weights of tracers collected from each area, indicated in Figure 7-79 (1) and (2), are summarized in Table 7-4. The “X” in this table means the weight of injected tracers.

| | X | I | II | III | IV |
|---|---|---|---|---|---|
| Fig.7-79(1) | 156 | 5 | 122 | 3 | 5 |

| | $a=X-I$ | $b=II+III$ | $b/a$ | $c=X-(I+II+III+IV)$ | $d=b+c$ | $d/a$ |
|---|---|---|---|---|---|---|
| Fig.7-79(1) | 151 | 125 | 0.83 | 21 | 146 | 0.97 |

According to the table, it is expected that “second groin” and “second groin + submerged breakwater 20 m” are effective for preventing deposition in the fishing port. However, the latter has an effect which is not numerically explained. In focusing on distribution areas of tracers in Figure 7-78 and Figure 7-79, the tracers are distributed near the second groin in the former (Figure 7-78), while distribution area moves northwards approximately 20 m, the same length with submerged breakwater, in the latter (Figure 7-79). Therefore, deposition is more unlikely to occur in the latter.

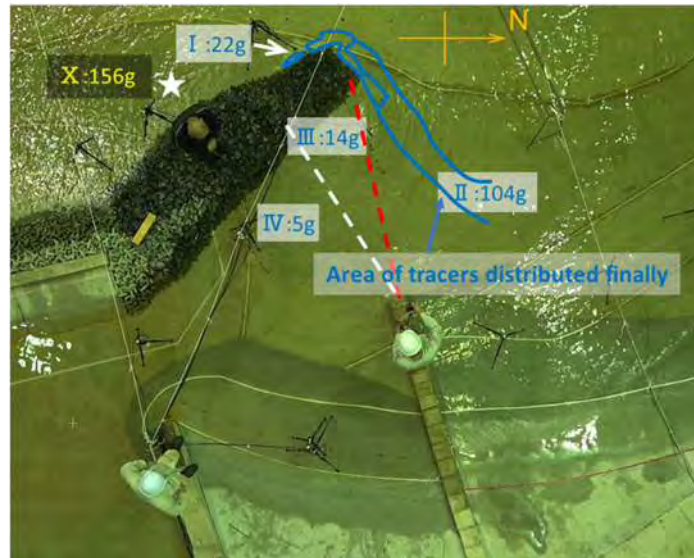
(2) Submerged breakwater of 20 m with outside gentle slope, corresponding to Figure 7-66 (1)

| | X | I | II | III | IV |
|---|---|---|---|---|---|
| Fig.7-79(2) | 156 | 22 | 104 | 14 | 5 |

| | $a=X-I$ | $b=II+III$ | $b/a$ | $c=X-(I+II+III+IV)$ | $d=b+c$ | $d/a$ |
|---|---|---|---|---|---|---|
| Fig.7-79(2) | 134 | 118 | 0.88 | 11 | 129 | 0.96 |
