Supporting Report-6

Public Consultation in Phase-1

## 11. Public Consultation

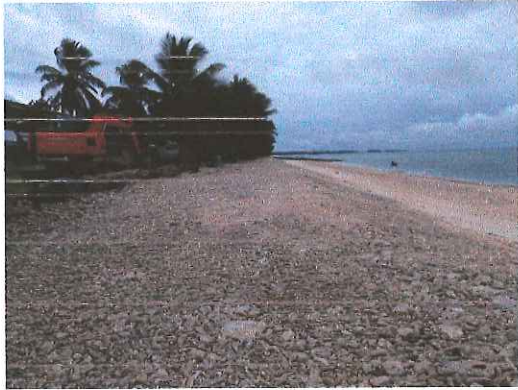
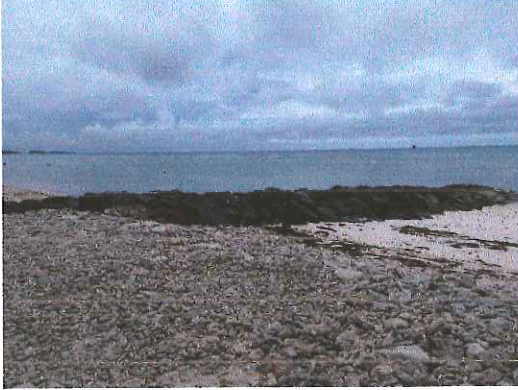
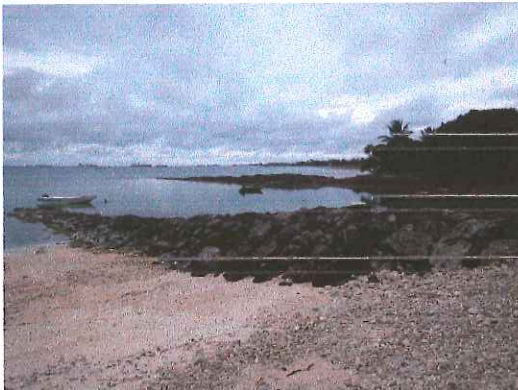
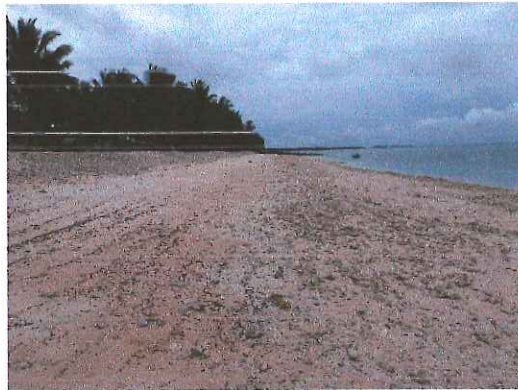
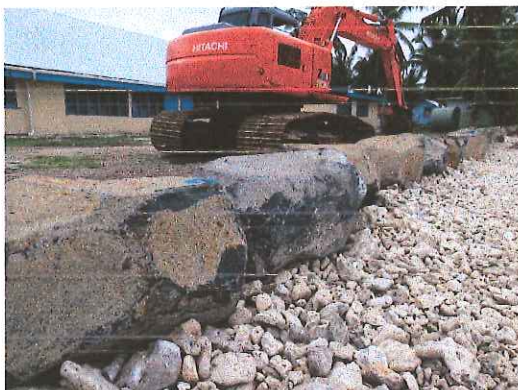
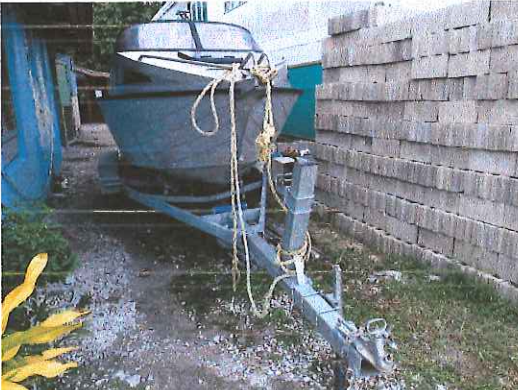
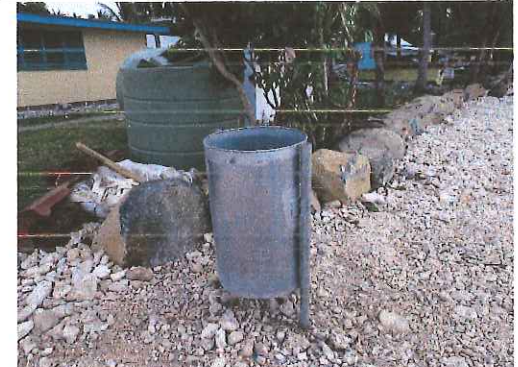
**Photo-1 Inspection Item Photos**

Photos of each inspection item are shown in Photo-1 and the inspection sheets are attached as following.

Inspection Items	Implementation Date
Gravel Beach Profile	1 <sup>st</sup> Dec, 11 <sup>th</sup> Dec., 2015
South Groin	8 <sup>th</sup> Dec., 2015
North Groin	16 <sup>th</sup> Dec., 2015
Gravel and Sand Profile	10 <sup>th</sup> Dec., 12 <sup>th</sup> Dec., 19 <sup>th</sup> Dec., 2015
Backshore stone	22 <sup>nd</sup> Dec., 2015
Facility(Boat Trailer)	22 <sup>nd</sup> Dec., 2015
Facility(Rubbish bin)	22 <sup>nd</sup> Dec., 2015

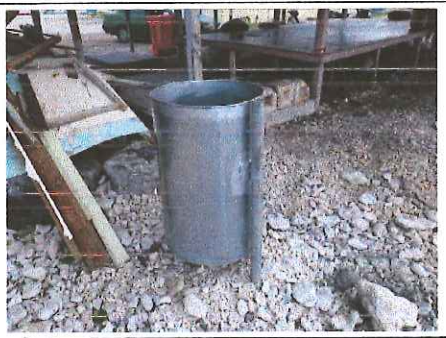
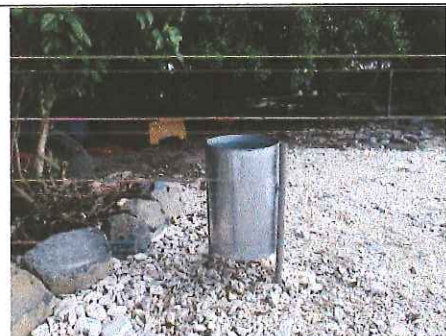
Diameter(0.6m)	Height of bin(0.9m)	Height from ground(1.15m)

Items	Design	Actual
No.1	0.6m(Diameter)×0.9m(Height)	0.6m(Diameter)×0.9m(Height)
No.2	0.6m(Diameter)×0.9m(Height)	0.6m(Diameter)×0.9m(Height)
No.3	0.6m(Diameter)×0.9m(Height)	0.6m(Diameter)×0.9m(Height)
No.4	0.6m(Diameter)×0.9m(Height)	0.6m(Diameter)×0.9m(Height)
No.5	0.6m(Diameter)×0.9m(Height)	0.6m(Diameter)×0.9m(Height)

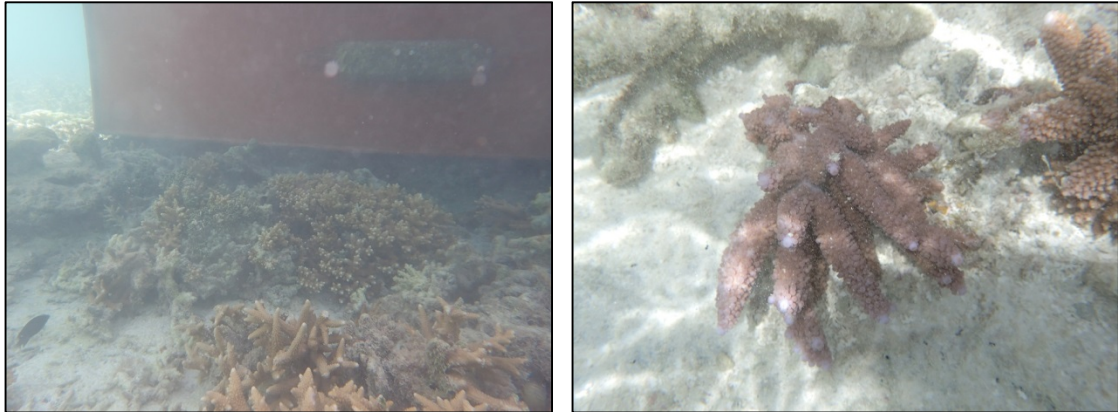
**Figure 3.6 Live corals around the rear-end of the barge (left) and examples of broken corals found around the barge (right)**

is a patchy distribution of live corals. These corals were probably broken by the barge during anchoring. Figure 3.6 shows the live corals around the barge and examples of broken corals found around the barge. However, this is considered to be of minor significance for the following reasons:

- ✓ The extent of coral damage is limited to a small area
- ✓ The damaged coral species (branching *Acropora*) are abundant in the area

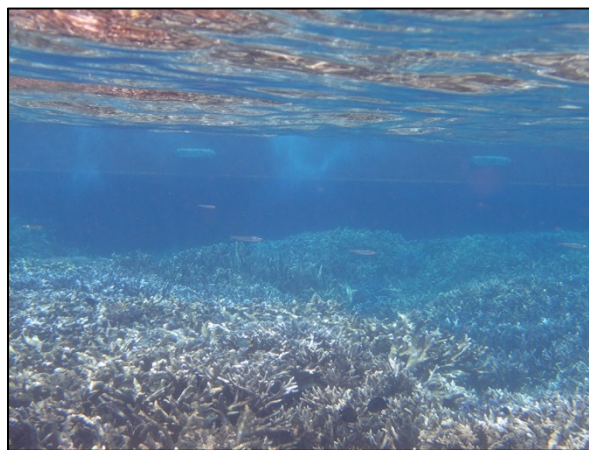
**Figure 3.10 Barge passing through the outer reef flat**

- According to underwater observation, there was about 40-50 cm clearance between the barge bottom and corals (barge draft was about 60 cm) when the barge passed through the shallow outer reef flat area (see Figure 3.10). Note that corals may be damaged if the gravel-loaded barge exits the reef flat area at the same water depth as the barge will have deeper draft. Therefore, the barge draft and water depth must be carefully considered when exiting. It is recommended that a clearance of at least 50 cm should be maintained between the barge and corals during barge entrance and exit.

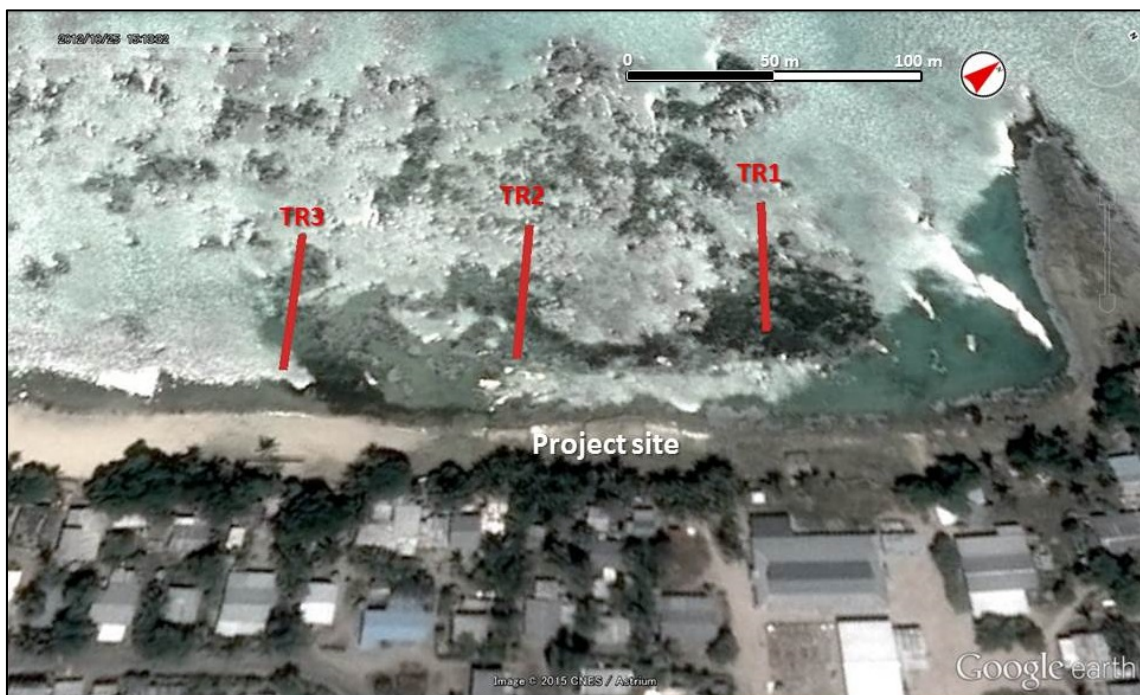
**Figure 3.11** Location of the monitoring transects of marine life monitoring

Three 50 m transects were set adjacent to the Project site. The marine life (benthic fauna and fish species) observed along the transects were recorded, including their abundance where possible. The survey was conducted on August 1<sup>st</sup>, 2015. Figure 3.11 shows the location of the survey transects.

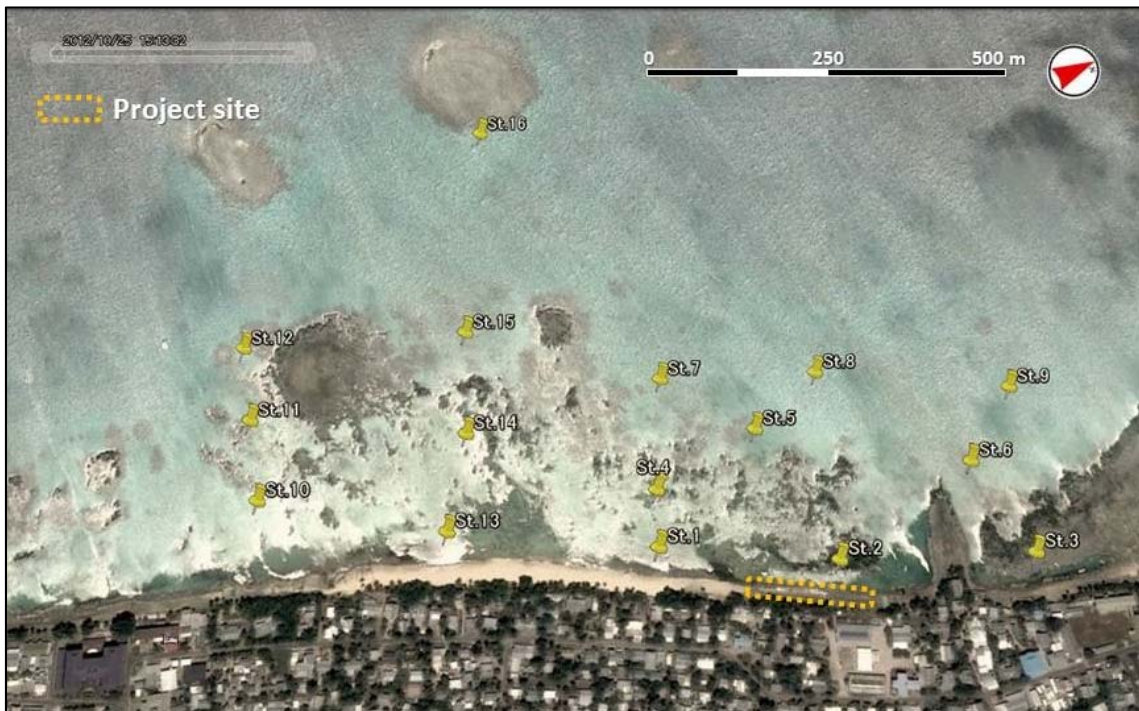
**Figure 3-1 Location of the turbidity monitoring sites**

During sand-placement works, surface turbidity levels were measured daily at three monitoring sites (Stations 1-3) set along the shore using portable turbidity meter (DKK-TOA TB-31). To understand the background turbidity levels, turbidity was also randomly measured at Stations 1-3 in the period prior to sand-placement works (August-November 2015). Although it was not a requirement under PEAR, turbidity was also measured over a wider area 1/week (Stations 4-16) to check the extent of turbidity dispersion. Figure 3-1 shows the location of the turbidity monitoring sites. The turbidity values measured at Stations 1 and 3 were compared with the threshold value of 15 NTU set under PEAR.

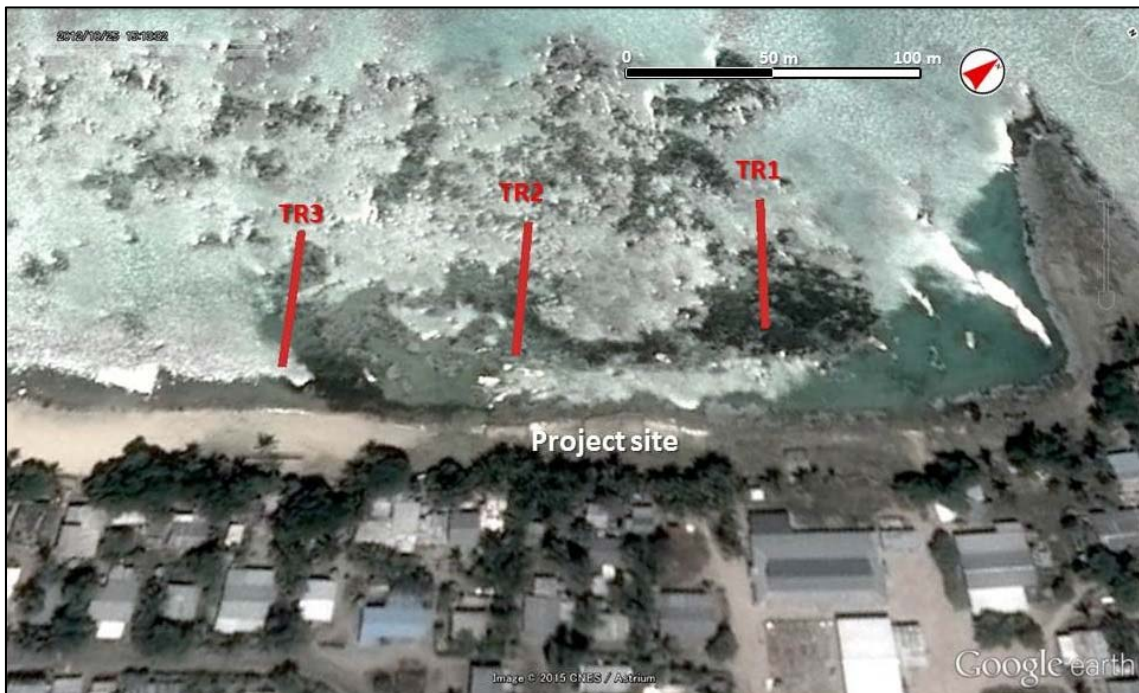
**Figure 3-9 Location of the marine life monitoring transects**

Three 50 m transects were set adjacent to the Project site. The marine life (benthic fauna and fish species) observed along the transects were recorded. The survey was conducted twice: first in the pre-construction stage (August 1<sup>st</sup>, 2015) and second in the post-construction stage (December 21<sup>st</sup>, 2015). In the post-construction survey, observations were also made along the north groin built through this Project. Figure 3-9 shows the location of the survey transects.

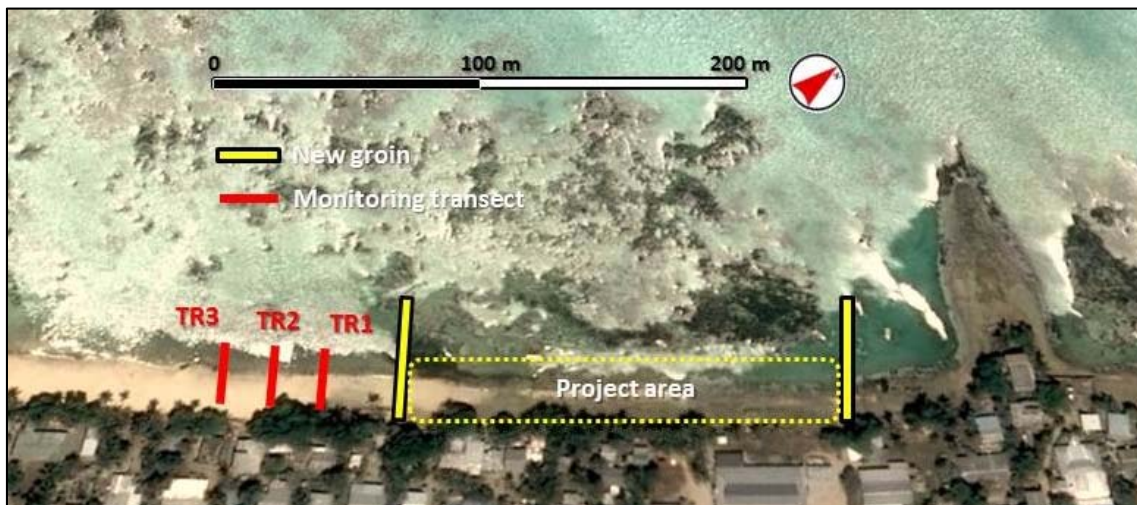
**Figure 3-11 Location of topographic survey monitoring transects**

<b>Method</b>	<b>Frequency</b>	<b>Location</b>
Topographic survey	Measurement of shoreline cross-section profile along 50 m transect	<b>Total 5 times</b> Pre-construction: 2015/2, 2015/6 Post-construction: 2015/12, 2016/3, 2016/6, 2016/12	<b>Project site:</b> 3 transects south of the south groin (See Figure 3-11 for the locations)
Satellite image analysis	Comparison of shoreline topography with satellite image	<b>Total 3 times</b> Pre-construction: 2015/6 Post-construction: 2016/1, 2016/12	Project site, Papaelise and North Funamanu:

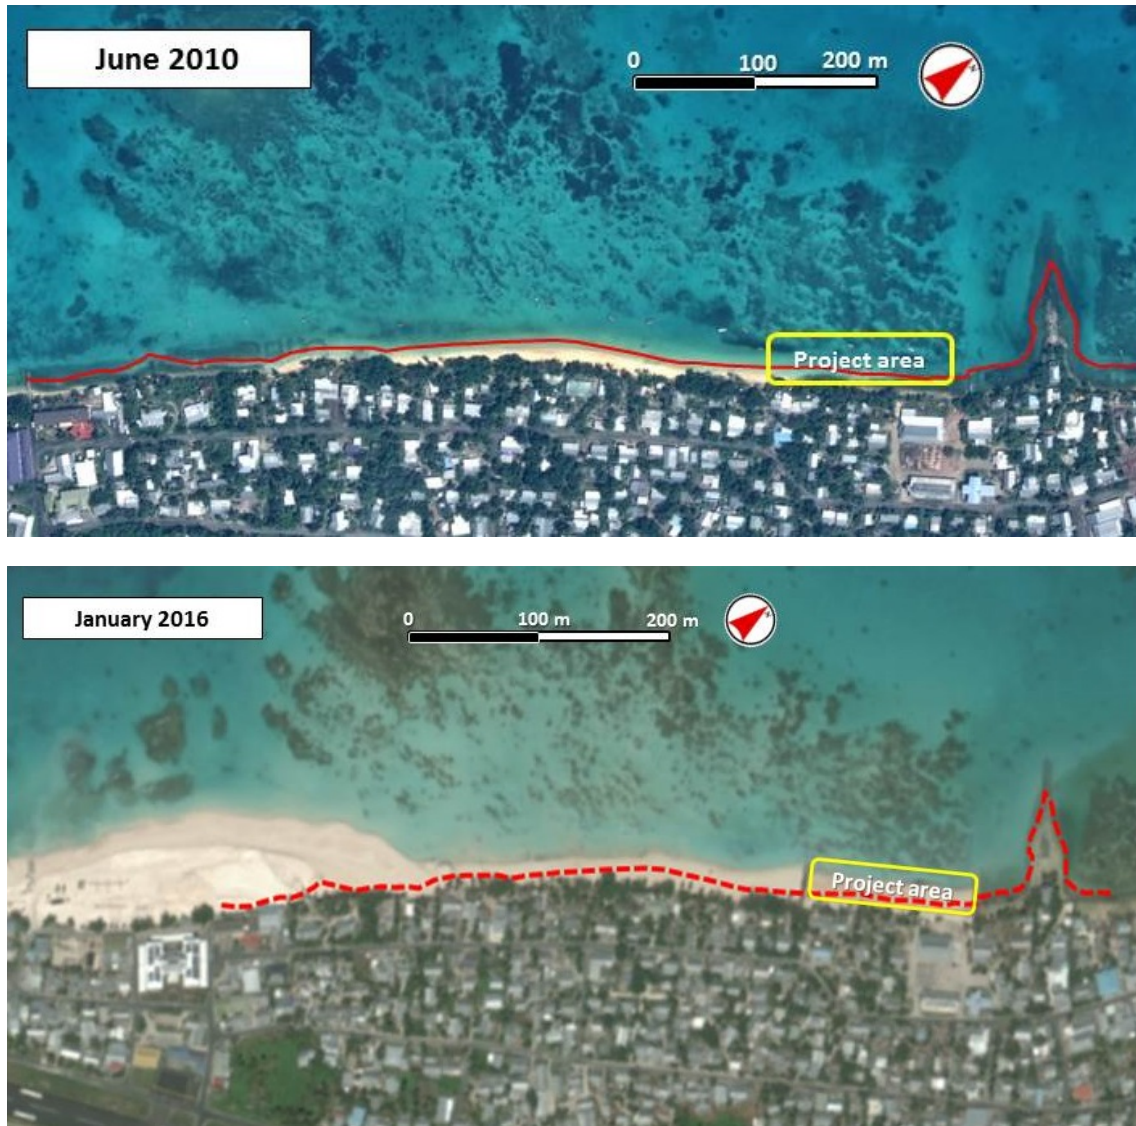
Figure 3-13 shows the satellite image of the shoreline around the Project site in June 2010 and post-construction stage (January 2016). The broken red line shown in the post-construction image indicates the shoreline boundary in June 2010. The post-construction image shows significant accretion of sand along the shoreline, which is likely due to the dispersion of sand from the reclamation project in front of the government building.

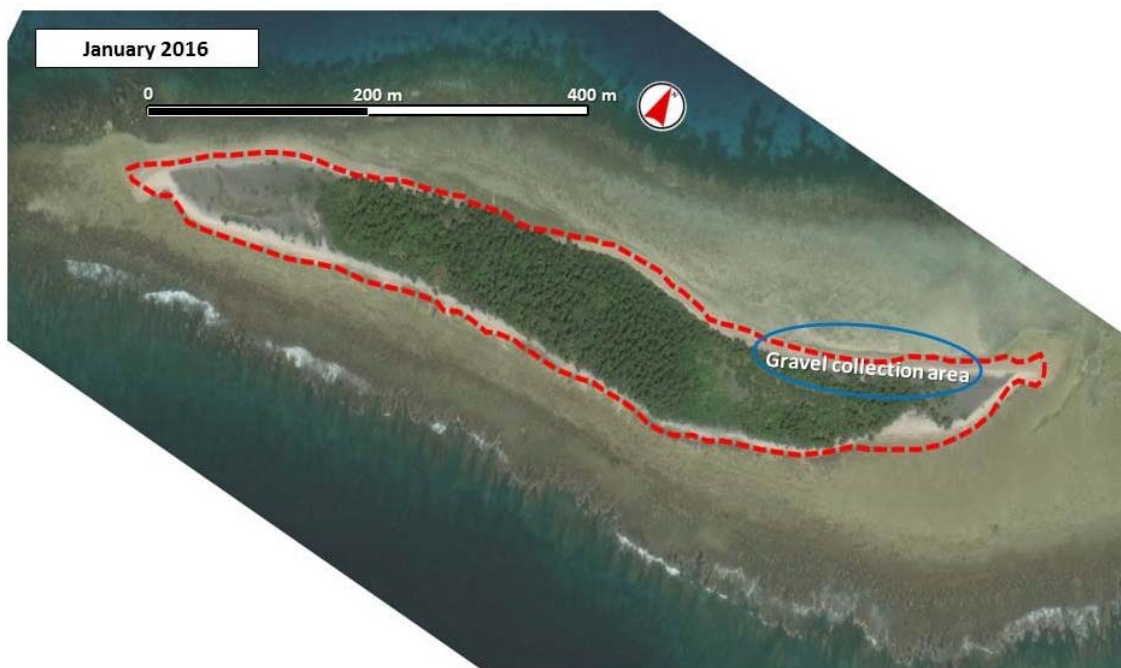
**Figure 3-15** Satellite image of the shoreline around the North Funamanu gravel collection area in June 2010 and January 2016

Figure 3-15 shows the satellite image of the shoreline around North Funamanu gravel collection area in June 2010 and post-construction stage (January 2016). The broken red line shown in the post-construction image indicates the shoreline boundary in June 2010. Apart from the gravel collection area no major shoreline erosion or accretion seems to have occurred after the gravel collection works.

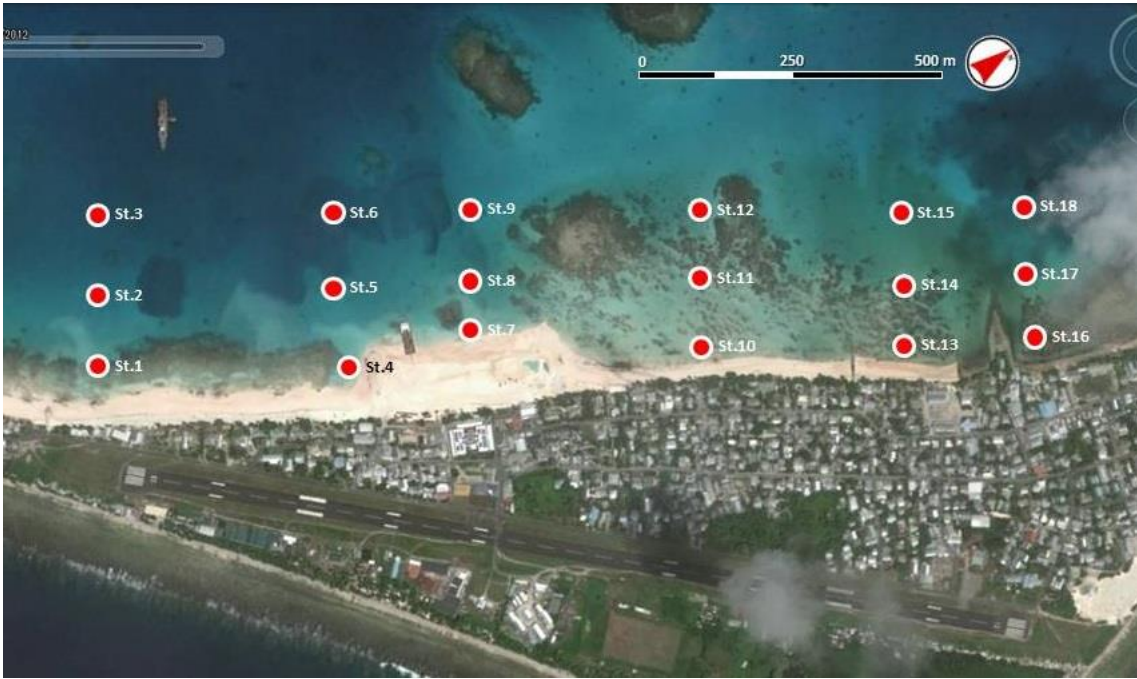
**Figure 2-1** Location of the turbidity monitoring sites

Turbidity was measured along the shore of the Project and surrounding areas on January 27<sup>th</sup>, February 13<sup>th</sup> and June 29<sup>th</sup>, 2016 using portable turbidity meter (DKK-TOA TB-31). Figure 2-1 shows the location of the turbidity monitoring sites.

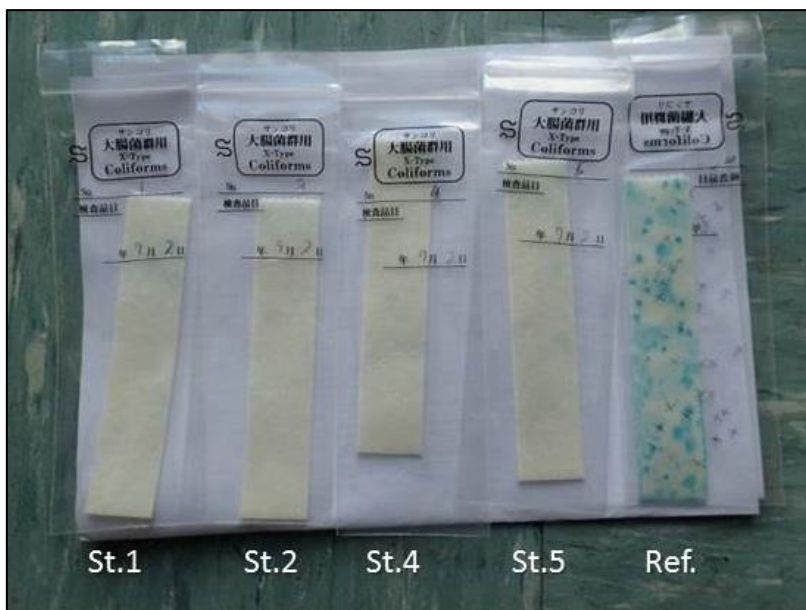
**Figure 2-3 Detection paper after incubation for 24 hours**

Coliform bacteria was not detected at all the sites, which implies that the waters adjacent to the Project beach is safe for bathing and swimming. Figure 2-3 shows the detection paper after incubation for 24 hours.

Note: Detection paper for St.3 not included in the photo as it went missing. Ref. was taken from local tap water which apparently was quite contaminated.

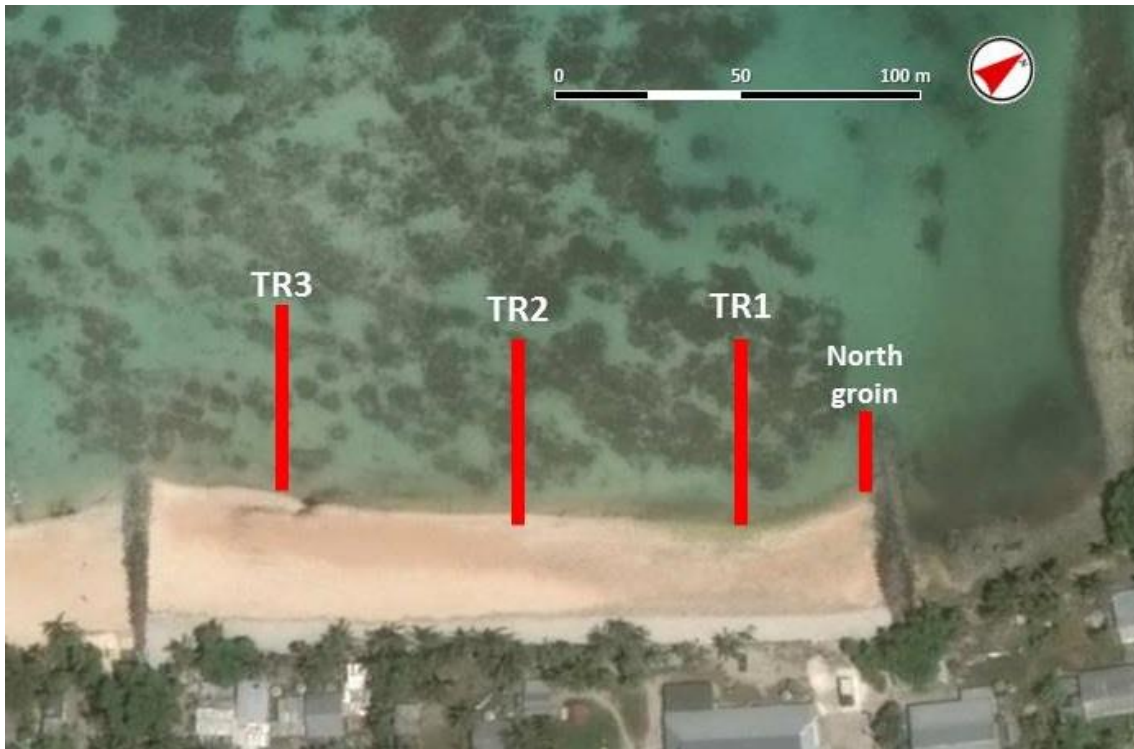
**Figure 2-4 Location of the marine life monitoring transects**

Three 50 m transects were set adjacent to the Project site and the marine life (benthic fauna and fish species) observed along the transects were recorded. Observations were also made along the north groin built through this Project. The survey was conducted in December 21<sup>st</sup>, 2015 and June 30<sup>th</sup>, 2016. Figure 2-4 shows the location of the survey transects.

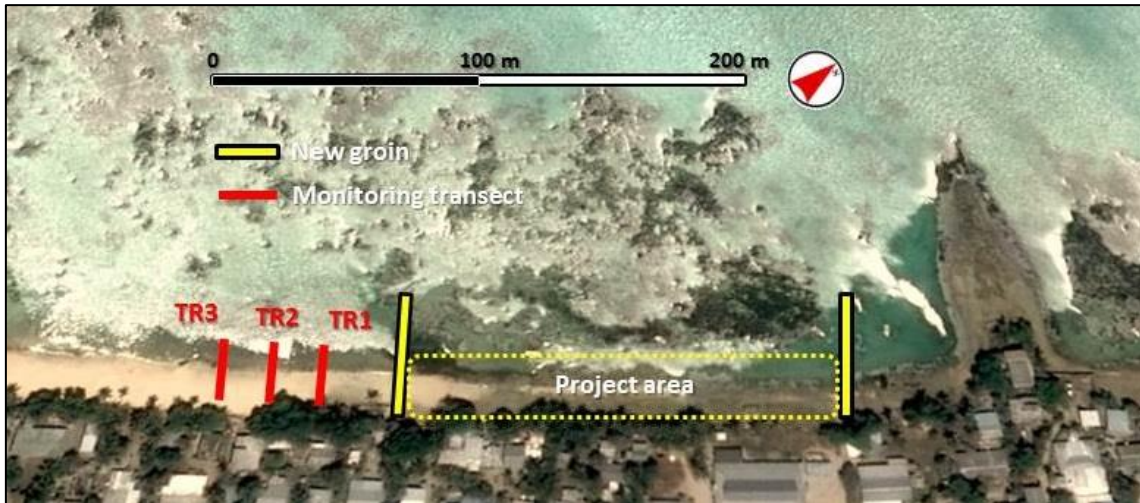
**Figure 2-6 Location of topographic survey monitoring transects**

The shoreline topography around the Project site was monitored by topographic survey. Figure 2-6 shows the location of topographic survey monitoring transects.

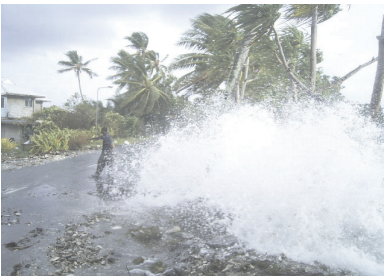
Fig. 2. Wave Overtopping at Hinterland.  
(Before the Project)

Due to the existence of the main community hole and church in Fongafale Island behind the target project area, a lot of residents are commonly gathering in this area since it is a main public area. However, the condition of the beach in front was seriously deteriorated. The sandy beach that existed in the past completely disappeared and the existing concrete block type seawall which was constructed as a remedy against coastal erosion also collapsed. Wave run up and overtopping in the hinter residential area frequently occurred as shown in Fig. 2. Due to such deterioration of beach condition, people could not use the beach space. Such change in the condition of the beach was causing the reduction of people's awareness on the beach environment, and the beach area became one of the dumping sites for garbage (Fig. 3).

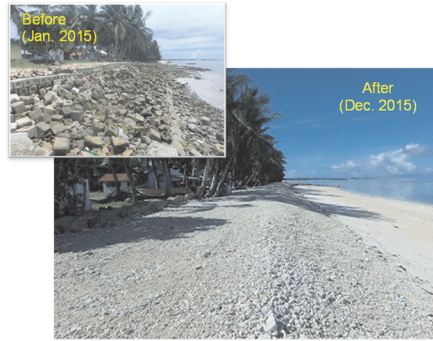
Fig. 4. Beach Condition Before and After the Project.

After the implementation of the project, the beach drastically changed as shown in Fig. 4. About 3,300 m<sup>3</sup> of coral gravel and 4,500 m<sup>3</sup> of coral sand were filled into the project area (Fig. 5), with a longshore distance of 180 m. Coral gravel was taken from the surrounding island which is located in the same atoll. These coral gravels were washed ashore during the Cyclone Bebe which attacked the Funafuti Atoll in 1972 (Maragos et al., 1973). The coral sands on the other hand were provided by the Tuvaluan government. This sand was dredged from the seabed at the lagoon side of Funafuti Atoll and stocked on land under the other implemented project. Average width of the nourished beach is about 20 m, in which gravel was filled at the backshore side with 6 m width and sand was filled at the foreshore side with an approximately 15 m width. Rock armor type groins (armor rock was imported from Fiji) were constructed at both ends of the project area in order to minimize the unexpected future loss of gravel

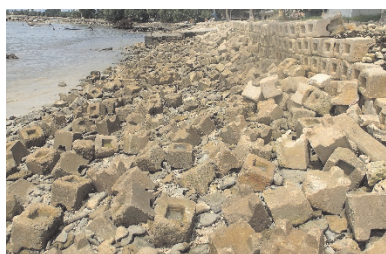
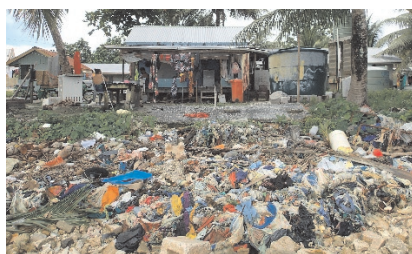
Fig. 3. Beach condition before the Project with scattered concrete blocks (left) and accumulated rubbish on the beach (right).

Beach condition before the Project implementation directly showed the people's lack of interest on the beach; concrete blocks used for temporary protection were scattered and rubbish dumped by residents was accumulated and smelled bad on the beach as shown in Fig. 3. Furthermore, it is anticipated that even if beach environment has been improved by the Project, it would go back to the same bad situation sooner or later if nothing changes regarding public awareness on beach.
