**THE FOLLOW-UP COOPERATION STUDY
ON
THE PROJECT FOR REHABILITATION OF
KILINCHCHI WATER SUPPLY SCHEME
IN
DEMOCRATIC SOCIALIST REPUBLIC OF SRI LANKA**

FOLLOW-UP SURVEY REPORT

MARCH 2020

NJS CONSULTANTS CO., LTD.

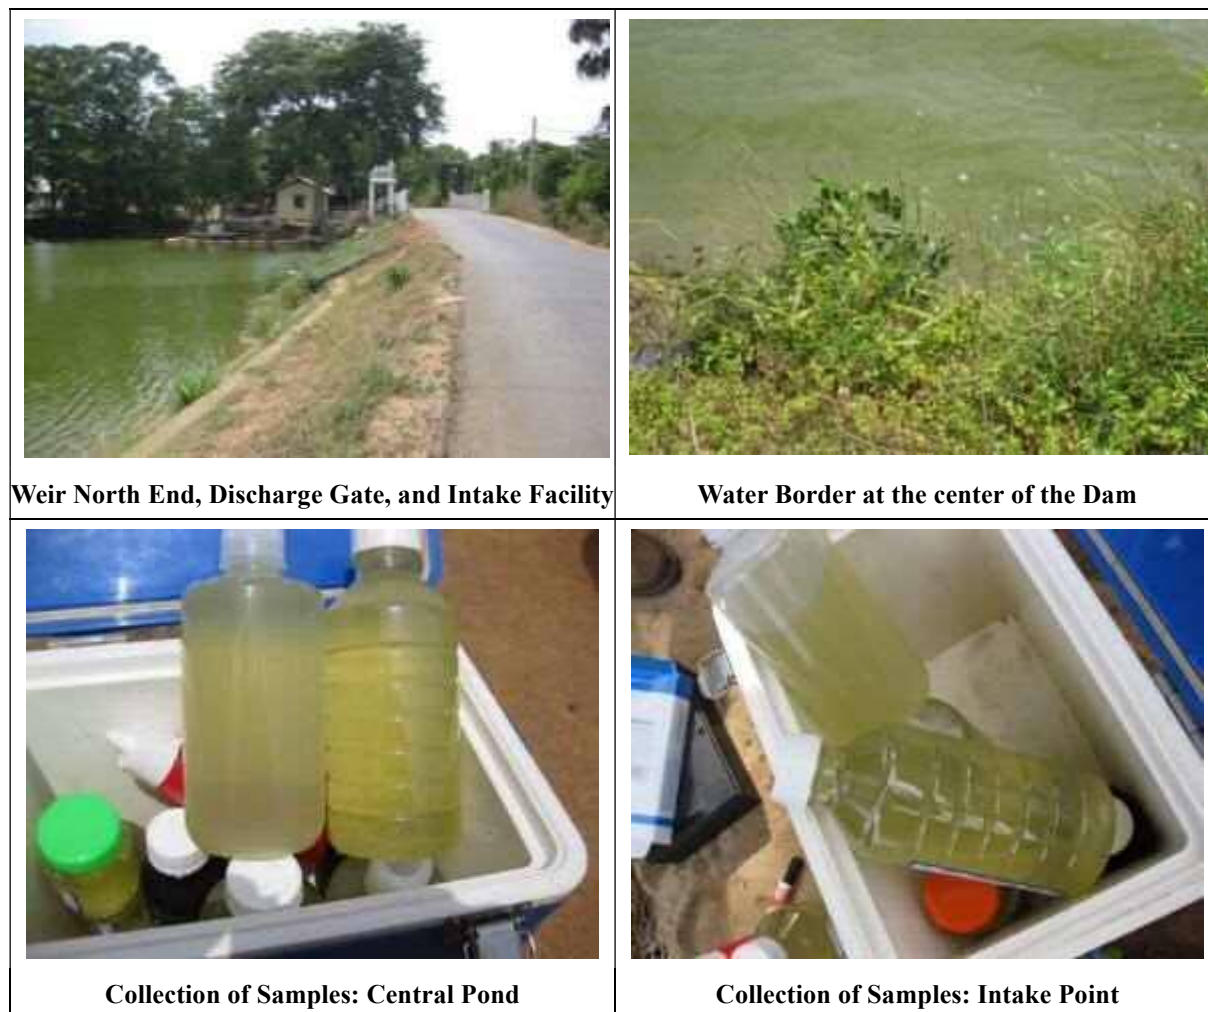
Photo 3-2 Status of Dry Aru Reservoir (Dry Season)

Even at the end of the dry season in the first half of September, the water was almost full although no spillage occurred. The shore (dam body) was filled with water, and the cattle were not eating grass at the bottom of the pond, but a herd of cattle was walking on the dam body. The appearance of water is slightly better than that of the Iranamadu reservoir. The below photos depict the status of Dry Aru Reservoir under dry period.

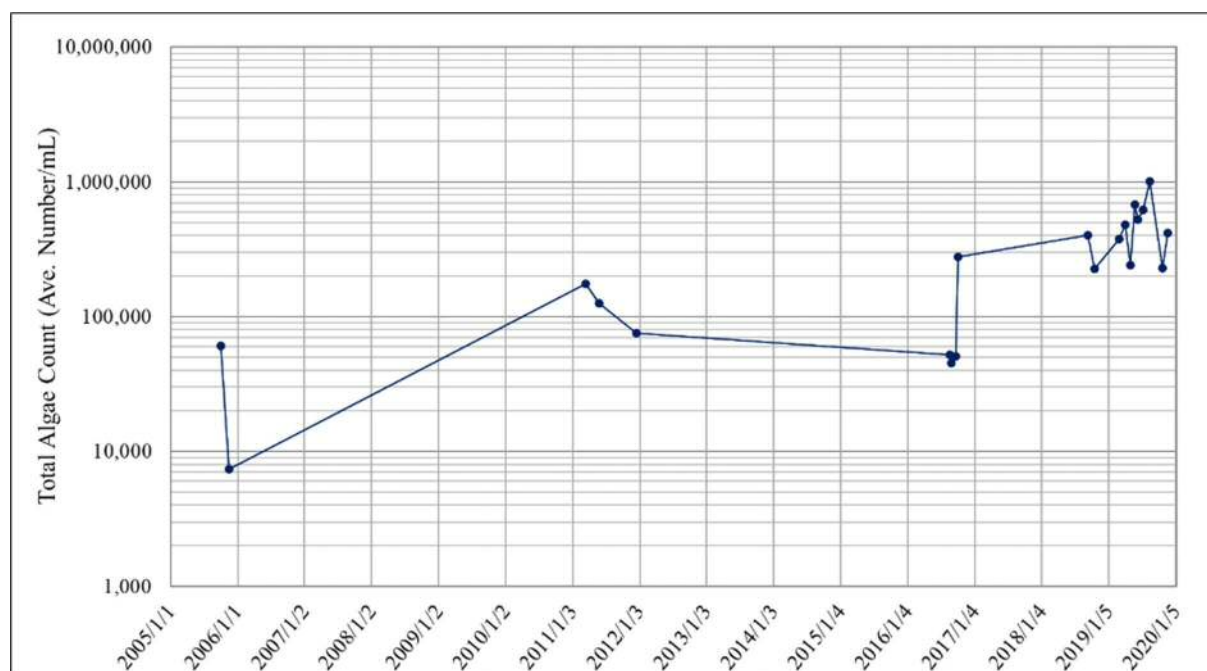
- ① Algal populations in Dry Aru reservoirs are on the rise (see **Figure 3-2**).
- ② Based on 2019 data, the dominant species of algae found in Dry Aru reservoirs is *Anacystis* species of blue-green algae.

From the above, it is inferred that eutrophication and accompanying algae multiplication are progressing in Iranamadu reservoirs, affecting the water quality of Dry Aru reservoirs during the dry season. Furthermore, since algae population in Dry Aru have been increasing and algae which adversely affect the water treatment have been detected, the water quality of Dry Aru reservoir in the dry season is considered as deteriorated.

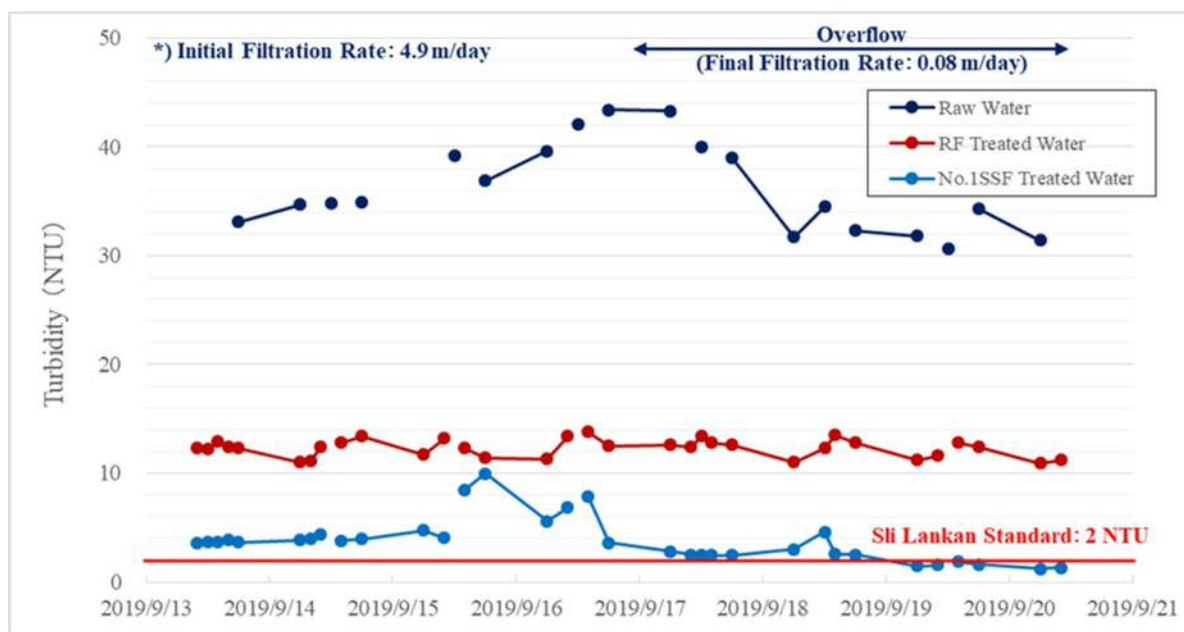
Figure 3-4 Result of Turbidity

Regarding odour, it was decreasing along with the decrease of treated water turbidity, and no odour was felt after September 18.

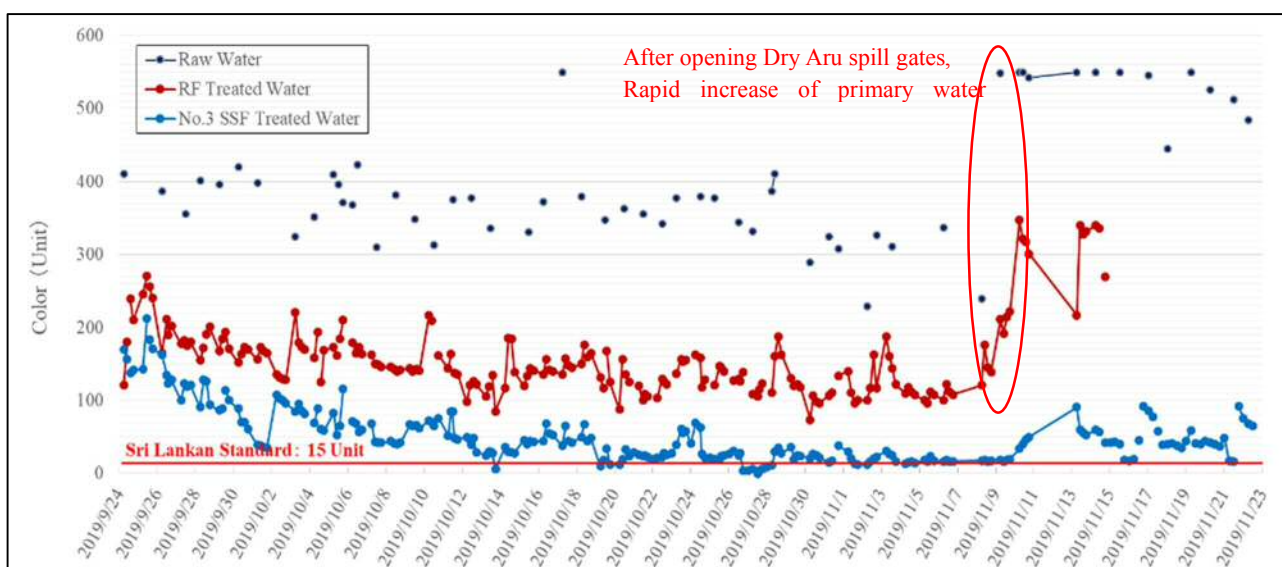
Figure 3-8 Result of Colour at No.3 SSF

- In addition to algae-derived turbidity and colour, it is inferred that the water flow generated by the opening of above-mentioned outflow gate caused the agitation of bottom sediments in the Dry Aru reservoir; hence the raw water turbidity and colour had increased significantly.

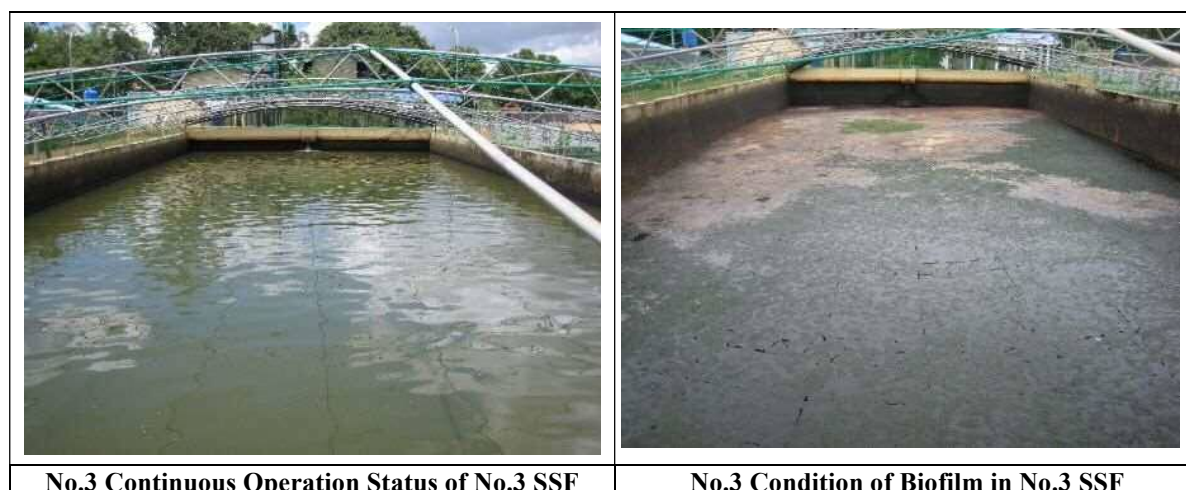
As shown in **Photo 3-6**, biofilm (mainly filamentous algae) were formed on almost the entire surface of the filter layer, and the DO values of treated water were also kept at about 3mg/L or more. Therefore, it is considered that the No. 3 SSF was operating in sound condition during this consecutive test period. However, it is inferred that the existing RF+SSF cannot sufficiently treat the current raw water quality including the multiplied algae, and that the filtration duration is also limited to about two months.

No.3 Continuous Operation Status of No.3 SSF

No.3 Condition of Biofilm in No.3 SSF

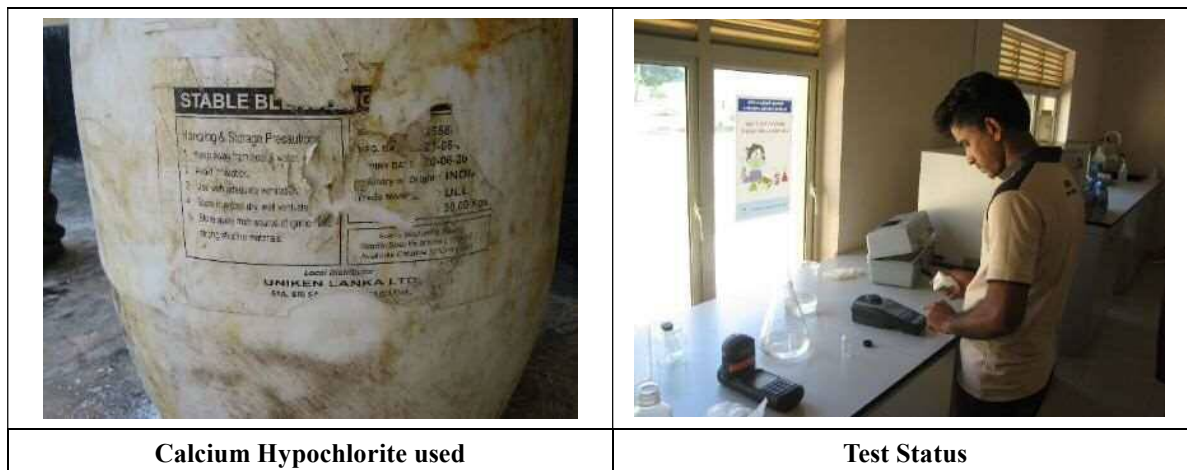
Photo 3-9 Chlorination Test for No.3 SSF Treated Water

The results are shown in the following table. Turbidity and colour of No. 3 SSF treated water were hardly reduced by reacting with 1mg/L of chlorine. This result suggests that the turbidity and colour components of the treated water leaked out, and that the cell membrane/wall was not oxidized and decomposed with 1mg/L of chlorine.

The results are shown in the following **Table 3-9**. When an effective chlorine concentration of 1mg/L was added to the No. 3 SSF treated water, the turbidity was almost equal but the colour is decreased by 5 units. And, the turbidity was almost equivalent, when the effective chlorine concentration of 3mg/L was added, but the colour rose 13 unit. From the results, it is considered that the turbidity and colour components in the treated water are the leaked algae and colloidal iron and manganese with particle size of 1µm or less. It is believed that the increase in colour due to the addition of chlorine was caused by the oxidation of iron and manganese with partial solubility (reduced state) by chlorine, resulting in development of colour.

From the above results, it was found that the turbidity of SSF treated water (mainly algal cells derived from raw water that leaked without being captured and removed by biofilm) was not reduced by post-chlorine treatment. And it was suggested that iron and manganese which were oxidized and immobilized by biofilm were temporarily eluted, however when DO value in process water was lowered, and then it was oxidized by post-chlorine treatment to develop colour.

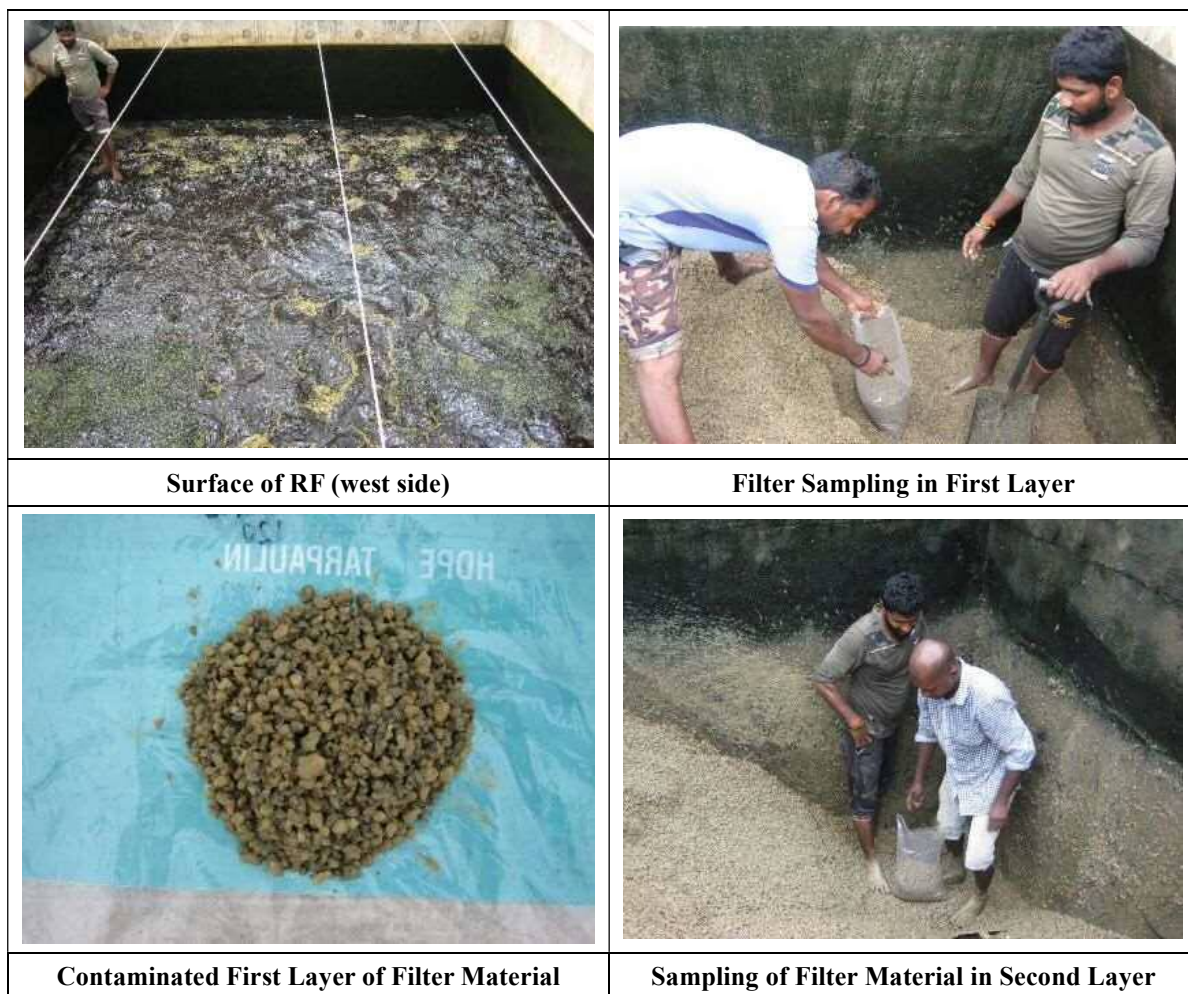
Photo 3-10 Investigation in RF (West)

On September 24, the filter layer condition checked, and filter material sampling were carried out for the RF (1 out of 2 basins) on the west side. When cleaning was carried out by opening the drain valve before starting work, the washout wastewater was yellow soil, and the turbidity was considerably high apparently. As black-green sticky algae were found on almost the entire surface of the filter layer, this was removed manually before the filter material was collected, and raw water was poured from the lower part and washed away. When we interviewed the Operator, they said that they had been removing algae and cleaning the walls in the same manner every two months (One out of two ponds was carried out once a month). No irregularities such as non-land was observed on the surface of the filter layer.

The mud-like turbidity adhering around the filter media was observed about 10 mm below the surface of the first layer (φ 4 to 8 mm). Since the layer thickness of the first layer is 1,000 mm, the filter material near the middle (about 500 mm from the top) was taken. Subsequently, it reached the second layer (φ 8 to 12 mm) and the filter material near the middle was taken in the same manner. The contamination situation of the filter material was the same for the second layer. As described above, adhesive algae were observed on the surface of the filter layer, and mud-like turbidity was observed in the first and second layers. Therefore, it is believed that that the biofilm was formed in the RF interior, resulting in upward-flow bio filtration.

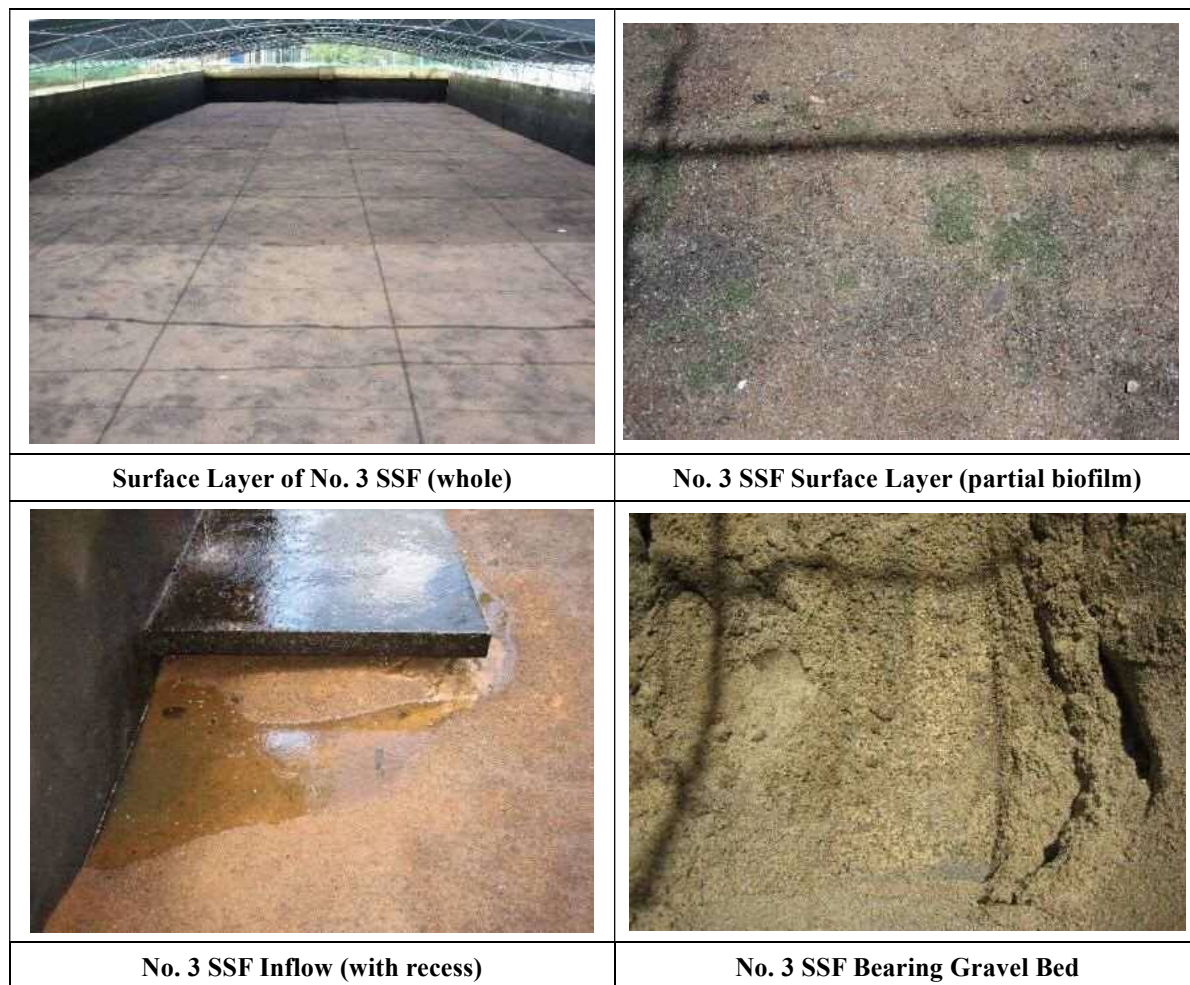
Photo 3-12 Filter Media Condition of No.3 SSF

addition, red-brown sticky substances, which seemed to be oxides of iron, had been deposited on the surface. No visible contamination was observed on the middle, lower and supported gravel surfaces of the filter layer.

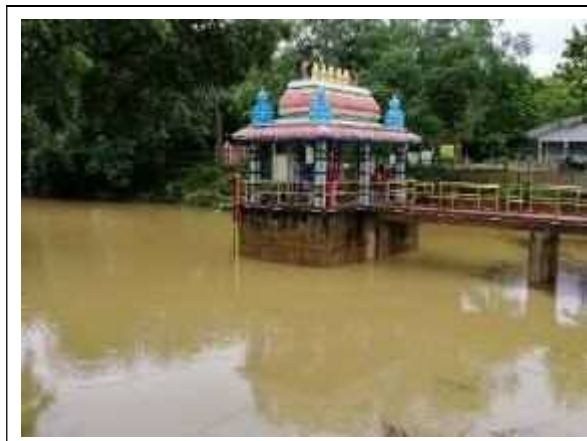
Photo 4-1 Current status of Iranamadu reservoirs (Rainy Season)

Photo 4-1 and 4-2 shows the status of Iranamadu and Dry Aru reservoirs in the rainy season and the Appendix-1 shows the results of the same quality analyses.

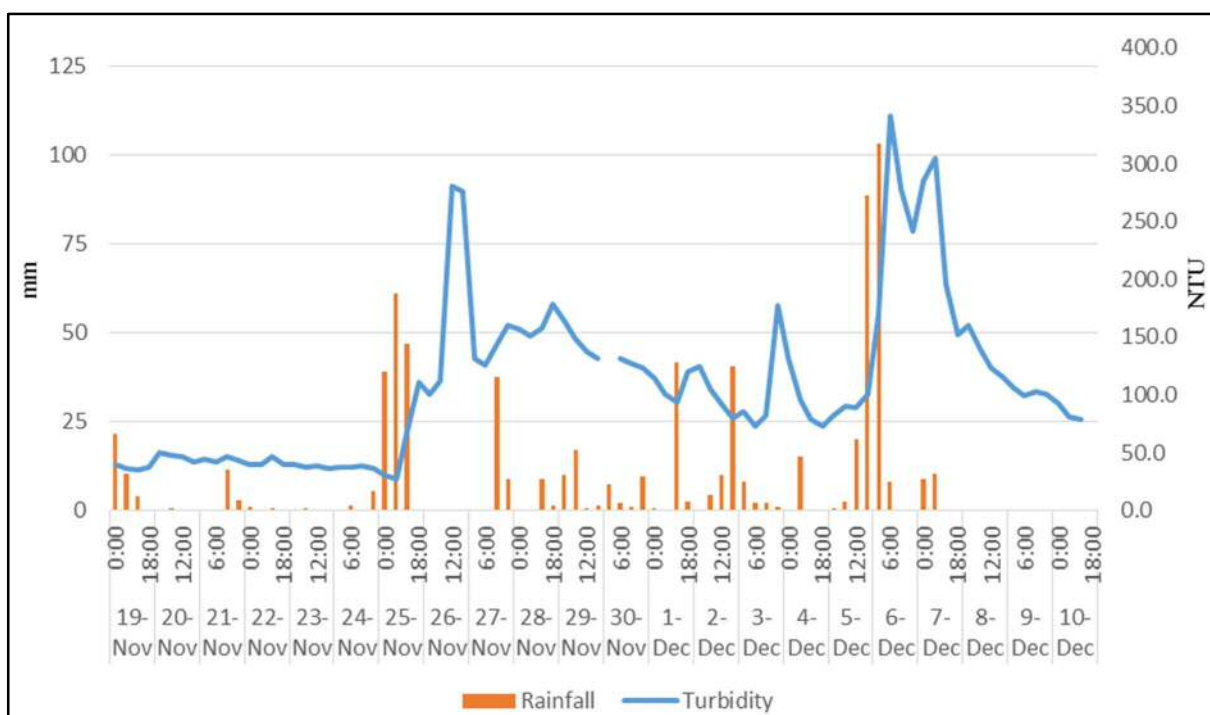
- Right after a 60mm/hr heavy rain event on November 25, a turbidity level of 111 NTU was recorded and next day the same had been increased up to 280 NTU. Since then, the turbidity levels decreased to 65 NTU until December 4.
- After a heavy rainfall event of 100mm/hr more on December 6, a turbidity level of 341 NTU was recorded.
- Subsequently, no rainfall occurred December 8 to 12, hence the turbidity levels decreased to 55.8 NTU on December 12 due to the sedimentation effects of the Dry Aru reservoir.

※ Measuring site: Rainfall amount is rain gauge data installed in NWSDB Kilinochchi office, and turbidity is raw water data of KWTP.

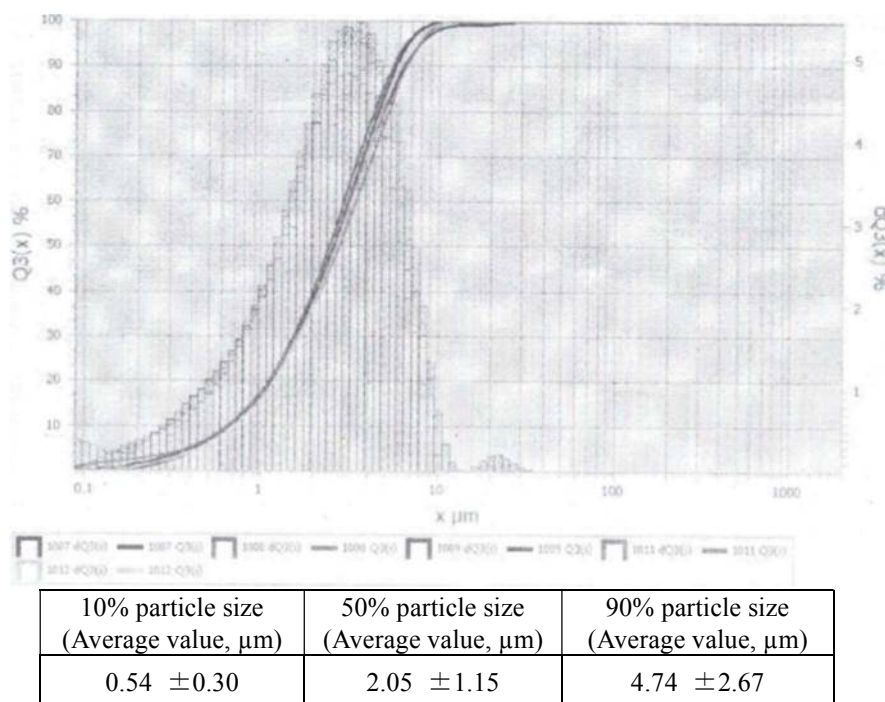
Figure 4-4 Particle Size Distribution of Turbid Matter in Raw Water in Dry Aru (water sampling date: December 6, 2019)

Regarding RF and SSF treated water turbidity, data were obtained after the evening of December 9 when the operation of the intake pump was resumed (temporarily stopped due to a decrease in the received voltage on December 7). After the raw water turbidity rose sharply due to the heavy rainfall of November 25, two RFs were cleaned one by one on December 10, since the decrease in the removal rate of RF was remarkable. However, since the turbidity removal rate was not improved, the operation of No. 1 SSF was started from December 12, and the SSF was operated in two ponds, and the filtration rate was halved from 5.3m/day to about 2.7m/day (the volume of treated water for No. 1 and No. 2 SSF could not be measured due to the runoff weir could not be overflowed at that time). The treated water turbidity of No.1 and No.2 SSF improved with the reduction of raw water turbidity and filtration rate, and the water quality standard values: the time to satisfy 2NTU increased after December 20. Photo 4-4 shows the appearance of raw water in the vicinity of the water intake facility, which is yellow soil with a whitish colour. **Figure 4-4** shows the measured particle size distributions of turbidity contained in the raw water of Dry Aru reservoir. The 10% particle size was $0.54 \pm 0.30 \mu\text{m}$, and the 50% particle size was $2.05 \pm 1.15 \mu\text{m}$, which was very fine. About half of the particles were clay particles of size $2 \mu\text{m}$ or less (based on the definitions of the International Union of Soil Sciences).

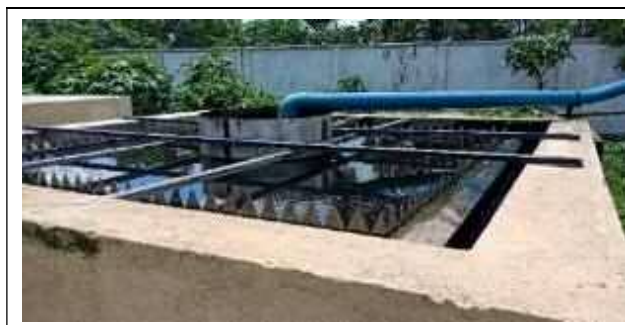
Photo 5-2 Sedimentation Tank

Wastewater generated in hospitals is treated at a sewage treatment facility with a capacity of 110m³/day. This facility was renewed and newly installed in July 2019, and sewage treatment is currently being carried out by sedimentation and filtration. Treated water is discharged into a small stream adjacent to hospitals, and this small stream flows from Kanagambikai reservoir to the Dry Aru reservoir.

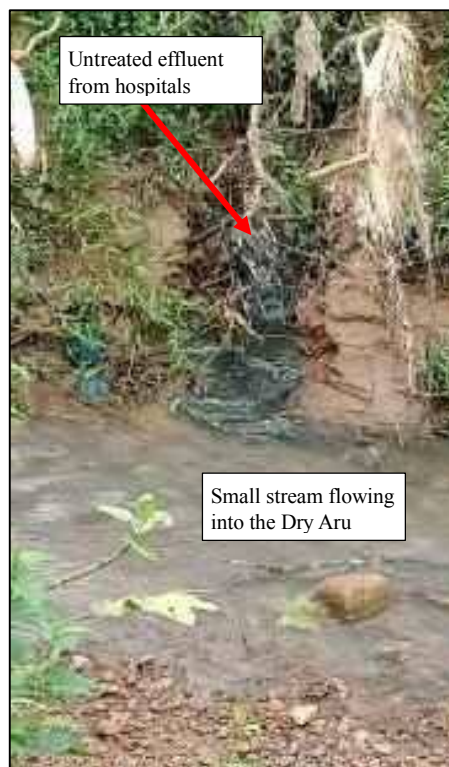
Photo 5-4 Outflow of Wastewater

Further, canal water flow shall be measured to get confirmed that the expected dilution is occurred according to the criteria for the discharge of Industrial Effluent into Inland surface water.

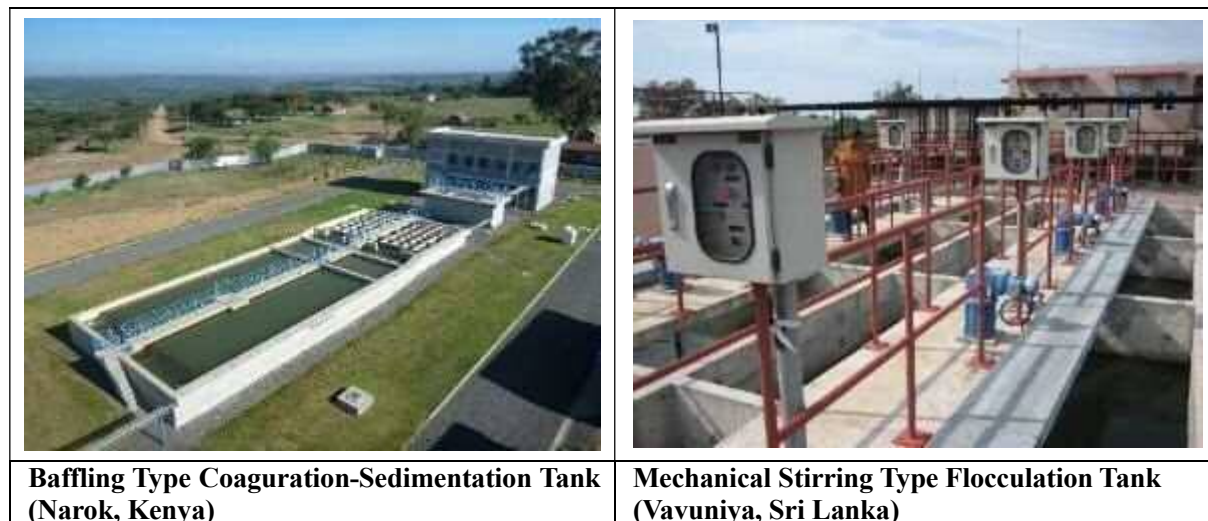
Photo 8-1 Introduction Example

Further, the period in which the coagulation-sedimentation treatment is not required except in the dry season and the rainy season, stops the chemical injection and mechanical stirring, it is possible to reduce the operation cost. Examples of the introduction of coagulation-sedimentation facility are shown in **Photo 8-1**.

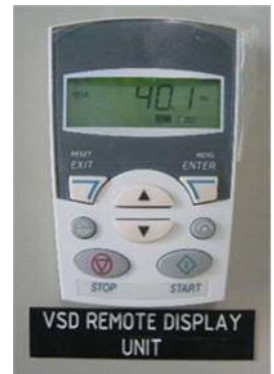
Figure 2-1 VSD REMOTE DISPLAY UNIT

- ✓ Select "R" for remote mode at KE-LP-1 in the Intake Pump House.
- ✓ Select "ALT" at KE-LP-1 in the Intake Pump House.
- ✓ Select "A" for Auto mode at KE-IS-1 and 2 in the Electrical Room .
- ✓ Adjust the flow rate to 158 m³/hour by "VSD REMOTE DISPLAY UNIT" (approx. 47.0 Hz).
- ✓ The Intake Pump will start above LWL (+16.4 m) automatically.

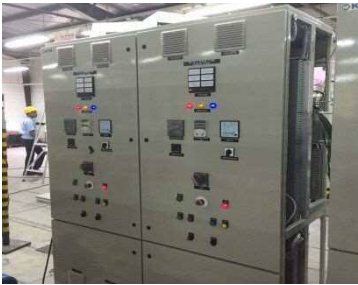
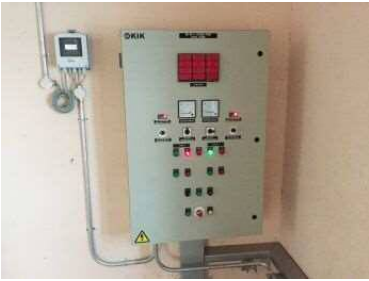
Table 2-1 Detail Operation Procedure of Intake Pump

Auto Operation	<p>Auto Operation</p> <ol style="list-style-type: none"> 1. Select “A” for auto mode at KE-IS-1&2 and select “R” for remote mode at KE-LP-1 2. Select the pump to be operated by “P1/ALT/P2” switch at KE-LP-1 2. The selected pump will operate continuously 3. You can adjust the pump operation speed manually at both KE-IS-1&2 or KE-LP-1 4. The pump will automatically stop in case of water level L @Intake sump. <p>< Setting for alternative operation ></p> <ol style="list-style-type: none"> 1. Select “A”, for auto mode at both KE-IS-1 & 2 2. Select “ALT” for alternation mode at KE-LP-01 	
Manual Operation	<p>Pump ON</p> <ol style="list-style-type: none"> 1. Select “M” for manual mode 2. Push “START” button 3. Pump operating speed can be adjusted by setting value on the VSD display (Note1) <p>Pump OFF</p> <ol style="list-style-type: none"> 1. Push “STOP” button in manual mode 2. Change the mode from “A” to “M” 	<p>Pump ON</p> <ol style="list-style-type: none"> 1. Select “L” for local mode 2. Push “START” button 3. Pump operating speed can be adjusted using speed controller (Note1) <p>Pump OFF</p> <ol style="list-style-type: none"> 1. Push “STOP” button in Local mode 2. Change the mode from “R” to “L”

Interlock Condition	<ol style="list-style-type: none"> 1. “L” (Local mode) selected at KE-LP-1 2. LL detects @ Intake sump (Dry run protection) 3. Electrical faults (Over Load, Earth Fault, Inverter Fault) 4. PLC Communication Failure (Note2) 	<p>Same as left except for No.1</p>
Remark	<p>Note1: In case of Inverter Fault, “STAR DELTA” mode can be selected and utilized as backup instead of “VSD” mode at KE-IS-1&2 although it does not have speed control function.</p> <p>Note2: Even in case of PLC Failure, the intake pump can be operated by KE-IS-1&2 only in manual mode. However, the dry run protection cannot function so please visually check the water level of intake pit in advance.</p>

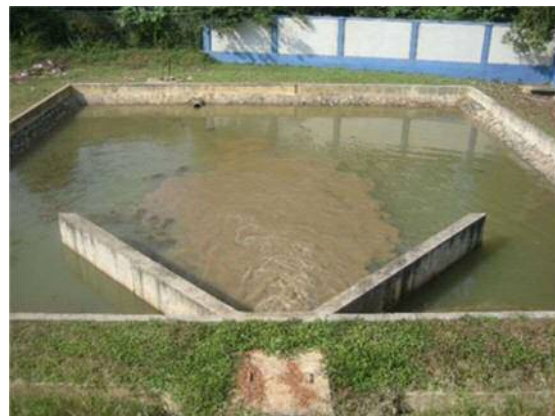
Figure 2-5 Appearance of Wash Waste Water of RF in SP

- ✓ Confirm the condition of the Storage Pond (SP); the inlet valve is fully opened, water level is low enough, the drain valve is closed.
- ✓ Reduce the intake flow up to 1.4 m³/min (half of design flow rate: 2.77 m³/min)
- ✓ Close the inlet valve of the selected RF.
- ✓ Open the drain valve-1 of the selected RF as quickly as possible and wash out the inside water completely. Calculated water amount of RF is shown in **Table 2-2**.
- ✓ Check the water level of SP.
- ✓ When the wash waste water of RF is stopped flowing, close the drain valve-1 of selected RF.
 - (Discharge flow rate: approx. 8.2 m³/min with full open of drain valve of RF, Effective volume of SP: approx. 172 m³)
- ✓ After suspended solid is settled enough in SP, open the drain valve of SP and discharge the supernatant.
- ✓ Open the inlet valve of the selected RF and increase the intake flow rate up to 2.77 m³/min.

- ✓ Fill the selected RF with raw water up to the surface of filter media.
- ✓ Repeat the above procedures until the appearance of wash waste water of **both** RFs will be clean.
- ✓ In case that the appearance of wash waste water is not clean enough at the end of washing, keep open the drain valve-1 and open the inlet valve of selected RF for washing out the sediments/mud remained at the bottom part. After the appearance of wash waste water is clean enough, close the drain valve-1.
- ✓ After finishing the RF washing, start operation in accordance with the procedure as shown in above (1). It is recommended to open the drain valve-2 until the treated water turbidity will be clean enough.

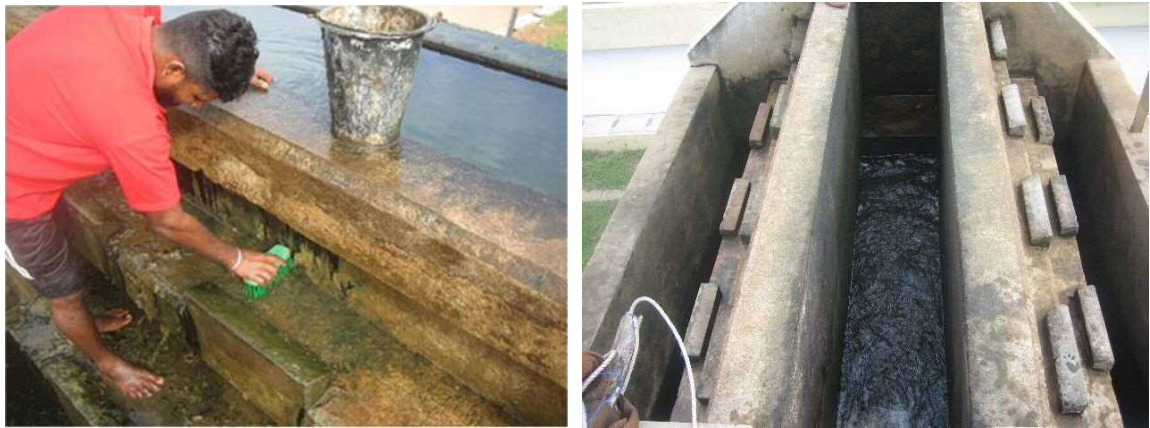
Figure 2-7 Cleaning Work of Aerator

- ✓ Close the Inlet valve of Receiving Well.
- ✓ Open the drain valves of Receiving Well and Aerator.
- ✓ Perform the maintenance or inspection work. Cleaning shall be done at least once a month.

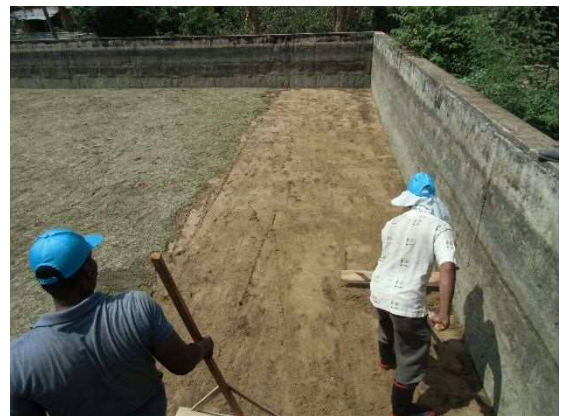
Figure 2-10 Sand Scraping Work by Using Wooden Scraper

- ✓ Put on gloves and cleaned boots before entering SSF.
- ✓ Close the inlet valve and remove all floating materials.
- ✓ Drain out water from the drain valve slowly and keep the water level approx.200 mm below the sand surface.
- ✓ Wash / clean the walls of filter.
- ✓ Remove algae and remaining scum on the surface sand.
- ✓ Start scraping approx. 10 mm of surface sand from one edge. Scraping must be finished within one day.
- ✓ Carry the scraped sand to the Storage Yard.
- ✓ Check / measure the sand thickness. If it is less than 500 mm, re-sanding must be done.
- ✓ Level the sand bed.

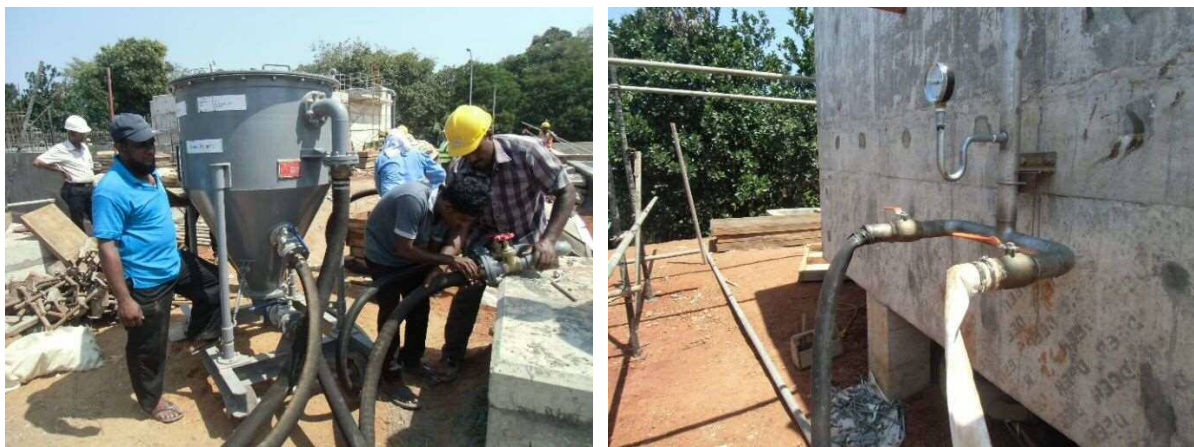
Figure 2-13 Setup of Sand Separator Tank (Left) and Connection Point of Pressure Water (Right)

- g) The ejector part of the Sand Ejector Unit (1) shall be replaced in case that the ability of ejector is decreased by wearing away. A clogging at the throat part of the ejector will cause a sudden drop of the suction force of the ejector. In this case, the clogging shall be removed.

- h) The shut valves (4) and (12) shall be fully opened during an operation. In case that these valves are not opened fully, the Sand Separator Tank (2) will be damaged due to wearing away by sand.

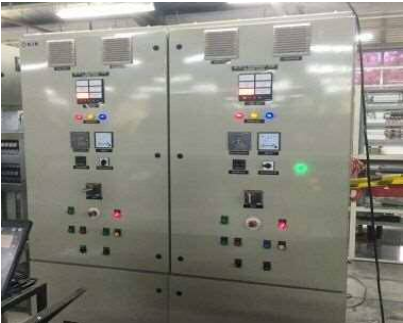
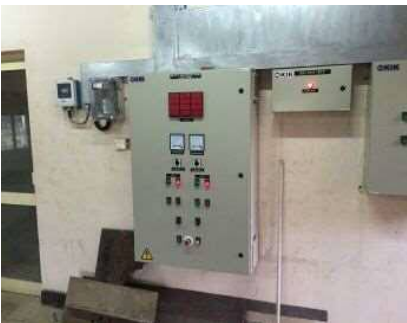
Table 2-3 Detail Operation Procedure of Transmission Pump

Auto Operation	<p><u>Auto Operation</u></p> <ol style="list-style-type: none"> 1. Select "A" for auto mode at KE-TS-1&2 and select "R" for remote mode at KE-LP-2 2. Select the pump to be operated by "P1/ALT/P2" switch at KE-LP-2 3. The selected pump will automatically operate according to water level of CWR and KWT as shown below. <ul style="list-style-type: none"> ● Start Condition "$\geq H@CWR$" and "$\leq @KWT$" ● Stop Condition "$< L @CWR$" or "$\geq H@KWT$" <p>< Setting for alternative operation ></p> <ol style="list-style-type: none"> 1. Select "A", for auto mode at both KE-TS-1 & 2 2. Select "ALT" for alternation mode at KE-LP-02 	
Manual Operation	<p><u>Pump ON</u></p> <ol style="list-style-type: none"> 1. Select "M" for manual mode 2. Push "START" button <p><u>Pump OFF</u></p> <ol style="list-style-type: none"> 1. Push "STOP" button in manual I mode 2. Change the mode from "A" to "M" 	<p><u>Pump ON</u></p> <ol style="list-style-type: none"> 1. Select "L" for local mode 2. Push "START" button <p><u>Pump OFF</u></p> <ol style="list-style-type: none"> 1. Push "STOP" button in local mode 2. Change the mode from "R" to "L"

Interlock Condition	<ol style="list-style-type: none"> 1. "L" (Local mode) is selected at KE-LP-2 2. LL detects @ CWR (Dry run protection) 3. $\geq H$ detects @ KWT 4. Electrical faults (Over Load, Earth Fault, Inverter Fault) 5. "Killinochchi Tower Power" Fails 6. "PLC Communication Failure" (Note1) 7. "GSM Communication Failure" 8. "High Pressure" and "Low Flow" detect together (Note2) 9. "Low Low Flow" detects (Note2) <p style="text-align: right;">Same as left except for No.1</p>	
Remarks	<p>Note1: Even in case of PLC Failure, the intake pump can be operated by KE-IS-1&2 only in Manual mode. However, the dry run protection cannot function so please visually check the water level of CWR in advance.</p> <p>Note2: See attached 【Setting Values】 in detail.</p>

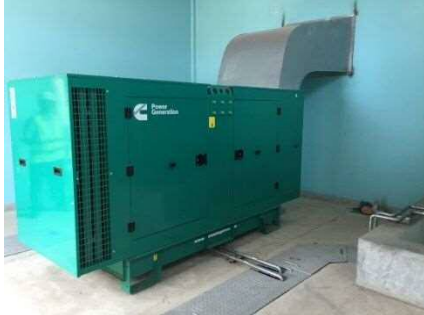
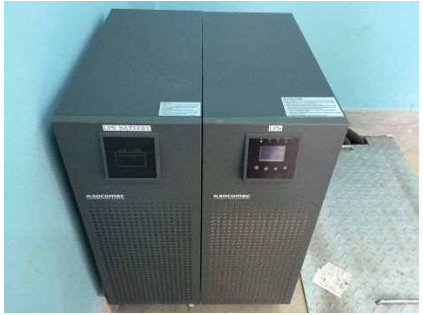
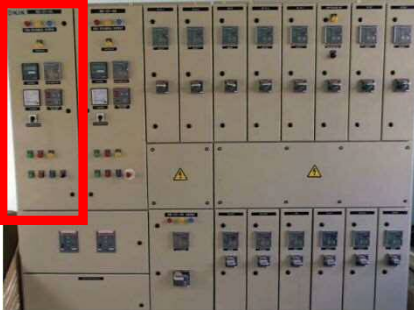
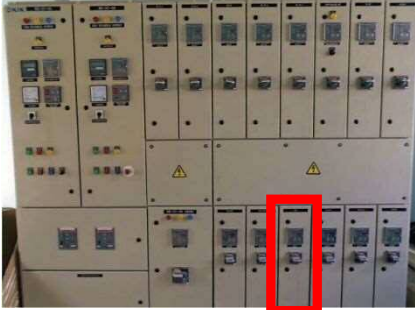
Table 2-5 Detail Operation Procedure of Power Source Equipment

Operation	Auto	<p><u>Auto Operation</u></p> <ol style="list-style-type: none"> 1. Confirm the main breaker of the Standby Generator itself (not KV-LV-2) is ON. 2. Select "A" for auto mode at KE-LV-1. <p>< In case of CEB power failure ></p> <ol style="list-style-type: none"> 1. The main circuit breaker for CEB will be automatically turned off. 2. The generator will automatically start. 3. After the voltage of the generator has become stable, a main circuit breaker for the generator will be automatically turned on. 	<p>< In case of CEB power recovery ></p> <ol style="list-style-type: none"> 1. When the recovery of CEB power is detected, the main breaker for CEB is turned on as soon as the main breaker for the generator is turned off automatically. 2. After some idling operation, the generator will stop automatically. 	<p><u>Auto Operation</u></p> <ol style="list-style-type: none"> 1. Confirm whether the UPS battery is ON. 2. Turn on the circuit breaker for UPS at KE-LV-3 <p>As long as the UPS battery itself and the circuit breaker for UPS at KE-LV-3 are turned on, they automatically function in case of power failure. On the other hand, if the circuit breaker at KE-LV-3 is turned off, even though the UPS power is on, it will not be able to provide back up control power to the PLCs and instruments during the power failure.</p>

Manual	<p><u>CEB ON</u></p> <ol style="list-style-type: none"> 1. Select "M" for manual mode at KE-LV-1. 2. Confirm the main breaker for Generator is OFF at KE-LV-2 (Note1). 3. Push "START" button at KE-LV-1. <p>Note1: There is an interlock function between two main breakers to prevent from human error. Therefore, even if you push START before turning off the other operating breaker, it will not be operated together.</p> <p><u>CEB OFF</u></p> <ol style="list-style-type: none"> 1. Push "STOP" button at KE-LV-1. <p>Note that there will be no automatic power back-up.</p>	<p><u>Generator ON</u></p> <ol style="list-style-type: none"> 1. Select "M" for manual mode at KE-LV-1. 2. Confirm the main breaker for CEB is OFF at KE-LV-1(Note2) 3. Push "START" button at KE-LV-2. <p>Note2: In case of a maintenance operation of the generator, you can manually operate it by the control panel equipped on itself even though the main breaker of KE-LV-2 is OFF.</p> <p><u>Generator OFF</u></p> <ol style="list-style-type: none"> 1. Push "STOP" button at KE-LV-2. 2. After some idling operation, the generator will stop automatically <p>Note that there will be no automatic power back-up.</p>	<p>No need to be operated manually.</p>

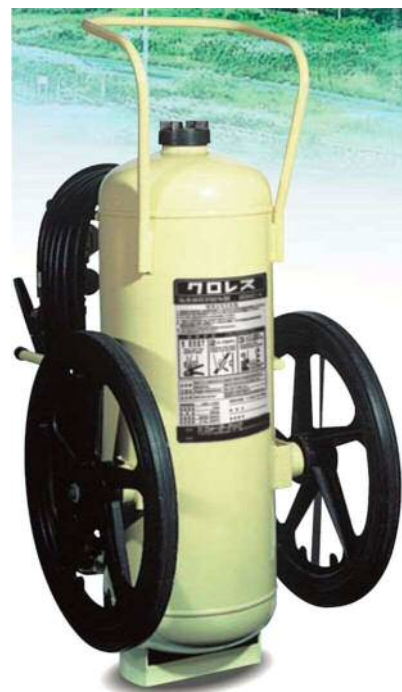
Figure 2-21 Appearance of Chloless

- ✓ The Chloless is a sprayer which sprays chlorine-absorbing powder. The powder is moisture proof and has high fluidity.
- ✓ The chemical powder reacts with the leaked chlorine gas immediately.
- ✓ Easy handling like an extinguisher.
- ✓ The chemical powder is safe and good for prolonged storage.
- ✓ Loaded chemical weight is 25kg.
- ✓ Spraying duration is approx. 300 sec.
- ✓ Average spray rate is approx. 5.0 kg/min.
- ✓ The chemical reaction formula is shown as below.
