資料 - 7: その他の活動実績

I. 流量モニタリングシステム

## 7.I Flow Monitoring System

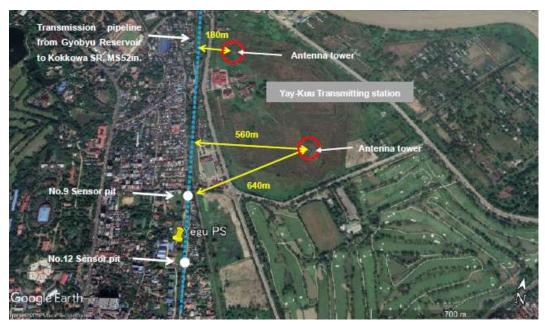
Figure 5 Location of Yegu PS and Yay-Kuu broadcasting station

Near YeguPS, there is a Ministry of Information broadcast station (Yay-Kuu broadcast station) (Figure 5). The broadcasting station is used for Myanmar radio national service and relay broadcasting of NHK (Nihon Housou Kyoukai) on medium and short-wave band with maximum power 50KW. The Gyobyu-Kokkine MS tube is located along the Yay-Kuu transmitter station, and the shortest distance between the transmitter station (aerial) and the pipeline is about 100m.

However, the Yay-Kuu transmitter station near YeguPS is the most likely source of AM modulated noise. Therefore, for the time being, the Yay-Kuu transmitter station is assumed to be the source of the noise, and countermeasures will be studied.

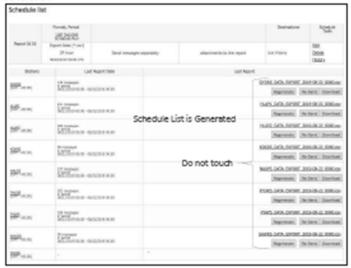
#### Schedule Report Generation

Delairco Japan KK will add function and update the WFM Software within maintenance period.
