Preparatory Survey on the Project for Improvement of Waste Management
in Juba, the Republic of South Sudan

資料 8 車両整備ワークショップ建設予定地
地盤・地質調査結果

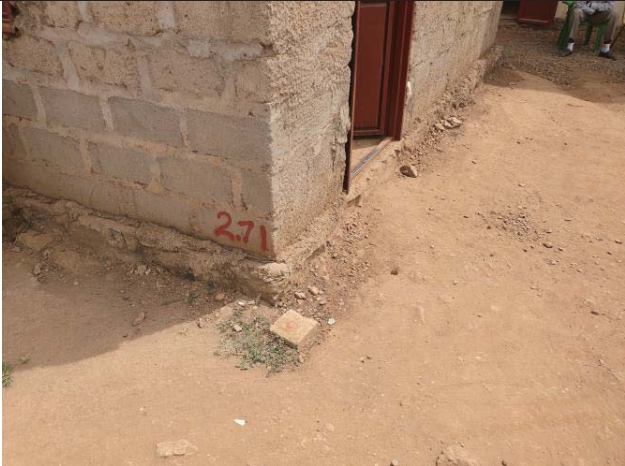
<p>CP 1</p> <p>Location: at the entrance main Gate</p> <p>Coordinate:</p> <p>Easting: 346643.936</p> <p>Northing: 536173.920</p>

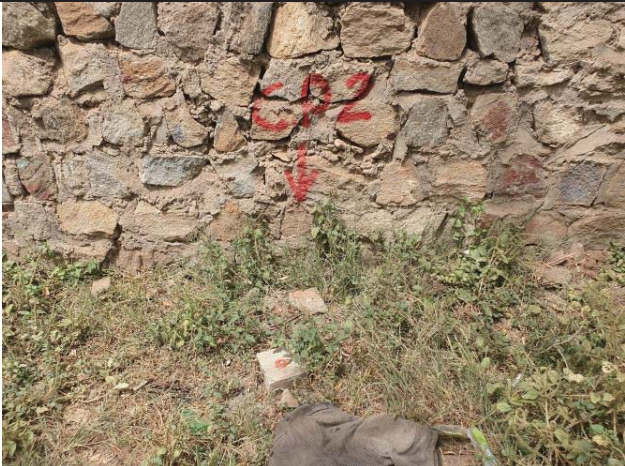
<p>CP 2</p> <p>Location: at Norther part of masnry wall</p> <p>Coordinate:</p> <p>Easting: 346643.813</p> <p>Northing: 536230.249</p>

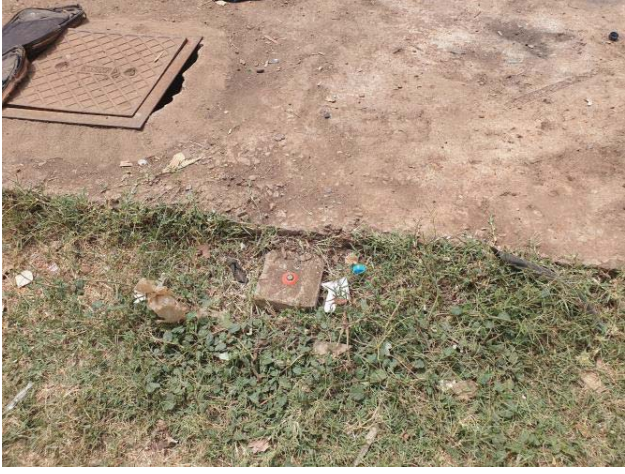
<p>CP 3</p> <p>Location: at Southern septic tank</p> <p>Coordinate:</p> <p>Easting: 346607.157</p> <p>Northing: 536177.975</p>
---	--

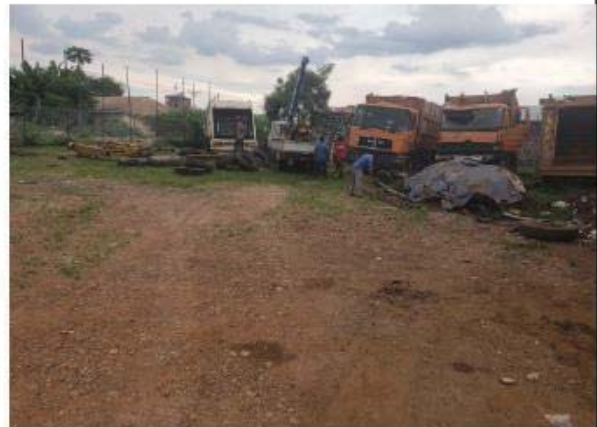
SPT Machine at the site in the location of BH2

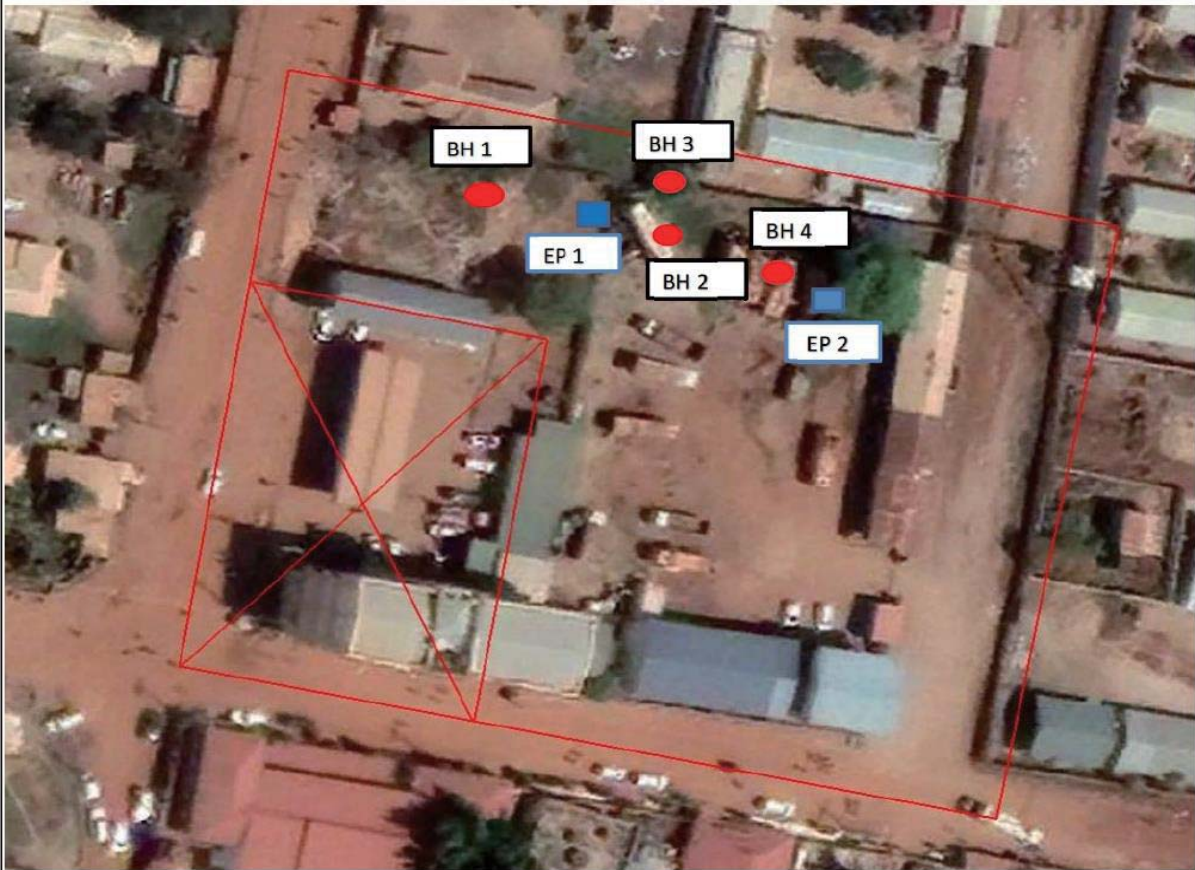
Location of Test Points

● : Boring points (BH)

■ : Excavation points (EP)
