1.8 Effect Evaluation

NRW Reduction in Kadobogo

Kyowa Engineering Consultants, Co., Ltd.

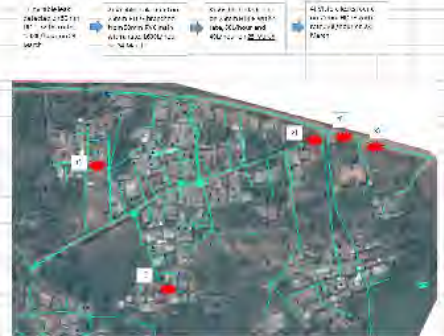
Leak detection and Repair in Subzone 3-2

Leak Detection in Kadobogo (1)

Date	Area	Dia.	Pipes	Causes	Leak rate (L/hour)	Visible or Invisible
22-Mar	PM3-2	25	HDPE Tertiary	High Pr. & Low Qty Pipe	1,500	Invisible
25-Mar	PM3-2	25	HDPE Service	High Pr. & Low Qty Pipe	2,000	Visible
25-Mar	PM3-2	25	HDPE Service	High Pr. & Low Qty Pipe	50	Visible
27-Mar	PM3-2	25	HDPE Tertiary	High Pr. & Low Qty Pipe	60	Visible
2-Apr	PM3-2	25	HDPE Tertiary	High Pr. & Low Qty Pipe	50	Visible
4-Apr	PM1	90	PVC Secondary	High Pr. & subsidence	10,000	Visible
5-Apr	PM2	50	HDPE Secondary	High Pr. & Low Qty Pipe	7,000	Visible

Leak Detection in Kadobogo (2)

Date	Area	Dia.	Pipes	Causes	Leak rate (L/hour)	Visible or Invisible
13-Apr	PM3-3	25	HDPE Service	High Pr. & Low Qty Pipe	1,800	Invisible
23-Apr	PM3-1	90	PVC Secondary	High Pr. & heavy load	1,500	Visible
24-Apr	PM3-1	25	HDPE Service	High Pr. & Low Qty Pipe	4,500	Invisible
Total					28,460L/hour (Invisible: 7,800L/hour)

- 1) Leak detected in the past one month totals 28,460L/hour(20,490M³/month), equivalent to **2.6 times of total NRW in Kadobogo, 7,940M³/month**
- 2) Invisible leakage, 7,800L/hour, accounts for **70% of the total NRW**

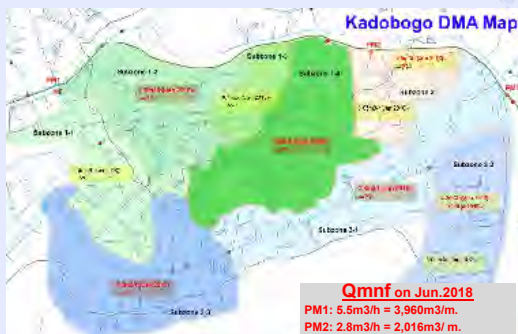
Qmnf & Step Test at Kadobogo

To measure the leakage volume of the subzone, Step test is useful.

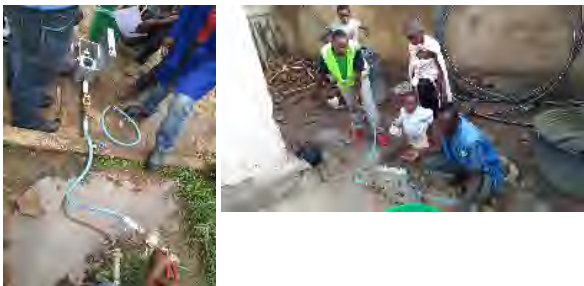
On-site meter testing

Result of Kadobogo Customer Survey

Meter Error		Defected etc.	Meter to be Replaced	Good condition	Disconnected	Total Surveyed
	<5%	>5%					
TOTAL	148	90	88	326	845	12	1183
	12.5%	7.6%	7.4%	27.6%	71.4%	1.0%	100%

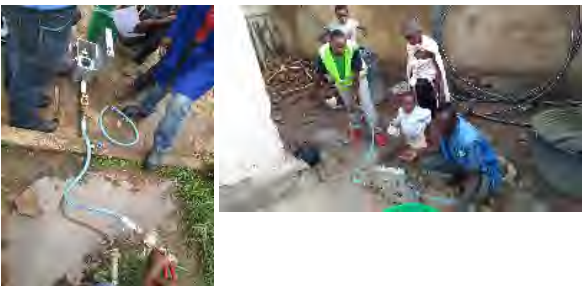
On-site meter testing

Result of Kadobogo Customer Survey

Meter Error		Defected etc.	Meter to be Replaced	Good condition	Disconnected	Total Surveyed
	<5%	>5%					
TOTAL	148	90	88	326	845	12	1183
	12.5%	7.6%	7.4%	27.6%	71.4%	1.0%	100%

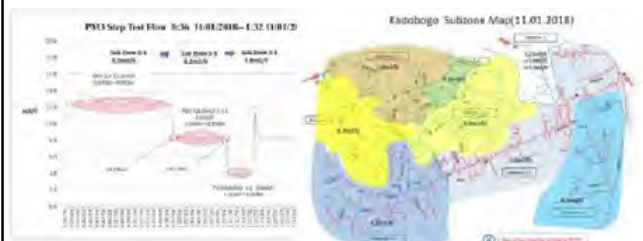
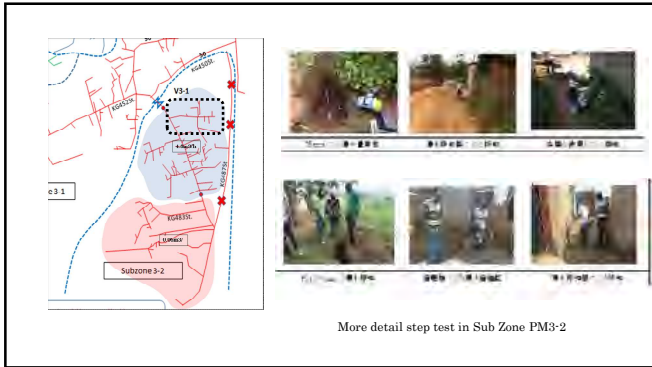
To measure the leakage volume of the subzone, Step test is useful.

※Night time is ideal to conduct Step test.

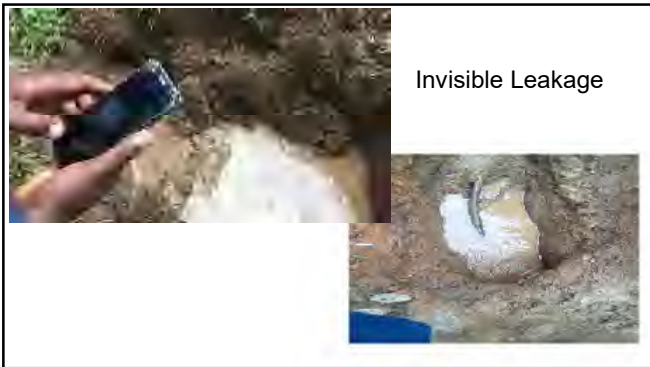
Invisible Leakage

- Most of the leakage comes from service pipes.

- The biggest cause of Physical Loss (Leakage) is high hydraulic pressure and poor quality of pipe material.
- The leakage recurs easily even if a leaking pipe was repaired unless an appropriate countermeasure is taken per these two points.
- Visible leakages are found in a high pressure area. It should be assumed that the invisible leakages exist further.
- The invisible leakage continues being left without being known.

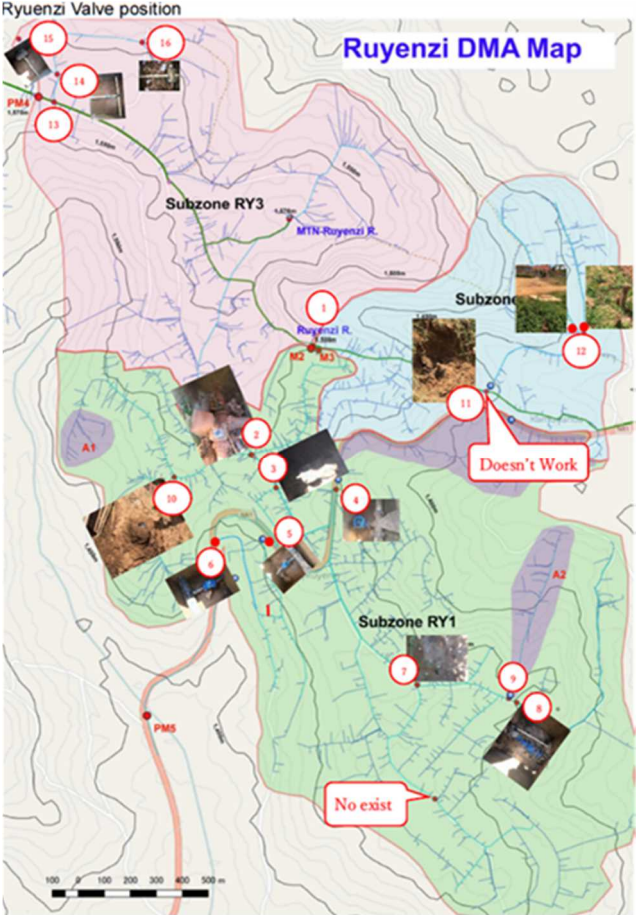
Figure 2.4.2. Locations and working status of gate valves

defective ones and those installed at wrong places were found.

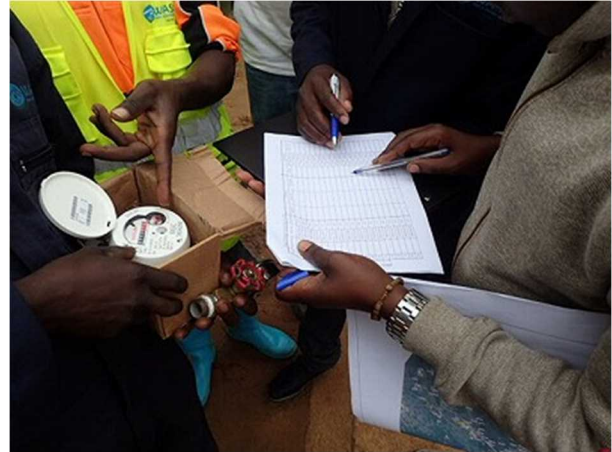
On-site meter error measurement

Measurement flow rate

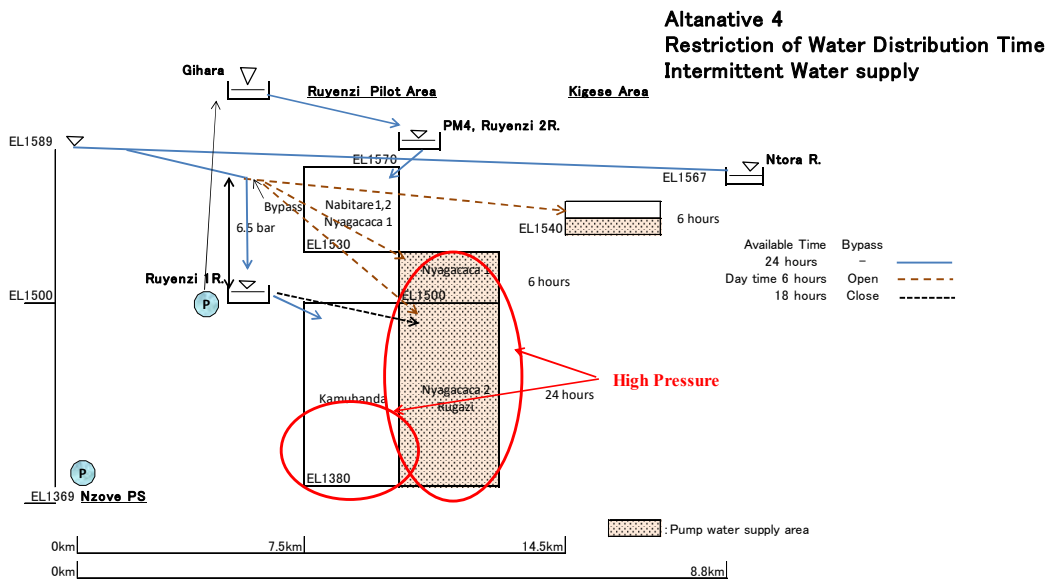
Figure 2.8.6: Schematic diagram of water distribution network of Plan 4

Water distribution to Kigese, outside the pilot area, shall be rationed. The water rationing will also be used in the pilot area to reduce water leakage in the night when the water pressure in the distribution pipes is the highest. A valve on the bypass will be closed completely to suspend water distribution for a certain period in the night. The distribution network of the distribution area of the bypass in the pilot area cannot be separated from the bypass, water distribution to this area will be rationed in the same way as that to Kigese. Customers in the water rationing area will have to install water storage tanks for domestic use.

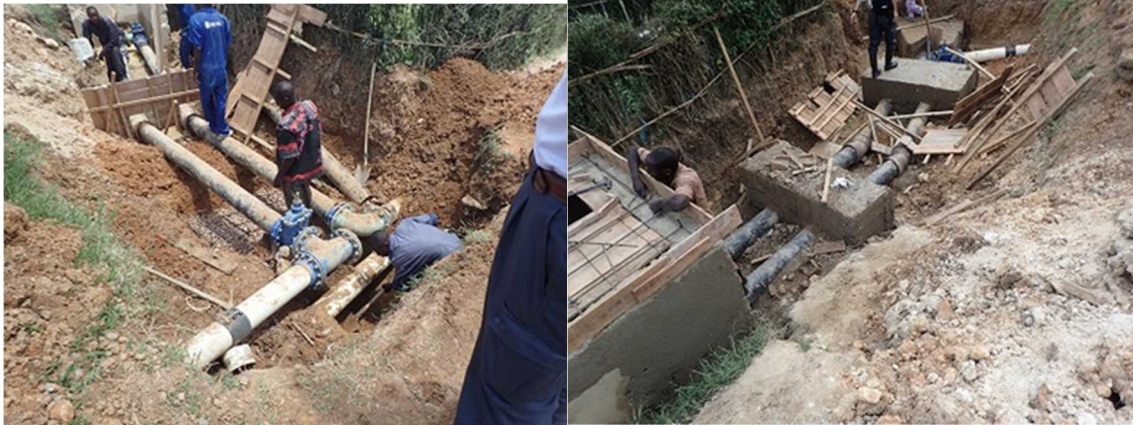
Installation of a PRV in Subzone RY2 (PRV2)

Preparation for the casting of protective concrete Valve assembly chamber and protective concrete

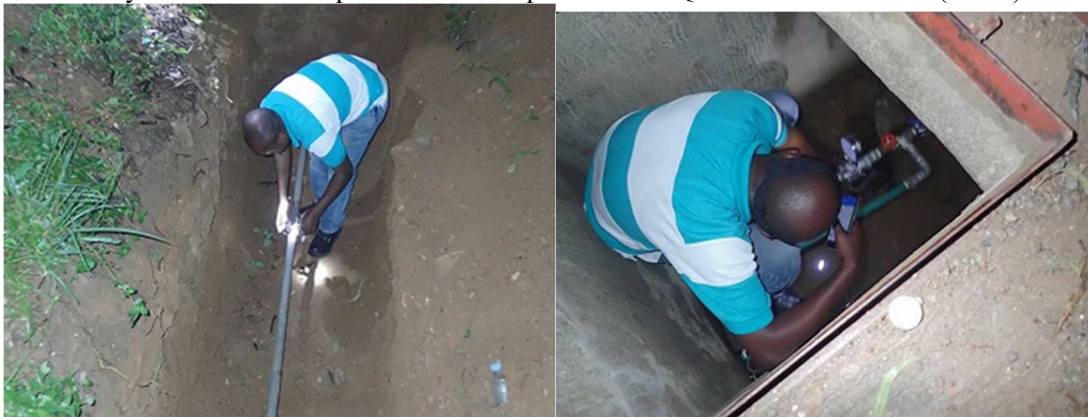
Survey of the relationship between water pressure and Qmnf in Subzone RY1 (PRV2)

Installation of ultrasonic flow meter

Adjustment of PRV

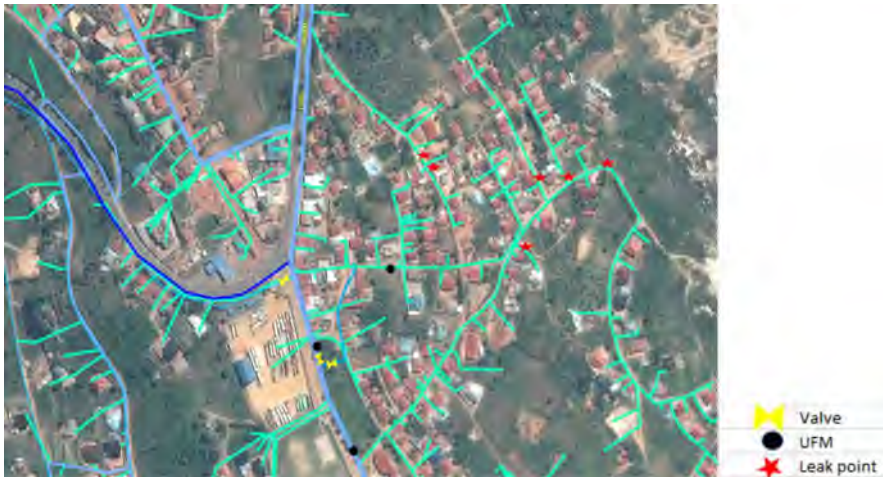
Figure 33. Measurement of flow rate in 63-mm distribution pipe, August 27 – 28, 2019

Water leaks detected at 8 locations on August 7

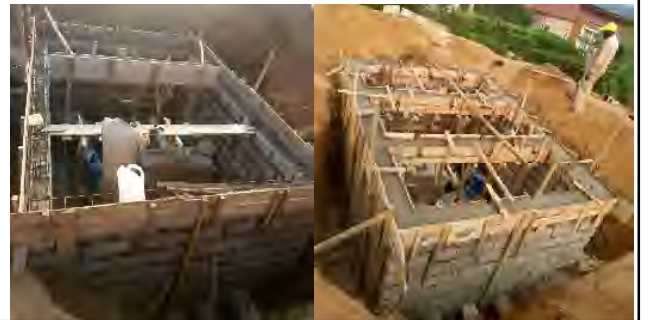
Steel bars, form work and Concrete for chaining & Beam

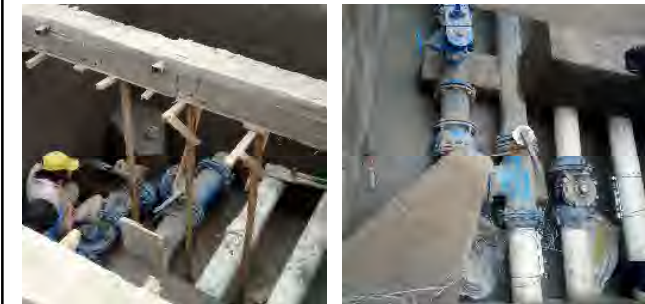
Finishing by mortar coating to the wall and finishing of pavement photos

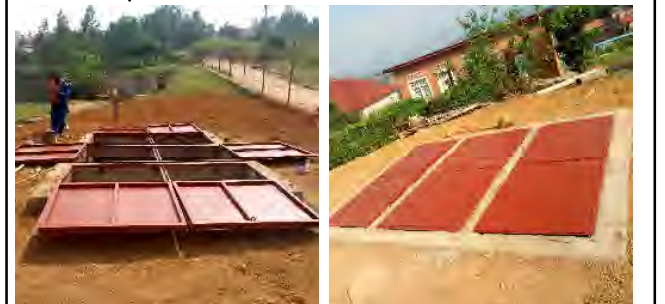
Manhole cover by welding metal tubes & metal sheet photos

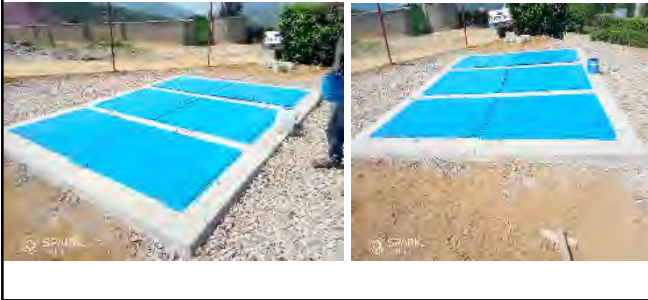
Top finishing after manhole covering and
Application of paint photos

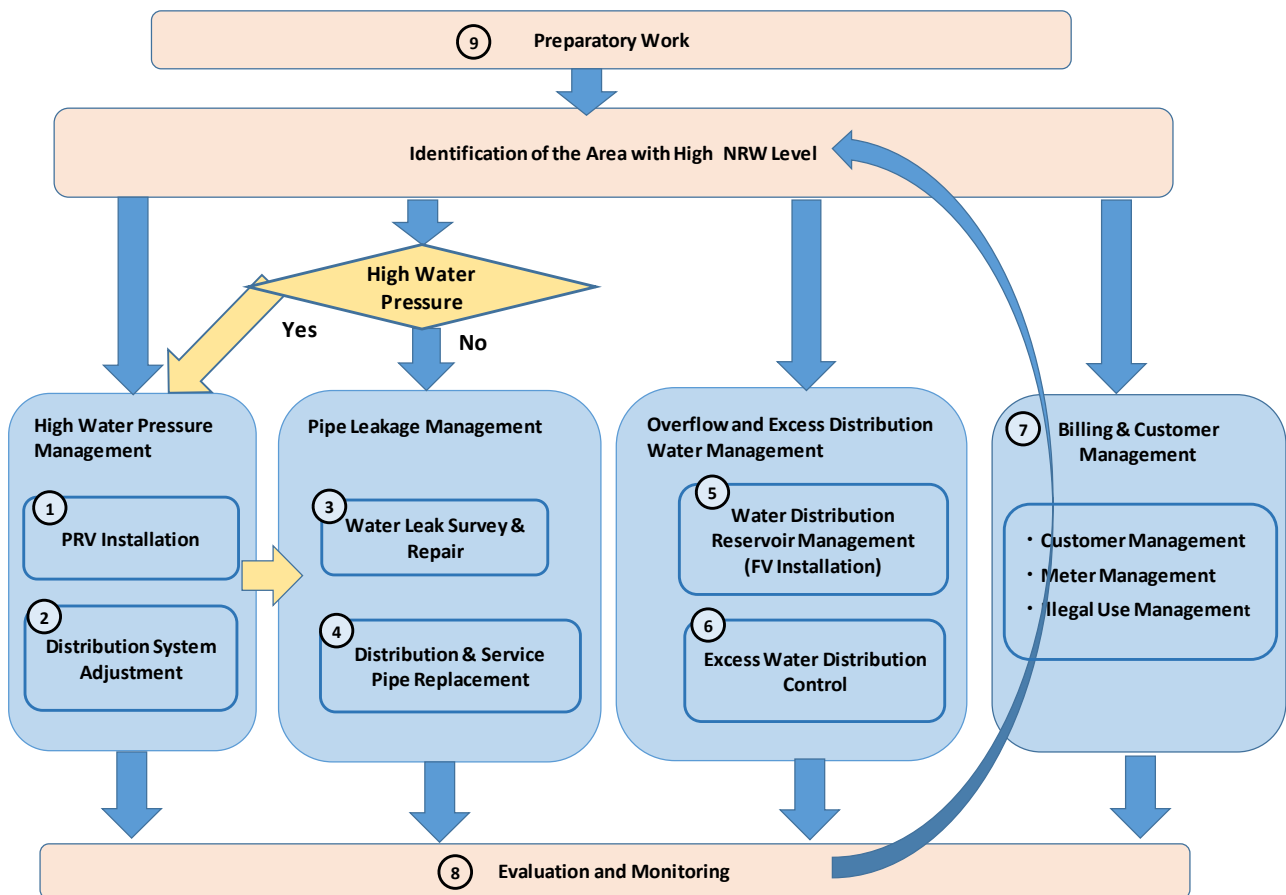
Fig. 1.3 NRW Reduction Activities with High Priority

- 1) High water pressure management
- 2) Distribution system adjustment
- 3) Water leak survey and repair
- 4) Distribution and service pipe replacement
- 5) Water distribution reservoir management
- 6) Water distribution management
- 7) Billing and customer management

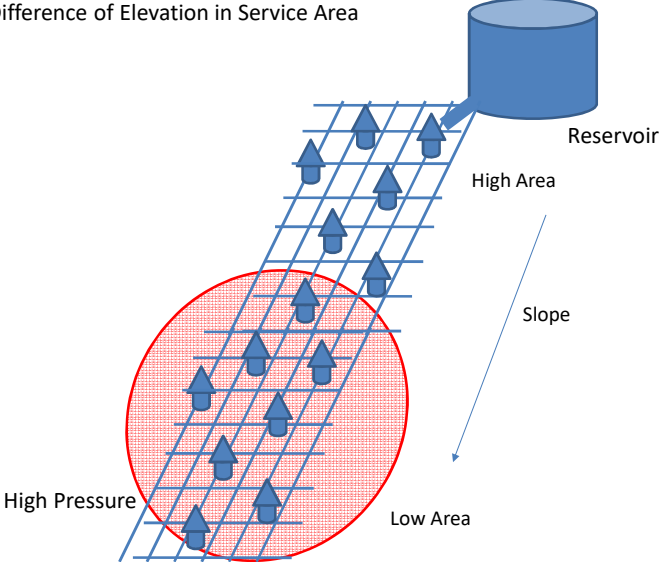
1. Big Difference of Elevation in Service Area

Cause of High Pressure

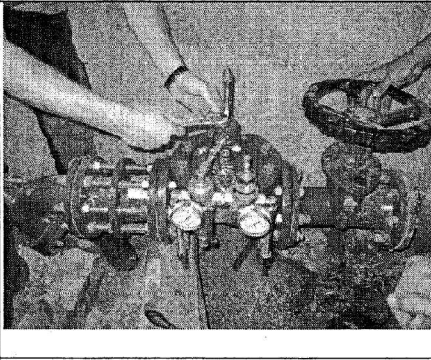
<p>① Install the position indicator which comes separately from the PRV assembly. (Refer to valve manufacture's manual for detail instructions)</p>

<p>② Close the by-pass valve and both upstream and downstream shut-off valves on the main line.</p>	<p>Refer to Fig. A11-1.</p>

<p>③ Make sure that the main line is filled with water and water is available for supply through this line.</p>	
<p>④ Open fully both the stop-cocks on pilot line if they are not open.</p>	<p>Refer to Fig. A11-1.</p>
<p>⑤ Partly open the upstream (U/S) valve on the main line for controlled filling of the PRV. At this time the U/S pressure gauge should start showing some pressure but the D/S pressure should show no pressure as there is no flow and the PRV is still closed.</p> <p>⑥ Purge the pilot line strainer by opening the valve on it and letting water flow through it.</p>

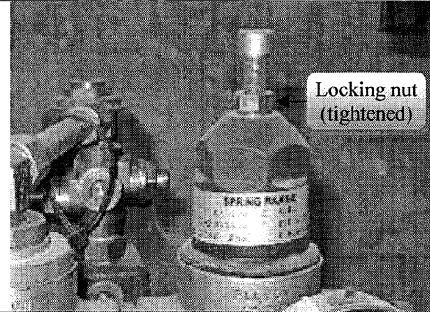
- ⑭ Once the initial setting is completed, fastened the locking nut of pilot control valve in order to fix the adjustment screw in this position. Once fixed, it is not necessary to adjust the pilot control valve in future unless a change in D/S pressure setting is required.
