**REPUBLIC OF RWANDA  
WATER AND SANITATION CORPORATION (WASAC)**

**PROJECT FOR STRENGTHENING  
NON-REVENUE WATER CONTROL IN  
KIGALI CITY WATER NETWORK**

**PROJECT COMPLETION REPORT**

**JAPAN INTERNATIONAL COOPERATION AGENCY (JICA)**

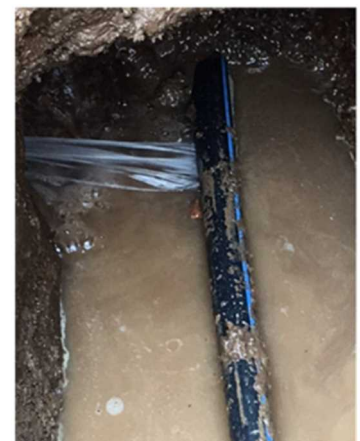
In one month, between March and April, the survey found water leakage at 10 points (of which three were underground leakage), which was subsequently fixed. The volume of underground leakage at the three points totaled 7.8m<sup>3</sup>/h. Since underground leakage continued without being

Water leakage from a HDPE pipe

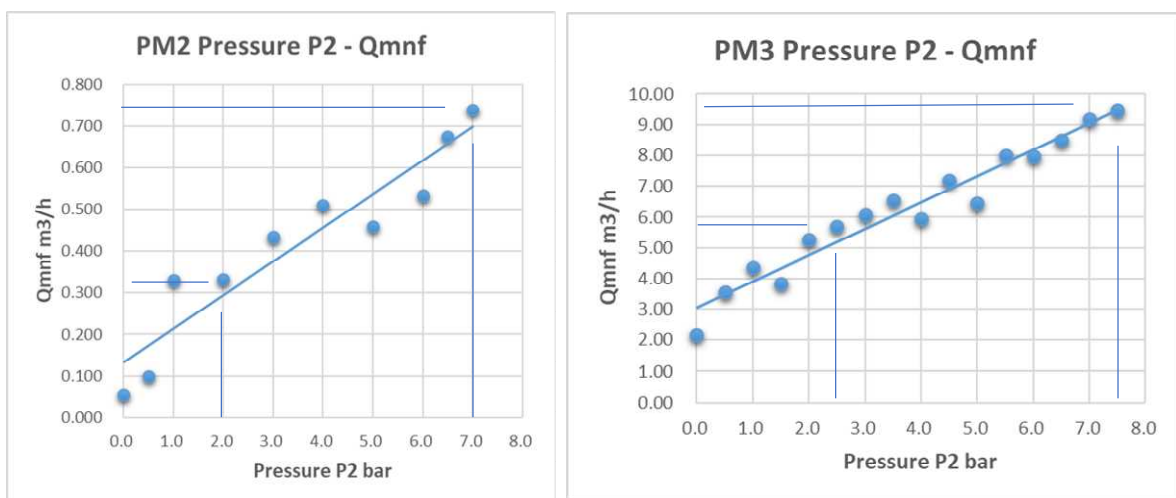
Fig. 2.6 Effectiveness of PRVs (staged P2-Qmhf measurement)

To verify the effect of PRVs, a staged measurement of the water pressure and Qmhf was conducted in October 2018 in PM2 and PM3. Qmhf was measured while the P2 was reduced by steps of 1.0 bar from the condition that the PRV is fully open. As shown in the figure below, correlation was found between P2 and Qmhf: As P2 is lowered by a PRV, Qmhf decreases.

As shown in the table below, the installation PRV effectively reduced the volume of water leakage by 40-60%.

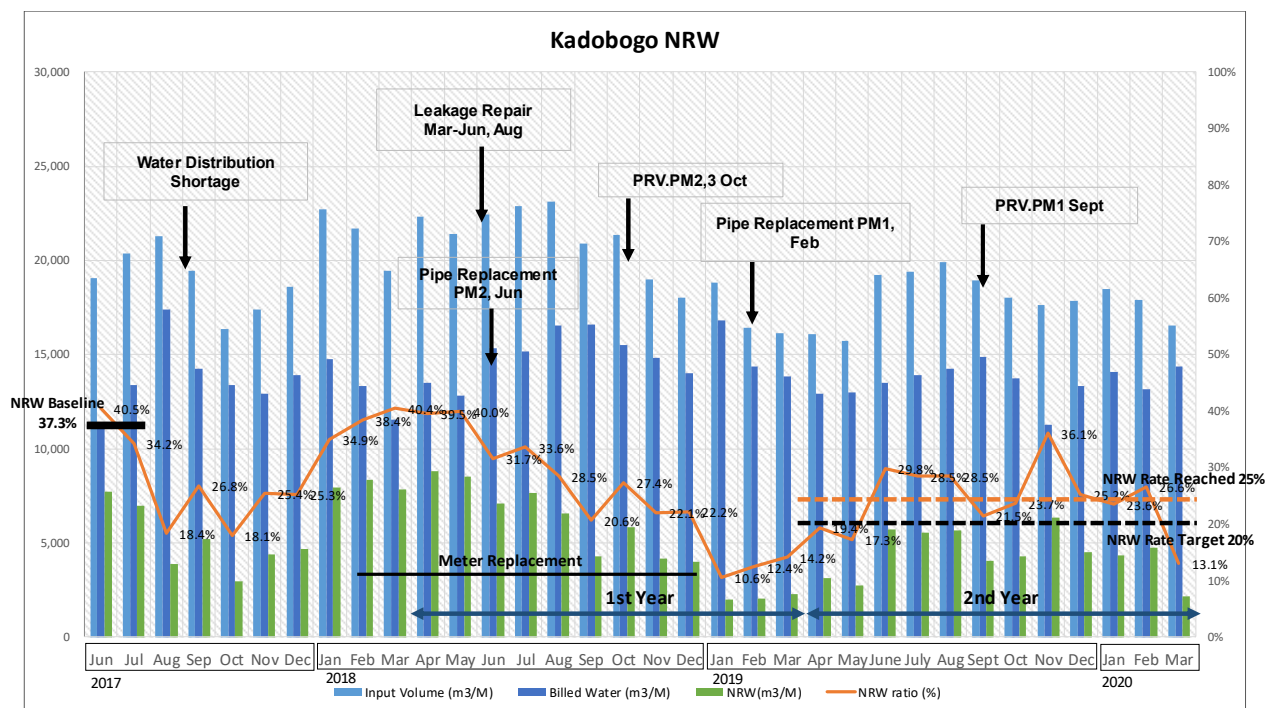
Fig. 2.7 Changes in the NRW volume and rate in Kadobogo

The transition of the amount of NRW water and the NRW rate of Kadobogo are shown in the following figure.

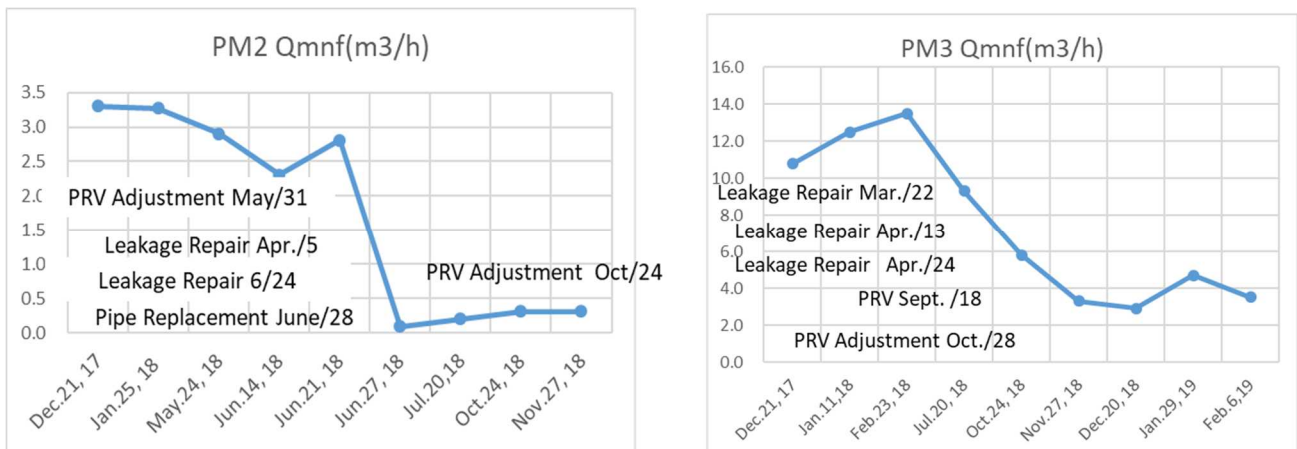
Fig. 2.10 Changes of Qmnf in Kadobogo (before and after the installation of PRVs)

The history of Qmnf measurement is shown in Table 2.46 above. The figure below, showing the change of Qmnf based on the measurement clearly indicates a decline in the value following the installation of PRV, leakage repair and water pipe replacement.

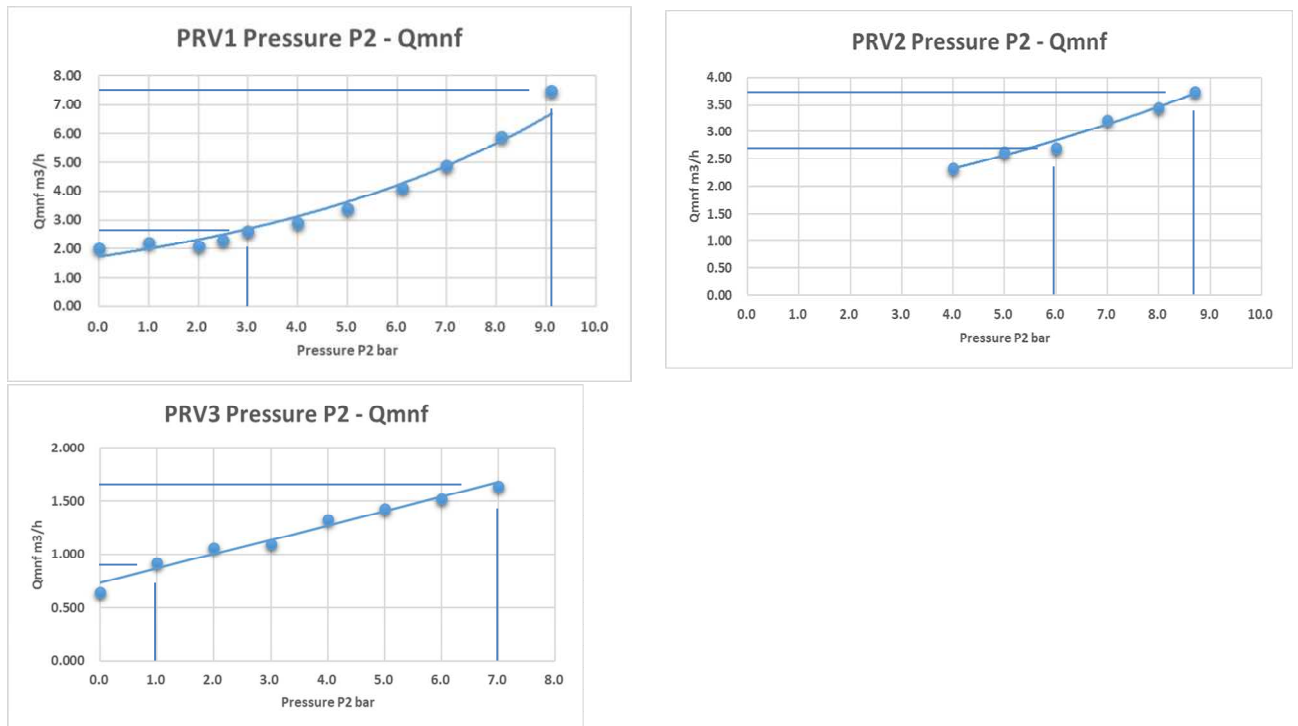
Fig. 2.16 Effectiveness of PRVs (staged P2-Qmnf measurement)

P2 was lowered by PRV.

The setting of the PRVs has effects of 30% to 80% water leakage reduction as shown in the table below.

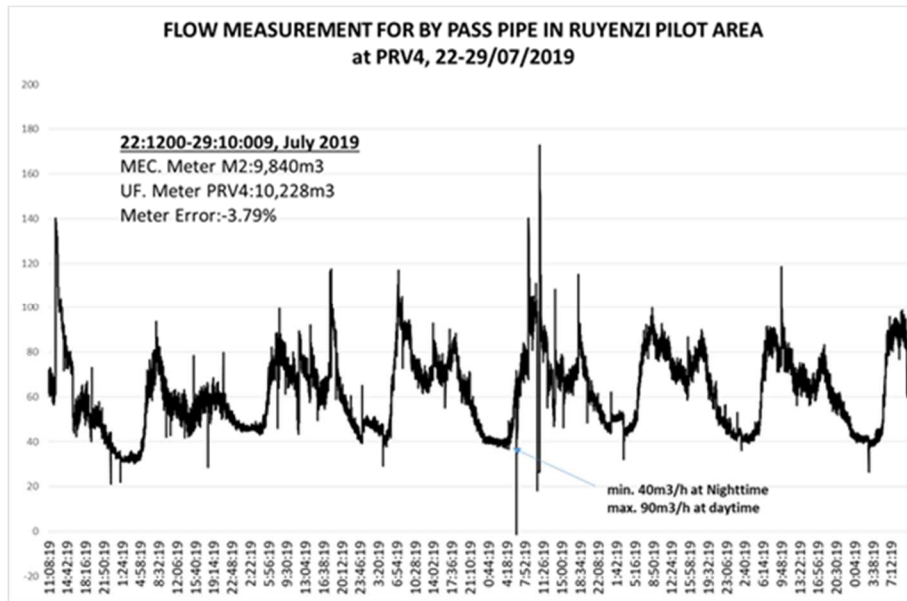
Fig. 2.19 Measurement of the flow rate for 7 days directly below the Ruyenzi reservoir  
(flow rate into the RY1 area)

In the flow rate measurements of PRV4 on the bypass at the Ruyenzi reservoir, the minimum flow rate at night time was about 40 m<sup>3</sup>/h in both July and August as shown in the figures below.

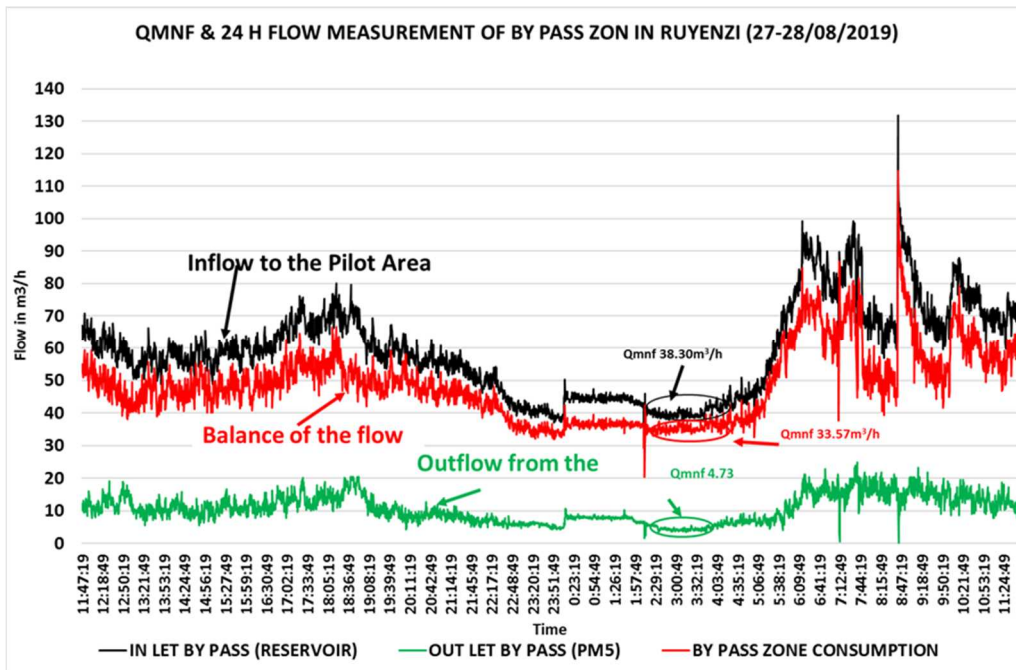
Fig. 2.20 Measurement of Flow Rate in RY1 (before the installation of PRV4)

The result of the effect measurement is shown in the figure below. The operation of PRV4 reduced the amount of NRW by 4.7 m<sup>3</sup>/h (33.6-28.9) at night, but the amount of NRW was still as high as 29 m<sup>3</sup>/h.

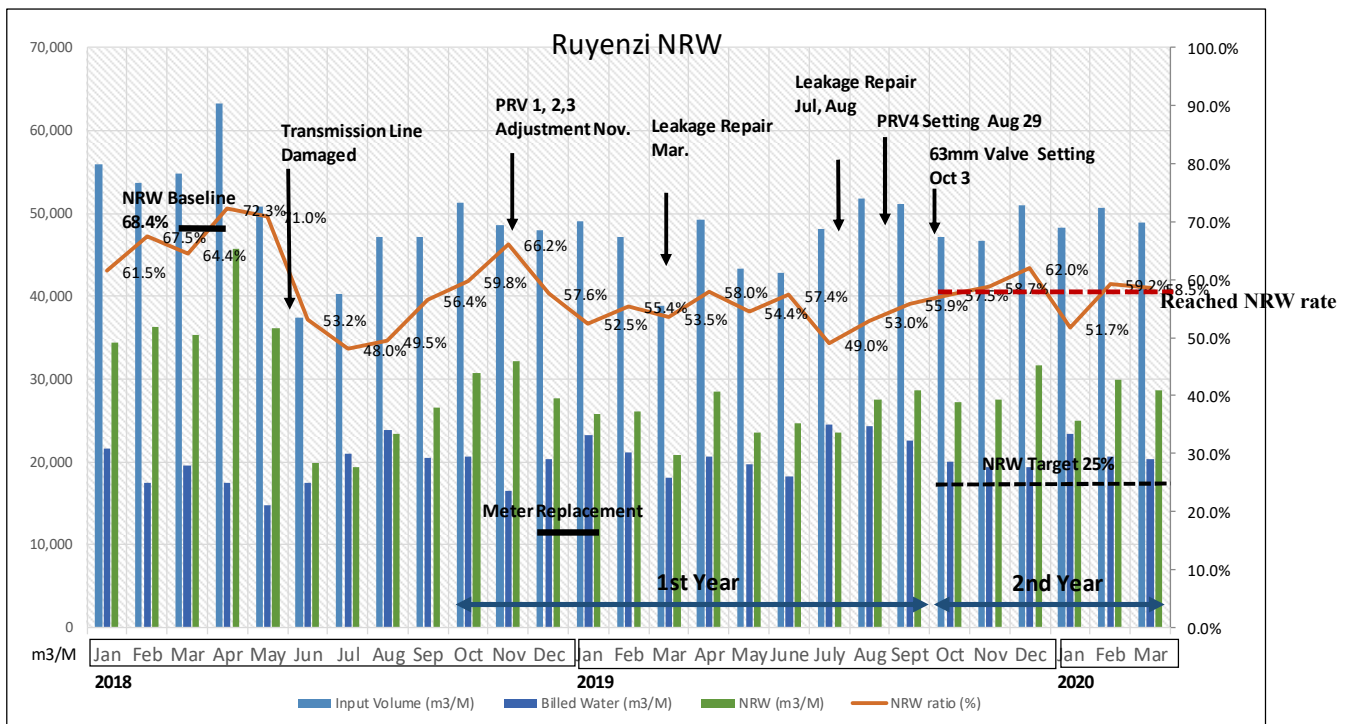
Fig. 2.22 Changes in the volume and rate of NRW in Pilot Area 2

The transition of NRW volume and NRW rate of Ruyenzi is shown below.

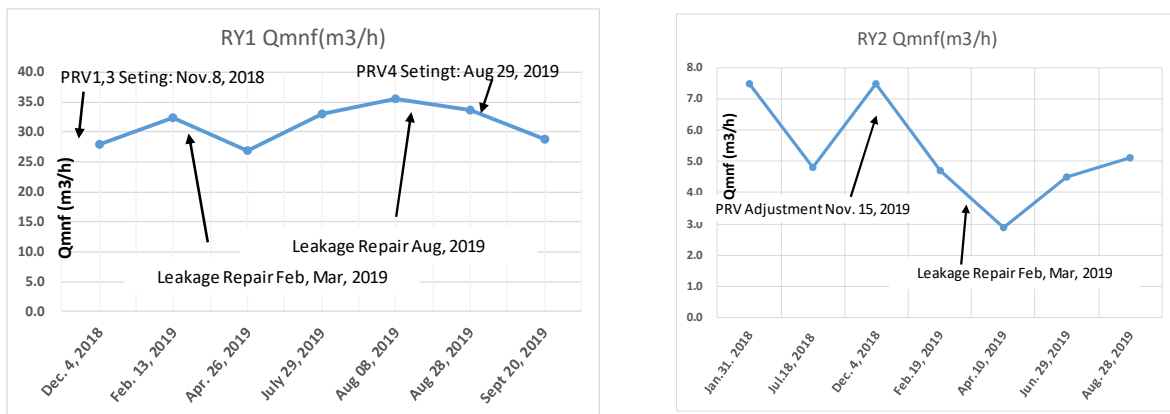
Fig. 2.25 Changes of Qmnf in Ruyenzi

The changes of Qmnf prepared based on the measurement result of table 2.59 is shown in the figure below. Qmnf decreases immediately after leak repair and PRV is installed, but Qmnf can be read that it has been restored afterwards.

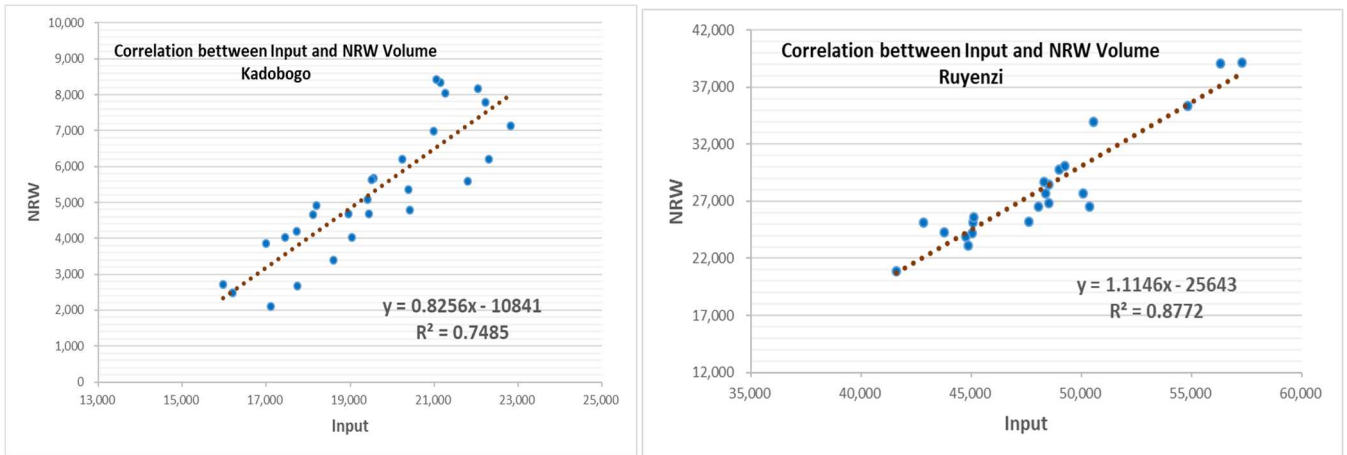
Fig. 4.1 Correlation between the volumes of distributed water and NRW in pilot area

Pilot Area	Correlation Coefficient (R <sup>2</sup> )				Remarks
	Whole	PM1	PM2	PM3	
Kadobogo					
NRW Rate%	27	22	38	29	
Input-Billed	0.12	0.63	0.23	0.06	Should be correlated. But actually low.
Input-NRW	0.75	0.64	0.96	0.88	High correlation
Billed-NRW	0.04	0.08	0.43	0.01	No correlation
Ruyenzi					
NRW Rate%	58	58	62	52	
Input-Billed	0.07	0.01	0.17	0.04	Should be correlated. But actually low.
Input-NRW	0.87	0.89	0.98	0.54	High correlation
Billed-NRW	0.34	0.18	0.29	0.27	No correlation
