Attachment 10: 5YSP Reports

5-Year Strategic Action Plan for NRW Reduction

5 Years Strategic Plan For Non-Revenue Water Reduction

WASAC Ltd

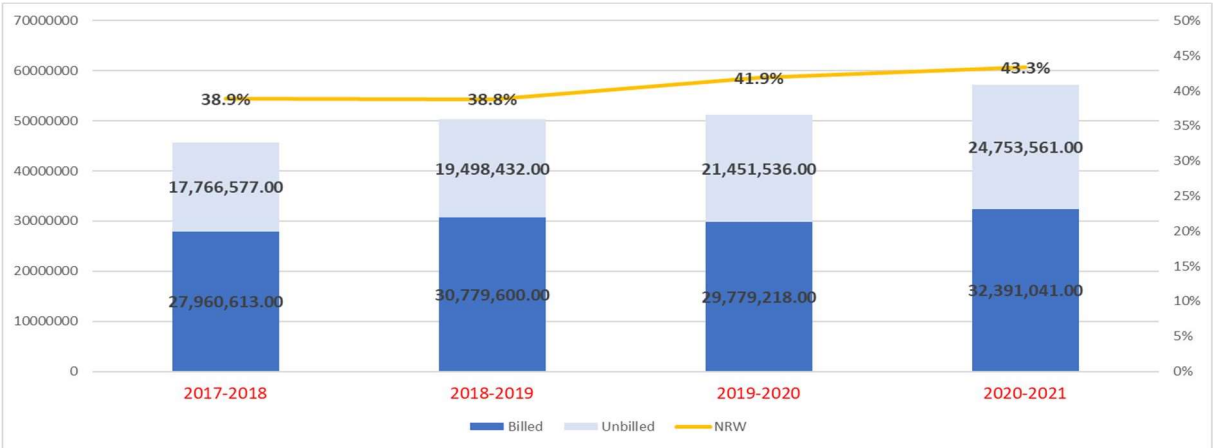
There is not yet a decrease of NRW (water loss) as expected at the beginning of the implementation of the 5YSP, the NRW rate still high and increasing compare to the set target. The two last years were more challenging mainly due the stoppage of activities to prevent the spread of Covid19 and the increase of production (mid feb2021) which brings pressure variation in the network and causes leakages in different part of the network in Kigali and satellite cities

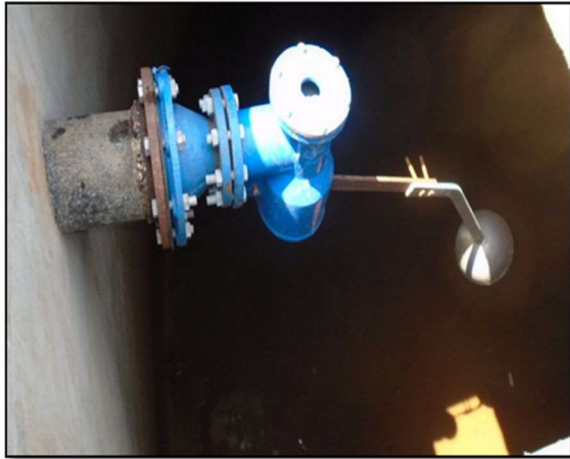
From the assessment done in WASAC water network, 49 reservoirs were found with not working floater valves, 29 floater valves were replaced to prevent any possible reservoir overflow. In this on-going fiscal year, remaining 20 not working floater valves are planned to be replaced.

Figure 3 . floater valve installed in the reservoir

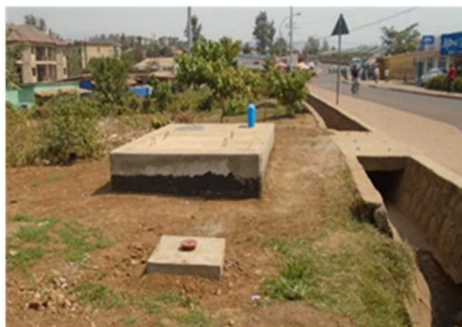
Figure 2.4.1 Drawing of water meter chamber

Water meter chamber and valve chamber

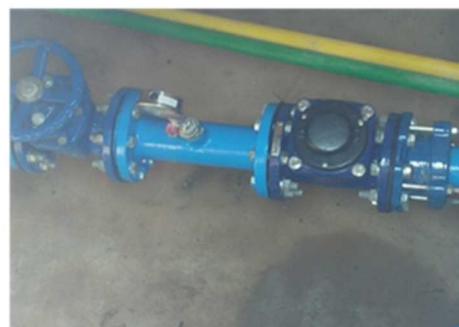
Inside of water meter chamber

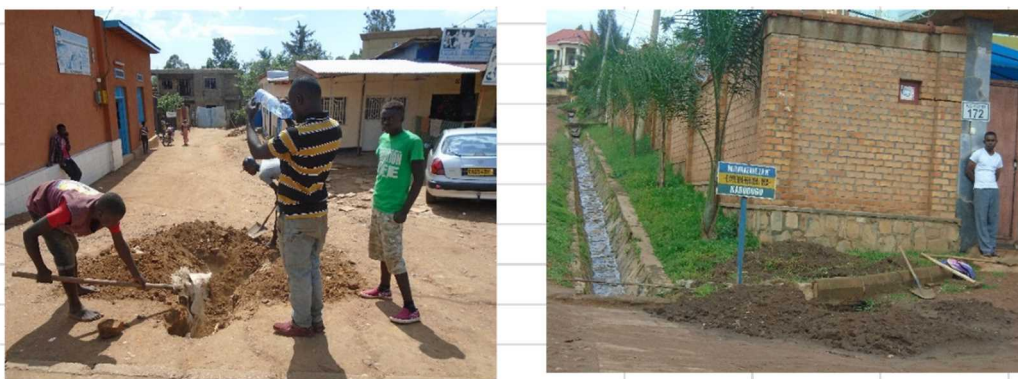
Test excavation at sites

Three teams (of three workers each) conducted new hydraulic isolation at the boundaries of the pilot area and those between the subzones of the area (PM1, PM2 and PM3) and corrected the locations of the boundaries on the drawing.

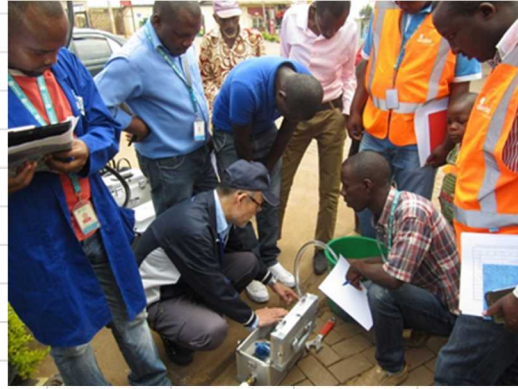
On-site training on measurement of meter accuracy

The test was conducted by two teams, each of which consisted of four members, one from the NRW Team, two from the branch office and one from JICA Expert Team. The allowable meter measurement error was set at $\pm 5\%$ in accordance with the standard of WASAC (WASAC, Ltd. Commercial Policy and Procedure Manual). It was decided that Kacyiru Branch would replace meters that did not satisfy the allowable range with the meters procured by JICA for this project. Each team measured meter errors at around 10 sites in a day.

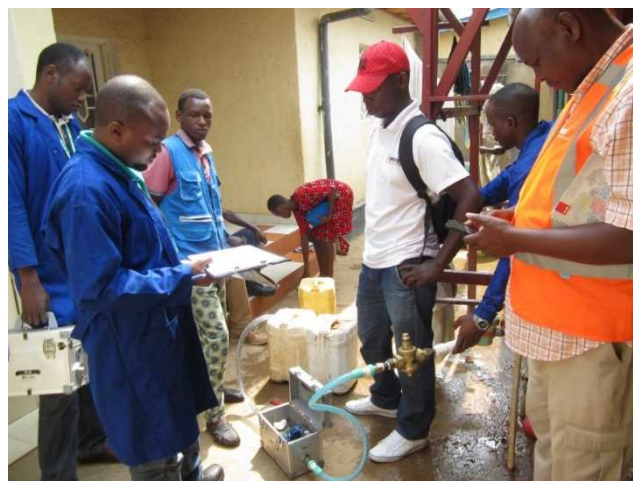
Photo 9 Measurement of meter accuracy

Measurement flow rate

In the beginning, a flow rate to be used in the test was set at 1,000 L/h, as described in the instructions of the measuring instrument. However, because this rate was too high compared with the water consumption of customers in the project area, the flow rate setting was changed. The test was conducted for one minute at a high flow rate of 800 – 1,000 L/h and for three minutes at a low flow rate of 100 – 300 L/h. The final decision on the meter replacement was supposed to be made based on the result of the accuracy test on the test bench in the laboratory of the Meter Unit of WASAC. However, as this laboratory test was found to be time-

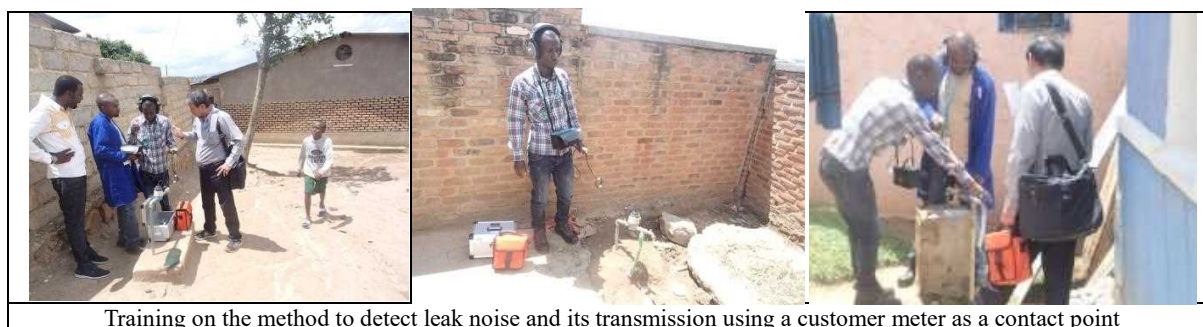
Training on the method to detect leak noise and its transmission using a customer meter as a contact point

A functional test of customer meters and leak detection were carried out at all water taps in the pilot area from August to December 2017. As meters that had not been recorded in the GIS data were found in the survey, the importance of updating GIS data was recognized.

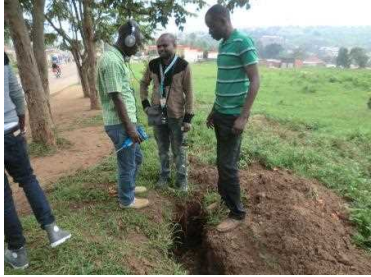
<p>Discovery a leak from a 50 mm pipe</p>	<p>Detection of leak noise with listening stick</p>	<p>Leak detection with leak detector</p>

The acoustic survey revealed 19 leaks and 10 suspected leaks on service pipes. A detailed survey of the 10 suspected leaks revealed that none of them was a leak. At a place where service pipes were installed close to each other, water consumption through one of them generates a noise similar to leak noise on other pipes.

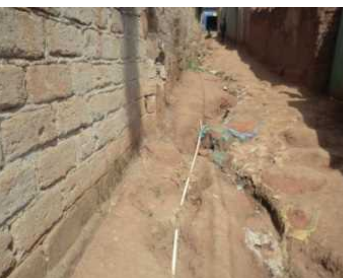
<p>Water meter with PRV</p>	<p>Surface leakage</p>	<p>Exposed service pipe</p>

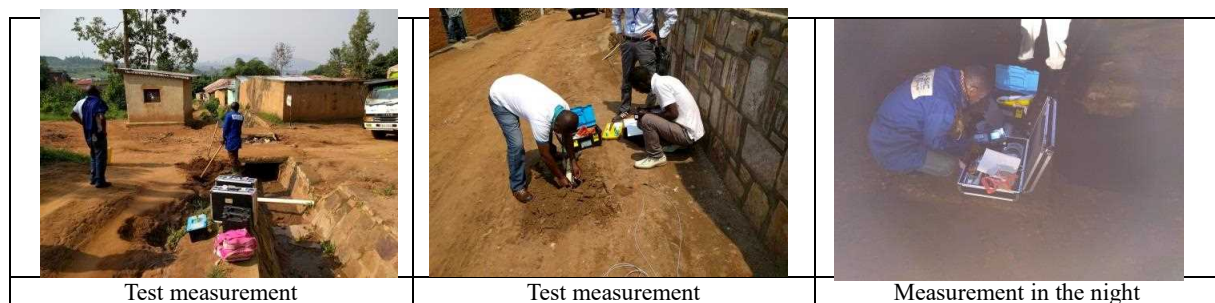
The figure below shows the volume of water leakage measured with a UFM in the daytime of 2 February. To measure the volume of the leakage directly, all the customers downstream of the measuring point were requested not to use water during the measurement of flow rate. Even though the measurement was taken in the daytime, the existence of 2,200 L/h of water leakage was confirmed.

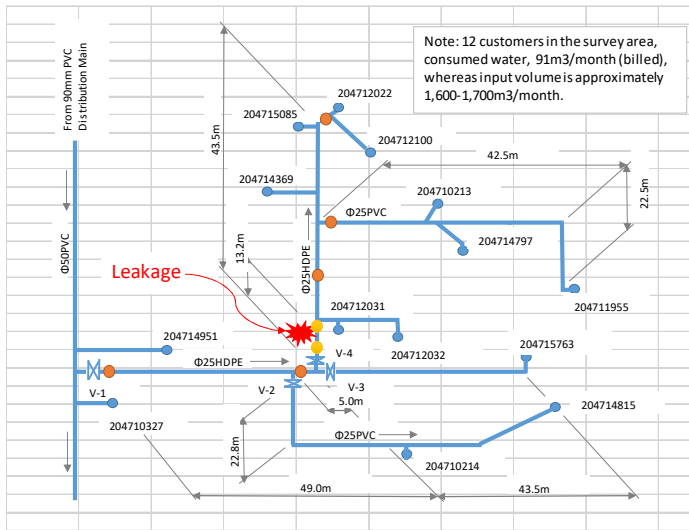
Figure 2.7.2 Schematic diagram of step test (locations of measurement with UFM)

The activities implemented in the step test and the locations of the flow rate measurement are described below (step test: a method to locate a part with large water leakage in a distribution network by installing portable UFM upstream and downstream of an inlet pipe to a survey area and measuring the flow rate while valves on the branch pipes in the section between the two UMFs are opened and closed in turns)

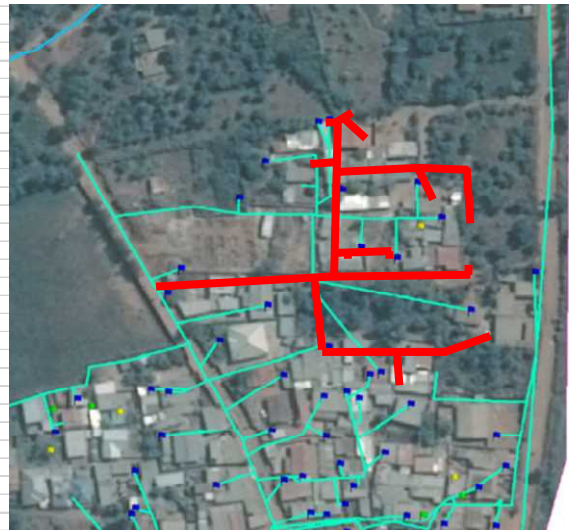
Figure 2.7.3 Pipe routes on GIS map (green) and those confirmed on site (red)

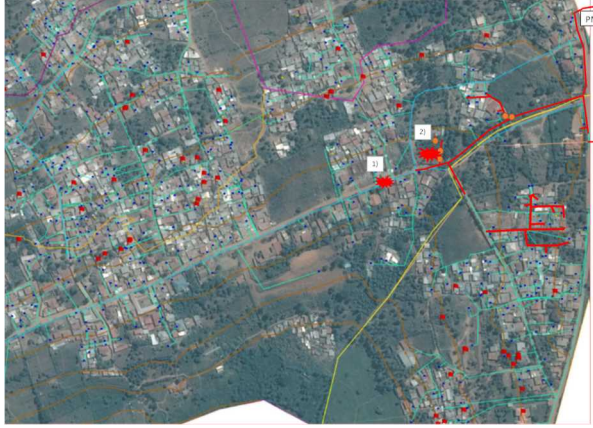
<ol style="list-style-type: none"> 1) Leak detection from 21 to 24 April 2) The leak on the left was a surface leak that on the right was an underground leak. A method to narrow down leakage sections with the installation of UFMs was used for the identification of leakage points. 3) The UFMs were installed six times to narrow down leakage sections. 4) Leak noise and conditions of ground surface and vegetation were used for identifying the likely leaking points. 5) The excavation at a likely point revealed an underground water leak (of 4,500 L/h) from a HDPE 25 mm service pipe. 6) It was confirmed that a large volume of leaked water infiltrated into the ground without emerging on the ground surface.
PM3-2

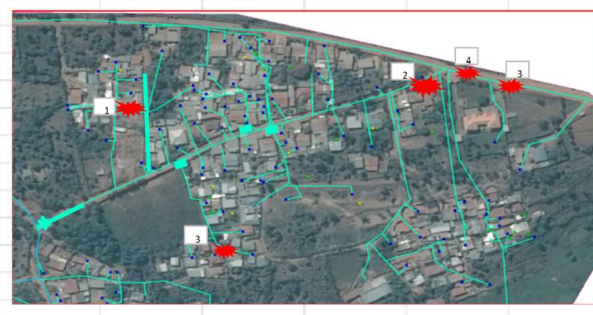
<ol style="list-style-type: none"> 1) Leak detection from 21 March to 2 April 2) Narrowing down of leakage sections with UFM measurement 3) A large-scale underground water leak (of 1,500 L/h) was discovered and repaired on 22 March. 4) A new surface leak (of 2,000 L/h) was discovered on 24 March. 5) 60 L/h and 40 L/h leaks were discovered on 25 March. 6) A 50 L/h water leak was discovered on 28 March. 7) It was confirmed that leakage repair led to creation of new leaks.

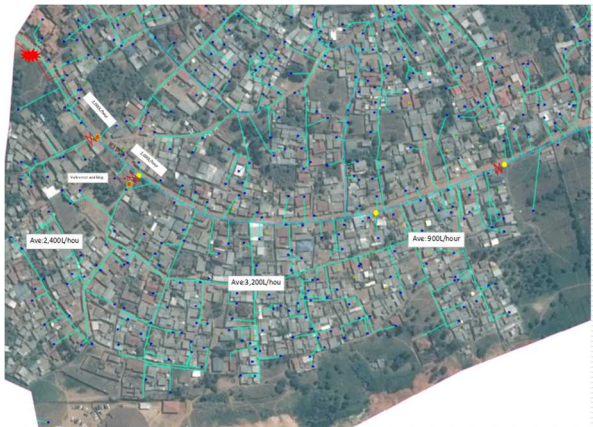
<ol style="list-style-type: none"> 8) Leak detection from 10 to 15 April 9) Identification of leaking pipes with UFM measurement 10) UFMs were installed four times at seven sites for the narrowing-down. 11) Large water flow was observed at the end of pipelines. 12) Although the location of the 20 m long section of the pipe at its end was identified, the location of the rest was not known. Therefore, it took long to excavate the pipe. 13) In the end, a 25 mm HDPE pipe buried 2.1 m below the ground level was discovered. It took two days to excavate the pipe. 14) An underground water leak of 1,800 L/h was discovered and repaired

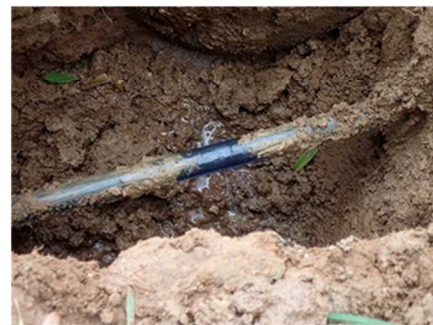
Minor water leak from a tertiary pipe

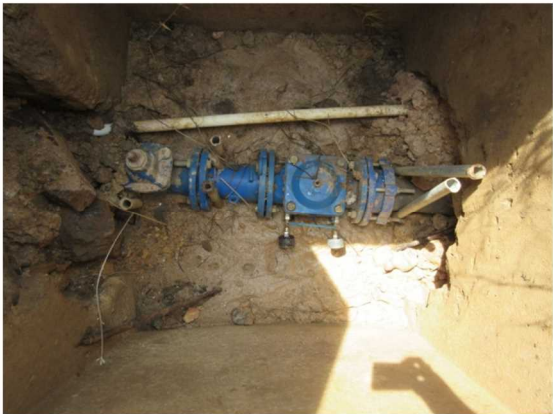
Figure 2.8.4 Typical PRV design

construct manholes. It is advisable to install a pipe that bypasses a PRVs shown in the figure below (Fig.2.8.4) not to disrupt water supply during the maintenance of the valve. However, the bypass was not installed because of the lack of fund. After the completion of the PRV installation in PM3 on 18 September, the PRV was used for reducing high pressure on the primary side to 4.0 bars on the secondary (output) side (P2) and the water distribution in PM3 with the reduced pressure began. The P2 pressure was reduced to 2.5 bars by adjusting the PRV pressure setting on 24 October.

Standard installation and composition of PRV of WASAC

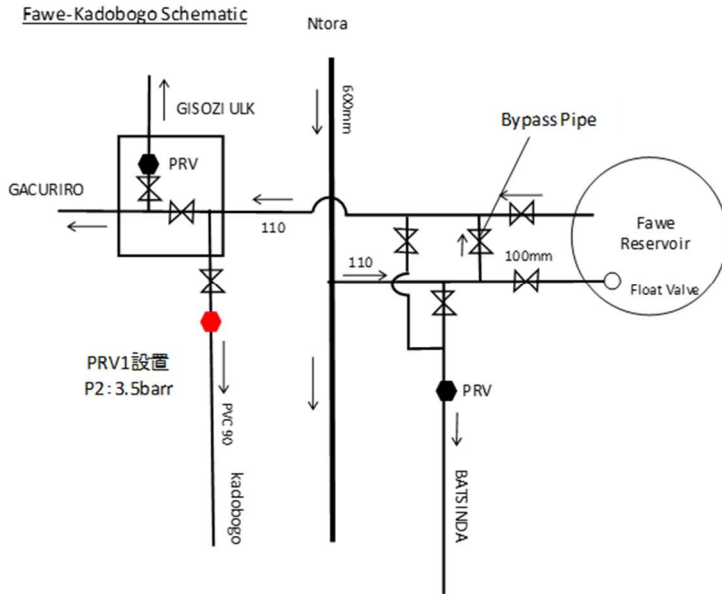
Water from Ntora is distributed to PM1 an PM2 through a pipe that bypasses the Fawe Reservoir located upstream of PM1. Therefore, the water distribution pressure at the inlet in PM1, which should be adjusted to approx. 5.5 bars, is 10 bars because the water pressure generated in the Ntora Reservoir is directly working in the inlet pipe. This high water pressure has been a cause of water leakage in PM1.

Figure 2.8.5 Water flow through and around the Fawe Reservoir

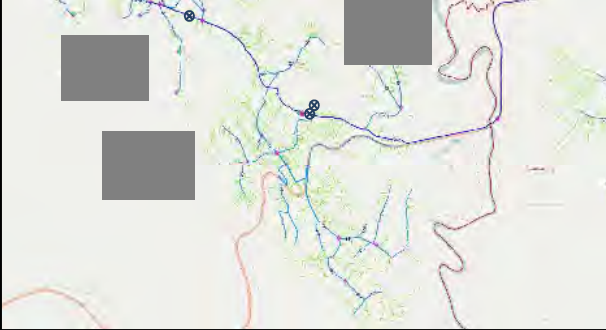
200m difference of altitude

Pressure measurement

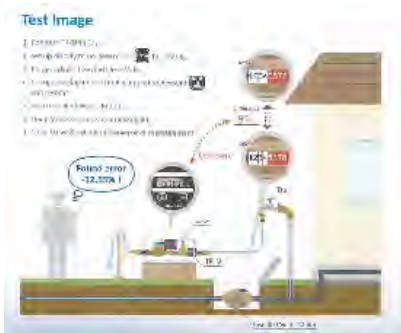
Water meter accuracy

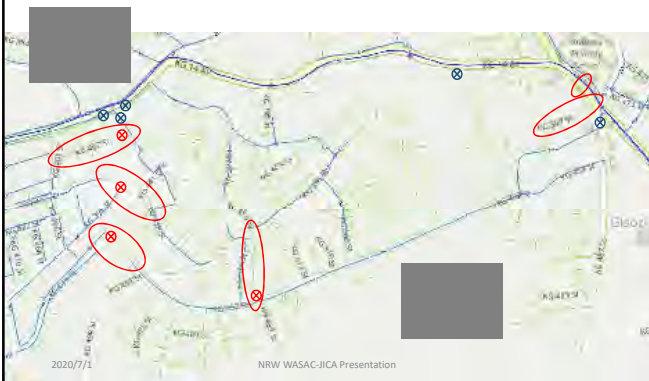
Distribution Blocks in KADOBOGO

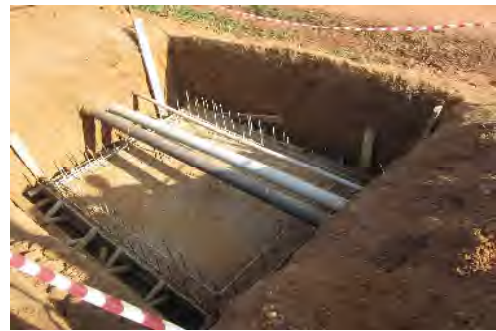
Base Concrete

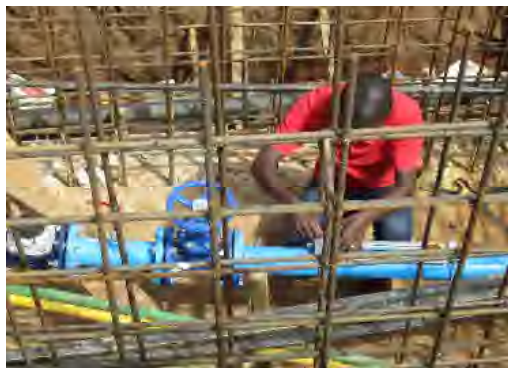
Structure of Reinforced Still.

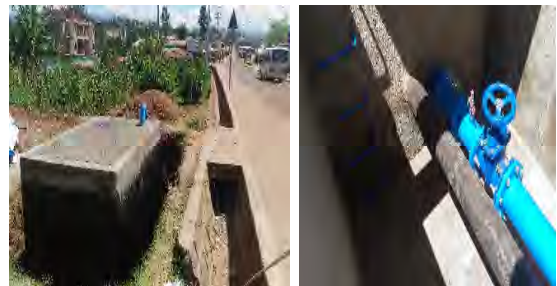
Construction of Chamber

Finished

Inside the Chamber

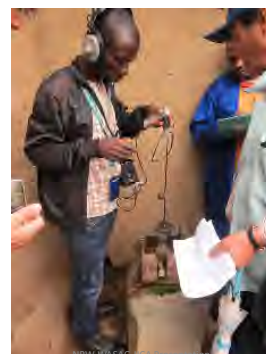
“Door to door” leak detection

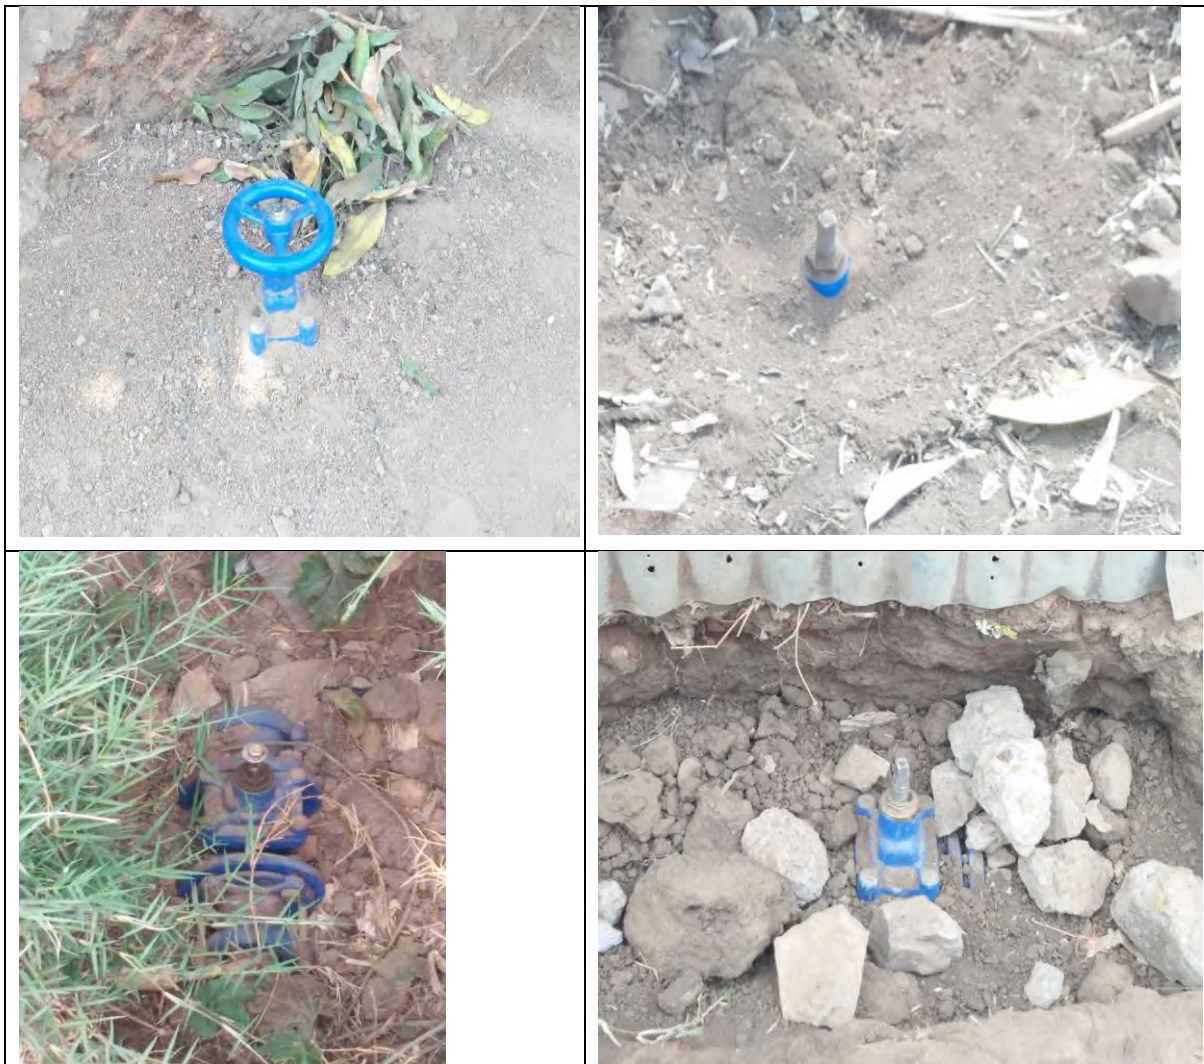
PHOTOS

The visit on 28th July 2017, we inspect six new valves installed, composed by five valves DE 65 and one valve DE 50. The last which is DE 40 will be also installed after getting the accessories (adaptors). The problem is all valves were installed are also underground. WASAC Kacyiru branch has not possibility(budget) for construction of six operating valves.

The map attached, the valve with yellow colors are installed and which is pink color not yet.

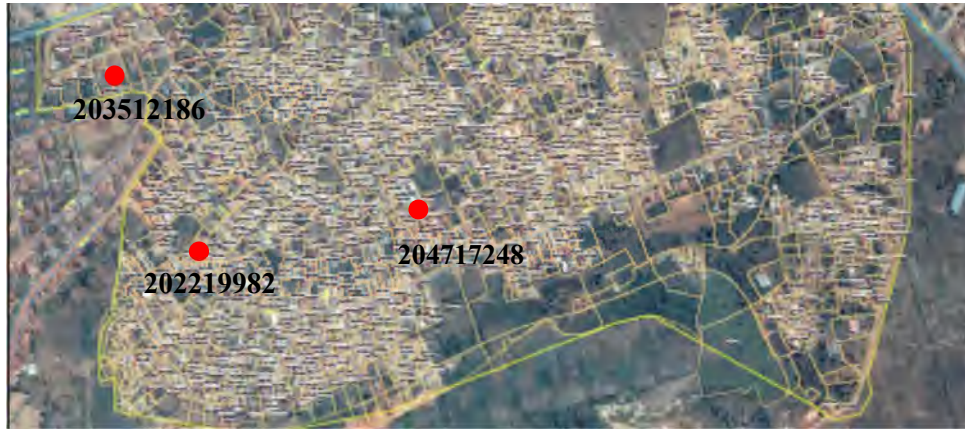
Figure-8 Locations of the surveyed households

The water consumption of three ordinary households in kadobogo Pilot Area was recorder in the survey.

The table below (Table-5) shows the monthly water consumption (m³/M) of the three households between June and December 2017

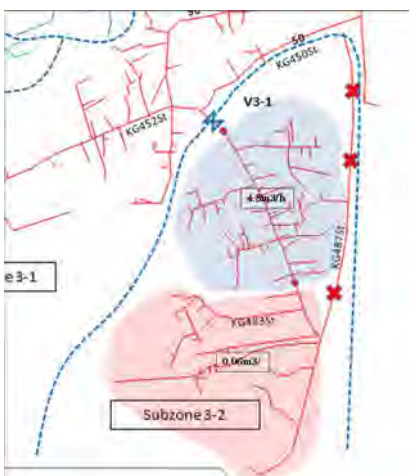
Dec. 20, 2018	Qmnf step test	Qmnf was 2.91 m ³ /h. The test revealed that Qmnf was 1.73 m ³ /h in Subzone 3-2, which indicated large water leakage in the subzone.
Jan. 28-29, 2019	Qmnf measurement	Qmnf was 4.71 m ³ /h.
Feb. 5-6, 2019	Qmnf step test	Qmnf was 3.53 m ³ /h. After the pressure had been adjusted with the PRV, no increase in the water leakage was observed as the values of Qmnf measured on November 27, 2018, December 20, 2018 and January 5-6, 2019 were 3.32 m ³ /h, 2.91 m ³ /h and 3.53 m ³ /h, respectively.

Map showing the result of the Qmfm measurement in sub-subzones of PM3-2

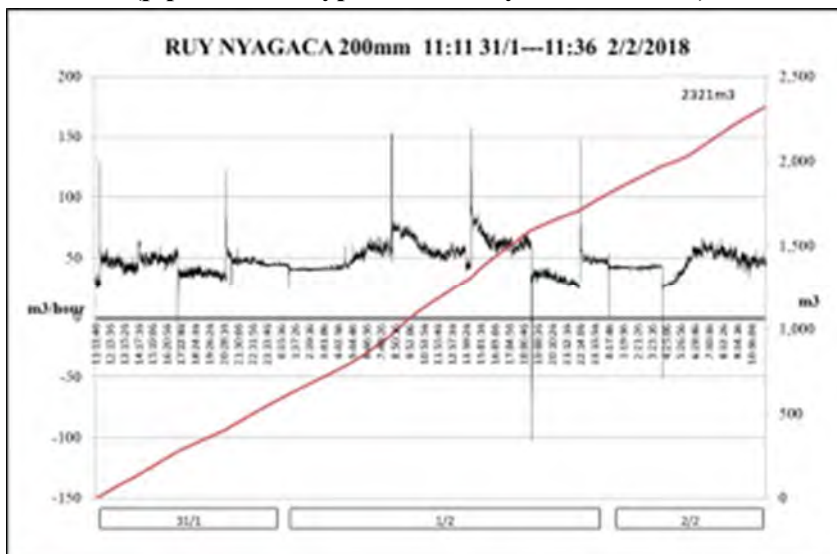
2. RY1 (pipeline that bypasses the Ruyenzi Reservoir)

Result of the QmNF measurement in RY1 (December 3-4)

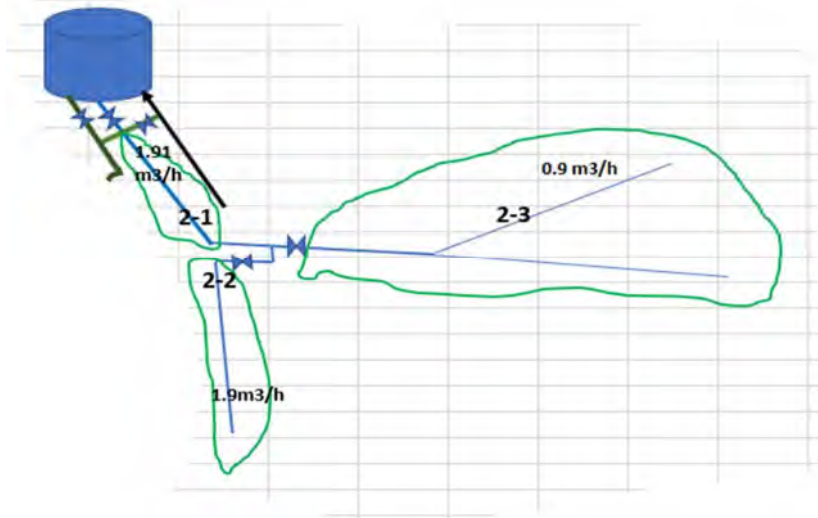
Result of the Qmnf measurement in RY2 (Gravity line) (December 3-4)

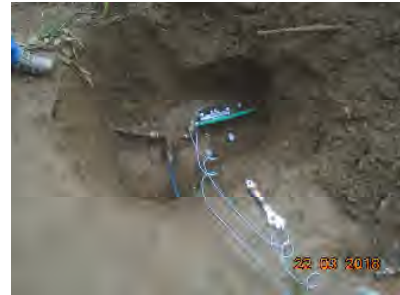
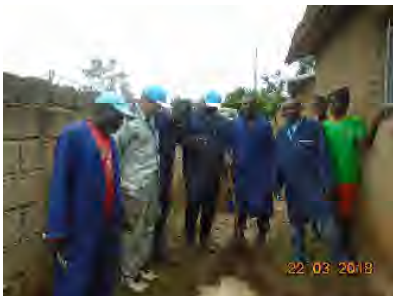
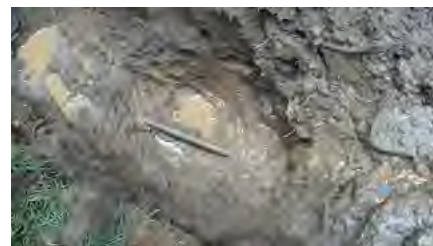
RESULTS OF LEAKAGE FOUND

- AVERAGE IN FLOW(UFM2):1972,379 L/h
- AVERAGE LEAKAGE FLOW:1911,902 L/h
- AVERAGE OUT LET FLOW(UFM3):60,47654L/h

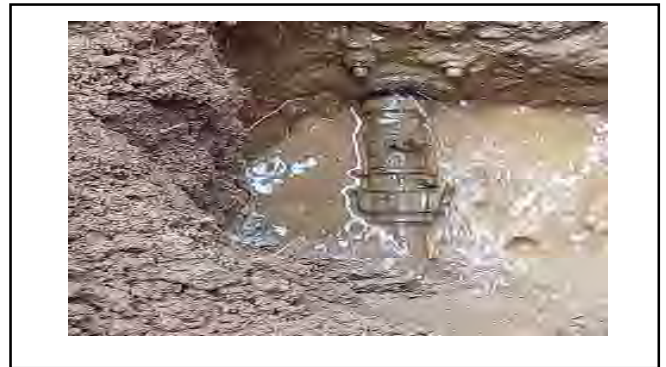
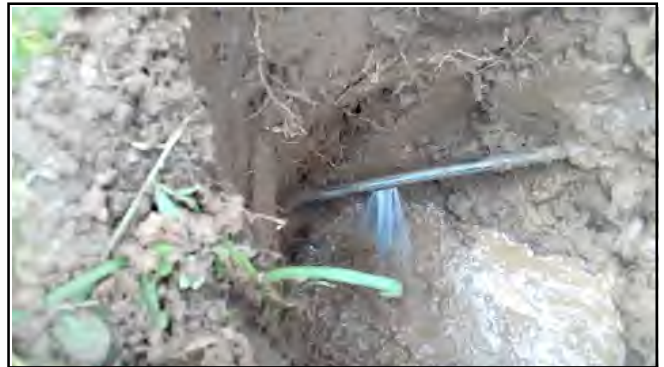
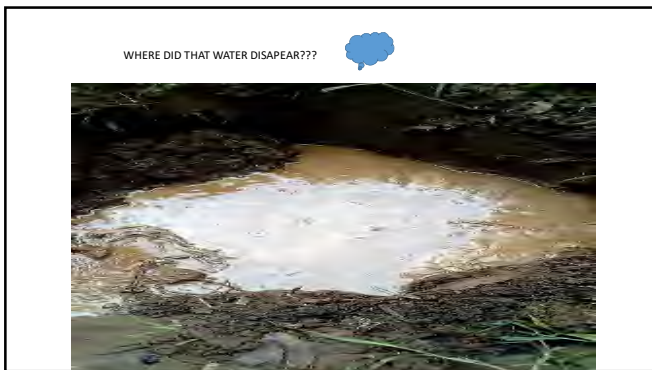
Leakage volume in rugende swamp

loss in 26 min	4.66m ³
per hour(m ³)	10.77m ³
per day(m ³)	258.55m ³
per month (m ³)	7756.573 m ³

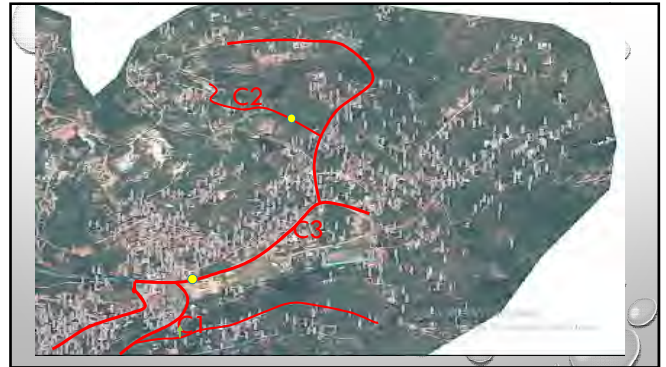
PRESSURE SURVEY

3 DAY PRESSURE SURVEY ON CUSTOMER 1 (26-28/06/2018)

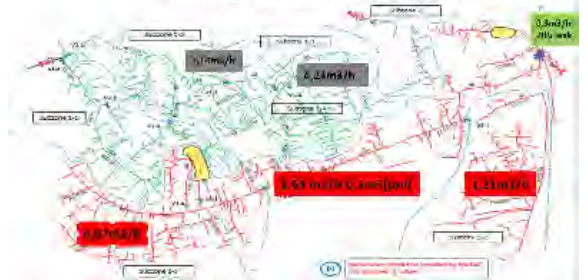
RY 1 STEP TEST

STEP TEST RESULT FOR BY-PASS RUYENZI DN 200 & RWAMUSHUMBA OUTLET PIPE DN 160 13/02/2019

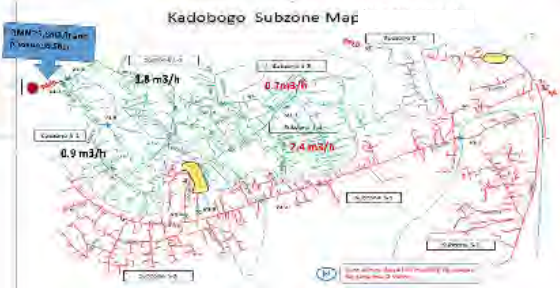
PM1 STEP TEST 26/03/2019(AFTER PIPE REPLACEMENT)

EFFECT OF PIPE REPLACEMENT IN PM1 (SUB-ZONE 1-4 & 1-3)

Date	sub zone 1-3	sub zone 1-4
20/07/2018	0,1	4,4
29/05/2018	1,1	0
05/07/2019	1,10	4,24
25/03/2019	0,7	2,4
