**CHAPTER 4 CURRENT SITUATION AND  
CHALLENGES OF THE  
TEGUCIGALPA EXECUTING  
AGENCY**

## **Chapter 4 Current Situation and Challenges of Tegucigalpa Executing Agency**

### 5-3-1 Tracer Gas Leak Detector

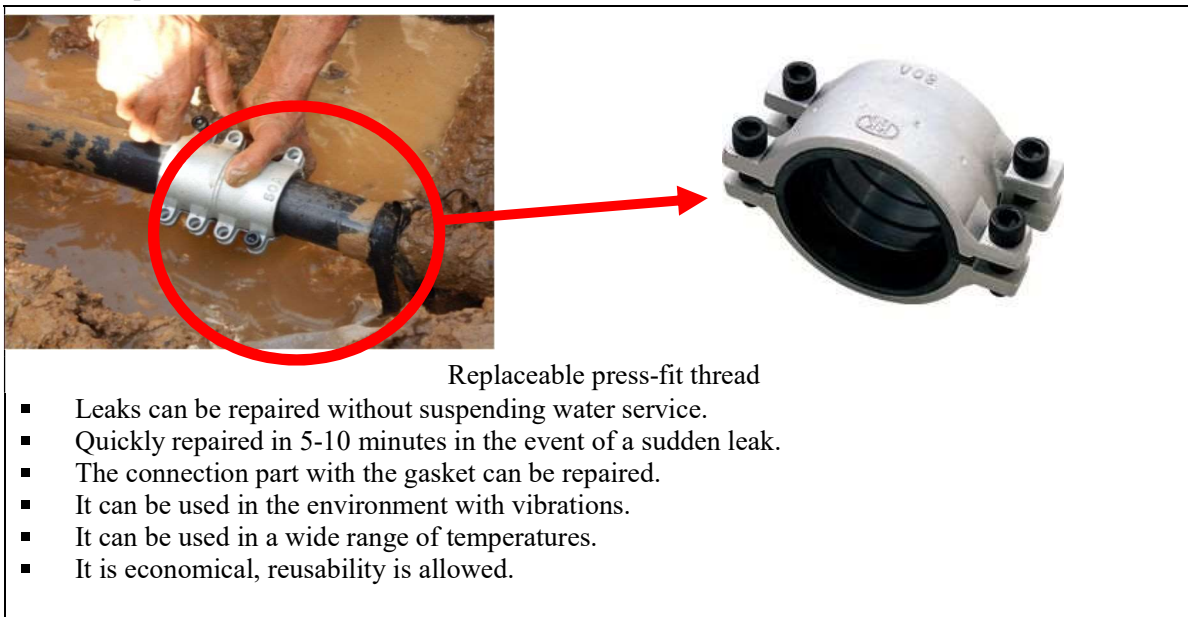
Figure 5-3-2 Repairing Leaks with Pressure Clamp

Both inside and outside Japan, more than 90% of EPS water leaks from distribution pipes and house connections are leaks from house connections, and many leaks are from the connection part of the pipe (thread, joint part). For this reason, it is important to repair water leaks at the connection point of the house connections. In the demonstration, it was proposed to use Japanese technologies also in the repair equipment to quickly repair localized leaks. It was proposed also to use the pipe repair clamp (pressurized thread) to repair the leaks in the distribution pipes, which is the temporary leak repair method, and to use the repair tape (rubber waterproof adhesive tape) to repair the leaks at the connection point of the house connections and at the branch collar.

2)	Pressure clamp	<ul style="list-style-type: none"> <li>Used to repair leaks in the connection part and straight line part of distribution pipelines.</li> </ul>	10	Japan

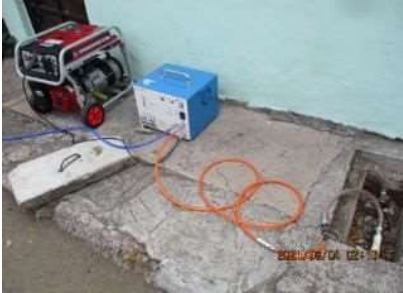
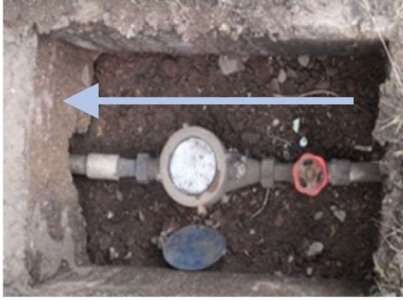
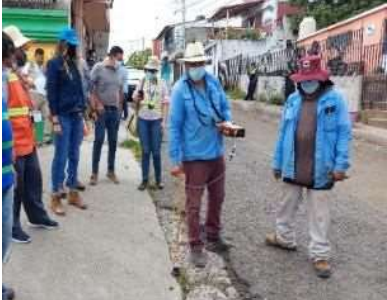
Figure 5-5-1 Conceptual Scheme of Water Leak Detection with Gas

The procedure is as follows. First, the valve from the primary pipe to the secondary pipe is closed (Conceptual diagram ①). Second, all valves from the secondary pipe to the house connections just before the water meter are closed (Conceptual drawing ②). The water meter in the isolated section is removed and the gas is injected from the plug side (Conceptual drawing ③). After confirming that gas was injected, gas detection is performed at the top of the secondary pipeline (Conceptual drawing ④).

<p>Procedure</p> <p>① Close the valve from the primary pipe to the secondary pipe.</p> <p>② Close the valves from the secondary pipe to the house connections just before the water meter (all valves in the block).</p> <p>③ Gas is injected from the water meter (about 30 minutes in case of a <math>\phi 50</math> mm pipe with a total length of 500m).</p> <p>④ Gas detection is performed at the part of the water meter joint located at the end of the gas injection point and it is confirmed that gas was filled into the house connections.</p> <p>⑤ Gas detection is initiated at the top of the secondary piping.</p>	
① Valve (from primary pipeline to secondary pipeline)	② Gas injection (from water meter connection)

③ Water meter	④ Leak Detection

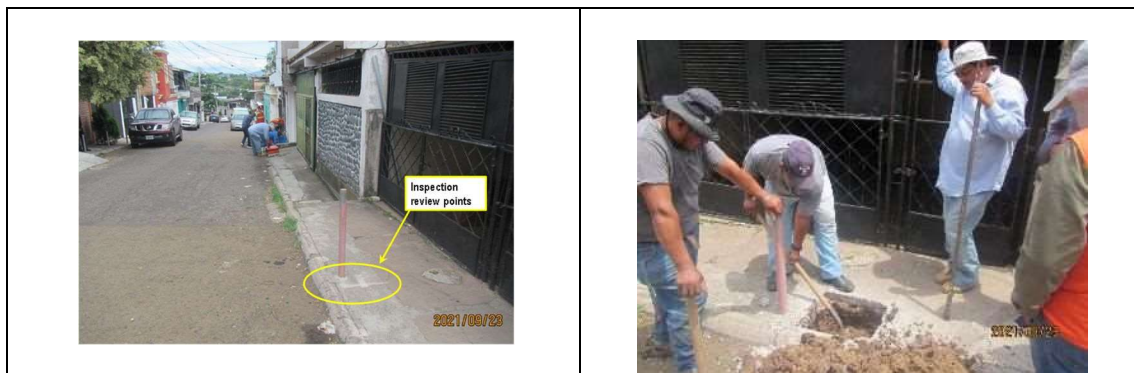
Figure 5-5-4 Exploratory Excavation Survey

Subsequently, on September 23, gas injection was again performed to locate the leaks at the points in Blocks A and B where gas concentrations of more than 2.0 ppm were recorded in the detection of water leaks by tracer gas. However, gas was not detected at the point where a gas concentration of 2.0-10.0 ppm was recorded in Block A and at the point with a concentration of more than 20.0 ppm in Block B. Given this result, an exploratory excavation was performed at the suspected leak site in Block A. The exploratory excavation images are shown in Figure 5-5-4. However, the leak was unsuccessful after the excavation and subsequent opening of the distribution tank valve for 30 minutes. After examining the cause, it was found that the location of the gas detection was in the vicinity of the generator, so the gas could have been caused by the effect of temporary wind-driven exhaust gases.

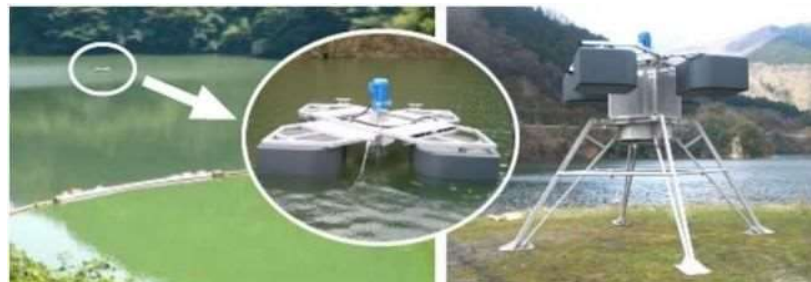
<p>③ Photos of NEOLOOP</p>

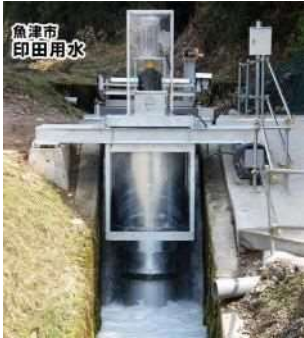
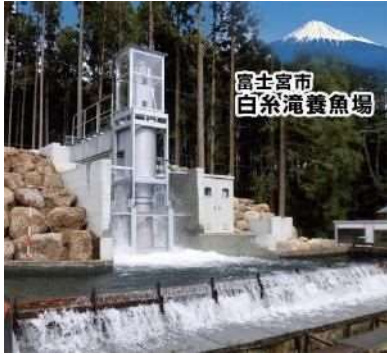
No.	Contents
	<p>Picacho Drinking Water Treatment Plant. This micro plant presented in the seminar allows to generate electric energy with little difference in height, so it could be installed in the aeration point of the three existing water treatment plants.</p> <p>(1) Characteristics</p> <ul style="list-style-type: none"> <li>• High generation efficiency with little head difference (less than 5 m) and low flow rate.</li> <li>• Allows the generating device to be installed directly in the water channel.</li> <li>• Easy installation of the device.</li> <li>• Easy maintenance.</li> </ul> <p>(2) Product name: Power Archimedes (HOKURIKU SEIKI CO., LTD.)</p> <p>Specifications</p> <ul style="list-style-type: none"> <li>• <math>Q=0.95 \text{ m}^3/\text{s}</math>, <math>H=3.5 \text{ m}</math>, 20kW</li> <li>• <math>Q=0.85 \text{ m}^3/\text{s}</math>, <math>H=2 \text{ m}</math>, 10kW</li> </ul> <div style="display: flex; justify-content: space-around; align-items: center;"> <div style="text-align: center;">

4	<p><b>Micro hydropower plant</b></p> <p>The micro hydroelectric plant presented in this seminar is another type of existing micro hydroelectric plants built through the Grant Aid of Japan in the pipeline of the La Concepción Drinking Water Treatment Plant and in the transmission pipeline of the El</p>

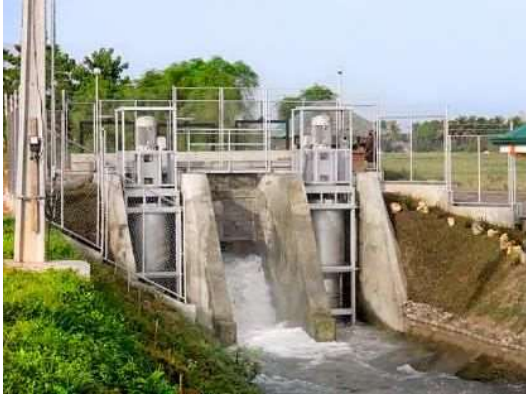
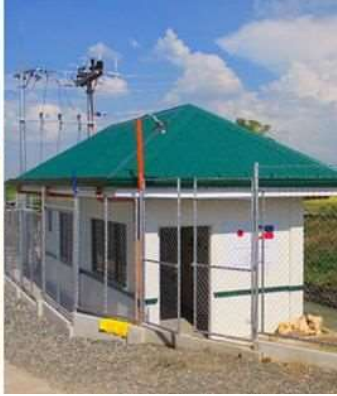
<p>富士宮市 白糸滝養魚場</p> </div> </div> <p>[Results from projects] obtained JICA</p> <ul style="list-style-type: none"> <li>• 2013 Micro hydropower plant plan in the Republic of the Philippines (micro hydropower plant plan in Ifugao province).</li> </ul> <p>Specifications: <math>Q=5 \text{ m}^3/\text{s}</math>, <math>H=3.0 \text{ m}</math>, 50 kW</p> <div style="display: flex; justify-content: space-around;">

Especificaciones	Caudal: 5 m <sup>3</sup> /sec Caída: 3.0m Potencia: 50kW ( 25kW x 2 )
Foto

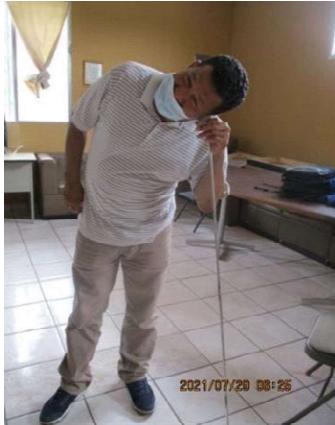
Varilla acústica

Para confirmar fuga de agua, confirmar sonido de fuga.

Generalmente, se utiliza Varilla acústica.

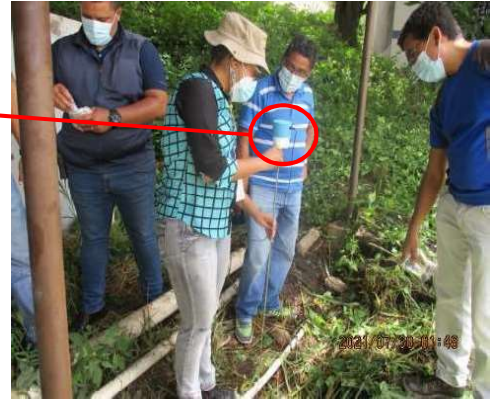
Varilla acústica con KIKUZO

Generalmente, se necesita larga experiencia para detectar sonido de fuga de agua

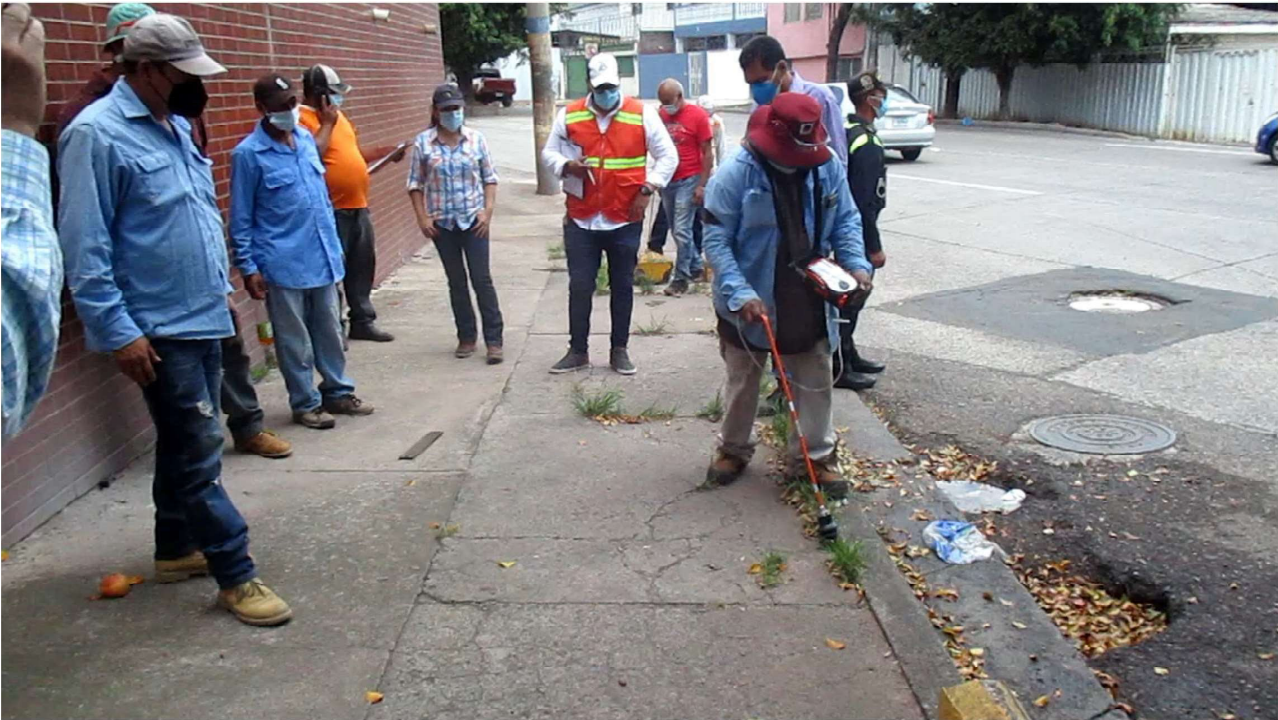
El pavimento de hormigón dificulta el paso de los gases, por lo que hay que explorar.

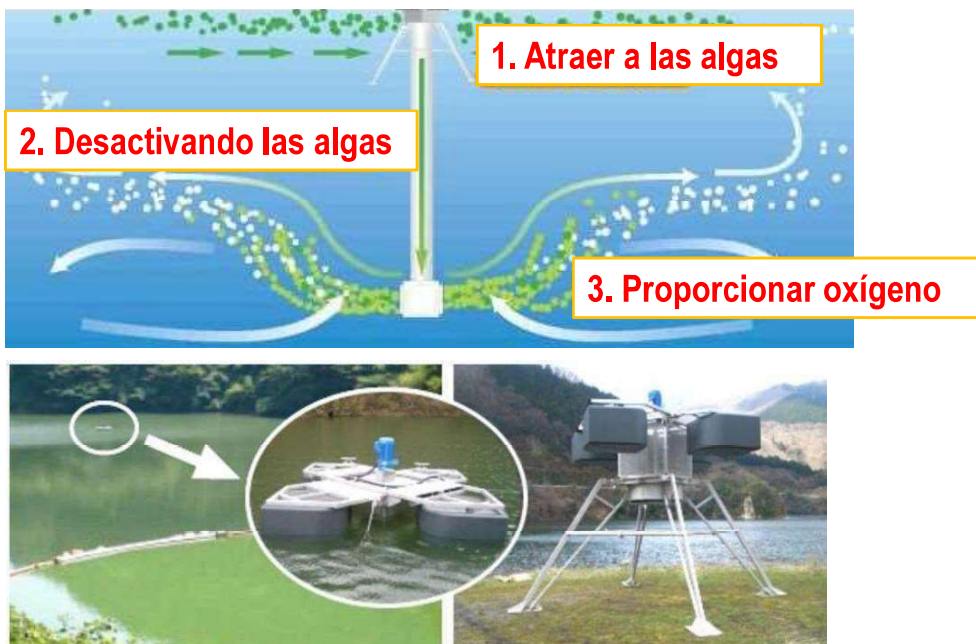
- Enviando el agua de la superficie a la capa inferior y **desactivando las algas** en la superficie.
- El oxígeno de la superficie se envía a la capa inferior y **por medio de aireación**, lo que reduce la producción del fósforo, el hierro y el manganeso del lodo del fondo y de sulfuro de hidrógeno.

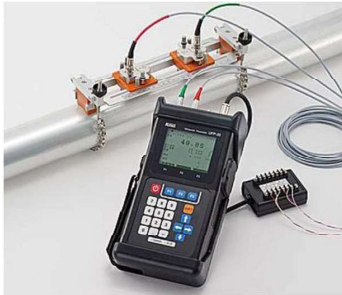
Nombre de producto	Caudalímetro ultrasónico fijo	Caudalímetro ultrasónico portátil	Medidores de nivel por radiofrecuencia
Foto

Especificación	DN 25mm -6000mm Precisión $\pm 1.0\%$	DN 65- 500mm Precisión $\pm 1.0-2.0\%$	Altura máxima : 30m

En este estudio, estamos utilizando un caudalímetro ultrasónico para realizar una auditoría energética de la bomba. El caudalímetro ultrasónico se entregara a UGASAM, y le daremos instrucciones y manuales sobre cómo medir.
