PREPARATORY SURVEY  
ON  
PROGRAMME FOR  
URGENT REHABILITATION  
OF  
FLOOD DAMAGED INFRASTRUCTURE  
IN  
TIMOR-LESTE

Final Report

JAPAN INTERNATIONAL COOPERATION AGENCY  
(JICA)

Comoro River Revetment, Bemos Water Supply Facilities

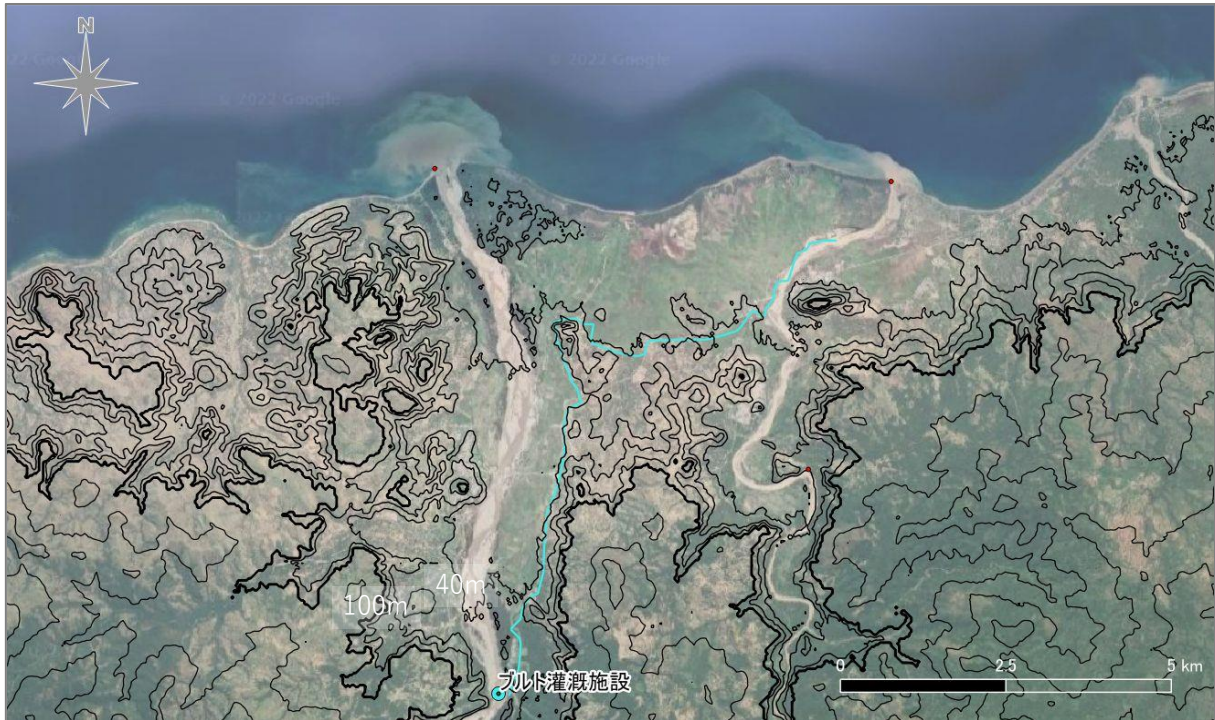
Figure 1-2-8 Topographic Features near the Buluto Irrigation Area

The Buluto irrigation facility is located on the right bank near the mouth of the Laleia River, on a gently sloping area with an elevation of less than 100 m.

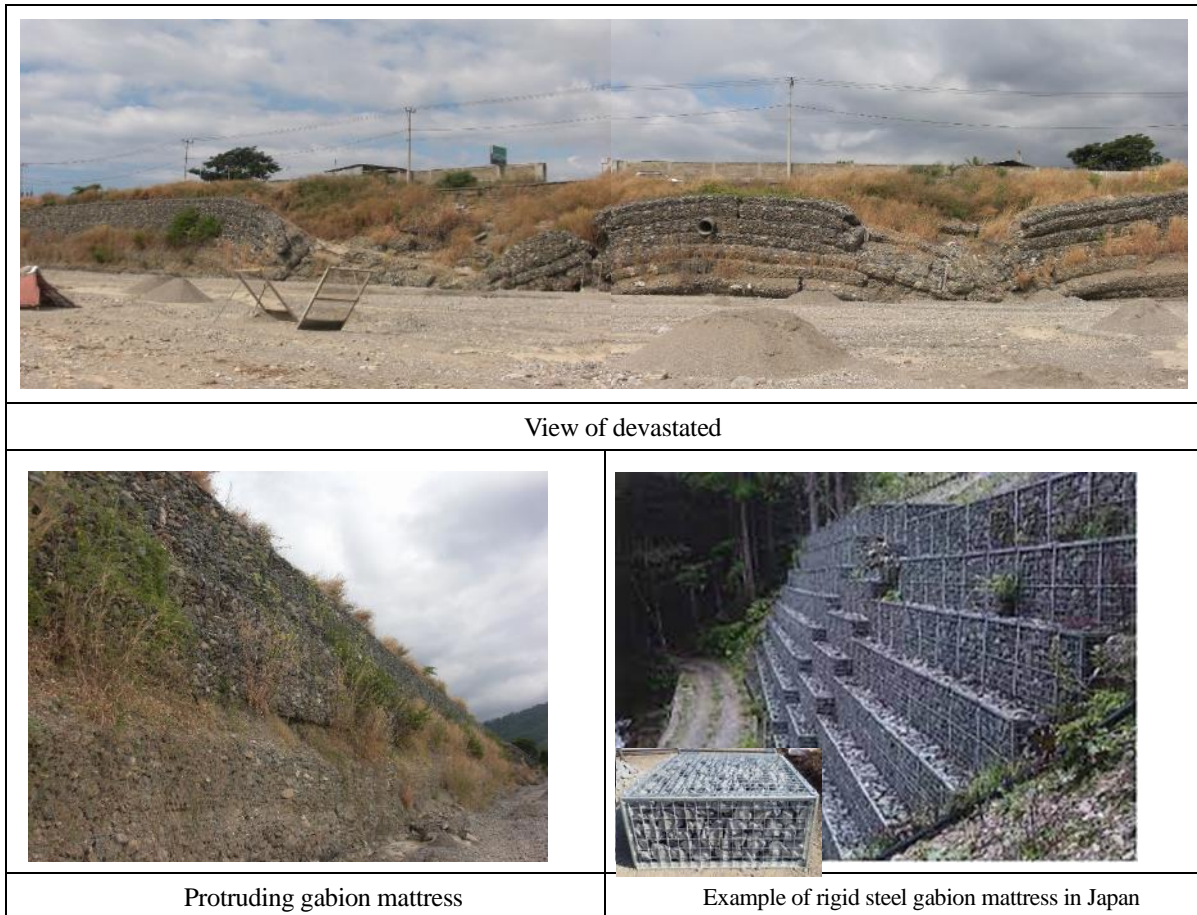
Figure 2-2-1 Situation of damaged R5 revetment

Instability of the revetment on R5 due to the installation of 11 mattress baskets to an excessive height of about 10 m was a contributing factor to the damage to the structure. In sections other than the recently damaged gabion mattress, protruding mattress baskets were observed, which were due to loosening of the deteriorated steel wires, and there is a risk of collapse. In Japan, rigid steel gabion mattress are used for installations of gabion mattress on revetments like R5.

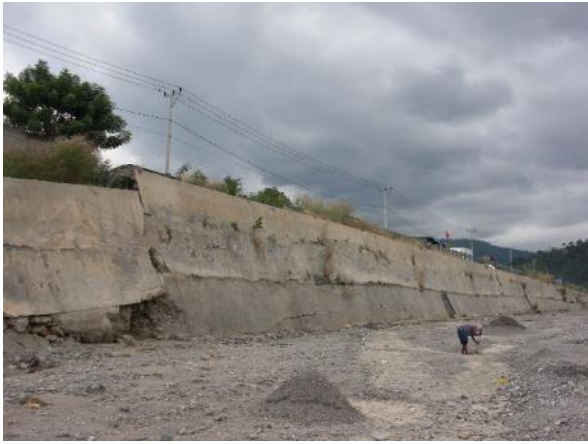
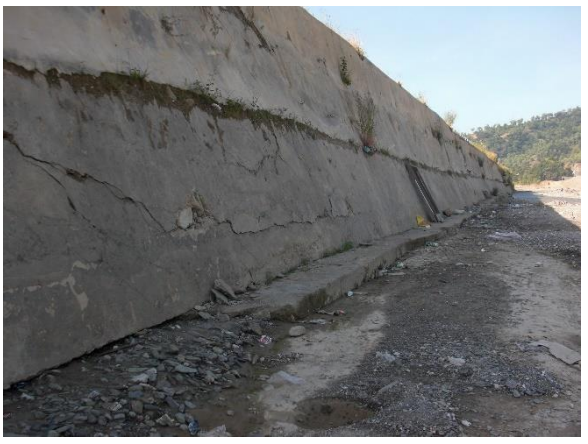
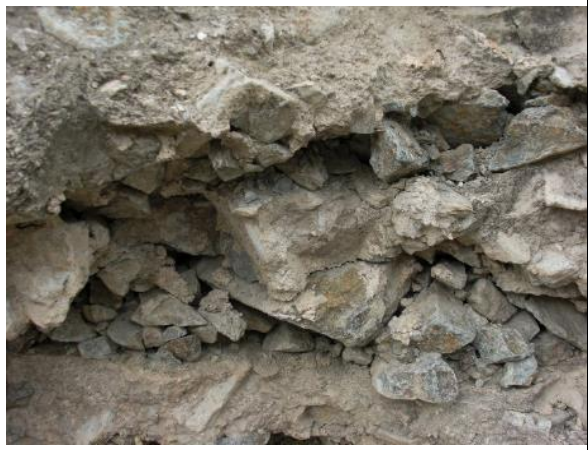
Figure 2-2-2 Situation of damaged R5 revetment

<p>Cracks caused by mortar on surface of retaining wall</p>	<p>Cracks caused by mortar on surface of retaining wall</p>

<p>Separation of cobble and concrete (poor concrete quality)</p>	<p>Separation of cobble and concrete (poor concrete quality)</p>

The existing revetment on R6 is a gravity retaining wall made of crushed stone and concrete. The height of the retaining wall was estimated to be approximately 6 m. Gravity retaining walls with a height of 6 m are not included in the Japanese standard collection of drawings, and the existing revetment is structurally unstable. Furthermore, the cobbles are not bonded to each other by the concrete, as shown in Figure 3.2, which further contributes to the instability of the retaining wall. The reason for the aggregates not being bound by the cement was judged to be that head-sized aggregates were put into the fresh concrete and that the cement did not fill the gaps between the aggregates, as shown in Figure 3.3. It was concluded that the cause of the damage to the revetment was due to the instability of the structure and problems with the construction of the retaining wall.

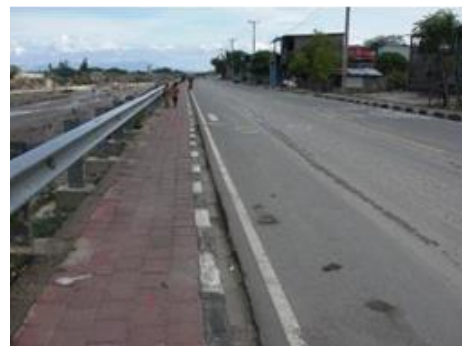
Figure 2-2-5 Existing road conditions

The existing roads shall be rehabilitated to their original condition and, as the road is partially collapsed, the specifications shall be equivalent to those of the existing road. The road pavement shall be asphalt concrete, the footpath pavement shall be interlocking blocks and guardrails shall be installed along the riverside.

- The following is the pavement configuration provided by the DRBFC.
- Surface course: 4 cm

- Binder course: 6 cm
  - Base course: 25 cm
- Subbase course: 35 cm

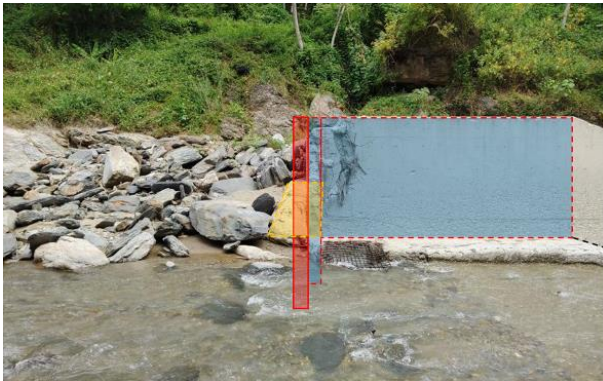
Figure 2-2-8 Rehabilitation Plan from No.1 to No.4

- No.1 : Partial removal and reconstruction of front wall of the intake facilities  
 No.2 : Partial removal of gravity retaining wall  
 No.3 : Reinforcement of the front wall of the intake facilities  
 (installation of reinforced concrete wall)  
 No.4 : Partial removal and reconstruction of side wall of the intake facilities (river side)

The damaged intake walls (front wall: No.1, side wall: No.4) will be reconstructed. Each walls were severely damaged by repeated rock impacts and will be protected from direct impacts by installing a reinforced concrete wall (No.3). The existing gravity retaining wall (No.2) will be partially removed in order to install the wall No.3.

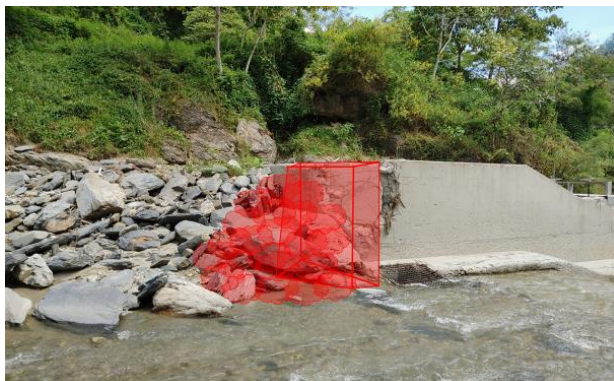
- No.5 : Protection in front of the No.3 Reinforced concrete wall (Casting plain concrete)  
 No.6 : Placement of boulders

Protective concrete (No.5) is placed in front of the protection wall (No.3). It is presumed that the protective concrete will be damaged and gradually destroyed by long-term operation. In order to keep this protective concrete as long as possible, boulders in the river are piled up around it to reduce direct damage (No.6).

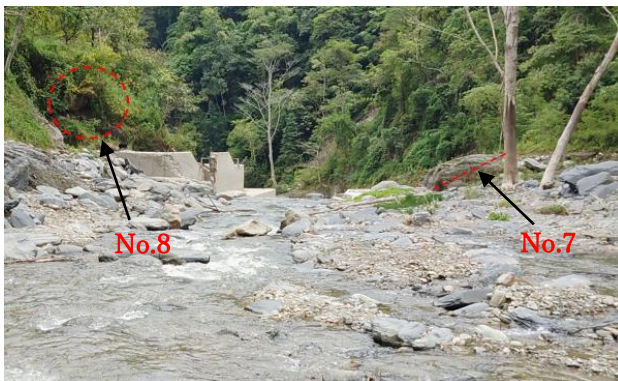
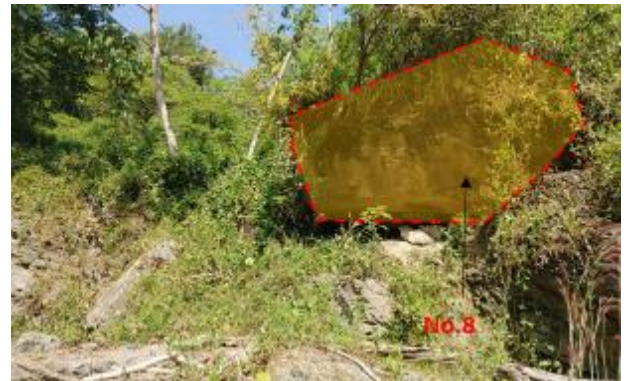
Figure 2-2-10 Rehabilitation Plan from No.7 to No.8

No.7 : Cutting a rock on the Right bank  
No.8 : Cutting a rock on the upper Left bank

Cutting a rock on the right bank revetment (No.7) to secure a wider cross-section for water passage. In addition, there is an unstable rocks (No.8) above the left bank of intake facilities. The rock will be cut to prevent them from falling into the intake facilities due to collision with the flowing rocks and boulders during flooding.

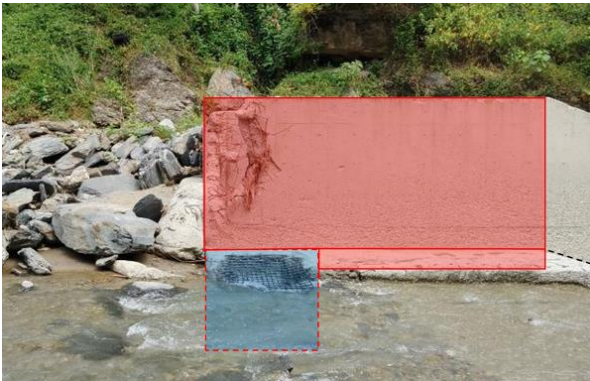
No.10 : Reinforcement of the Inlet and surrounding area (casting plain concrete)

Reconstruction will be implemented for the damaged inlet (No.9). The temporary screen currently in place will be removed.

Protection wall made of plain concrete (No.10) will be installed over the inlet and surrounding area to protect the inlet (No.9) and side wall (No.4) from rocks and boulders flowing in the river.

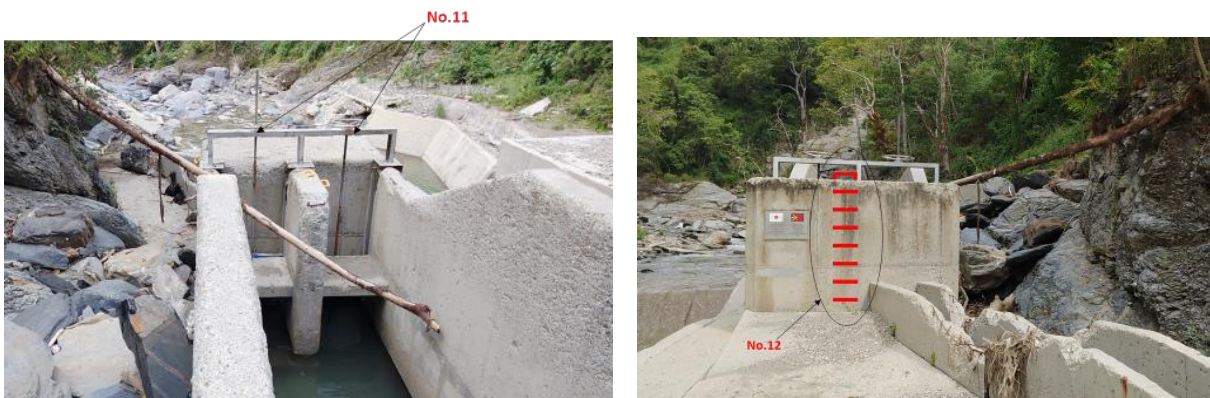
Figure 2-2-12 Rehabilitation Plan from No.11 to No.12

No.12 : Installation of Steps

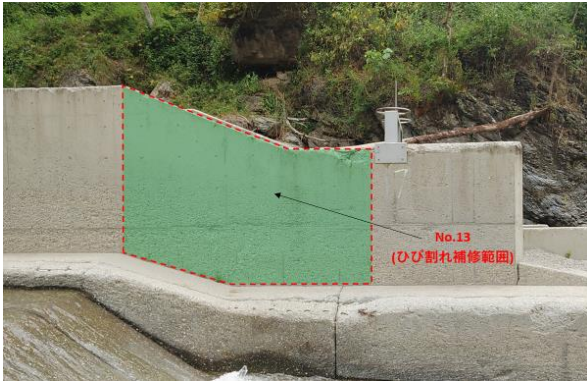
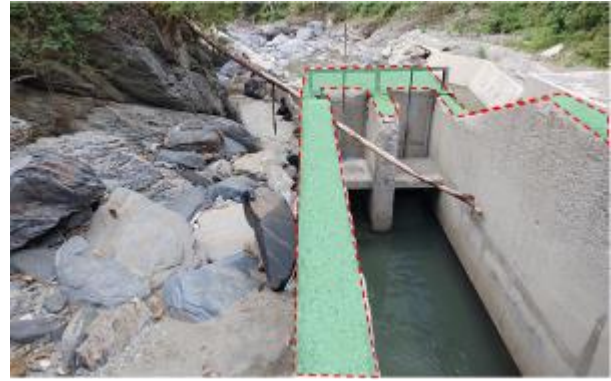
Figure 2-2-13 Rehabilitation Plan from No.13 to No.14

The upstream side wall of the intake works (No.4) was severely damaged and the inner surface was heavily cracked, so it will be reconstructed. The downstream side wall (No.13) has cracks of 0.3 to 0.6 mm on the river side, so the cracks will be repaired using a low-pressure injection method with a resin-based injection material.

In addition, the top surface of the wall has sectional defects due to the impact of rocks during flooding, so it will be repaired (No.14).

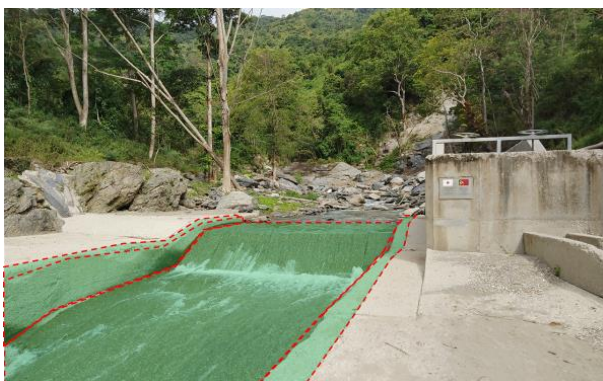
No.15 : Repair of defective areas of the intake weir

No.16 : Repair of defective areas of the top and side of the inverted T-type retaining wall on the left and right banks

The surface of the fixed weir (No. 15) is heavily scraped and damaged by considerable rocks flow during the annual rainy season as well as during flooding. The bottom and sides of the inverted T-type retaining wall (No.16) have exposed rebar. These sections will be repaired with high-strength concrete.

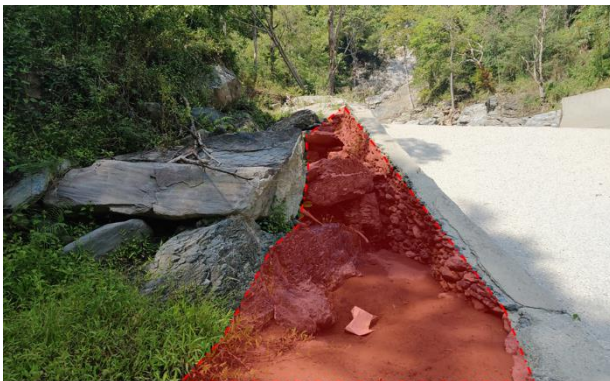
No.17 : Repair of defective areas of the upper side on the high waterbed of the right bank

No.18 : Reinforcement of the outside of the high waterbed of the right bank (boulder concrete)

The surface of the right bank revetment will be repaired (No. 17).

It is presumed that the flood flowed into the back of the high waterbed (outside) of the right bank revetment during the flood, and it was affected that the backfill soil was sucked out of the retaining wall downstream. Therefore, this outside area will be backfilled with concrete (No. 18).

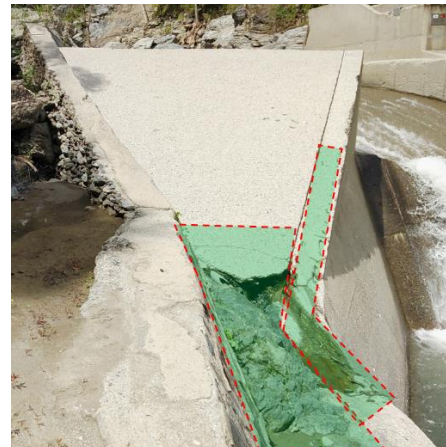
Figure 2-2-16 Rehabilitation Plan from No.19 to No.20

The surface of the right bank revetment will be repaired (No.19). The structure was constructed avoiding existing rock, so care should be taken with the bedrock when placing the concrete. In addition, a drainage pipe runs under the concrete to drain water from the back of the high waterbed, which will be repaired at the same time.

The retaining wall on the right bank of the Grit chamber(No.20) is severely damaged and the rebar is completely exposed. During the repair, the rust on the surface of the rebar should be carefully stripped and repaired using high-strength concrete.

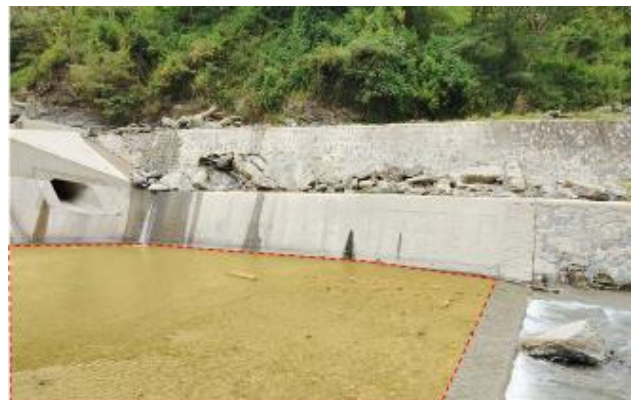
Figure 2-2-17 Rehabilitation No.21

No.21 : Dredging in the grit chamber

The dredging of the grit chamber will be implemented. The depth of the grit chamber is 4.5m, but sediments have accumulated up to the full water level. The dredging is planned to be carried out at the end of the construction process because it will serve as a scaffold for the repair of the retaining wall (No.20).

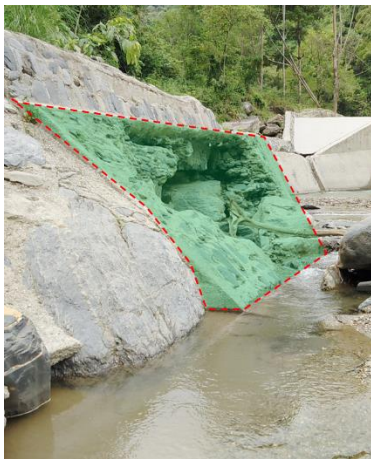
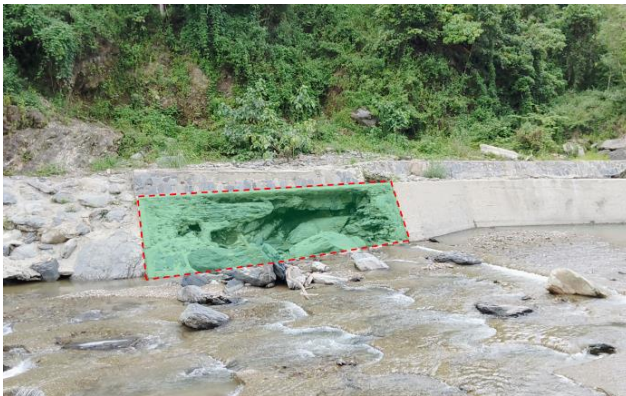
Figure 2-2-18 Rehabilitation No.22

No.22 : Repair of defective areas of the retaining wall in the right bank of the riverbed

In the right bank of the riverbed, in addition to damage caused by rock and boulders runoff, it is presumed that the backfill sediment was sucked out of the structure due to the rising water level behind the structure caused by flooding, so it is important to properly install weep holes to reduce the rising water level behind the retaining wall.

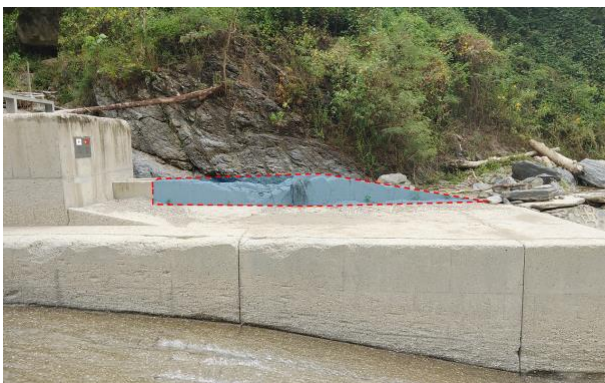
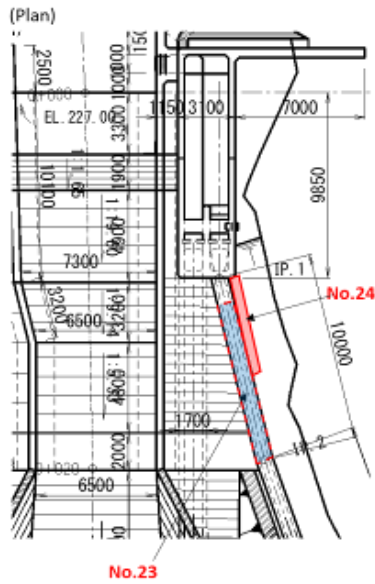
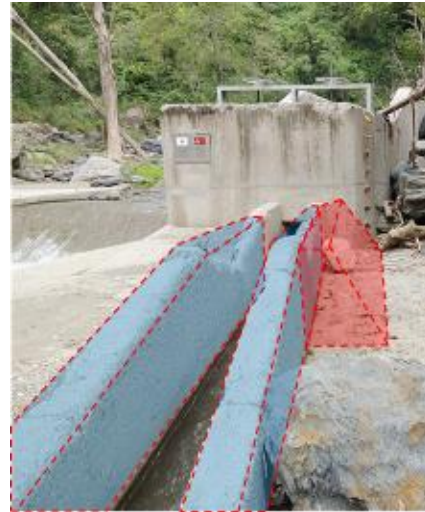
Figure 2-2-19 Rehabilitation Plan from No.23 to No.24

No.23 : Partial removal and reconstruction of the upper wall of the connecting canal

No.24 : Reinforcement of the upper wall of the connecting canal (outside)

The upper wall of the connecting canal (No.23) was damaged by rocks and boulders that went around the back of the intake facilities. The intake facilities is located at the narrowest point of the river cross-section, and there is concern that rocks and boulders may pass through the back of the intake facilities in the same manner if a flood of this magnitude were to occur again. As a countermeasure, the protection wall made of concrete (No.24) will be constructed.

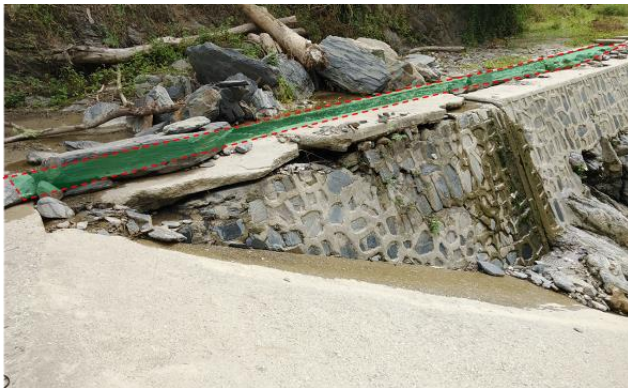
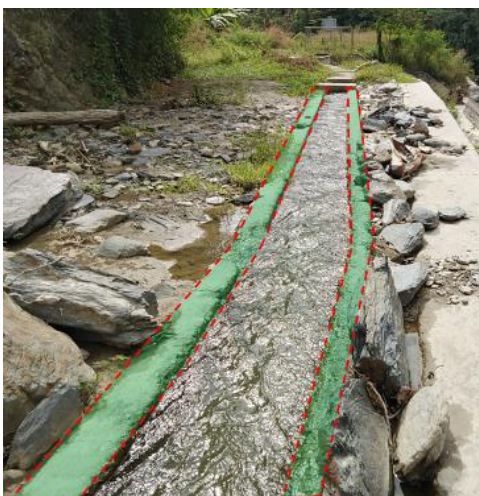
Figure 2-2-20 Rehabilitation No.25

No.25 : Repair of the top of the side wall of the Connecting Canal, and Installation of the concrete covers

The top of the sidewall of the connecting canal was damaged by rocks and boulders. Currently, it is operating at maximum volume of intake water in the Beamos water supply system, so that water is being lost from the damaged portion of the canal. The top of the side wall will be repaired with the objective of reducing water intake loss. In addition, the concrete covers of the canal were lost by the flood, which is deteriorating water quality at the water treatment plant, so the covers will be installed.

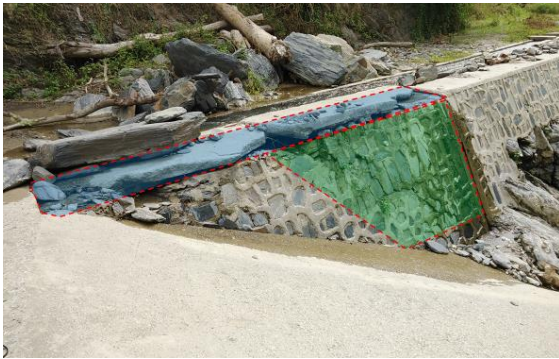
Figure 2-2-21 Rehabilitation No.26

No.26 : Repair of defective areas of the retaining wall in the left bank on the high waterbed of the grit chamber

The top-end concrete has been damaged by rocks and boulders that flowed around the back of the intake facilities, and the retaining wall itself is also damaged. The top-end concrete will be removed and reconstructed, and the retaining wall section will be repaired.

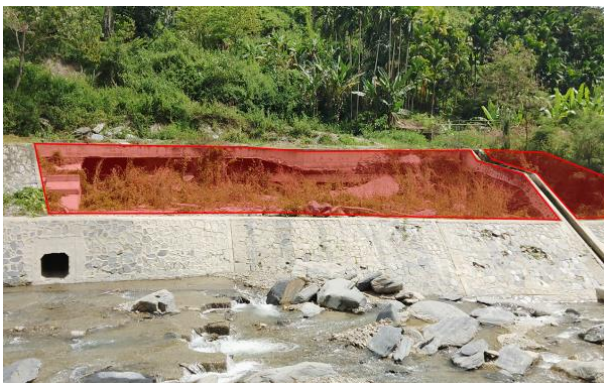
Figure 2-2-22 Rehabilitation No.27

No.27 : Installation of the protection wall of the upper side of the left bank of the riverbed (backfill and wet masonry)

The embankment slope of the upper side of the left bank in the downstream was damaged by the flood. It will be newly constructed by made of wet masonry to prevent erosion.

Below the connecting canal is hollow due to soil runoff, exposing a steel pipe that has been left unused. During the construction, the backfill must be carefully compacted.

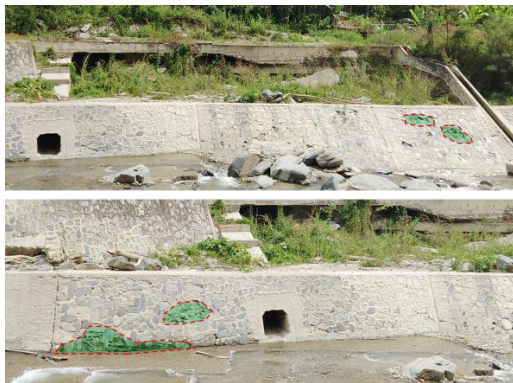
No.28 : Repair of defective areas of the left bank of the riverbed

It is presumed to have been damaged by rock impact. This repair will prevent the damage from progressing.

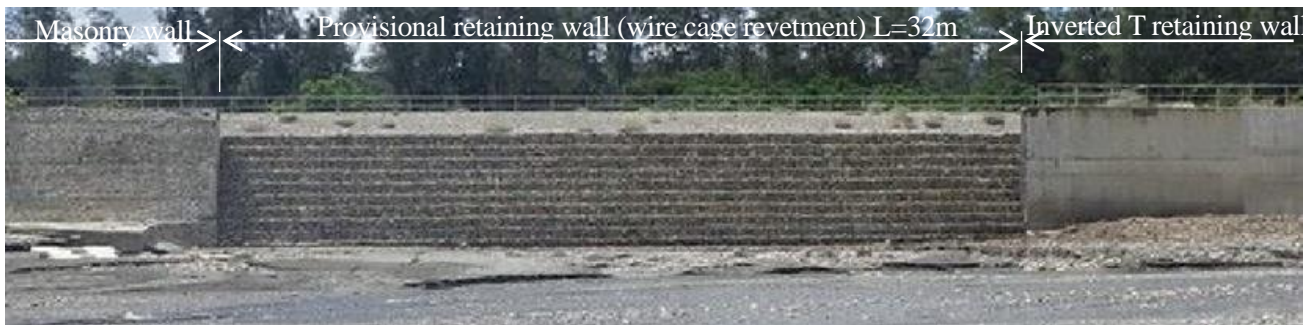
Figure 2-2-26 Provisional retaining wall

As a result of the comparative study shown in comparison table, the revetment restoration plan proposes the Rehabilitation plan (2) Inverted-T retaining wall + Embedment + Root fixing. In this proposal, a 32 m section of the emergency restored steel cage revetment is replaced with a reinforced concrete retaining wall, and in front of the concrete retaining wall, embedment concrete is installed to a depth of 1.2 m below the current deepest river bed level as a scour prevention measure. In the 31.2 m section downstream, which was not affected by the flood, revetment blocks will be installed in front of the masonry retaining wall as a scour prevention measure.

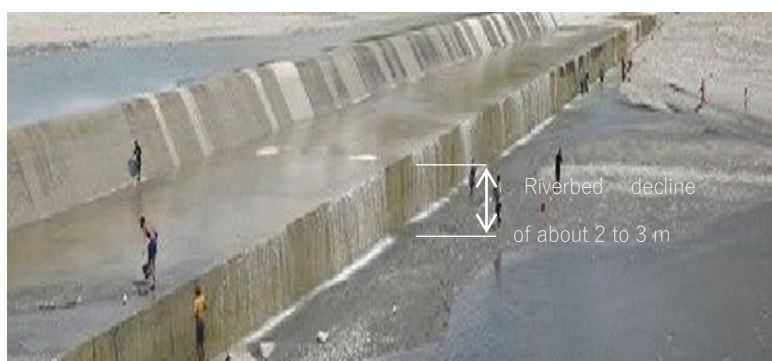
Figure 2-2-29 Scour downstream of the apron of the headworks

The apron section downstream of the Buluto headworks is lowering by a large scour of 2 to 3 m. This is a section where the flow is disturbed by high velocity currents during floods, and there is concern that unpredictable upstream and downstream riverbed fluctuations may occur in the future. In order to cope with unpredictable river bed fluctuations, it is necessary to install revetment blocks downstream of the apron. The following is a study of the necessary revetment blocks.

Taken May 4, 2022

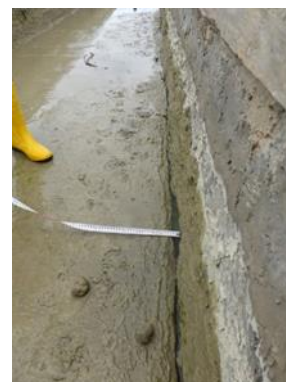
(Photo taken May 7, 2022)

i. Type A (gap between sidewall and bottom slab)

Loosening of the embankment due to insufficient compaction of the back of the sidewall caused the sidewall to tilt slightly outward, resulting in a gap. The embankment is now stable and the gap between the sidewall and base slab is not expected to develop further.

The cracks will be repaired as follows

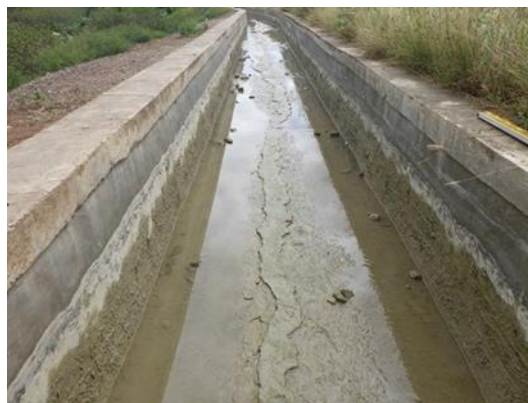
#### Type C (Cracks in the longitudinal direction in the center of the canal)

The sidewall settled slightly due to own weight of the sidewall concrete, and the stress was transferred to the bottom slab, causing a bending moment to act on the bottom slab in the opposite direction of the sidewall settlement, resulting in cracks on the top surface of the center of the bottom slab which is the tension side.

The repair method for the bottom slab is not to add strength to the bottom slab, but to prevent cracks from forming in the bottom slab by installing reinforcing wire mesh.

(Photo taken May 7, 2022)

The method of repairing cracks shall be as follows

- a) The existing concrete slab shall be broken and removed. The ground shall then be compacted and leveled. If the ground beneath the bottom slab has settled, backfill and compaction with soil shall be done.

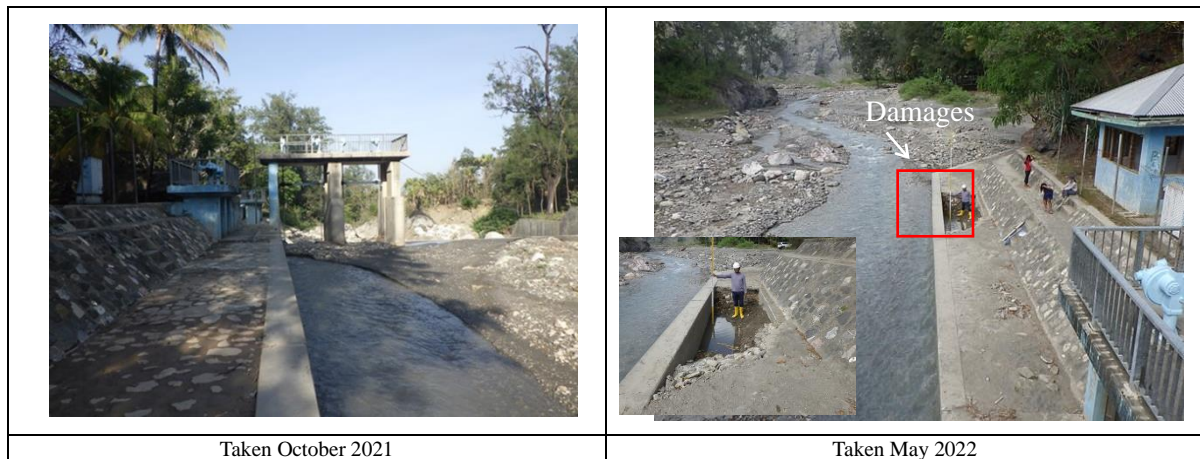
(c) Administrative corridor damaged by flooding in February of this year.

The flooding that occurred in February of this year caused new damage to the Administrative corridor on the left bank of the headwall.

Since the damaged administrative corridor will be an obstacle during the construction work, we propose to backfill the damaged administrative corridor as a temporary work and repair it with unreinforced concrete to ensure the safety of the construction work.

Backfill the sunken management corridor that was damaged by scouring and suction of the ground due to the damage and outflow of the apron downstream of the scouring sluice channel, and repair the management corridor with unreinforced concrete.
