**Republic of India
Uttarakhand Forest Department (UKFD)**

**The Project for Natural Disaster
Management in Forest Areas in
Uttarakhand
Republic of India**

Final Report

April 2024

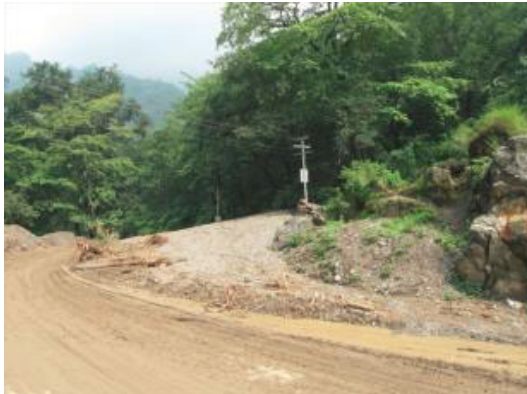
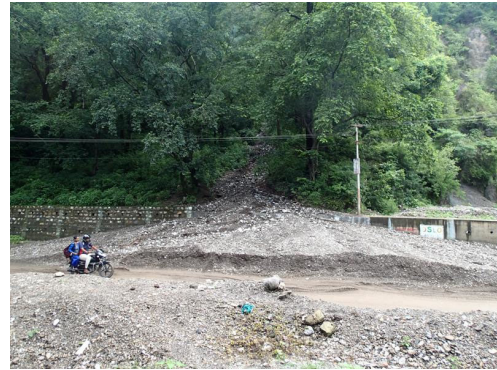
Photo 3.1 Debris flow on model site in Nirgad

In 2013 in Nirgad, heavy rainfall triggered debris flow, causing damage to National Highway 58, leading to frequent traffic congestion. Since 2013, debris flow has occurred

during continuous rainfall, again depositing sediment on Route 58 and frequently disrupting traffic.

Site conditions in August 2014

Site conditions in August 2017

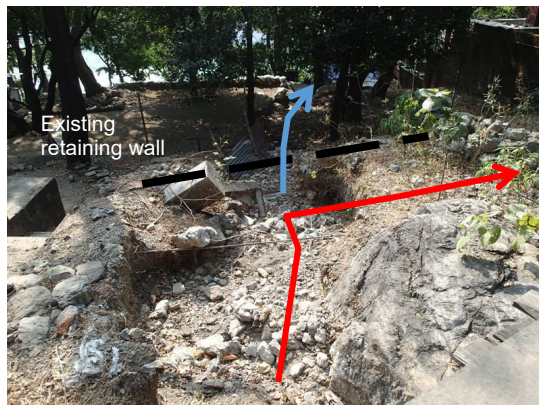
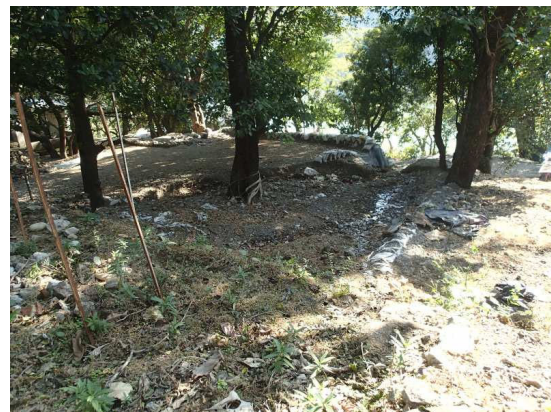
Photo 3.2 Site conditions of the lower stream

There are religious and lodging facilities downstream from the NH. Usually, there is no water flow in the natural channel normally; rather, it occurs only temporarily, during heavy rains. Until 2013, when the major disaster occurred, water was channelled to the nursery of the UKFD on the right bank. During the 2013 disaster, the retaining wall at the channel conversion point was destroyed by the debris flow that occurred. Since then, water has flowed straight into the Ganges River without passing through the nursery (Photo 3.2). In addition, during the 2013 disaster, some lodging facilities downstream were also impacted by runoff that contained debris. The cause was a failure to properly divert high-energy debris flow at the channel conversion points.

Red line: direction until 2013
Blue line: direction after 2013

Stream after the existing retaining wall

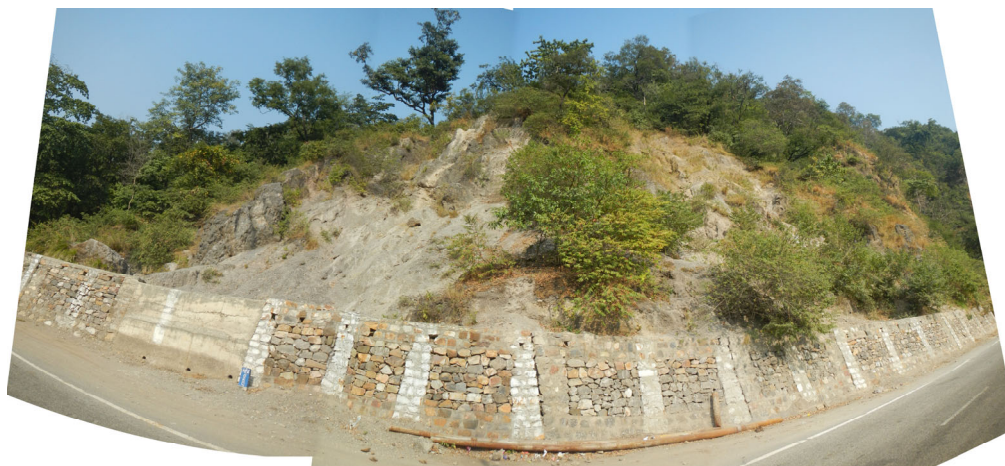
Photo 3.3 Steep slopes (Slope No. 1 (left), Slope No. 2 (right))

In 2013, traffic on NH 58 was disrupted due to fallen debris from steep rock slopes in Nirgad. Since this disaster, the traffic on NH 58 in this section has been disrupted during the rainy season every year. In 2016, the National Highway Authority of India and the PWD installed a 2.5 meter-high protection wall along the steep slopes to prevent debris from the steep slopes falling on the road.

The steep rock slopes are 30 m high at a 50°-60° angle and consist of shale, with clumped or veined dolomite in the Krol Formation. The shale is extremely friable and easily broken into smaller pieces. The cut slope areas used to be borrow pits, from which and shale was mined as construction material. Rock material is still mined by hand despite the protection wall.

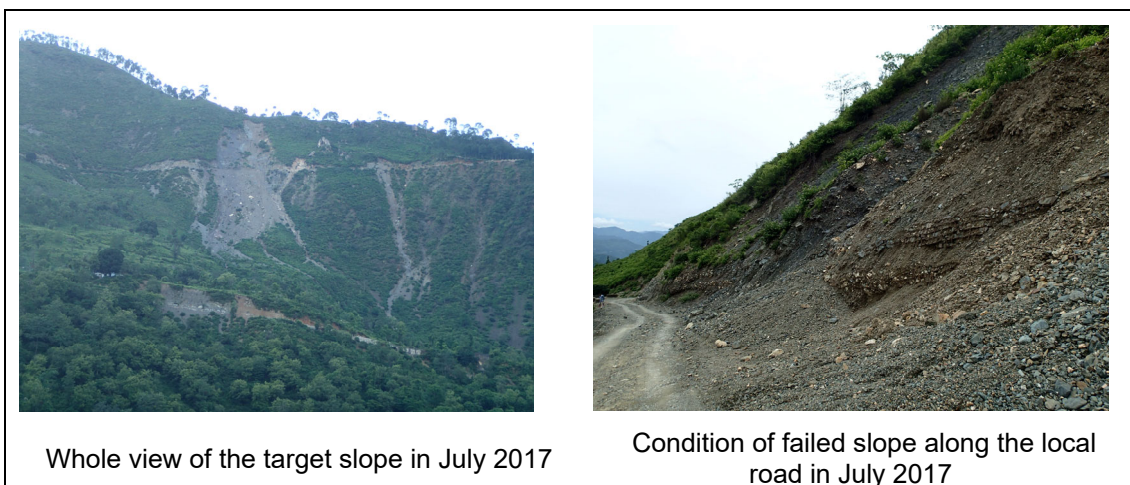
Photo 3.4 Site conditions in Jawadi 1

The Jawadi site is located on the opposite slope of Rudraprayag City, across the Alaknanda River. Heavy rains in June 2013 caused a slope failure, with the collapsed debris causing damage to a local road. Farmland also was damaged by debris that flowed downstream together with the surface water. Slope failure has occurred every year since 2013 during the rainy season, causing damage to downstream farmland. The expansion of the collapsed slope is also evident.

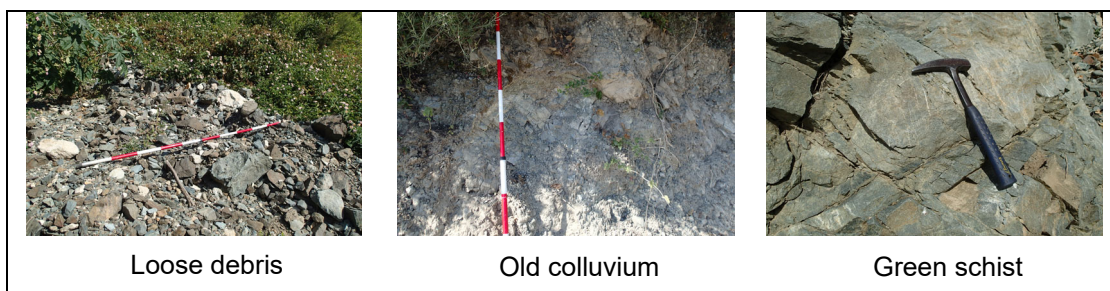
Photo 3.5 Main geological distribution in the area of Jawadi 1

The geology in and around the target slope consists of green schist, slate, quartz schist, and shale. Green schist is distributed as the base rock in the failed slope area. The schistosity is finely developed and exhibits an anti-dip structure against the slope direction (N60°W 60°E). An older compacted colluvium layer is widely distributed above the base rock. The materials of colluvium are thought to have been generated during a large-scale landslide, as assumed by topographic interpretation, and are composed of 20 cm to 50 cm boulders of schist and sandy or gravelly slate. The well-developed schist is easily eroded to form gully landforms, as seen on the lower slope of the road. Loose debris and talus deposits transported by the 2013 failure and debris flow is distributed along the collapsed sediment flow path. Those soil layers are extremely loose, sandy soil with small to large gravel of the surrounding base rock.

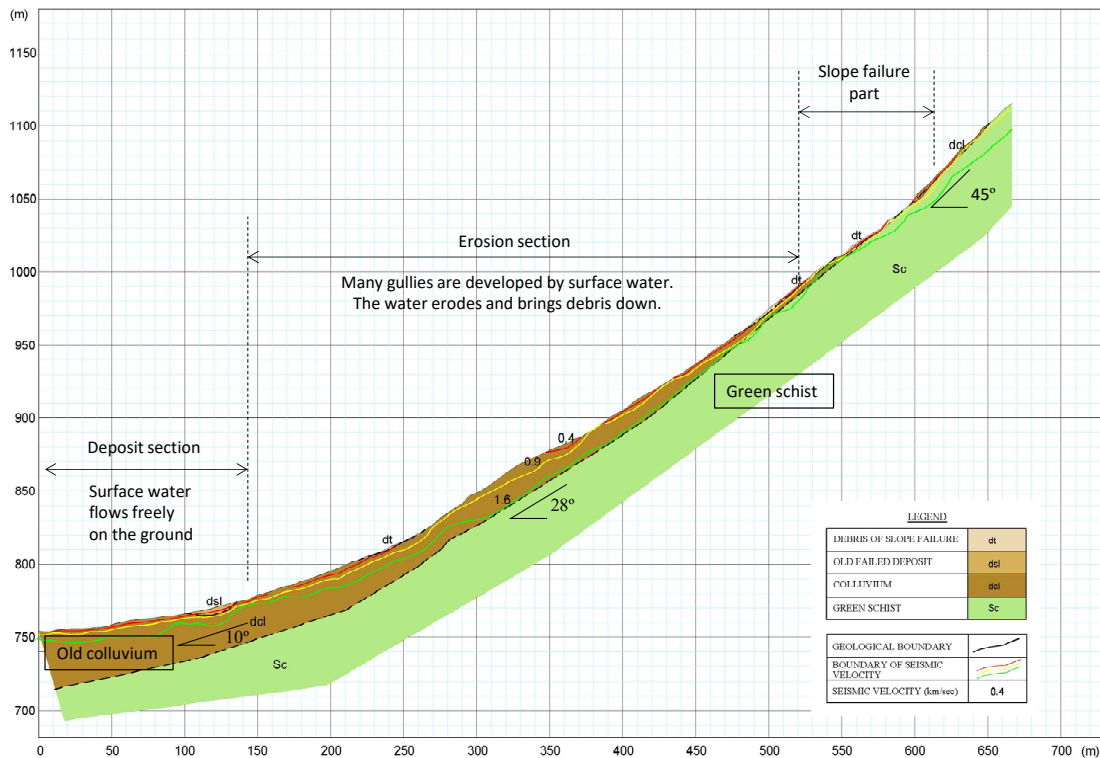
Figure 3.6 Geological Cross Section of the Slope in Jawadi 1

The target slopes are divided into three main sections based on slope gradient and slope surface conditions: the failure section, the flow-down section, and the sedimentation section.

The following geological cross sections, prepared based on the results of the geological reconnaissance and seismic exploration, show the sections discussed above.

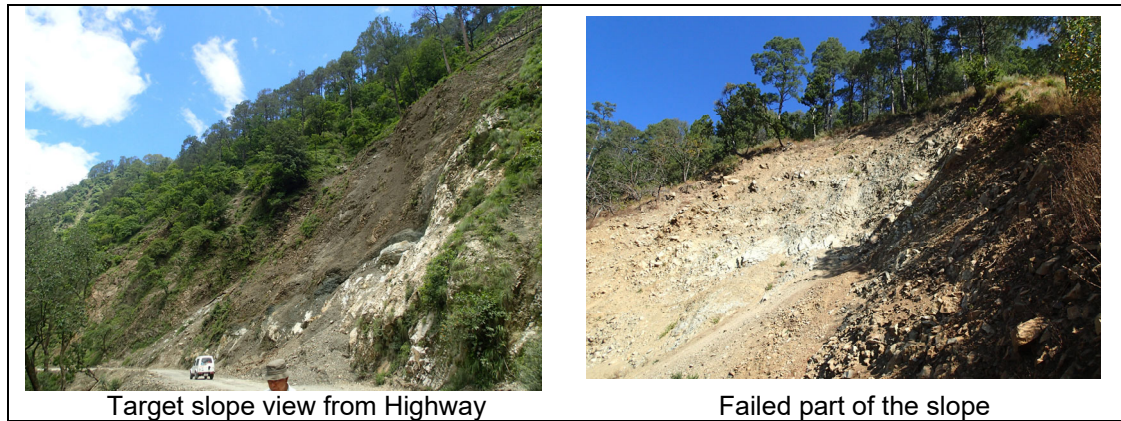
Photo 3.6 Condition of the site in Padli

The target site in Padli experienced a slope failure during the monsoon season in 2016, causing a large amount of debris to hit NH 109, severely disrupting traffic. During continuous rainfall events since 2016, debris flow from slopes and frequent rock falls even during normal times have had a significant impact on traffic.

The target slope is a long and large slope with a height of approximately 200 m. The slope gradient is steep with an almost uniform slope gradient of 40-45° from the slope failure area to the NH below the slope. Since the slope features before the failure occurred exhibit the topography of an old landslide, even though the whole slope is covered with dense trees, it can be surmised that the slope experienced failure before 2016. Multiple traces of springs were observed in the slope failure area, suggesting that the slope may have springs during the rainy season, which may be one of the factors contributing to slope instability. The slope has a watershed feature due to its landslide topography, and surface water from the surrounding area flows down this slope, forming several gullies in the mid-slope area. The slope behind the failure area is also steep, and several cracks have been observed, which may lead to future expansion of the failure area if no measures are taken.

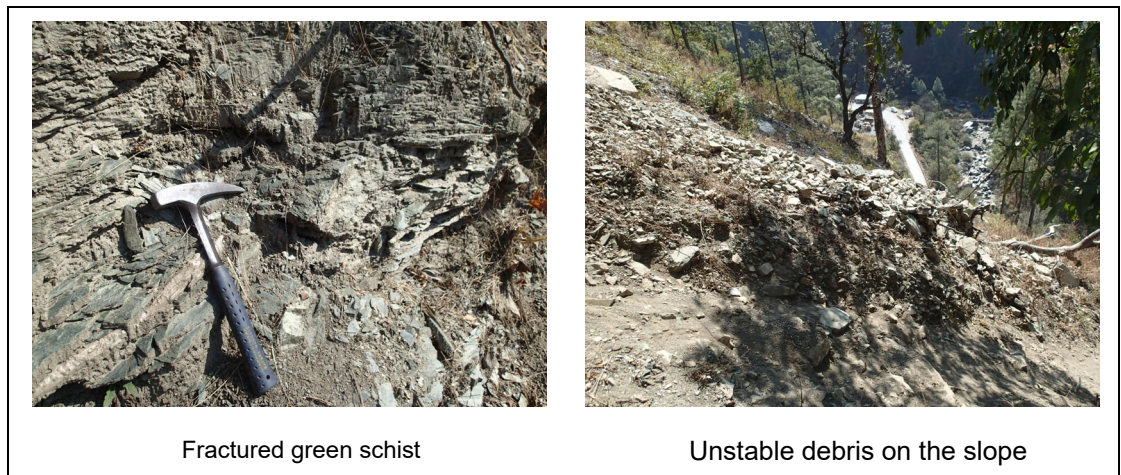
Photo 3.7 Unstable geology on the slope in Padli

The geology of the target slope consists mainly of green schist, shale, and quartzite as base rocks. The quartzite is massive and hard with few fractures. On the other hand, the green schist and shale are moderately weathered, with finely developed and opened schistosity at the surface, making them unstable and susceptible to collapse. The source of most of the debris on the slope is the green schist and shale. In the subject area, the strata are distributed in the order of quartzite, shale, and green schist, from the bottom. The geological structure exhibits an anti-dip structure against the slope direction (N70°E, 75°N). Old colluvium and collapsed debris are deposited above the base rock. The old colluvium is relatively compact, but the collapsed debris is extremely unstable because when the slope failed, the debris flowed downward and was left on the slope. This unstable debris falls easily due to wind and/or animal activity, not only during rainfall but also at normal times.

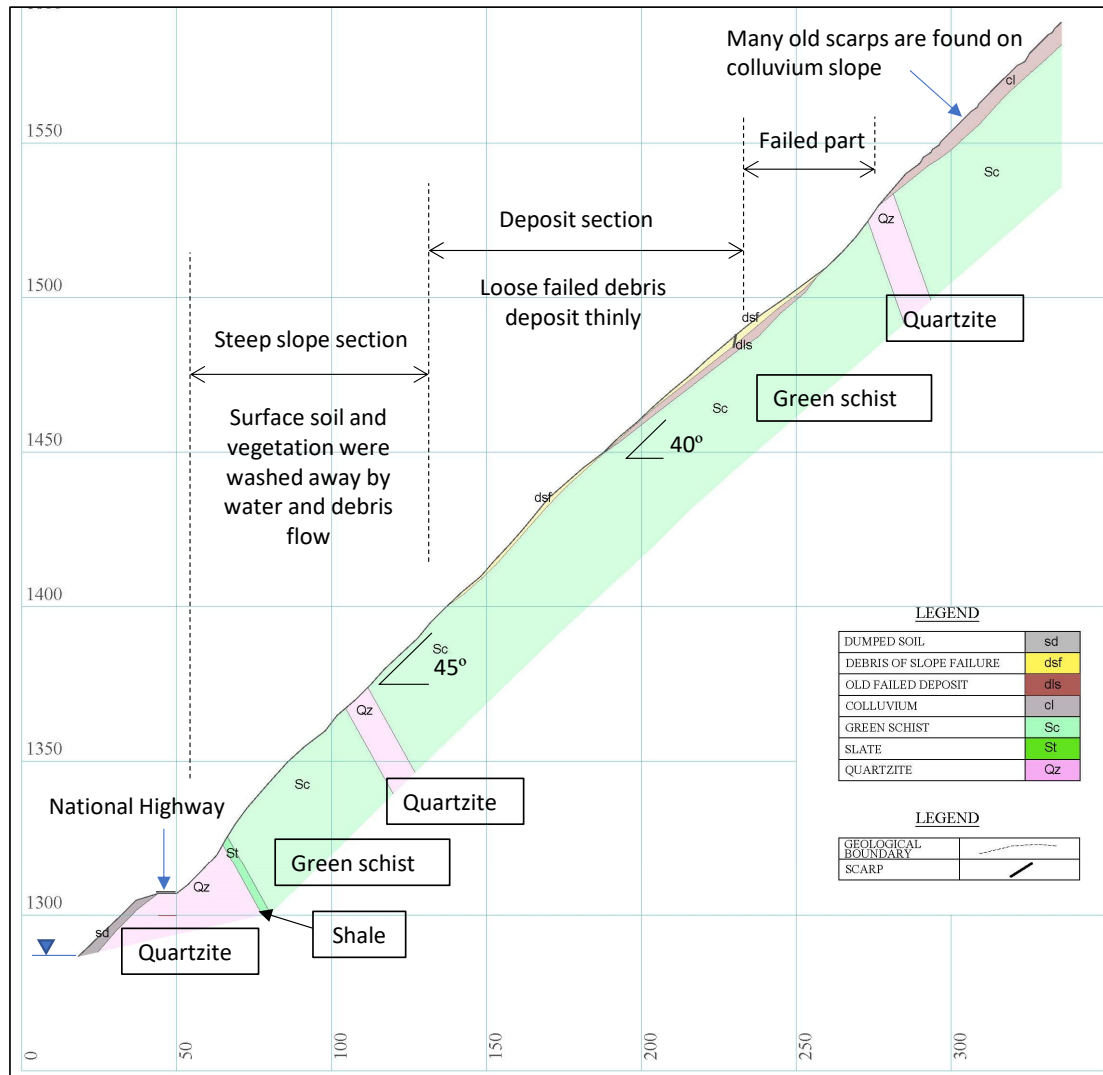
Figure 3.8 Geological Cross Section of the Slope in Jawadi 1

It can be surmised from the results of site reconnaissance that the area of the failure that occurred in 2016 was located above the slope deemed to be the area of an old landslide; moreover, the area has not failed again, but the slope above the area failed and collapsed debris washed down the old landslide area. Further, in the process of flowing down the slope, the debris fell on the NH, denuding the surface sediment and vegetation.

The following geological cross sections, prepared based on the results of the geological reconnaissance and seismic exploration, show the sections discussed above.

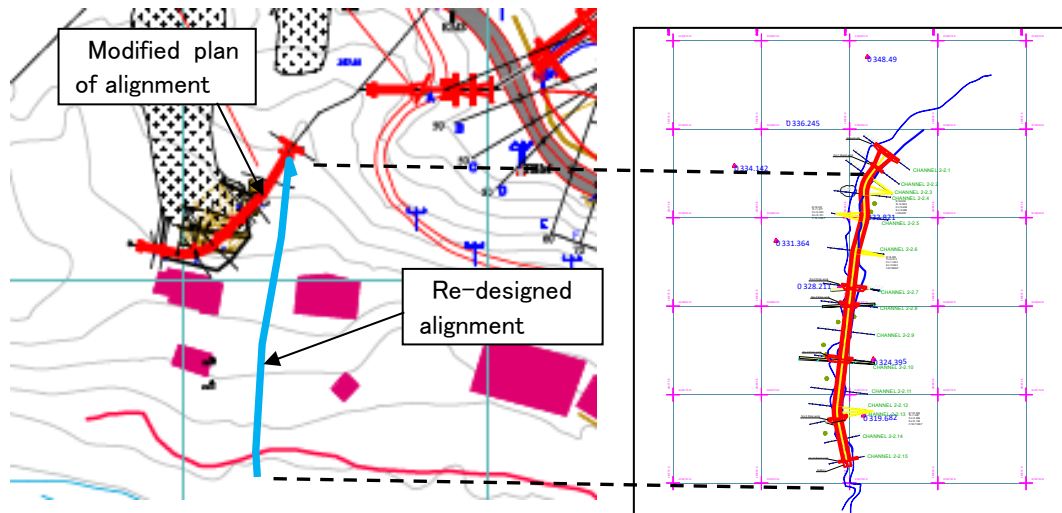
Figure 3.11 Final Alignment of Channel 2-2 in Nirgad

During the process of the design work, it was ascertained that the original alignment of the channel work passes through the disputed area (a land ownership dispute) of a religious facility (an ashram). The proposed alignment was therefore modified to avoid the disputed area. However, as the result of discussion between the UFRMP and the ashram, the channel has been re-designed with the original alignment.

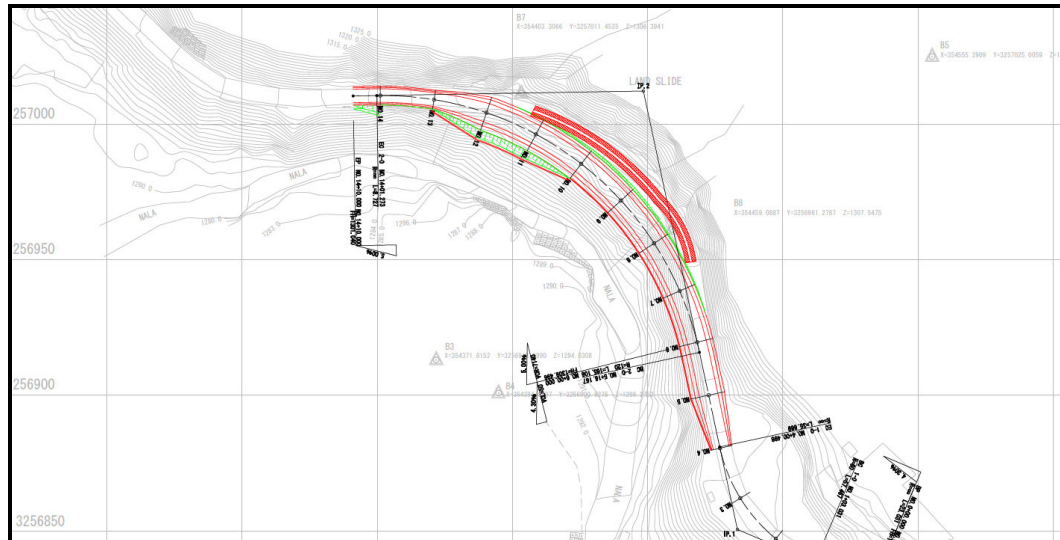
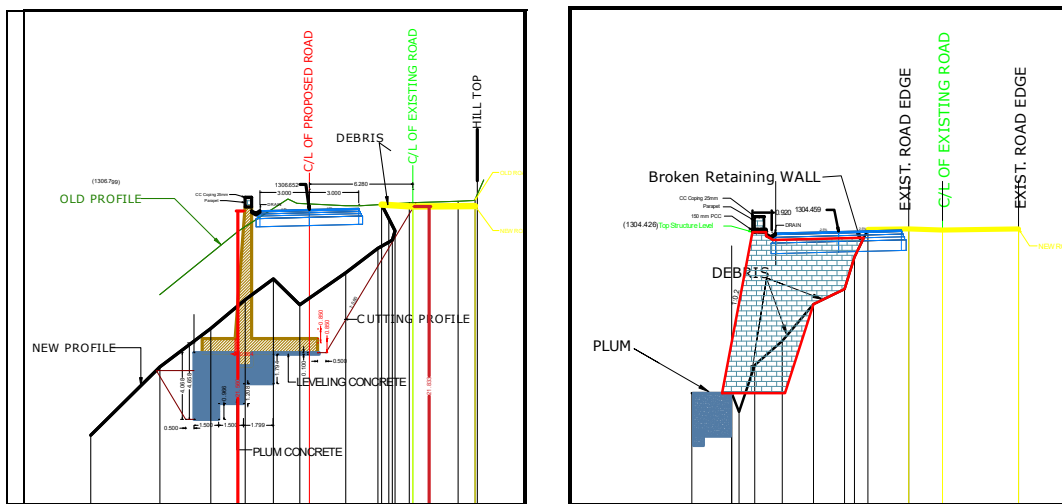
Figure 3.14 Design Drawings of Temporary Road in Padli
(Above: Road Alignment. Left: Cantilever Retaining Wall. Right: Wet Masonry Wall)

The NH crossing under the slope needed to be temporarily moved away from the slope during construction of the erosion control works, and although not directly subject to the works, a plan and design for the temporary diversion of the NH was developed. Joint discussions were held onsite with the National Highway Authority of India (NHAI), which manages the NH, to confirm the design conditions. Based on these discussions, a road alignment plan was prepared and detailed design was carried out. The design of the NH was conducted in accordance with Indian Road Congress (IRC) Standard SP-73-2015. The road was intended only as a temporary road for common use during the construction period. Two types of retaining wall structures were proposed by the contractor: a cantilever retaining wall and a wet masonry retaining wall.

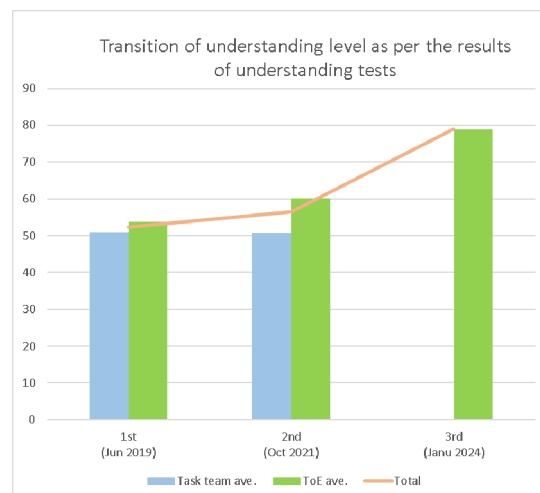
Figure 3.17 Transition of Test Results

The passing score for the test was at 40, a common passing score in India. All of the ToE and task teams scored 40 or higher on each of the last three tests. The figure on the right shows the average score for the ToE and the task team for each test session, with the average score for the ToE improving significantly as the test was taken. On the other hand, the average score of the second test for the task team improved slightly compared to the first test. This is mainly due to the fact that the task team was not able to take full advantage of

the opportunity to improve their skills, since it was difficult for them to participate in the project after COVID-19 pandemic. The challenge is how the ToE, which has

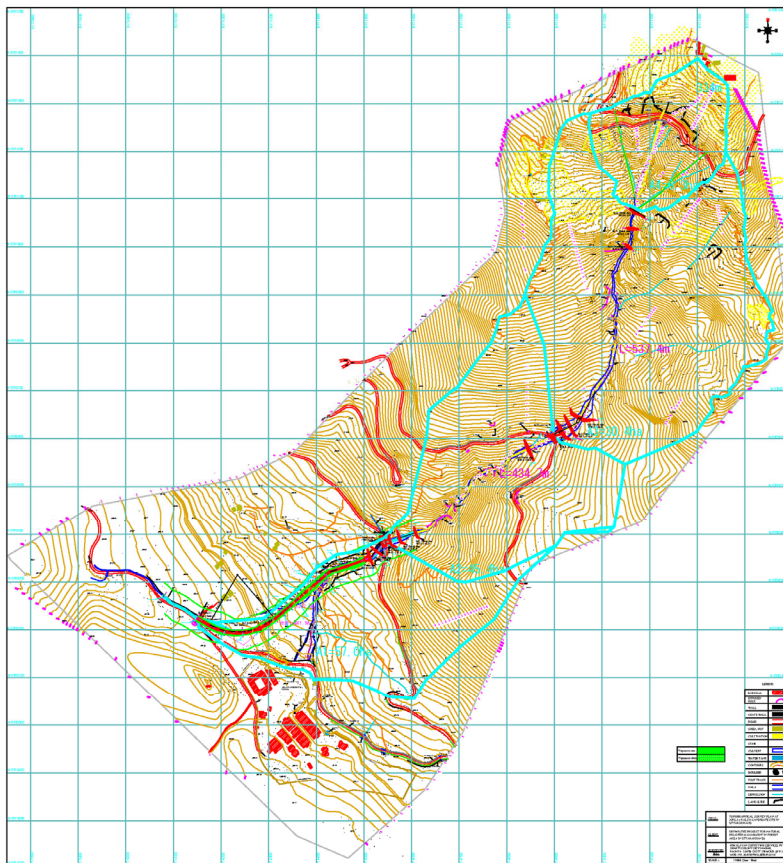
Figure 3.18 Plan View of the Site in Jokla
(Countermeasure work: hillside work in the upper area, 12 check dams in the stream, 400 m of channel work)

Basic design was completed in March 2020, when the Short-term Experts were in India. In June 2020, the ToE restarted its activity with remote instructions from the Short-term Experts and placed an order for a site survey with the local surveying company. As a result, the cross-section design was completed in September 2020. In October 2020, the ToE started designing the 12 check dams with instructions from the Short-term Experts.
