Nepal
Department of Roads (DOR)
Ministry of Physical Infrastructure and Transport
(MOPIT)

Data Collection Survey
on Road Disaster Prevention
in Nepal

Final Report

April 2024

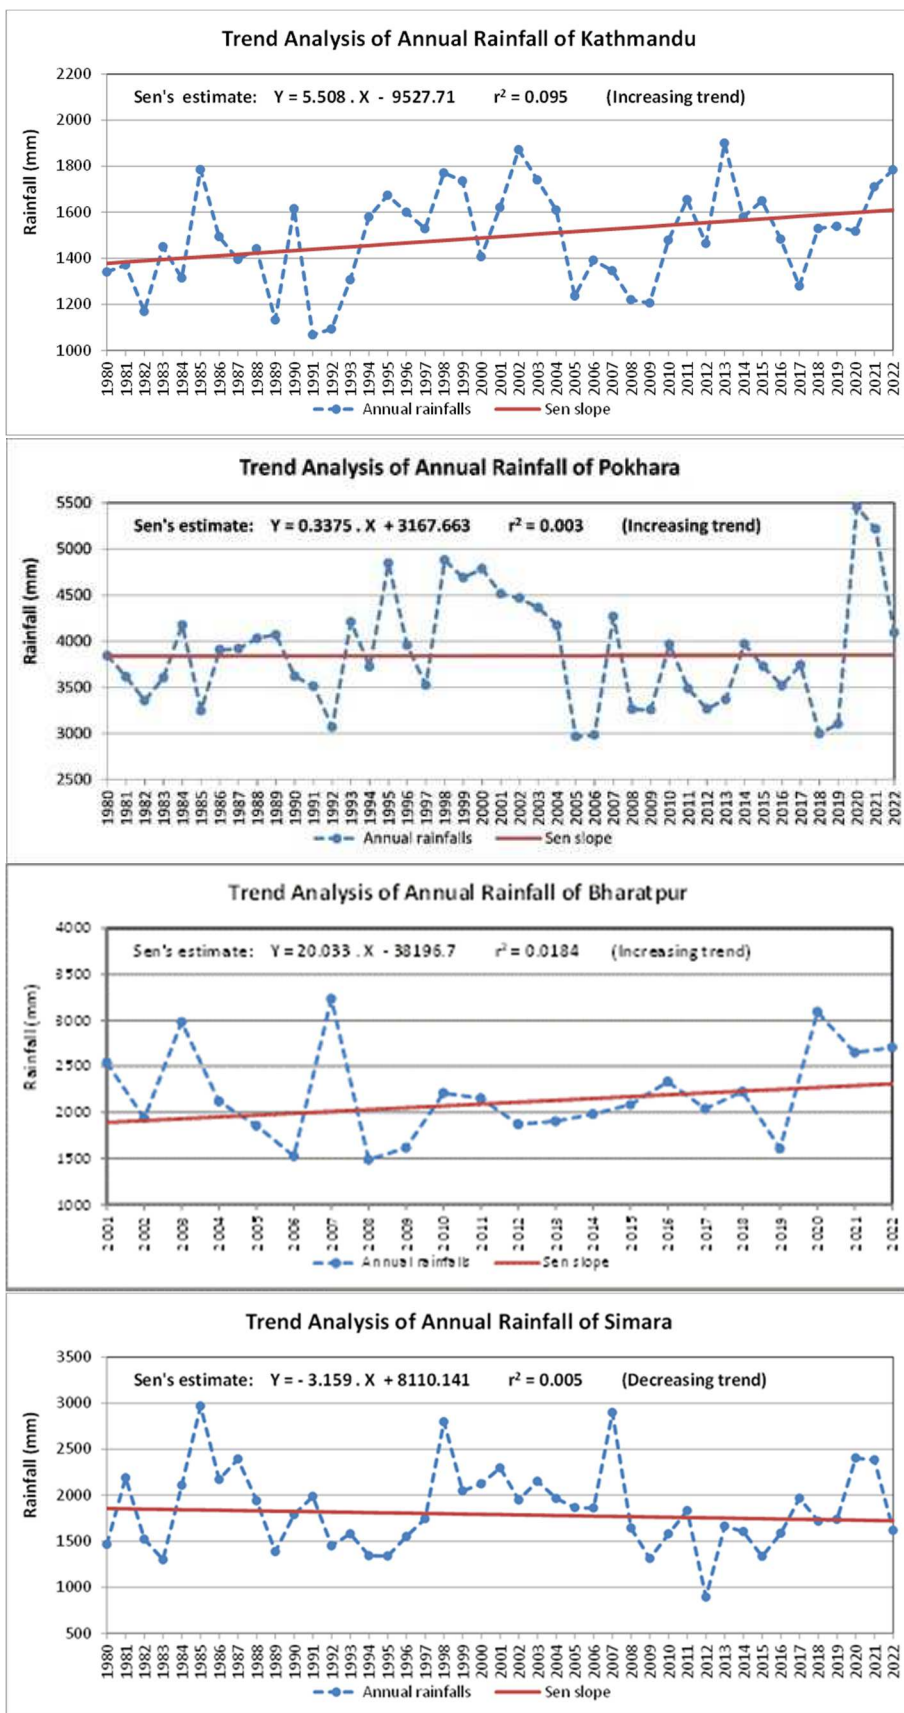
Figure 2-9 Trend of Annual Rainfall in the Three Largest Cities in Nepal and the Largest Indian Border Logistics Hub (1980-2022)

Figure 2-9 shows the interannual variation of annual rainfall and Sen's slope, which indicates a trend of temperature and rainfall. An upward trend is observed in Kathmandu and Bharatpur, whereas the situation in Pokhara shows little change, and Simara has a weak downward trend.

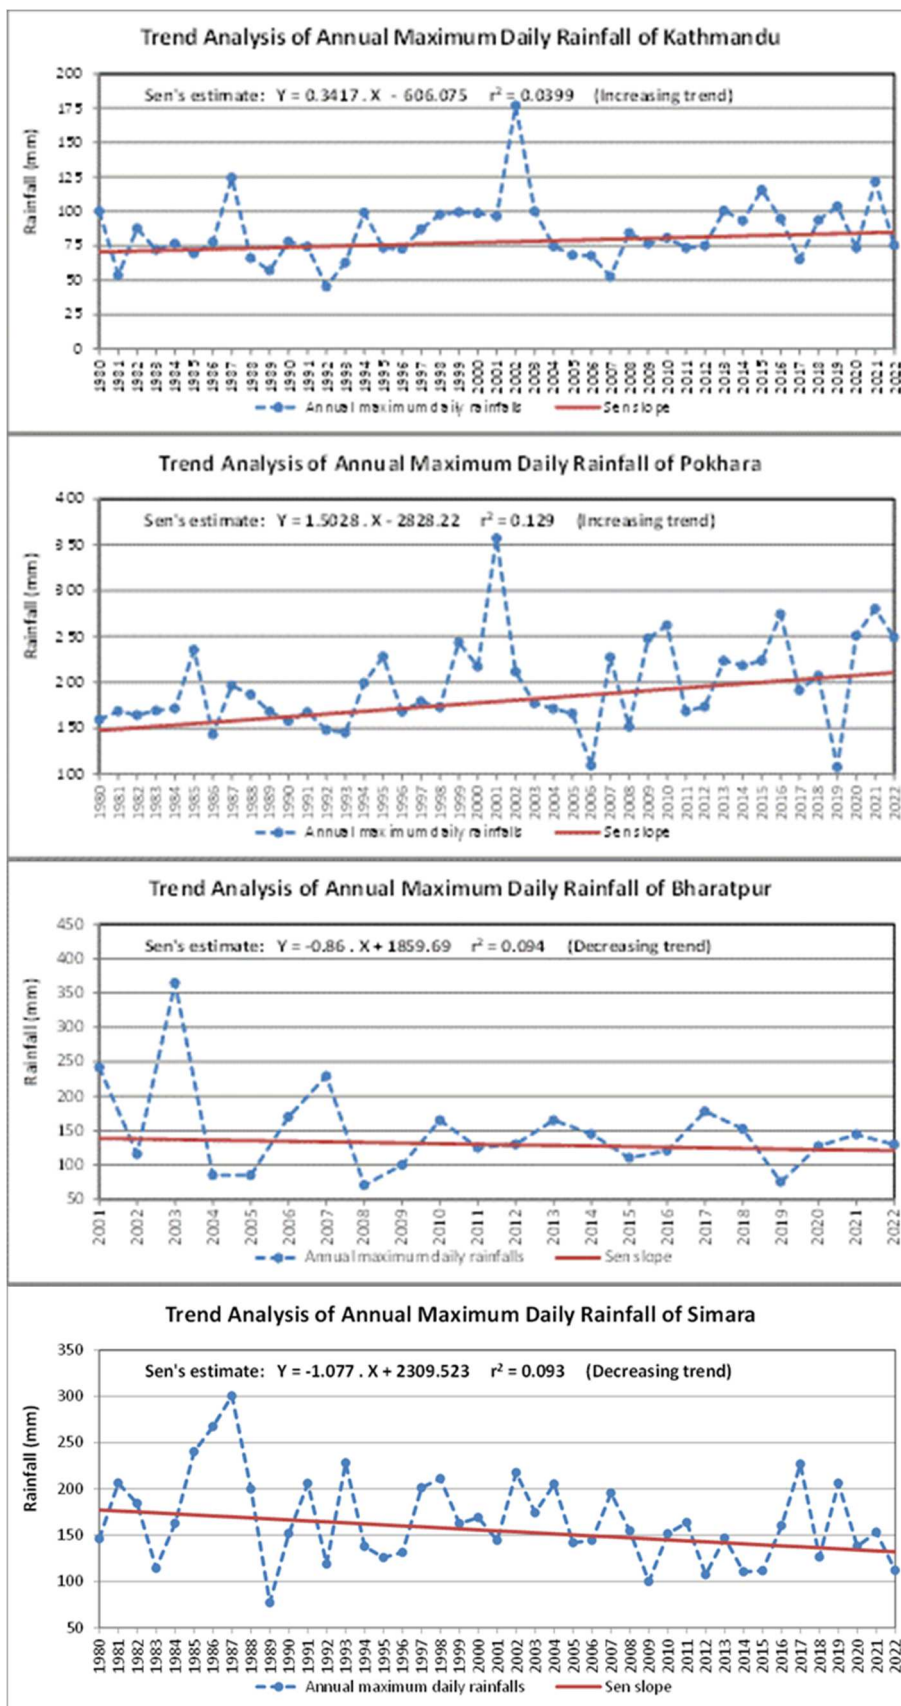
Figure 2-10 shows the interannual variation of maximum daily rainfall and its Sen's slope¹. Kathmandu and Pokhara in the temperate zone show an increasing trend over time, whereas Bharatpur and Simara in the sub-tropical zone show a decreasing trend. An increase in short-term heavy rains is also known in sub-tropical regions, and it is thought that periods of dry conditions and short-term heavy rains are increasing together.

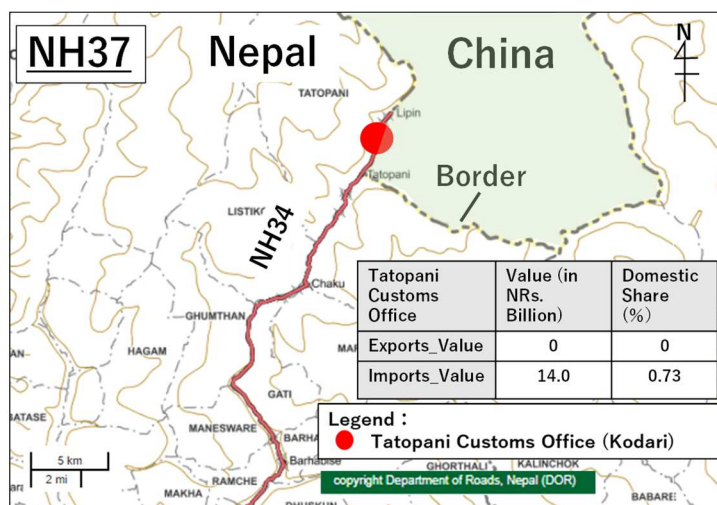
Figure 2-15 Site of Major NHs, Customs Offices, and Dry Ports for Trade

Five dry ports (Birgunj, Biratnagar, Bhairahawa, Kakarbhitta, and Chobhar), as shown in Figure 2-15, are in operation in Nepal. As a landlocked country, Nepal relies on the Indian port of Kolkata for most of its sea freight imports, and the above dry ports serve as transshipment points for transporting exported and imported goods.

Twelve overland NHs are bordering on India and eight NHs bordering on China. Of these, the major overland highways, especially for trade, are shown in **Figure 2-15**. In the north (Chinese side), NH42 and NH34 are the primary land highways; in the south (Indian side), NH47, NH41, and NH08; and in the east (Indian side), NH01 is the major land highway.

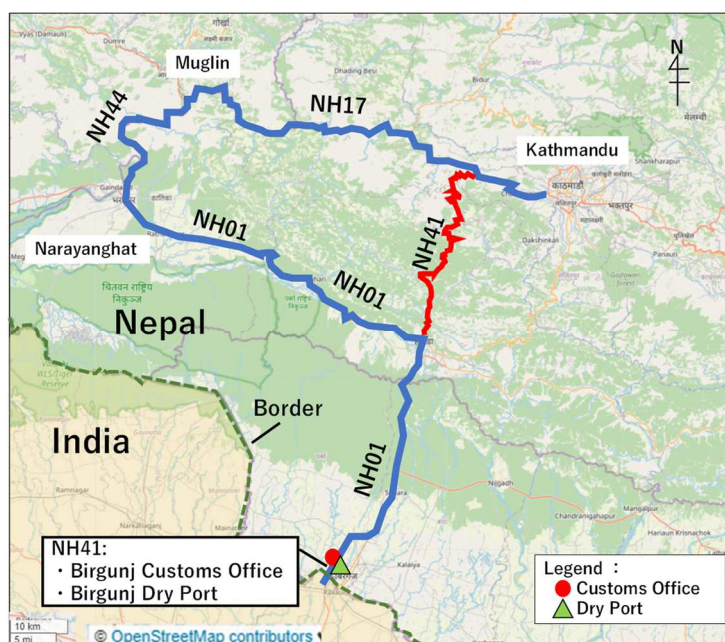
Figure 2-16 Highway of Goods Transported from Birgunj Dry Port to Kathmandu

through Narayanghat, and Mugling. This highway is an essential highway for overland trade with India. On the other hand, as shown in **Figure 2-16**, the overland highway from Birgunj to the capital Kathmandu is shorter via NH41 Tribhuvan Highway. However, since many sections have less than two lanes, large vehicles such as buses and heavy-duty trucks cannot pass through NH41. The only route available for large vehicles is via Narayanghat and Mugling. The distance between Narayanghat and Mugling is about 300 km, and the time required is about 8 to 10 hours (Source: <https://cuts-citee.org/pdf/field-diary-birgunj.pdf>).

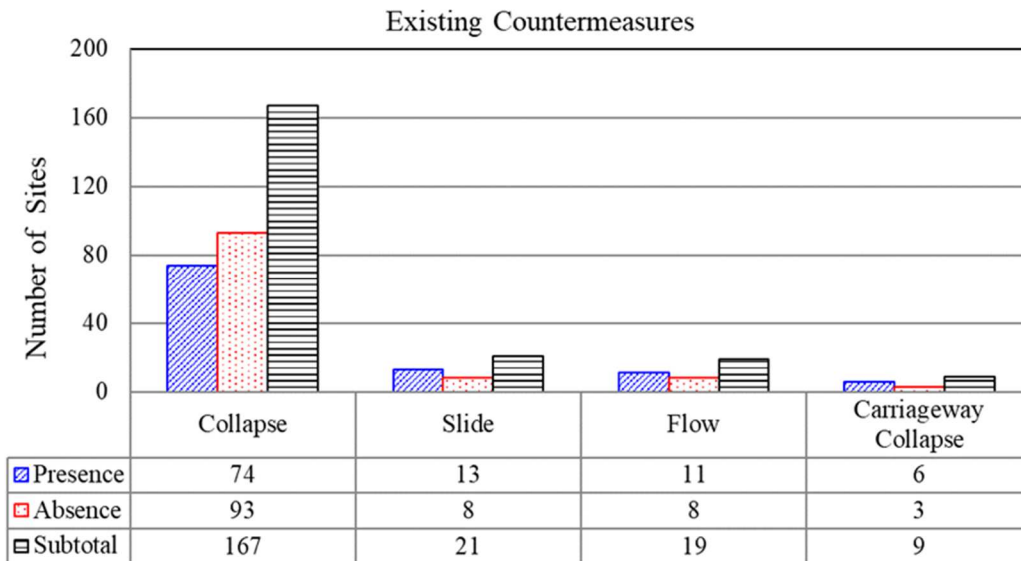
Figure 3-8 Implementation Situation of Existing Engineering Measures for Different Landslide Types

As for specific/preventive maintenance, **Figure 3-8** and **Figure 3-9** show the situation of engineering measures implementation at the 216 road landslide sites found by the site survey. The ratio of the sites with implementation of engineering measures works among the surveyed collapse sites was about 40%. The installed engineering measures works were emergency measures such as small-size masonry walls (34%), gabion walls (28%), and concrete retaining walls (10%), as shown in **Figure 3-9** and **Figure 3-10**. Although it is implemented by outsourcing, there are problems with delays in implementing works by external contractors and low work quality.

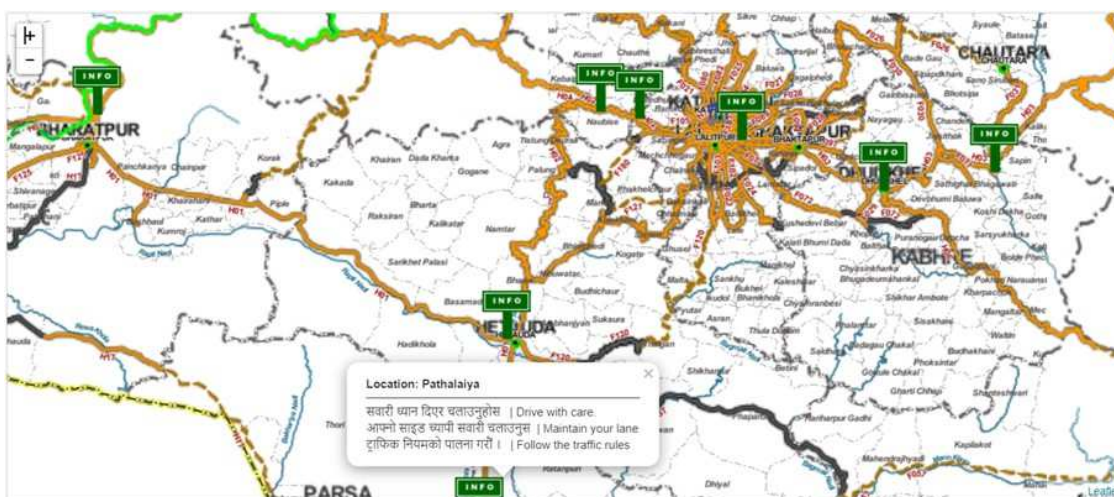
Figure 3-19 System Screen of EIS

The Emergency Information System (EIS) was developed and implemented as part of “The Project for Operation and Maintenance of the Sindhuli Road” (JICA, 2016), which was conducted as a technical cooperation by JICA to improve and enhance the management capacity of DOR with the target of NH13 Sindhuli Road. The system consists of a central server, rain gauges, road information boards along the road, battery equipment, and communication equipment. The service helps users obtain real-time information on road conditions such as heavy rainfall, floods, landslides, traffic accidents, traffic congestion, and road closures. The service can also disseminate information on traffic rules, regulations, and driving manners. EIS can be updated and viewed on the DOR website and smartphones. The warning criteria for the original EIS rainfall observation are designed to issue three levels of warnings based on rainfall levels, as shown in the conceptual diagram in Figure 3-19.

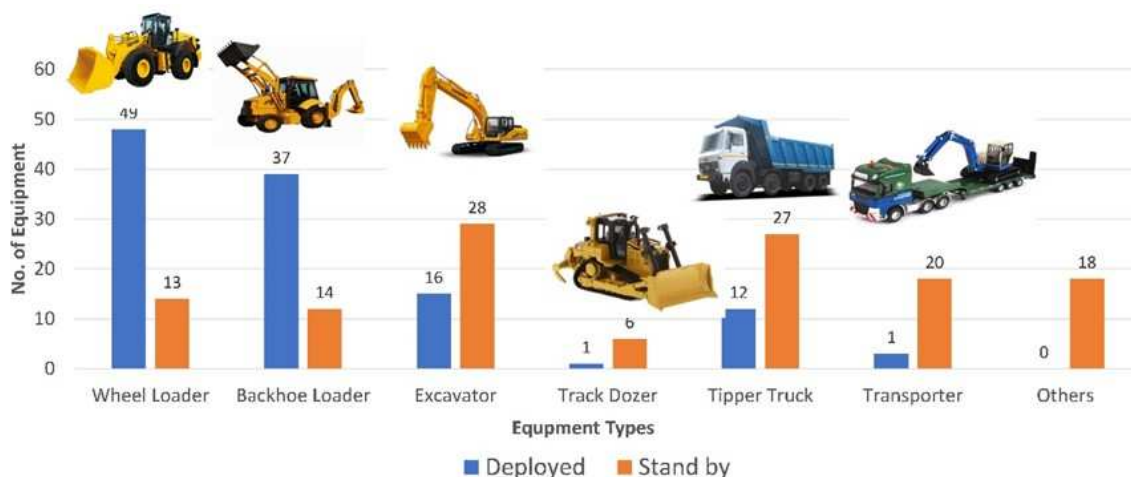
Figure 3-21 Total Number of Heavy Vehicles Deployed/Standby on Site by Type of Vehicle

In addition to the heavy equipment stored at HED, there is also heavy equipment in operation on each roadway or temporarily stored along the highway in preparation for requests. The deployment status of each type of heavy equipment is shown in **Figure 3-21**. Most wheel loaders and backhoe loaders are deployed on-site. Many other machines are on standby in the HED.

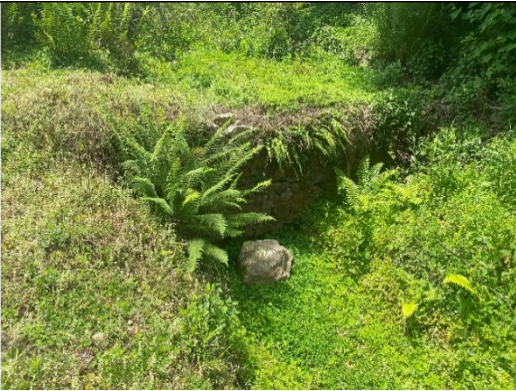
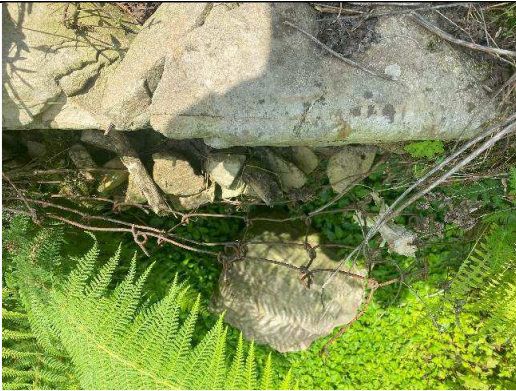
<p>The situation of the downstream check dam. The sediment prevention function is maintained.</p>	<p>Enlargement of the drainage part. The gabion wire has corroded and partially disappeared.</p>

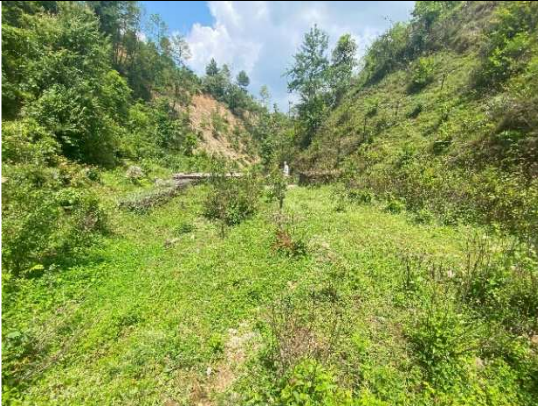
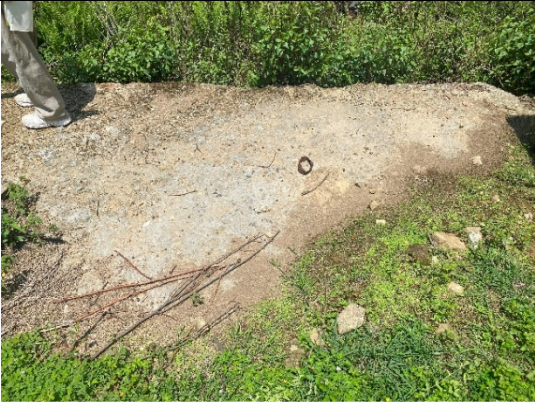
<p>The status of the upstream check dam. It is sedimented, and the sediment runoff prevention function is maintained.</p>	<p>Leveling concert of the water passage part. Wear, etc., is not recognized.</p>

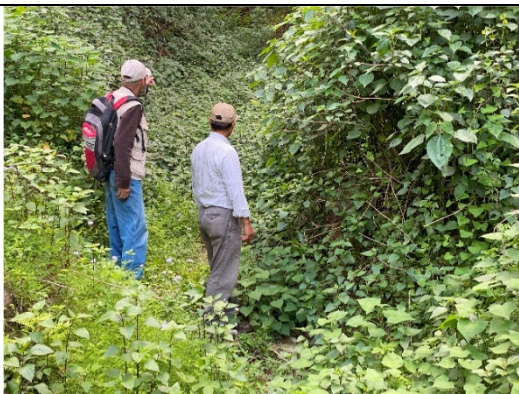
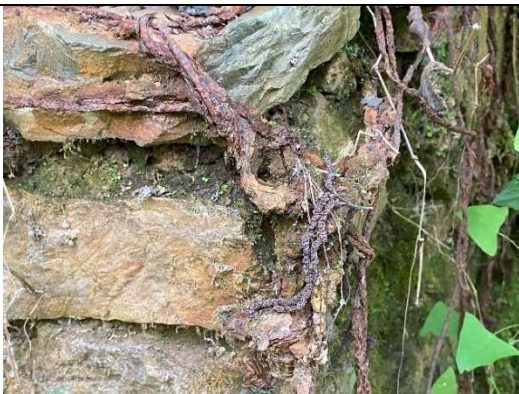
<p>Status of upstream check dam</p>	<p>Expansion of the upstream check dam. Gabion wires are corroded and partially missing.</p>

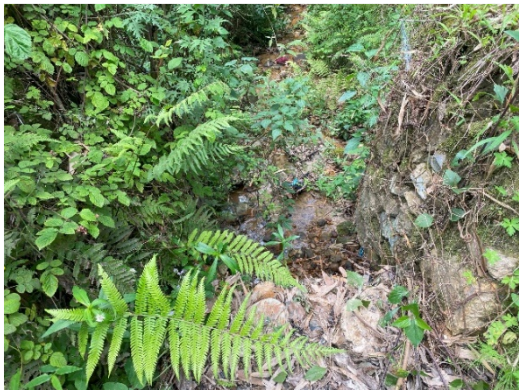
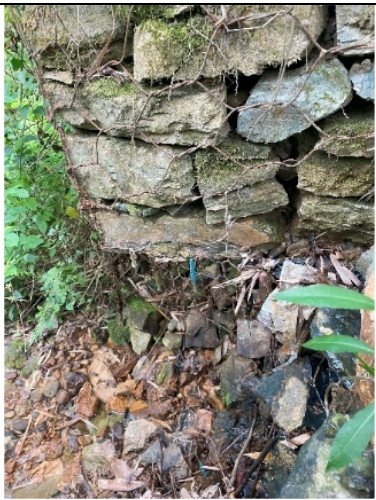
<p>Downstream check dam situation. The front foundation is eroded.</p>	<p>Downstream check dam situation. Gabion wires are corroded and partially missing.</p>

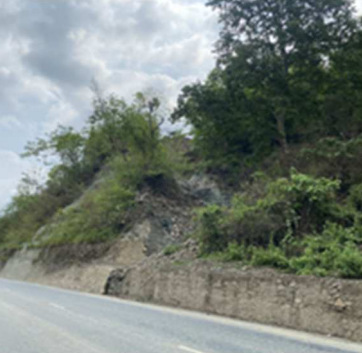
<p>Risk Index Ranking of Longlist 34, 20+500, L5, Flow Probability year of whole-width damage event: 0.2 years Reopening duration from whole-width road closure 0.1 days DOR has no plan for engineering measures. A bridge risk avoidance plan (PLAN II for debris flow) with the highest EIRR is selected after a comparison with the two watershed erosion control alternative planes (PLAN I and PLAN III). All alternative plan (PLAN I, II, III) have positive NPVs. The realignment by bridge to the road valley side is selected for the 100 probability years of peak debris flow rate x 1.1 that flow debris flow safely.</p>

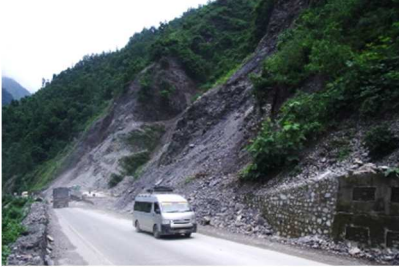
<p>Risk Index Ranking of longlist 4, 31+400, L25, Collapse. Probability year of whole-width damage event: 0.2 years Reopening duration from whole-width road closure: 0.1 days DOR and GESU are planning and designing slope engineering measures projects in the watershed under a WB-funded ADPC contract. DOR's DRO is in the process of planning and designing engineering measures. After comparing the frame work with the lockbolt, realignment by reinforced earth, the slope cut plan is selected with the highest EIRR and target safety level of 50 probability years.</p>

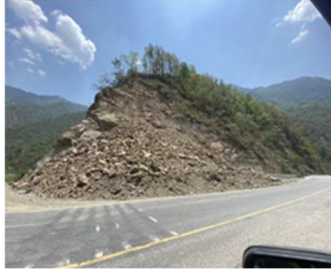
<p>Risk Index Ranking of longlist 14, 33+150, L24, Collapse. Probability year of whole-width damage event: 0.1 years Reopening duration from whole-width road closure: 0.1 days DOR's DRO is in the process of planning and designing engineering measures. After comparing the frame work with the lockbolt and realignment with reinforced earth, the slope cut plan with a high EIRR and target safety level of 50 probability years is selected.</p>

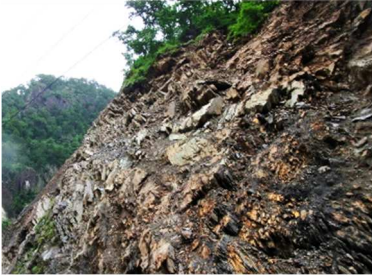
<p>Risk Index Ranking of longlist 15, 33+800, L26, Collapse. Probability year of whole-width damage event: 0.2 years Reopening from whole-width road closure: 0.2 days DOR and GESU are planning and designing slope engineering measures projects in the watershed under a WB-funded ADPC contract. After comparing the results with the frame work with lockbolt and realignment with reinforced earth, the slope cut plan with a high internal return rate and target safety level of 50 probability years probability is selected.</p>

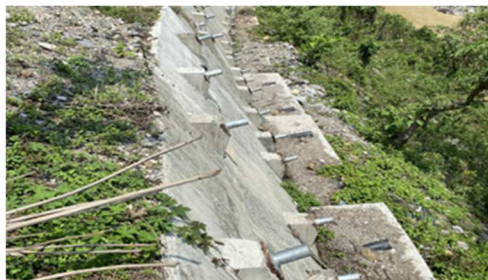
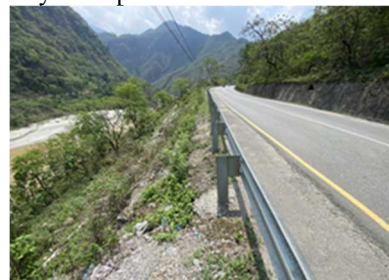
Ground anchors have been taken to measure landslides and road collapse in 2022. Minor road surface subsidence is observed at 15+300 adjacent to the road but can be addressed by visual monitoring.

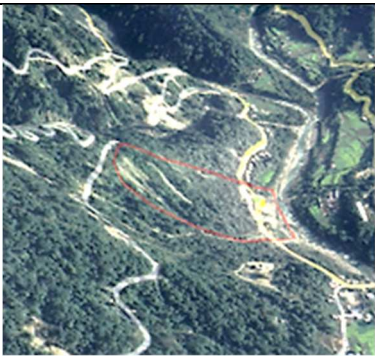
<p>Google Earth Image, Dec.2022</p>	<p>Risk Index Ranking of Longlist 2, Slide Probability year of whole-width damage event: 3years Reopening duration for whole-width road closure: 2.7 days 9th of DOR's priority list of requests to Japan (10th October 2023) After comparison with the plans of engineering measures, including drainage wells, the horizontal subsurface drain is selected with the highest EIRR, less cutting of standing trees, and target safety level of 25 probability years.</p>

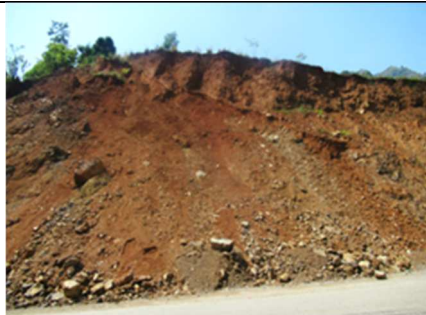
<p>Risk Index Ranking of Longlist 29, Collapse Probability year of whole-width damage event: 10 years Reopening duration for whole-width road closure: 0.5 days 13th of DOR's priority list of requests to Japan (10th October 2023). After comparing the frame work with the rock bolt, the slope cut is selected with the highest internal return rate and target safety level of 50 probability years.</p>

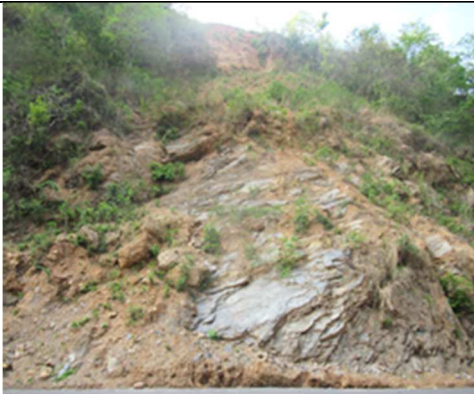
<p>Risk Index Ranking of longlist 12, Collapse. Probability year of whole-width damage event: 7 years Reopening duration for whole-width road closure:1.6 days. 12th of DOR's priority list of requests to Japan. As a result of comparison with the frame work with anchor and high intensity rockfall protection barrier, the slope cut is selected with the highest EIRR and the target safety level of 50 probability years.</p>

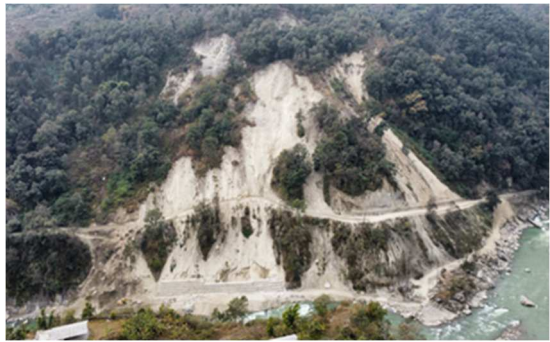
<p>Risk Index Ranking of Longlist 16, Collapse Probability year of whole-width damage: 3 years Reopening duration from whole-width road closure: 5.8 days 23rd DOR's priority list requests to Japan on 10th October 2023.</p> <p>The assessment results of the alternative plans of engineering measures with slope bioengineering and high energy debris protection barrier all have positive NPV. Plan III for the gabion catch works and road realignment with reinforced earth was selected, because of the highest EIRR among alternative Plan I, II, and III for collapse. The selected Plan III has a target safety level of 25 probability years.</p> <p>Since the project is in the Annapurna Nature Reserve, it is necessary to comply with regulations regarding tree cutting, bioengineering, etc.</p>
---	---

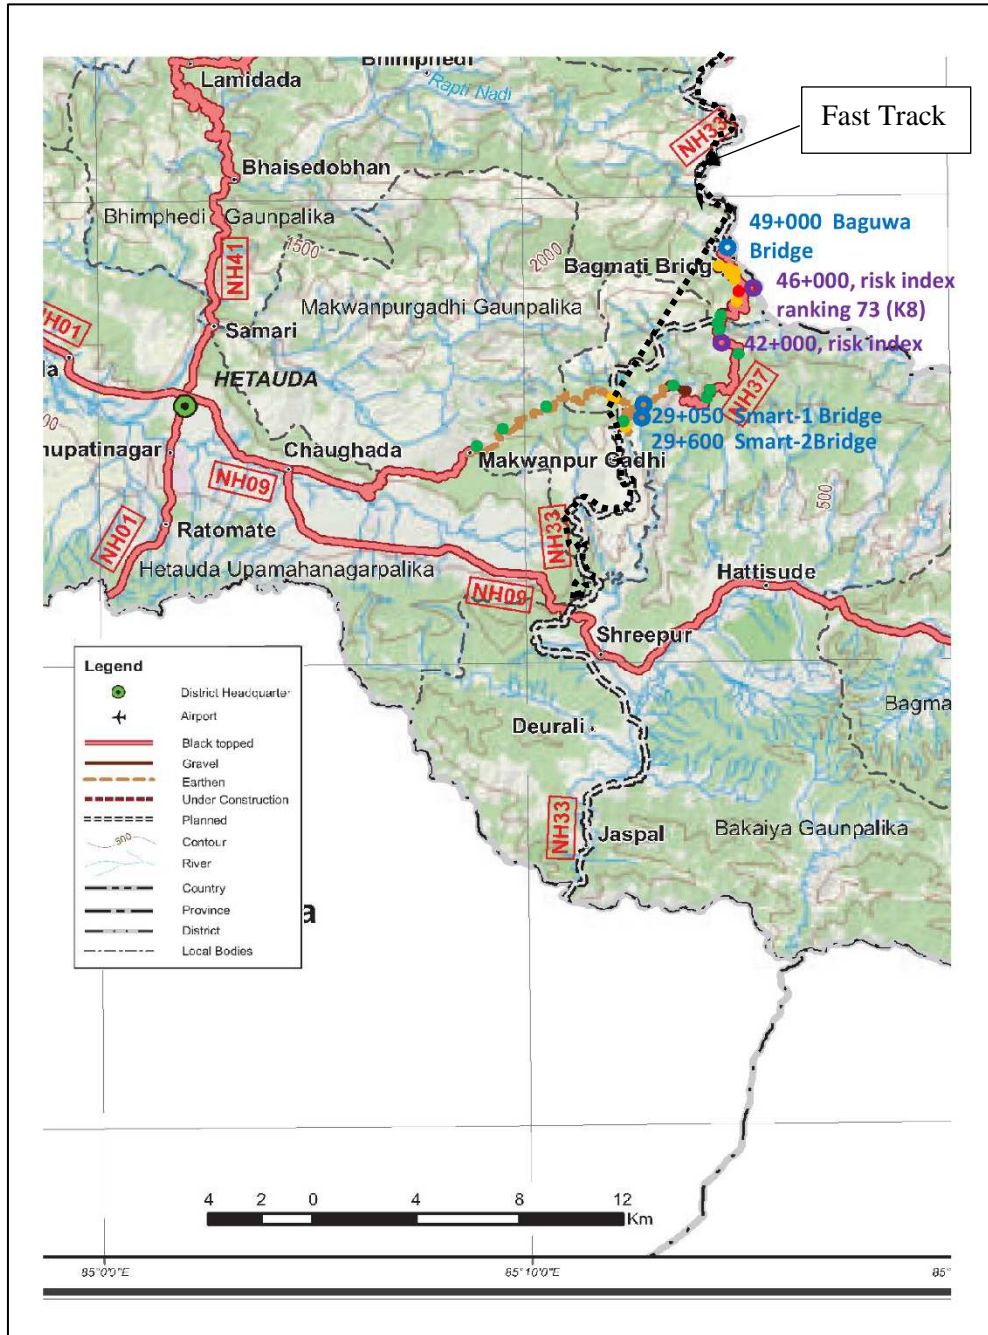
Figure 14-1 Map of the Sites of Large Scale Landslides and Road Improvement Projects (Lalitpur District)

Symbol	Description
●	Sites affected by large-scale landslides where DOR expects support
●	Road widening by mountain slope cutting + asphalt paving
●	Asphalt pavement (road widening by cutting the mountain side slope has been completed)
●	Bridge Replacement
●	Landslide avoidance plan using tunnels

The alternative to the project to the landslide engineering measures and road improvement project may be the construction of tunnels and shortening the road length, as shown in **Figure 14-1**. Four sites with large-scale collapses require extensive and technically difficult measures in the case of the construction of physical structures. The concerned four sites are listed below:

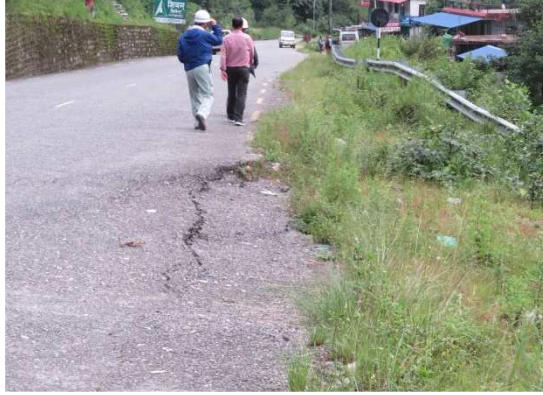
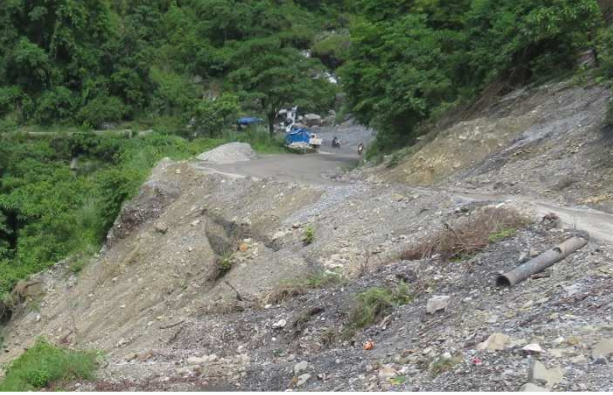
<p>Road carriage collapse has occurred due to landslide movement within a large-scale landslide.</p> <p>NH03 37+900 (Risk Index Ranking 25)</p>	<p>The road lies on top of the colluvium, and road carriage collapse occurs due to the collapse and movement of colluvium.</p> <p>NH47 39+600(Risk Index Ranking 28)</p>
