Department of Surface Transport

Project for Capacity Development on
Countermeasures of Slope Disaster on
Roads in Bhutan

Project Completion Report

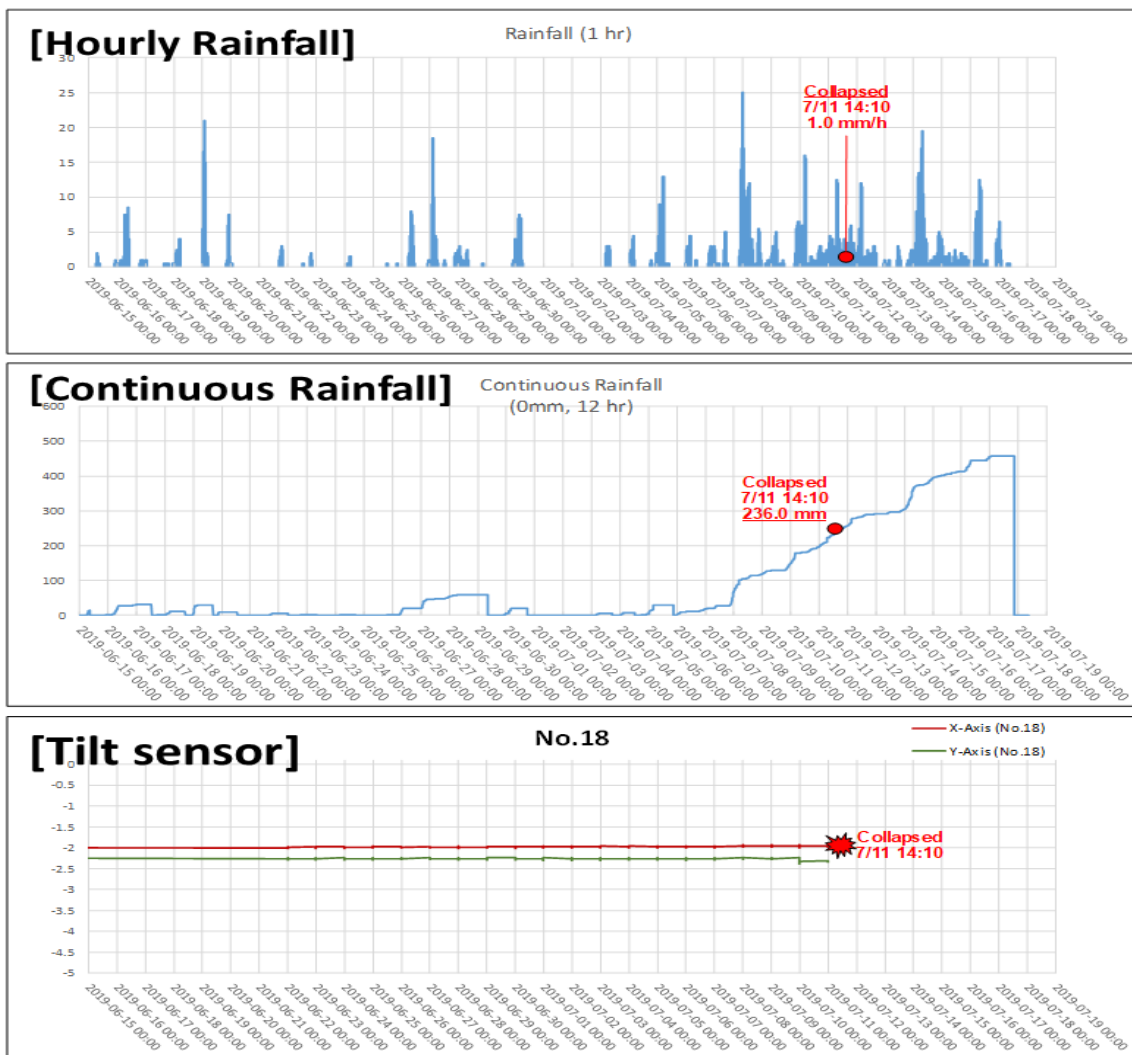
From these graphs, the continuous rainfall at the time of slope failure is 236.0 mm and the hourly rainfall is 1.0 mm / h. This is a guideline for setting the regulatory standard rainfall.

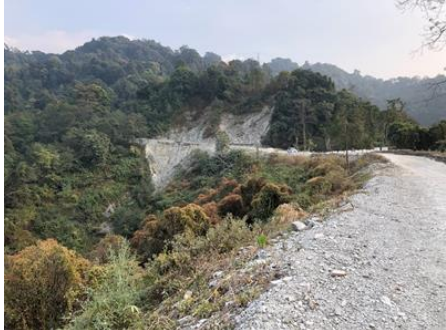
The site is a bedrock cut slope with road subsidence due to a landslide in an adjacent area. Regarding the surrounding conditions, the surface of the slope under the road in the direction of Gelephu is unstable.

Photo 3.3-7 Distant view of the candidate slope (Road slope in front is unstable).

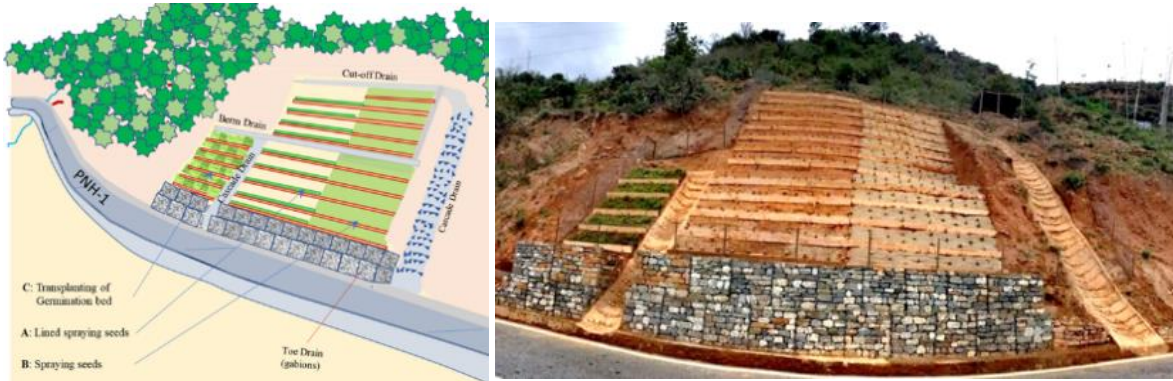
For the first test construction, which was completed at the end of May 2020, the figure shows the overall view of the plan and the condition of the slope after the completion of the test construction. The photo shows the condition of the slope approximately 3 months after the completion of the construction (September 26, 2020). At this point, the vegetation is thriving best in Type B: full surface seed application (jute netting), followed by Type C: turfing, and although Type A: strip seed application has germinated, it is considerably inferior to the lower part of Type B and Type C. The photo shows that the vegetation is thriving well in Type B, but not in Type C.

(Source: JET)
 Figure 3.3-29 Overall view of the project (left), slope immediately after vegetation construction (right) (May 31, 2020).

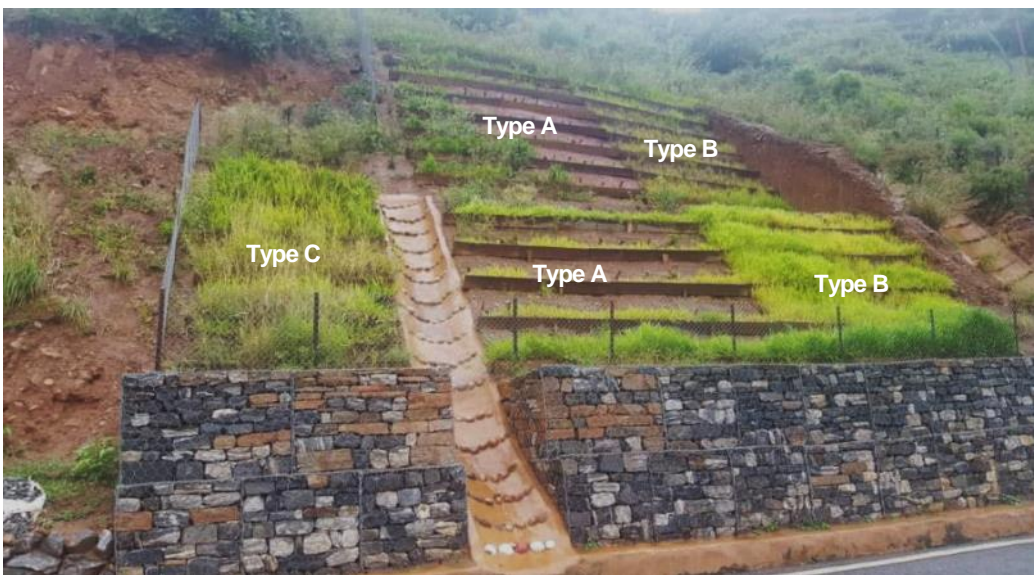
(Source: JET)
 Photo 3.3-31 Slope conditions about three months after vegetation construction (September 26, 2020)

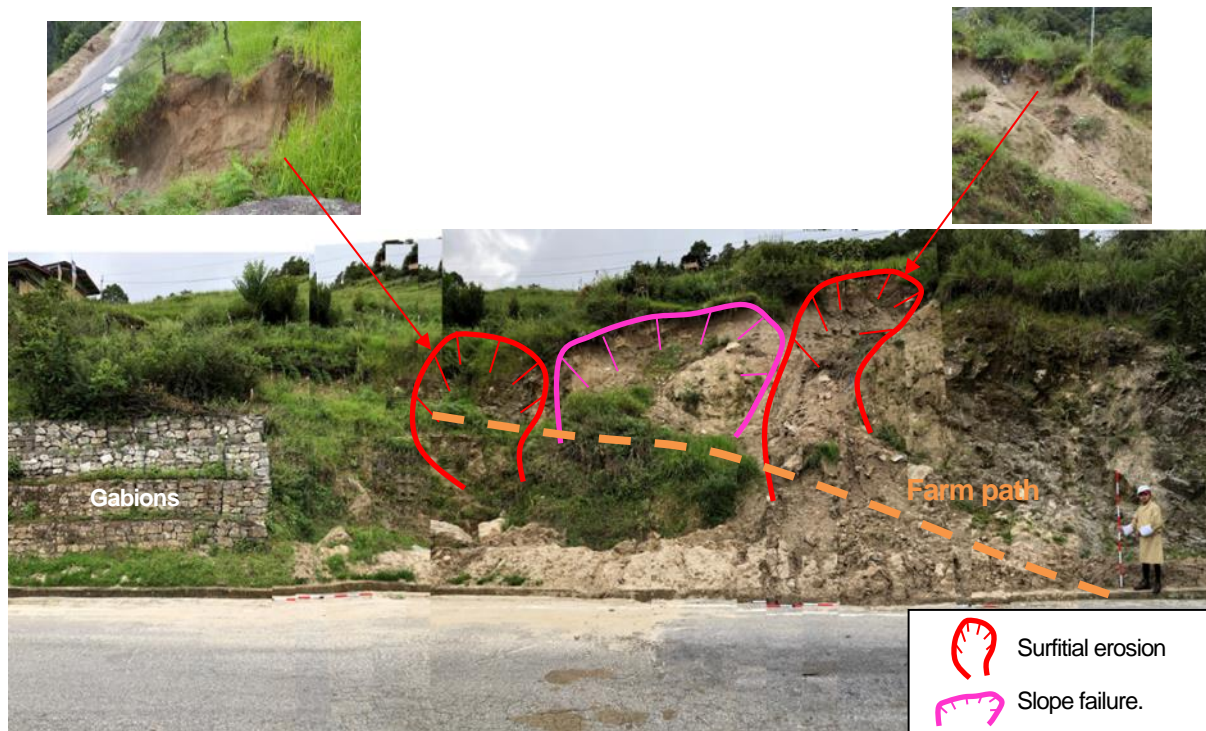
In the center of the slope, there are the remains of an agricultural trail, and on the left side of the slope, a futon basket was constructed as a countermeasure to a previous slope failure.

Photo 3.3-32 Local conditions of the slope adjacent to the east of the second test slope (T-veg. 014, Yangkhil Resort)

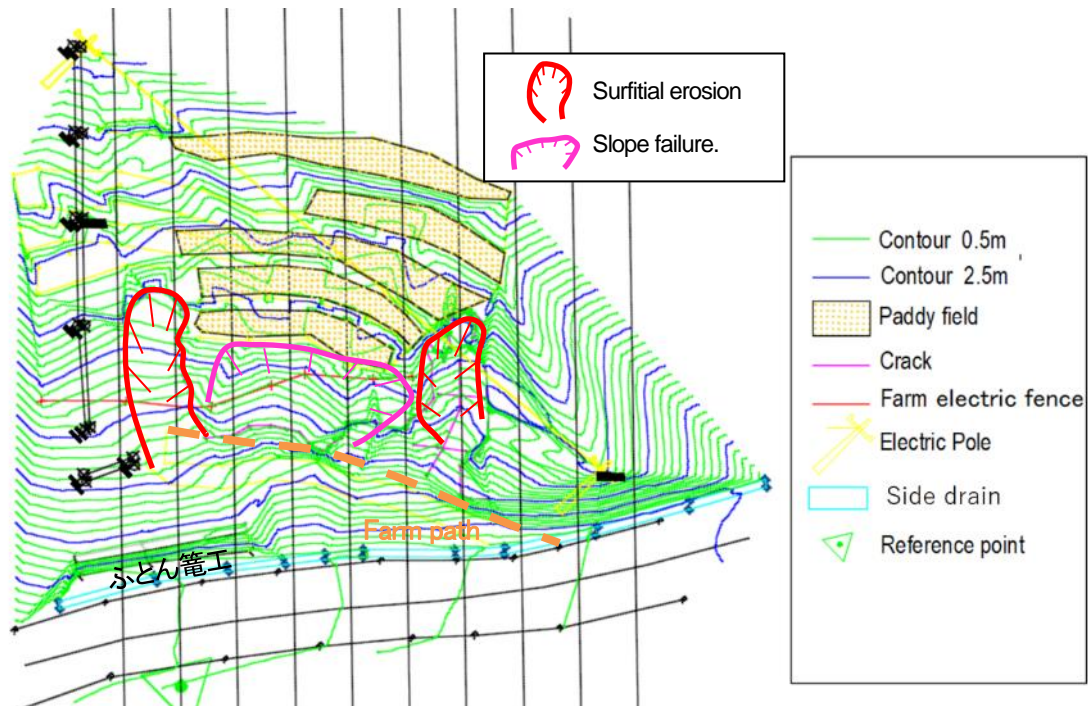
(Source: JET)
Figure 3.3-30 Plan of the slope adjacent to the east of the 2nd test construction slope (T-veg. 014, Yangkhil Resort).
