3.4 Output 3: Standards for cut slope angles for “debris slope failure” and “rock slope failure” are revised.

3.5 Output 4: Suitable countermeasure works are implemented for “rock slope failure (rock fall).”

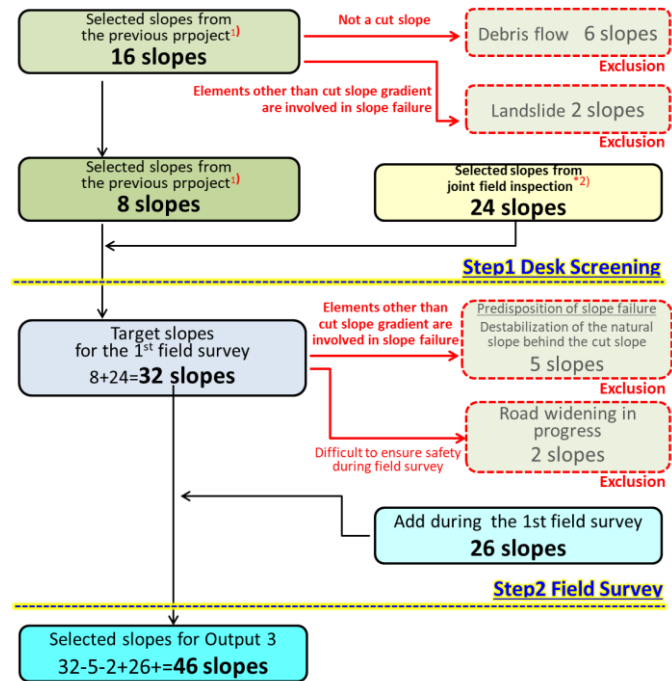
Figure. 3.4-1 Output 3: Selection flow of target slope

In order to study standard cut slope slopes, cut slopes under various conditions (geological conditions and stability) need to be included in the study. The selection process consists of two steps: 1) desk screening and 2) field survey.

In the desk screening, in addition to the slopes with high priority for countermeasures identified in the previous project "Project for Master Plan Study on Road Slope Management in Bhutan," the results of the field inspection conducted jointly with the C/P at the start of this project (The target

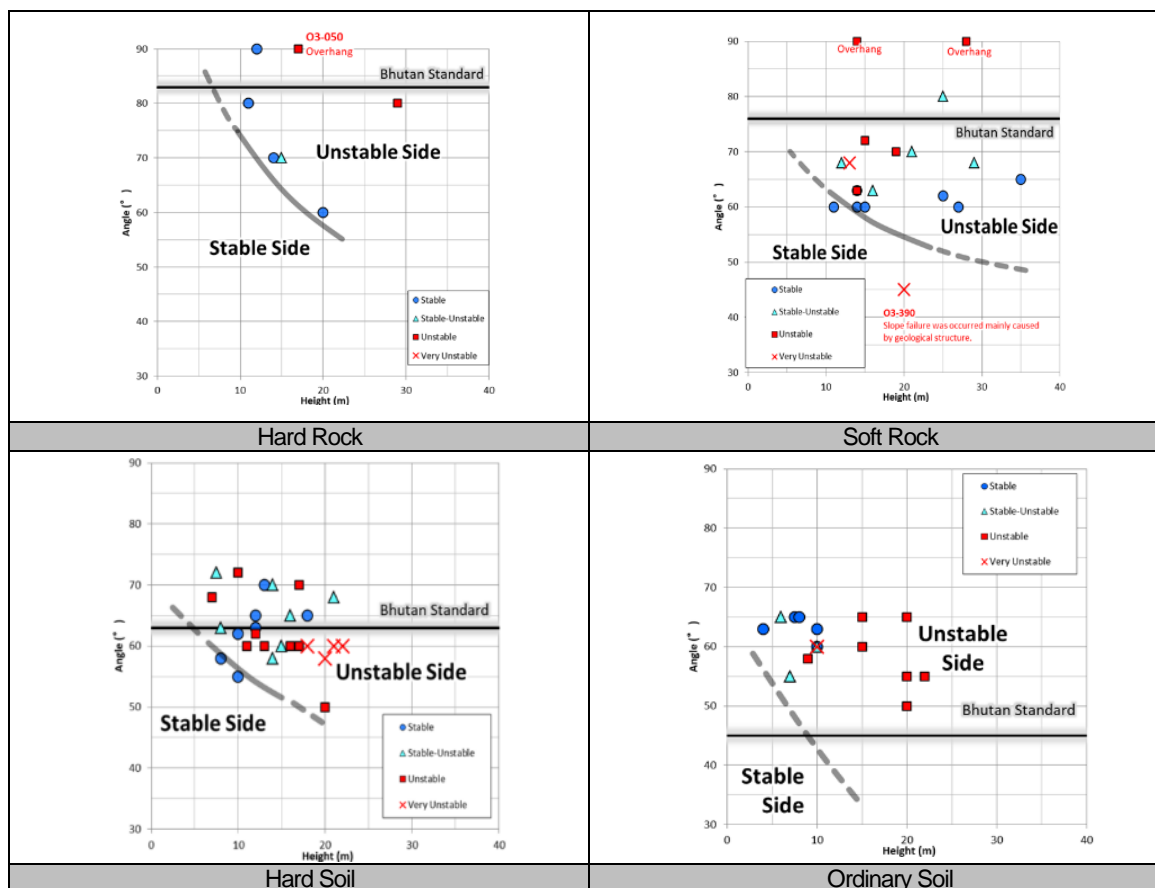
For each of the four categories in the evaluation of geological properties, a correlation map of cut slope on the vertical axis and cut height on the horizontal axis is created. By adding the stability assessment of the cut slope obtained from the interviews to these correlation charts, it is possible to estimate the stable/unstable areas of the cut slope for each geological feature. The correlation graphs are shown below, and the problems with the current cut slope standards in Bhutan are summarized.

*1 Slope specifications (Horizontal axis: Height of cut slope Vertical axis: Angle of cut slope)

- Unstable cut slopes were observed even at cut slope gradients gentler than the current Bhutan standard, suggesting that the cut slope gradients in the current standard are steeper than the appropriate gradient.
- There are some unstable one on cut slopes over 10 m high, but there is not specified the slope height in the current standard as with other classifications.
- All of the cut slopes with overhangs are unstable.
- Collapse occurs even when the slope gradients is gentle, but this is due to the geological structure, such as the dip slope, and can be considered an anomaly. However, it is an important factor for stability and should be considered when constructing cut slope.

- Unstable cut slopes were observed even at cut slope gradients gentler than the current Bhutan standard, suggesting that the cut slope gradients in the current standard are steeper than the appropriate gradient.
- Unlike the above two categories, unstable conditions were observed even in areas with low slope heights of 10 m or less, and stable conditions could not be observed in areas with slope heights exceeding 20 m. As in the other category, there is no standard for slope height in the current standard.

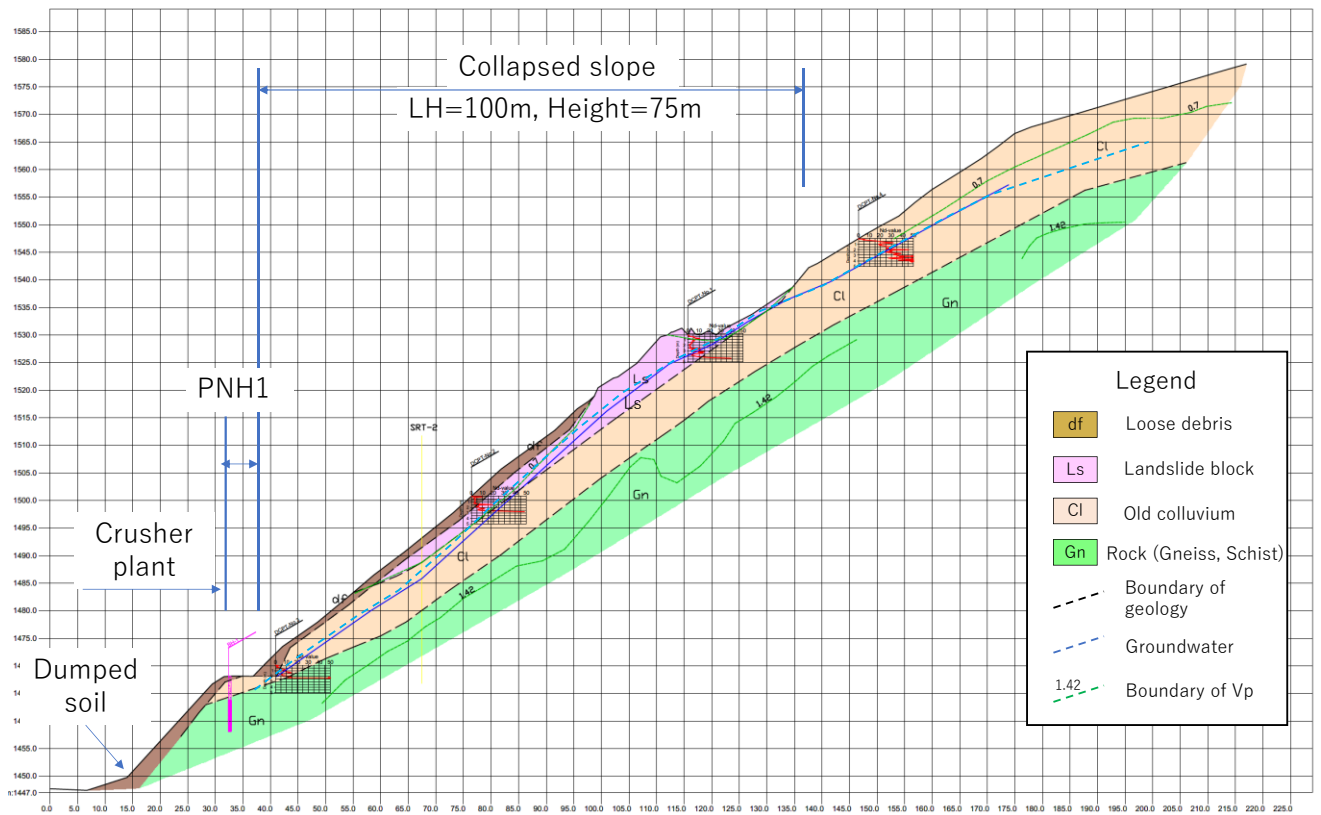
A geologic cross section of the subject slope was prepared based on the results of the field transects, borehole investigations, and seismic surveys.

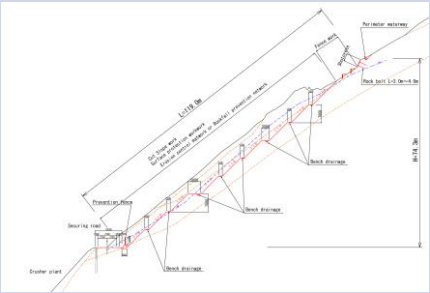
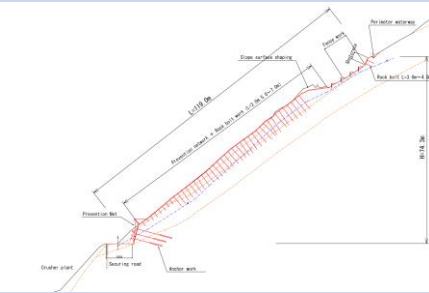
Plan 1 To stabilize by changing to stable shape (remove all unstable part)	Plan 2 To stabilize by structural force (mechanical countermeasure)
Standard cross section

Advantage	<ul style="list-style-type: none"> Stability of the slope can be secure after countermeasures due to removing all unstable part. Maintenance after work is easy. 	<ul style="list-style-type: none"> Reduce the risk of secondary slope failure during construction due to minimal removal of unstable part
Issue	<ul style="list-style-type: none"> A long-term construction period will be required. It is difficult to ensure the safety of the national highway during cutting work (road closure measures are required) 	<ul style="list-style-type: none"> Material and machinery may be brought from out of country (construction costs will increase) Maintenance of the structures is required regularly after completion of the construction

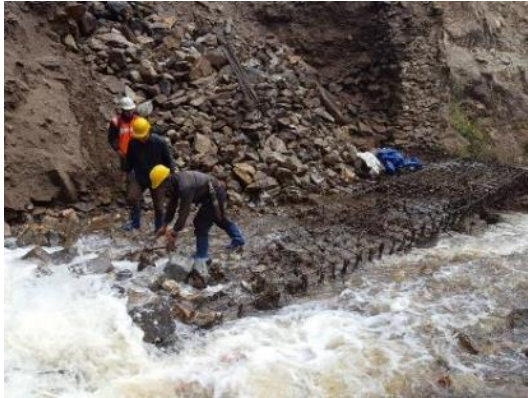
Damage to right bank foundation (Apr/19/2020)

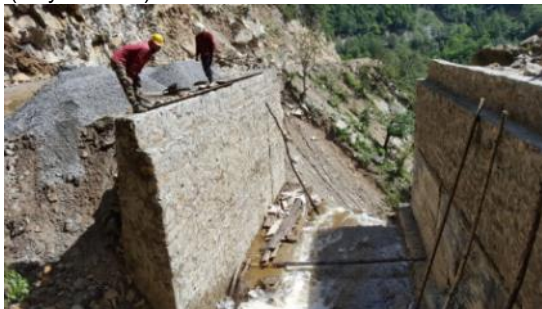
Damage to right bank foundation due to rising water (Jun/4/2020)

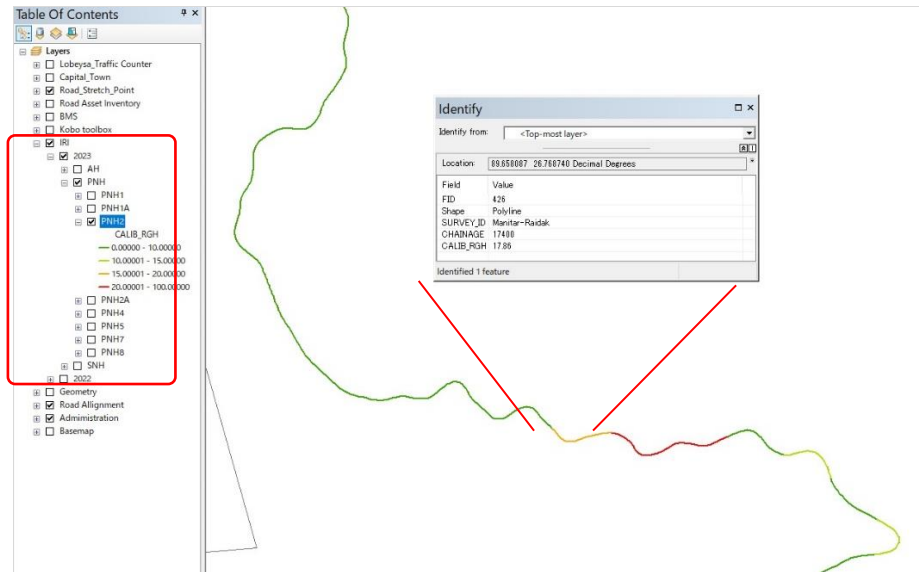
This data was measured every 100 m by ROMDAS as an indicator of the degree of road surface unevenness. The data is displayed in a gradation of colors from green to red, from low (less uneven) to high (more uneven). In the case of Bhutan, since pavement maintenance and regular maintenance and repair have not progressed in many areas, the IRI indicator is often used to identify unpaved sections and sections with severe damage due to potholes, etc. on the map, rather than to plan repairs due to age-related deterioration. For this reason, the range of gradation colors shown on the map is set wider for larger values so that unpaved sections and sections with large damage can be recognized more easily.
