Republic of Zambia  
The Bridge Maintenance Capacity Building  
Project in Zambia, Phase II

Project Completion Report

February 2025

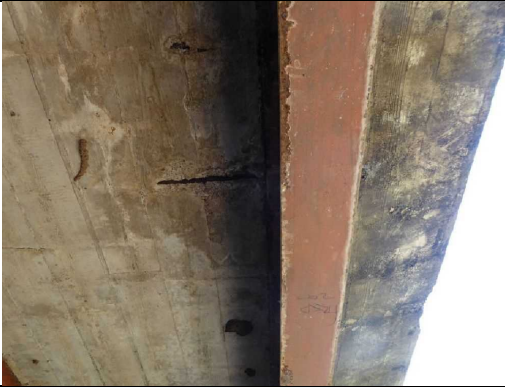
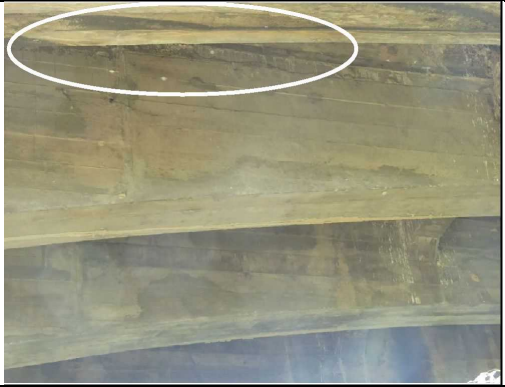
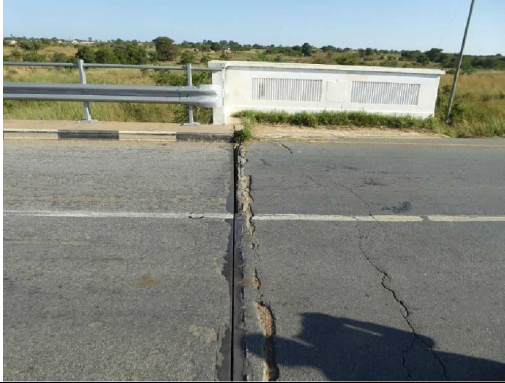
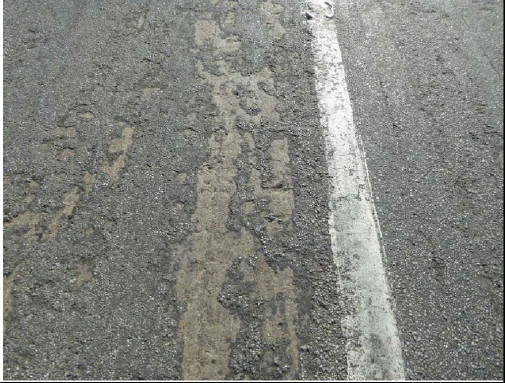
Table II-13: Photographs of the On-site Survey of the Target Bridge in the Southern Region

Damage Case 1) Exposed rebar	Damage Case 2) Janka

Damage Case 3) Damage to the expansion joint	Damage Case 4) Damage to the pavement

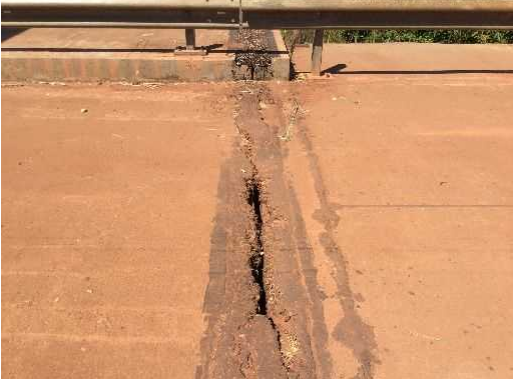
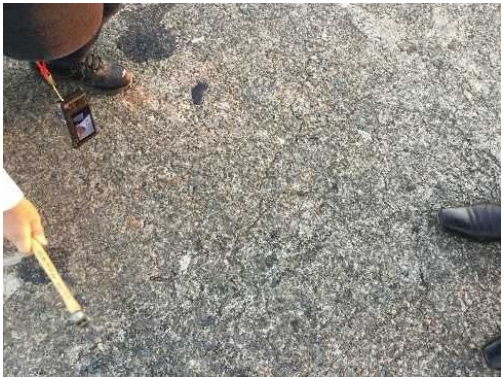
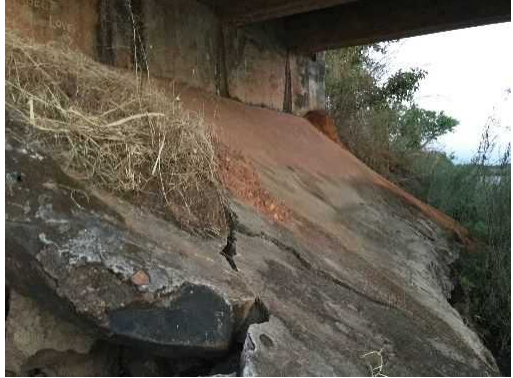
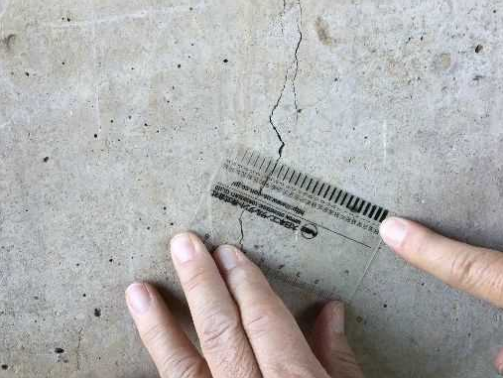
Table II-15: Photos of the Field Survey of the Target Bridges in the Northern Region

<p>Damage Case 1) Joint damage</p>	<p>Damage Case 2) Cracks in the deck</p>

<p>Damage Case 3) Damage to slope protection works</p>	<p>Damage Case 4) Cracks in the piers</p>

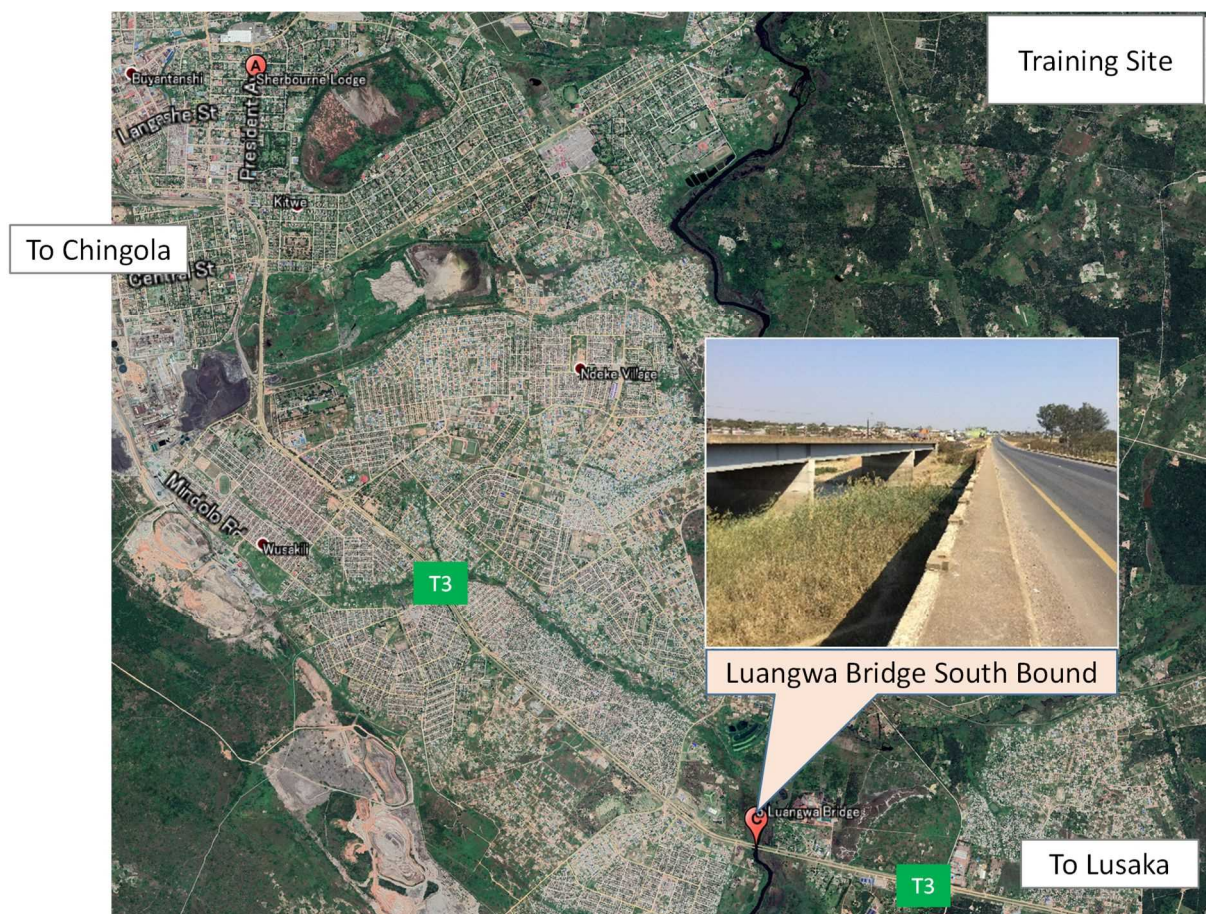
Figure II-12 Bridge Subject to Remote Guidance in Copperbelt RO (Luangwa Bridge)

- **Cracking**: Epoxy coating (less than 0.3mm), Epoxy Injection (more than 0.3mm)
- **Spalling, Honeycomb, Rebar Exposure**: Patching (Polymer Cement Mortar)
- **Scaling**: Coating (Polymer Cement Mortar)
- **Water leakage**: chipping and patching
- **Expansion Joint**: installation of Expansion Joint (Asphaltic Plug Joint)
- **Asphalt Pavement**: Patching, Overlay
- **Slope protection**: repair by reinforced concrete
- **Railing & Post**: Replacement and/or repair
- **Corrosion**: Touch up -painting

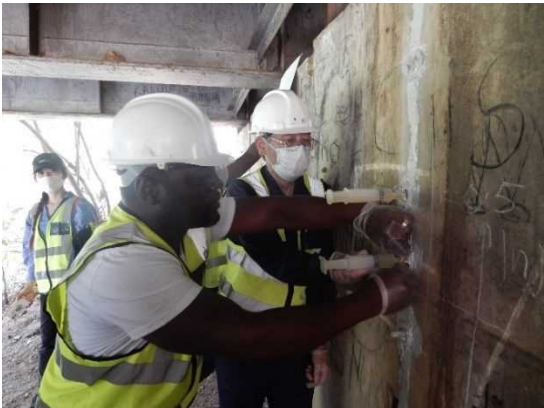
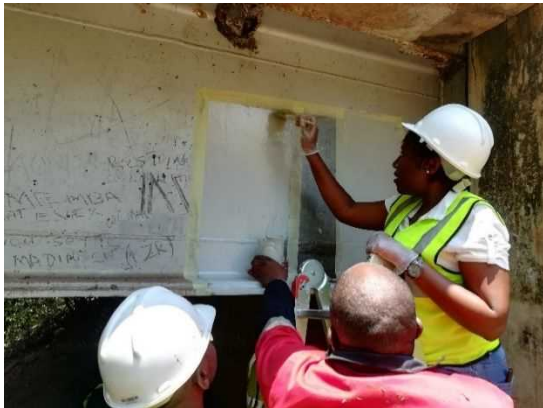
Day 2: Epoxy Injection	Day 2: Touch-up Painting

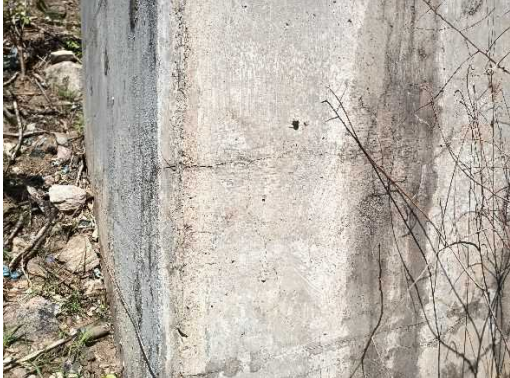
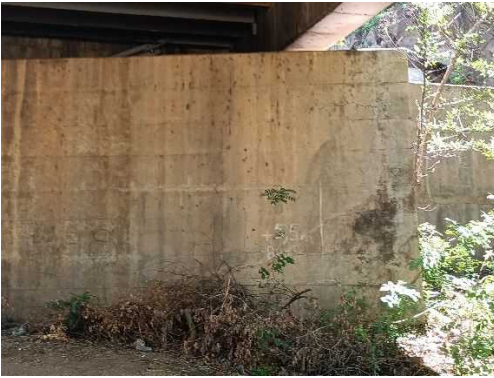
Piers: many cracks	Abutments: many cracks

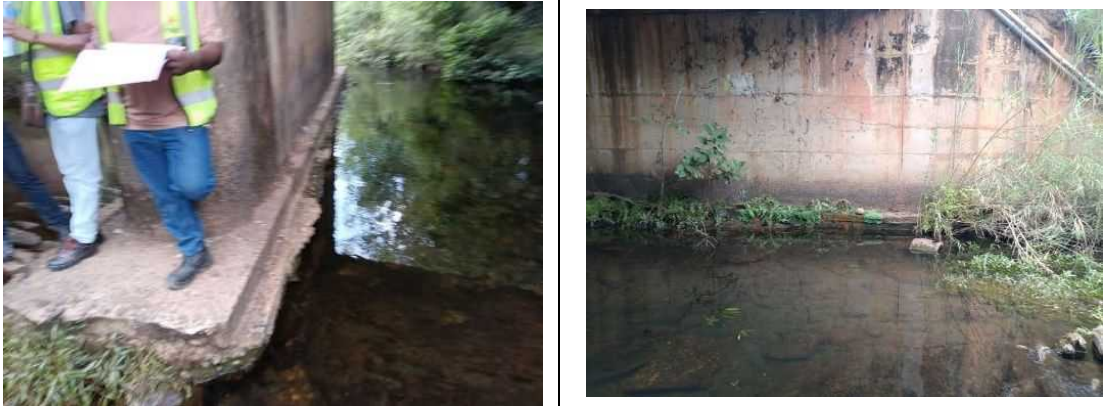
Substructure: damage/loss of protection work

Both bridges require urgent attention to the damage to the guardrails and parapets, and I have instructed that this be coordinated and dealt with between RO and the headquarters. I have also instructed that a bridge inspection vehicle be used to check the underside of the deck and the condition of the steel girders (close-up visual inspection) using the BIV owned by RDA. Overall, I think that the level of damage that has occurred and the selection of countermeasures are generally not a problem.

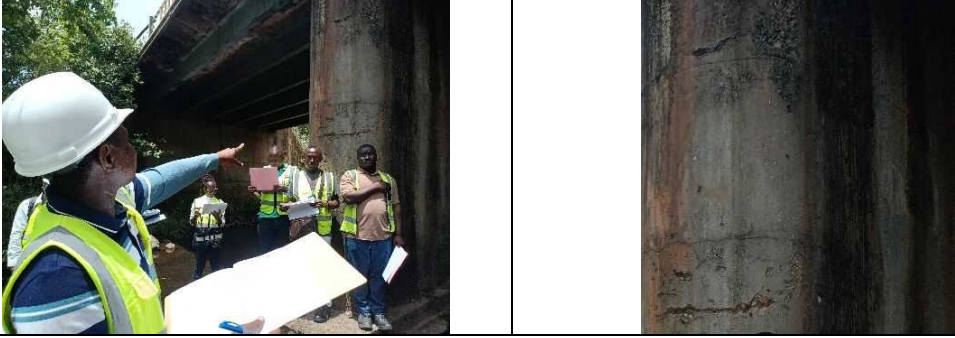
Pillar: crack, uplift

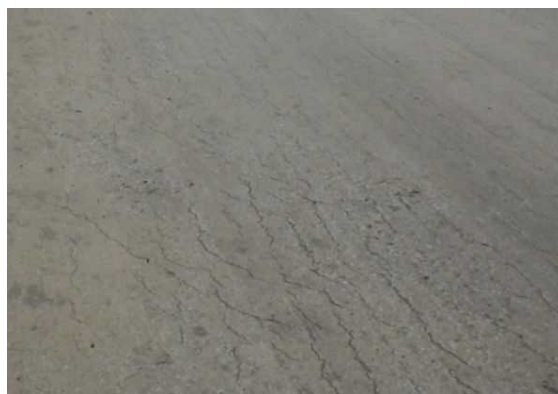
Longitudinal Cracks of Bridge Deck

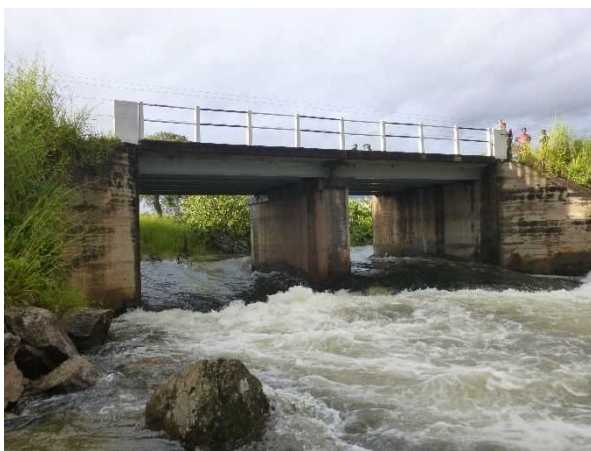
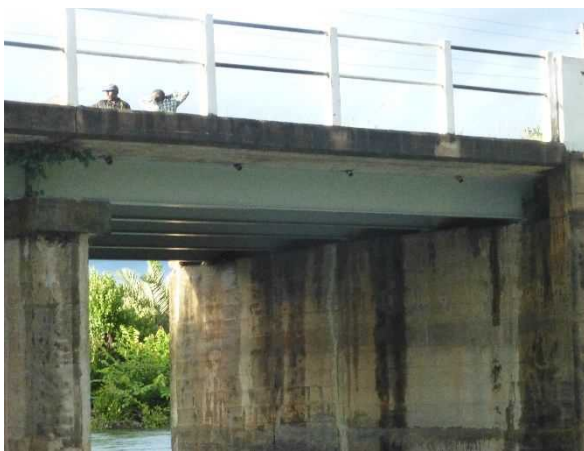
Lubansenshi Bridge	Crack repair (epoxy injection)

Lukashya Bridge	Crack repair (epoxy injection)

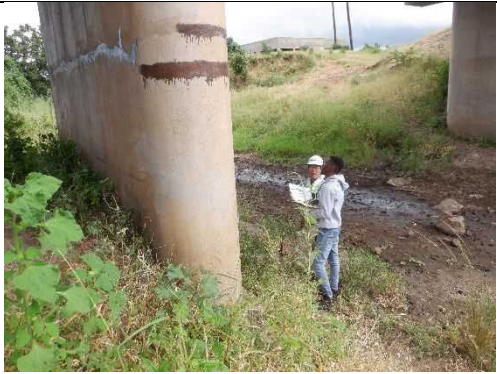
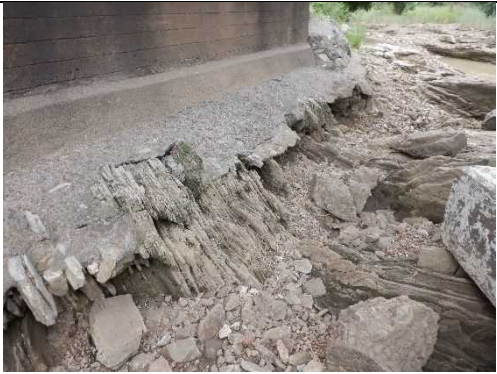
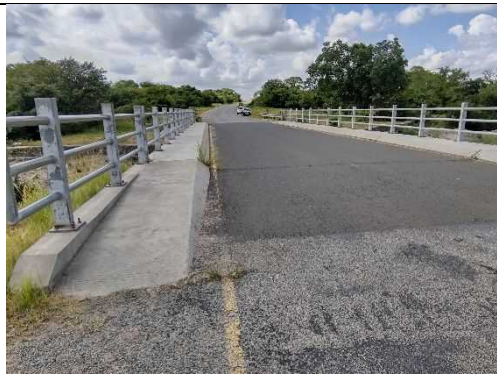
<p>Routine maintenance monitoring (pier repair)</p>

<p>Routine maintenance monitoring (foundation scour)</p>

<p>Narrow width at bridge section</p>

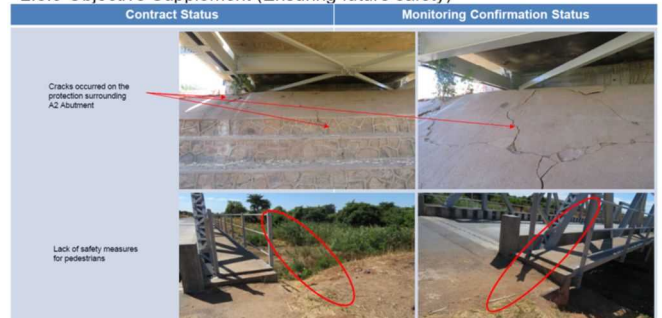
### 2.3.9 Objective Supplement (Ensuring future safety)

**Results:** Heavy cracks on the protection surrounding A2 Abutment, Lack of safety facilities on the walkway
