Result of Field Geological Survey and Ground Truth for the Satellite Image Analysis

Date:	2007/7/5	Location (UTM)		Elev	Geological Unit			
Point No.	NT-01	X (m)	Y (m)	(m)	VSW Index	V	S	W
		265,220	1,268,119	49

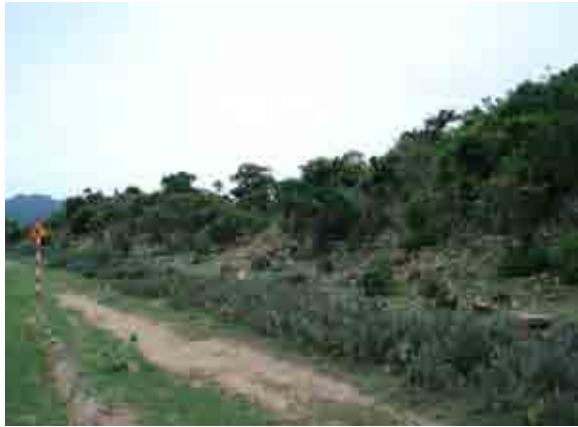
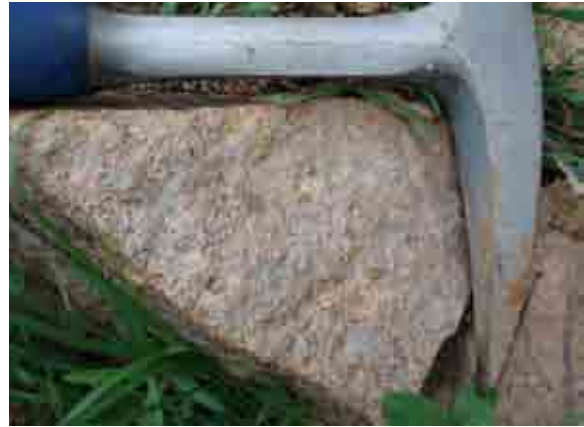
Photo

Topography of granite hill in flat land

Lithology: Medium grained hornblende granite.

Topography: Small hill extend NNE-SSW.

Land use: Grass land for pasturage.

Water use: no water in dug well.

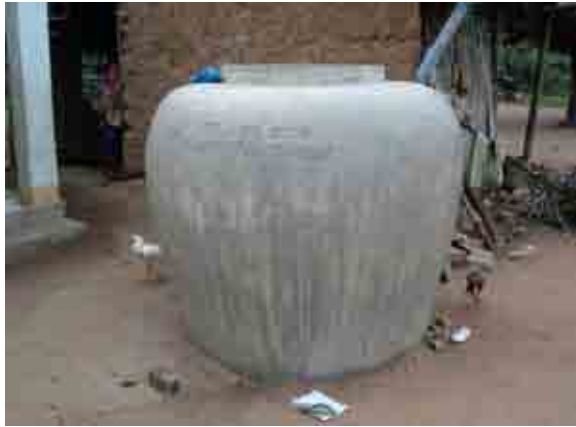
Photo

Village of minority group (Cham tribe)

Water use: Water jar for rain water donated by UNICEF.

Land use: Farmland (corn field).

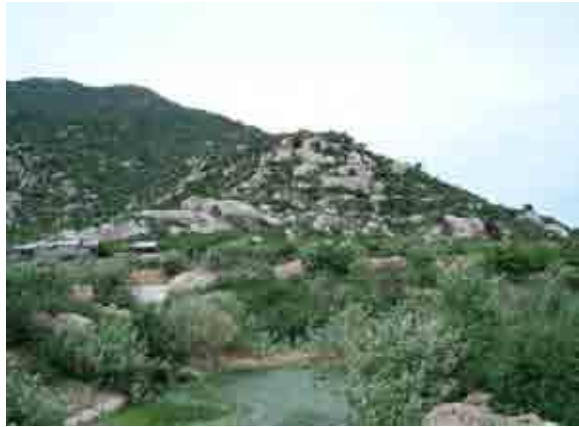
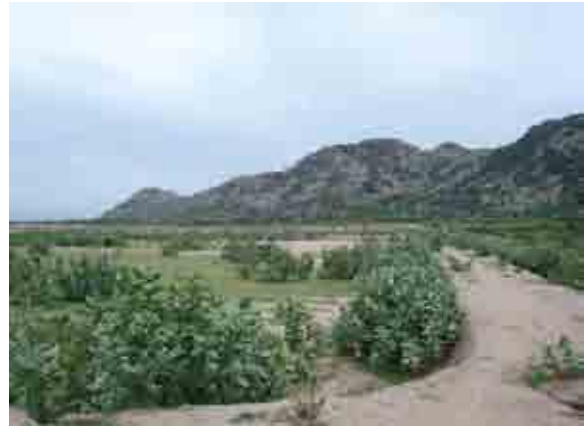
Photo

Salt field near granite mountain

Land use: Salt field operated by VISALCO (almsit field under construction), water pumping unit donated by Japanese Governmnet?

Topography: Steep mountain of Cretaceous granite and flat land.

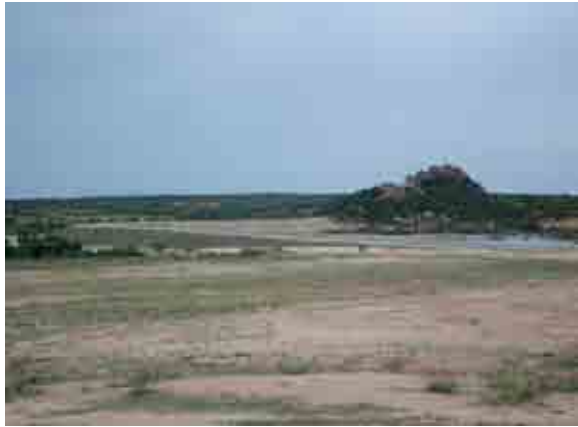
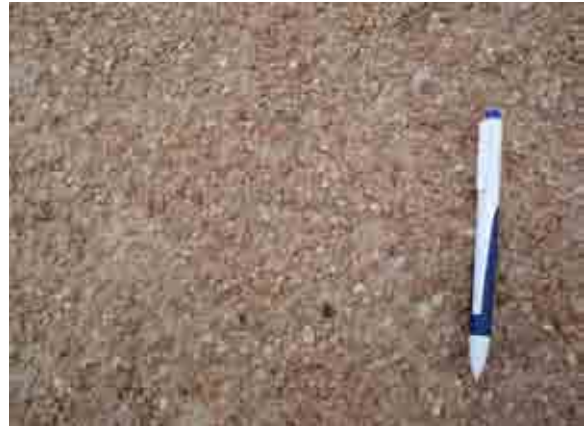
Photo

Dam site for agricultural water supply

Water use: Dam for agricultural water supply operated by the department of agricultural development, dug well (D = 4 - 5m).
 Land use: Farmland (peanut, corn, water melon, paddy field in low land).

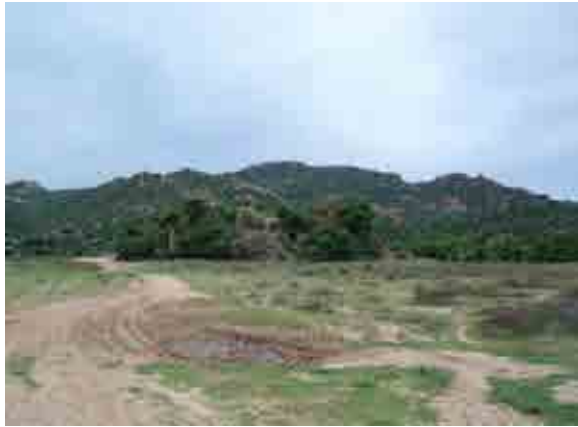
Photo

Topography of granite and sand dune

Topography: Steep mountain of granite and flat land with gentle relief of sand dune

Land use: Bare land of whitish brown colored soil (granule and pebble of quartz, feldspar).

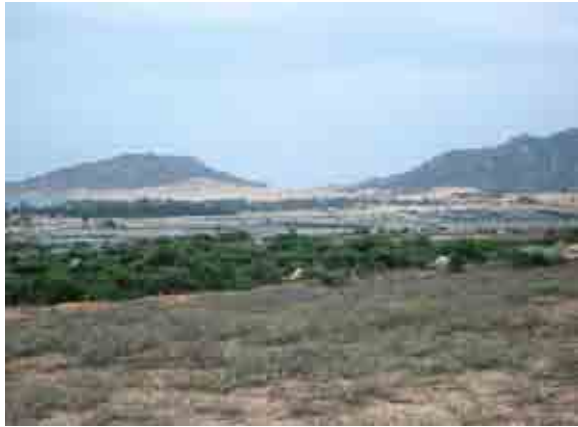
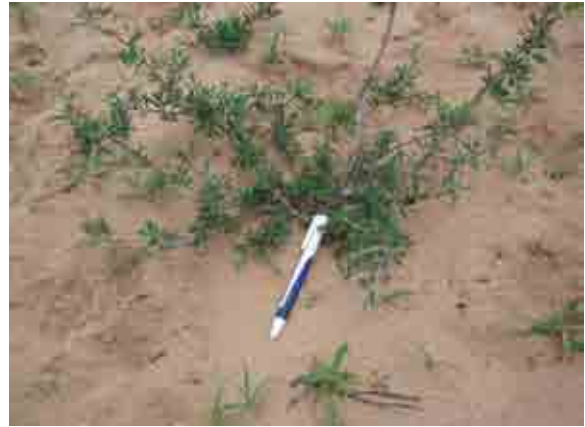
Photo

Topography of sand dune

Topography: Gentle slope hill with whitish brown sand (fine to medium grain of quartz, feldspar)
 Land use: Farmland (bean), fish breeding pond (shrimp) near coast line.

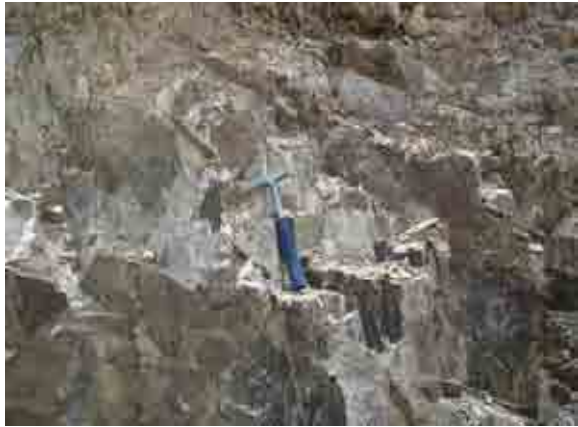
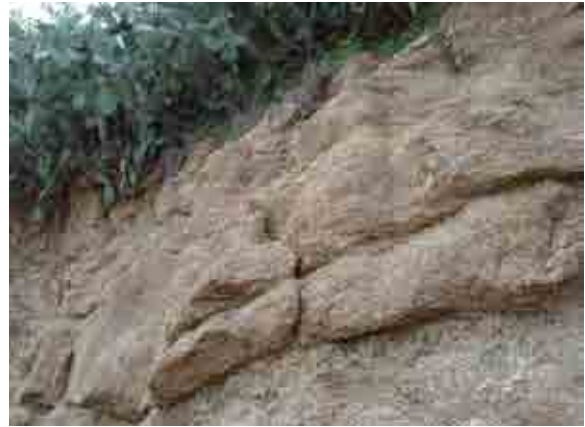
Photo

Outcrop of Cretaceous granite

Lithology: Weathered medium to coarse grained granite.
 Topography: Gentle hill extend NE-SW.

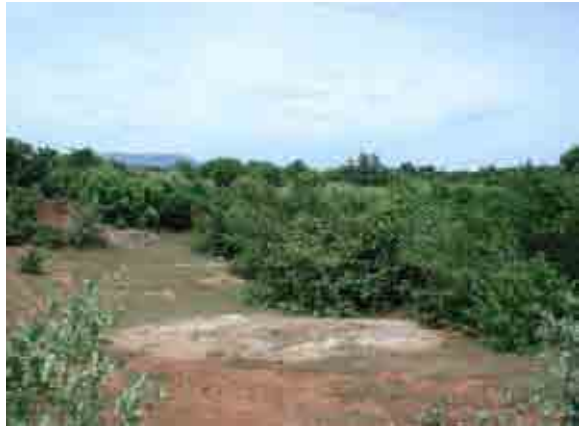
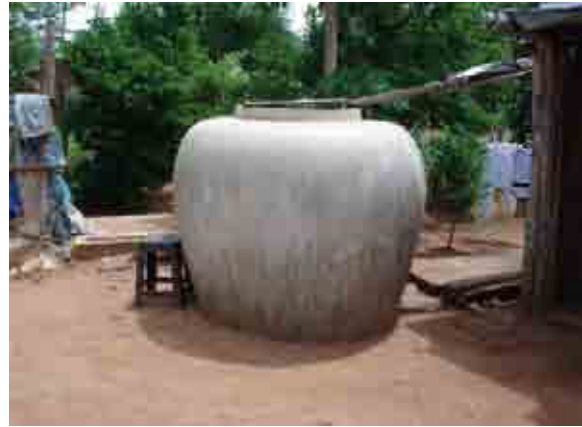
Photo

Water use in Cretaceous granite area

Water use: Dug well (D = 8m) and water jar for rain water, salinity and fluorine problem in dug well, dry up in dry season.
 Topography: Gentle hill, granite exist in shallow part (difficult to drill under 20m).

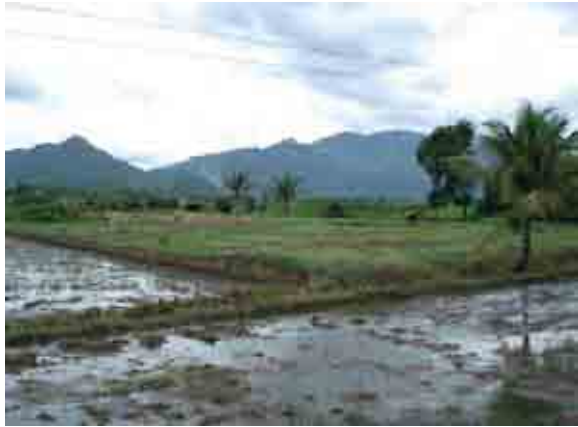
Photo

Land use in intermountane basin

Land use: Farmland (paddy field).

Water use: Agricultural water supply from river water.

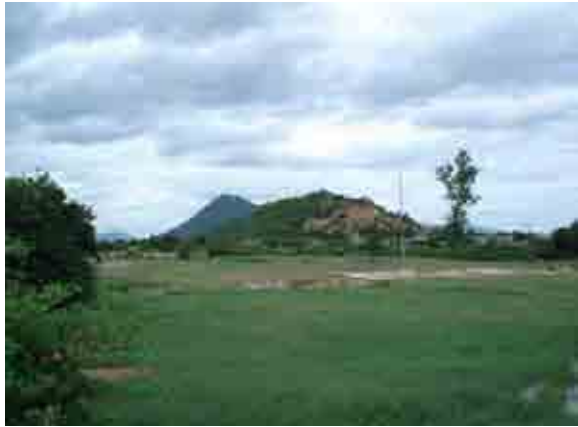
Photo

Topography in intermountane basin of granite

Topography: Small mountain extend NE-SW.

Water use: Dug well for drinking (D = 4m), calcium problem in groundwater.

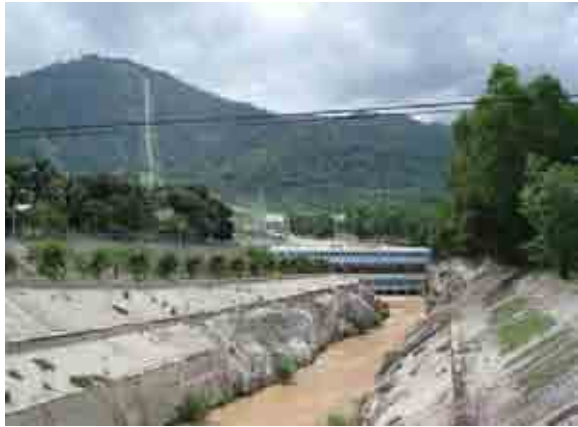
Date:	2007/7/5	Location (UTM)		Elev	Geological Unit			
Point No.	NT-12	X (m)	Y (m)	(m)	VSW Index	V	S	W
		247,769	1,309,003	214

Hydraulic power plant in granite area

"Song Pha" hydraulic power plant, water from dam in the opposite side of mountain by pipeline.

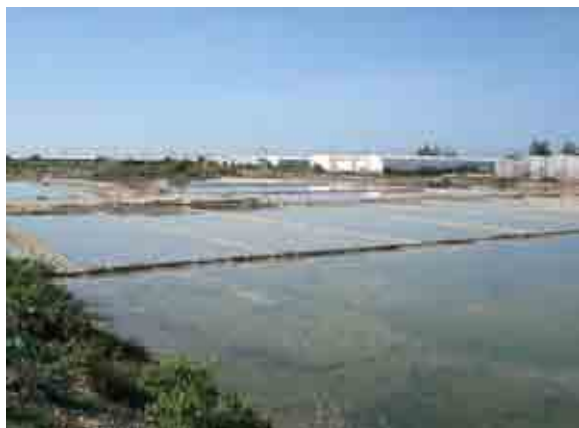
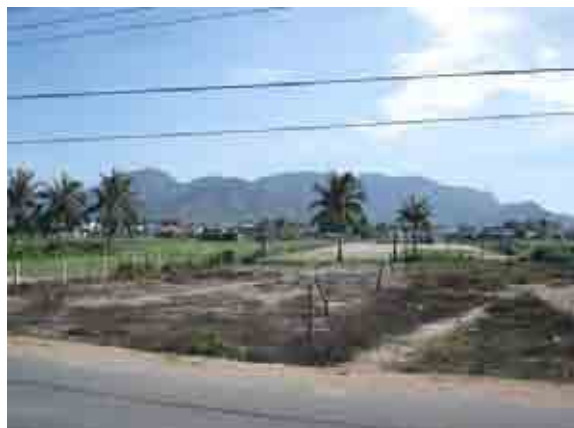
Date:	2007/7/6	Location (UTM)		Elev	Geological Unit			
Point No.	NT-13	X (m)	Y (m)	(m)	VSW Index	V	S	W
		292,821	1,281,532	5

Land use in flat land near coast

Land use: Fish breeding pond (Shrimp) and salt field, factory for salt manufacturing, farmland (garlic and onion).
 Water use: Dug well, salinity problem.

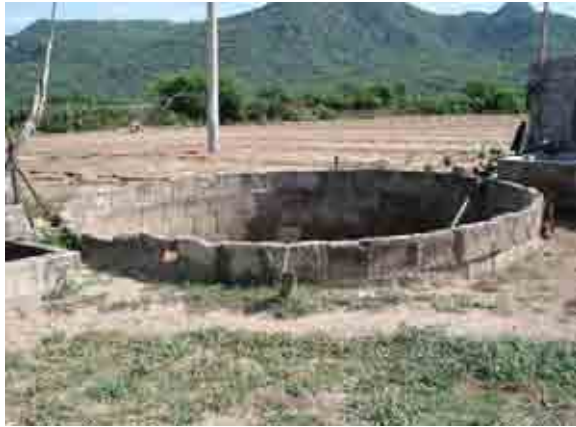
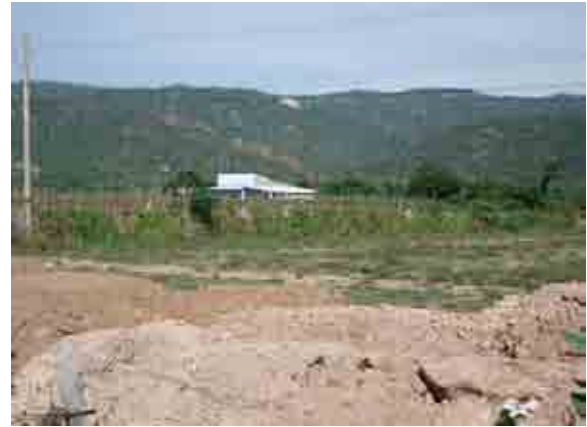
Date:	2007/7/6	Location (UTM)		Elev	Geological Unit			
Point No.	NT-14	X (m)	Y (m)	(m)	VSW Index	V	S	W
		300,011	1,289,182	14

Water use in intermountane small basin

Water use: Dug well for drinking (D = 3m, W = 5m), quality of water is good, volume is rich, water supply system from dam.

Land use: Farmland (grape, garlic and onion)

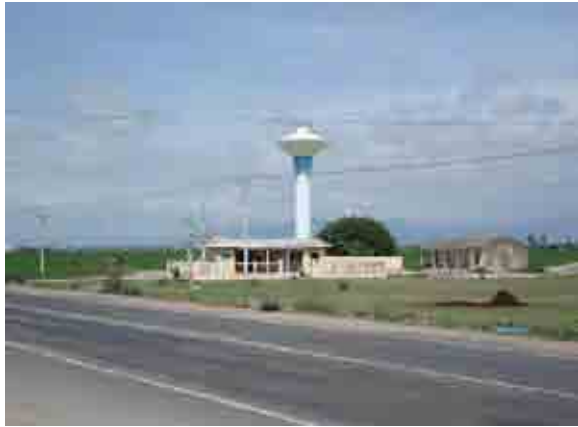
Date:	2007/7/6	Location (UTM)		Elev	Geological Unit			
Point No.	NT-15	X (m)	Y (m)	(m)	VSW Index	V	S	W
		284,763	1,289,243	5

Water supply system

Water use: Water supply center for drinking, dug well and river water for irrigation.
 Land use: Farmland (paddy field) and grass land.

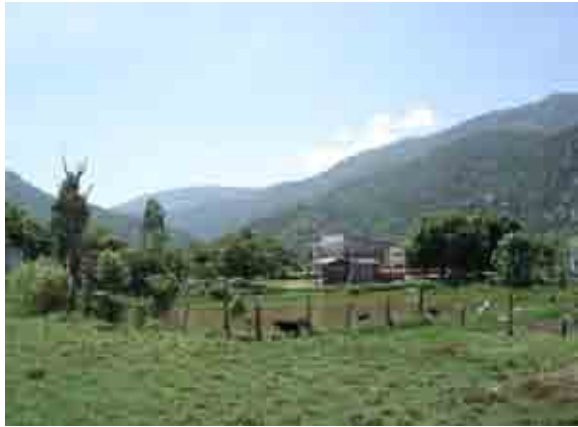
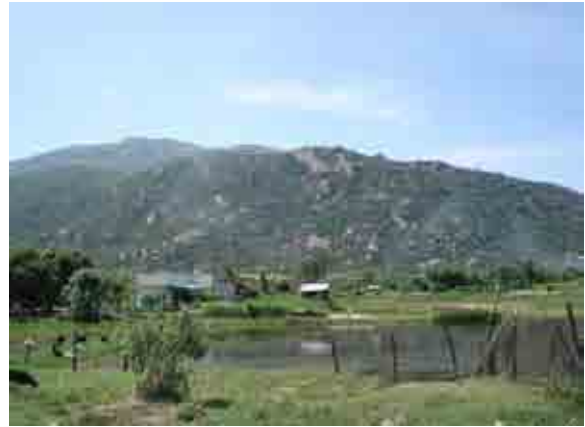
Date:	2007/7/6	Location (UTM)		Elev	Geological Unit			
Point No.	NT-16	X (m)	Y (m)	(m)	VSW Index	V	S	W
		288,448	1,294,463	21

Topography in Cretaceous granite.

Topography: Steep mountain and valley extend NE-SW along lineament.
 Land use: Farmland (paddy field with reservoir).

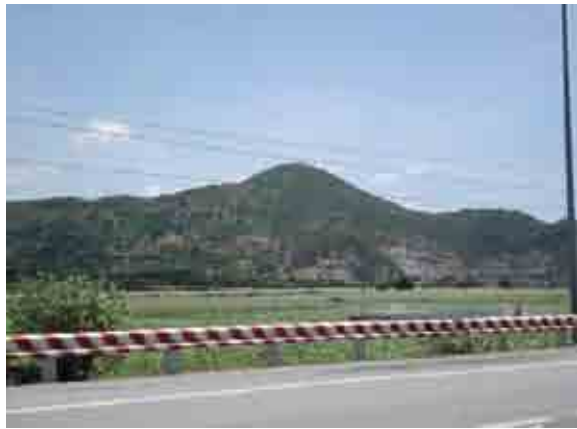
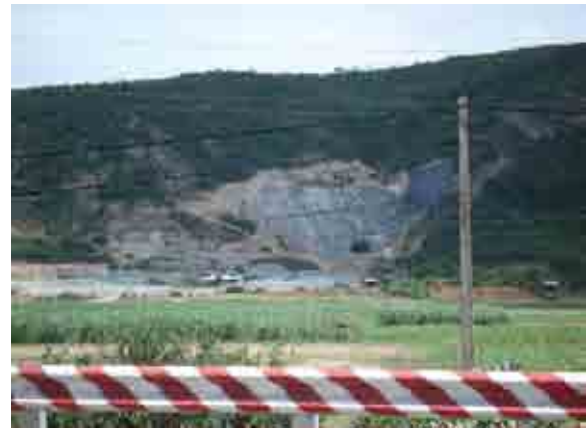
Date:	2007/7/6	Location (UTM)		Elev	Geological Unit			
Point No.	NT-17	X (m)	Y (m)	(m)	VSW Index	V	S	W
		292,246	1,304,465	19

Topography of Jurassic or Cretaceous volcanic rock

Topography: Steep mountain, edge of mountain is clear.

Land use: Quarry for volcanic rock, farmland in flat land (paddy field).

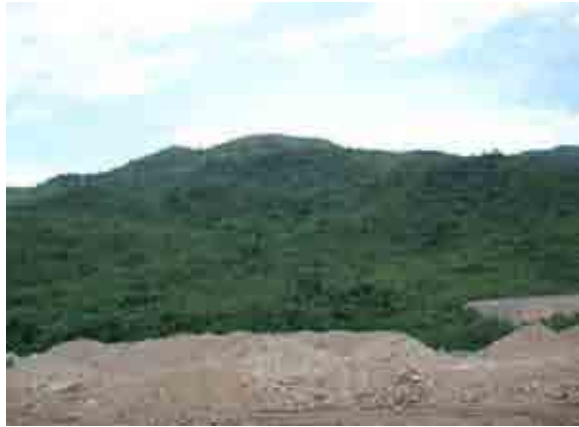
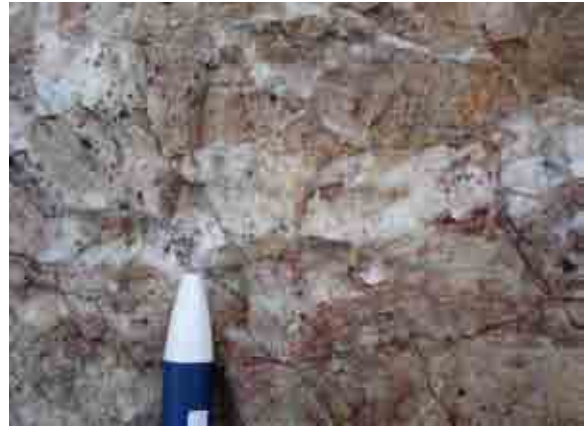
Date:	2007/7/6	Location (UTM)		Elev	Geological Unit			
Point No.	NT-18	X (m)	Y (m)	(m)	VSW Index	V	S	W
		264,720	1,298,615	133

Outcrop of Jurassic or Cretaceous volcanic rock

Lithology: Silicified rhyolitic rock with quartz vein (W = 10mm).

Topography: Steep mountain covered with vegetation.

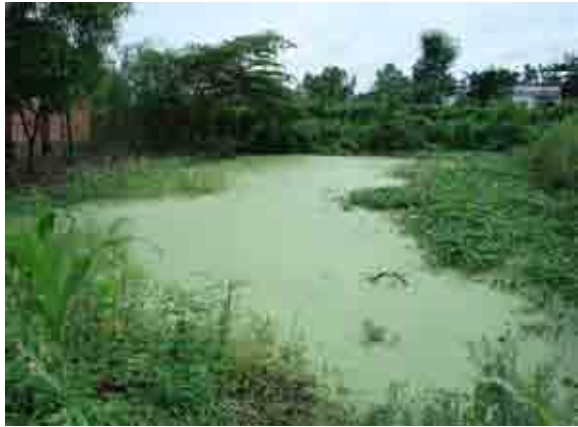
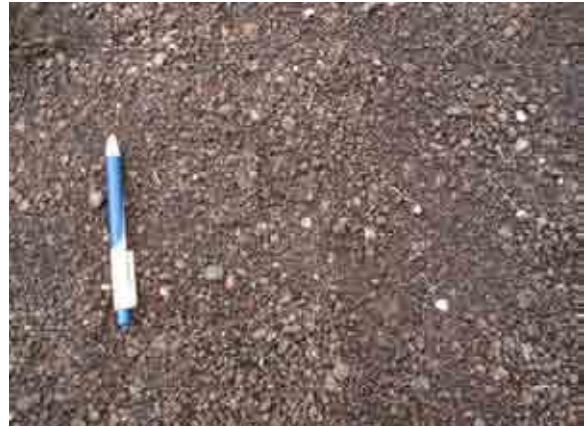
Date:	2007/7/2	Location (UTM)		Elev	Geological Unit			
Point No.	BT-01	X (m)	Y (m)	(m)	VSW Index	V	S	W
		99,294	1,208,023	120

Soil in Quarternary volcanic rock

Soil: Brown colored gravel of basalt.

Land use: Farmland (corn and vegetable).

Water use: Dug well, villager purchase water in dry season for dry up of well water.

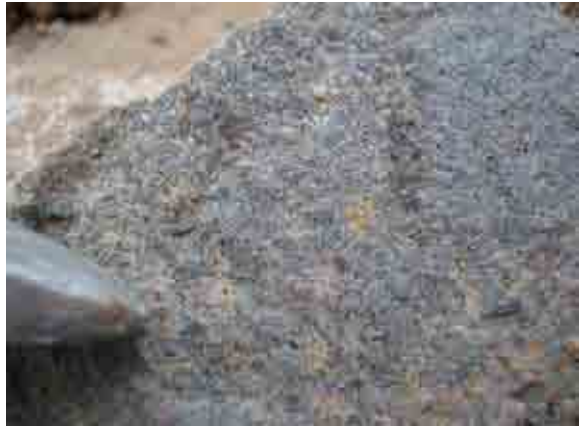
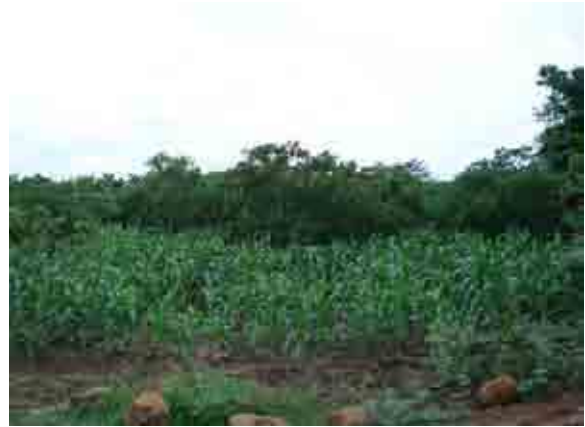
Date:	2007/7/2	Location (UTM)		Elev	Geological Unit			
Point No.	BT-02	X (m)	Y (m)	(m)	VSW Index	V	S	W
		110,452	1,227,846	90

Land use in Quaternary volcanic rock

Land use: Farmland (corn, vegetable, coffee and cashew nut).

Water use: Drilled well for drinking (D = 30m), agricultural water supply for irrigation from river water.

Soil: Brown colored soil with basalt boulder.

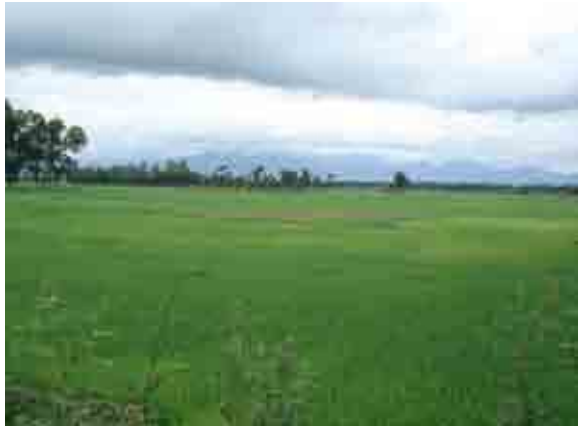
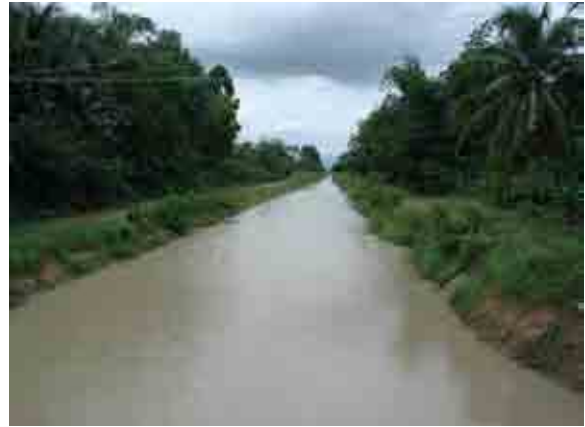
Date:	2007/7/2	Location (UTM)		Elev	Geological Unit			
Point No.	BT-03	X (m)	Y (m)	(m)	VSW Index	V	S	W
		126,108	1,239,787	111

Land use in alluvium plain

Land use: Farmland (paddy field).

Water use: Dug well (dry up in dry season), agricultural water supply from river water, volume of water is rich.

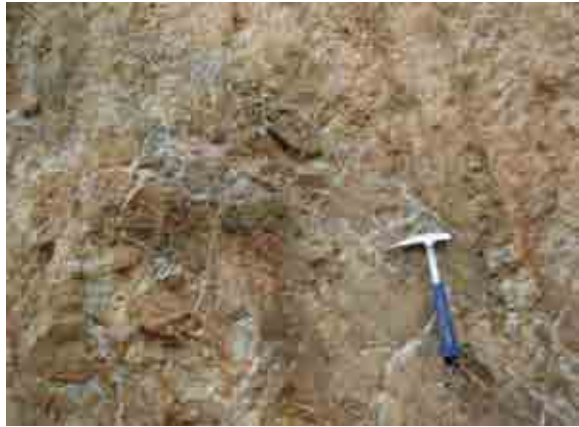
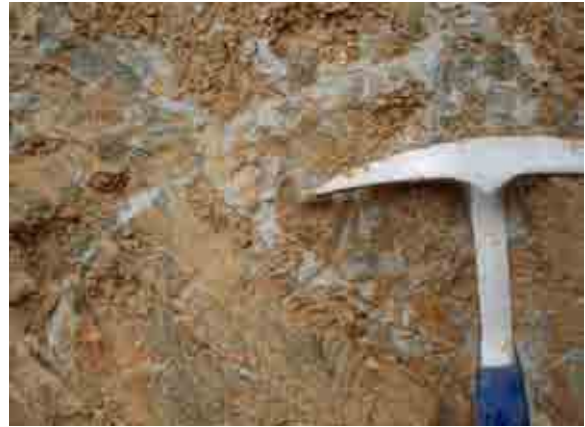
Date:	2007/7/2	Location (UTM)		Elev	Geological Unit			
Point No.	BT-04	X (m)	Y (m)	(m)	VSW Index	V	S	W
		142,777	1,234,480	143

Outcrop of Jurassic sedimentary rock

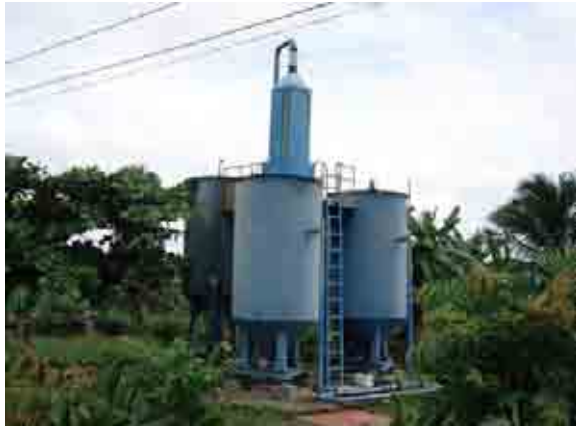
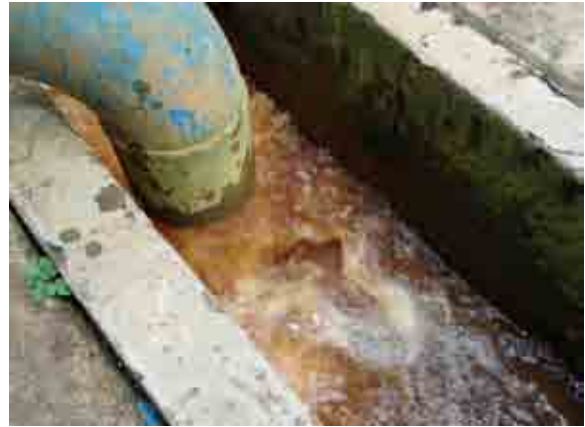
Date:	2007/7/2	Location (UTM)		Elev	Geological Unit			
Point No.	BT-05	X (m)	Y (m)	(m)	VSW Index	V	S	W
		139,029	1,227,106	124

Water supply center

Water supply center operated by P-CERWASS with iron elimination facility.

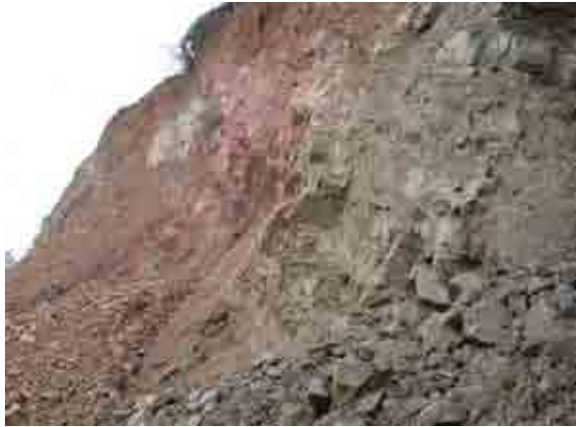
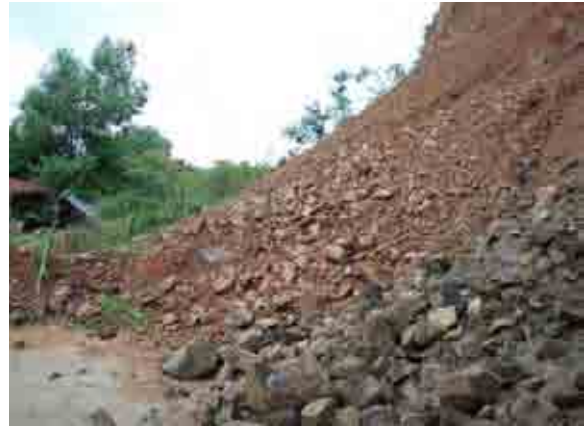
Date:	2007/7/2	Location (UTM)		Elev	Geological Unit			
Point No.	BT-06	X (m)	Y (m)	(m)	VSW Index	V	S	W
		137,342	1,225,006	136

Outcrop of Jurassic sedimentary rock

Lithology: Light gray colored fine sandstone and siltstone which are hard by silicification, landslide in oxidation zone.

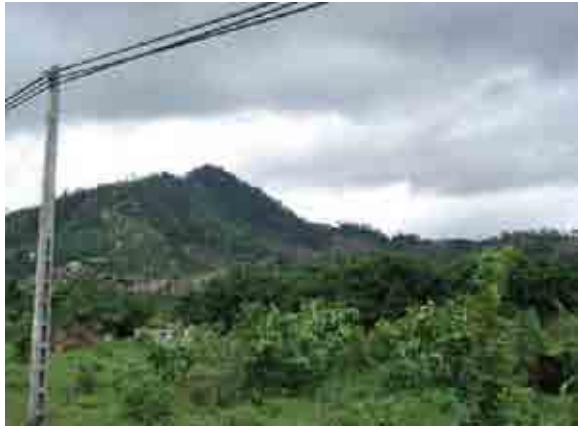
Date:	2007/7/2	Location (UTM)		Elev	Geological Unit			
Point No.	BT-07	X (m)	Y (m)	(m)	VSW Index	V	S	W
		132,062	1,214,368	134

Granite mountain with lineament

Topography: Steep mountain and valley extend NE-SW.
 Land use: Farmland (mango, cashew nut and cassava).

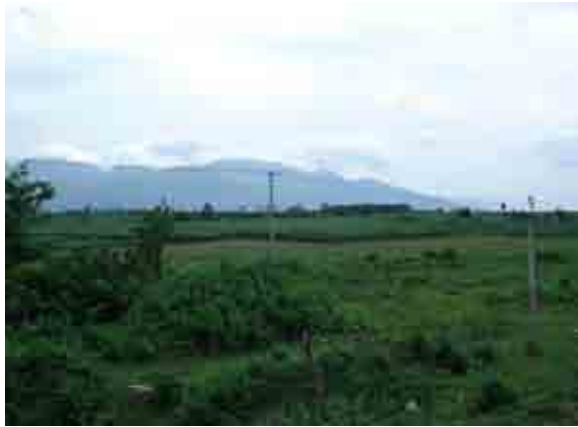
Date:	2007/7/2	Location (UTM)		Elev	Geological Unit			
Point No.	BT-08	X (m)	Y (m)	(m)	VSW Index	V	S	W
		138,813	1,197,891	65

Land use in Jurassic sedimentary rock

Land use: Farmland (paddy, sugarcane and corn field).

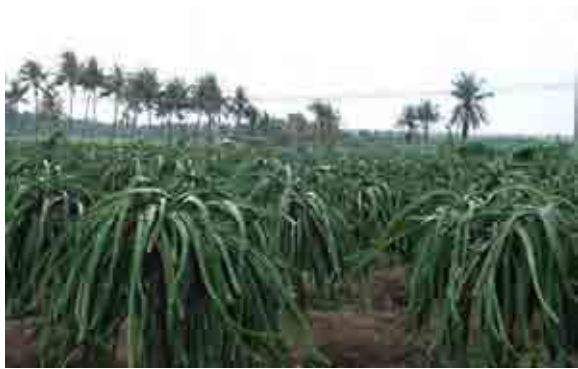
Date:	2007/7/3	Location (UTM)		Elev	Geological Unit			
Point No.	BT-10	X (m)	Y (m)	(m)	VSW Index	V	S	W
		189,625	1,218,271	13

Land use in flat land near sand dune

Land use: Farmland (dragon fruits and paddy field).

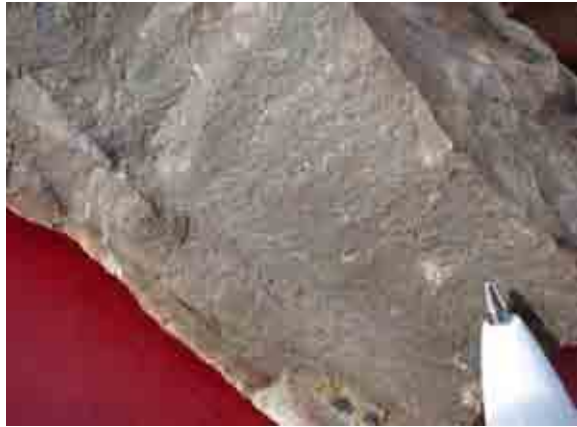
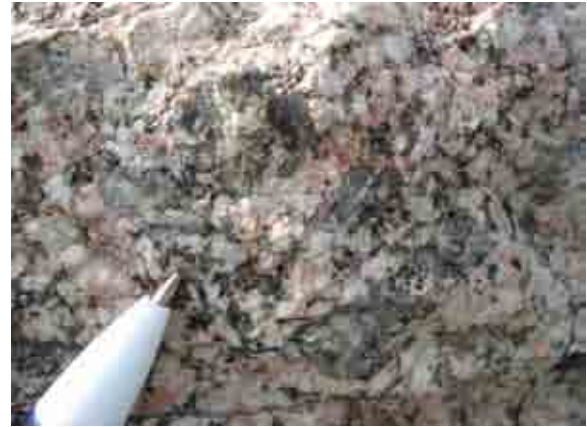
Date:	2007/7/3	Location (UTM)		Elev	Geological Unit			
Point No.	BT-11	X (m)	Y (m)	(m)	VSW Index	V	S	W
		191,285	1,223,593	29

Outcrop of Cretaceous volcanic rock

Lithology: Gray colored silicified rock (andesitic?) on slope, medium grained hornblende granite boulder with quartz vein (1cm).

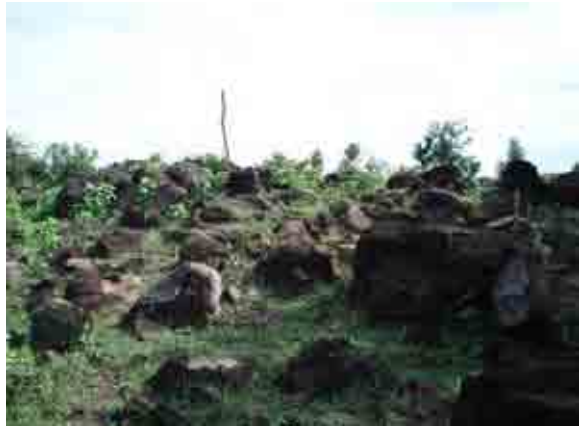
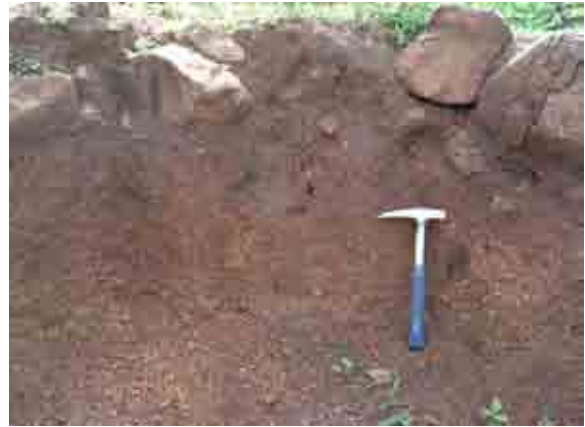
Date:	2007/7/3	Location (UTM)		Elev	Geological Unit			
Point No.	BT-12	X (m)	Y (m)	(m)	VSW Index	V	S	W
		210,436	1,241,254	36

Boulder of basalt and basaltic soil section

Lithology: Dark colored porous basalt.

Soil: Dark brown colored soil, many granules in B layer.

Land use: Grass land for pasturage, farmland (cassava, cashew nut, paddy near pond).

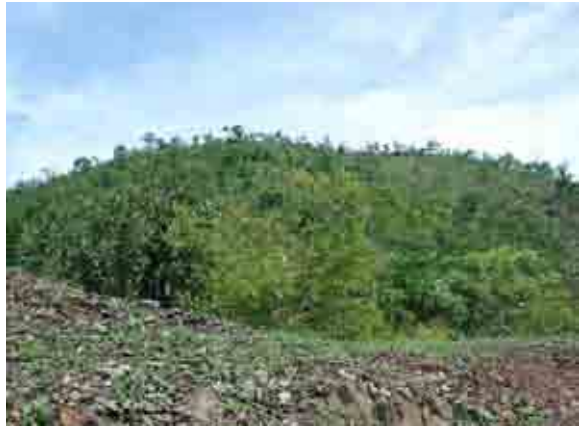
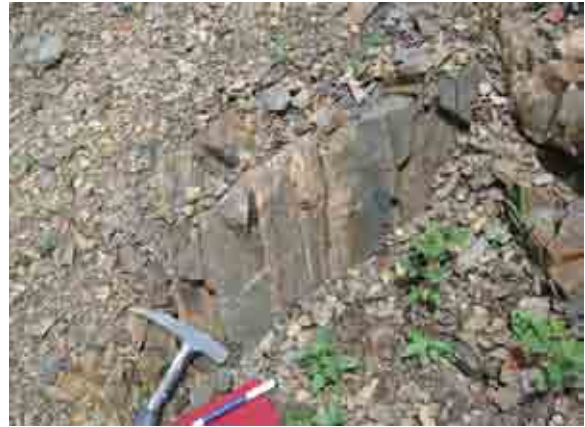
Date:	2007/7/3	Location (UTM)		Elev	Geological Unit			
Point No.	BT-13	X (m)	Y (m)	(m)	VSW Index	V	S	W
		210,451	1,250,615	78

Outcrop of Jurassic sedimentary rock

Lithology: Dark gray colored fine sandstone - siltstone, well bedded and lamination, silicified, N40E vertical.
 Topography: Flat land with gentle relief, low mountain extend N-S in Jurassic volcanics?

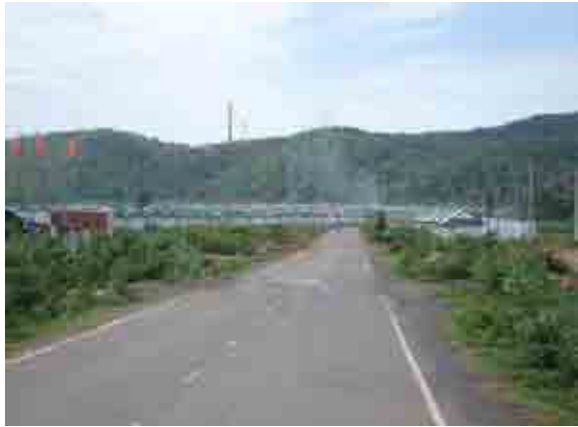
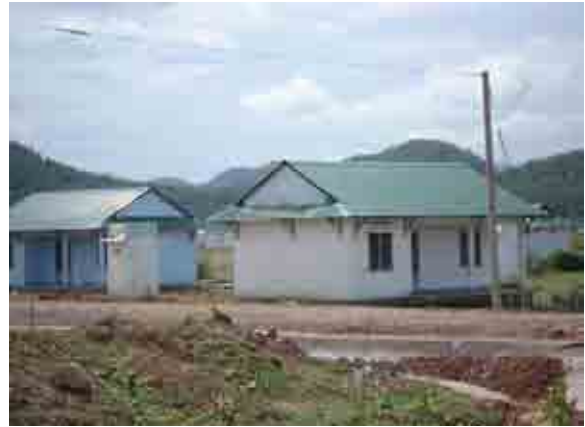
Date:	2007/7/3	Location (UTM)		Elev	Geological Unit			
Point No.	BT-14	X (m)	Y (m)	(m)	VSW Index	V	S	W
		211,524	1,263,344	144

Residence area for minority group

New residences for the settlement plan of minority group with water supply system, bath and toilet.

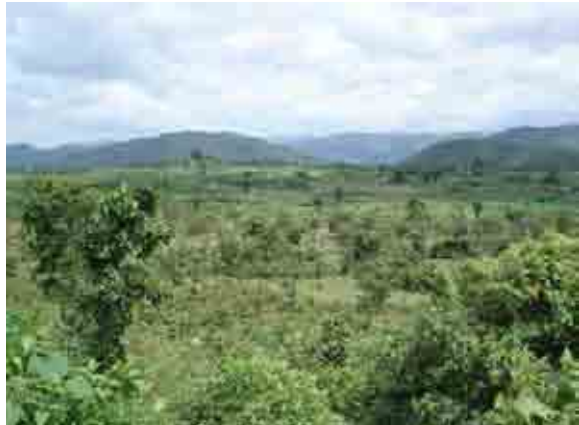
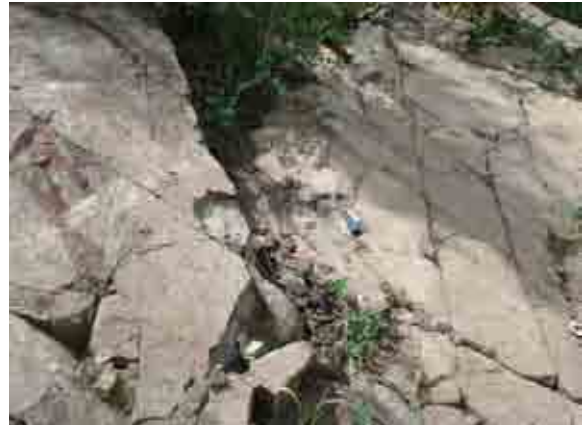
Photo

Land use: Farmland (paddy in flat land and corn field on slope).

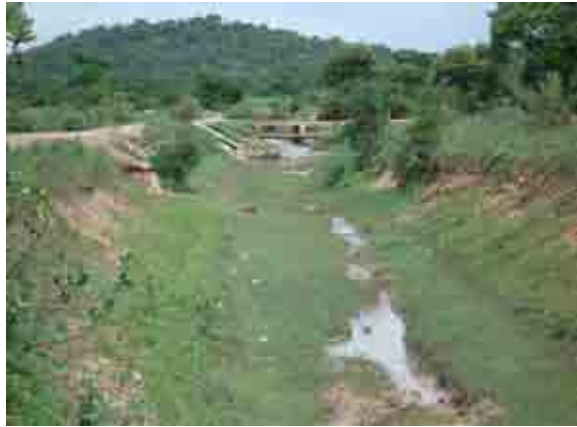
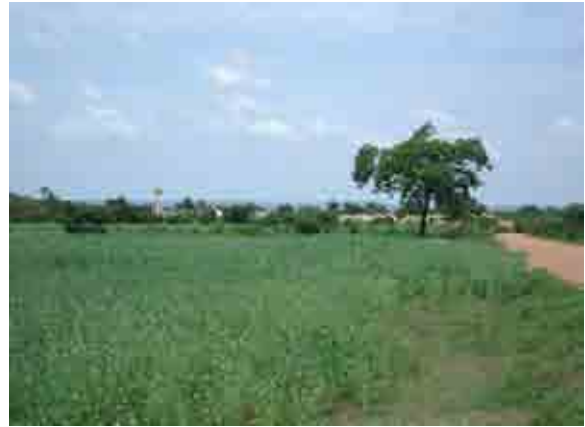
Photo

Aguricultural water supply system near granite mountain

Water use: Irrigation canal, volume of water is poor, pipeline and water service tower for water supply system.
 Land use: Farmland (sesame and corn, no cropping in dry season).

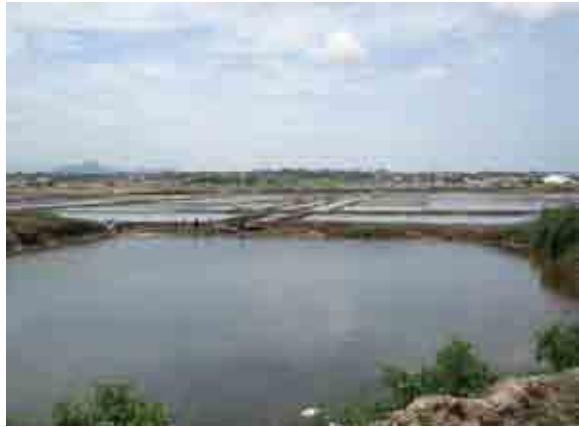
Photo

Land use in flat land along coast

Land use: Fish breeding pond (shrimp) and salt field.

Water use: Fluorine problem in dug well, villager purchase drinking water.

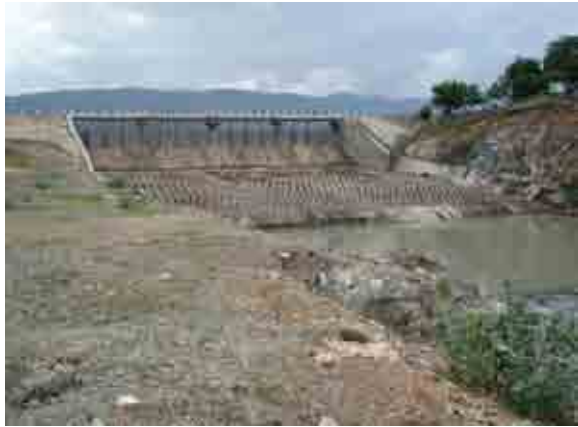
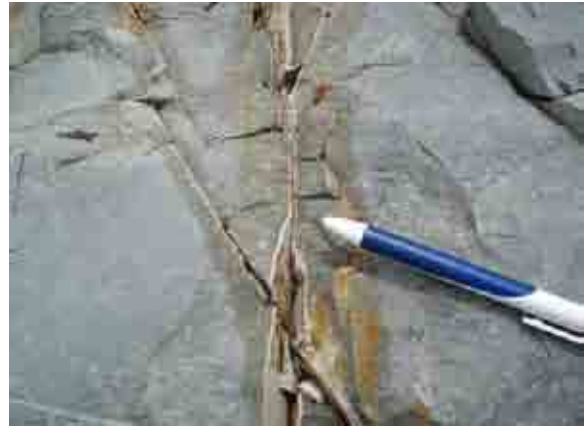
Photo

Outcrop of Cretaceous volcanic rock near dam

Lithology: Silicified rhyolite with quartz veinlets (max. 50cm, ave. joint (N40W, N80E).

Water use: Dam for agricultural water supply operated by Hydrologic engineering, control and exploring company.

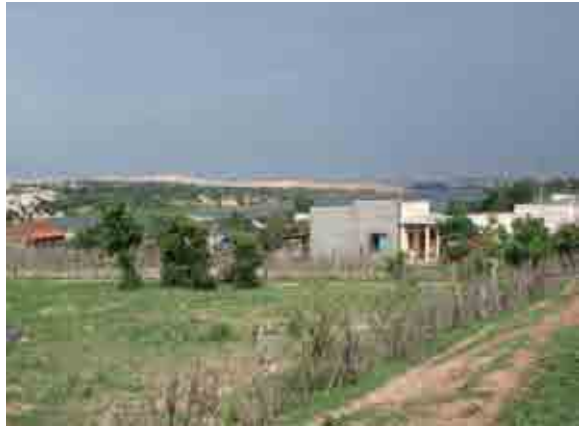
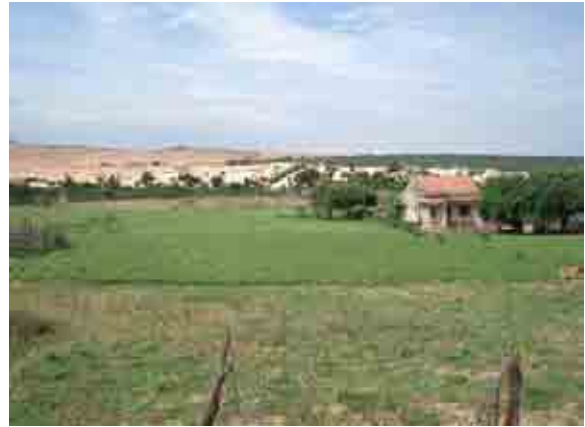
Photo

Land use in sand dune

Land use: Farmland (peanut) and grass land.
 Water use: Reservoir in valley among sand dune.

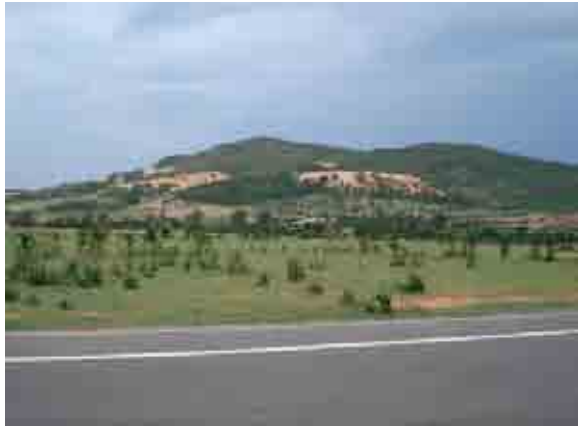
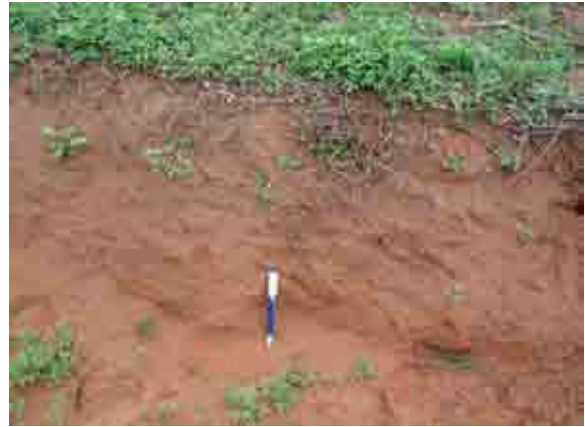
Photo

Soil of sand dune

Soil: Reddish brown colored quartz sand, sand dune on slope of mountain.
 Land use: Grass land.

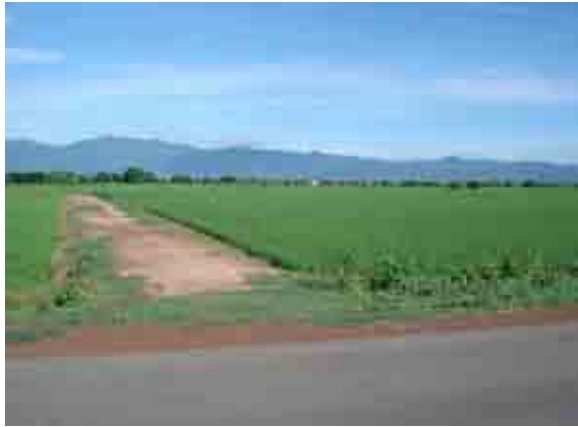
Photo

Land use in alluvium

Land use: Farmland (paddy field), the biggest paddy field in Binh Thuan Province.
 Water use: Dug well (dry up in dry season), water supply system is under construction.

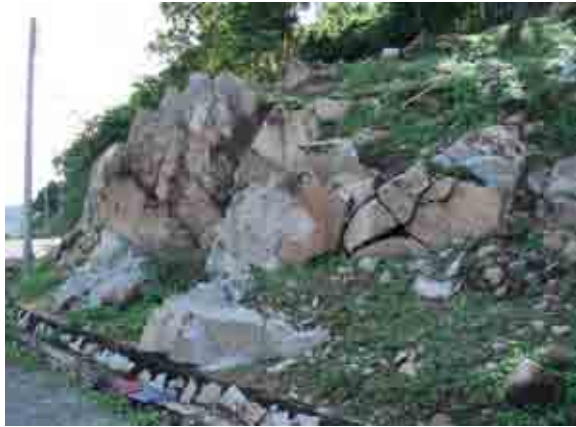
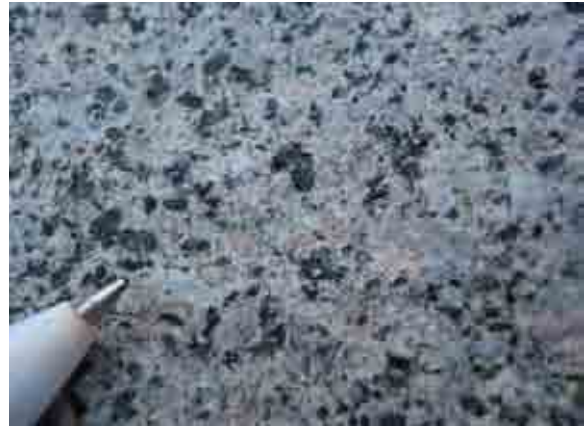
Photo

Outcrop of Cretaceous granite near dam site

Lithology: Medium grained hornblende granite with volcanics nodule, joint (N50E).

Water use: Dam for agricultural water supply.

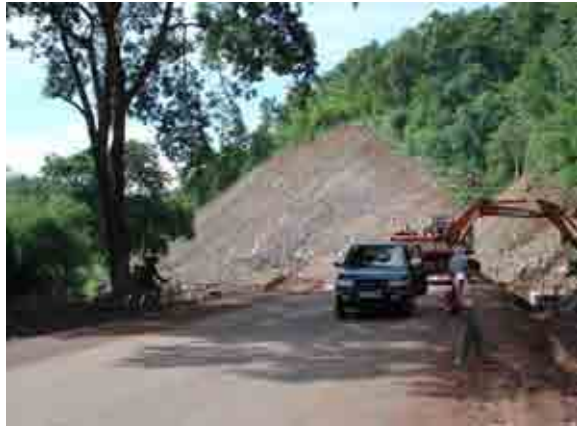
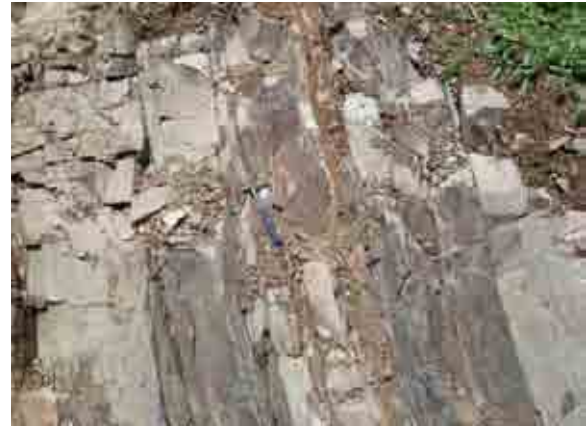
Photo

Outcrop of Jurassic sedimentary rock

Lithology: Alternation of dark gray colored siltstone / brown colored mussive sandstone, N50E 80S.

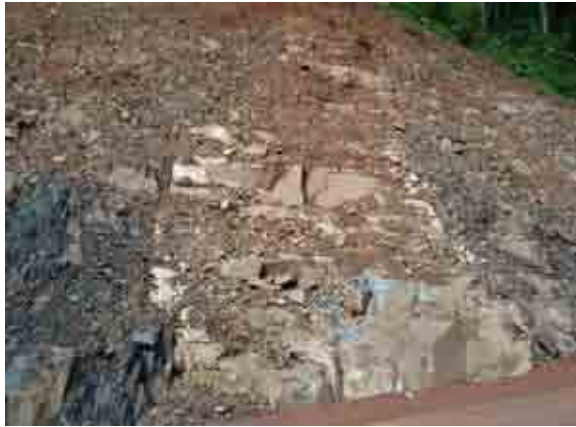
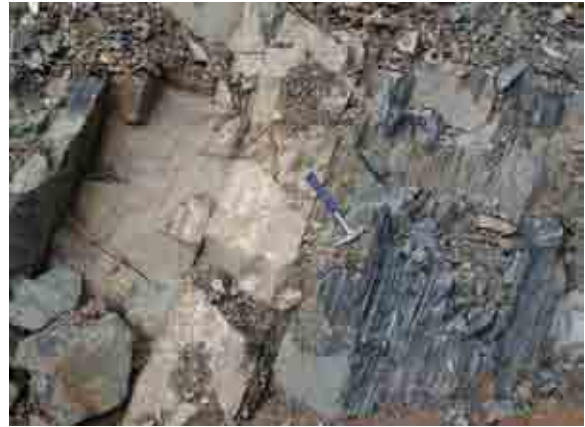
Photo

Outcrop of Jurassic sediments and Cretaceous volcanics

Lithology: Dark gray colored siltstone (shale) with heat alteration, intrusive of light gray colored andesite (W = 6 - 7m).
 Topography: Gentle hill and mountain.
 Land use: Farmland (corn).

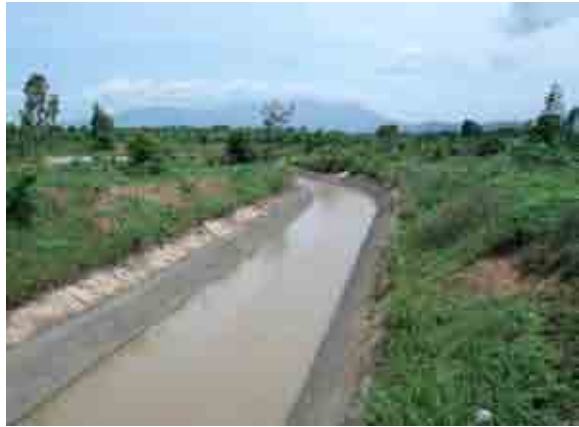
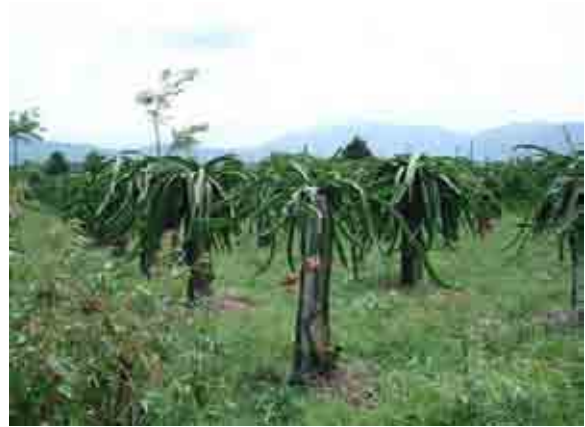
Photo

Land use in Alluvium plain

Land use: Farmland (dragon fruits) with reddish colored soil.

Water use: Irrigation canal from river, water supply system for drinking water.

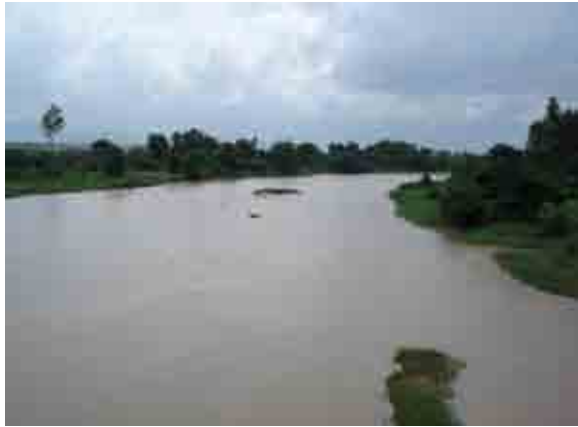
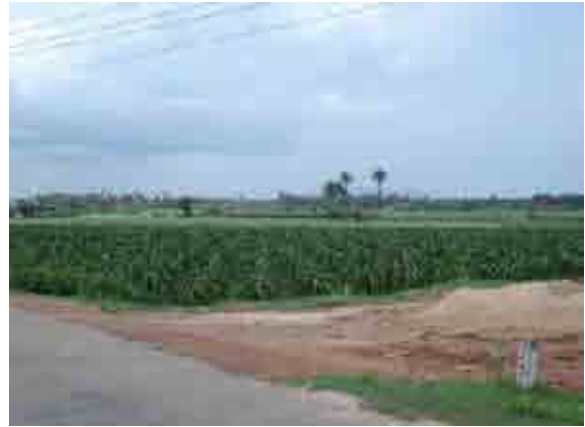
Photo

Land use in Alluvium plain near coast

Land use: Farmland (dragon fruits and paddy field).
 Surface water: River, volume of water is rich.

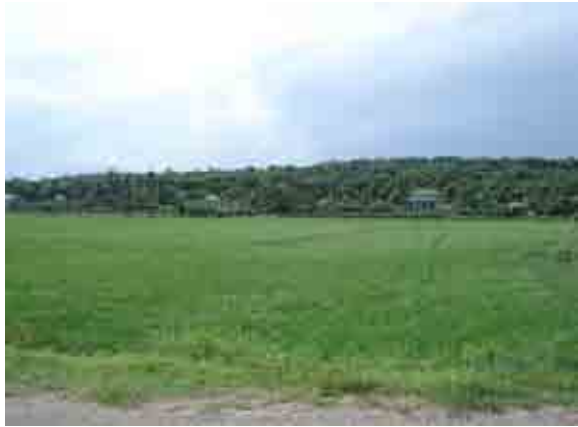
Photo

Land use in Alluvium plain near coast

Land use: Farmland (paddy and dragon fruits field).

Water use: Dug well (D = 11m), iron and fluorine problem in drinking water.

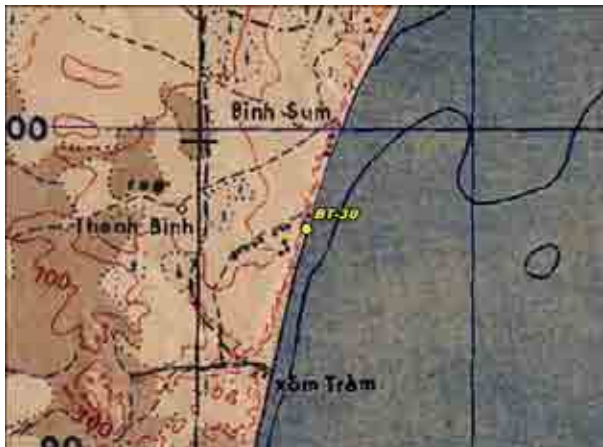
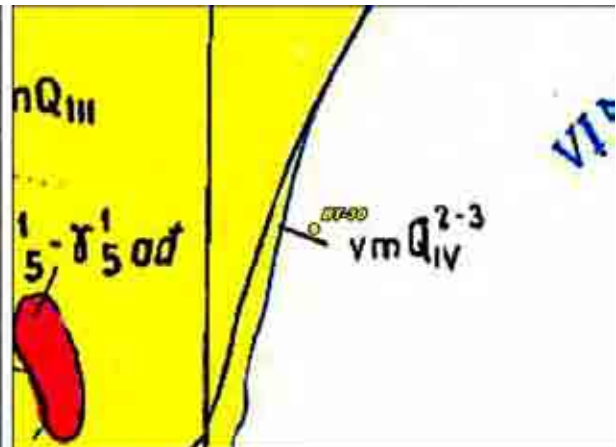
Existing Map

Landslide (earth slide) in sand dune
