- Port of Lobito -

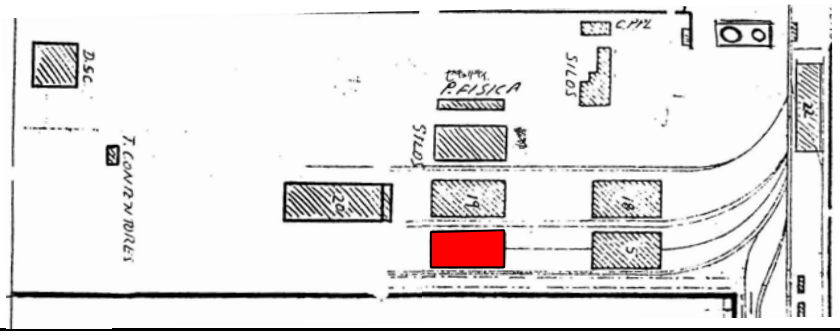
Facility ID	Lo -12 -005	Survey Date	2005/05/31
Port Name	Lobito	Category	Warehouse
Year Constructed	1942		
Maintenance Record	unknown		
Facility Description	North Quay No.6 One-story Plan area: 30.0x60.0=1800m^2 Stacking Height: approx. 4.0m		
Existing Condition	There can not be seen any damages to be pointed out.		
Structural Condition Assessment	**Grade 0** The facility is in sound condition. Detailed survey is not rquired.		
Location

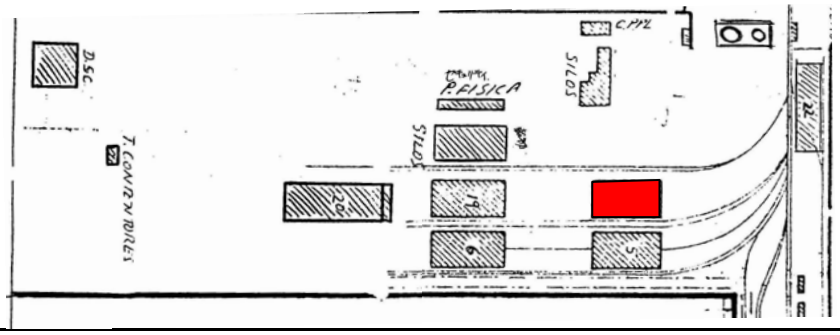
Facility ID	Lo -12 -015	Survey Date	2005/05/31
Port Name	Lobito	Category	Warehouse
Year Constructed	1942		
Maintenance Record	unknown		
Facility Description	North Quay No.18 One-story Plan area: 30.0x60.0=1800m^2 Stacking Height: approx. 6.0m		
Existing Condition	There can not be seen any damages to be pointed out.		
Structural Condition Assessment	**Grade 0** The facility is in sound condition. Detailed survey is not rquired.		
Location

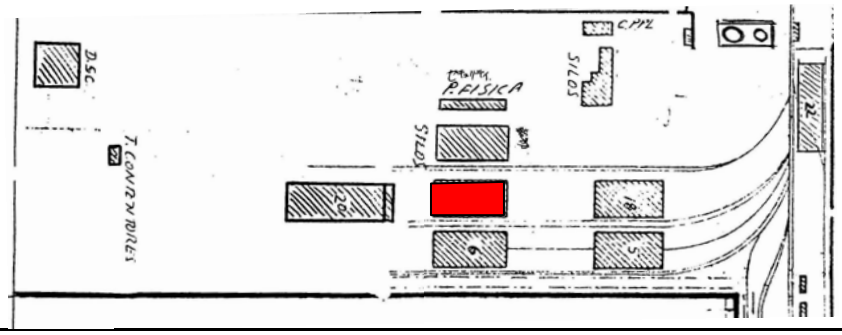
Facility ID	Lo -12 -016	Survey Date	2005/05/31, 10/04
Port Name	Lobito	Category	Warehouse
Year Constructed	1942		
Maintenance Record	unknown		
Facility Description	North Quay No.19 One-story Plan area: 30.0x60.0=1800m^2 Stacking Height: approx. 3.5m		
Existing Condition	There can not be seen any damages to be pointed out.		
Structural Condition Assessment	**Grade 0** The facility is in sound condition. Detailed survey is not rquired.		
Location

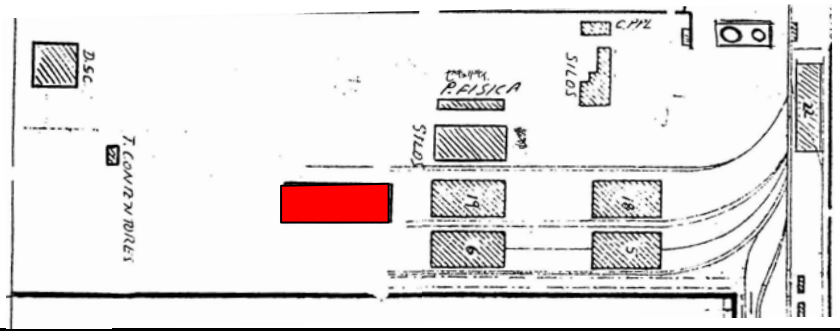
Facility ID	Lo -12 -017	Survey Date	2005/05/31, 10/03
Port Name	Lobito	Category	Warehouse
Year Constructed	1942		
Maintenance Record	unknown		
Facility Description	North Quay No.20 One-story Plan area: 110.0x30.0=3300m^2 Stacking Height: approx. 5.5m		
Existing Condition	Small holes were found in places on its roof. Some doors were not able to be opened due to the deformation of the rail. General condition is sound.		
Structural Condition Assessment	**Grade 0** The facility is in sound condition. Detailed survey is not rquired.		
Location

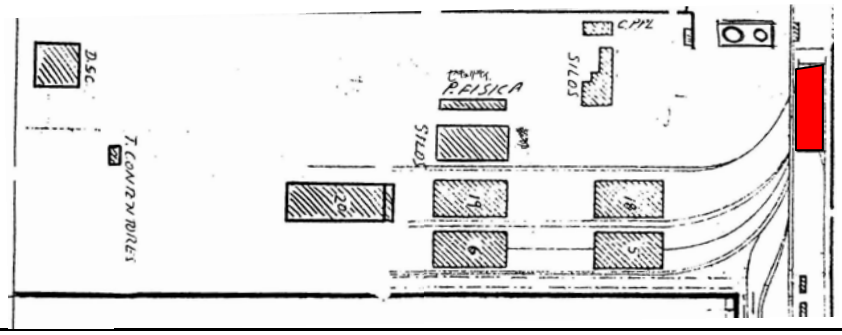
Facility ID	Lo -12 -018	Survey Date	2005/05/31
Port Name	Lobito	Category	Warehouse
Year Constructed	1953		
Maintenance Record	unknown		
Facility Description	North Quay No.22 One-story Plan area: 155.0x24.0=3720m^2 Stacking Height: approx. 5.0m		
Existing Condition	There can not be seen any damages to be pointed out.		
Structural Condition Assessment	**Grade 0** The facility is in sound condition. Detailed survey is not rquired.		
Location

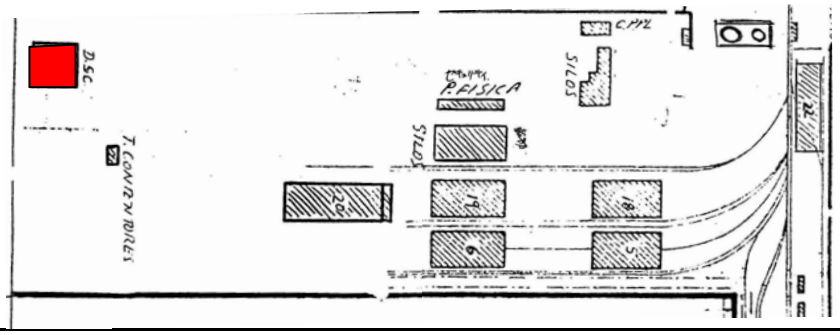
Facility ID	Lo -12 -019	Survey Date	2005/05/31
Port Name	Lobito	Category	Warehouse
Year Constructed	unknown		
Maintenance Record	unknown		
Facility Description	South Quay DSC (Direct Commercial Services - obsolete company) One-story Plan area: 58.6x50.8=2977m^2 Stacking Height: approx. 5.0m		
Existing Condition	There can not be seen any damages to be pointed out.		
Structural Condition Assessment	**Grade 0** The facility is in sound condition. Detailed survey is not rquired.		
Location

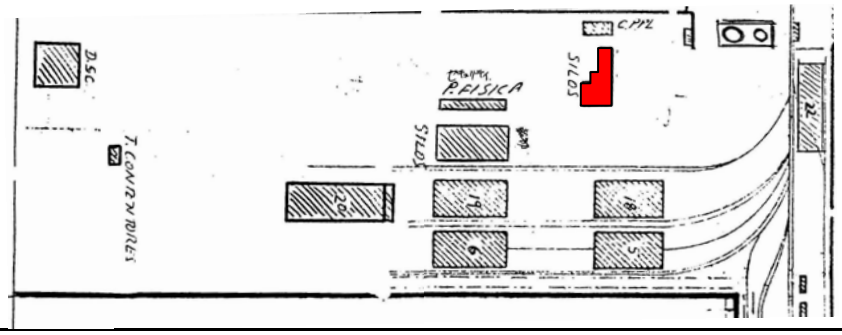
Facility ID	Lo -12 -020	Survey Date	2005/05/31, 10/03
Port Name	Lobito	Category	Warehouse
Year Constructed	unknown		
Maintenance Record	unknown		
Facility Description	South Quay Silo, behind Warehouse No.18 Out of service		
Existing Condition	Severely damaged. The port of Lobito plans to refurbish it and use as an office.		
Structural Condition Assessment	**Grade 2** The facility is in structurally bad condition. It will become the object of rehabilitation plan.		
Location

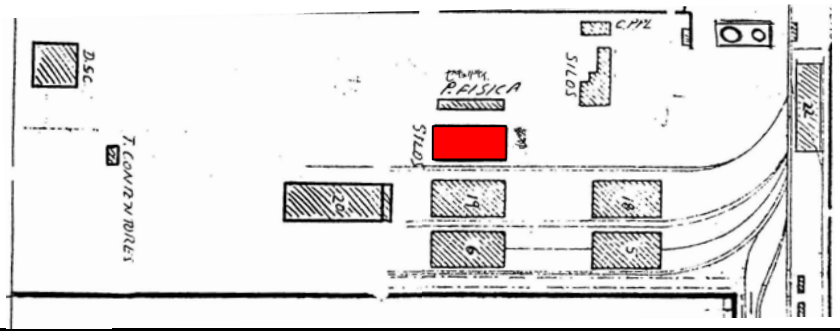
Facility ID	Lo -12 -021	Survey Date	2005/04/07, 10/03
Port Name	Lobito	Category	Warehouse
Year Constructed	1956		
Maintenance Record	unknown		
Facility Description	South Quay Silo, behind Warehouse No.19 Capacity: 20,000 t Stacking machinery is made by German company, MIAG. It is now out of operation.		
Existing Condition	Some crack was found on the external surface of silo. Stacking machinery is very old but well maintained. General condition is sound.		
Structural Condition Assessment	**Grade 0** The facility is in sound condition. Detailed survey is not rquired.		
Location

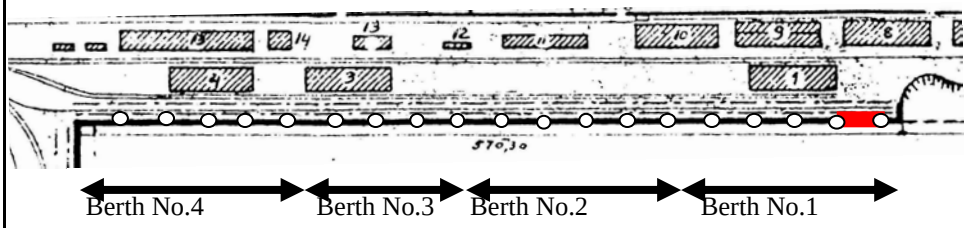
Facility ID	Lo -14 -001	Survey Date	2005/09/27
Port Name	Lobito	Category	Miscellaneous Accessories
Year Constructed	unknown		
Maintenance Record	unknown		
Facility Description	Berth No.1 Steel Ladder and Mooring Ring, North Quay Between Bollard No.1 and No.2		
Existing Condition	The steel ladder is missing and the mooring ring is severely corroded (encircled in the photo hereunder).		
Structural Condition Assessment	**Grade 2** The facility is in structurally bad condition. It will become the object of rehabilitation plan.		
Location

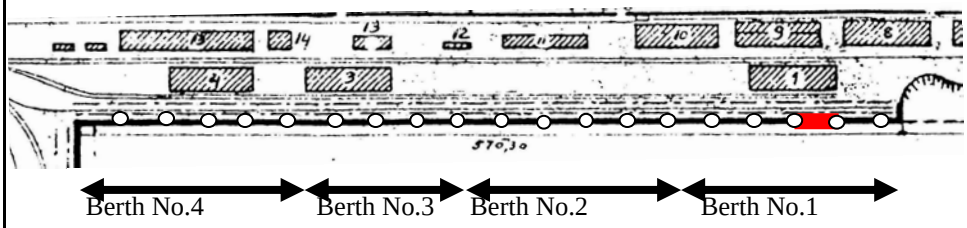
Facility ID	Lo -14 -002	Survey Date	2005/06/01, 09/27
Port Name	Lobito	Category	Miscellaneous Accessories
Year Constructed	unknown		
Maintenance Record	unknown		
Facility Description	Berth No.1 Steel Ladder and Mooring Ring, North Quay Between Bollard No.2 and No.3		
Existing Condition	The steel ladder is missing and the mooring ring is severely corroded (encircled in the photo hereunder).		
Structural Condition Assessment	**Grade 2** The facility is in structurally bad condition. It will become the object of rehabilitation plan.		
Location

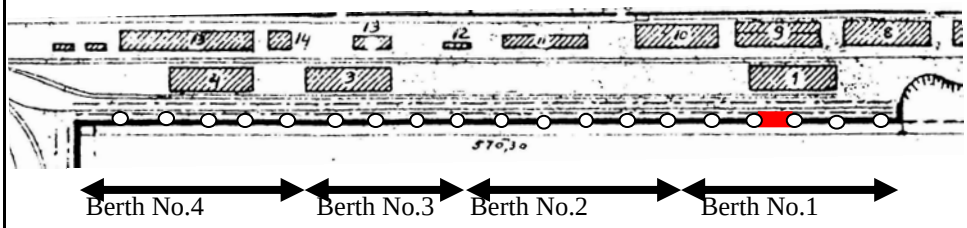
Facility ID	Lo -14 -003	Survey Date	2005/06/01, 09/27
Port Name	Lobito	Category	Miscellaneous Accessories
Year Constructed	unknown		
Maintenance Record	unknown		
Facility Description	Berth No.1 Steel Ladder and Mooring Ring, North Quay Between Bollard No.3 and No.4		
Existing Condition	The steel ladder is missing and the mooring ring is also missing (encircled in the photo hereunder).		
Structural Condition Assessment	**Grade 2** The facility is in structurally bad condition. It will become the object of rehabilitation plan.		
Location

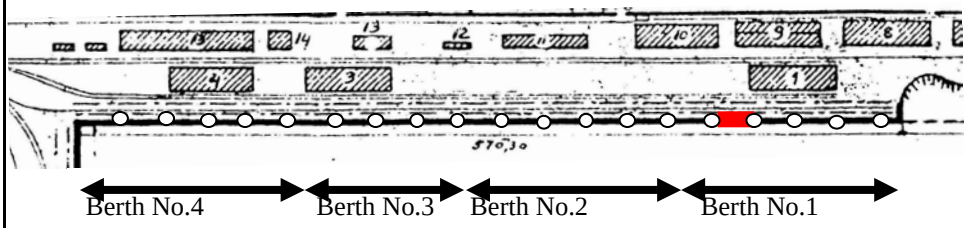
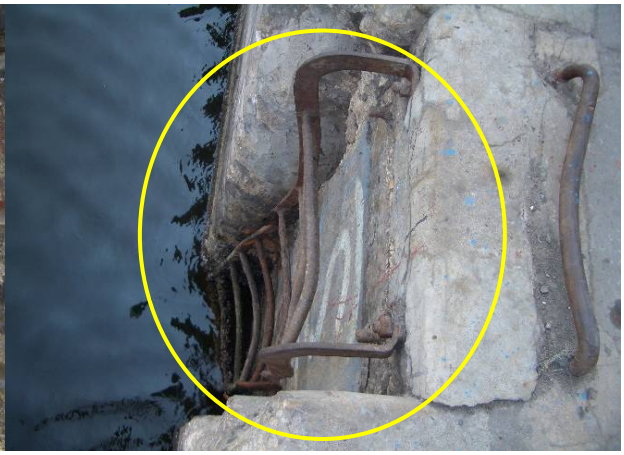
Facility ID	Lo -14 -004	Survey Date	2005/06/01, 09/27
Port Name	Lobito	Category	Miscellaneous Accessories
Year Constructed	unknown		
Maintenance Record	unknown		
Facility Description	Berth No.1 Steel Ladder and Mooring Ring, North Quay Between Bollard No.4 and No.5		
Existing Condition	The steel ladder is severely corroded and the mooring ring is missing (encircled in the photo hereunder).		
Structural Condition Assessment	**Grade 2** The facility is in structurally bad condition. It will become the object of rehabilitation plan.		
Location

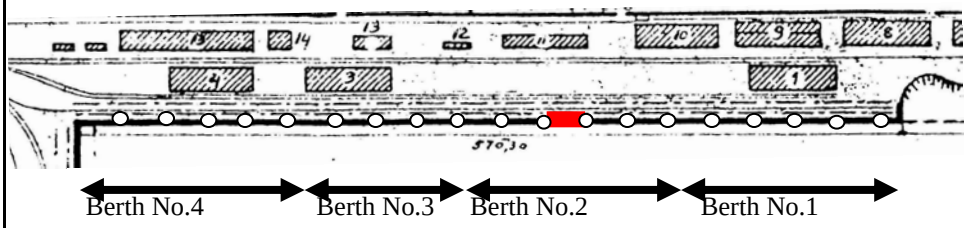
Facility ID	Lo -14 -005	Survey Date	2005/06/01
Port Name	Lobito	Category	Miscellaneous Accessories
Year Constructed	unknown		
Maintenance Record	unknown		
Facility Description	Berth No.2 Steel Ladder, North Quay Between Bollard No.8 and No.9		
Existing Condition	The steel ladder is missing (encircled in the photo hereunder).		
Structural Condition Assessment	**Grade 2** The facility is in structurally bad condition. It will become the object of rehabilitation plan.		
Location

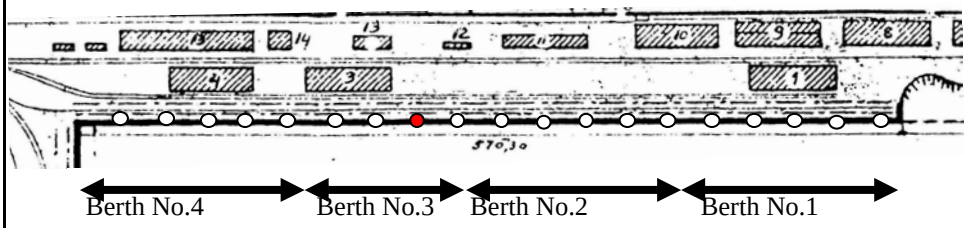
Facility ID	Lo -14 -006	Survey Date	2005/06/01, 09/27
Port Name	Lobito	Category	Miscellaneous Accessories
Year Constructed	unknown		
Maintenance Record	unknown		
Facility Description	Berth No.3 Steel Ladder, North Quay at Bollard No.12		
Existing Condition	The steel ladder is missing (encircled in the photo hereunder).		
Structural Condition Assessment	**Grade 2** The facility is in structurally bad condition. It will become the object of rehabilitation plan.		
Location

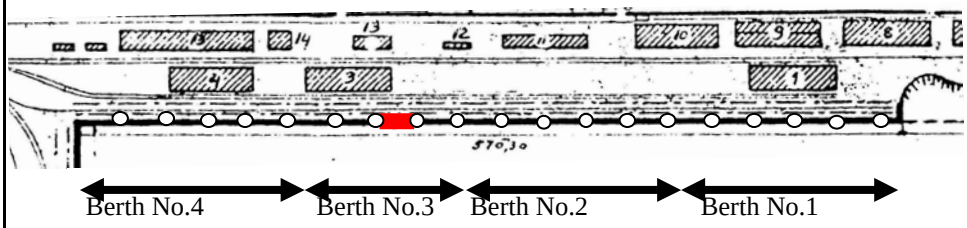
Facility ID	Lo -14 -007	Survey Date	2005/06/01, 09/27
Port Name	Lobito	Category	Miscellaneous Accessories
Year Constructed	unknown		
Maintenance Record	unknown		
Facility Description	Berth No.3 Steel Ladder and Mooring Ring, North Quay Between Bollard No.12 and No.13		
Existing Condition	The steel ladder is missing and the mooring ring is severely corroded (encircled in the photo hereunder).		
Structural Condition Assessment	**Grade 2** The facility is in structurally bad condition. It will become the object of rehabilitation plan.		
Location

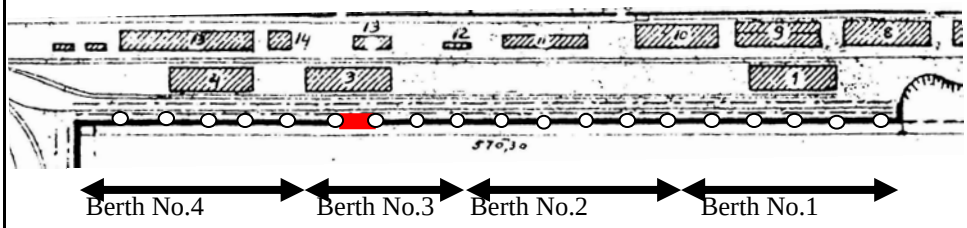
Facility ID	Lo -14 -008	Survey Date	2005/06/01, 09/27
Port Name	Lobito	Category	Miscellaneous Accessories
Year Constructed	unknown		
Maintenance Record	unknown		
Facility Description	Berth No.3 Steel Ladder and Mooring Ring, North Quay Between Bollard No.13 and No.14		
Existing Condition	The steel ladder is recently replaced by a new one. The mooring ring is severely corroded (encircled in the photo hereunder).		
Structural Condition Assessment	**Grade 2** The facility is in structurally bad condition. It will become the object of rehabilitation plan.		
Location

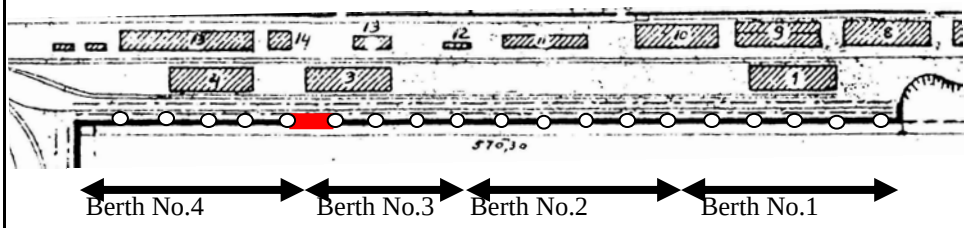
Facility ID	Lo -14 -009	Survey Date	2005/09/27
Port Name	Lobito	Category	Miscellaneous Accessories
Year Constructed	unknown		
Maintenance Record	unknown		
Facility Description	Berth No.3 Steel Ladder, North Quay Between Bollard No.14 and No.15		
Existing Condition	The steel ladder is missing.		
Structural Condition Assessment	**Grade 2** The facility is in structurally bad condition. It will become the object of rehabilitation plan.		
Location

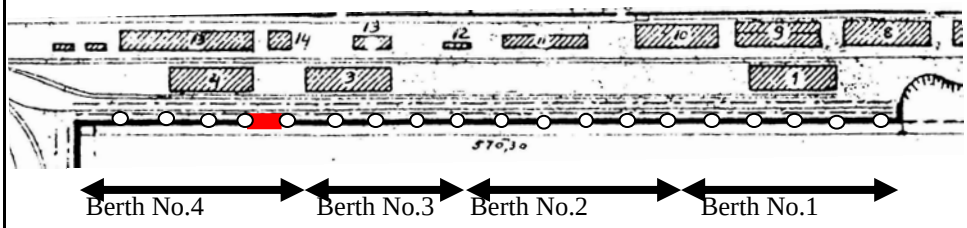
Facility ID	Lo -14 -010	Survey Date	2005/06/01, 09/27
Port Name	Lobito	Category	Miscellaneous Accessories
Year Constructed	unknown		
Maintenance Record	unknown		
Facility Description	Berth No.4 Steel Ladder, North Quay Between Bollard No.15 and No.16		
Existing Condition	The steel ladder is corroded and deformed.		
Structural Condition Assessment	**Grade 2** The facility is in structurally bad condition. It will become the object of rehabilitation plan.		
Location

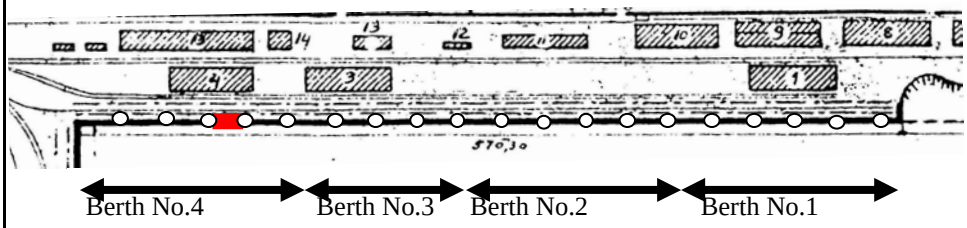
Facility ID	Lo -14 -011	Survey Date	2005/06/01, 09/27
Port Name	Lobito	Category	Miscellaneous Accessories
Year Constructed	unknown		
Maintenance Record	unknown		
Facility Description	Berth No.4 Steel Ladder, North Quay Between Bollard No.16 and No.17		
Existing Condition	The steel ladder is recently replaced by a new one.		
Structural Condition Assessment	**Grade 0** The facility is in sound condition. Detailed survey is not rquired.		
Location

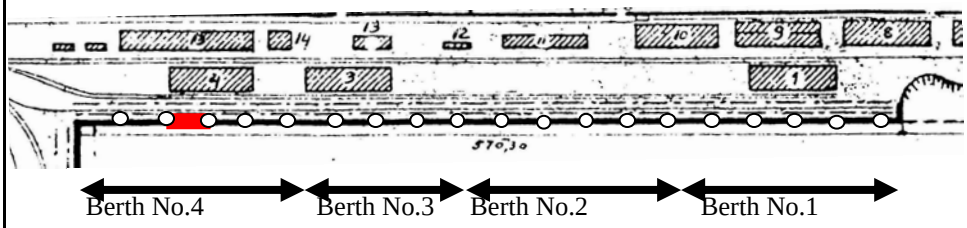
Facility ID	Lo -14 -012	Survey Date	2005/06/01, 09/27
Port Name	Lobito	Category	Miscellaneous Accessories
Year Constructed	unknown		
Maintenance Record	unknown		
Facility Description	Berth No.4 Steel Ladder, North Quay Between Bollard No.17 and No.18		
Existing Condition	The steel ladder is missing (encircled in the photo hereunder).		
Structural Condition Assessment	**Grade 2** The facility is in structurally bad condition. It will become the object of rehabilitation plan.		
Location

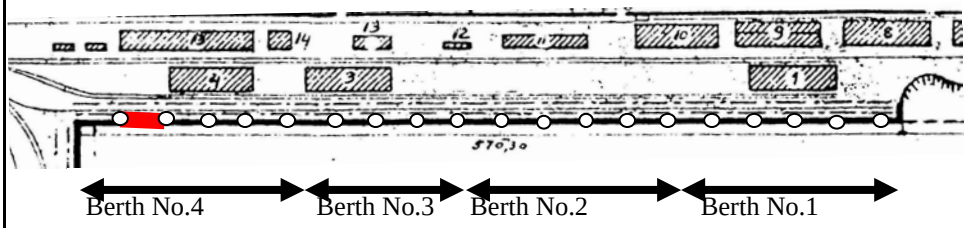
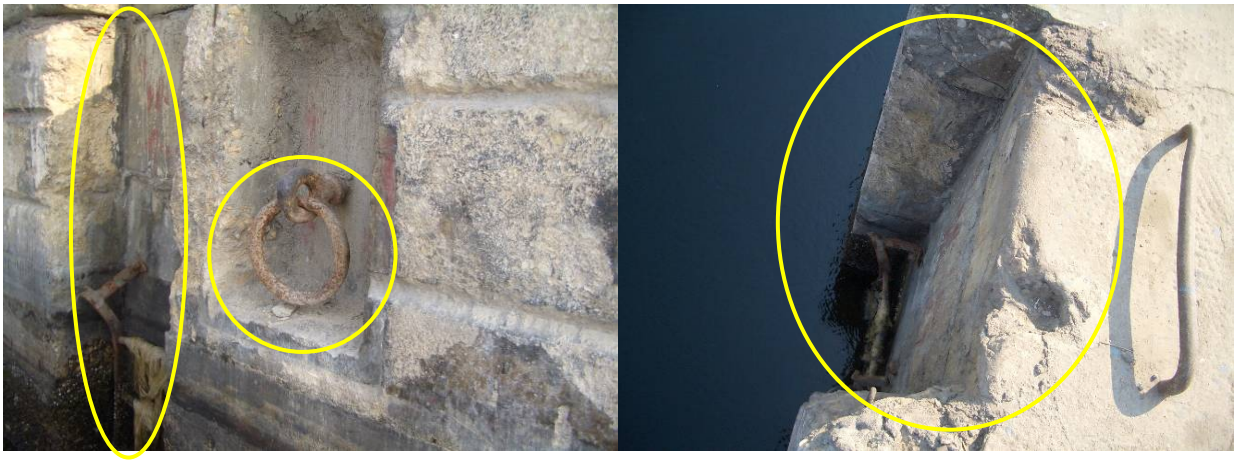
Facility ID	Lo -14 -013	Survey Date	2005/06/01, 09/27
Port Name	Lobito	Category	Miscellaneous Accessories
Year Constructed	unknown		
Maintenance Record	unknown		
Facility Description	Berth No.4 Steel Ladder and Mooring Ring, North Quay Between Bollard No.18 and No.19		
Existing Condition	The steel ladder is missing and the mooring ring is severely corroded (encircled in the photo hereunder).		
Structural Condition Assessment	**Grade 2** The facility is in structurally bad condition. It will become the object of rehabilitation plan.		
Location

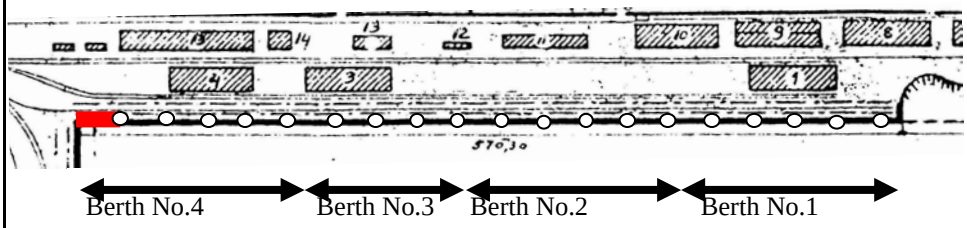
Facility ID	Lo -14 -014	Survey Date	2005/06/01
Port Name	Lobito	Category	Miscellaneous Accessories
Year Constructed	unknown		
Maintenance Record	unknown		
Facility Description	Berth No.4 Mooring Ring, North Quay Between Bollard No.19 and Southend		
Existing Condition	The mooring ring is missing (encircled in the photo hereunder).		
Structural Condition Assessment	**Grade 2** The facility is in structurally bad condition. It will become the object of rehabilitation plan.		
Location

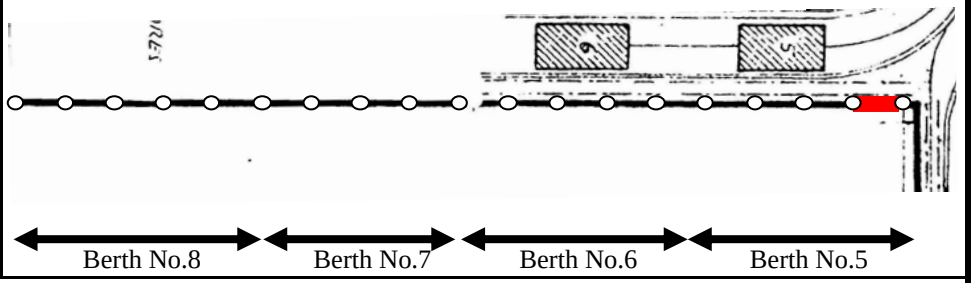
Facility ID	Lo -14 -015	Survey Date	2005/06/01, 09/27
Port Name	Lobito	Category	Miscellaneous Accessories
Year Constructed	unknown		
Maintenance Record	unknown		
Facility Description	Berth No.5 Steel Ladder and Mooring Ring, South Quay Between Bollard No.20 and No.21		
Existing Condition	Both the steel ladder and the mooring ring are missing (encircled in the photo hereunder).		
Structural Condition Assessment	**Grade 2** The facility is in structurally bad condition. It will become the object of rehabilitation plan.		
Location
