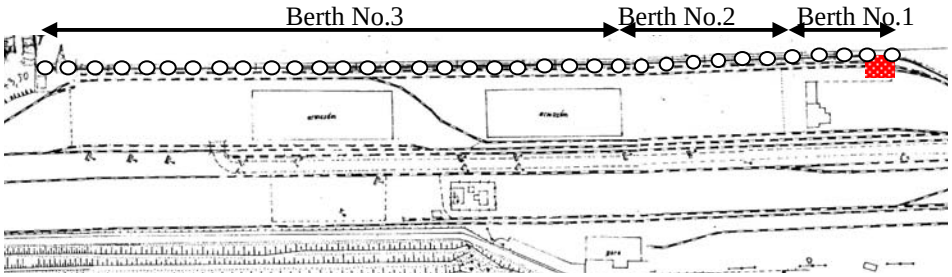
Facility ID	Na -07 -035	Survey Date	2005/10/14
Port Name	Namibe	Category	Apron Pavement
Year Constructed	1953-1957		
Maintenance Record	unknown		
Facility Description	Berth No.1 From Bollard No.34 to No.35		
Existing Condition	Pavement is found to have been removed in many places. The maximum unevenness is more than 20cm.		
Structural Condition Assessment	**Grade 2** The facility is in structurally bad condition. It will become the object of rehabilitation plan.		
Location

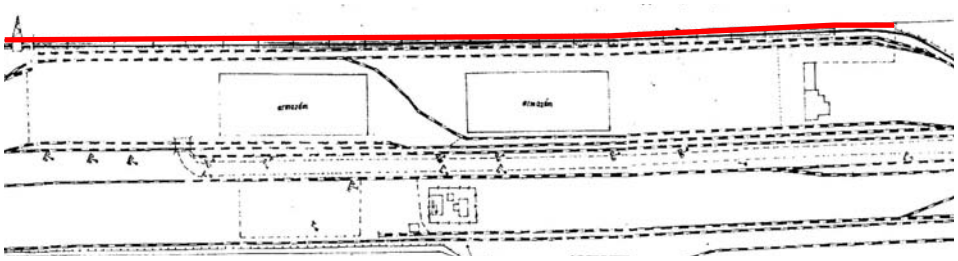
Facility ID	Na -08 -001	Survey Date	2005/05/16
Port Name	Namibe	Category	Crane Rail
Year Constructed	1967		
Maintenance Record	unknown		
Facility Description	Crane rail		
Existing Condition	There can be seen some deviation and unevenness and some crane rail is removed at the south of the quay.(encircled in the photos hereunder).		
Structural Condition Assessment	**Grade 2** The facility is in structurally bad condition. It will become the object of rehabilitation plan.		
Location

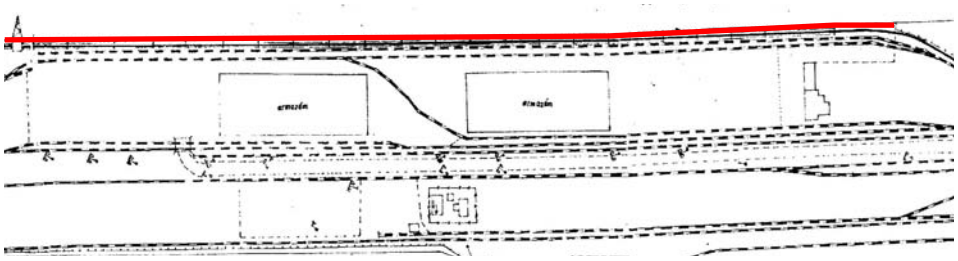
Facility ID	Na -10 -001	Survey Date	2005/05/17
Port Name	Namibe	Category	Fendering System
Year Purchased	unknown	Manufacturer	
Maintenance Record	unknown		
Facility Description	Berthing facility of the quay		
Existing Condition	Used truck tyres are used as rubber fenders. They are inadequate to absorb ship's berthing energy.		
Structural Condition Assessment	**Grade 2** The facility is in structurally bad condition. It will become the object of rehabilitation plan.		
Location

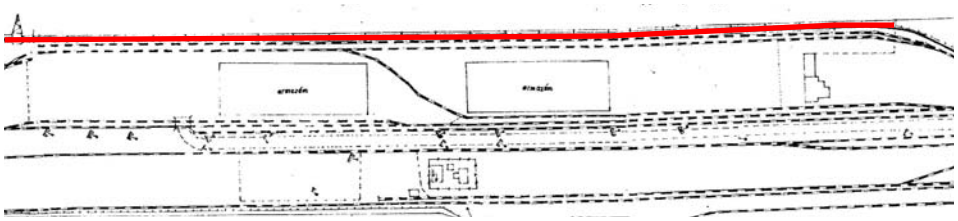
Facility ID	Na -09 -001	Survey Date	2005/05/16
Port Name	Namibe	Category	Railway
Year Constructed	1967		
Maintenance Record	unknown		
Facility Description	Railway lying most close to the quay face (indecated by arrows in the photos hereunder)		
Existing Condition	There can be seen some deviation and unevenness (encircled in the photos hereunder)		
Structural Condition Assessment	**Grade 2** The facility is in structurally bad condition. It will become the object of rehabilitation plan.		
Location

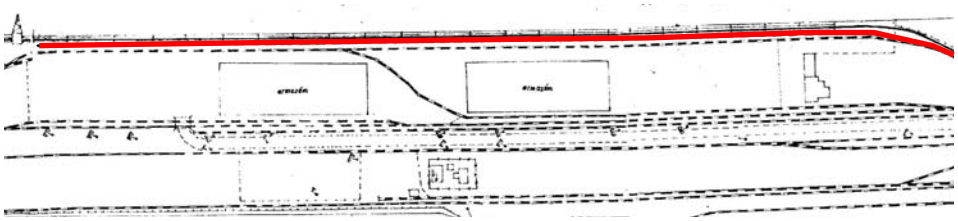
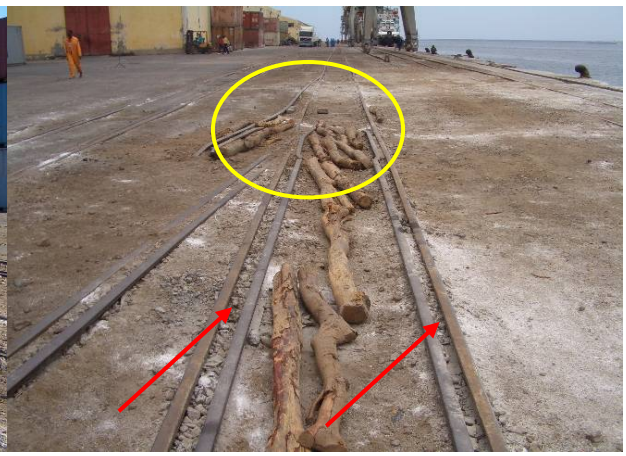
Facility ID	Na -09 -002	Survey Date	2005/05/16, 10/12
Port Name	Namibe	Category	Railway
Year Constructed	1967		
Maintenance Record	unknown		
Facility Description	The second railway from the quay face (indecated by arrows in the photos hereunder)		
Existing Condition	There can be seen some deviation and unevenness (encircled in the photos hereunder)		
Structural Condition Assessment	Grade 2 The facility is in structurally bad condition. It will become the object of rehabilitation plan.		
Location

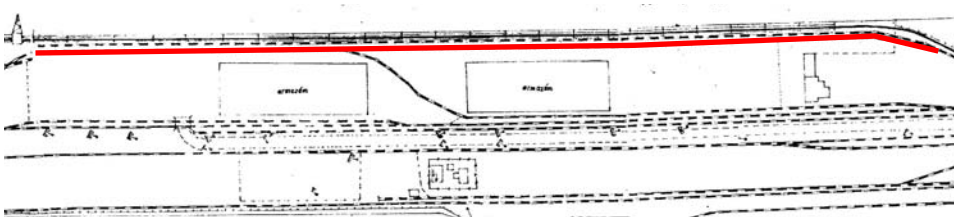
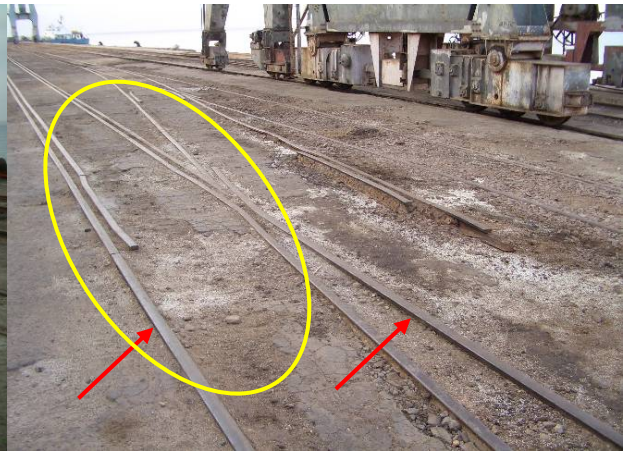
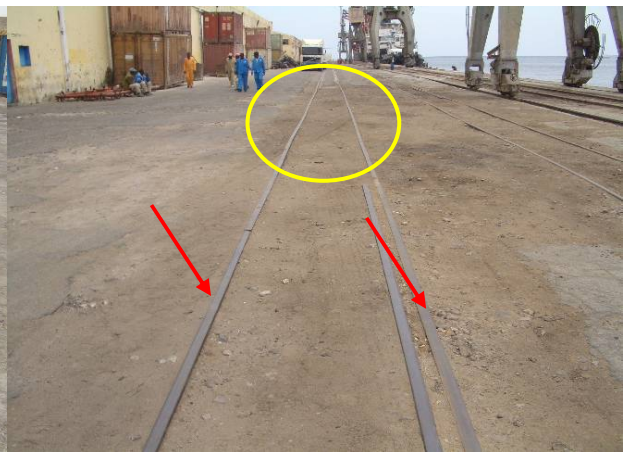
Facility ID	Na -09 -003	Survey Date	2005/05/16, 10/12
Port Name	Namibe	Category	Railway
Year Constructed	1967		
Maintenance Record	unknown		
Facility Description	The third railway from the quay face (indecated by arrows in the photos hereunder)		
Existing Condition	There can be seen some deviation and unevenness (encircled in the photos hereunder)		
Structural Condition Assessment	Grade 2 The facility is in structurally bad condition. It will become the object of rehabilitation plan.		
Location

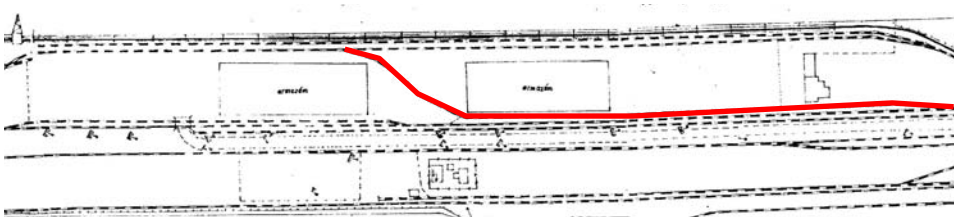
Facility ID	Na -09 -004	Survey Date	2005/05/16, 10/14
Port Name	Namibe	Category	Railway
Year Constructed	1967		
Maintenance Record	unknown		
Facility Description	The fourth railway from the quay face (indecated by arrows in the photos hereunder)		
Existing Condition	There can be seen some deviation and unevenness (encircled in the photos hereunder) Debris is found on the railway.		
Structural Condition Assessment	**Grade 2** The facility is in structurally bad condition. It will become the object of rehabilitation plan.		
Location

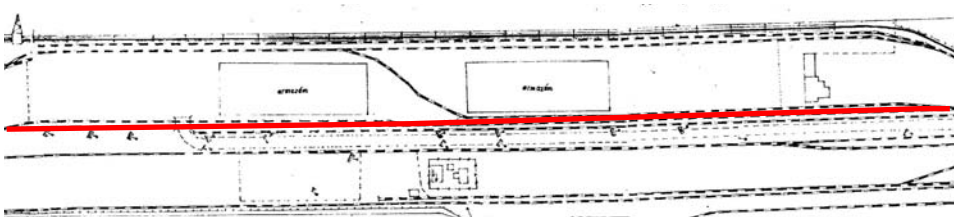
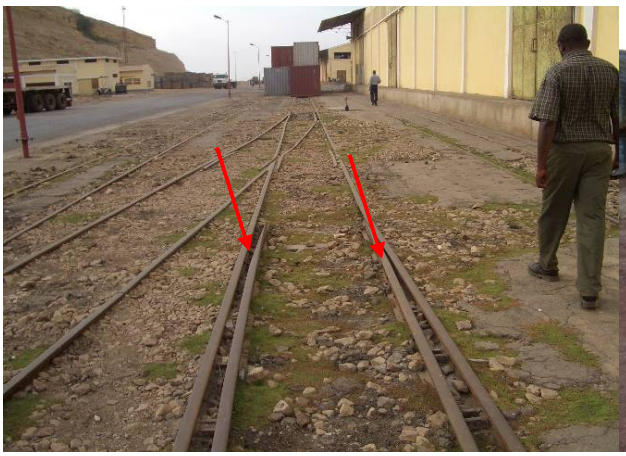
Facility ID	Na -09 -005	Survey Date	2005/05/16, 10/14
Port Name	Namibe	Category	Railway
Year Constructed	1967		
Maintenance Record	unknown		
Facility Description	The fifth railway from the quay face (indecated by arrows in the photos hereunder)		
Existing Condition	There can be seen some deviation and unevenness. Some part of rail is removed for the traffic of forklift Containers are found on the railway.		
Structural Condition Assessment	**Grade 2** The facility is in structurally bad condition. It will become the object of rehabilitation plan.		
Location

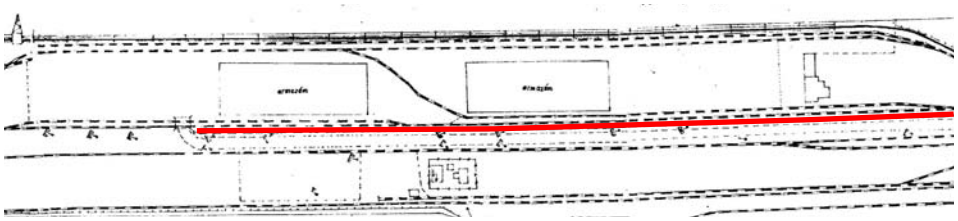
Facility ID	Na -09 -006	Survey Date	2005/05/16, 10/14
Port Name	Namibe	Category	Railway
Year Constructed	1967		
Maintenance Record	unknown		
Facility Description	The sixth railway from the quay face (indecated by arrows in the photos hereunder)		
Existing Condition	There can be seen some deviation and unevenness. Some balast is found to have been repaired by using crushed stone.		
Structural Condition Assessment	**Grade 2** The facility is in structurally bad condition. It will become the object of rehabilitation plan.		
Location

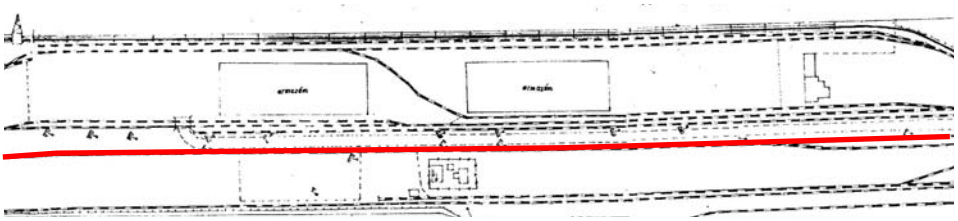
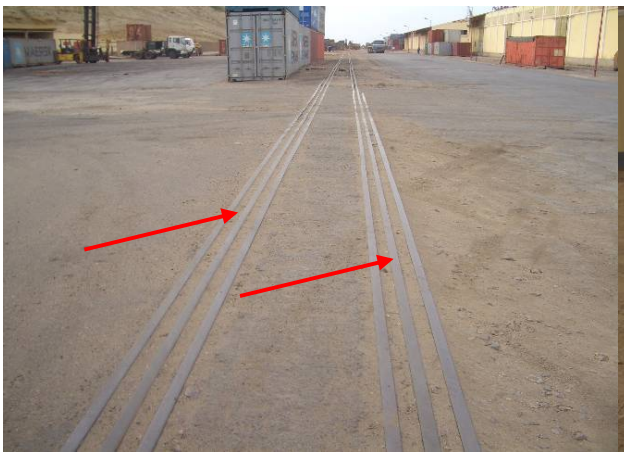
Facility ID	Na -09 -007	Survey Date	2005/05/16, 10/14
Port Name	Namibe	Category	Railway
Year Constructed	1967		
Maintenance Record	unknown		
Facility Description	The seventh railway from the quay face (indecated by arrows in the photos hereunder) The port of Namibe uses it for transporting granite stones		
Existing Condition	There can be seen some deviation and unevenness.		
Structural Condition Assessment	**Grade 2** The facility is in structurally bad condition. It will become the object of rehabilitation plan.		
Location

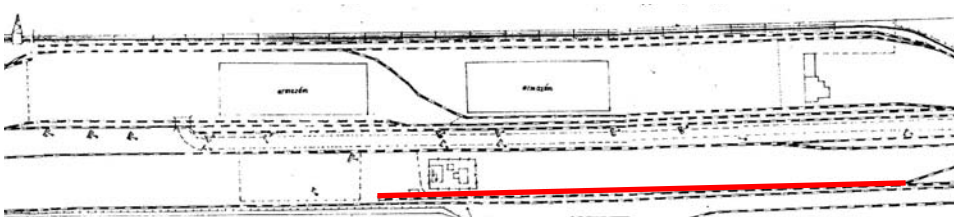
Facility ID	Na -09 -008	Survey Date	2005/05/16, 10/14
Port Name	Namibe	Category	Railway
Year Constructed	1967		
Maintenance Record	unknown		
Facility Description	The eighth railway from the quay face (indecated by arrows in the photos hereunder)		
Existing Condition	There can be seen some deviation and unevenness. Some part of rail is found to have been removed. The port of Namibe does not use it.		
Structural Condition Assessment	**Grade 2** The facility is in structurally bad condition. It will become the object of rehabilitation plan.		
Location

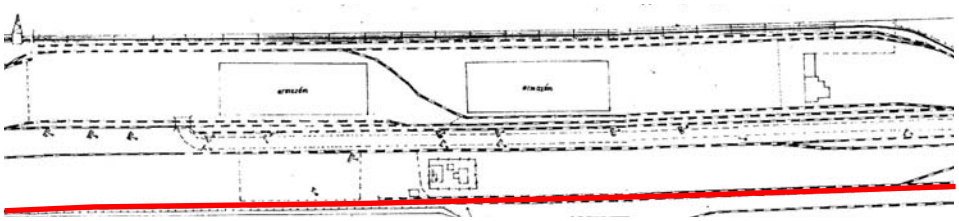
Facility ID	Na -09 -009	Survey Date	2005/10/14
Port Name	Namibe	Category	Railway
Year Constructed	1967		
Maintenance Record	unknown		
Facility Description	The nineth railway from the quay face (indecated by arrows in the photos hereunder)		
Existing Condition	There can be seen some deviation and unevenness. Some part of rail is found to have been removed. The port of Namibe does not use it.		
Structural Condition Assessment	**Grade 2** The facility is in structurally bad condition. It will become the object of rehabilitation plan.		
Location

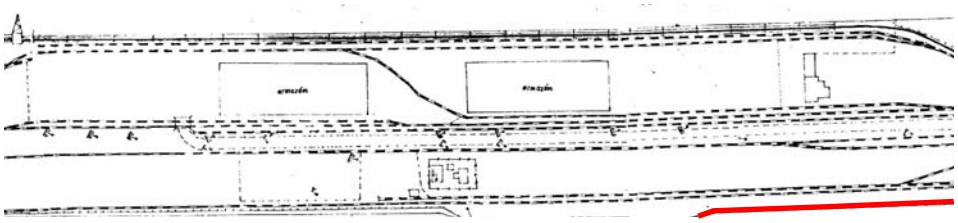
Facility ID	Na -09 -010	Survey Date	2005/05/16, 10/14
Port Name	Namibe	Category	Railway
Year Constructed	1967		
Maintenance Record	unknown		
Facility Description	The tenth railway from the quay face (indecated by arrows in the photos hereunder)		
Existing Condition	Railway is found to have been removed.		
Structural Condition Assessment	Grade 2 The facility is in structurally bad condition. It will become the object of rehabilitation plan.		
Location
