CHAPTER 8

REHABILITATION AND RETROFITTING OF EXISTING BRIDGES

8.1 Background

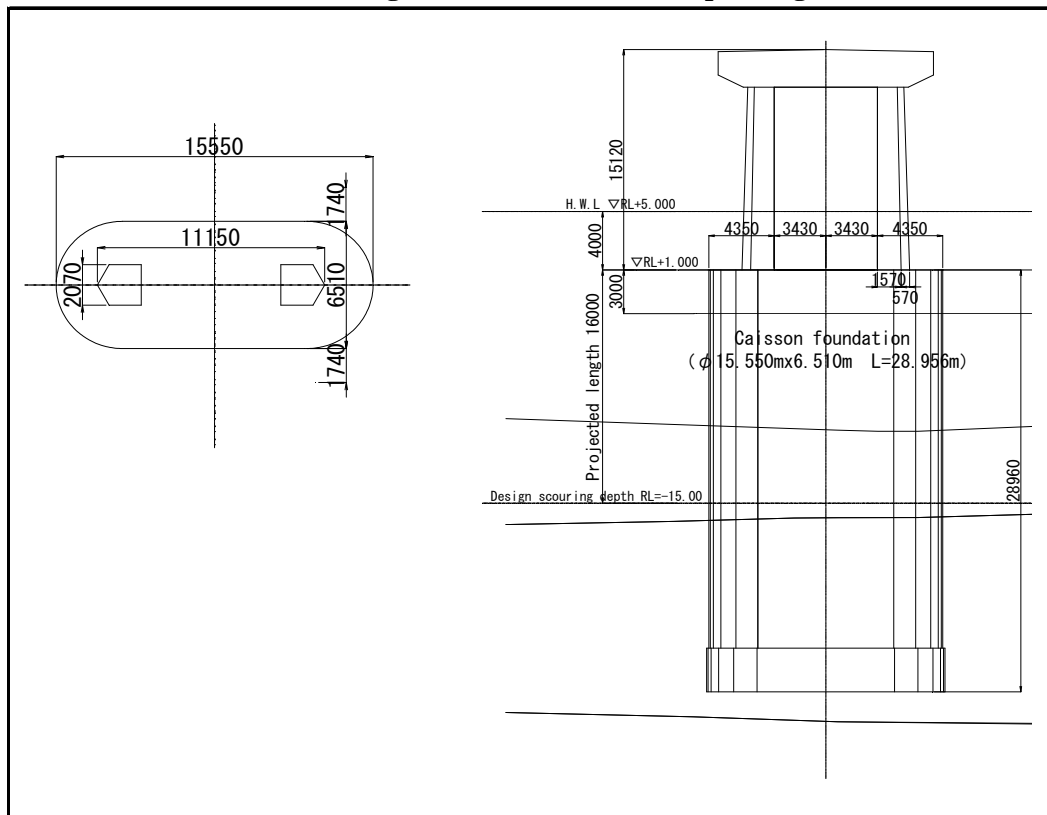
Table 8.5.8 State of Strength of Foundation Corresponding to Pier P5

As per the original design standards, the capacity of the existing bridge pier foundation is assessed by applying the restoration design concept. Then, the computed results are compared with the results computed by the current design specifications in Table 8.5.8. The current design specifications consider the seismic force as per BNBC along with the higher scouring level that is expected. It shows that the capacity of the foundation corresponding to pier P5 does not meet the requirements as per current design standards. Therefore, it requires retrofitting /additional reinforcement.

Unit	Periodic time	Spectral acceleration coefficient	Demand	Capacity	Check
Longitudinal direction						
Displacement	mm			29	50	OK
Subgrade reaction in axial direction	kN/m2	1.89	0.15	833	637	OUT
Subgrade shearing action	kN			7707	8292	OK
Transverse direction						
Displacement	mm			92	50	OUT
Subgrade reaction in axial direction	kN/m2	0.89	0.15	1894	734	OUT
Subgrade shearing action	kN			7967	5860	OUT

Based on the above results, it is necessary to increase the strength of the foundation for the existing bridge piers so that they can withstand strong seismic excitation. Accordingly, the JICA study team has adopted two plans;

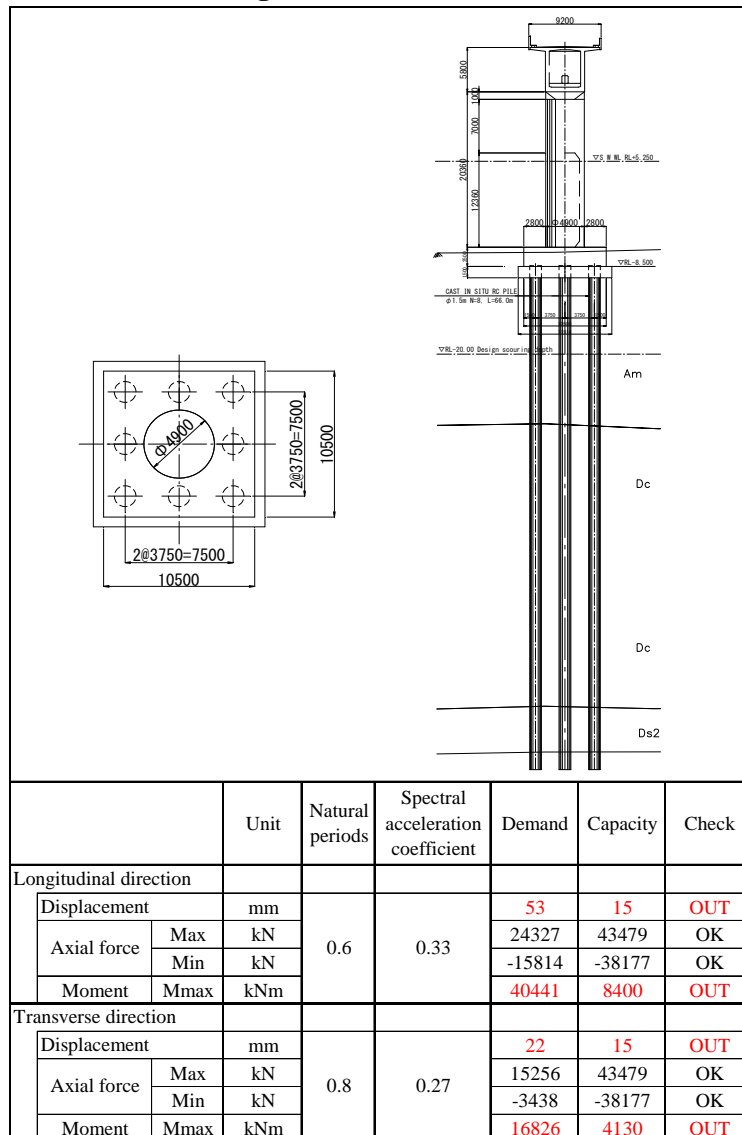
Table 8.7.4 Strength Check for Foundation of Pier P6

Following a method similar to that stated above for Kanchpur and Meghna Bridges, the capacity of Gumti Bridge foundations is verified under load specifications in the current design standards. The current design specifications consider the seismic force as per BNBC along with the higher scouring level that is expected. The computed result shows a similar tendency that has been verified for Kanchpur and Meghna Bridges. The capacity of the foundation corresponding to pier P6 does not meet the demand requirements and requires retrofitting /additional reinforcement.

Unit	Natural periods	Spectral acceleration coefficient	Demand	Capacity	Check
Longitudinal direction							
Displacement		mm			53	15	OUT
Axial force	Max	kN	0.6	0.33	24327	43479	OK
	Min	kN			-15814	-38177	OK
Moment	Mmax	kNm			40441	8400	OUT
Transverse direction							
Displacement		mm			22	15	OUT
Axial force	Max	kN	0.8	0.27	15256	43479	OK
	Min	kN			-3438	-38177	OK
Moment	Mmax	kNm			16826	4130	OUT

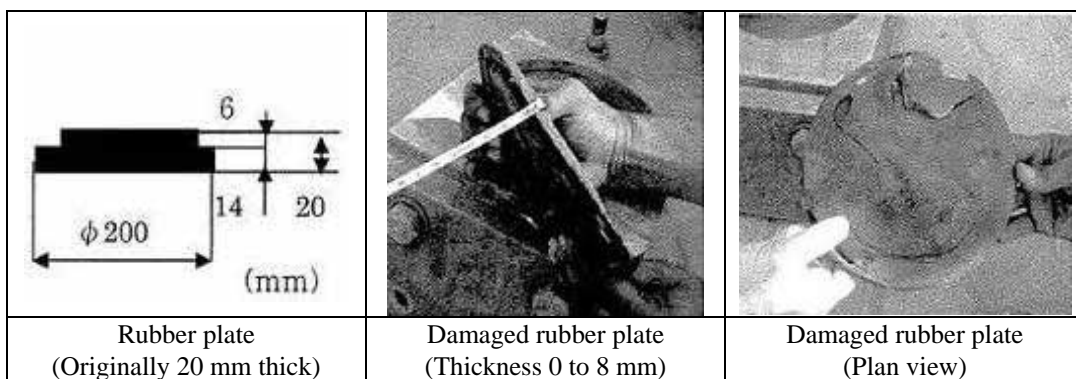
Figure 8.8.1 Deterioration in Hinges

It has been observed that the hinges lost their proper function to transmit the shearing forces between the cantilevers projecting from the piers, generating noises and unfavorable impact forces on the expansion joints when vehicles move from one cantilever to the other cantilever. Recent investigations showed the deteriorated rubber plates in the hinges as below.

| Rubber plate (Originally 20 mm thick) | Damaged rubber plate (Thickness 0 to 8 mm) | Damaged rubber plate (Plan view) |

Historically, the common types of hinges used to be the line touch type shown in Figure 8.8.3. As this type is vulnerable to abrasion from the steel components in the contact points due to the horizontal movement, there were many cases where the line touch type was replaced by the plane touch type shown in Figure 8.8.3 as the repair works.

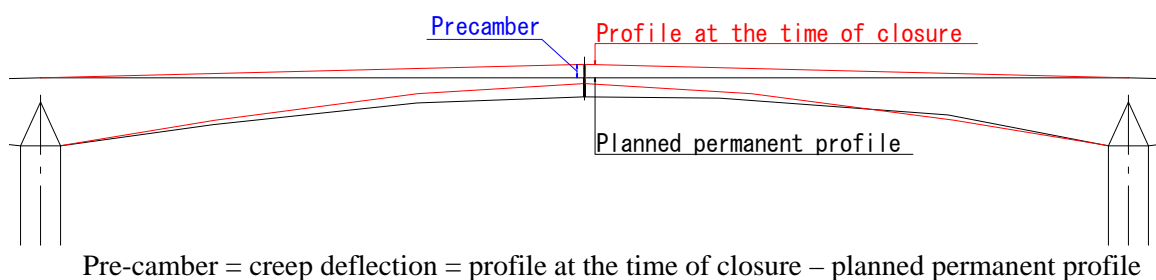
Figure 8.8.4 Creep Deflection of the Bridge Girders

In the case of a newly constructed bridge, however, a pre-camber is prescribed in the girder to accommodate the creep deflection and as a result of it a considerable amount of rotation will be generated between at the time of completion and at the time of reaching the permanent condition—the creep is finished. See Figure 8.8.4.

Pre-camber = creep deflection = profile at the time of closure – planned permanent profile

Meghna Bridge and Gumti Bridge adopted the plane touch type of hinges as shown in Figure 8.8.5. There could have been a possibility that the rubber plates in the hinges had a distorted deformation due to the rotation caused by the creep deflection with an amount exceeding the planned value, since the actual magnitude of the creep could have been larger than the planned depending on various conditions such as not only the actual mix proportion and characteristics of the materials used for the concrete but also the climate or environmental conditions. If that was the case then the rubber plates which had already been stressed some amount could have been excessively stressed when they were subjected to the live loading effects.
