土砂災害対策強化プロジェクト
【有償勘定技術支援】

プロジェクト完了報告書
添付資料（2/2）

パイロットサイト工事完了報告書

PILOT PROJECT FOR LANDSLIDE AND ROCKFALL MITIGATION WORKS IN BADULLA, NUWARAELIYA AND MATALE

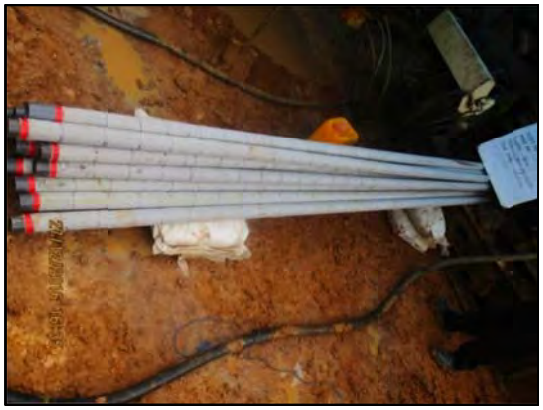
Stone filling behind and beside gabion wall

PVC pipes prepared and numbered before installation

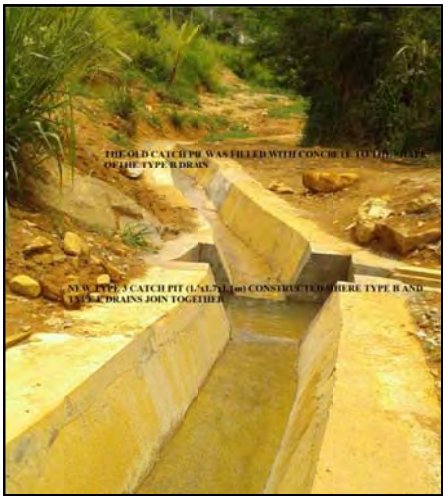
Type 3 catch pit constructed far down the drain where types B and E drains join together

Catch pit type 3 replacement work completed

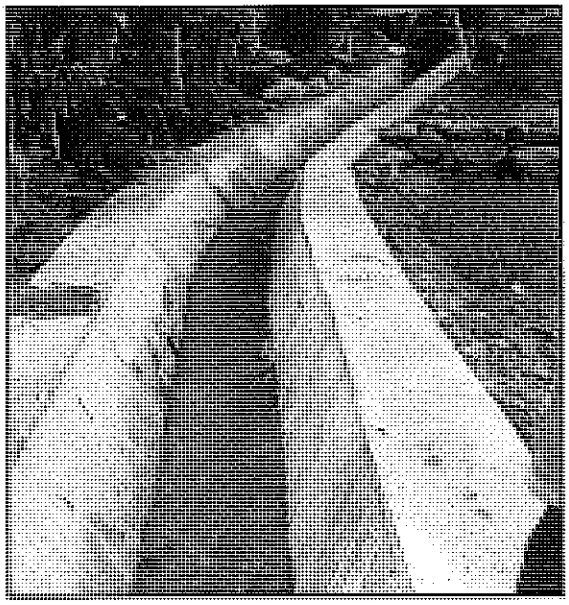
Soil erosion was noticed on one embankment of the drain during heavy rainy season. Rubble filing was done on that embankment in order to stabilize the filling.

Fig 14: Rubble pitching on embankments to minimize soil erosion

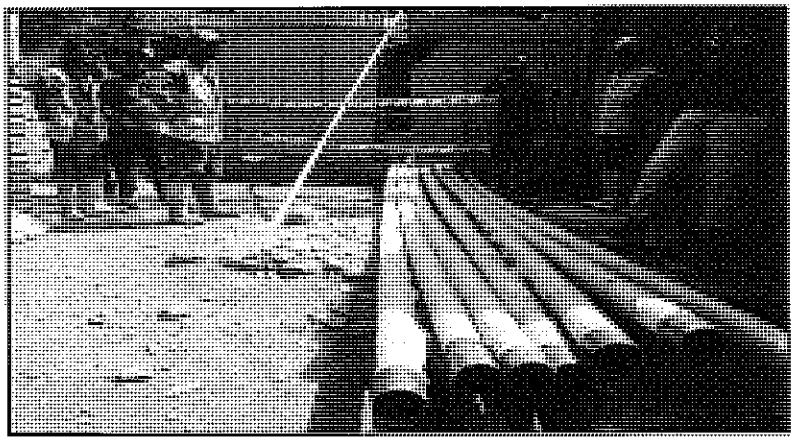
Fig 24: Installation of Geotextile wrapped PVC

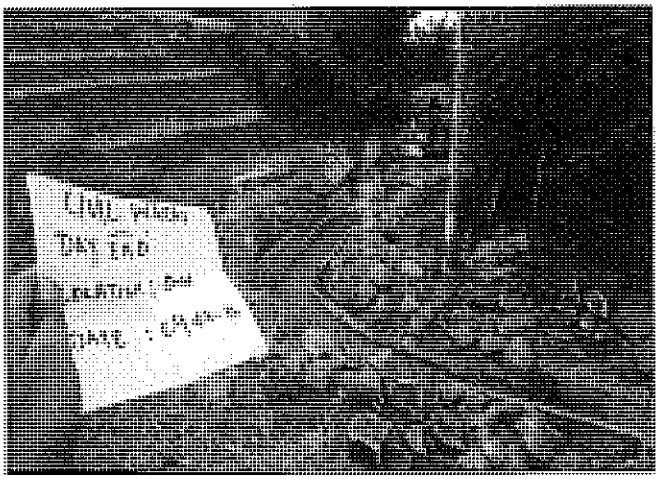
There were many transported boulders were observed within the proposed drainage line. Therefore rock excavations and demolitions were required for the excavations. Few photographs of each stage of the ditch construction is shown below.

Fig 27: Rock excavation

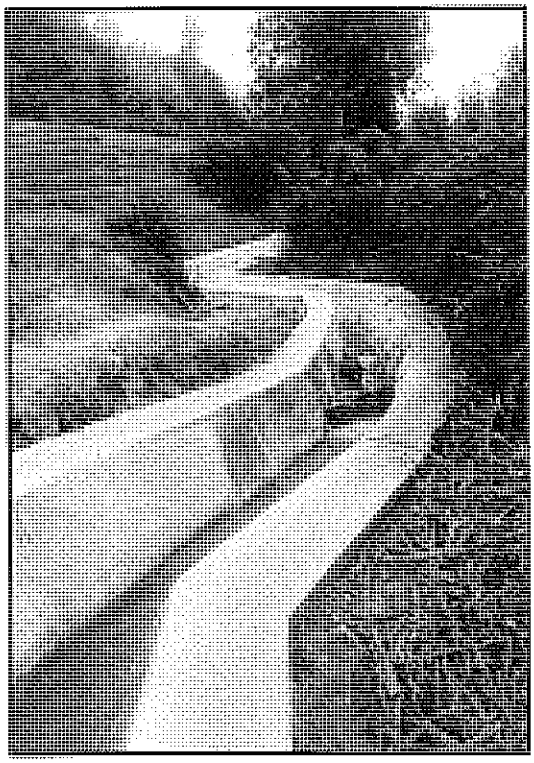
Fig 29: Completed drain section

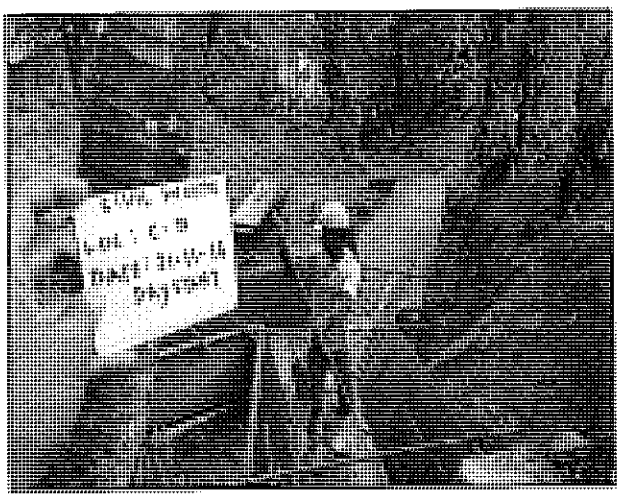
Fig 31: Form working in the "Y" Junction

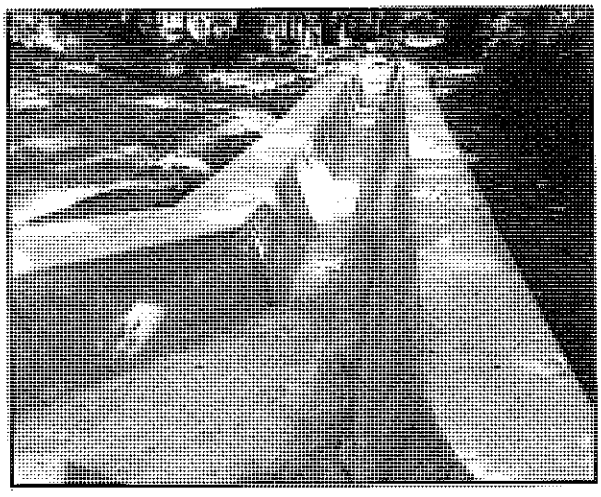
Fig 32: Completion of the work

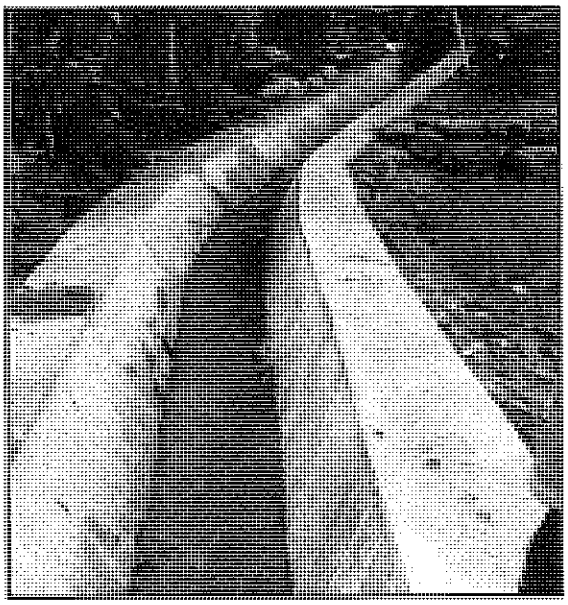
Soil erosion was noticed on one embankment of the drain during heavy rainy season. Rubble filing was done on that embankment in order to stabilize the filling.

Fig 14: Rubble pitching on embankments to minimize soil erosion

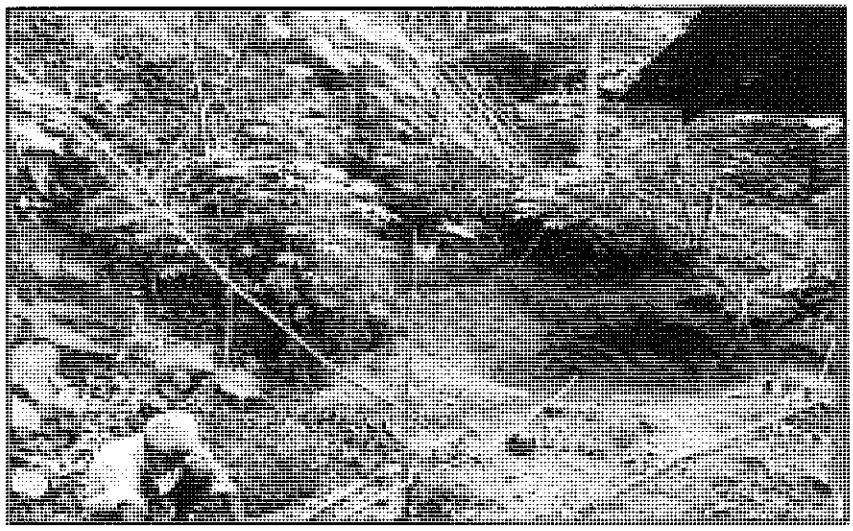
Fig 20: Proposed Drilling Point

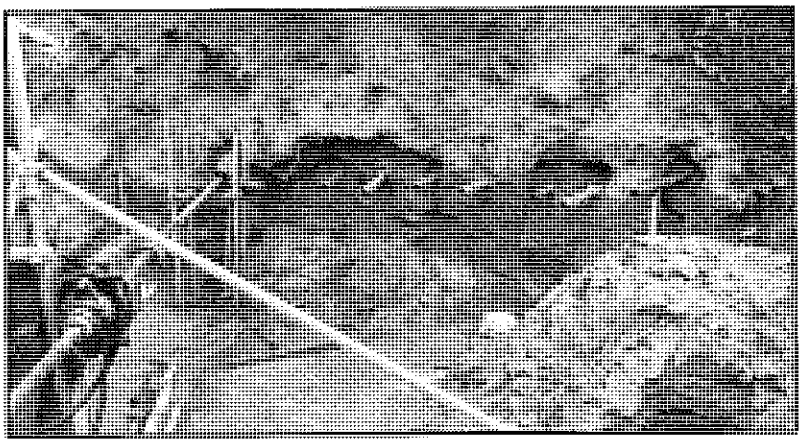
Fig 24: Drilling of last 10th Hole

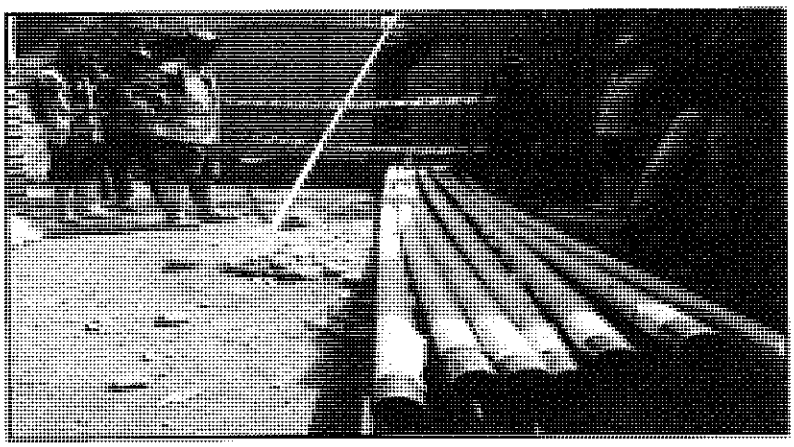
Fig 24: Installation of Geotextile wrapped PVC

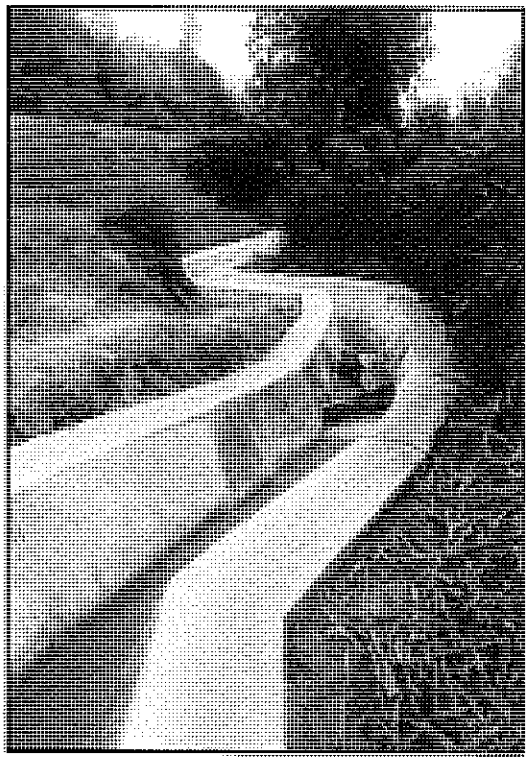
Fig 29: Completed drain section

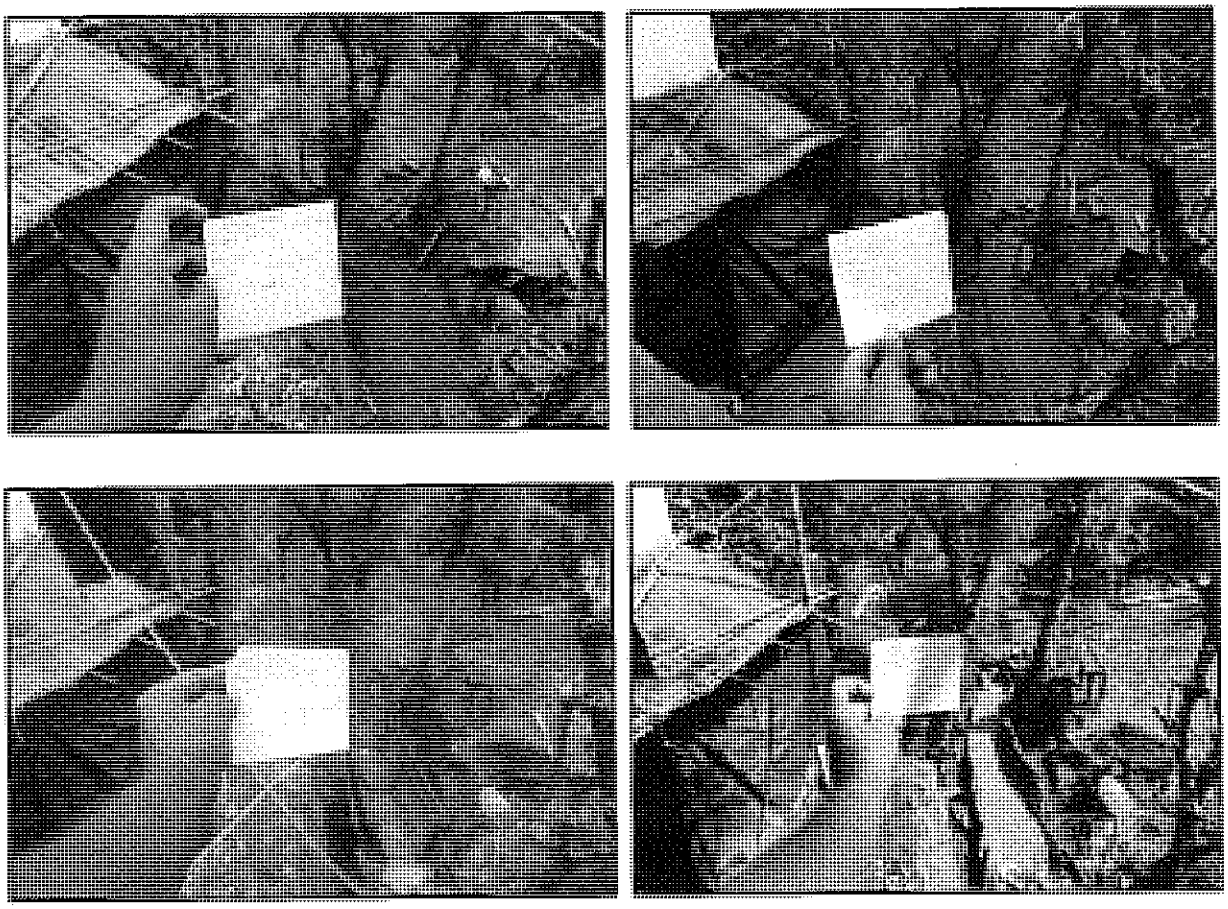
Fig 30: Progress of the construction work from the same location

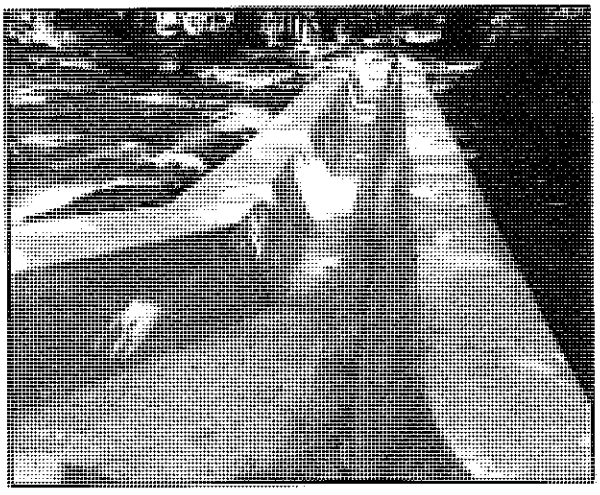
Fig 32: Completion of the work

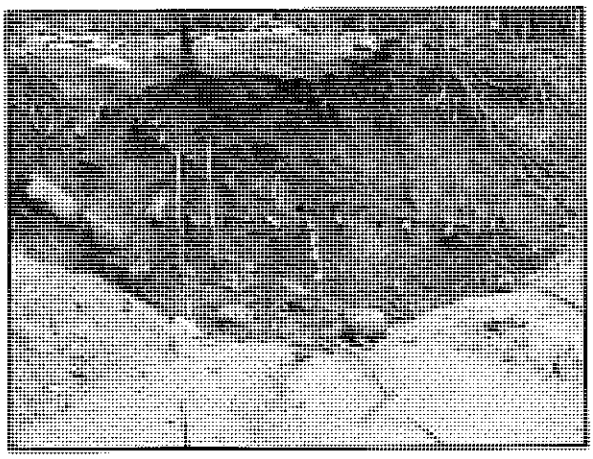
Fig 37: After drilling completed

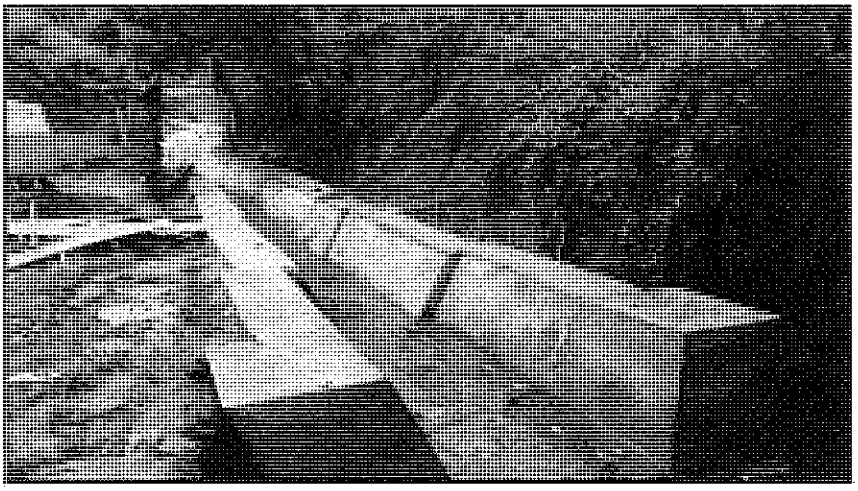
Related BOQ Item: 11.2 Lower Concrete Dam

Total size of the dam is 10.0 m^3. Measurement sheet of the Lower small dam certified by the engineer is attached in annexure-06.

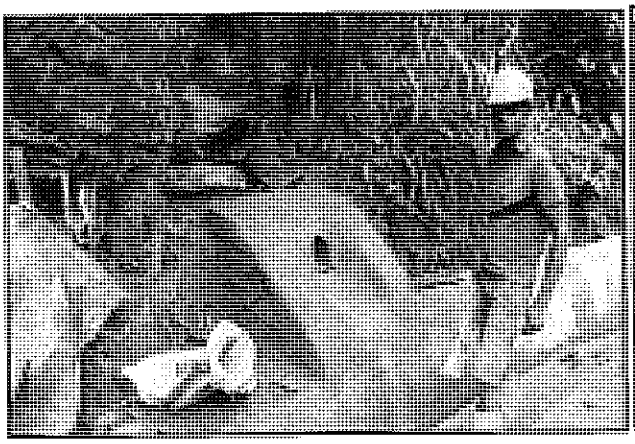
Fig : Water collecting pit and Laying of HDPE pipe
