4 第6章（橋梁の基本設計）の関連資料

4.1 現況橋梁諸元

List record field survey and renovation policy decision(1)

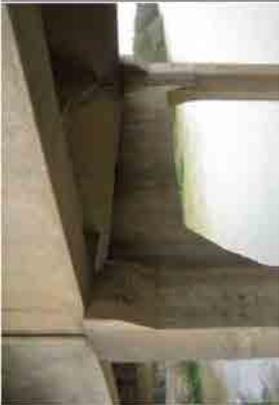
Width of Pillar (m)	0.60		
Height (m)	unknown		
Material	<input checked="" type="checkbox"/> RC <input type="checkbox"/> Stone <input type="checkbox"/> Other		
Form	<input type="checkbox"/> Inverted I type <input type="checkbox"/> Gravity type <input checked="" type="checkbox"/> Wall <input type="checkbox"/> unknown		
Height (m)	unknown		
Width of abutment (m)	8.20		
Location map			
Deterioration & damage		Condition	Not good
Main Deterioration		支間中央の曲げひびわれ、支点付近のせん断ひびわれ、コンクリート剥離、鉄筋露出、鋼材腐食	
Construction Overview

1. Excavation			
2. Reconstruction (1. のみでは困難の場合)			
Other important issues			
①劣化・損傷程度が大きい、			
②交通量が多く、架け替え時は仮橋が必要。			
Pictures of Site		Pictures of Site

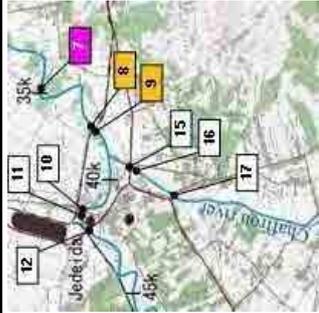
Condition	Not good	
		①欄柵のひび割れ、漏水 ②主径間の深刻な損傷 ③土砂堆積による部分的な河道閉塞		
		Construction Overview

1. removing of sediment. 2. constructing of by-pass		
		Other important issues		
		Because of historical bridge, removing bridge is difficult.		
		Picture-1 Deck surface

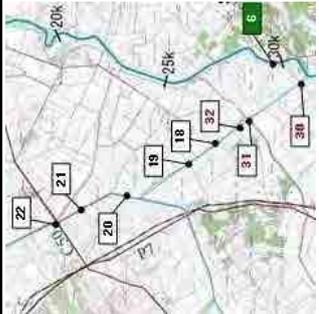
Width of Pillar (m)	Longitudinal	Transverse	-
Height (m)	Pier	beam	-
Material	<input checked="" type="checkbox"/> RC <input type="checkbox"/> Stone <input type="checkbox"/> Other		
Form	<input checked="" type="checkbox"/> Inverted I type <input type="checkbox"/> Gravity type <input type="checkbox"/> Other		
Height (m)	Parapet	Wall	unknown
Width of abutment (m)			unknown
Location map			
Deterioration & damage		Condition	Mild damage
①排水装置の欠陥

Construction Overview			
Reconstruction (既存水路50m3/sから200m3/sへの改修のため、断面不足は明らか)			
Other important issues			
Picture-1 Deck surface		Picture-2 Side	
Picture-3 The underside of the beam		Picture-4 Substructure	
Picture-5 Bearing or Attachment		Picture-6 Environment	
Creation Date		2012/8/8	
Revised Date			
Shooting Date		2012/9/1

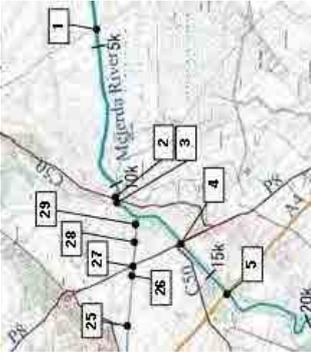
Mild damage		
		Deterioration		
		①伸縮装置の劣化		
		②排水装置の欠陥		
		No measures		
		Construction Overview		
		Other important issues		
		①河床を掘削する場合は掛け替えとなる。		
		②側面に添架管有り。
