**DATA COLLECTION SURVEY
FOR
RECONSTRUCTION OF TEOUMA BRIDGE
ON EFATE RING ROAD**

SURVEY REPORT

JANUARY 2017

CTI ENGINEERING INTERNATIONAL CO., LTD.

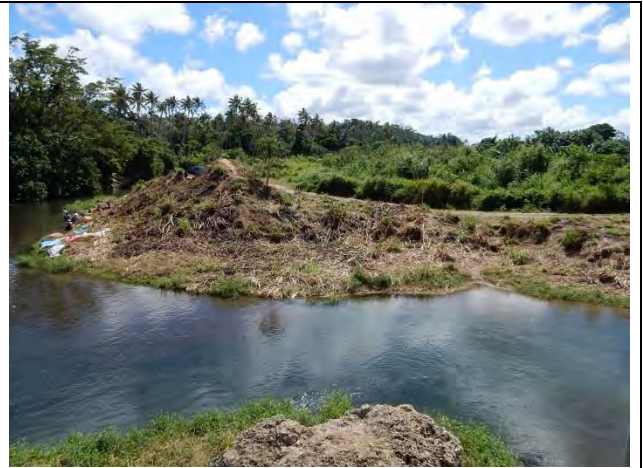
**Sedimentation inside of Curve
(Upstream, Left Side)**

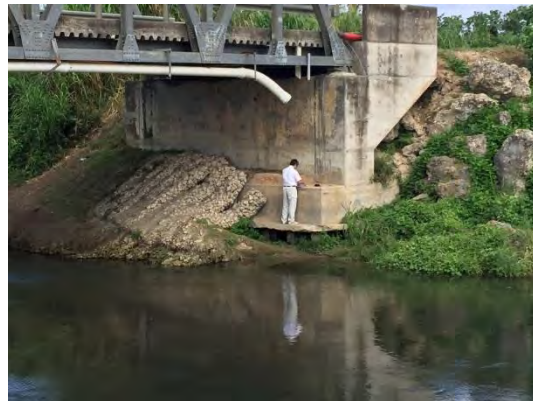
Measurement for Rebound Number on Right Abutment

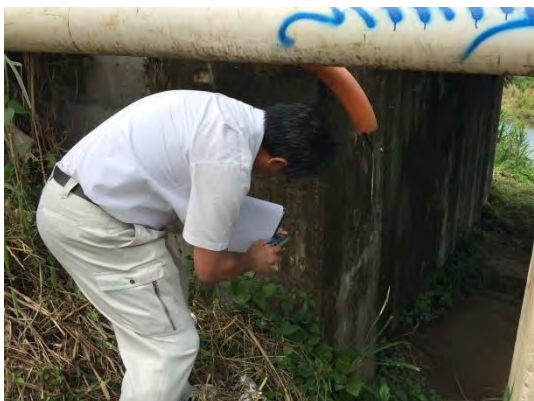
Measurement for Rebound Number on Left Abutment

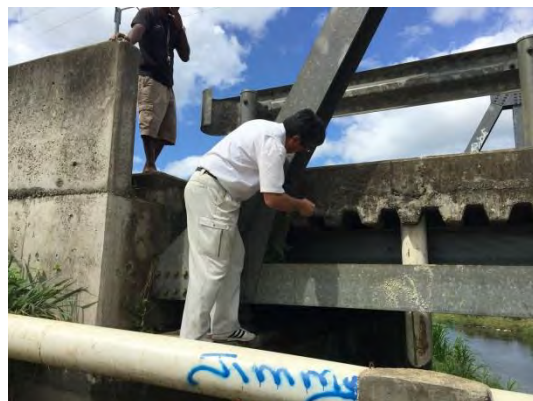
Measurement for Rebound Number on Concrete Deck Slab
