FOLLOW-UP COOPERATION
ON
THE PROJECT FOR IMPROVEMENT
OF
INTERNATIONAL COOPERATION AND TRAINING CENTER
IN
LAO PEOPLE'S DEMOCRATIC REPUBLIC

Interim Report

August, 2015

Azusa Sekkei CO., LTD.

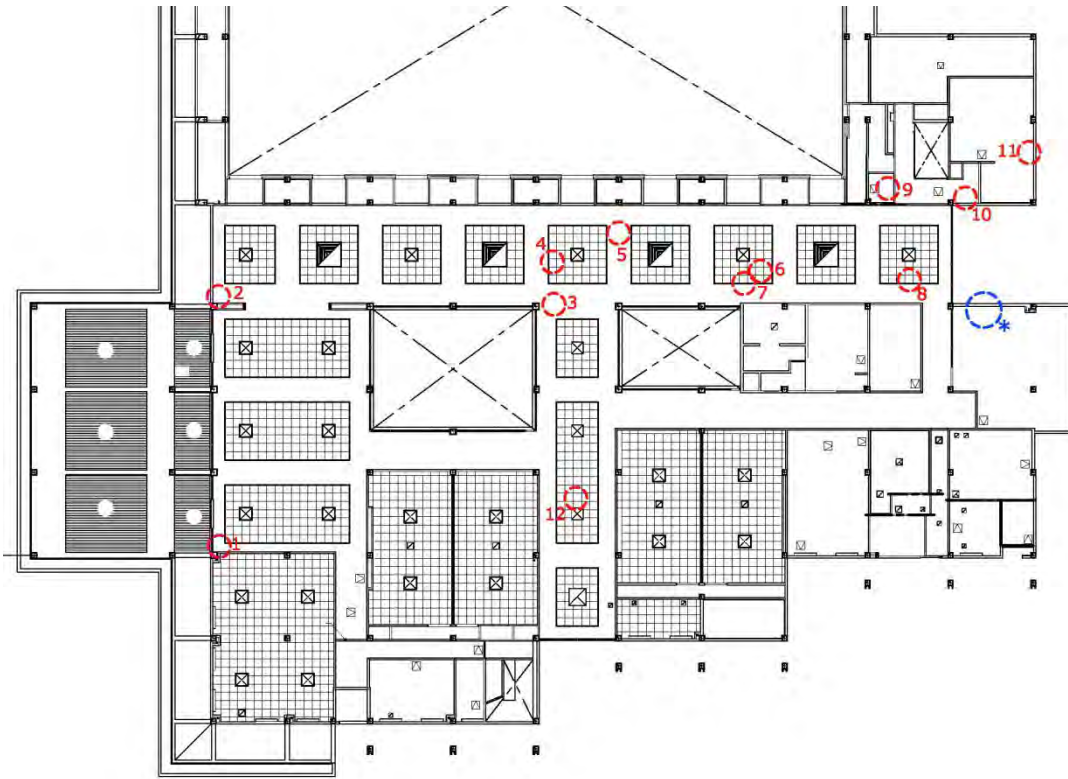
Ceiling stain locations and the ceiling space

- Watermarks on some of the ceilings were observed.
- The causes are the rain water leakage and the leakage of condensation water from the air conditioner drain pipes.

If the ceiling is a part of system ceiling, the stained panel can be simply replaced after the water proofing work for the roof is finished. If the stain is due to the air conditioning unit, clean the drain pan and advice the regular maintenance before changing the ceiling panel. If the stain is on the plaster board portion, enough area needs to be replaced with new plaster board. After puttying the surface, paint it in the matching color. (Defected areas are shown in the attached drawings.)
