Inventory Sheet A

District	Nuwara Eliya	Management office	Nuwara Eliya	Road No	A-005	Road Name	Peradeniya - Badulla - Chenkaladi road						
Site No.	2		Disaster Type	Landslide	Location	Start	46/2	End	46/3	latitude	7°02'57.7"N	longitude	80°41'57.8"E
Main body	Both	Traffic control	Hourly	mm	Traffic volume	Week day	4442/12h	holiday		Bus route		Detour

Inventory Sheet B

Checked by	Yang Pucai
Organization	JICA Survey Team

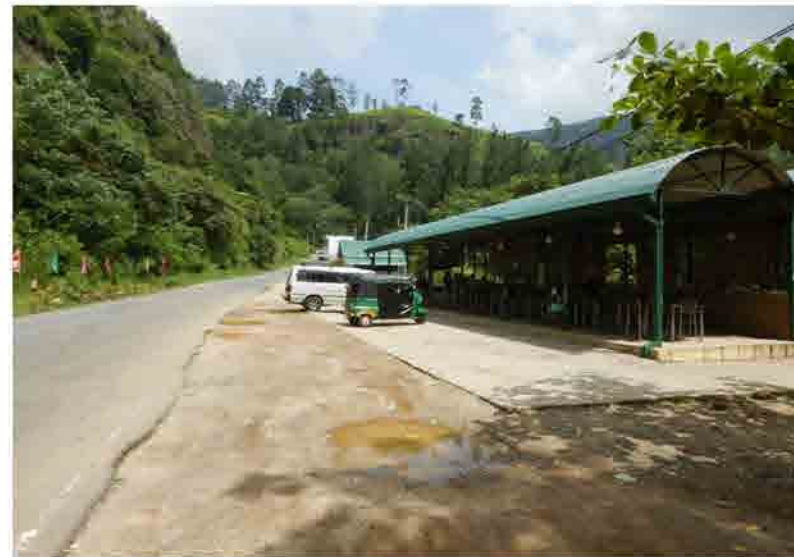
P4 A public restaurant within the landslide

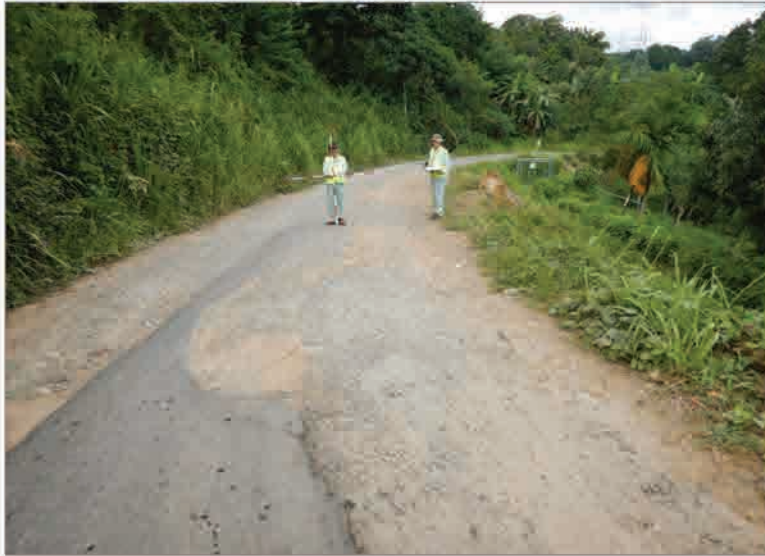
P1 The deformed situation of the village road on the upper slope of the landslide

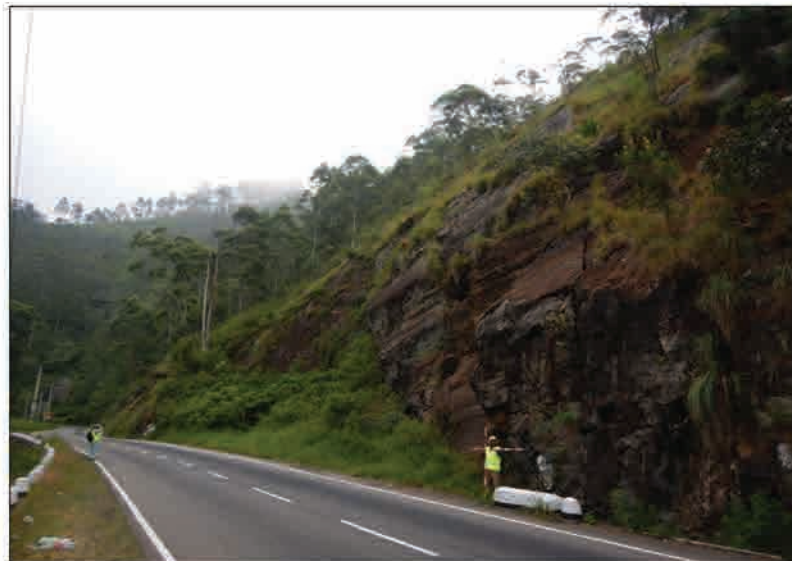
P6: The cut slope of bedrock

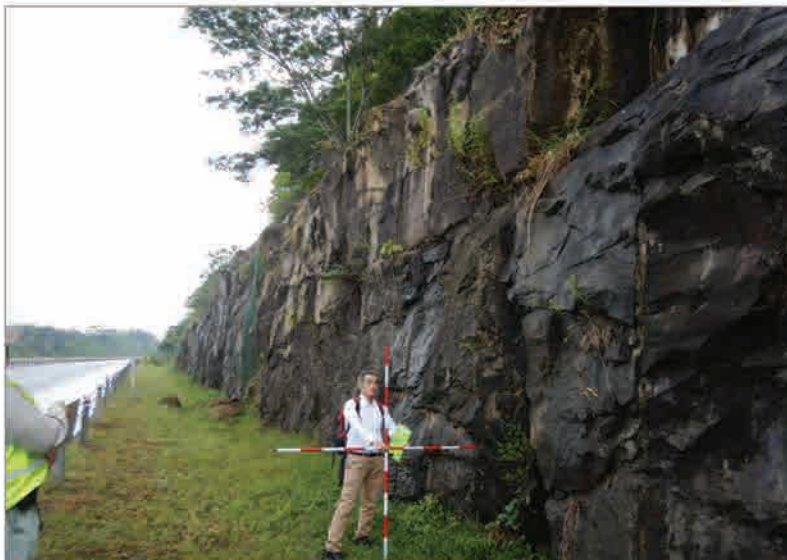
P2 Major joints dipping adversely out of the cut slope, showing high potential for rockfall

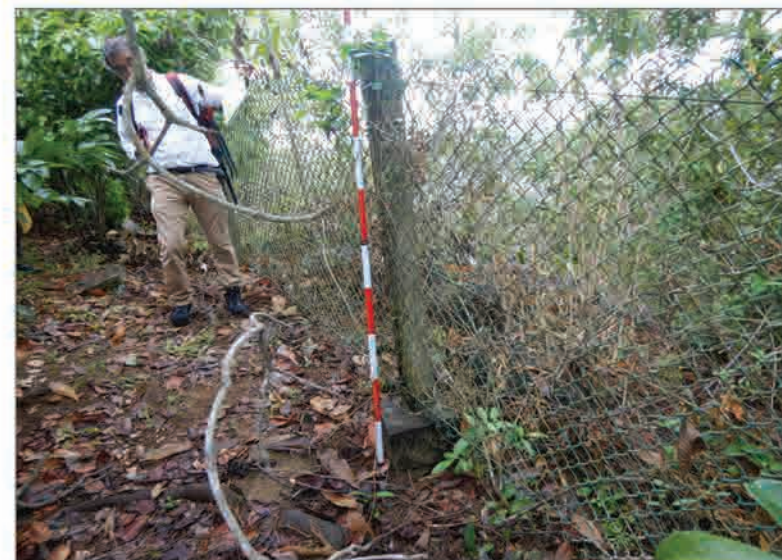
P4 Unstable stones (at max size, $\phi 20 \times 50 \times 80$ cm), distributed around the ROW boundary fences of RDA.

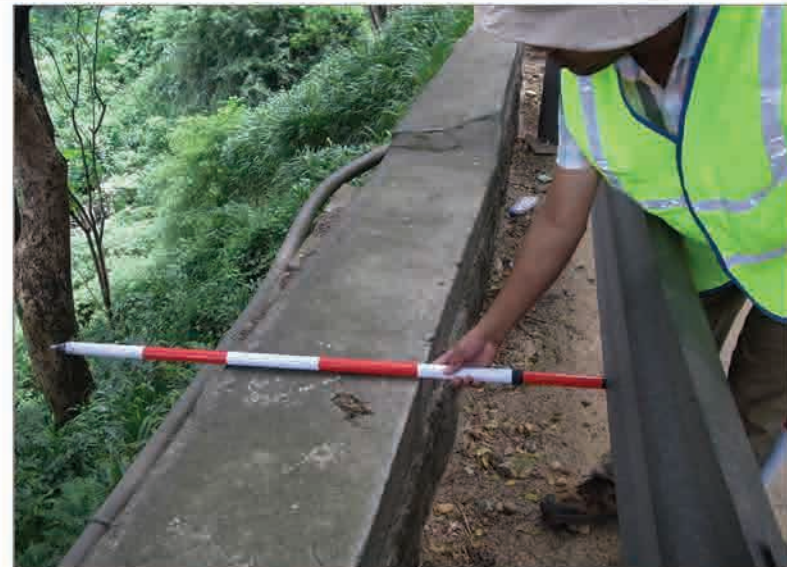
P2 Deformed concrete wall due presumably to movement on the valley side of the road.
