**THE DETAILED DESIGN STUDY
FOR
THE PASIG-MARIKINA RIVER
CHANNEL
IMPROVEMENT PROJECT
(PHASE IV)**

**FINAL REPORT
(PRIOR RELEASE VERSION)**

**VOLUME-2
APPENDIX**

Table 6.2.1 The Result of Drainage Survey (RIGHT BANK) (1/30)

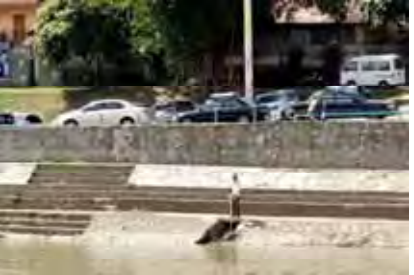
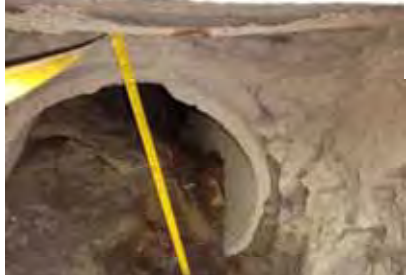
<p>NEW OUTLET</p> <p>Drainage Outlet No.= MR001A Northing= 1618661.915 Easting= 509853.144 Elevation= 11.606 Dimension= D450mm T50mm Type= RC Date= 2020/1/8 Station no.= 13+327</p> <p>REMARKS: CLOGGED RC inside BC BC dimensions: H: 550mm W: 800mm Distance from mouth of BC to RC: 2 meters</p>
<p>Photo (distant view)</p>

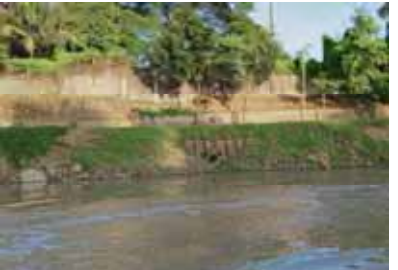
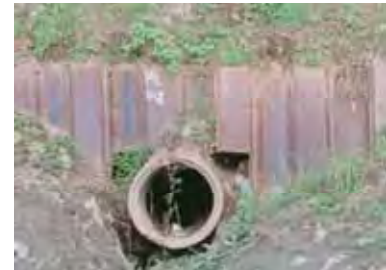
<p>Drainage Outlet No.= Northing= Easting= Elevation= Dimension= Type= Date= Station no.=</p>	<p>NEW OUTLET ML017.2 1617733.464 510011.600 12.325 H450mm W550mm RC inside BC 2019/9/25 12+388</p> <p>Remarks: RC inside cannot be measured because area is covered in soil.</p>

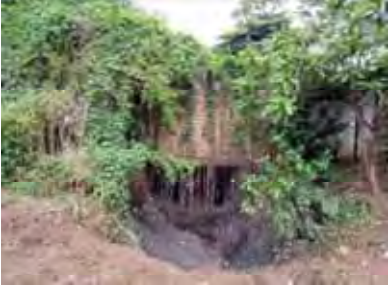
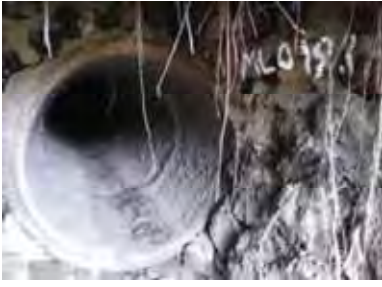
<p>Drainage Outlet No.= Northing= Easting= Elevation= Dimension= Type= Date= Station no.=</p>	<p>ML019 1617588.389 510007.673 14.898 D1200mm T130mm RC 2019/10/9 12+251</p> <p>Remarks Outlets ML19 and ML19.1 are not of the same/equal elevation as shown in the picture</p>

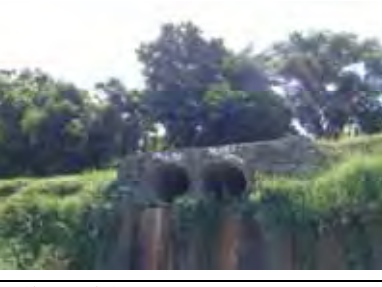
<p>Drainage Outlet No.= ML019.1 Northing= 1617586.600 Easting= 510007.867 Elevation= 14.997 Dimension= D1200mm T130mm Type= RC Date= 2019/10/9 Station no.= 12+249</p>	<p>Remarks: Outlets ML19 and ML19.1 are not of the same/equal elevation as shown in the picture</p>
<p>Photo (distant view)</p>  	<p>Photo (short range view)</p>

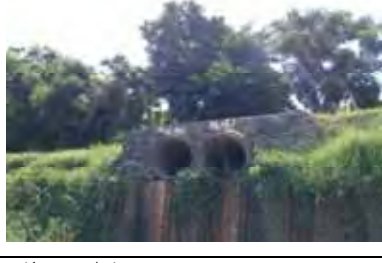
<p>Drainage Outlet No.= ML020 Northing= 1617493.886 Easting= 509940.938 Elevation= 13.340 Dimension= D900mm T100mm Type= RC Date= 2019/10/9 Station no.= 12+146</p>	<p>REMARKS: elevation is not equal to ML21 elev</p>
<p>Photo (distant view)</p>  	<p>Photo (short range view)</p>

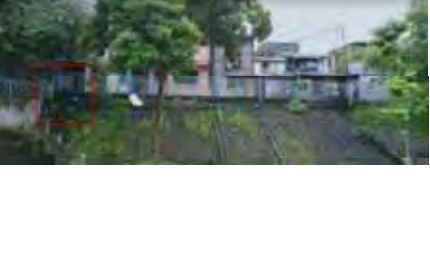
<p>Drainage Outlet No.= ML022A Northing= 1617378.031 Easting= 509841.442 Elevation= 12.033 Dimension= D1100mm T100mm Type= RC Date= 2019/10/9 Station no.= 12+011</p>	<p>Remarks: Old outlet (ML022) was extended for about 80 cm towards the river. The extended portion was the one surveyed.</p>
<p>Photo (distant view)</p>

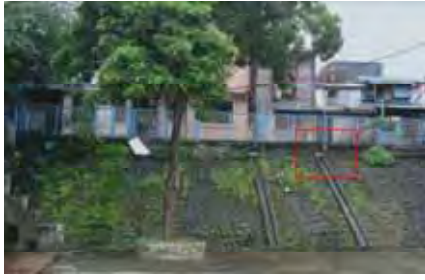
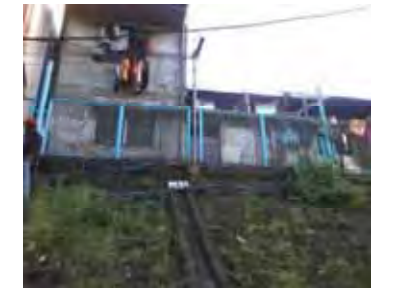
<p>Drainage Outlet No.= ML024 Northing= 1617345.336 Easting= 509829.385 Elevation= 19.979 Dimension= D120mm Type= PVC Date= 2019/6/13 Station no.= 11+990</p>	<p>Remarks: PVC is damaged.</p>
<p>Photo (distant view)</p>

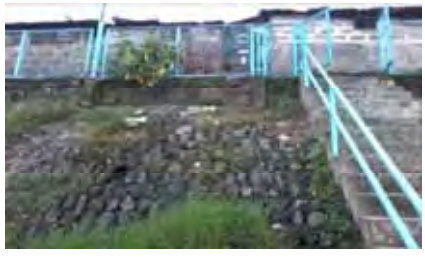
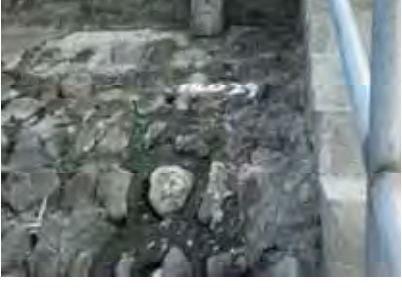
<p>Photo (short range view)</p>  	<p>Drainage Outlet No.= ML028 Northing= 1617345.232 Easting= 509799.915 Elevation= 19.628 Dimension= D200mm Type= PVC Date= 2019/10/9 Station no.= 11+968</p>	<p>Remarks: PVC is damaged.</p>
<p>Photo (distant view)</p>

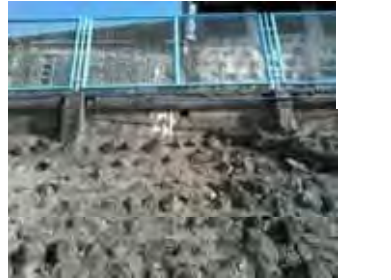
<p>Drainage Outlet No.= ML030A Northing= 1617349.876 Easting= 509784.858 Elevation= 15.437 Dimension= D600mm T80mm Type= RC Date= 2019/10/9 Station no.= 11+956</p>	<p>Remarks: Old outlet ML030 was extended for about 50 cm. The extended drainage was constructed and relocated adjacent to the stairs.</p>
<p>Photo (distant view)</p>

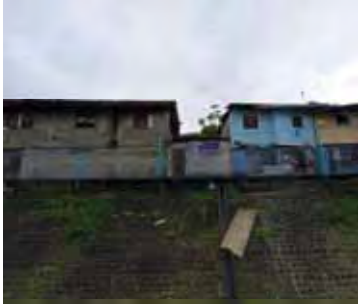
<p>Drainage Outlet No.= Northing= Easting= Elevation= Dimension= Type= Date= Station no.=</p>	<p>ML041 1617343.212 509679.002 20.399 D160mm PVC 2019/10/15 11+864</p> <p>Remarks: PVC is damaged.</p>

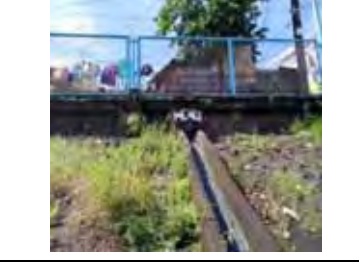
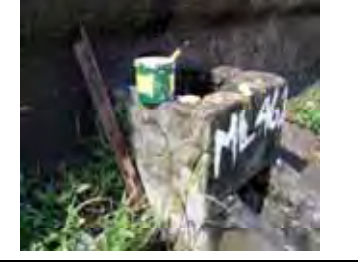
Photo (distant view)  	Photo (short range view)  	Drainage Outlet No.= Northing= Easting= Elevation= Dimension= Type= Date= Station no.= Remarks:	ML046 1617358.714 509633.207 14.925 D800mm T100mm RC 2019/10/10 11+822 Dimension cannot be measured properly because drainage is submerged. The dimension above are estimated measurements.
Photo (distant view)

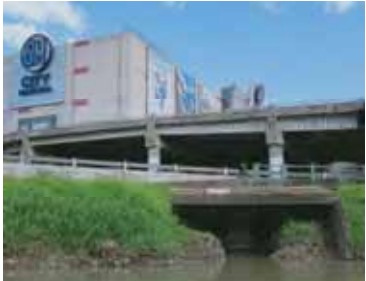
<p>Drainage Outlet No.= Northing= Easting= Elevation= Dimension= Type= Date= Station no.=</p>	<p>ML062A 1617669.324 508757.802 11.867 D1200mm T100mm RC 2019/9/25 10+361</p> <p>Remarks: Old outlet ML062 was a box culvert before and the drainage improvement resulted to three drainage outlets (ML062A, ML062.1B, ML062.2C) which were surveyed here.</p>
<p>Photo (distant view)</p>

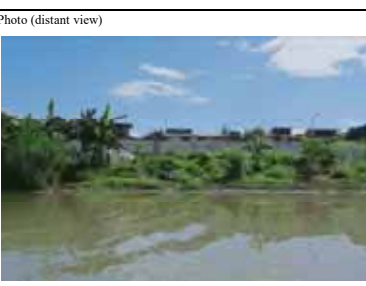
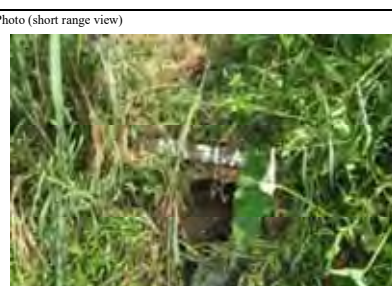
<p>Drainage Outlet No.= Northing= Easting= Elevation= Dimension= Type= Date= Station no.=</p>	<p>ML070A 1616313.703 508386.943 12.085 D600mm T80mm RC 2019/10/12 8+848</p> <p>Remarks Old outlet (ML070) was destroyed and was part of a road construction located along the centerline. A new drainage was relocated and constructed.</p>

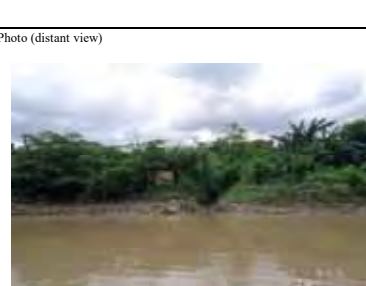
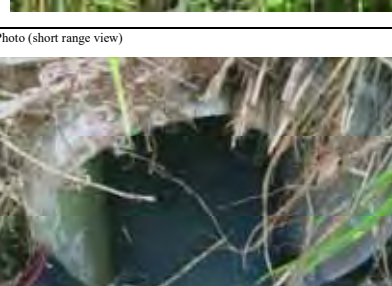
<p>Drainage Outlet No.= Northing= Easting= Elevation= Dimension= Type= Date= Station no.=</p>	<p>ML071A 1616263.343 508400.069 12.397 D600mm T80mm RC 2019/10/12 8+791</p> <p>Remarks Old outlet (ML071) was destroyed and was part of a road construction located along the centerline. A new drainage was relocated and constructed.</p>
<p>Photo (distant view)</p>

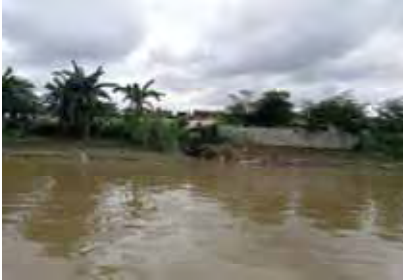
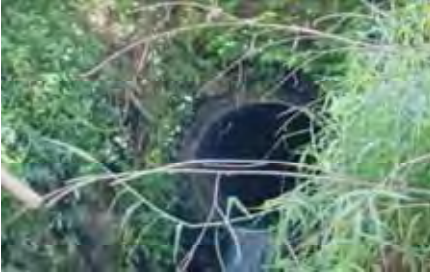
<p>Drainage Outlet No.= Northing= Easting= Elevation= Dimension= Type= Date= Station no.=</p>	<p>ML072A 1616137.448 508500.447 14.443 D900mm T100mm RC 2019/10/14 8+611</p> <p>Remarks Old outlet (ML072) was destroyed and was part of a road construction located along the centerline. A new drainage was relocated and constructed.</p>

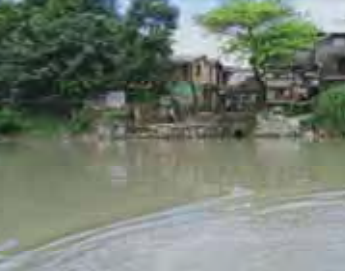
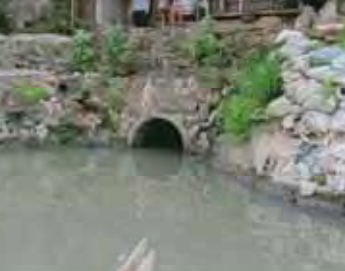
<p>Drainage Outlet No.= Northing= Easting= Elevation= Dimension= Type= Date= Station no.=</p>	<p>ML091A 1615651.410 509131.366 12.789 D100mm PVC 2019/10/14 7+805</p> <p>Remarks: Old outlet (ML091) has been cut down and the remaining portion has been surveyed.</p>
<p>Photo (distant view)</p>

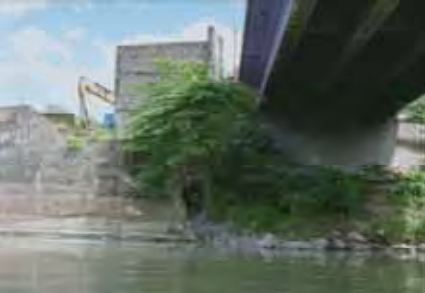
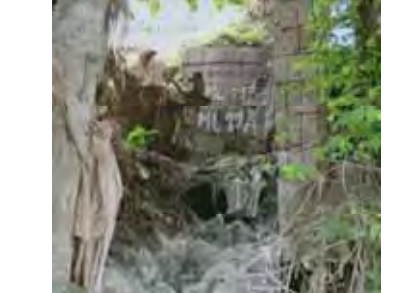
<p>Drainage Outlet No.= Northing= Easting= Elevation= Dimension= Type= Date= Station no.=</p>	<p>ML096 1615561.007 509267.353 17.627 D100mm T10mm PVC 2019/10/14 7+652</p>

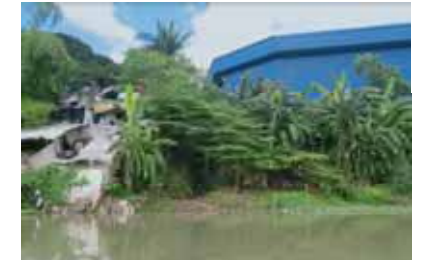
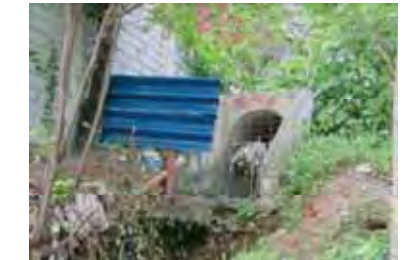
<p>Drainage Outlet No.= ML097A Northing= 1615168.637 Easting= 509480.304 Elevation= 12.511 Dimension= D770mm, T120mm Type= RC Date= 2019/10/16 Station no.= 7+216</p>	<p>Remarks: Old outlet (ML097) has been cut down and the remaining portion has been surveyed.</p>
<p>Photo (distant view)</p>

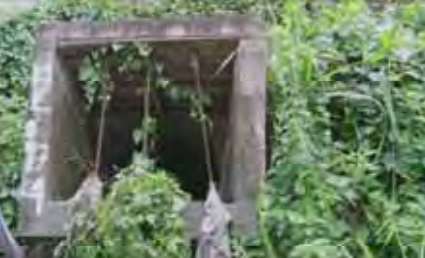
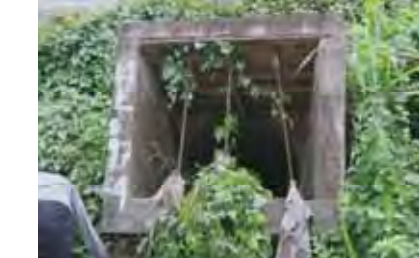
<p>Drainage Outlet No.= ML097.3 Northing= 1615564.777 Easting= 509252.930 Elevation= 15.009 Dimension= D1180mm Type= RC Date= 2019/10/14 Station no.= 7+658</p>	<p>NEW OUTLET</p>
<p>Photo (distant view)</p>

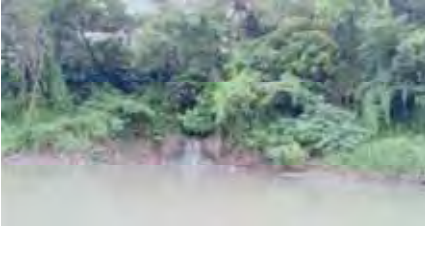
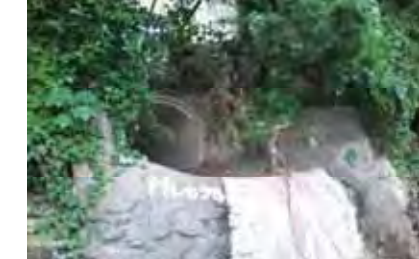
<p>Drainage Outlet No.= ML097.4 Northing= 1615335.585 Easting= 509390.223 Elevation= 13.665 Dimension= D1200mm T50mm Type= RC Date= 2019/8/15 Station no.= 7+406</p>	<p>NEW OUTLET</p>
<p>Photo (distant view)</p>

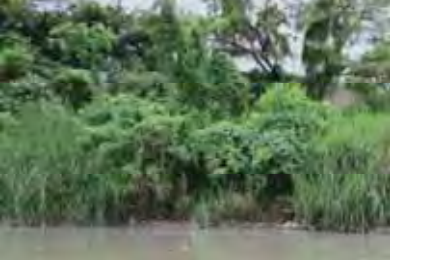
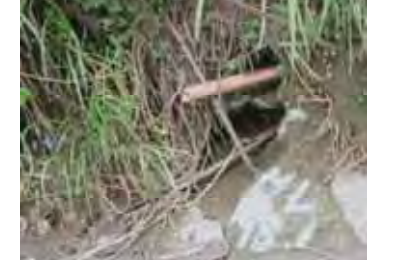
<p>Drainage Outlet No.= ML098 Northing= 1615139.331 Easting= 509507.087 Elevation= 13.508 Dimension= D1520mm T160mm Type= RC Date= 2019/8/30 Station no.= 7+178</p>	<p>NEW OUTLET</p>
