**The Democratic Republic of Timor-Leste
Ministry of Public Works
Directorate of Roads, Bridges and Flood Control**

**Timor-Leste
The Post-Disaster Survey for
New Comoro Upriver Bridge
Construction Plan
Post-Disaster Survey Report (Summary)**

December 2021

**INGÉROSEC CORPORATION
IDEA CONSULTANTS, INC**

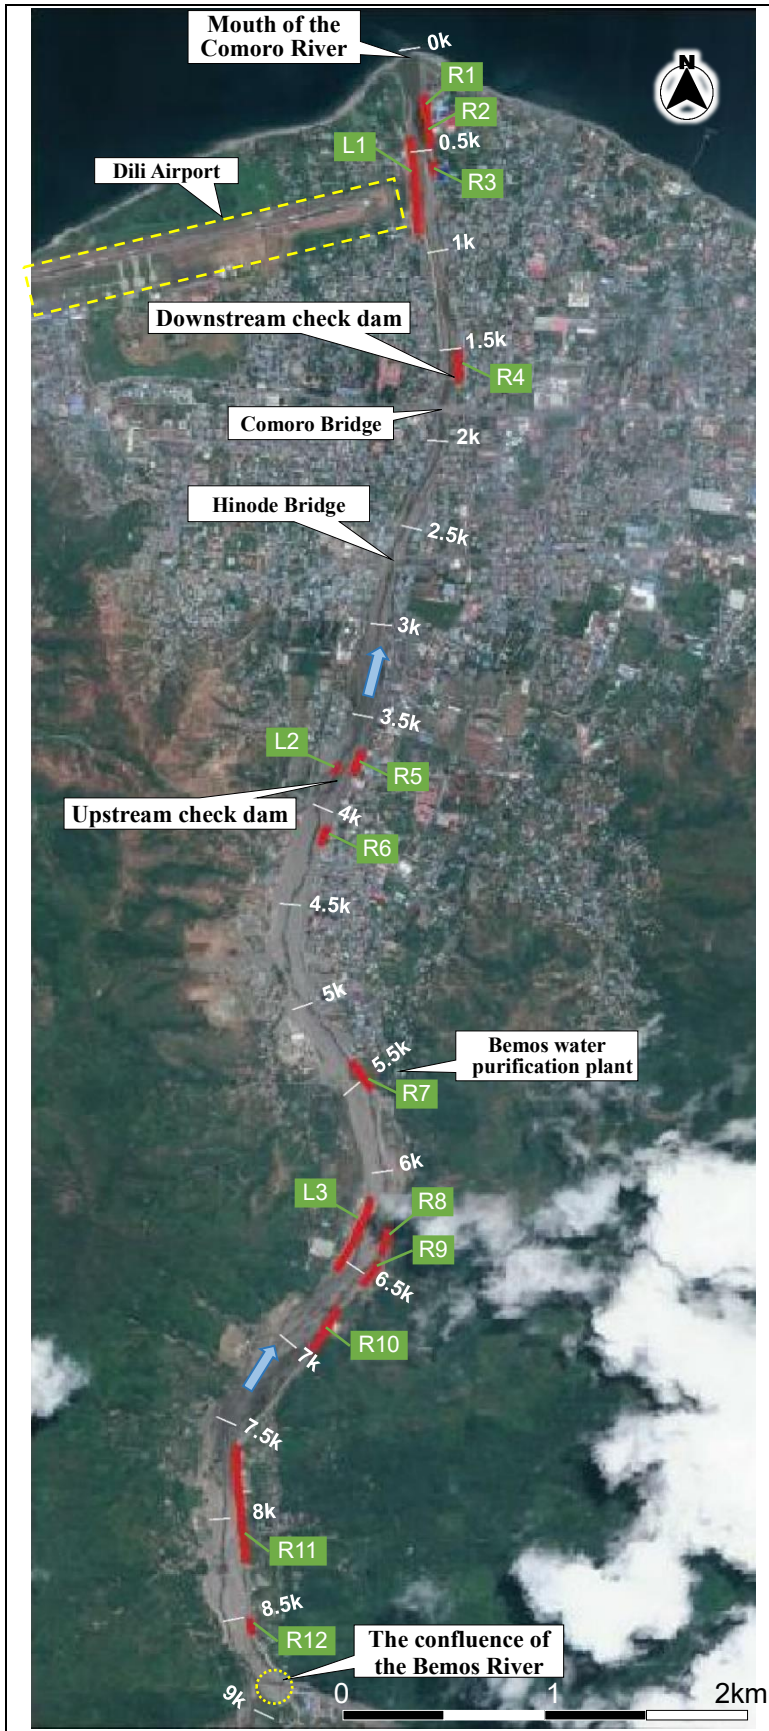
Survey area

R1-12 = damaged areas on the right side, L1-3 = damaged areas on the left side

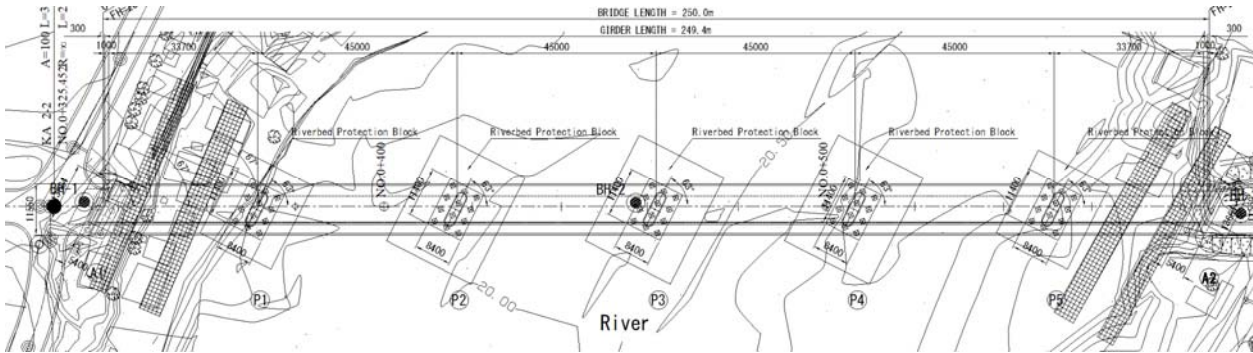
Figure 3 Plan of Hinode Bridge

The survey results for bridges and ancillary structures are shown below. The abutments and piers P1 and P5 near the riverbank are almost unaffected by floods. The protective blocks of piers P2, P3 and P4 located in the center of the river have been damaged.
