Appendix-2

Emergency Repairing Work Plan

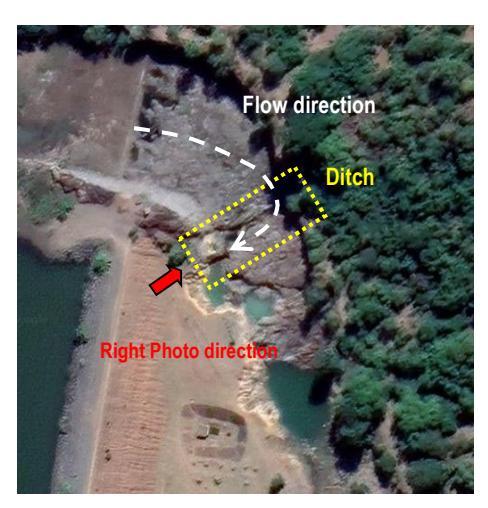
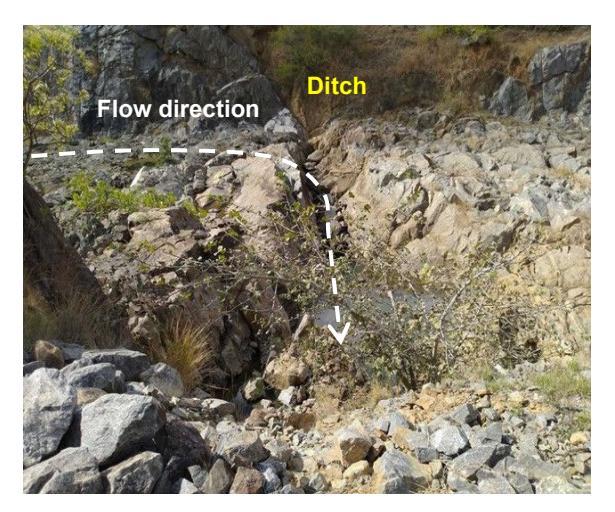
Figure 3.1 Suspected Cause of Collapses on the Right Bank Side (Embankment Side) Wall

There is a ditch across the connection canal and collapses may be caused by flow along this ditch. Although this part might have a flat surface just after construction, it may have been eroded by floods over the past 30 years since this portion might be relatively soft. It is supposed that the flood flow changed its direction from downstream to right side due to this ditch, and eroded the right bank side wall leading the collapses (see Figure 3.1).

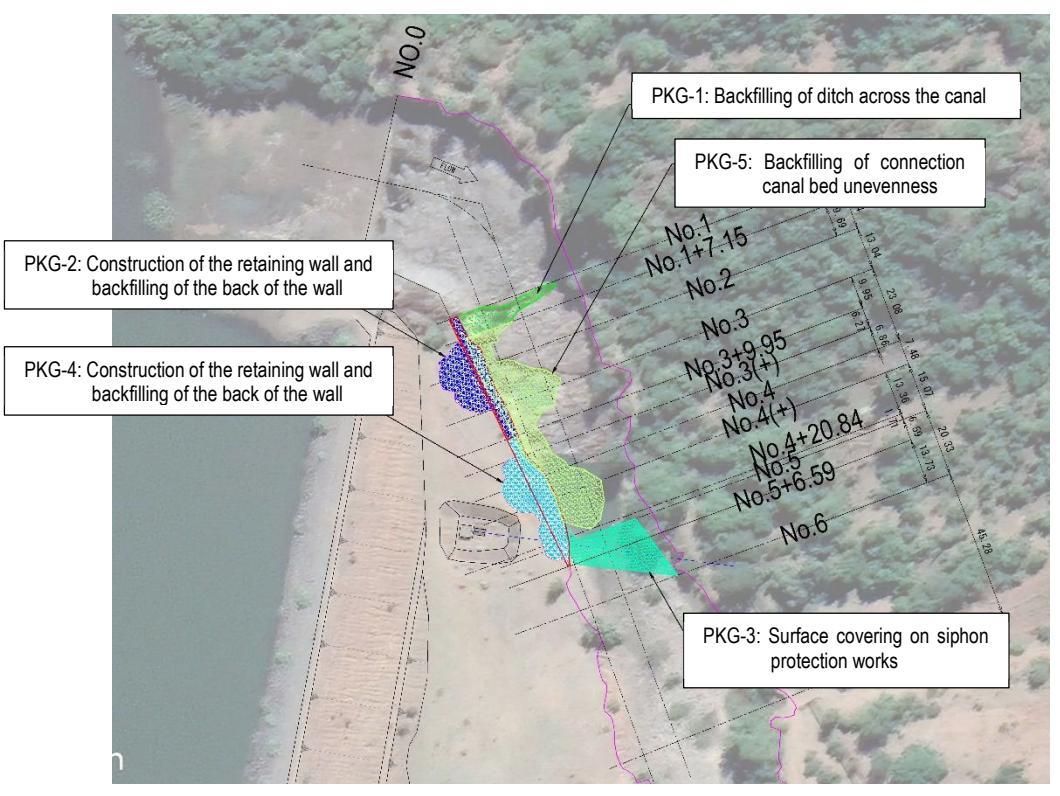
Figure 6.1 Construction Package Division of Emergency Repairing Measures

PKG	Target Area	Main target	Priority	Remarks
PKG-1	No. 1 - No.1+7.15	A collapse progressing to a point 6.0m from the embankment * If this collapse extends, it could lead to the	1	Backfilling of the ditch across the connection canal which is the main cause of the collapse
PKG-2	No. 1 - No.3+9.95	collapse of the embankment and loss of life.	2	Construction of the retaining wall and backfilling of the back of the wall to control the progression of the collapse
PKG-3	No.4+20.84 - No.6	Exposed siphon protection works * If the siphon pipe is damaged, the irrigation water supply will be interrupted. This may result in impoverishment, but not loss of life.	3	Surface covering to prevent damage on siphon protection works
PKG-4	No.3+9.95 - No.5+6.59	A collapse progressing to a point 1.5m from discharge valve house slope protection works * Even if the slope protection works are damaged, the valve can be operated for a while by removing the earth and sand manually.	4	Construction of the retaining wall and backfilling of the back of the wall to control the progression of the collapse

PKG-5	No.1+7.15 - No.4+20.84	Unevenness on throughout the connection canal bed	5	Backfilling of connection canal bed unevenness (mainly recesses)

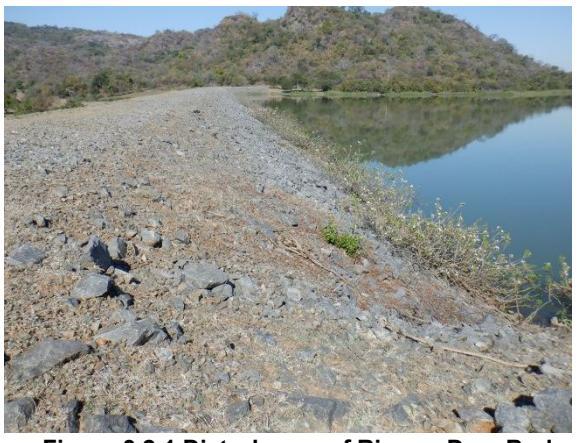
Figure 3.2.1 Disturbance of Riprap, Dam Body Exposure, and Erosion (Crest and Upstream Slope)

[Crest and upstream slope] Disturbance of riprap, dam body exposure, and erosion

Disturbance of riprap, dam body exposure, erosion, and trees around the embankment is caused by thinning of the surface riprap due to weathering and livestock invasion on the embankment slope. To repair the embankment and to prevent similar problems in the future, the surface layer (including trees) is removed, the embankment replaced with new material, and riprap is placed on both upstream and downstream sides. Since riprap has not been installed downstream of the Magudu dam, new riprap is installed. In addition, Geotextile is placed between the dam body and the riprap to prevent the runoff of

the dam body.

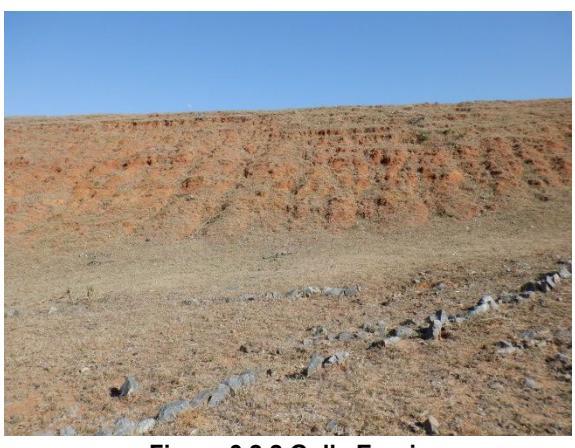
Figure 3.2.2 Gully Erosion (Downstream Slope)

[Downstream slope] Gully erosion

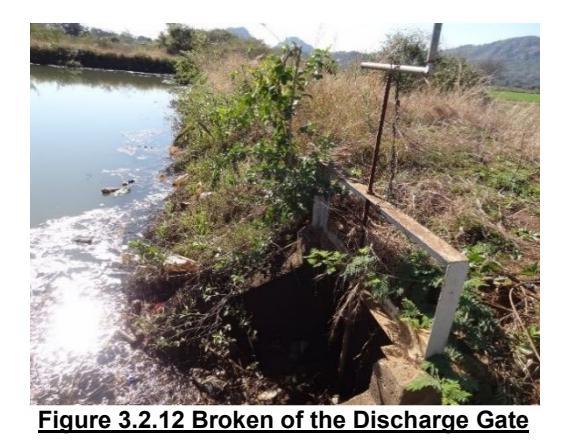
[Night storage] Broken of the discharge gate

Since the scale of the damage is small, the Zimbabwean side will deal with the damage through regular maintenance.

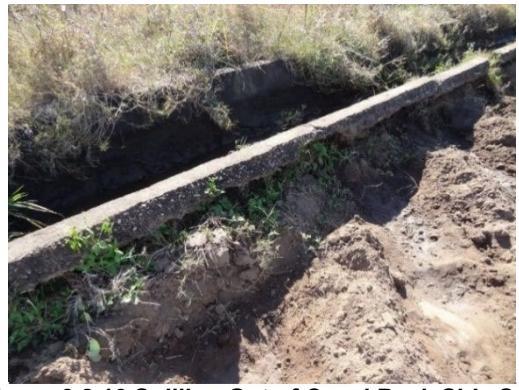
Figure 3.2.13 Spilling Out of Canal Back Side Soil

[Canal] Spilling out of backside soil

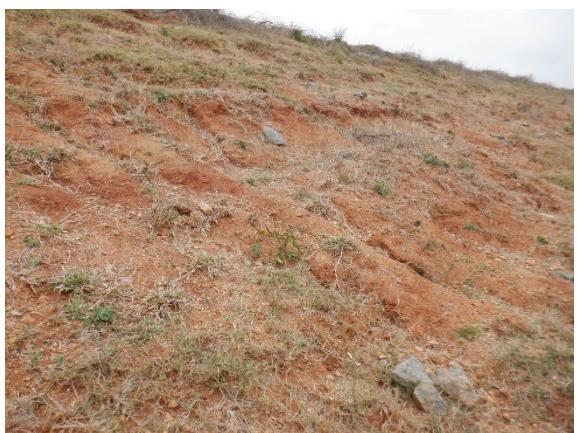
Figure 3.2.2 Gully Erosion (Downstream Slope)

[Downstream slope] Gully erosion

Disturbance of riprap, dam body exposure, erosion, and trees around the embankment is caused by thinning of the surface riprap due to weathering and livestock invasion on the embankment slope. To repair the embankment and to prevent similar problems in the future, the surface layer (including trees) is removed, the embankment replaced with new material, and riprap is placed on both upstream and downstream sides. Since riprap has not been installed downstream of the Musaverema dam, new riprap is installed. In addition, Geotextile is placed between the dam body and the riprap to prevent the runoff of the dam body.

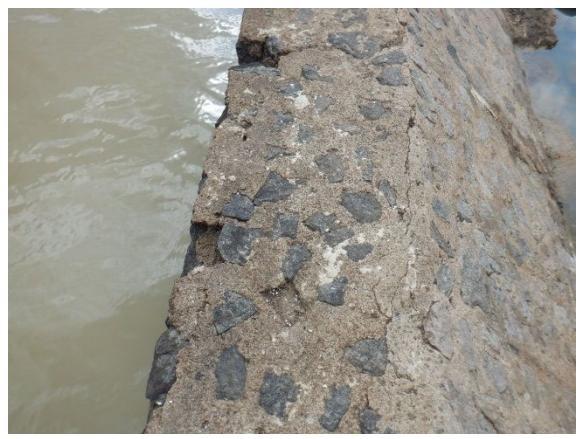
Figure 3.2.6 Surface Peeling and Lack of Stones

[Weir] Surface peeling and lack of stones at the crest

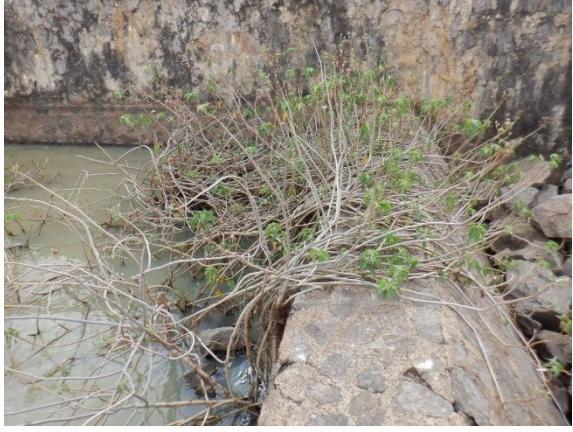
Figure 3.2.5 Plants on the Left Side

[Weir] A slight plant on the left side

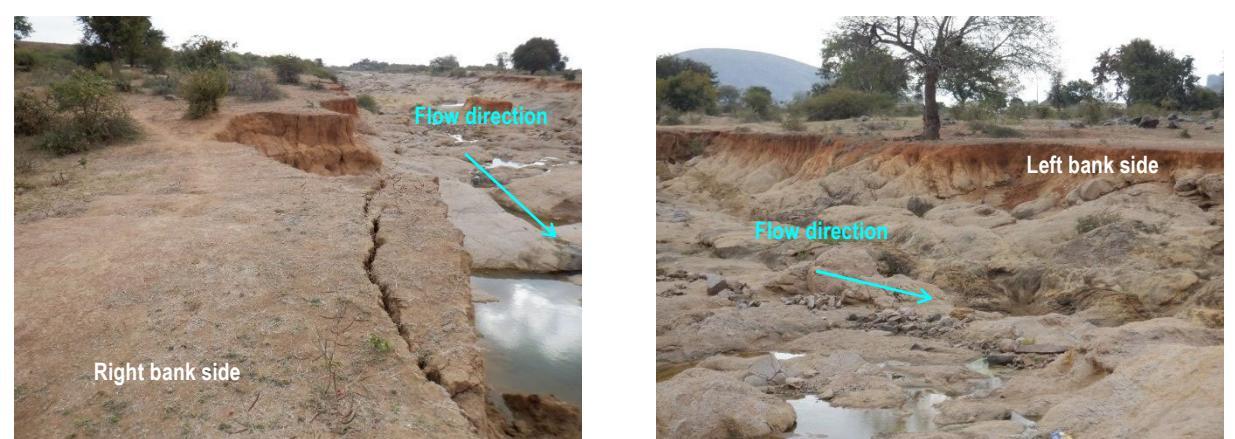
Figure 3.2.9 Collapse of Side Walls on Both Bank Sides

[Both bank sides walls] Collapse of sidewalls

As for the collapse of the sidewall, even if it progresses, the Zimbabwean government will conduct continuous monitoring to determine whether or not countermeasures are necessary, as the impact on other facilities and the surrounding environment cannot be measured at this time.

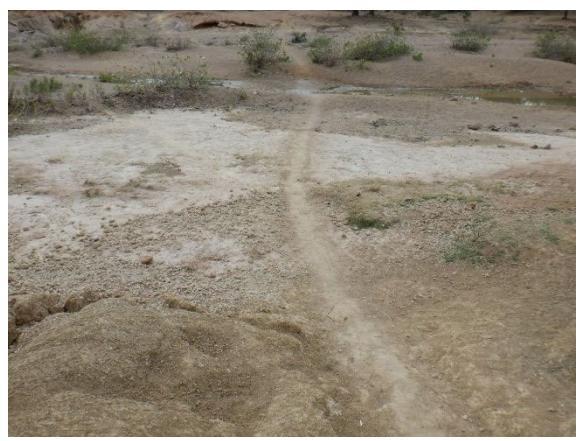
Figure 3.2.7 Crossing Road

[Other] Crossing road across canal

It is predicted that the reason why the inside of the connection canal was used as a passageway is due to the lack of passageway bridges in the surrounding area. Especially during the rainy season, the intrusion into the waterway is very dangerous and must be prevented without fail. Therefore, a bridge

for crossing will be installed at an appropriate location in the connection canal.

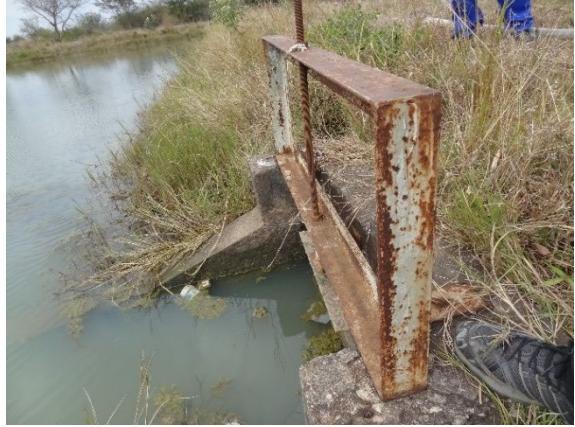
[Night storage] Broken of the discharge gate

Figure 3.2.12 Broken of the Discharge Gate

Since the scale of the damage is small, the Zimbabwean side will deal with the damage through regular maintenance.

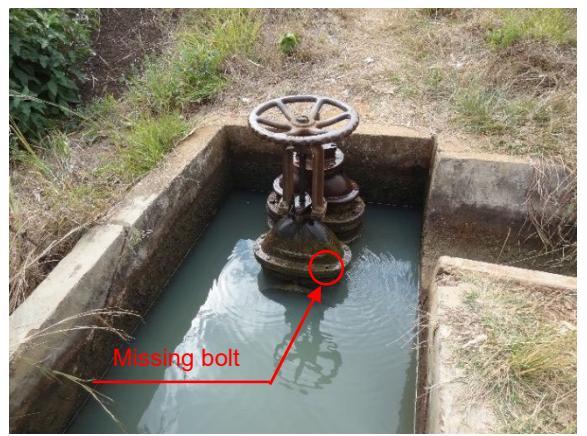
[Sluice valve] Missing parts

Figure 3.2.11 Missing Parts of Sluice Valve

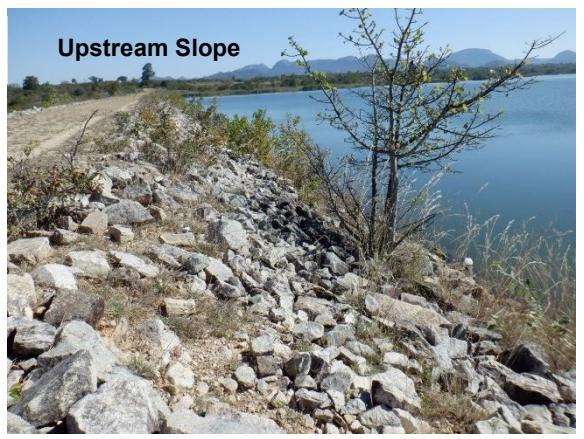
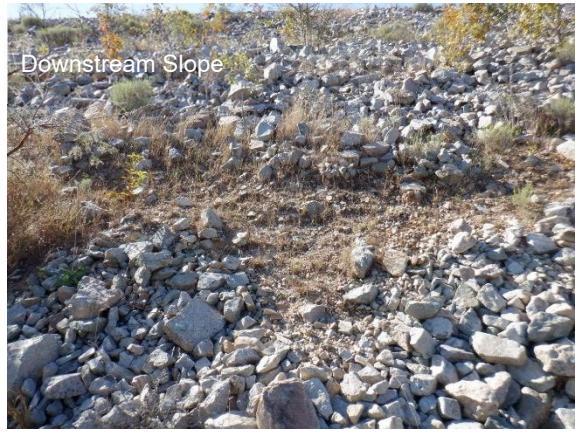
[Upstream and downstream slope] Disturbance of riprap, gully erosion under riprap, dam body exposure, and trees

Figure 3.2.1 Upstream and Downstream Slope

Disturbance of riprap, dam body exposure, erosion, and around the embankment is caused by thinning of the surface riprap due to weathering and livestock invasion on the embankment slope. To repair the embankment and to prevent similar problems in the future, the surface layer (including trees) is removed, the embankment replaced with new material, and riprap is placed on both upstream and downstream sides. In addition, Geotextile is placed between the dam body and the riprap to prevent the runoff of the dam body.

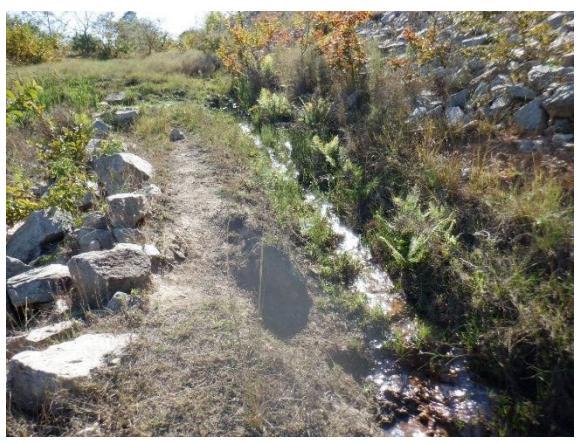
[Downstream slope edge of the right side abutment] Seepage and slight flow

Figure 3.2.2 Downstream Slope Edge of the Right Side Abutment

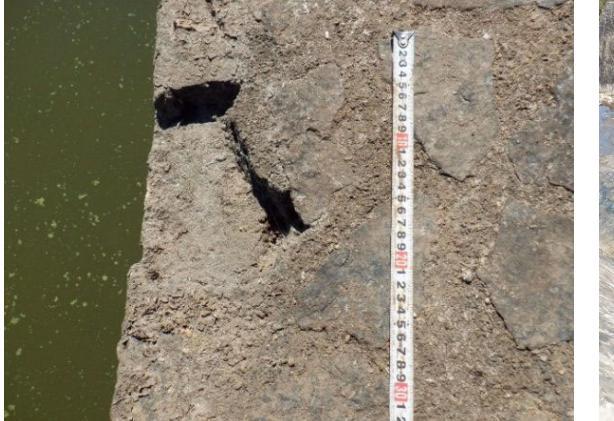
[Weir] Slight damage on the crest

Figure 3.2.7 Slight Damage on the Crest

Since the scale of the damage is small, the Zimbabwean side will deal with the damage through regular maintenance.

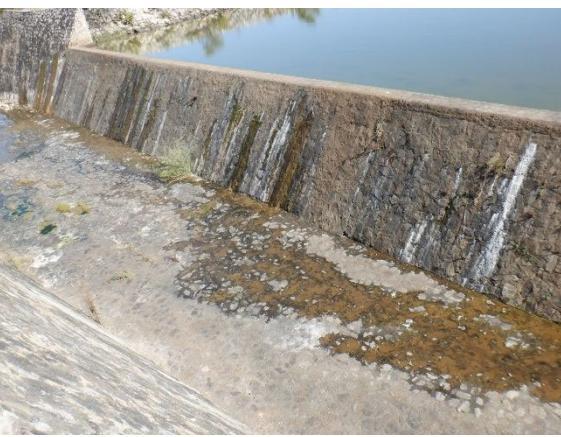
[Weir] Leakage from downstream slope

Figure 3.2.8 Leakage from Downstream Slope

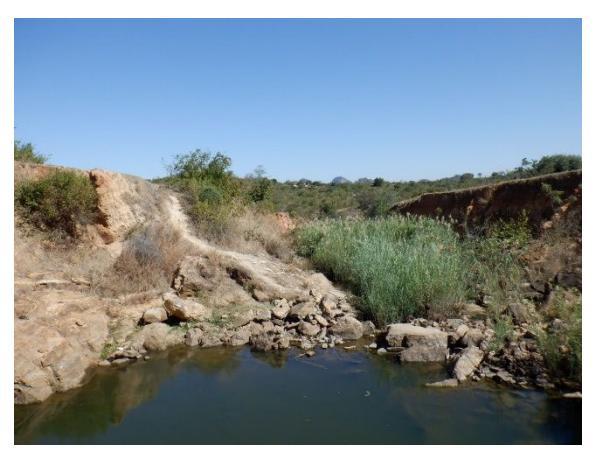
[Other] Crossing Road across canal

Figure 3.2.9 Crossing Road

For use as a crossing in the channel, a bridge for crossing should be installed at an appropriate location between the spillway channel and the connection channel.

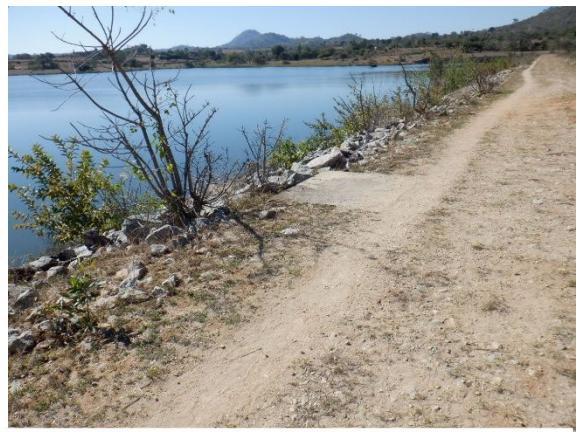
[Inlet] Disappearance of the gate operation facilities

Figure 3.2.14 Disappearance of the Intake Gate Operation Facilities

To restore the gate operation function and to prevent a similar problem in the future, an operation house is built at the crest and a new winch is installed in it. In addition, the steel wires leading to the intake gate are arranged in the protection pipe set under the riprap at the upstream side to prevent theft and deterioration.

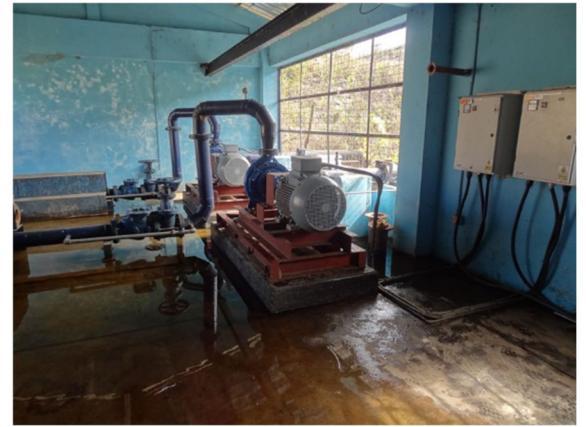
[Pump] Insufficient supply volume

Figure 3.2.15 Sisutaiton of Pumps

The insufficient pump capacity was supposed to be caused by the transformer being located about 500m away from the pumping facility and not being able to supply the required amount of current due to transmission losses. Therefore, relocation of the transformer is planned.

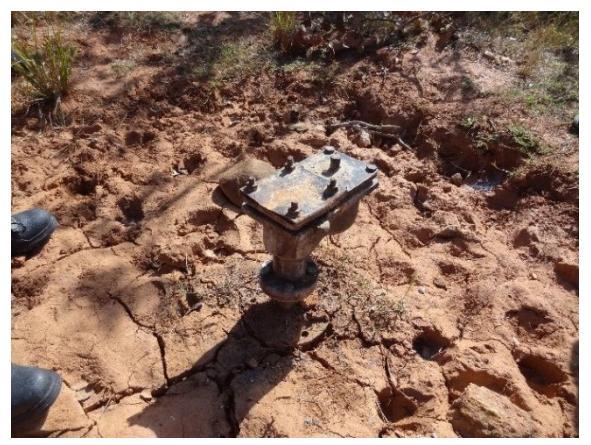
[Air valve] Small amount of water leakage

Figure 3.2.17 Mark of Water Leakage from Air Valve

Since the scale of the damage of the air valves is small, the Zimbabwean side will deal with the damage through regular maintenance.

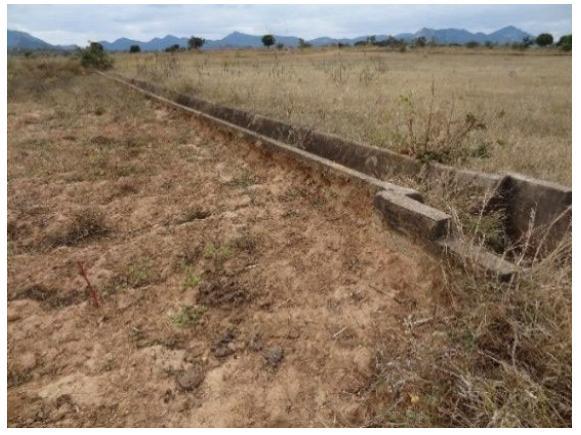
Figure 3.2.18 Spilling Out of Canal Back Side Soil

Since the scale of the damage is small, the Zimbabwean side will deal with the damage through regular maintenance.

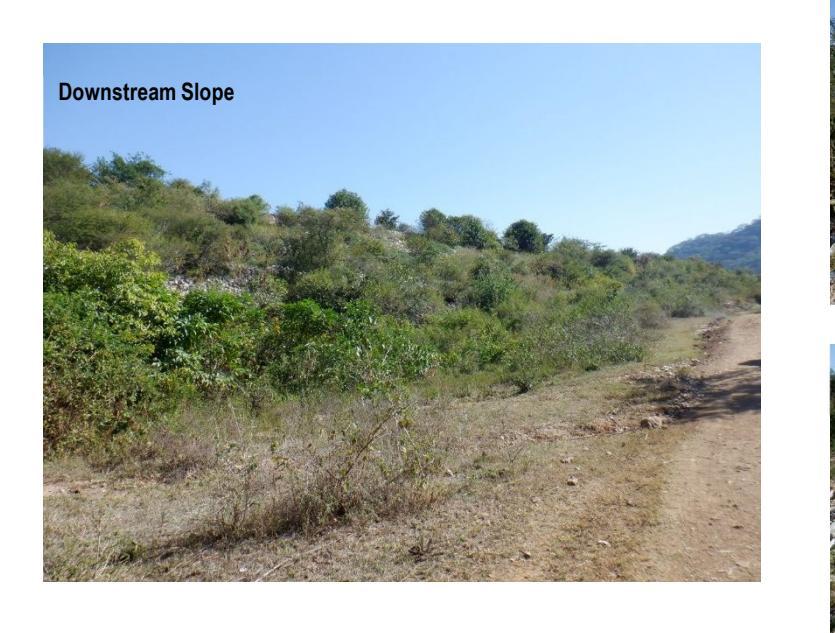
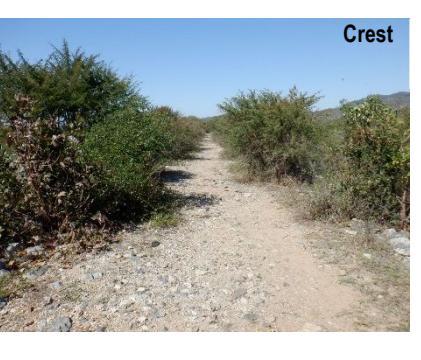
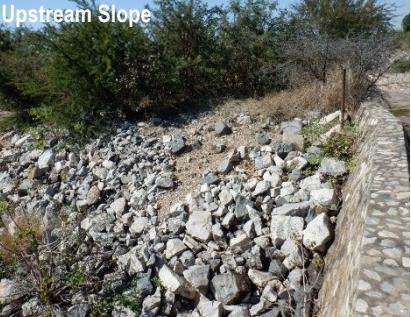
[Upstream and downstream slope] Partial disturbance of riprap and dam body exposure

[Crest, and upstream and downstream slope] Many trees

Figure 3.2.1 Partial Disturbance of Riprap, Dam Body Exposure, and Many Trees

Disturbance of riprap, dam body exposure, erosion, and trees around the embankment is caused by thinning of the surface riprap due to weathering and livestock invasion on the embankment slope. To repair the embankment and to prevent similar problems in the future, the surface layer (including trees) is removed, the embankment replaced with new material, and riprap is placed on both upstream and downstream sides. In addition, Geotextile is placed between the dam body and the riprap to prevent the runoff of the dam body.

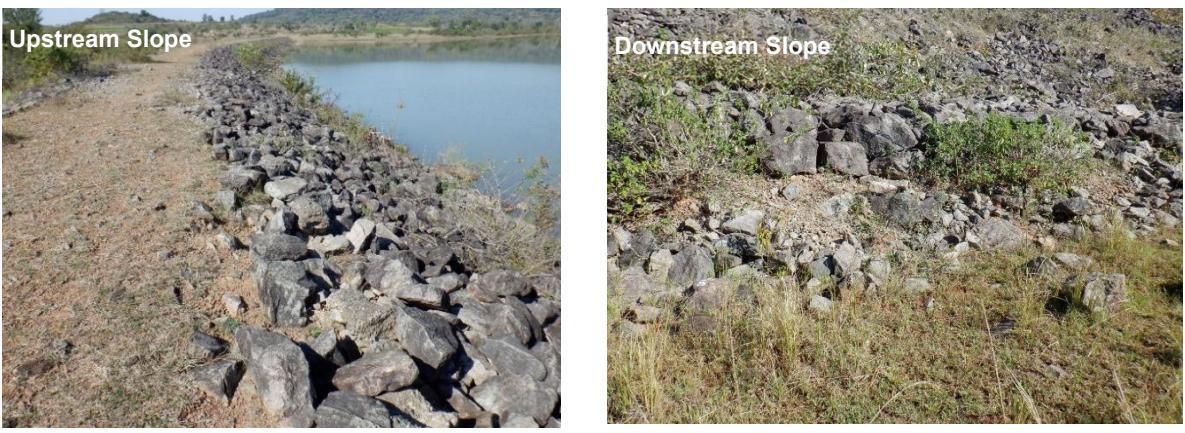
Figure 3.2.1 Upstream and Downstream Slope

[Upstream and downstream slope] Disturbance of riprap, gully erosion under riprap, dam body exposure, and trees

Disturbance of riprap, dam body exposure, erosion, and trees around the embankment is caused by thinning of the surface riprap due to weathering and livestock invasion on the embankment slope. To repair the embankment and to prevent similar problems in the future, the surface layer (including trees) is removed, the embankment replaced with new material, and riprap is placed on both upstream and downstream sides. In addition, Geotextile is placed between the dam body and the riprap to prevent the runoff of the dam body.

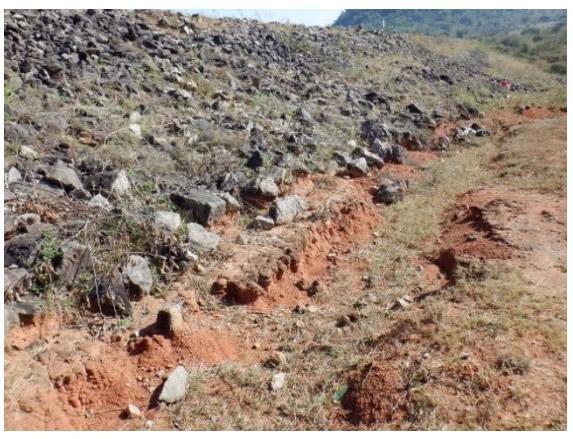
Figure 3.2.2 Downstream Slope Edge

[Downstream slope edge of the abutment] Erosion

In addition, there were cases of erosion at the boundary of the embankment, where surface water generated by rainfall tends to collect, at nearby dams. Since this kind of deformation may occur in all dams during long-term operation, a drainage channel at the edge of the embankment will be installed to quickly remove surface water from the surrounding area and prevent erosion.

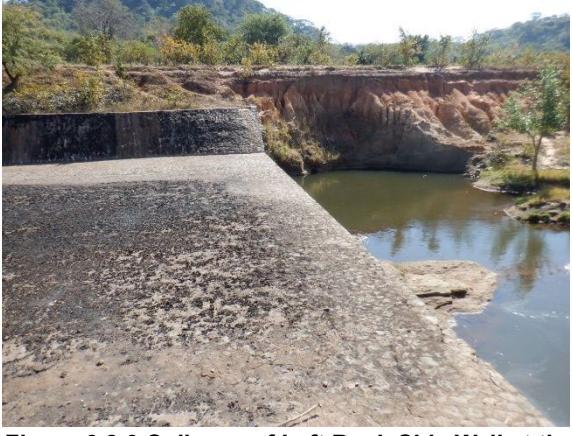
Figure 3.2.6 Collapse of Left Bank Side Wall at the End of the Spillway Channel

[Left bank side wall] Collapse of side walls at the end of the spillway channel

Significant erosion and collapse of the side walls will be prevented by installing revetments made of wet masonry.

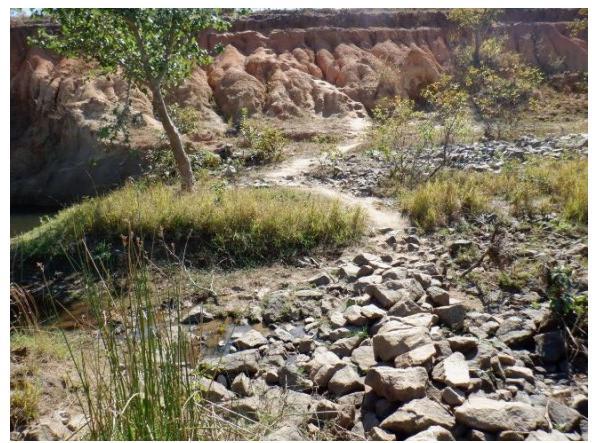
Figure 3.2.7 Crossing Road

[Other] Crossing Road across the canal

For use as a crossing in the channel, a bridge for crossing should be installed at an appropriate location between the spillway channel and the connection channel.

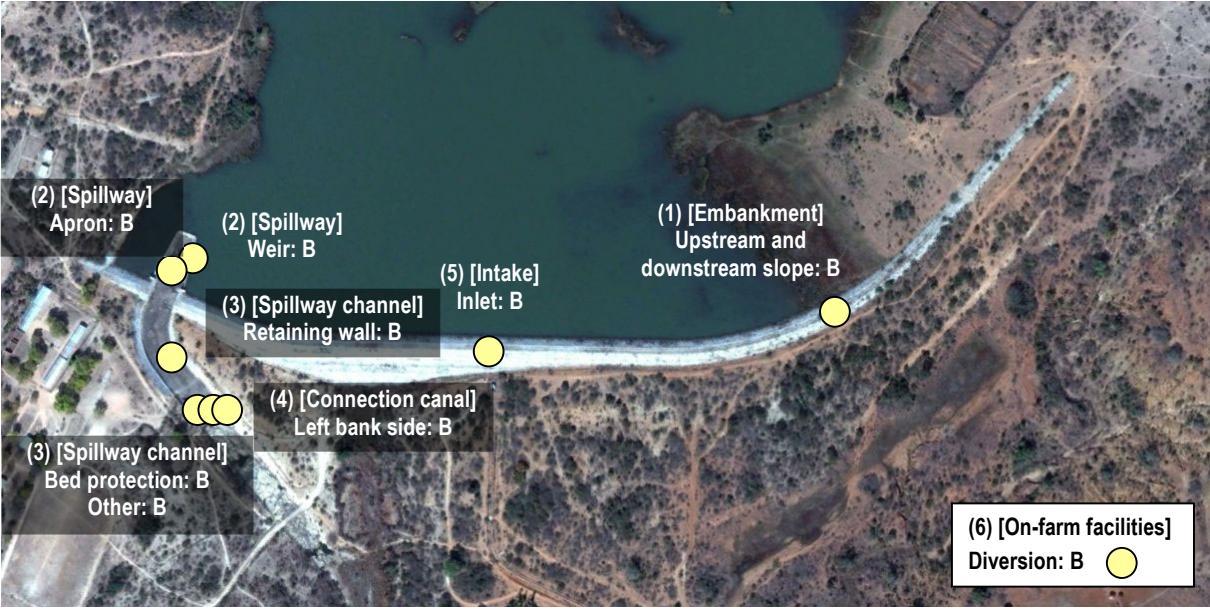
Figure 3.1.1 Locations of Deteriorations/Damages on Munjanganja Dam

NO.	FA	CILITIES	EVALUATION (A or B)	CONFIRMED PHENOMENON		
(1)	Embankment	Upstream and downstream slope	В	- Disturbance of riprap, gully erosion under riprap, dam body exposure, and trees		
(2)	Spillwov	Weir B		- Leakage from downstream slope		
(2)	Spillway	Apron	В	- Open and damaged joints		
(3)	Spillway	Retaining wall	В	- Cracks at the top of walls		
(3)	channel	Bed protection	В	- Spilling out of basket mat on the right bank side		
NO.	FACILITIES		EVALUATION (A or B)	CONFIRMED PHENOMENON		
-----	-----------------------	---------------------	------------------------	---		
		Other	В	- Crossing road across the canal		
(4)	Connection canal	Left bank side wall	В	- Collapse of side walls at the end of the spillway channel		
(5)	Intake	Inlet	В	- Missing of the wires		
(6)	On-farm facilities	Diversion	В	- Broken of sluice gate

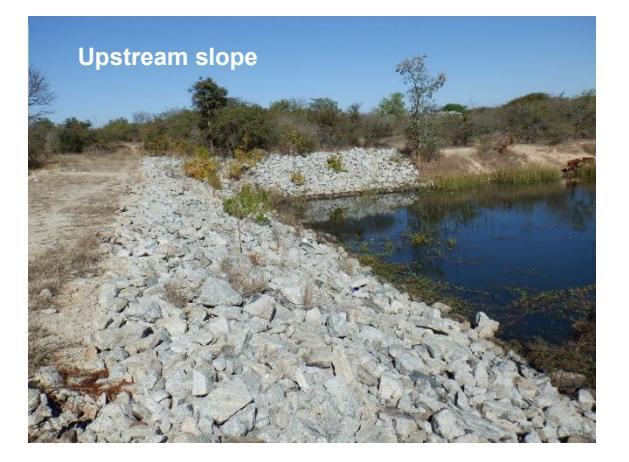
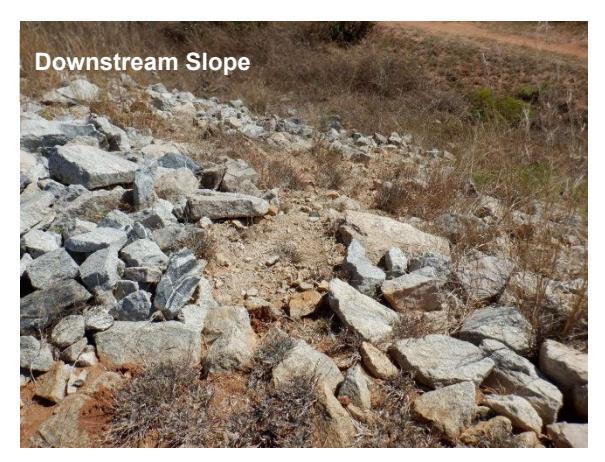
Figure 3.2.1 Upstream and Downstream Slope

[Upstream and downstream slope] Disturbance of riprap, gully erosion under riprap, dam body exposure, and trees

Disturbance of riprap, dam body exposure, erosion, and around the embankment is caused by thinning of the surface riprap due to weathering and livestock invasion on the embankment slope. To repair the embankment and to prevent similar problems in the future, the surface layer (including trees) is removed, the embankment replaced with new material, and riprap is placed on both upstream and downstream sides. In addition, Geotextile is placed between the dam body and the riprap to prevent the runoff of the dam body.

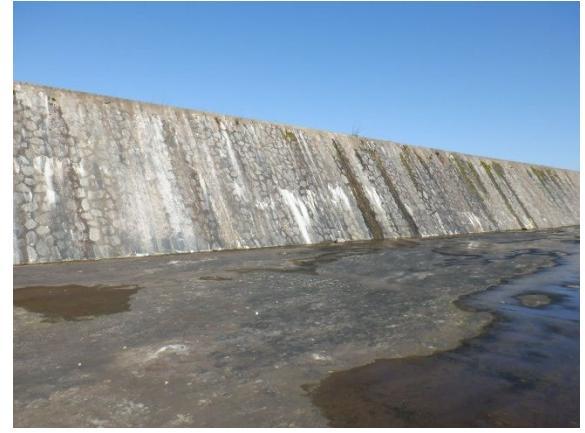
Figure 3.2.6 Leakage from Downstream Slope

[Weir] Leakage from downstream slope

Since the scale of the damage is small, the Zimbabwean side will deal with the damage through regular maintenance.

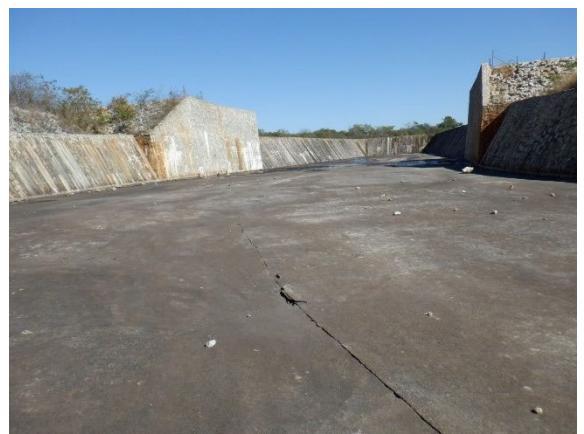
Figure 3.2.7 Joints of the Apron

[Apron] Open and damaged joints

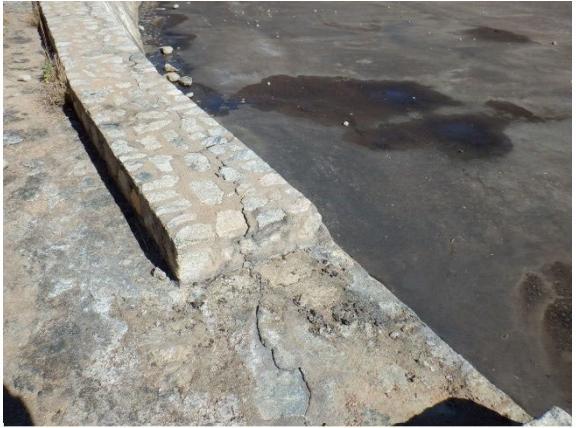
Figure 3.2.8 Cracks at the Top of Retaining Walls

[Retaining wall] Cracks at the top of walls

In the case of the cracks at the top of walls on the left and right side, since the scale of the damage is small, the Zimbabwean side will deal with the damage through regular maintenance.

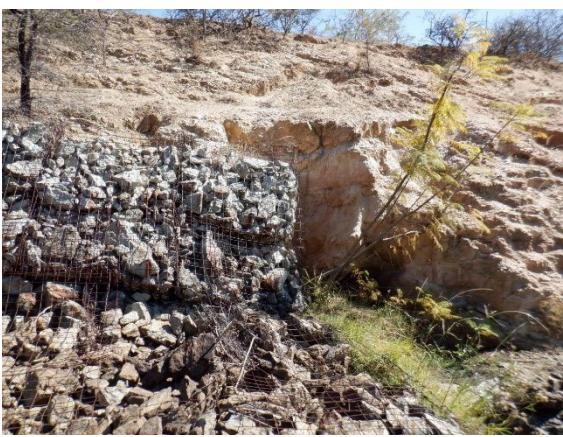
Figure 3.2.12 Collapse of Left Side Bank

As for the collapse of the sidewalls, erosion will be prevented by the rehabilitation of wet masonry.

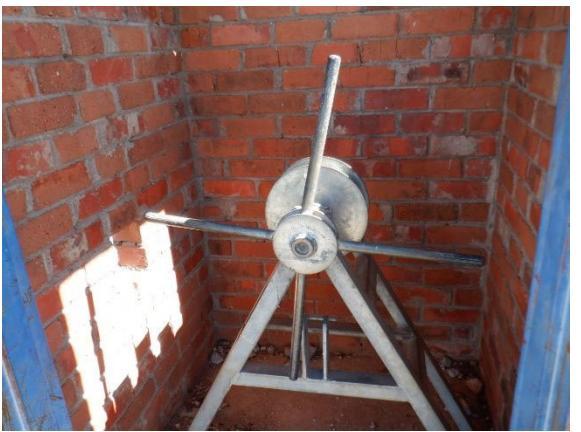
[Inlet] Missing of the wires

To restore the gate operation function and to prevent a similar problem in the future, an operation house is built at the crest and a new winch is installed in it. In addition, the steel wires leading to the intake gate are arranged in the protection pipe

set under the riprap at the upstream side to prevent theft and deterioration.

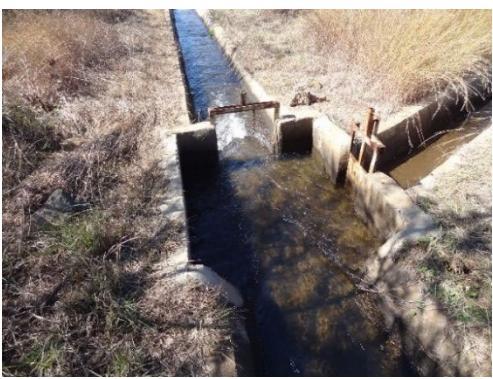
[Diversion] Broken of sluice gate

Figure 3.2.16 Broken Sluice Gate

Since the scale of the damage is small, the Zimbabwean side will deal with the damage through regular maintenance.

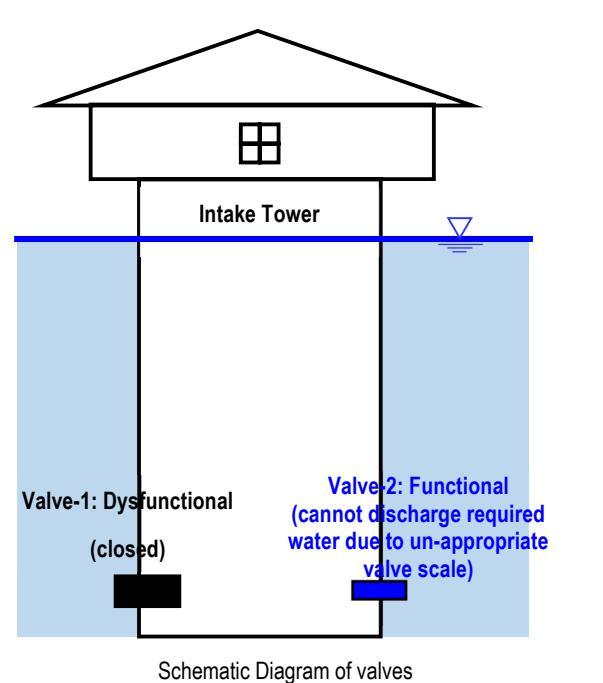
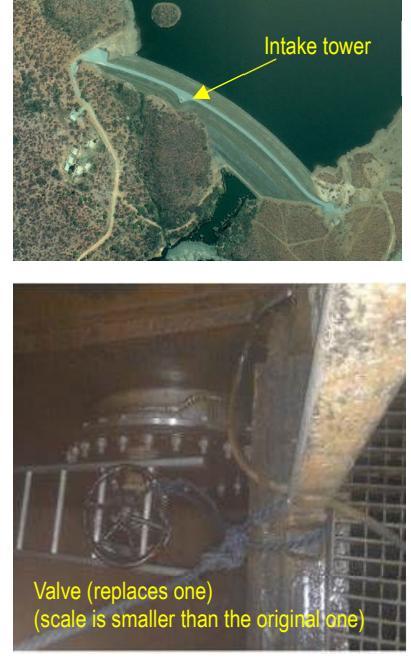
Figure 1.2 Status of Valves

Both of these two valve units have failed in the past, after then one unit is blocked and dysfunctional, another is in operation with a replaced valve. The replaced valve has smaller scale than the original one as it stated as a temporary measure. However, this valve has been in operation since then without being replaced by valve of the appropriate size (see Figure 1.2)

Therefore, these valves need to be replaced with the appropriate size to supply irrigation water to all the beneficiary area under Muzhwi dam, including the target Region.

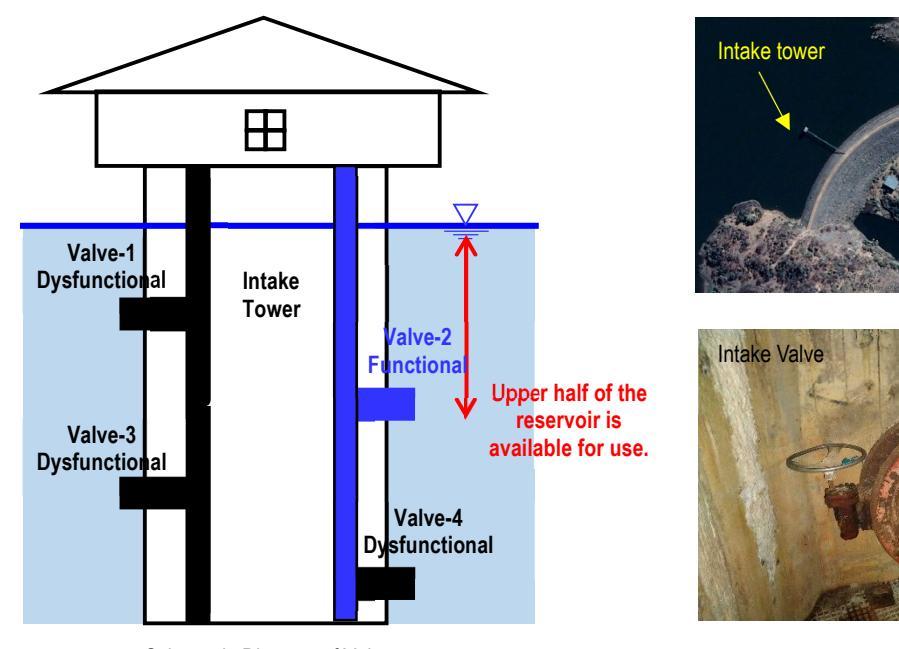
Figure 1.2 Status of Intake Valves

two valves at different elevations. Only one out these four valves is in operation and only the upper half of the reservoir is available for use (see Figure 1.2). Therefore, in order to supply irrigation water to the entire beneficiary area under Mundi Mataga Area, including the target Region, it is necessary to replace the inactive three valves.

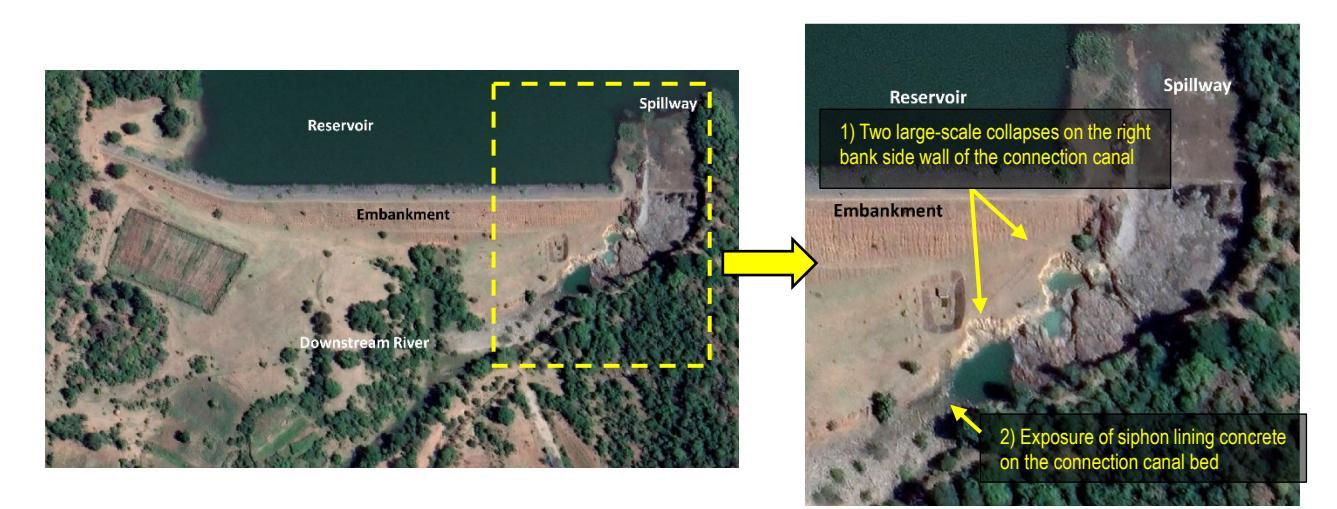
Figure 2.1 Deteriorations/Damages Evaluated as "A"-1

There are two deteriorations/damages which are evaluated as "A", 1) Two large-scale collapses on the right bank side wall of the connection canal, and 2) Exposure of siphon lining concrete on the connection canal bed (see Figure 2.1 and Figure 2.2). In respect to 1), a collapse reaches to the point 6m from the edge of embankment. It would reach to the edge after seven years and affect the stability of embankment. Also, another one reaches to the point 1.5 m from slope protection works for valve house. It would reach to the slope protection works within two years and affect the operation of valve.

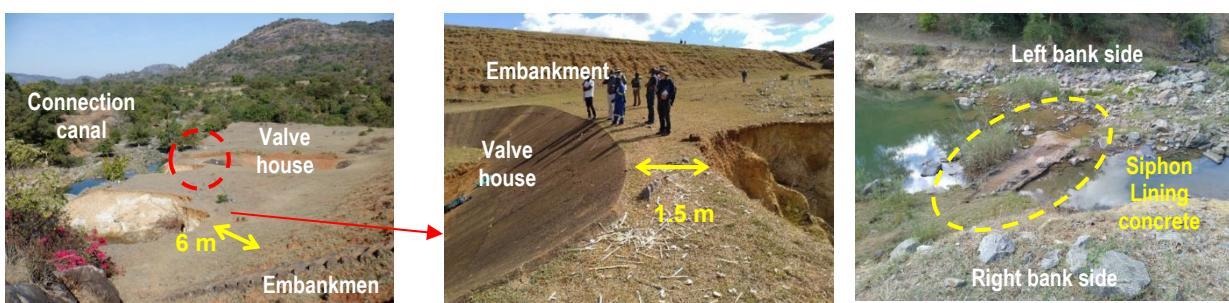
Figure 2.2 Deteriorations/Damages Evaluated as "A"-2

While in respect to 2), since rocks are scattered around and upstream of the siphon lining concrete, erosion is likely to occur when rocks are delivered by floods and impact the lining concrete. As the erosion progresses and siphon pipes are damaged, sufficient irrigation water would not be supplied to farmland and the irrigation scheme may be dysfunctional.

1) Two large-scale collapses on the right bank side wall of the connection canal

2) Exposure of siphon lining concrete on the connection canal bed

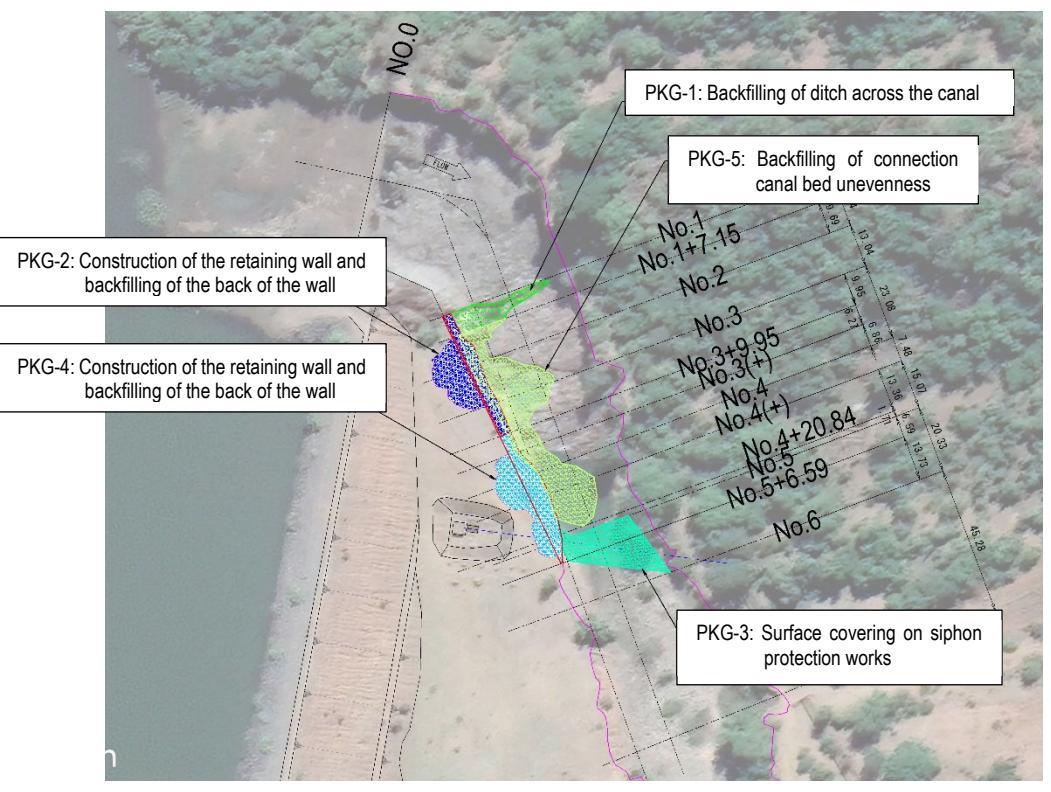
Figure 3.1 Construction Package Division of Emergency Repairing Measures

DIZA	-		D	<u> </u>
PKG	larget Area	Main target	Priority	Remarks
PKG-1	No. 1 - No.1+7.15	A collapse progressing to a point 6.0m from the embankment * If this collapse extends, it could lead to the	1	Backfilling of the ditch across the connection canal which is the main cause of the collapse
PKG-2	No. 1 - No.3+9.95	collapse of the embankment and loss of life.	2	Construction of the retaining wall and backfilling of the back of the wall to control the progression of the collapse
PKG-3	No.4+20.84 - No.6	Exposed siphon protection works * If the siphon pipe is damaged, the irrigation water supply will be interrupted. This may result in impoverishment, but not loss of life.	3	Surface covering to prevent damage on siphon protection works
PKG-4	No.3+9.95 - No.5+6.59	A collapse progressing to a point 1.5m from discharge valve house slope protection works * Even if the slope protection works are damaged, the valve can be operated for a while by removing the earth and sand manually.	4	Construction of the retaining wall and backfilling of the back of the wall to control the progression of the collapse

PKG-5	No.1+7.15 - No.4+20.84	Unevenness on throughout the connection canal bed	5	Backfilling of connection canal bed unevenness (mainly recesses)
