**INFORMATION COLLECTION AND  
PRELIMINARY SURVEY  
FOR THE FORMATION OF  
DISASTER RECOVERY PROJECTS  
AGAINST VOLCANIC ERUPTIONS AND  
TSUNAMI DAMAGE  
IN KINGDOM OF TONGA**

**FINAL REPORT**

**OCTOBER 2023**

**JAPAN INTERNATIONAL COOPERATION AGENCY (JICA)**

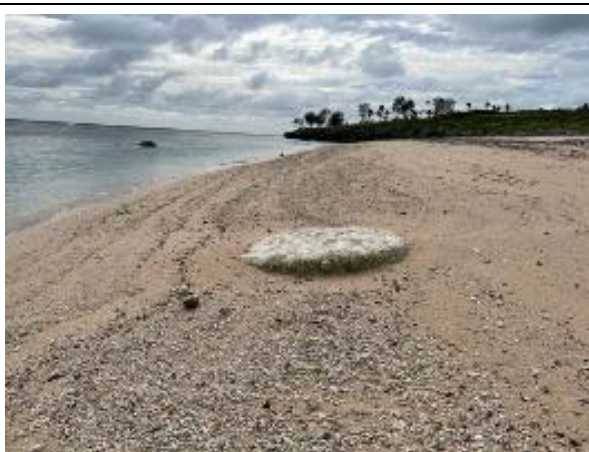
**Photo 2.7.1 Rocky Area with Sand Washed ashore by Tsunami**

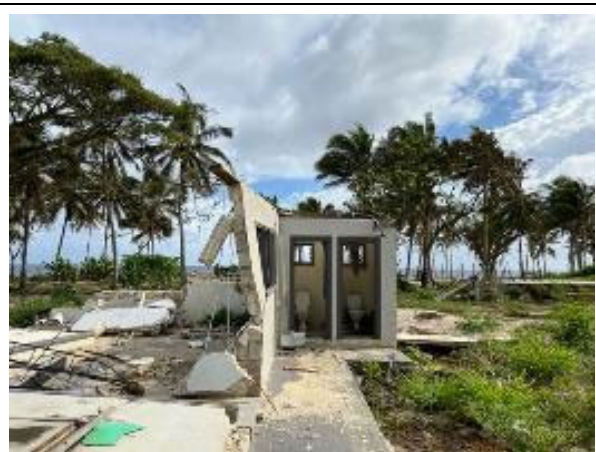
**Photo 2.7.2 Building Destroyed by Tsunami**

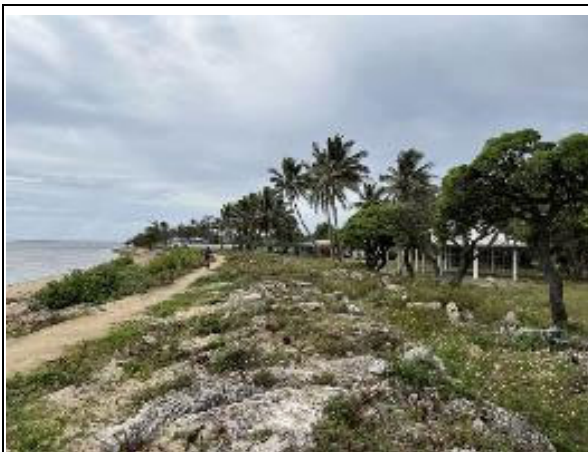
Although the tsunami force was attenuated and the tsunami height was low, waves of about 1 meter intrude inland over the existing seawall. The tsunami moved away the stone materials of the existing masonry seawalls.

**Photo 2.7.5 Scattered Stones on Masonry Seawall**

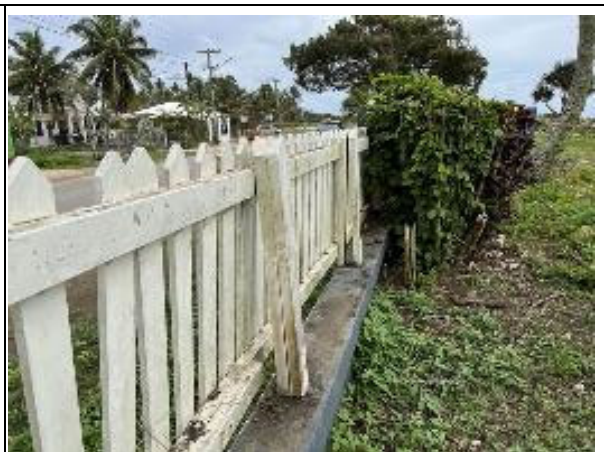
**Photo 2.7.6 Fence Pushed back by Tsunami**

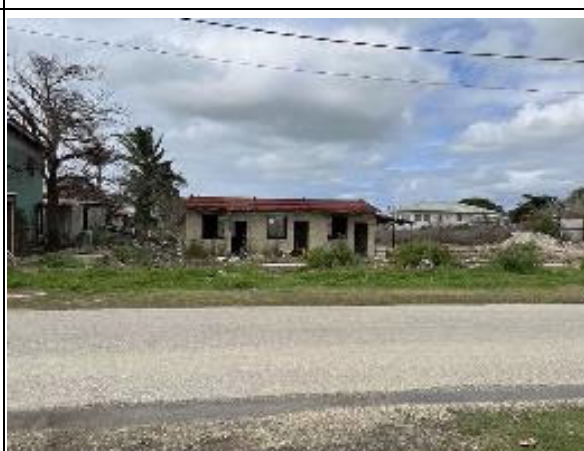
**Photo 2.7.10 House Parts Washed away by Tsunami**

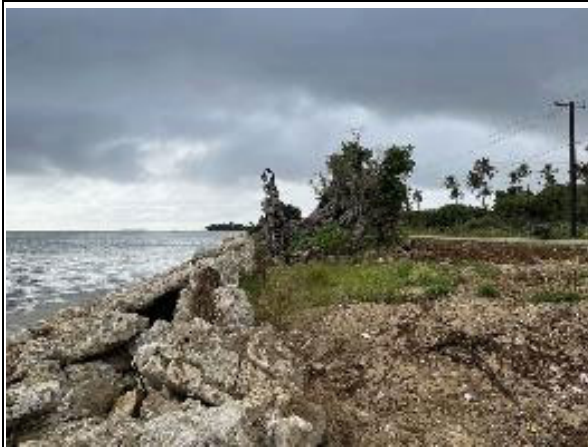
**Photo 2.7.13 Destroyed Concrete Coating**

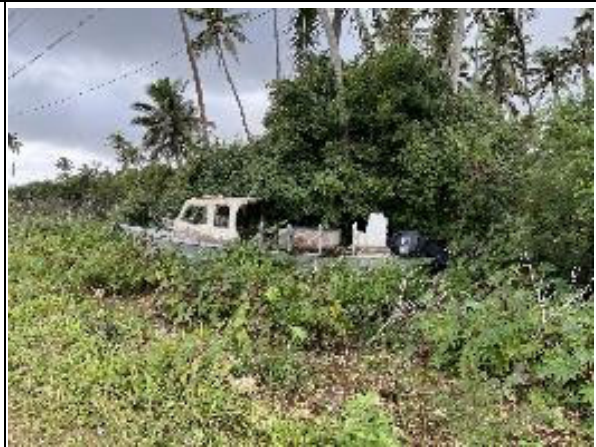
**Photo 2.7.14 Ship Washed Inland by Tsunami**

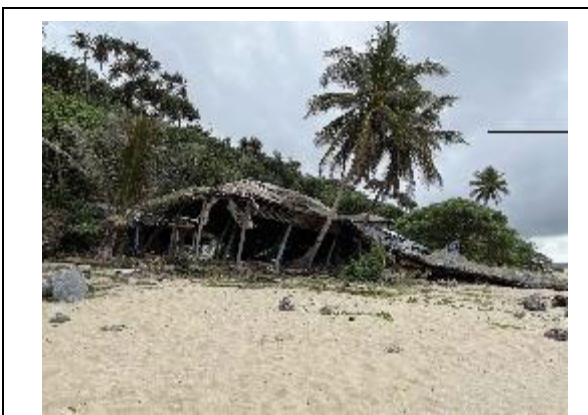
**Photo 2.7.15 Resort Destroyed by Tsunami**

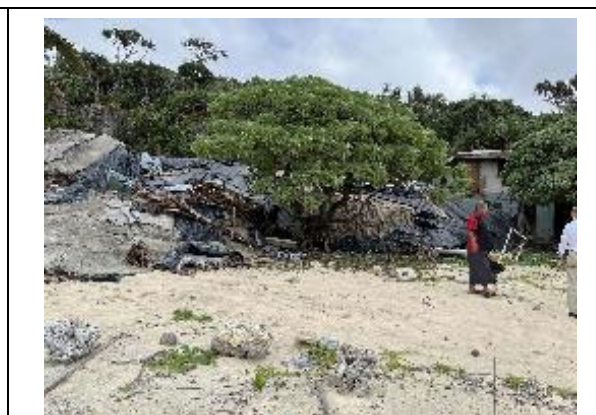
**Photo 2.7.16 Resort Destroyed by Tsunami**

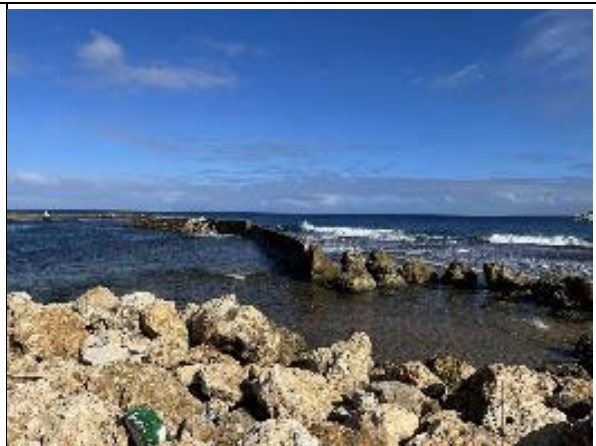
**Photo 2.7.18 Masonry Breakwater has Collapsed**

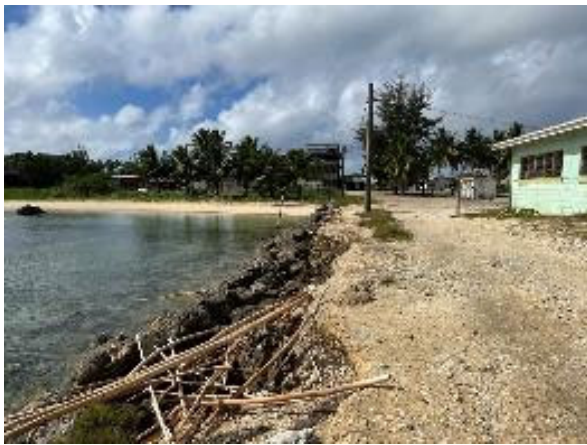
Based on the assessment of the JICA Study Team from this field survey at site, it seems that the damages of the port are actually concentrated at the northern seawall and on the caisson type mixed breakwater. This is the reason why the effect of breakwater is very important, because this breakwater installed in the sea was not able to protect the quay on the north side.

Photo 2.7.25 ①Masonry seawall of north wharf

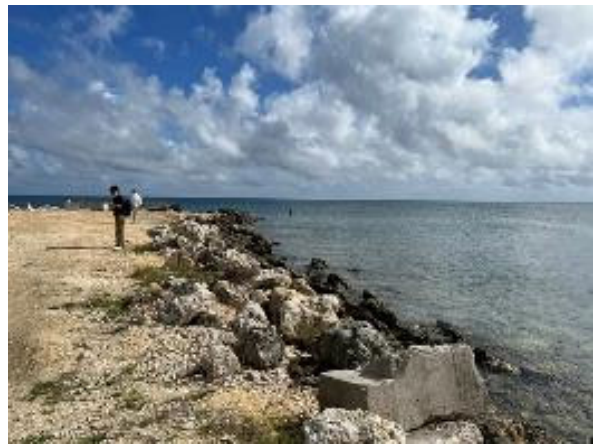
Photo 2.7.26 ②Length of seawall is about 130m

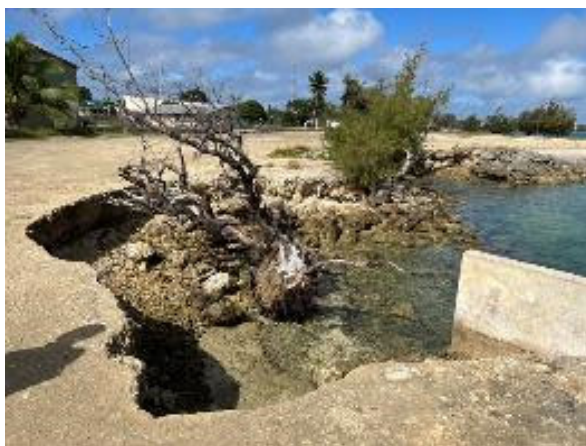
Photo 2.7.33 ⑨Scouring bottom of the slipway

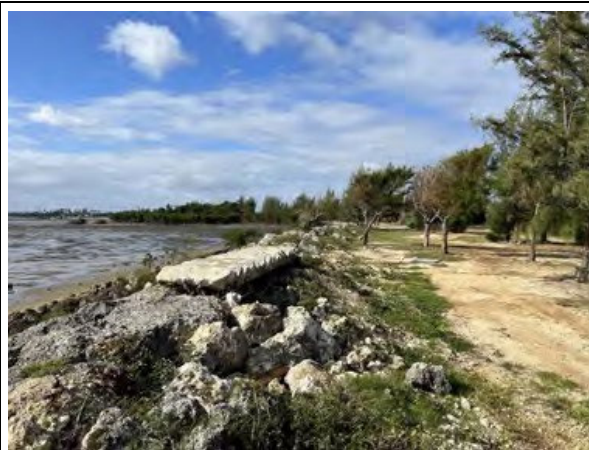
Photo 4.1.3 Restoration by casually piling up stones

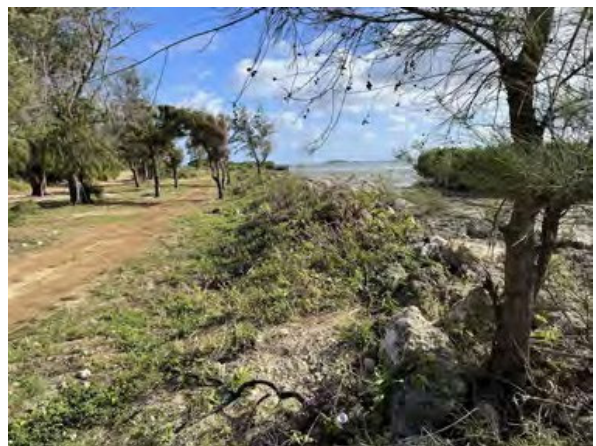
Photo 4.1.4 The height of seawall is lower

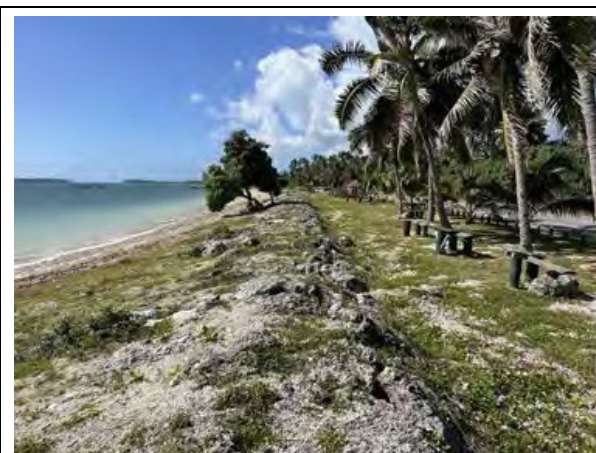
**Photo 4.1.8 This can no longer be called a seawall.**

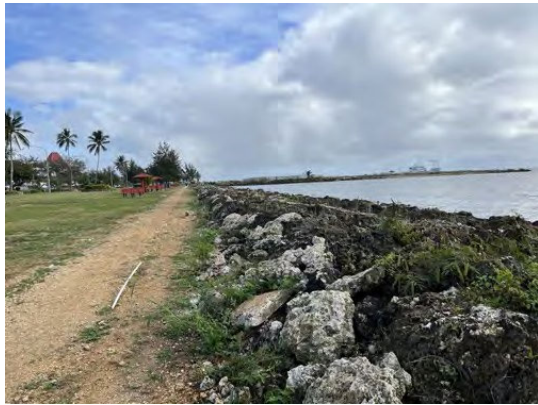
**Photo 4.1.11 Seawall collapsed at Vuna Wharf**

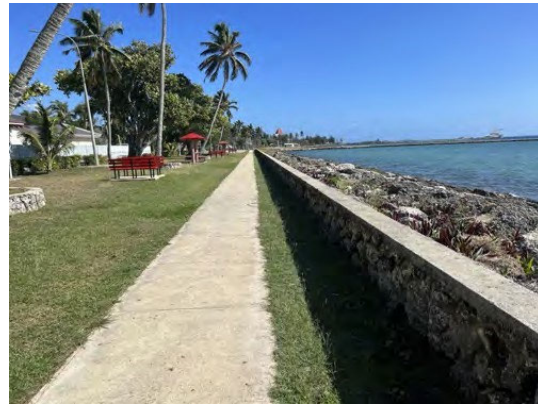
**Photo 4.1.12 The seawall is partially maintained.**

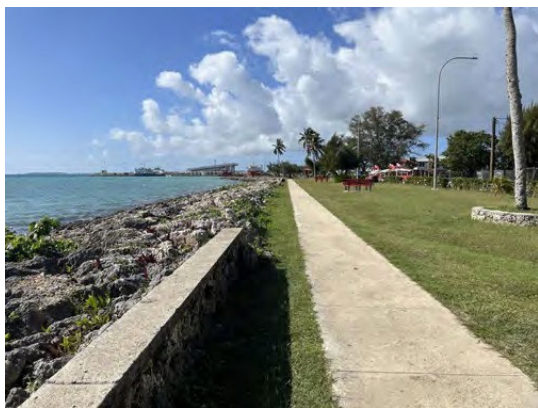
**Photo 4.1.13 Damaged part from here**

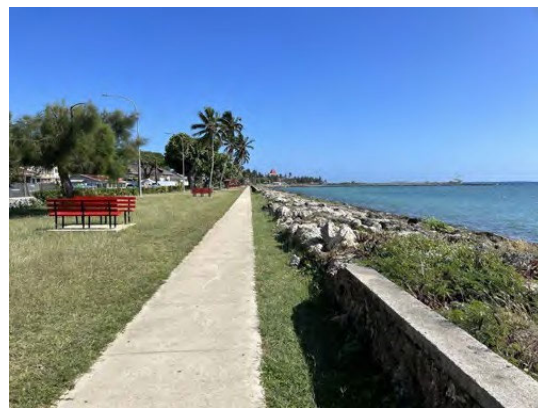
**Photo 4.1.14 Collapsed part about 60m from left photo**

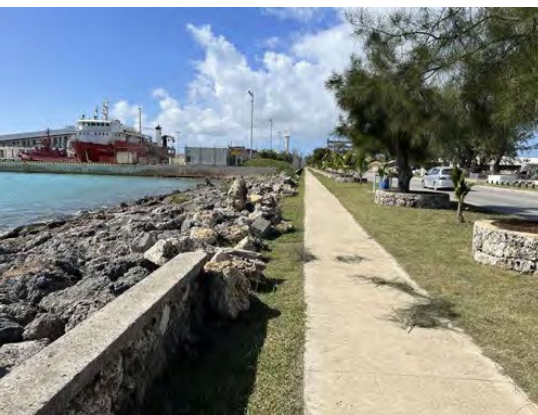
**Photo 4.1.15 Collapsed part about 45m from here**
