## 2-3 Survey of Leakage

### 2-3-1 City-Owned Systems

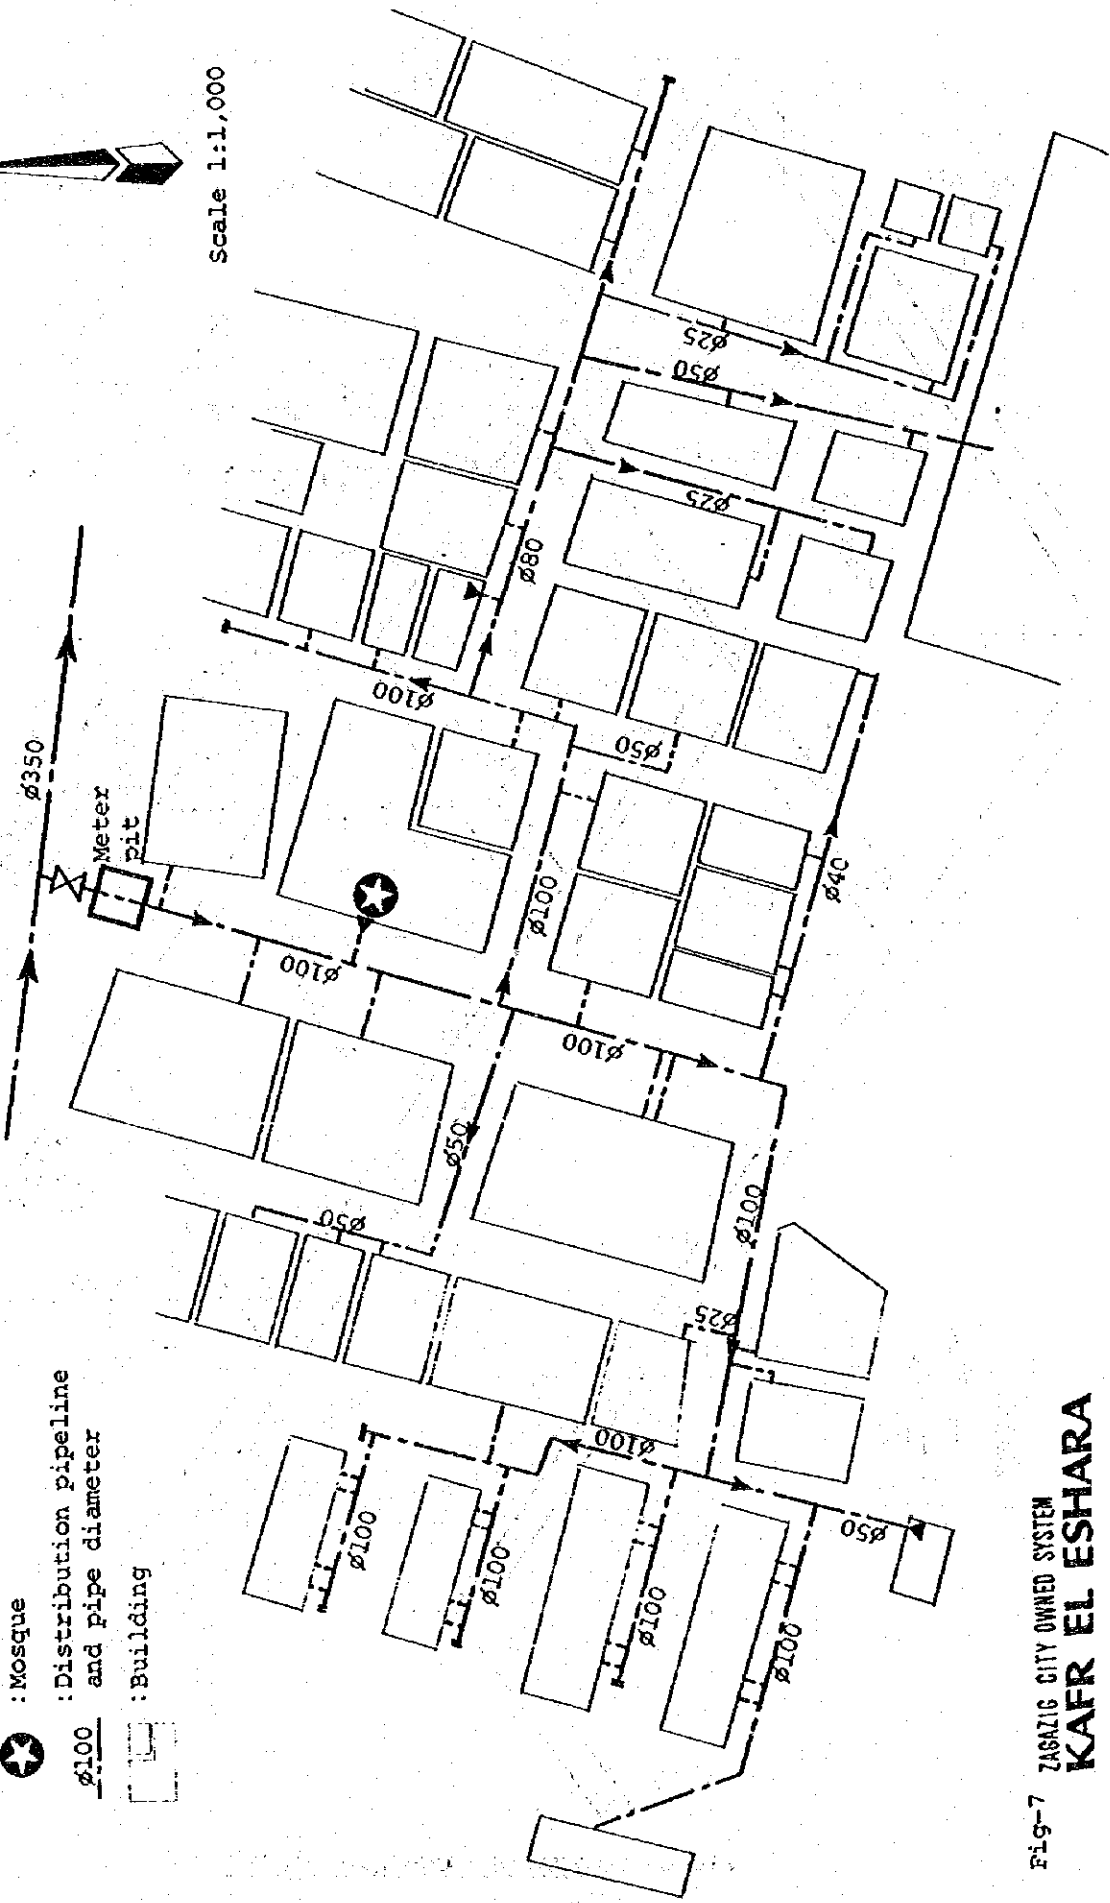
Fig-7 ZAGAZIG CITY OWNED SYSTEM  
**KAFR EL ESHARA**

The water flow was measured from 11 a.m. on June 12 to 11 a.m. next day for 24 hours as scheduled, under cooperation of the municipal engineer and staff. The meter pit and three water pressure observation points were located as shown in Fig-7. Fig-8 shows the survey results.

After the levelling off, the flow was still substantial and unidentified leakage was suspected. The JICA study members, remembering that sound had been detected during the preliminary survey, tracked the route and found a leakage at a corner of the school's playground. A 2 inch steel pipe, rising above ground and supplying water to the gymnasium of school, was leaking heavily at the downstream valve of water meter. The leaking water was scouring the ground and spilling widely over the playground. Without doubt, it caused the sound detected previously.

As there was another valve installed on the upstream side of the leaking spot, it was immediately closed and the flow meter responded, showing reduction of flow. Opening and closing the valve, the leakage could be measured.

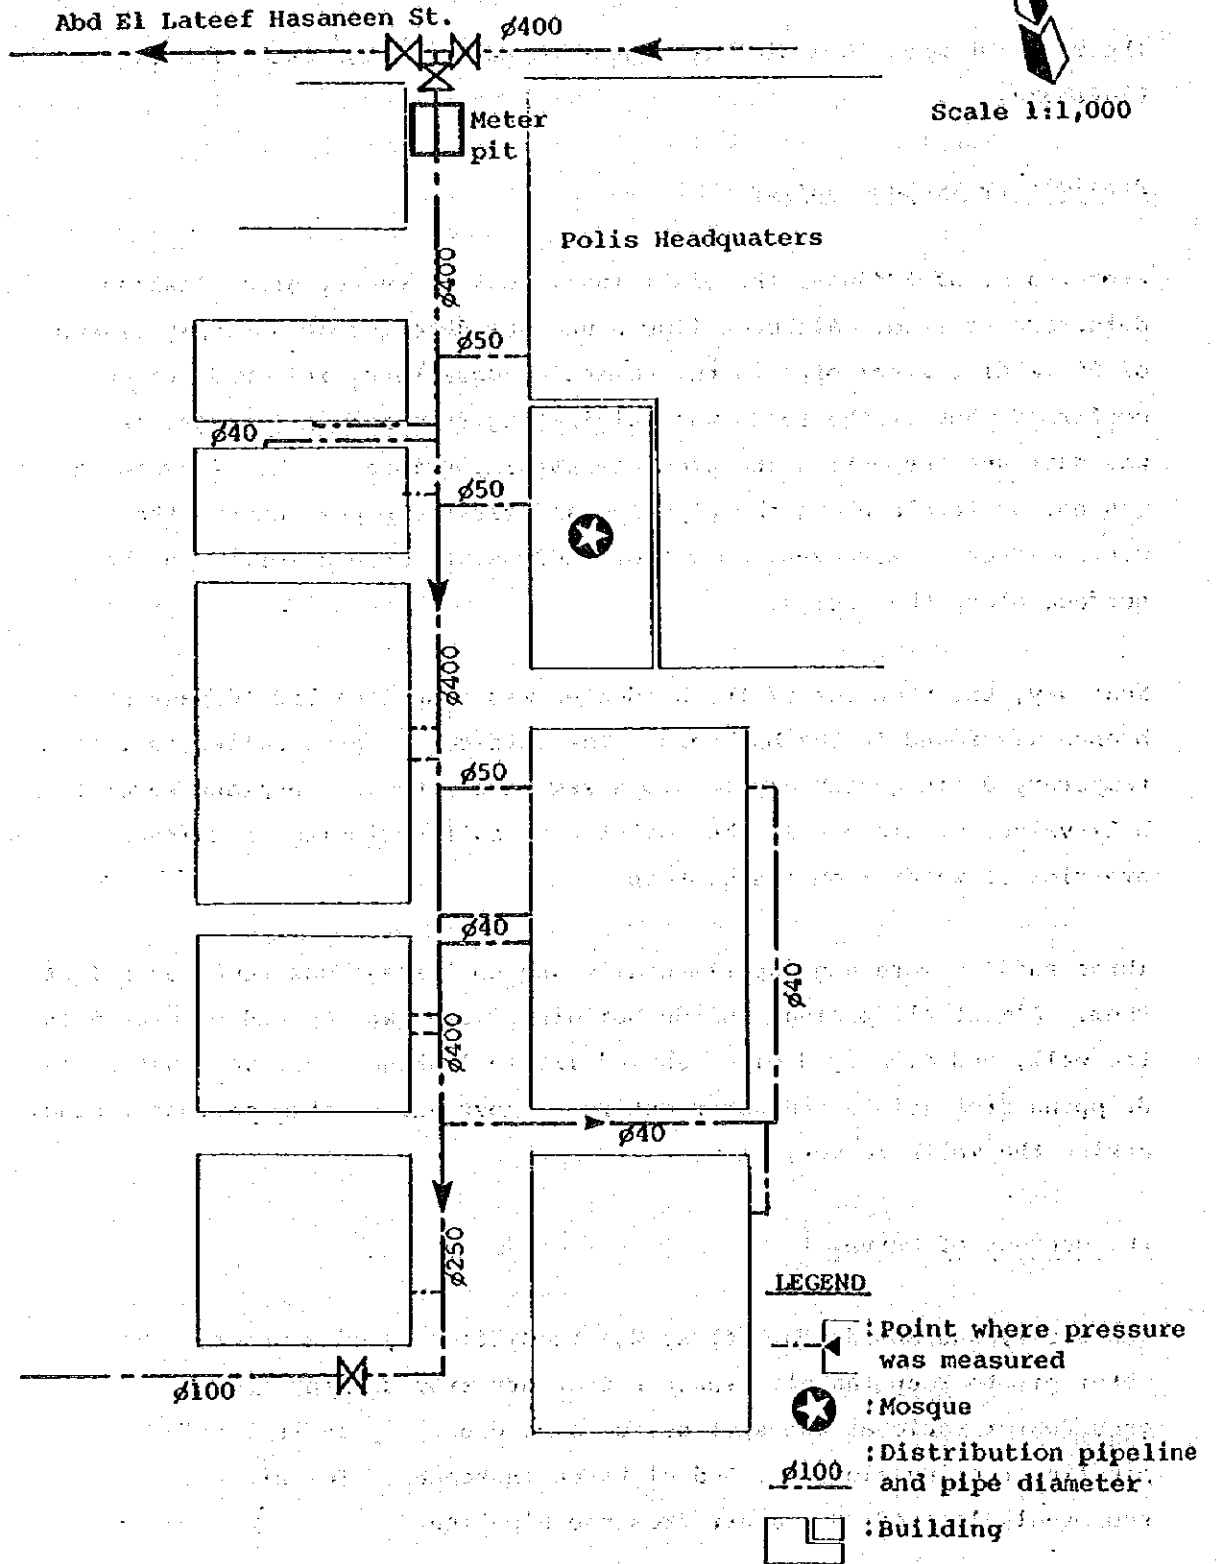
Fig-10 ZAGAZIG CITY OWNED SYSTEM  
**MIDAN MONTAZA**

From 2 a.m. of 18 June, the preliminary leakage survey using leakage detectors started. Although flow sound was detected at a supply branch of 50 mm dia. steel pipe to the police headquarters, it could not be confirmed whether the sound was originating from actual leakage, as it was dark and inspecting the premises was impossible. Other flow sound was not noticeable along the pipeline and service pipes, except the mentioned one. Moreover, no wet or muddy spots were observed on the surface along the routes.

The survey was abandoned halfway due to difficulty of dewatering the meter pit to keep the ultrasonic sensor dry from soaking. High groundwater table at the spot seems to be caused by an irrigation pipeline running along St. Abd el Lateed Hasaneen. The pit was supposedly located 30 m apart from the pipeline.

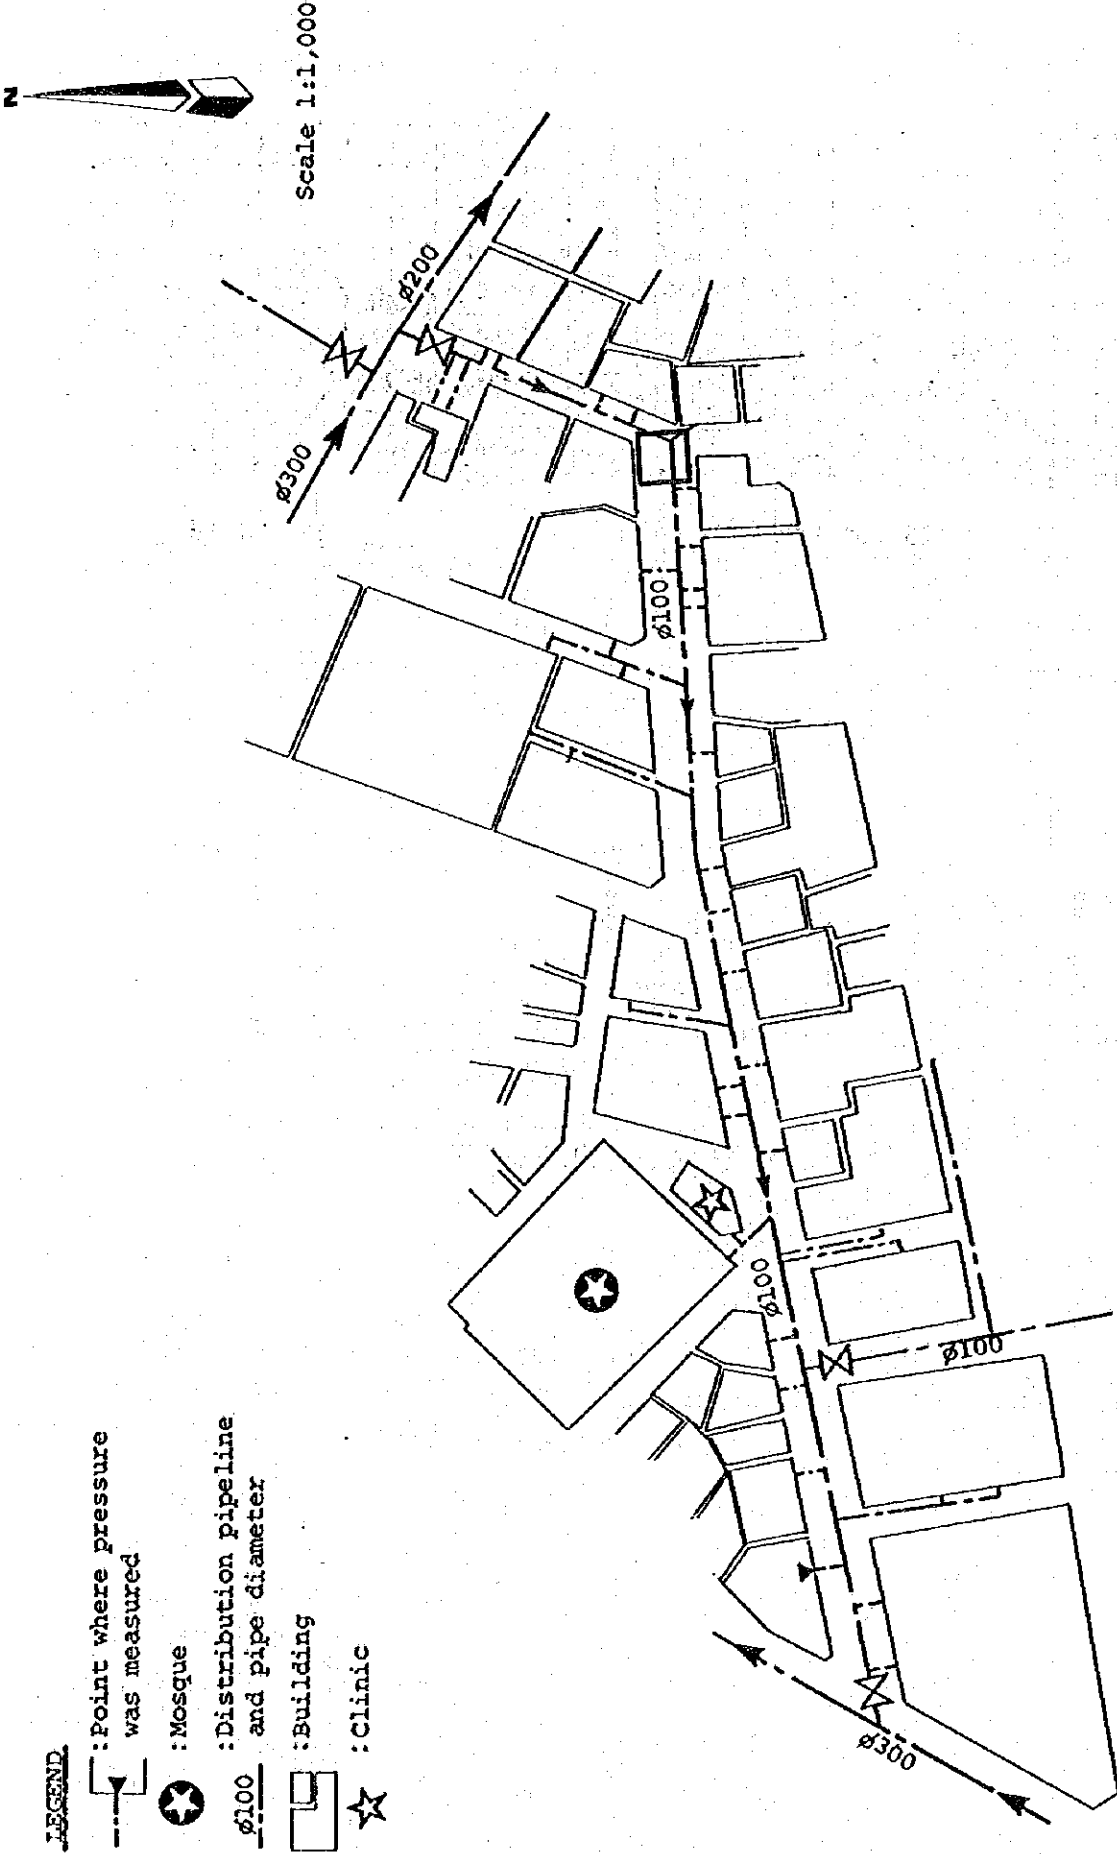
FIG-11 ZAGAZIG CITY OWNED SYSTEM  
**EL FARAKHA STREET**

The location of the tap where pressure was measured is shown in Fig-11, and the survey results of the flow and pressure are shown in Fig-12.

The observed minimum flow was below the sensitivity of the meter, as shown in Fig-12, consequently. And it verifies that leakage in the area is almost non-existent.

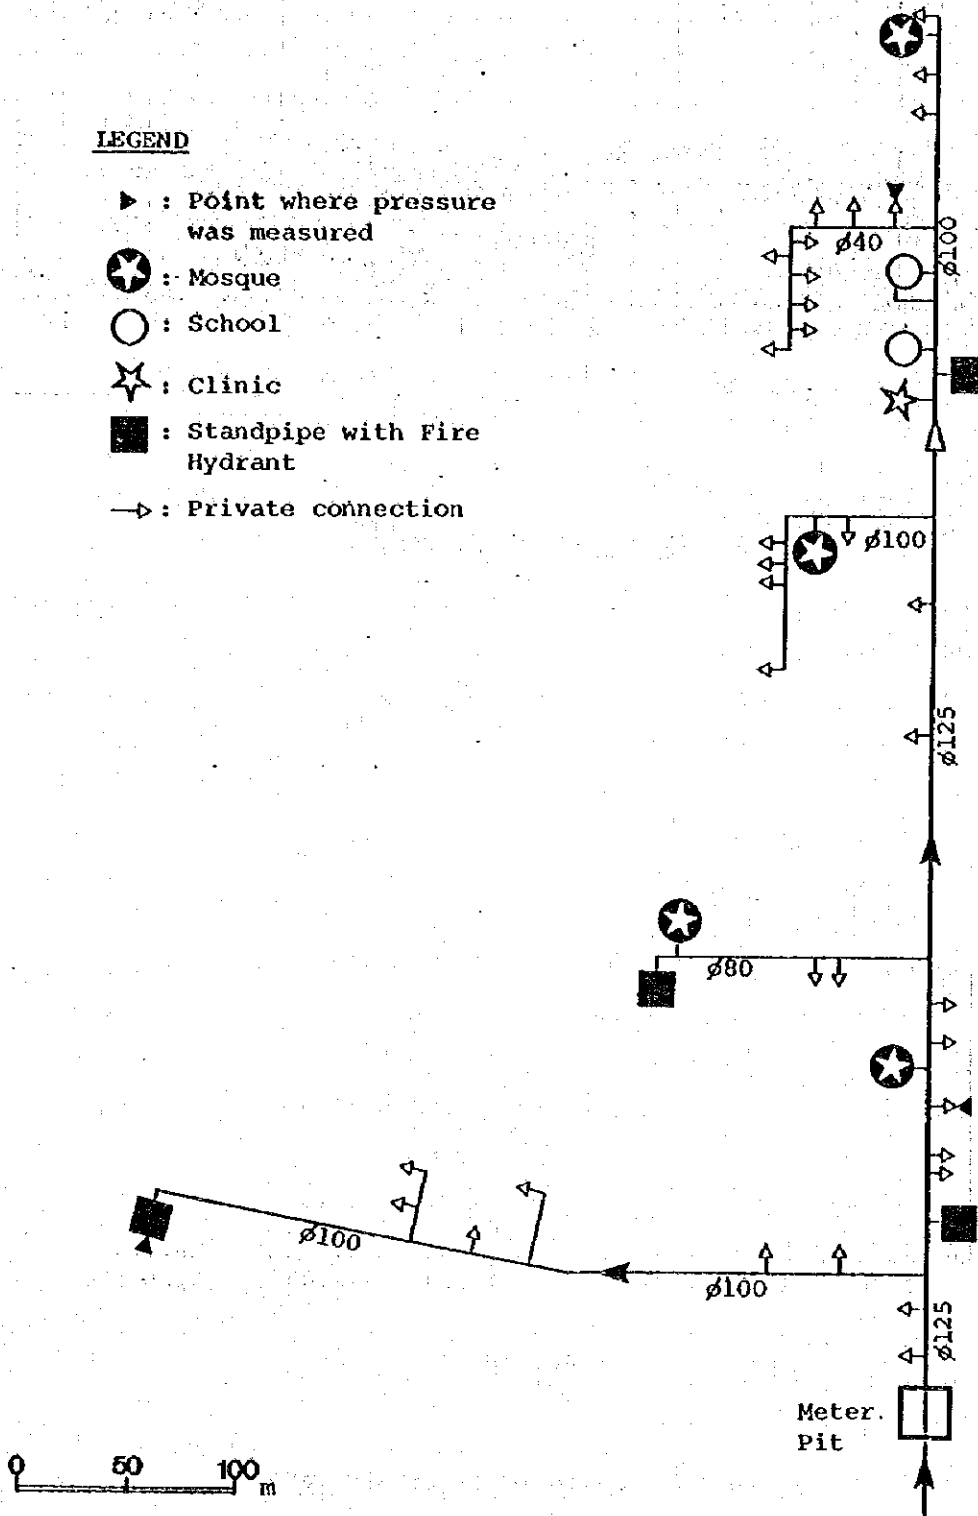
HOUSING DEP. SYSTEM  
**Fig-14 BANY CORESH**

During the flow observation, the pressure was measured at two taps hourly. The taps location is shown in Fig-14 and the survey results are in Fig-15. At the end of the 24 hours flow observation, all taps closed condition was brought on for 1 hour from 11 a.m. on a July As it was anticipated, the flow rate fell down to nearly zero.

Measurement of the flow was carried out under such a condition and the result, as shown in Figs. 14 - 16, indicates that no leakage was existent in the pipelines and service pipes. As the figure shows also, the nearly zero flow continued even after the closed valves had been responded by the

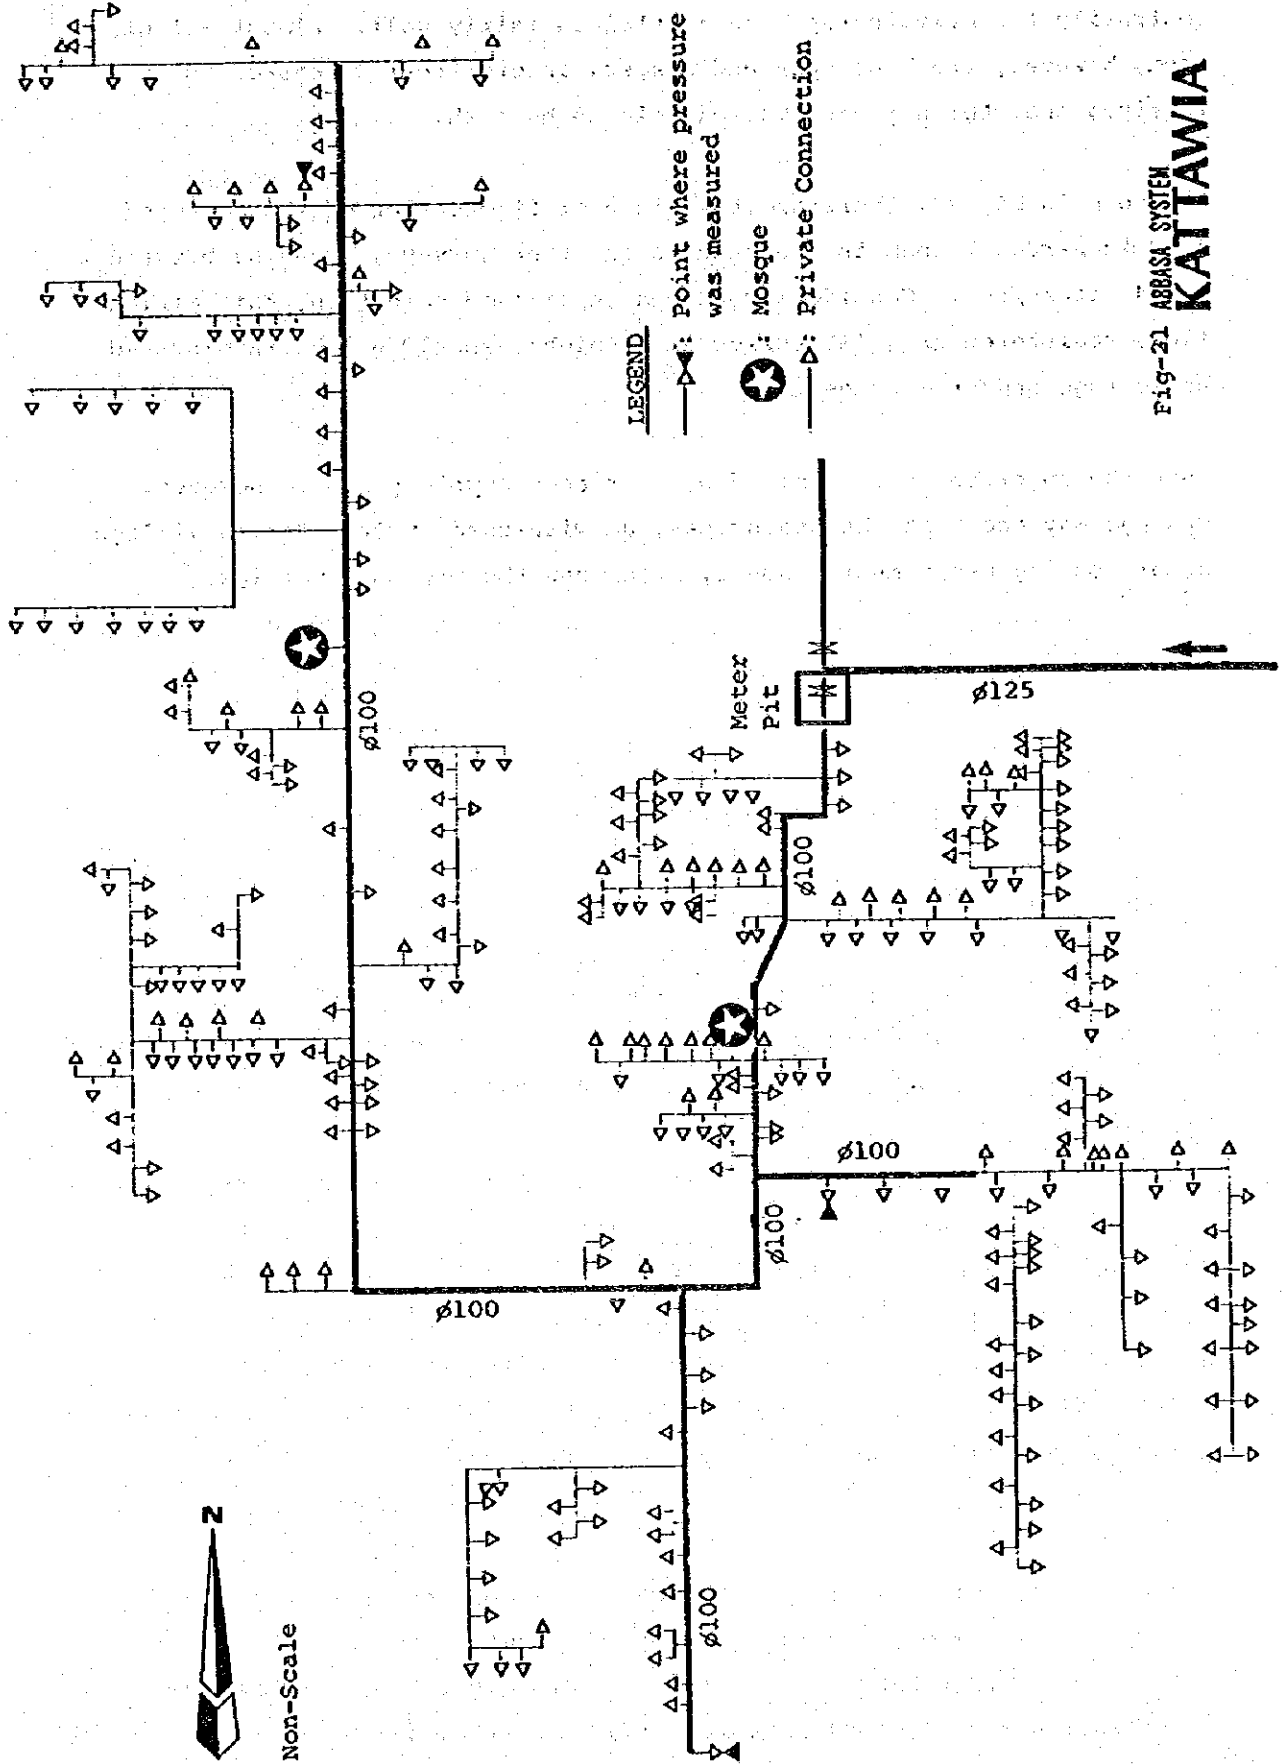
Fig-21 ABBASA SYSTEM  
**KATTAWIA**

Three locations of the pressure measured taps is shown in Fig-21, and the survey results of the flow and pressure are shown in Fig-22.

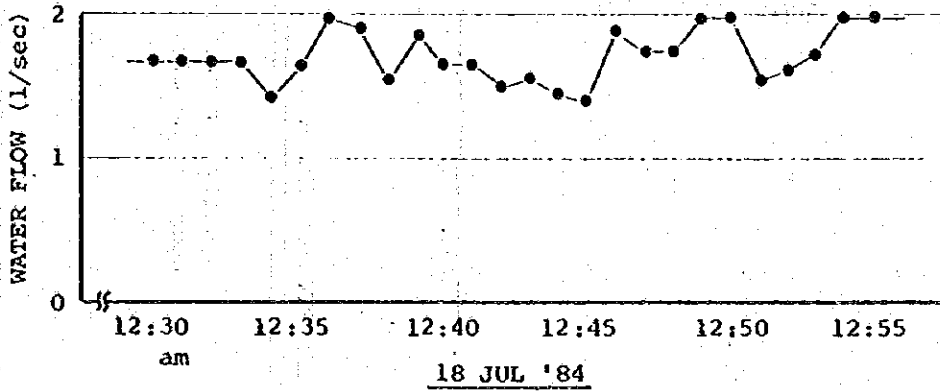
Fig-23 WATER FLOW UNDER CLOSED TAPS

After the 24 hours observation, the water flow measurement under all taps closed condition was conducted, starting at 11 a.m. on 18 July. Every means of instructing the people was employed, but it was not effective as the result, shown in Fig-23, tells. The observed minimum flow was about 1.4 liters/sec. When all valves/cocks of the service pipes and public branches were closed by technicians and workers from 10 a.m. on the next day, 19 July, the water flow fell as low as below the sensitivity of the flow meter. (Fig-24)

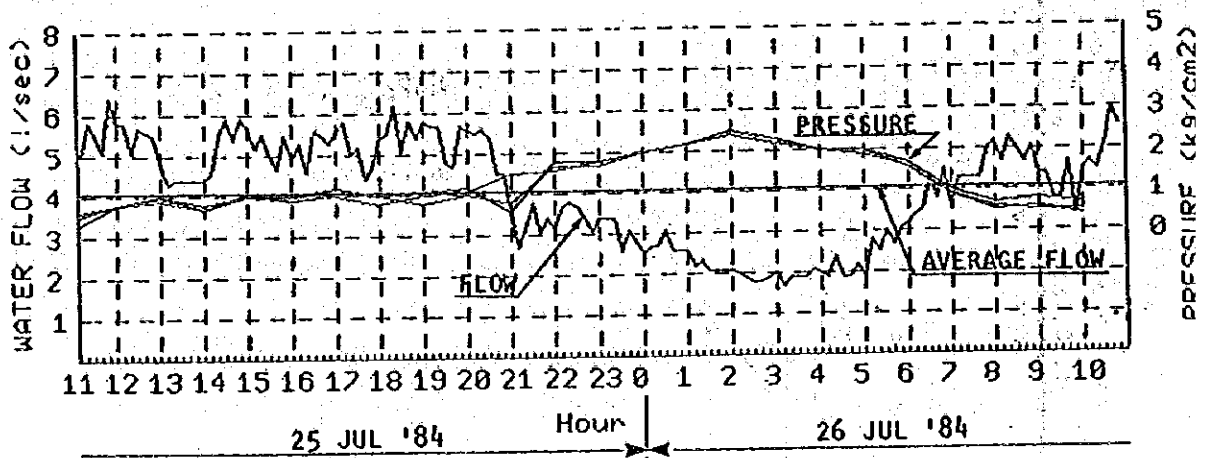
Fig-27 WATER FLOW AND PRESSURE

The survey results obtained from the 24 hours observation showed a fluctuating flow of between about 2 and 6 liters/sec, as seen in Fig-27. The minimum flow of 2 liters/sec or less occurred from 2 to 5 a.m.

Almost all the villagers are farmers and most of them were taking rest during the time, as the local assistants patrolling the area witnessed.

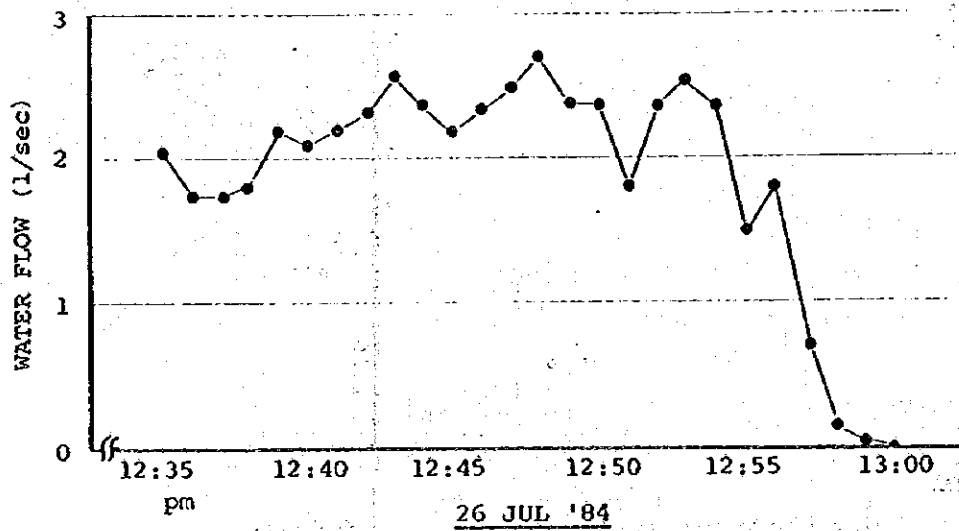
Fig-28 WATER FLOW UNDER CLOSED TAPS

Another flow observation made under all taps closed condition showed that the flow was zero and it was deduced that the leakage was negligibly small.

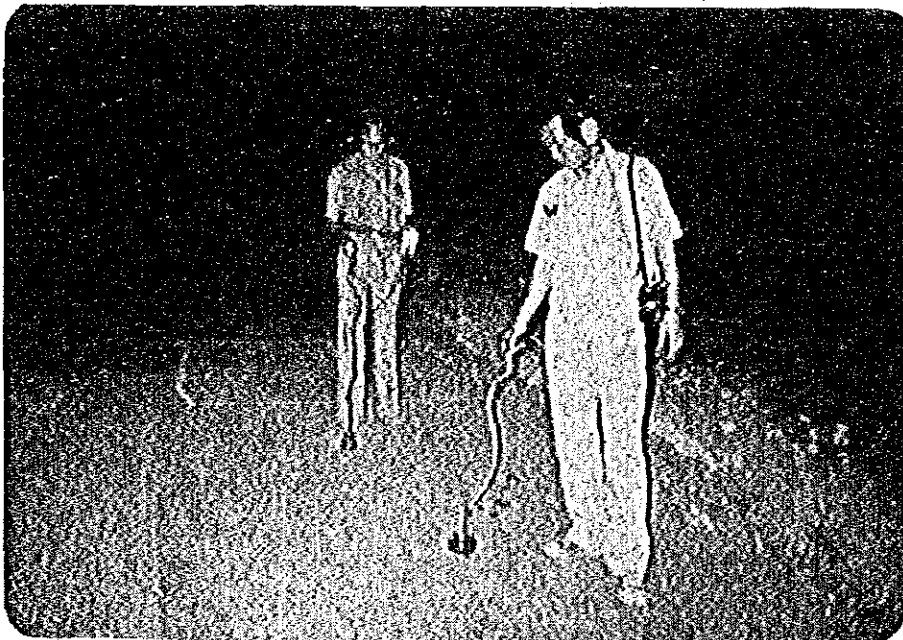
Leak detection at Kafr El-Eshara area of Zagazig city

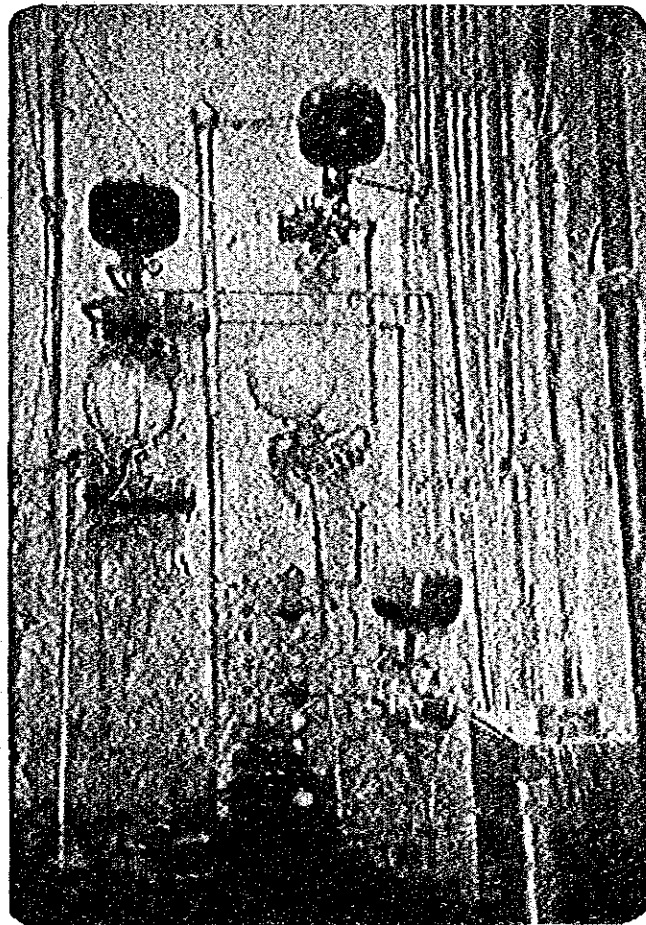
Installed private booster pumps
