REPORT ON DAMAGE TO PORT FACILITIES  
IN THE PORT OF VALPARAISO  
BY THE EARTHQUAKE ON MARCH, 3 1985

APRIL 2, 1985

JAPANESE EXPERT MISSION

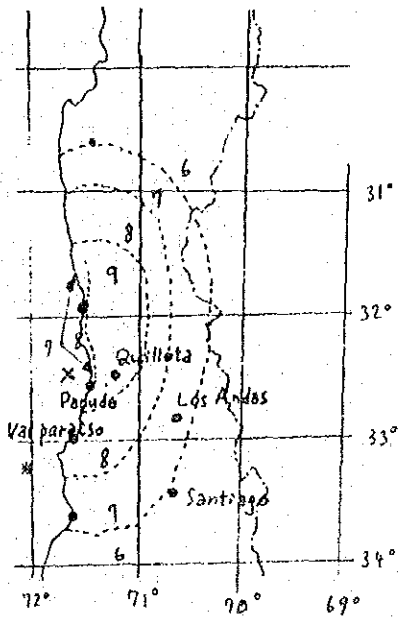
Fig. 3-1 Isoseismal map of  
the earthquake of March 3,  
1985 (After ERCILLA,  
13 marzo 1985)

The isoseismal map is presented in Fig. 3-1. The seismic intensities at several cities are shown in Fig. 3-2. The intensity scale used here is the Modified Mercalli Scale. The location of epicenter is shown in both figures. The seismic intensities in Valparaiso City were 7 to 8, and those in San Antonio City were 8.

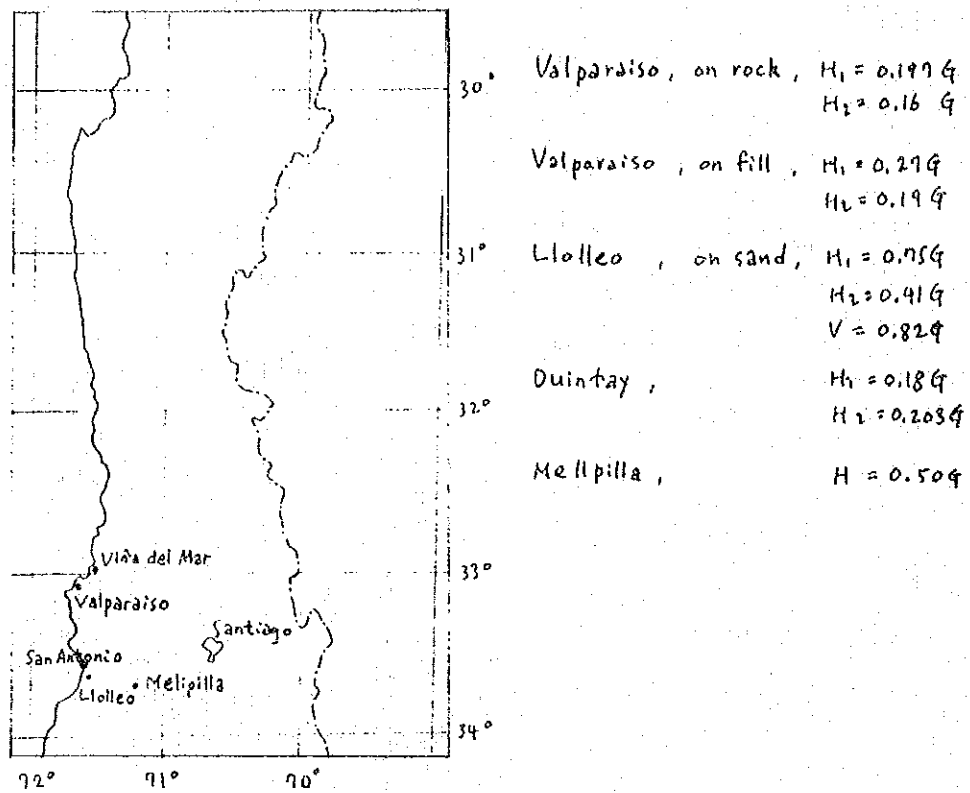
Fig. 3-3 Accelerograph locations in and around Valparaíso and peak component acceleration

The locations of accelerographs around Valparaiso and the peak component accelerations are shown in Fig. 3-3. The locations of two accelerographs near Valparaiso Port are shown in Fig. 3-4. H<sub>1</sub> & H<sub>2</sub> denote two horizontal peak component accelerations, H denotes one of the two horizontal peak component accelerations. The azimuth of each component was under confirmation, and the information on it has not been available. V denotes a vertical peak component acceleration.

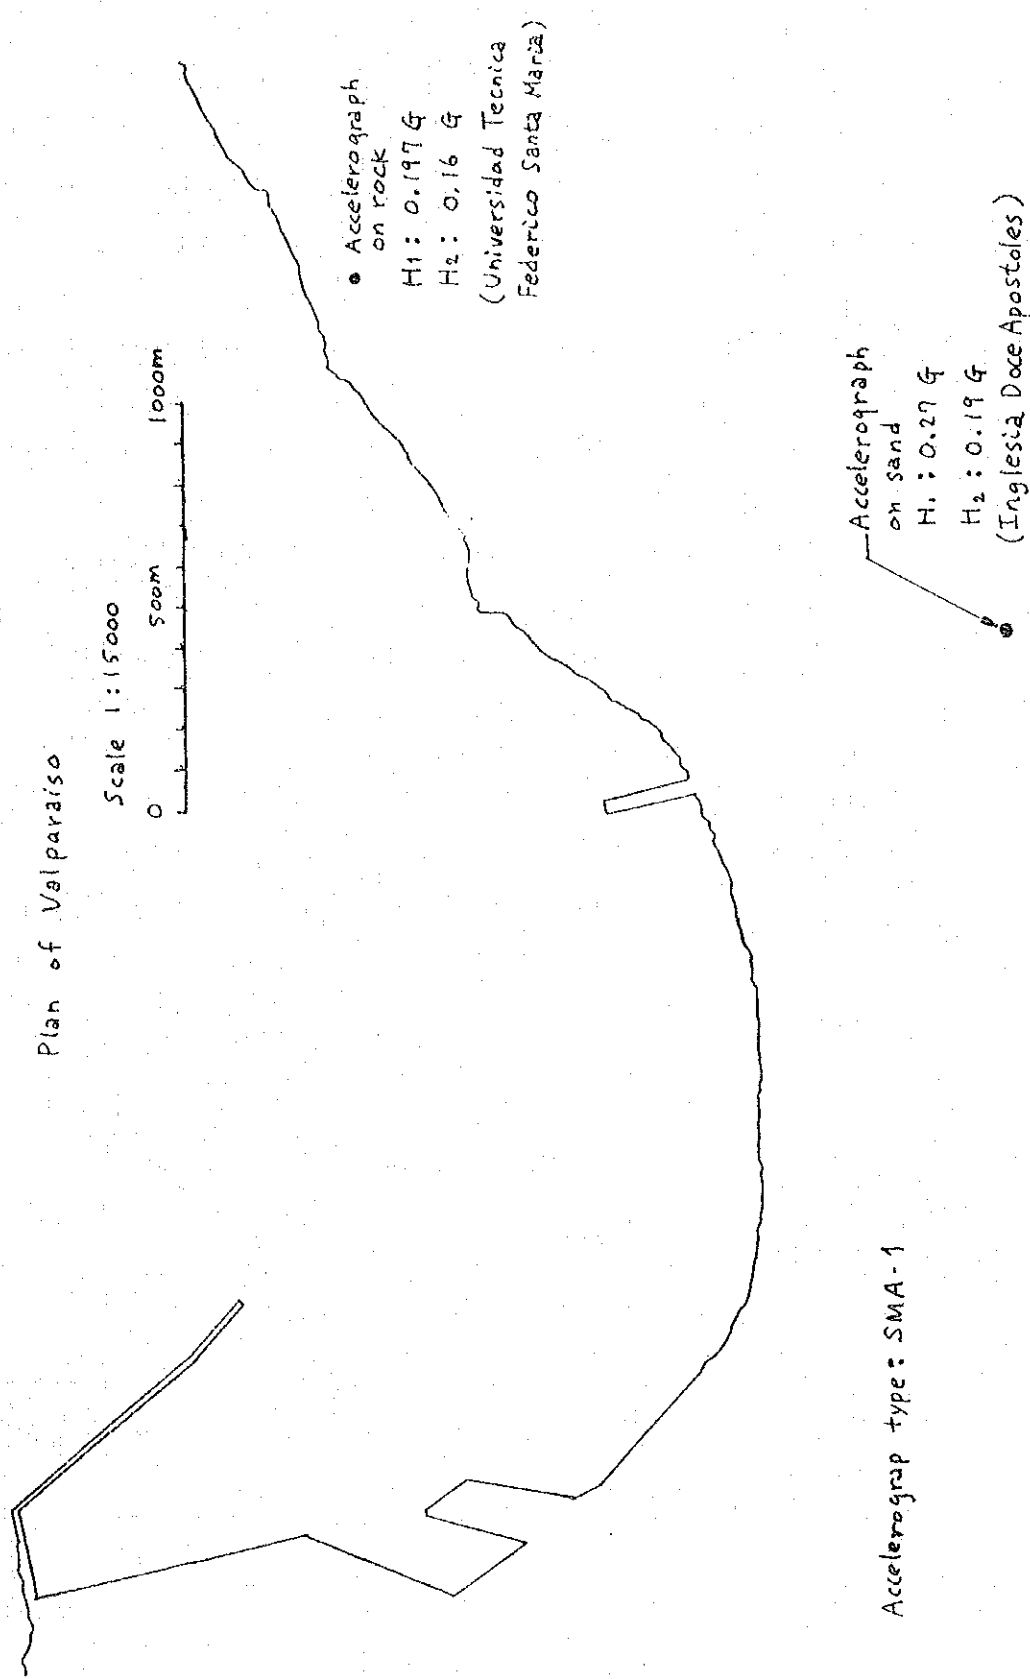
Fig.3-4 Accelerograph locations in Valparaiso and peak component accelerations of the earthquake of March 3, 1985

The accelerometers at the two sites in Fig. 3-4 are the SMA-1 accelerographs.

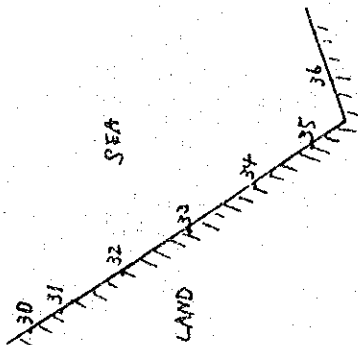
BERTH No. 5

INVESTIGATION POINT	H	S1	S2	D	NOTE
31	14.85 <sup>m</sup>	50cm	15cm	Bottom	SEE FIG 1
32	14.90	70cm	120cm	4.8m	SEE FIG 2
33	14.00	"	70cm	"	SMOOTH SURFACE
34	13.85	4	64cm	Bottom	"
35	6.00	6	30cm	"	"

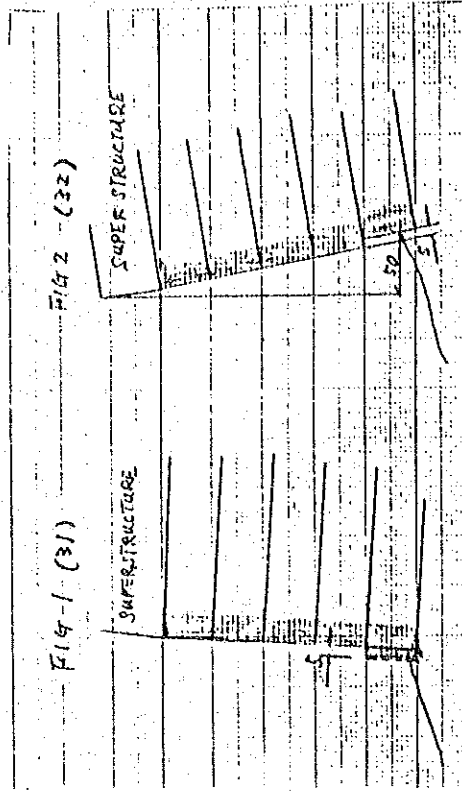
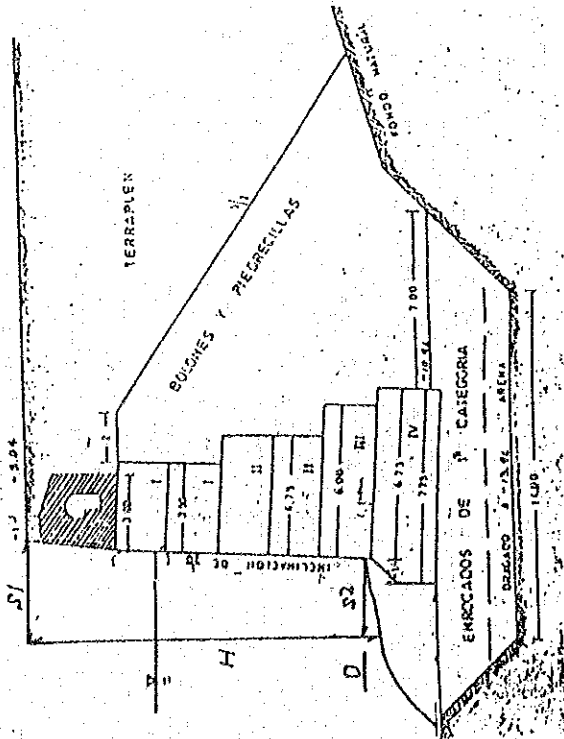
Fig. 4-4-d

INVESTIGATION POINT	H	H'	B	S1	S2	D	NOTE
50	13.45m	2.90m	3.0m	70cm	20cm	9.1m	
49	13.40m	3.20m	5.0m	"	35cm	9.1m	
47	12.70m	3.20m	over 5.0m	"	25cm	9.1m	
45	13.40m	3.30m	over 5.0m	"	28cm	9.1m	
43	6.95m	3.50m	over 5.0m	"	50cm	3.9m

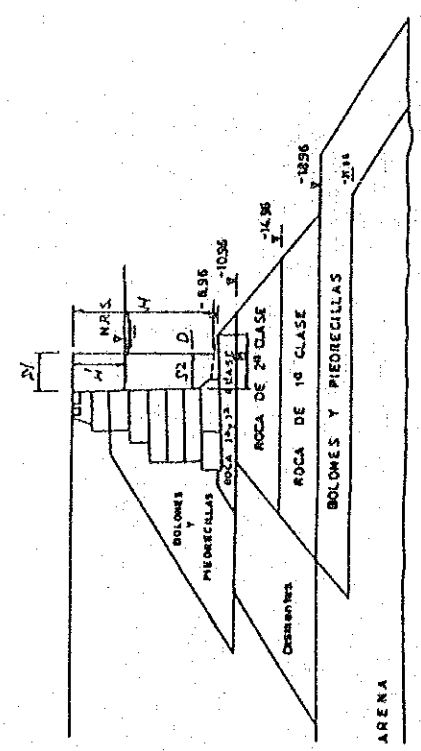
SITIO 8

INVESTIGATION POINT	H	H'	G	S1	S2	D
1	13.5m	3.0m	—	50cm	30cm	9.8m
2	13.05m	3.2m	2.0m	"	40cm	9.8m
3	12.5cm	3.5m	2.0m	"	35cm	9.8m
4	12.7m	3.5m	5.0m	"	45cm	9.1m
5	12.5m	3.8m	5.0m	"	15cm	9.1m
