CHAPTER - 6

EXISTING CONDITION
OF
THE PROJECT ROAD

6-1 General

The Project Road is part of the national road, stretching over a distance of about 500 km from Bogota, the capital of Colombia, to the Port of Buenaventura, and which crosses the Cordillera, mountain range for a distance of about 310 km. It is this 310 km portion which is the object of this study.

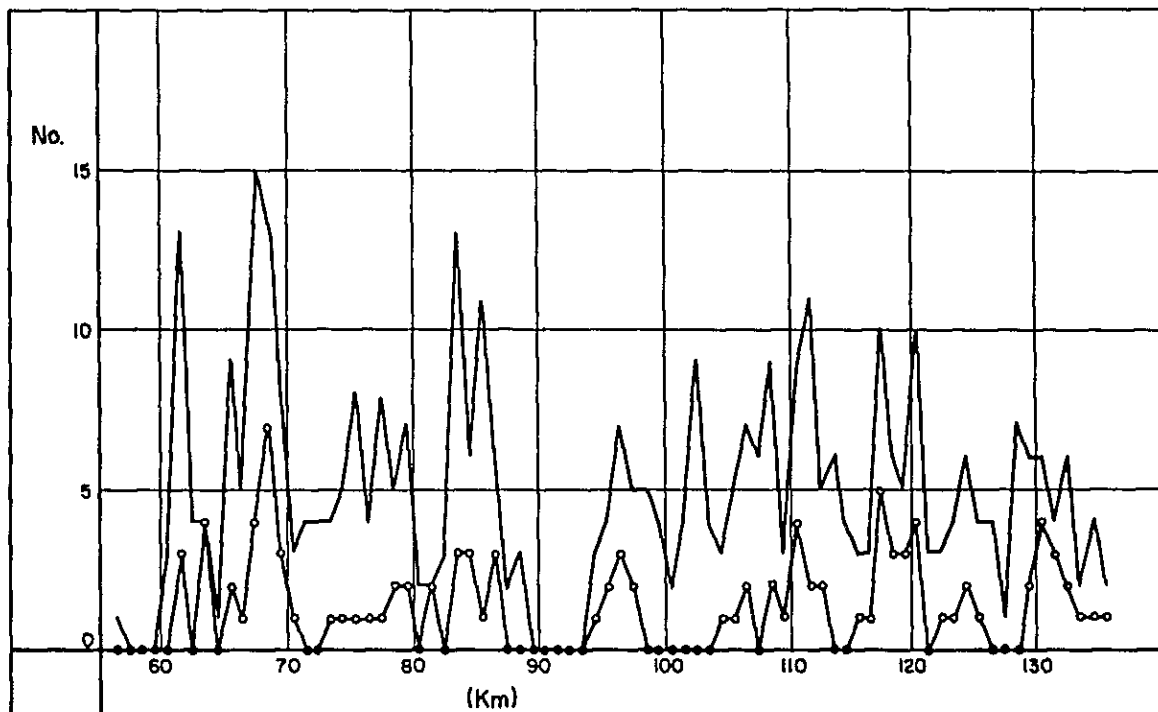
(a) Horizontal Curve Distribution by km

Generally, this segment shows poor alignment as illustrated in Fig. 6-2 and Annex Table 6-1. The MOPT carried out rehabilitation work from 1979 to 1981, which included pavement overlays, shoulder paving, improvement of side ditches, and additional construction and improvement of retaining walls. Neither alignment improvement nor failure prevention measures were included in the rehabilitation program. Additionally, the following observations relative to the Ibague-Calarca segment have also been noted.

- 1) There are many curves which have radii of curvature less than the 25 m minimum stipulated for a design speed of 30 km/h. In fact the curves are so sharp that in many places it is impossible for large vehicles to pass each other. (Refer to Annex 7-1, "Widening of Road to Facilitate Passing of Large Vehicles at Curves" and Annex Table 7-3 "Present Status of Passing Condition and Summary of Improvement Plan"
