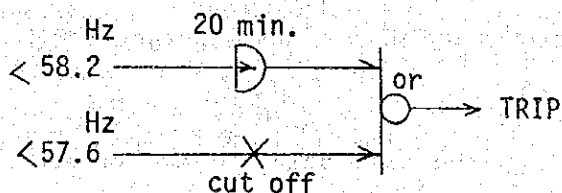
- (i) Economizer inlet pressure low trip to be set at 2480 psig is defeated due to reduced pressure limited to 2100 psig at turbine inlet.
- (ii) HP heater level high trip is defeated due to HP heater leaking.
- (iii) LP heater level high trip is defeated in order to avoid faulty action caused by vibration.
- (iv) Under frequency relay is defeated to extreme low frequency.

(i) Economizer inlet pressure low trip should be put in service at reduced pressure setting by manufacturer recommendation because that the M-1 boiler has probability of tube failure due to thinning of tube thickness.

(ii) HP heater level high trip should be in service after replacement of heater and also LP and HP heater level switches which are recommended to use micro switch type to be more reliable, easy setting and strong against vibration.

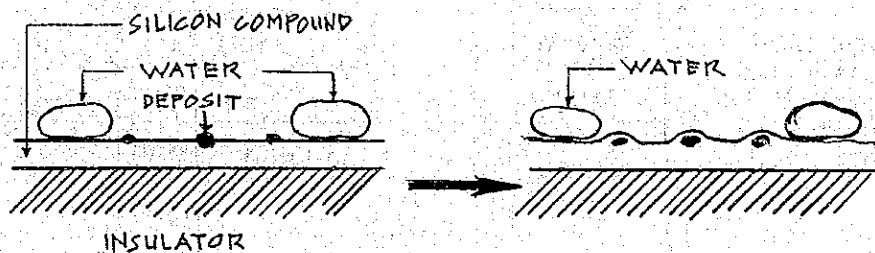
In order to prevent bursting of the lightning arresters, coating of the insulator surface with silicon compound (not silicon grease) will be effective.

Silicon compound will contribute to maintain the insulation performance of the insulator surface by the effect of amoeba action, thus deriving uniform voltage distribution of the discharging elements so that characteristic of discharge can be kept stable.

Thickness of silicon compound is recommendable to be kept between 0.5mm to 1.0mm.
