Table 5C-36 DAILY WATER ANALYSIS REPORT REGARDING TO HOUSE SERVICE CLOSED CYCLE (Malaya Plant)

Table 5C-37 ANALYSIS DATA OF HOUSE SERVICE COOLING SYSTEM REQUESTED BY JICA TEAM (GSTP)

b. Condenser Cooling Water

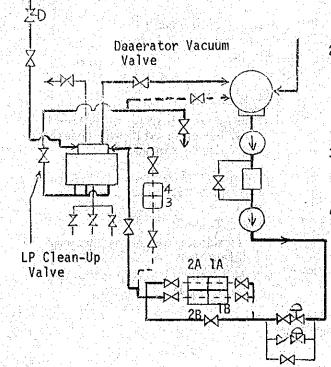
Low Pressure Clean-Up

- 1. Start deaerator vacuum up (LP Htr: Bypass, Blow off) NH40H injection (pH 9.3 - 9.5)
- LP Htr. in service Deaerator inlet turbidity < 3 ppm CBP discharge 0₂ < 100 ppb
 After LP 1.2 Htr. in service, when upper water quality is kept, LP
 - 3.4 Htr. becomes available.
- 3. Recirculation
 - Deaerator tank turbidity < 3 ppm CBP dsicharge 0₂ < 100 ppb
- 4. For next step
 - Deaerator tank outlet turbidity < 1 ppm (Target Fe < 100 ppb)
 - $0_{2} < 10 \text{ ppb}$
 - $(pH 9.3 9.5, N_2H_4 > 200 ppb)$

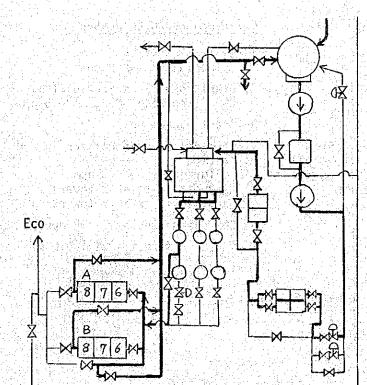
PRE BOILER Clean-up

- Water filling → Blow off without HPHtr (Max 255T/H. Design 128T/H)
- 2. A-HPHtr \rightarrow B-HPHtr
 - → A, B HPHtr ---> recirculation for each steps =>
 - Turbidity in blowdown water < 3 ppm
 - Deaerator 0₂ < 10 ppb
- 3. for next step
 - HPHtr outlet = Fe < 50 ppb, Gu < 20 ppb, SiO₂ < 30 ppb
 - Cation conductivity < luS/cm
 - Deaerator tank outlet 0₂ < 10 ppb pH 9.3 - 9.6 , oil < 1 ppm (at initial clean-up only)
 - N₂H₄ 200 300 ppb
 - Feedwater flow Max 508 T/H Feedwater temp. > 80°C

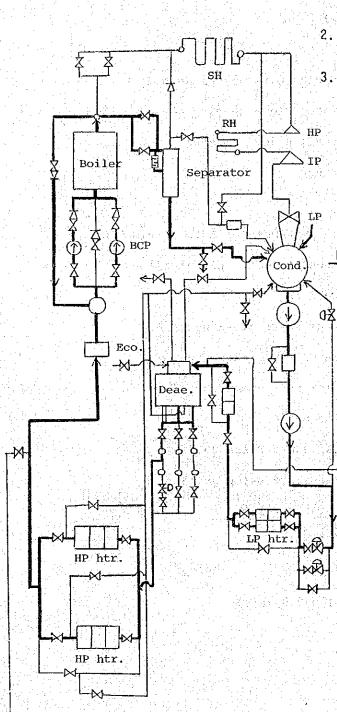
Boiler Cold Clean-up

- To boiler at about 10% MCR Feed water flow rate
- 2. Blow off \Rightarrow recirculation
- Start-up separator turbidity < 3 ppm
- 3. for next step Eco inlet Fe < 50 ppb, Cu < 20 ppb Si0 $_2$ < 30 ppb,
 - cation conductivity < 1 uS/cm
 - Deaerator tank $0_2 < 10$ ppb
 - Water-wall outlet Fe < 200 ppb (Target Fe < 100)
