STUDY REPORT
ON
PLANT RENOVATION PROJECT OF
THE SENTOSA-1 EARTH STATION
IN
THE REPUBLIC OF SINGAPORE

JULY 1986

JAPAN INTERNATIONAL COOPERATION AGENCY (JICA)

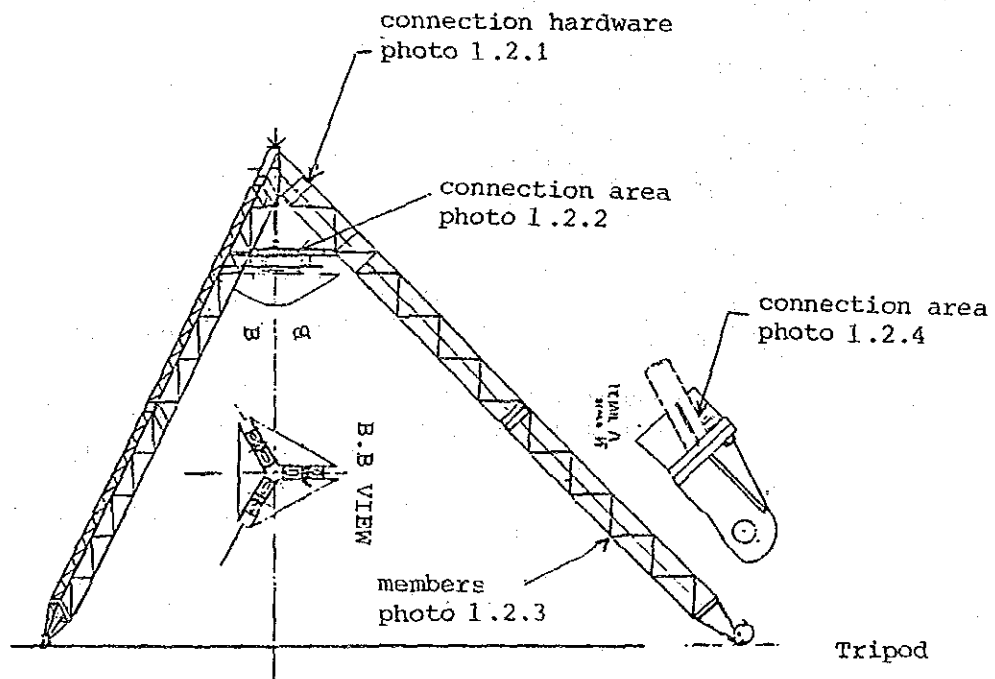
- (3) Main reflector panel (photograph 1.3.1 - 1.3.6)
Two panels are damaged and rear faces of panels are rusted.
No problem practically.
 - (4) Panel Support (photograph 1.4.1 - 1.4.2)
Almost all bases are partially corroded though only a few bolts are rusted. It is preferable to replace ten percents of bases with new ones.

Degradation : whole panels (photo 1.3.1)

2) Rust : rear face of whole panels (photo 1.3.2)

3) Dirt : moss on almost all panels (photo 1.3.5)  
rust dropped from tripod (photo 1.3.3, 1.3.4)

5) Distortion : one panel (photo 1.3.4)

6) Rivet : fall off in two panels (photo 1.3.5, 1.3.6)

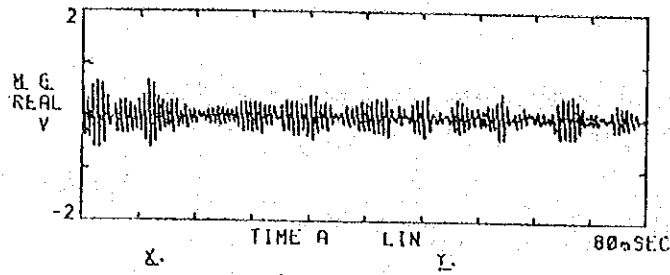
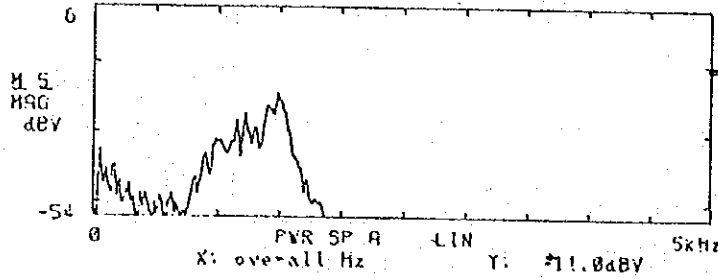
Fig 2.1.1

| No. | COMPONENT | EVALUATION | JUDGEMENT |
|---|---|---|---|
| 1. | AZ Bearing | No remarkable peaks and pulse in analyzed ENVELOPE wave mode. Peak of natural frequency revealed in analyzed SPECTRUM wave mode. However no remarkable peak in SPECTRUM wave mode.<br>(Refer to Fig. 2.1.1, 2.1.2) | No problem in practical use |

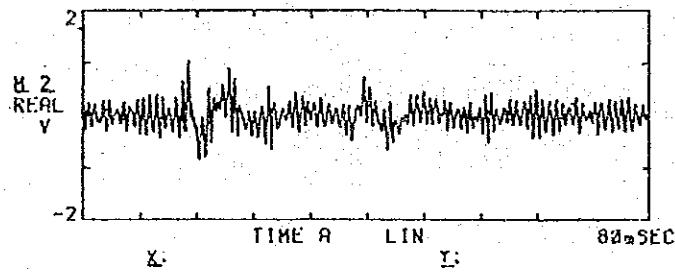
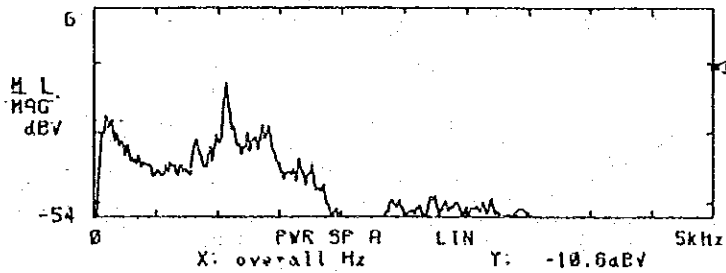
Fig 2.2.1

| No. | COMPONENT | EVALUATION | JUDGEMENT |
|---|---|---|---|
| 2. | EL Bearing A | same as above<br>(Refer to Fig. 2.2.1, 2.2.2) | " |

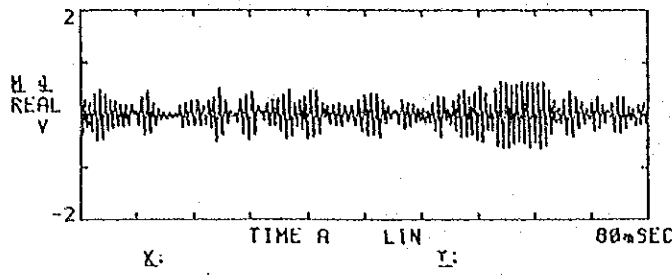
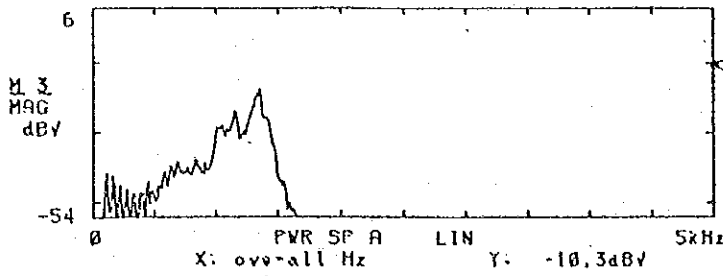
Fig 2.3.1  
ENVELOPE

| No. | COMPONENT | EVALUATION | JUDGEMENT |
|---|---|---|---|
| 3. | EL Bearing B | same as above<br>(Refer to Fig. 2.3.1, 2.3.2) | " |

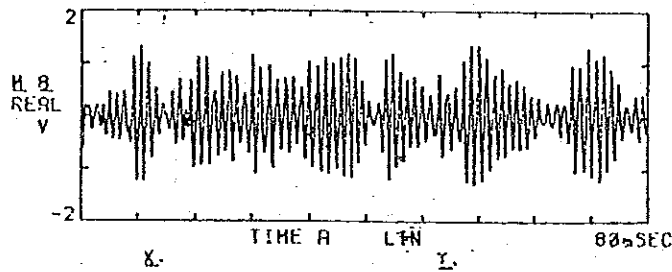
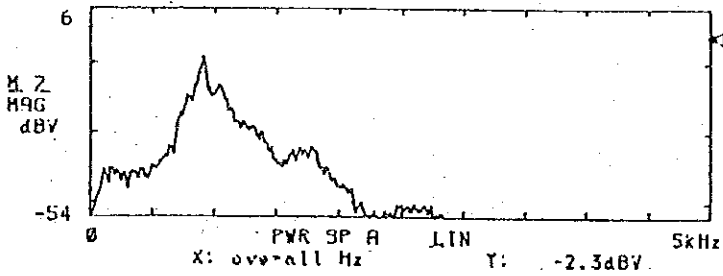
Fig 2.4.1  
ENVELOPE

| No. | COMPONENT | EVALUATION | JUDGEMENT |
|---|---|---|---|
| 4. | EL Speed Reducer A | Periodical peaks revealed in analyzed ENVELOPE wavemode. We assume that it will be caused by other source not related to the bearing damage. However we think the damage is small and no problem in practical use because peak factor Table 1 is smaller than 6.2.<br>(Refer to Fig. 2.4.1, 2.4.2) | " |

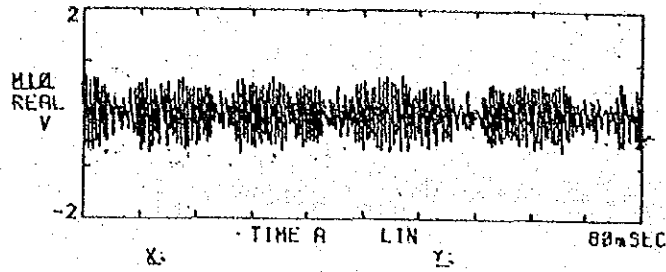
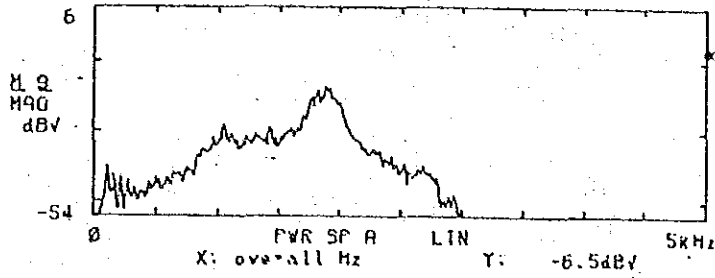
Fig 2.5.1

| No. | COMPONENT | EVALUATION | JUDGEMENT |
|---|---|---|---|
| 5. | EL Speed Reducer B | Same as AZ Bearing<br>(Refer to Fig. 2.5.1, 2.5.2) | " |

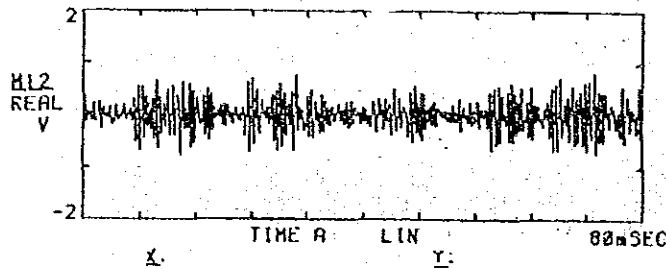
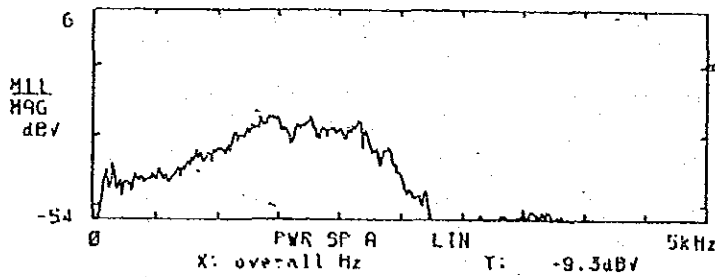
Fig 2.6.1

| No. | COMPONENT | EVALUATION | JUDGEMENT |
|---|---|---|---|
| 6. | AZ Speed Reducer A | Same as AZ Bearing<br>(Refer to Fig. 2.6.1, 2.6.2) | " |

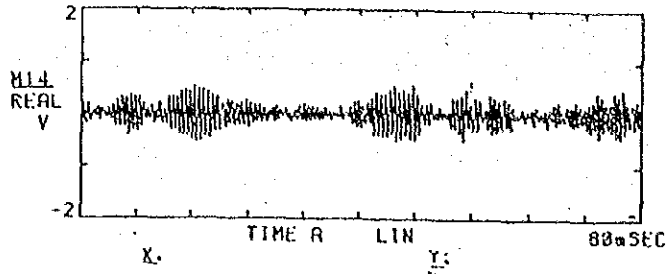
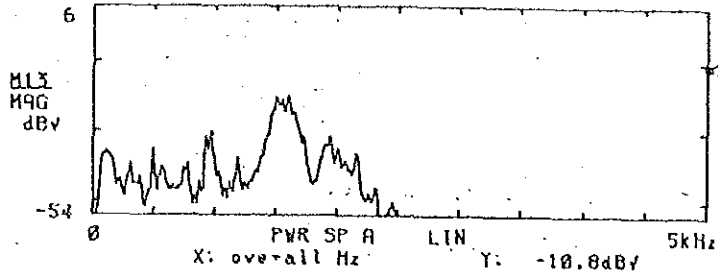
Fig 2.7.1

| NO. | COMPONENT | EVALUATION | JUDGEMENT |
|---|---|---|---|
| 7. | AZ Speed<br>Reducer B | Same as AZ Bearing<br>(Refer to Fig. 2.7.1, 2.7.2) | No problem in<br>practical use |

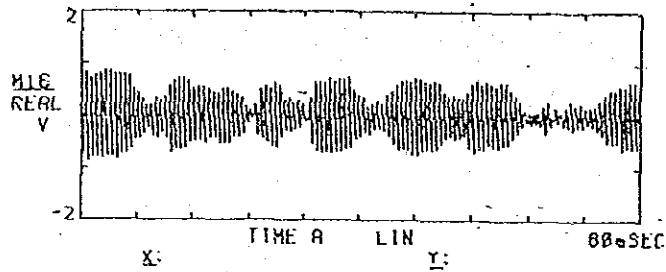
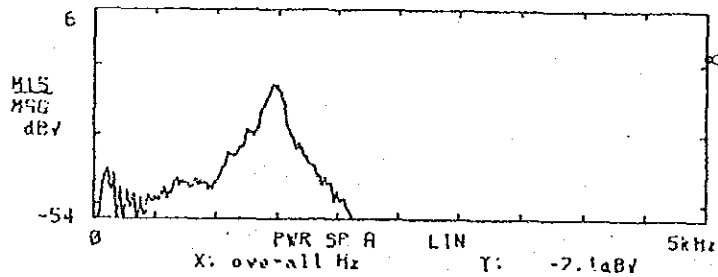
Fig 2.8.1

| NO. | COMPONENT | EVALUATION | JUDGEMENT |
|---|---|---|---|
| 8. | AZ Speed<br>Reducer C | Periodical peaks revealed in<br>analyzed ENVELOPE wave mode.<br>We assume that it will be caused<br>by other source not related to<br>the bearing damage.<br>However we think the damage is<br>small and no problem in practical<br>use because peak factor in Table 1<br>is smaller than 6.2.<br>(Refer to Fig. 2.8.1, 2.8.2) | " |

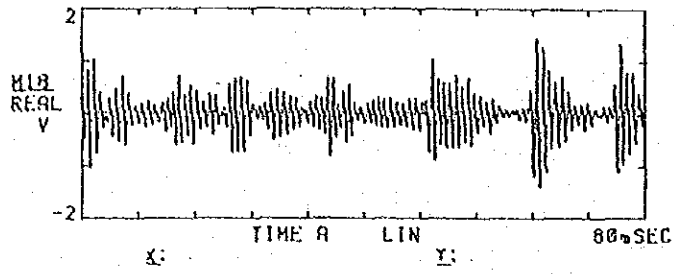
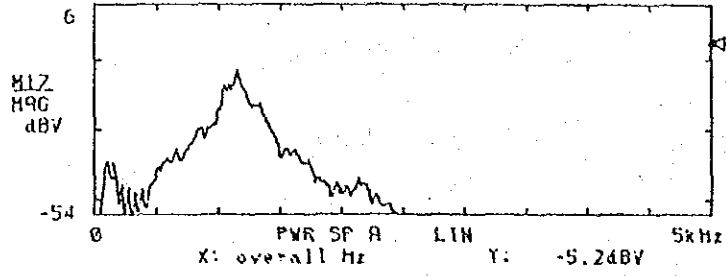
Fig 2.9.1

| NO. | COMPONENT | EVALUATION | JUDGEMENT |
|---|---|---|---|
| 9. | AZ Speed<br>Reducer D | "<br>(Refer to Fig. 2.9.1, 2.9.2) | " |
