REPORT ON  
THE RAMA VI BRIDGE  
REHABILITATION PROJECT

DECEMBER, 1982

JAPAN INTERNATIONAL COOPERATION AGENCY  
(JICA)

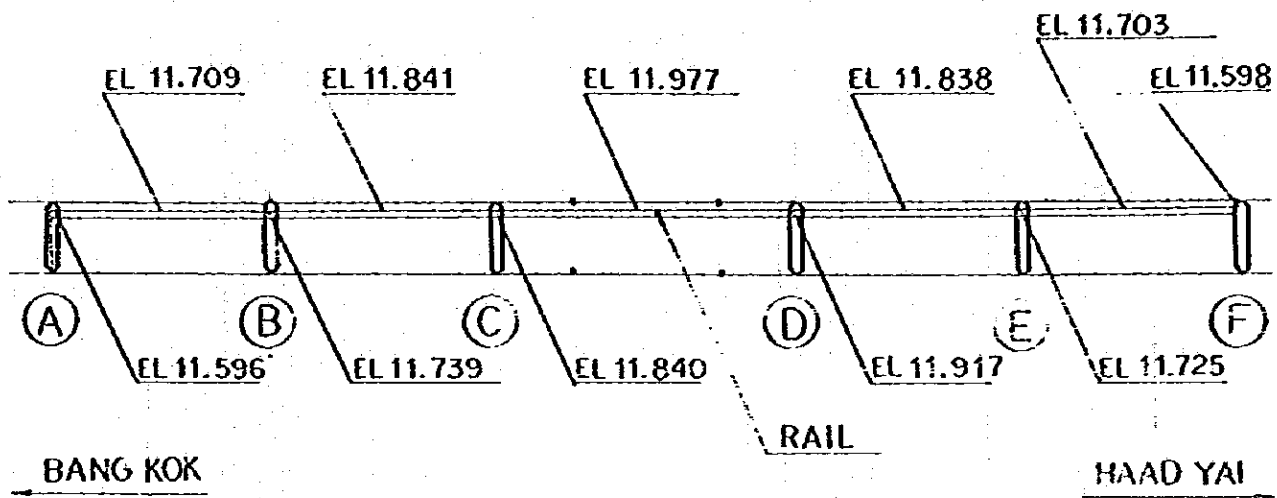
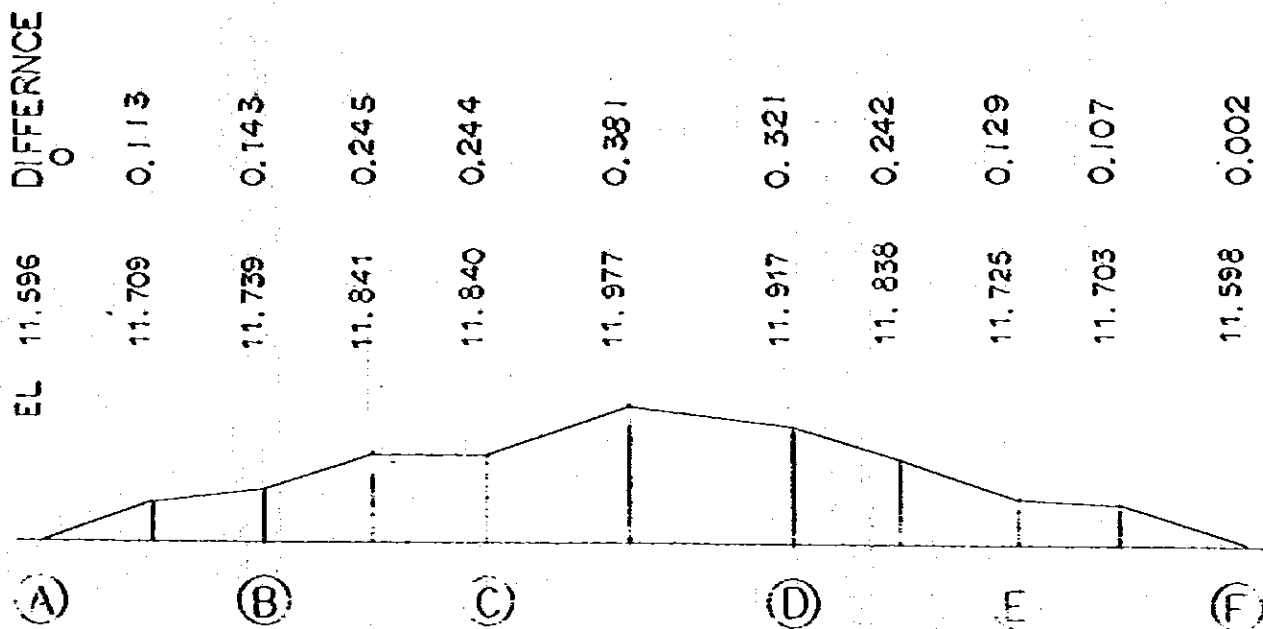
Fig. 1-9 Elevation of Top of Rail for Longl. Section

The result of level surveying is as shown in Fig. 1-9 and reveals that Abutments A and F on both sides are sagged down in a shape of

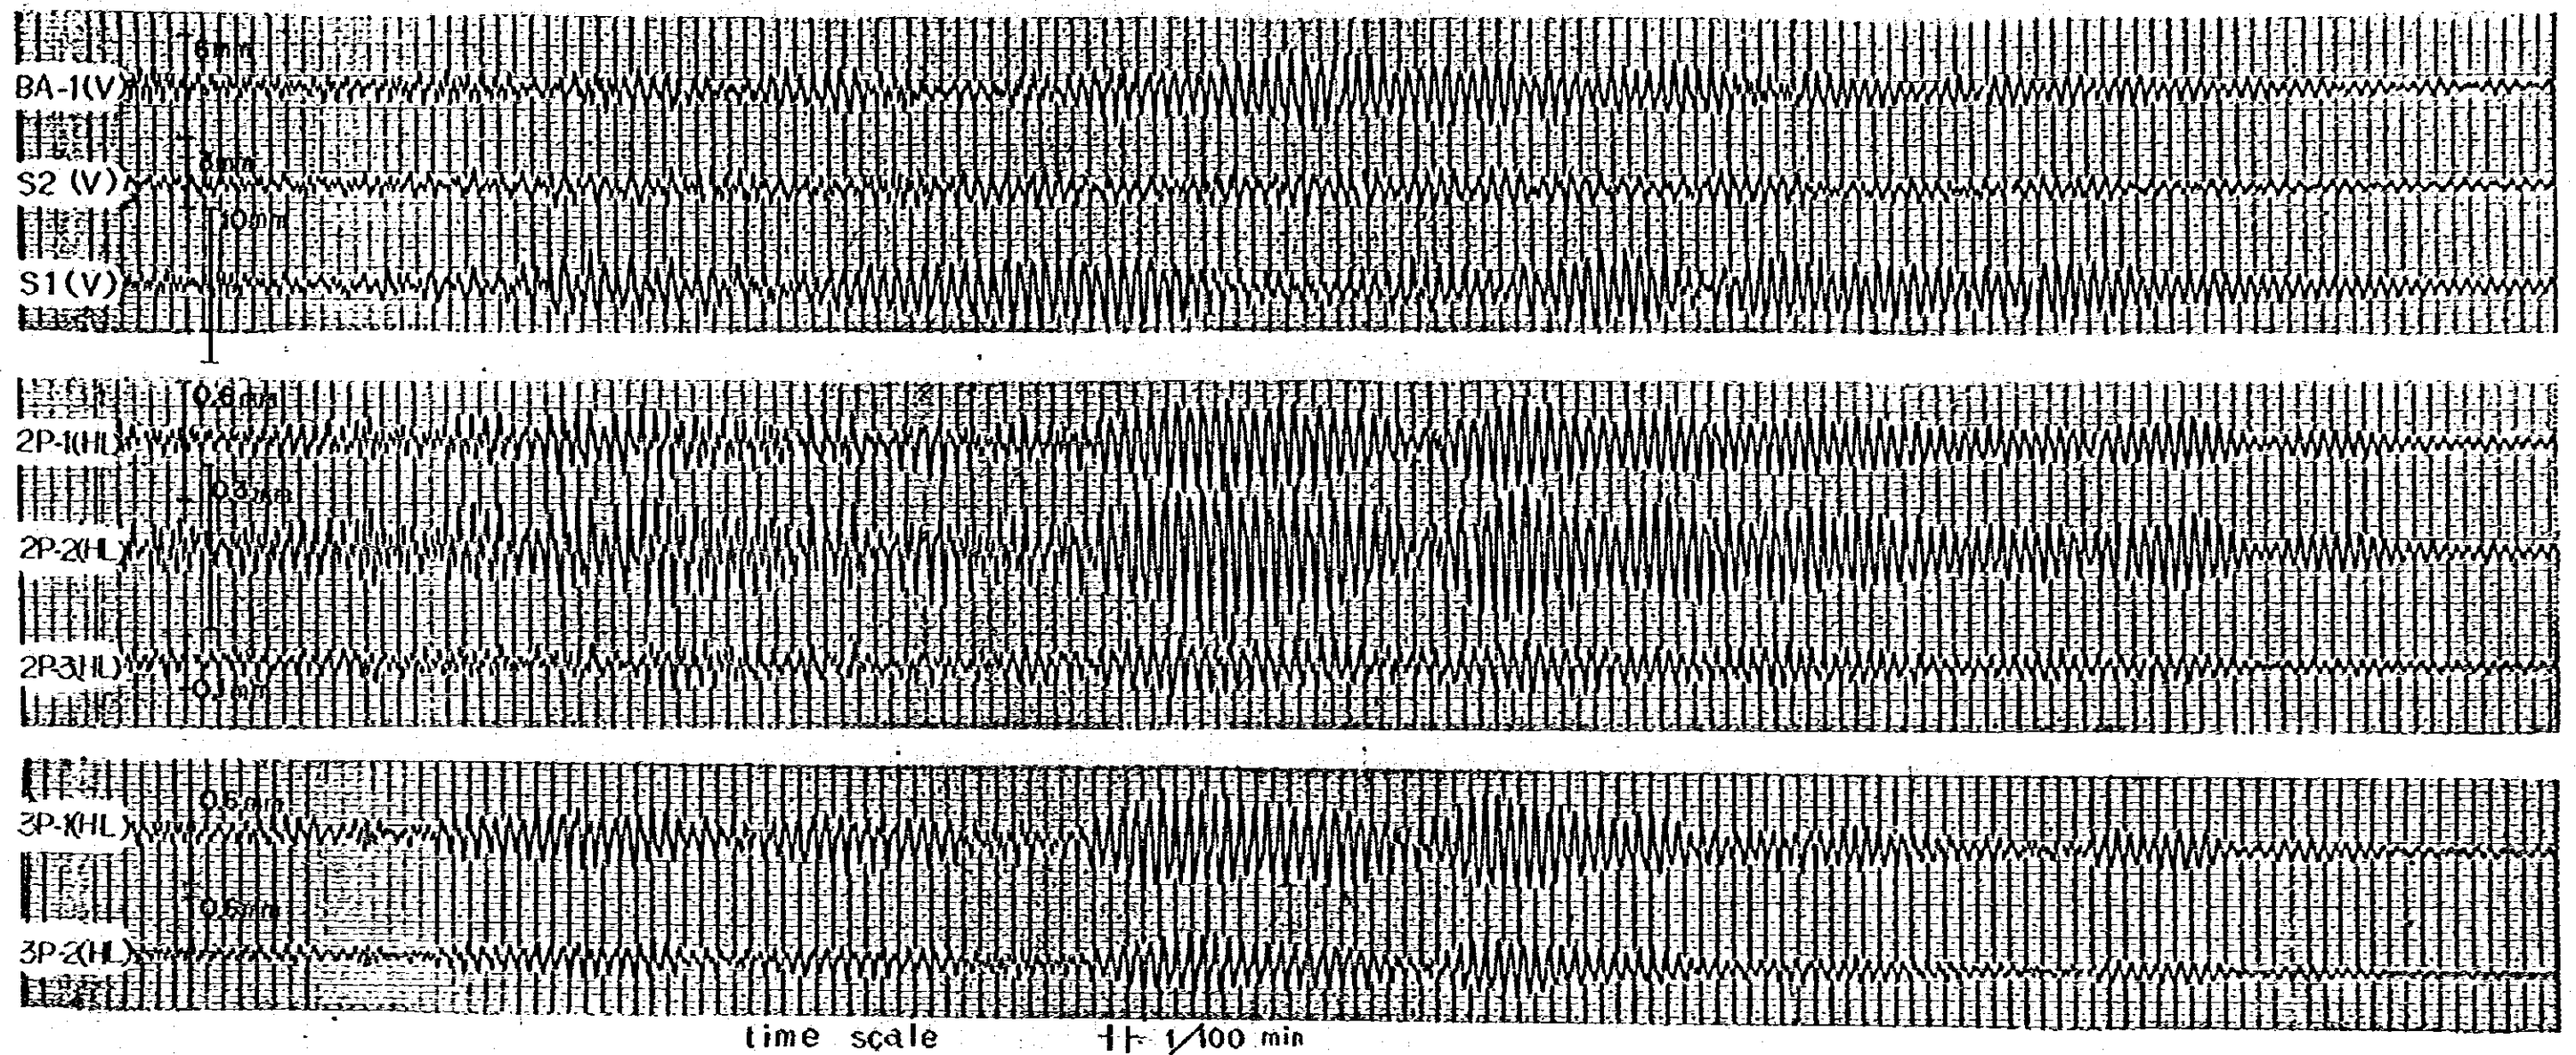
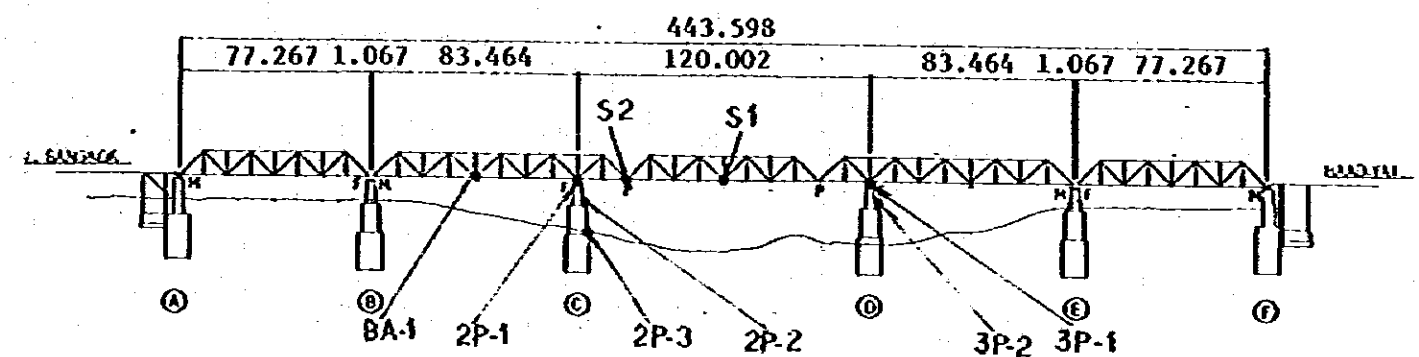
Fig. 2-1 Examples Responded Waves

If there were any gap or crack at upper, middle and lower parts of the pier, the test results would reveal any difference or discrepancy in the normal vibration, thus obtaining response waves of different characteristics at each measured point of the pier. In the reality of test results, however, no difference or discrepancy was observed as shown in Fig. 2-1.

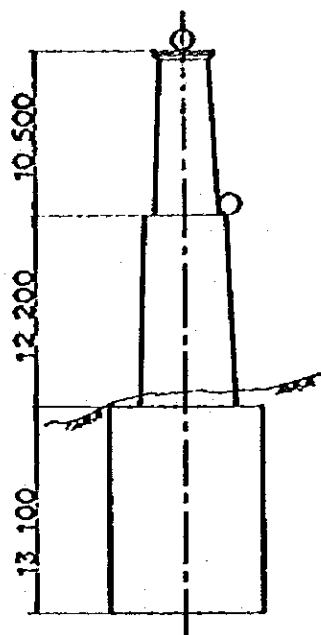
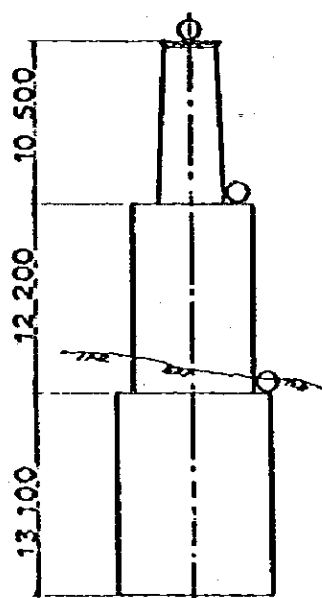
Fig. 2-2 Vibration Mode at Piers

If there were any gap or crack at upper, middle and lower parts of the pier, the mode of vibration would not indicate any form of rigidity rocking (which means the linear shape of mode). The real result shows, however, the linear line as shown in Fig. 2-2.

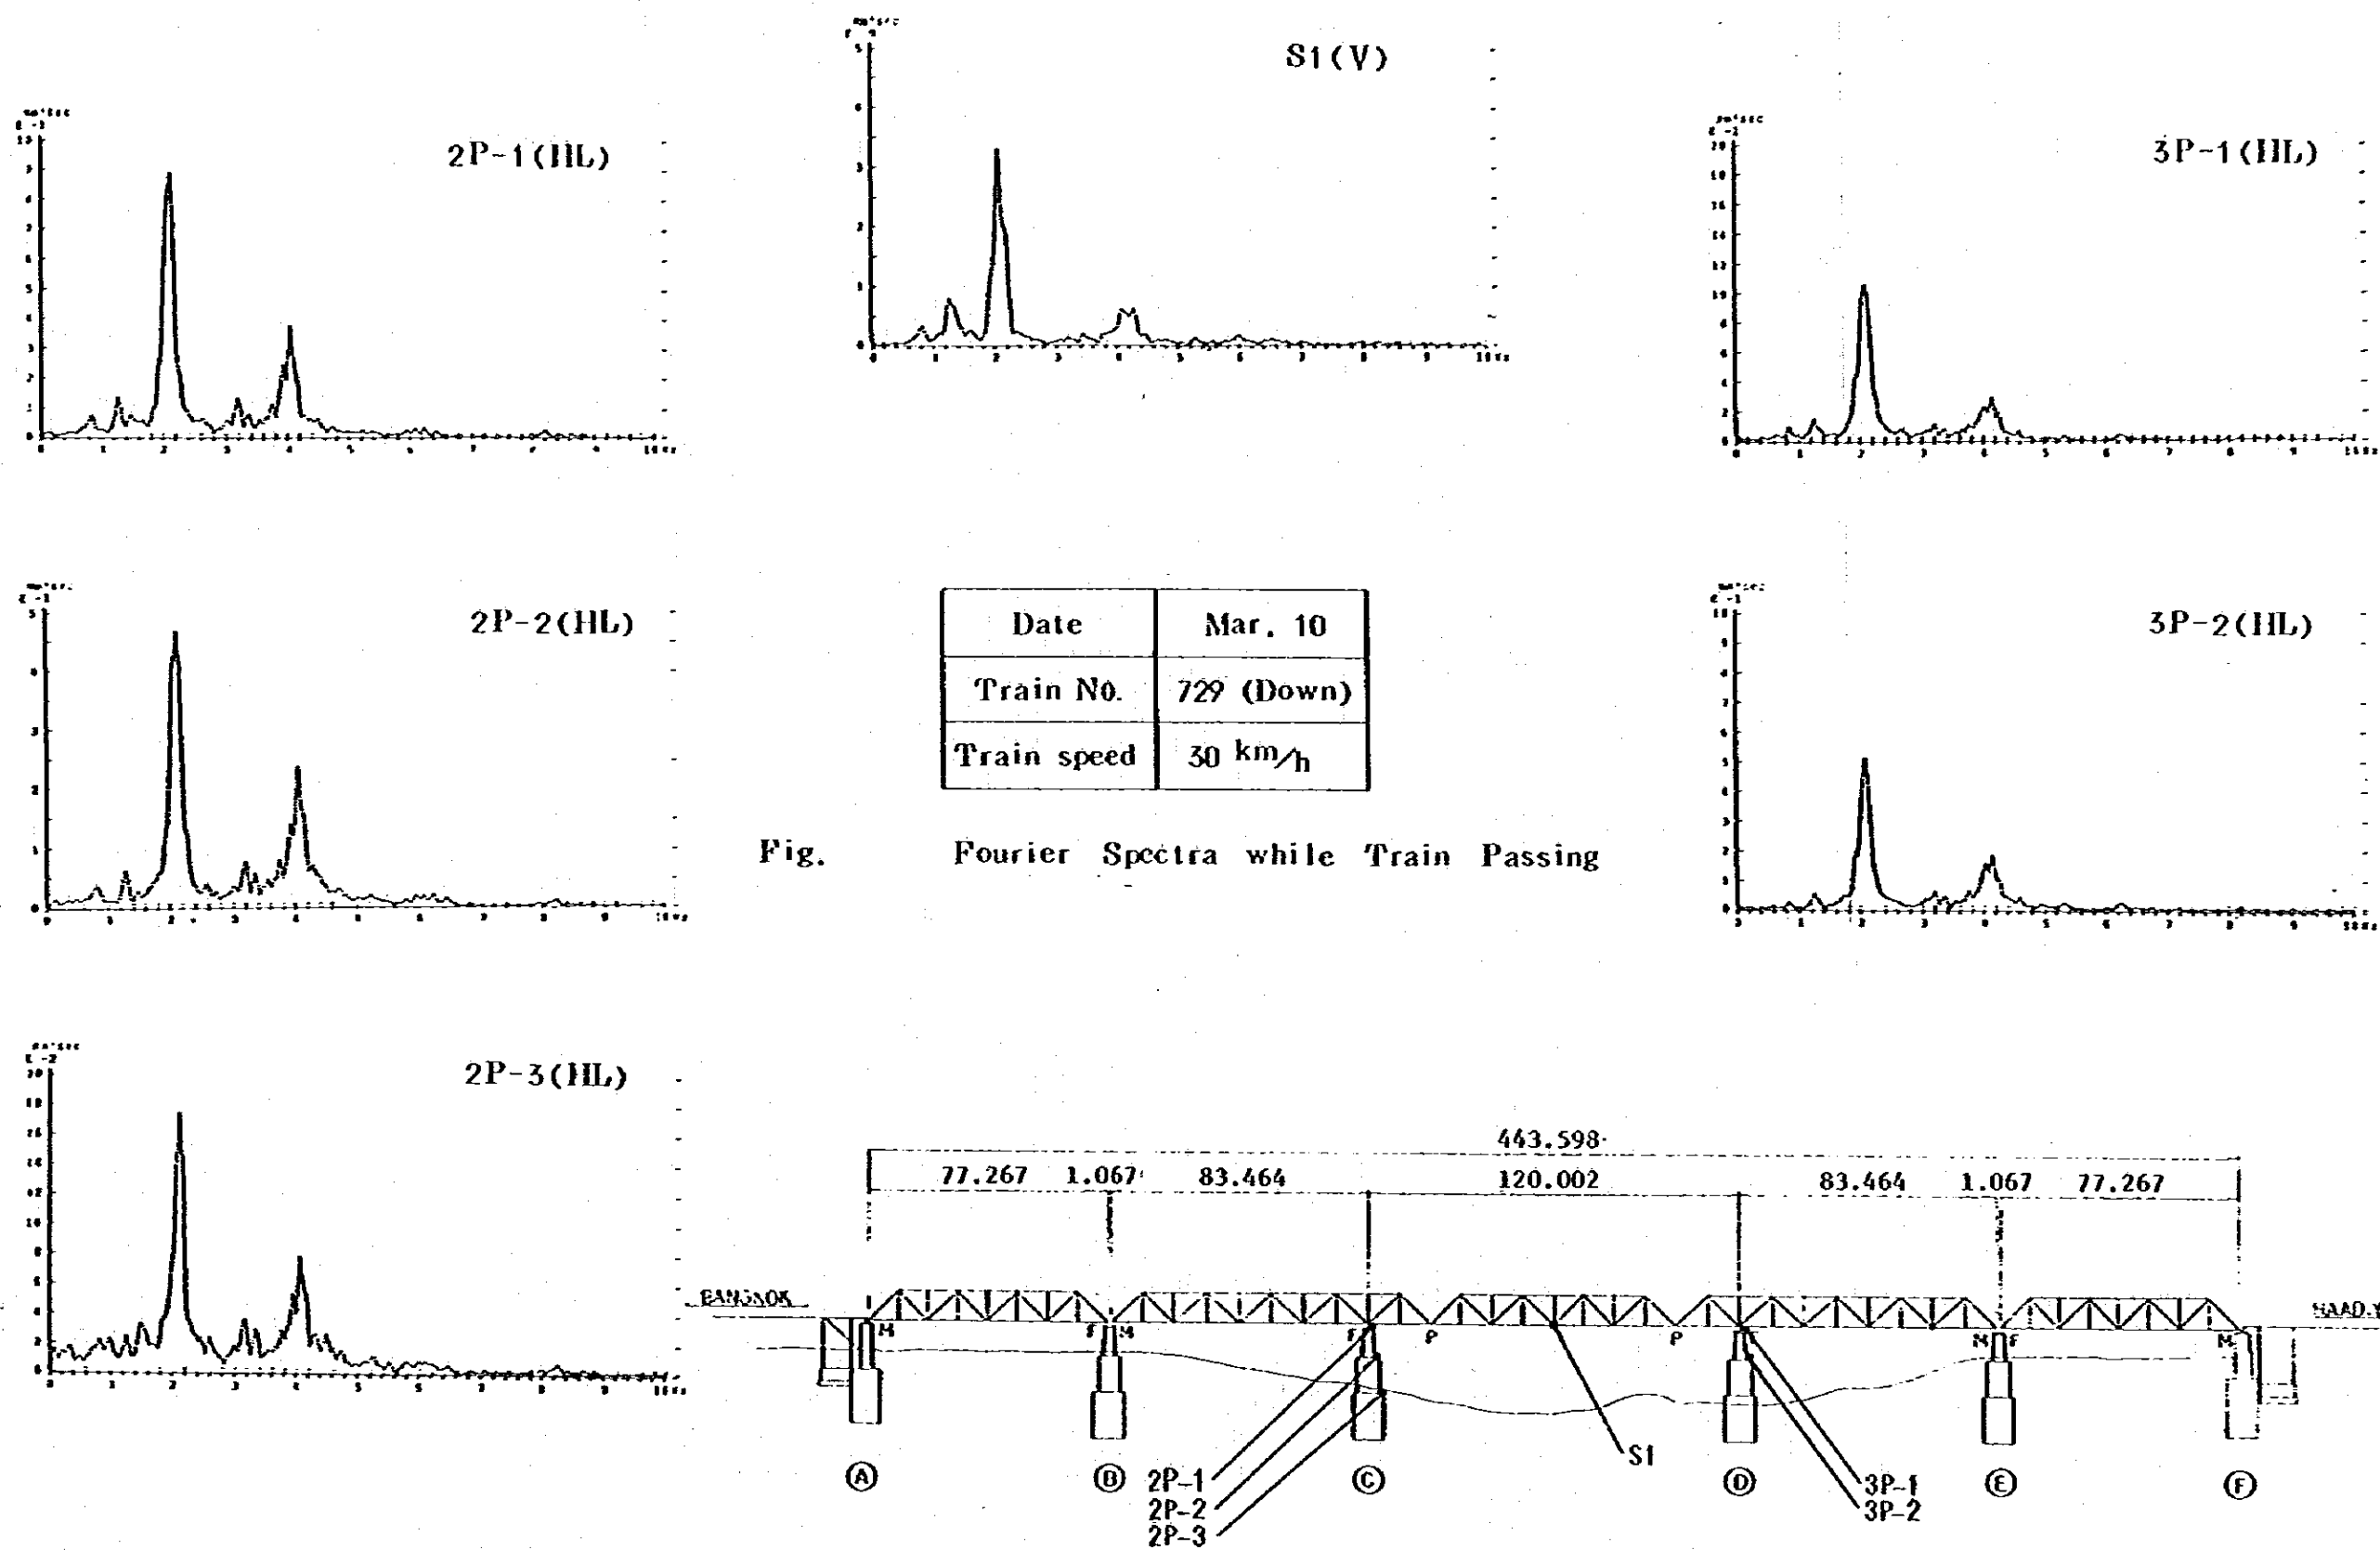
Fig. 2-3 Spectrom While Train is Passing

If there were any gap or crack at upper, middle and lower parts of the pier, the peak in prominence should be observed at a different frequency. In the reality, however, such peak is seen at any phase of same frequency as shown in Fig. 2-3.

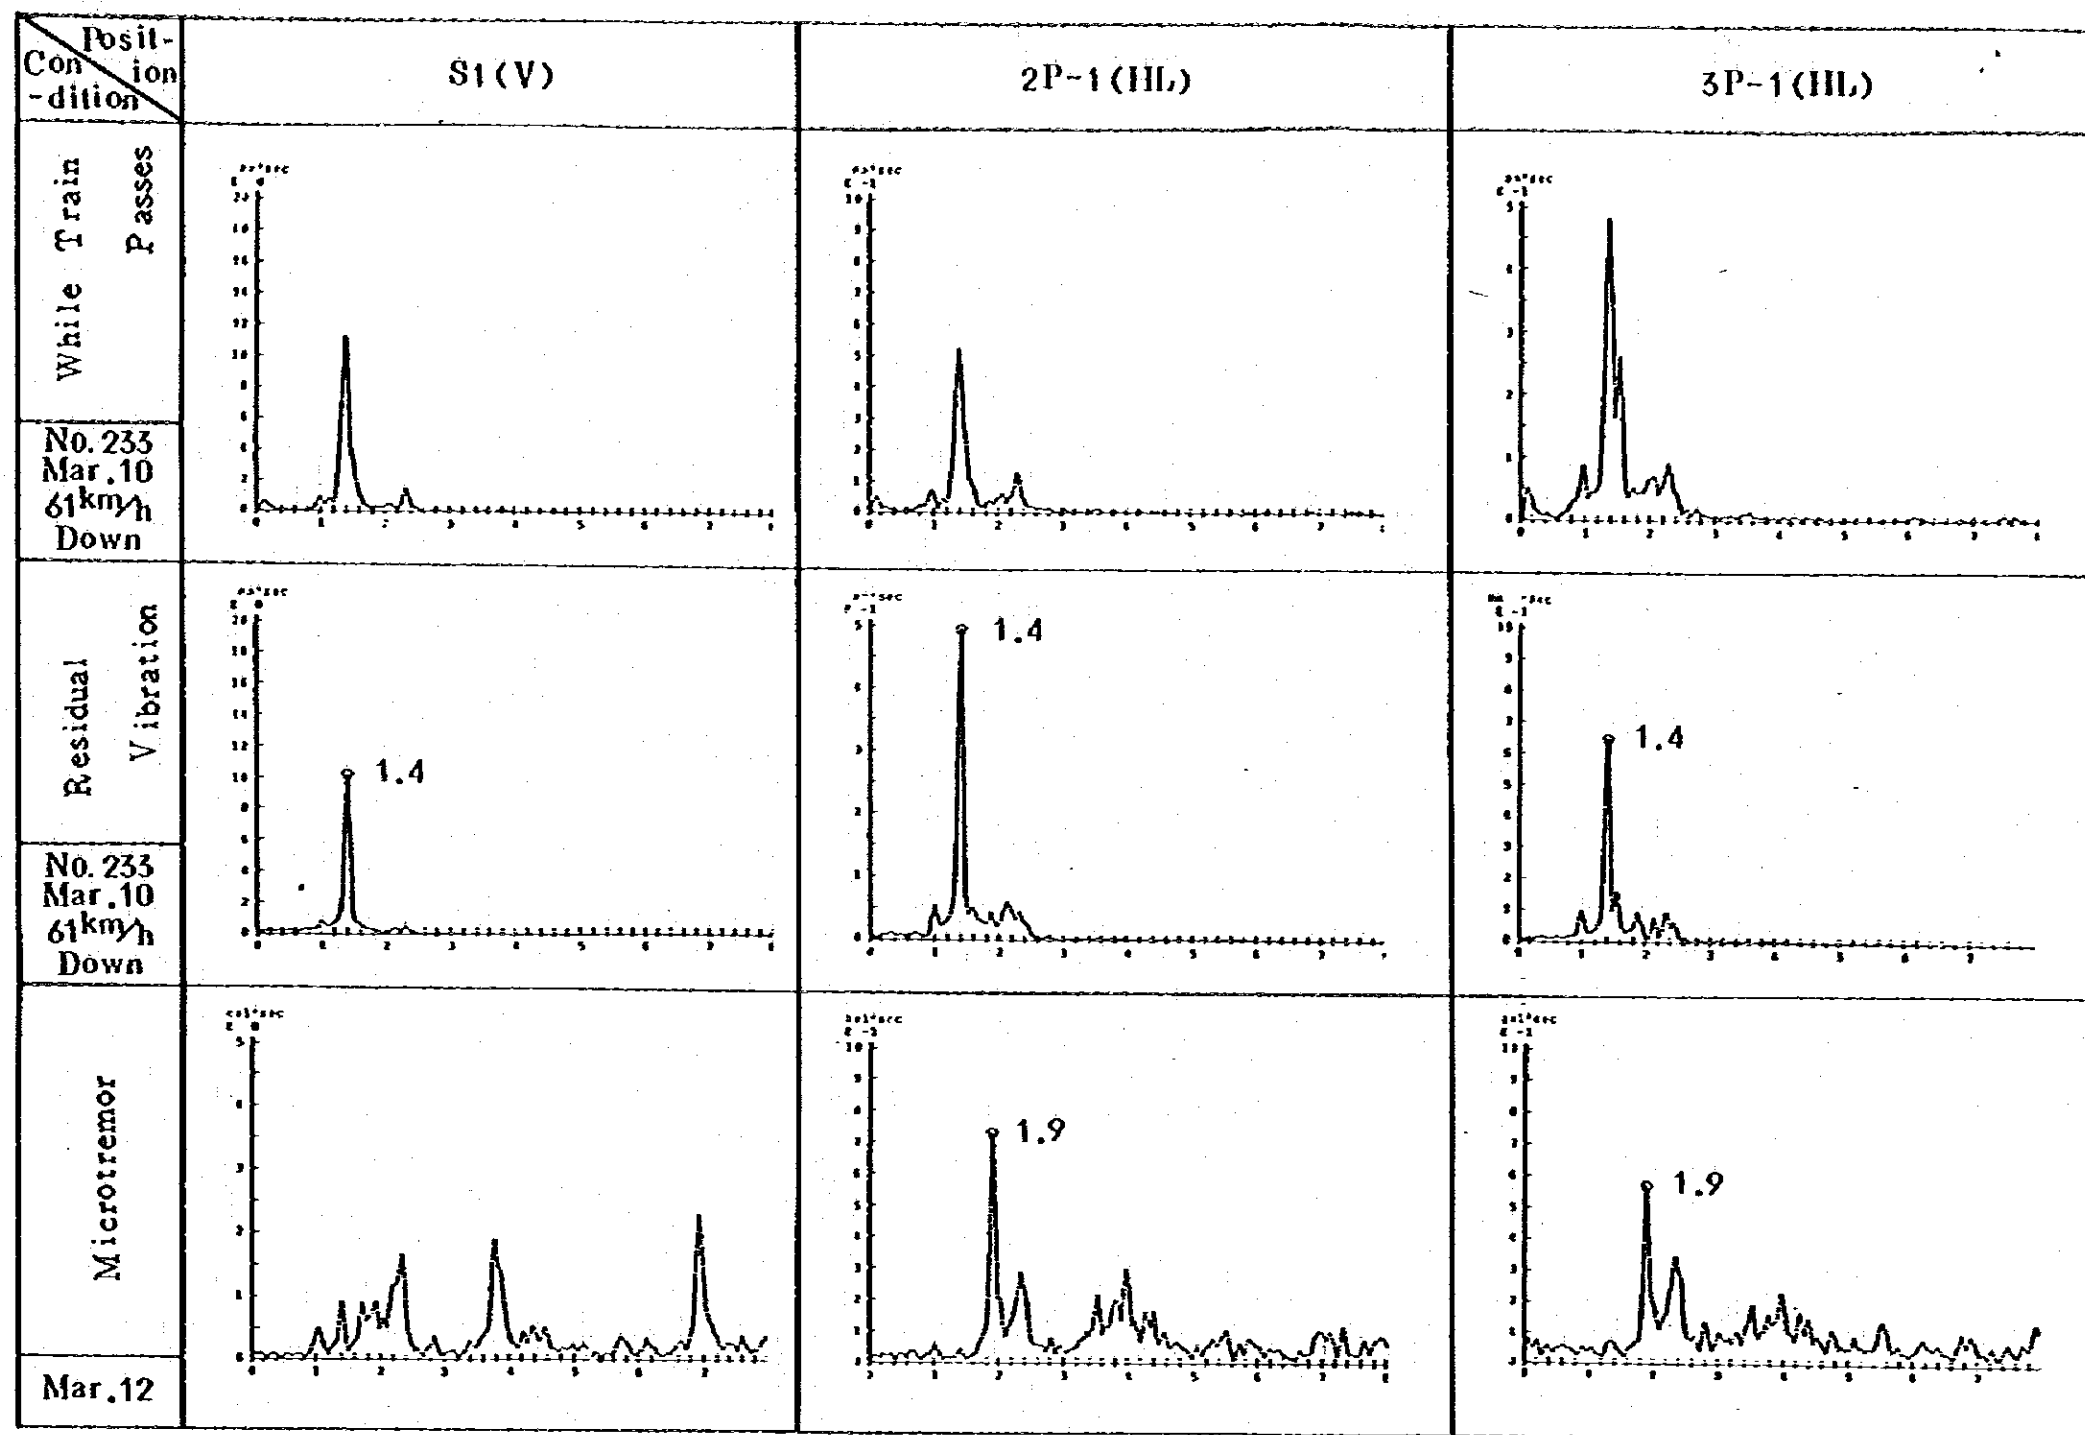
Fig. 2-6 Estimation for Natural Frequency in the Structure (1)

In line with the above assumption, the whole bridge structure was divided into three (3) blocks and examined on vibration during passage of train, reverberation and constant microvibration. The result of this comparative check is, as shown in Figs. 2-6 thru 2-8, conspicuous of 1.4 Hz for the central span, in addition to predominance at and near 2 Hz.

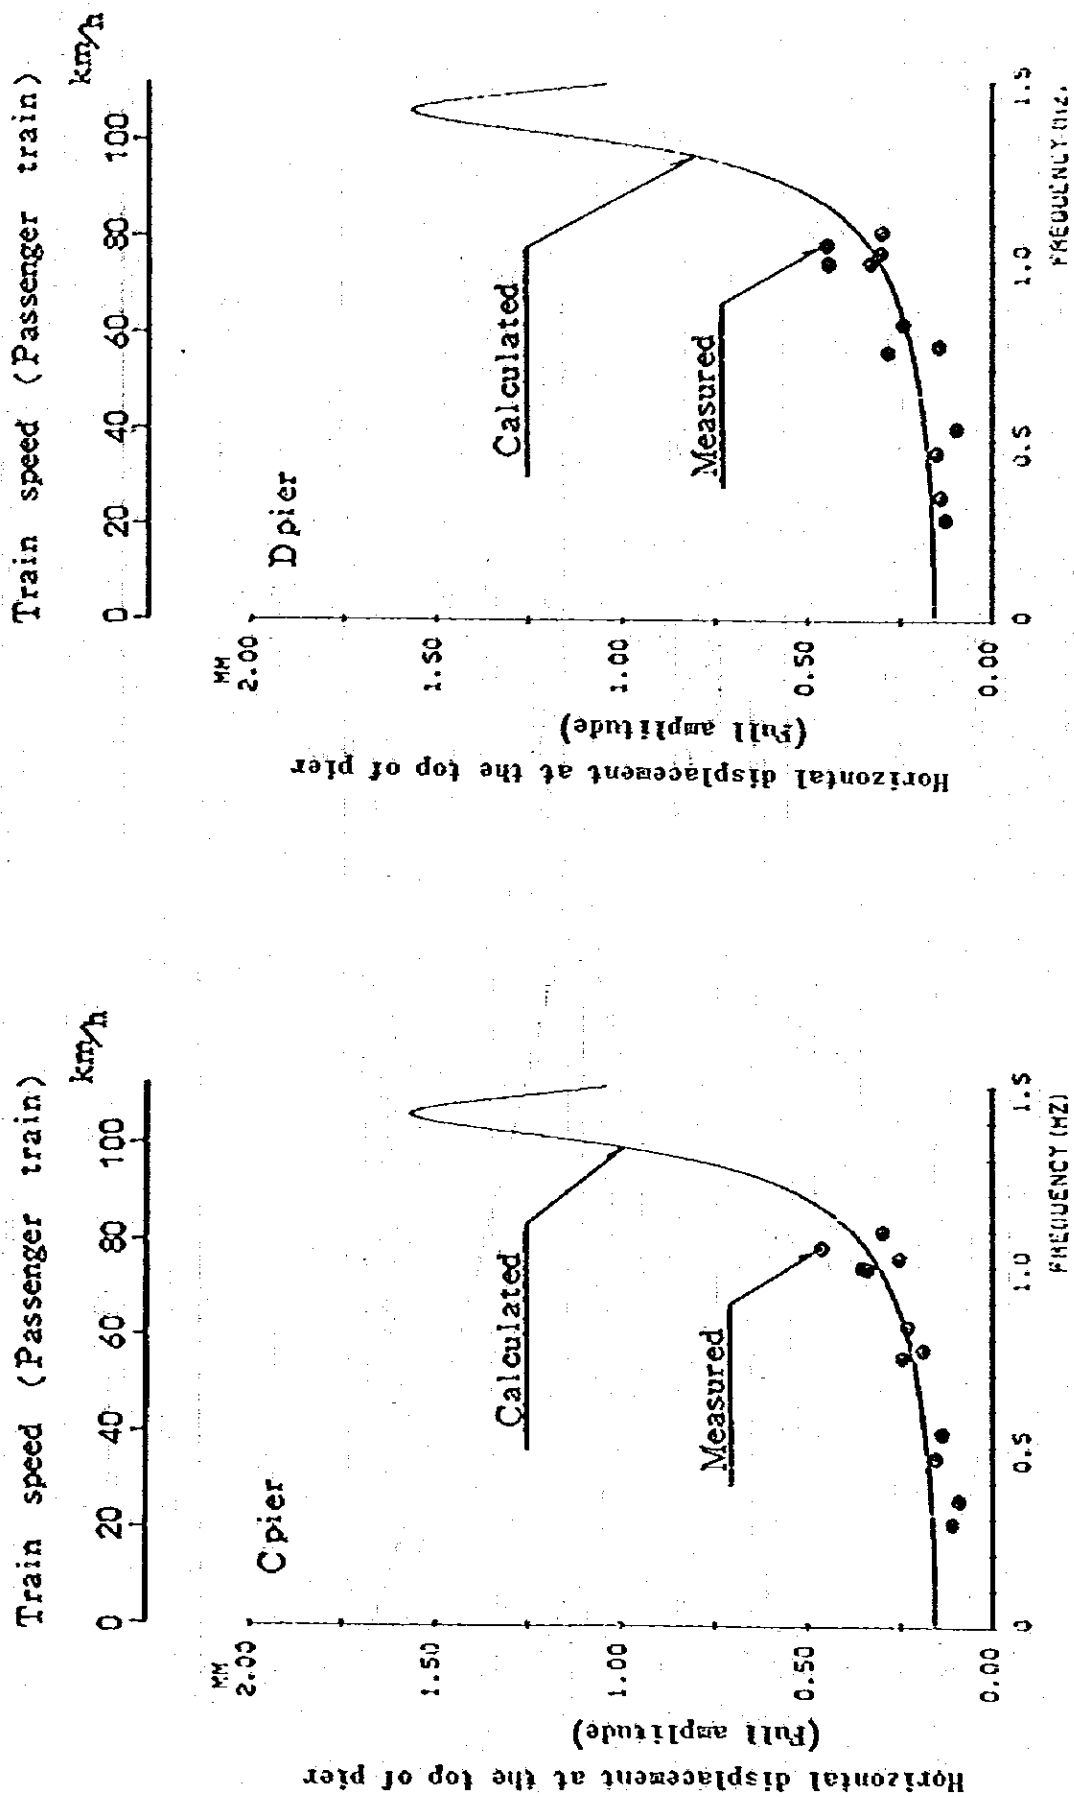
Fig. 2-12 Variation of Responses due to Change in Train Speed

The result of train running simulation is shown in Fig. 2-12. Although the maximum response value could hardly be assessed strictly because the train speed was limited up to 80 km per hour, it was certain that response characteristics of actual measurement could almost be justified by the simulation test result.

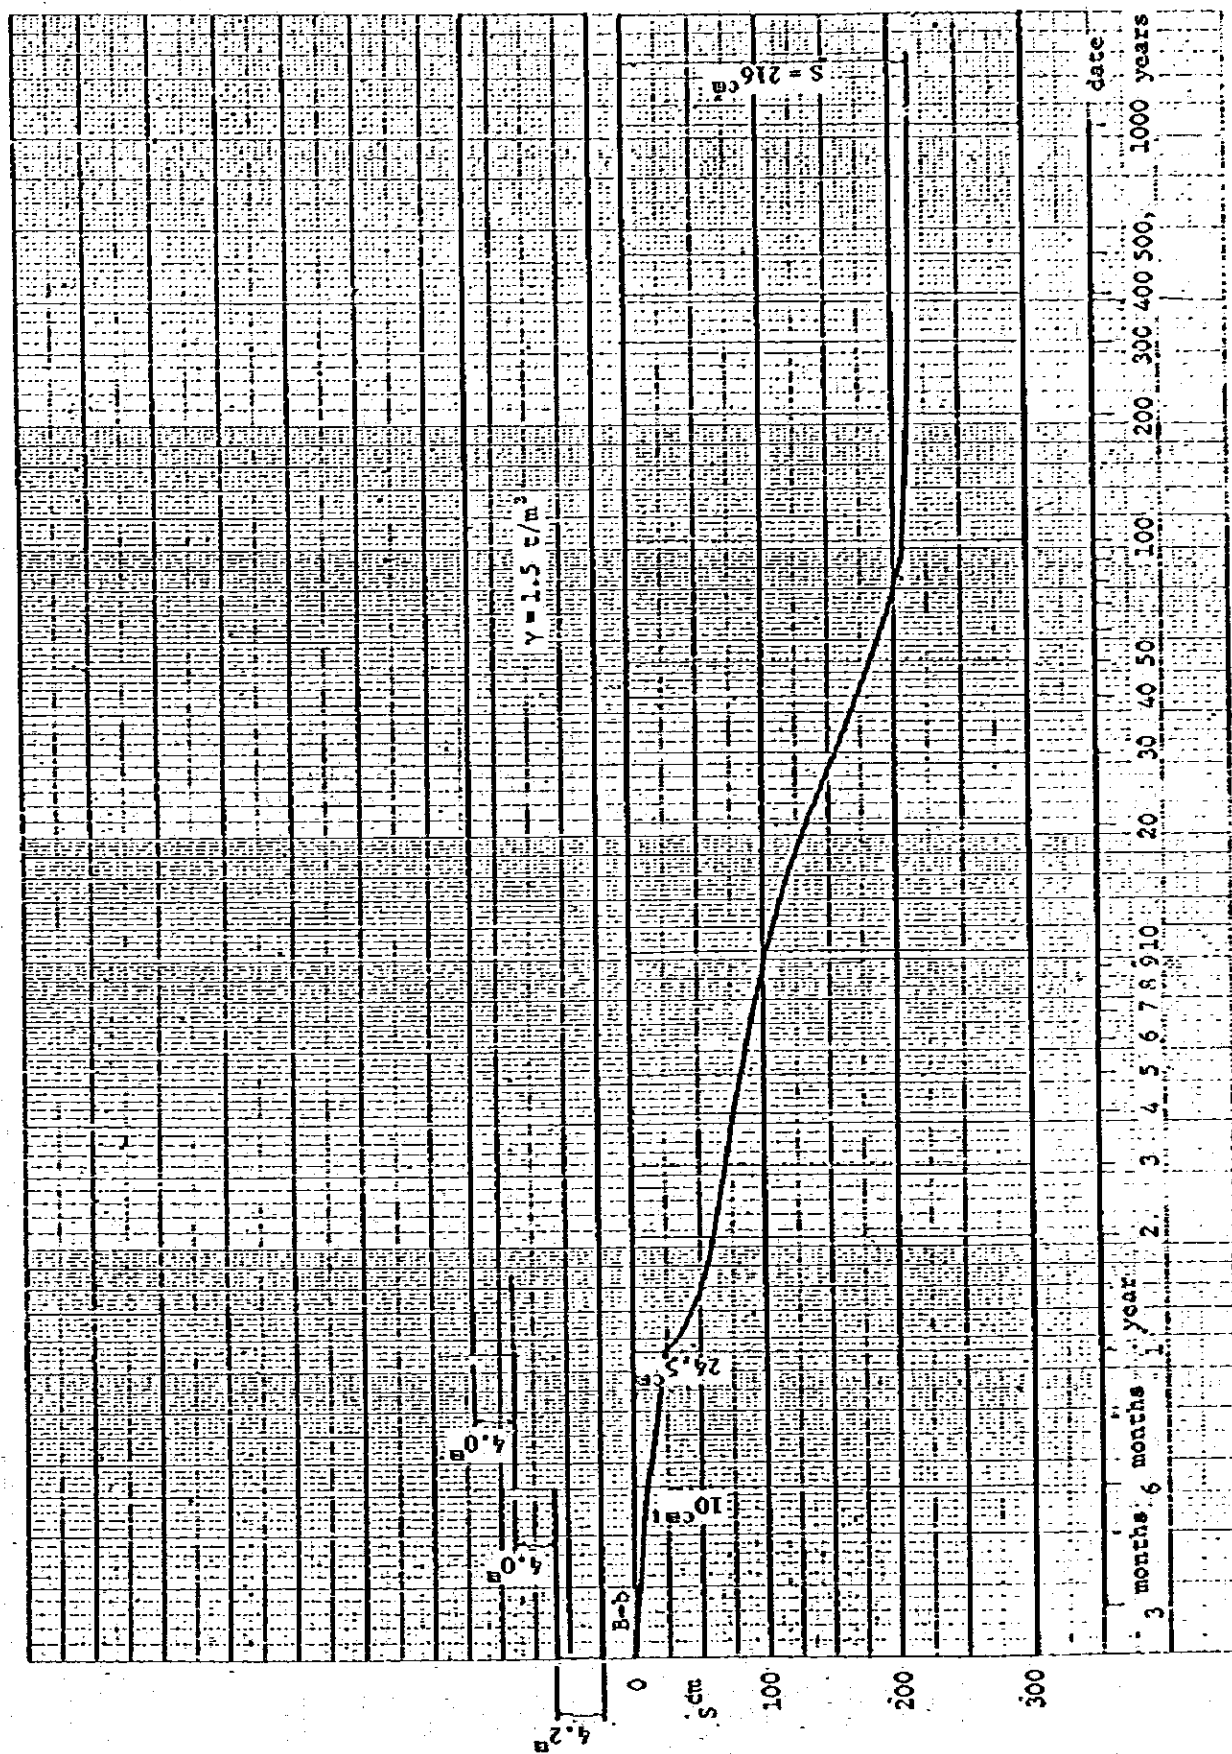
Fig. 2-21 Settlement Curve

- (1) Settlement due to consolidation as shown in Fig. 2-21 show the fact that there exist some amount of unfinished consolidation in the Dc layer after almost completion of consolidation in the Ac layer as shown in Fig. 1-1.  
However, it may possibly be conceivable that consolidation and settlement have been almost completed in general as a matter of fact and, therefore, there may hardly be any possibility of causing such deterioration as may be attributable to consolidation and settlement.

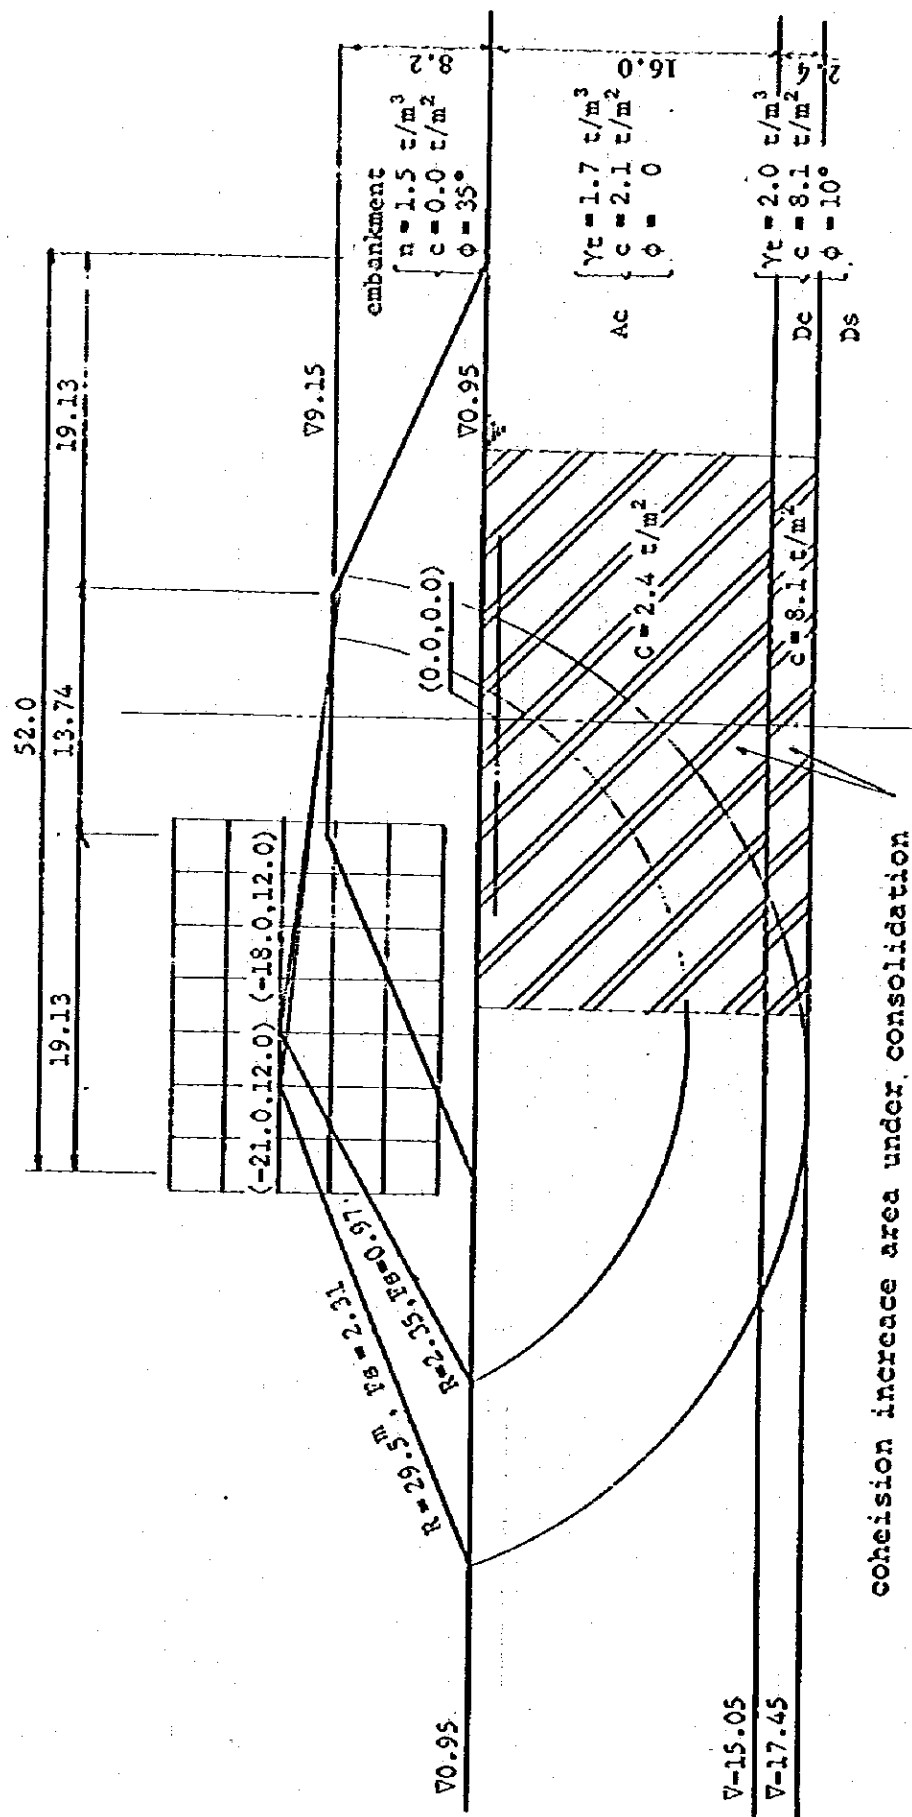
Fig. 2-23 2nd Stage: 2nd Embankment ( $t = 6$  months)

There is a case where the value of  $F_s$  (the safety factor) falls down below 1 at those steps of embankment as shown in Figs. 2-23 and 2-24. It appears that this declined value may implicate outbreak of slide failure on the embankment, thereby providing difficult jobs done for such embankment at sacrifice of human effort.

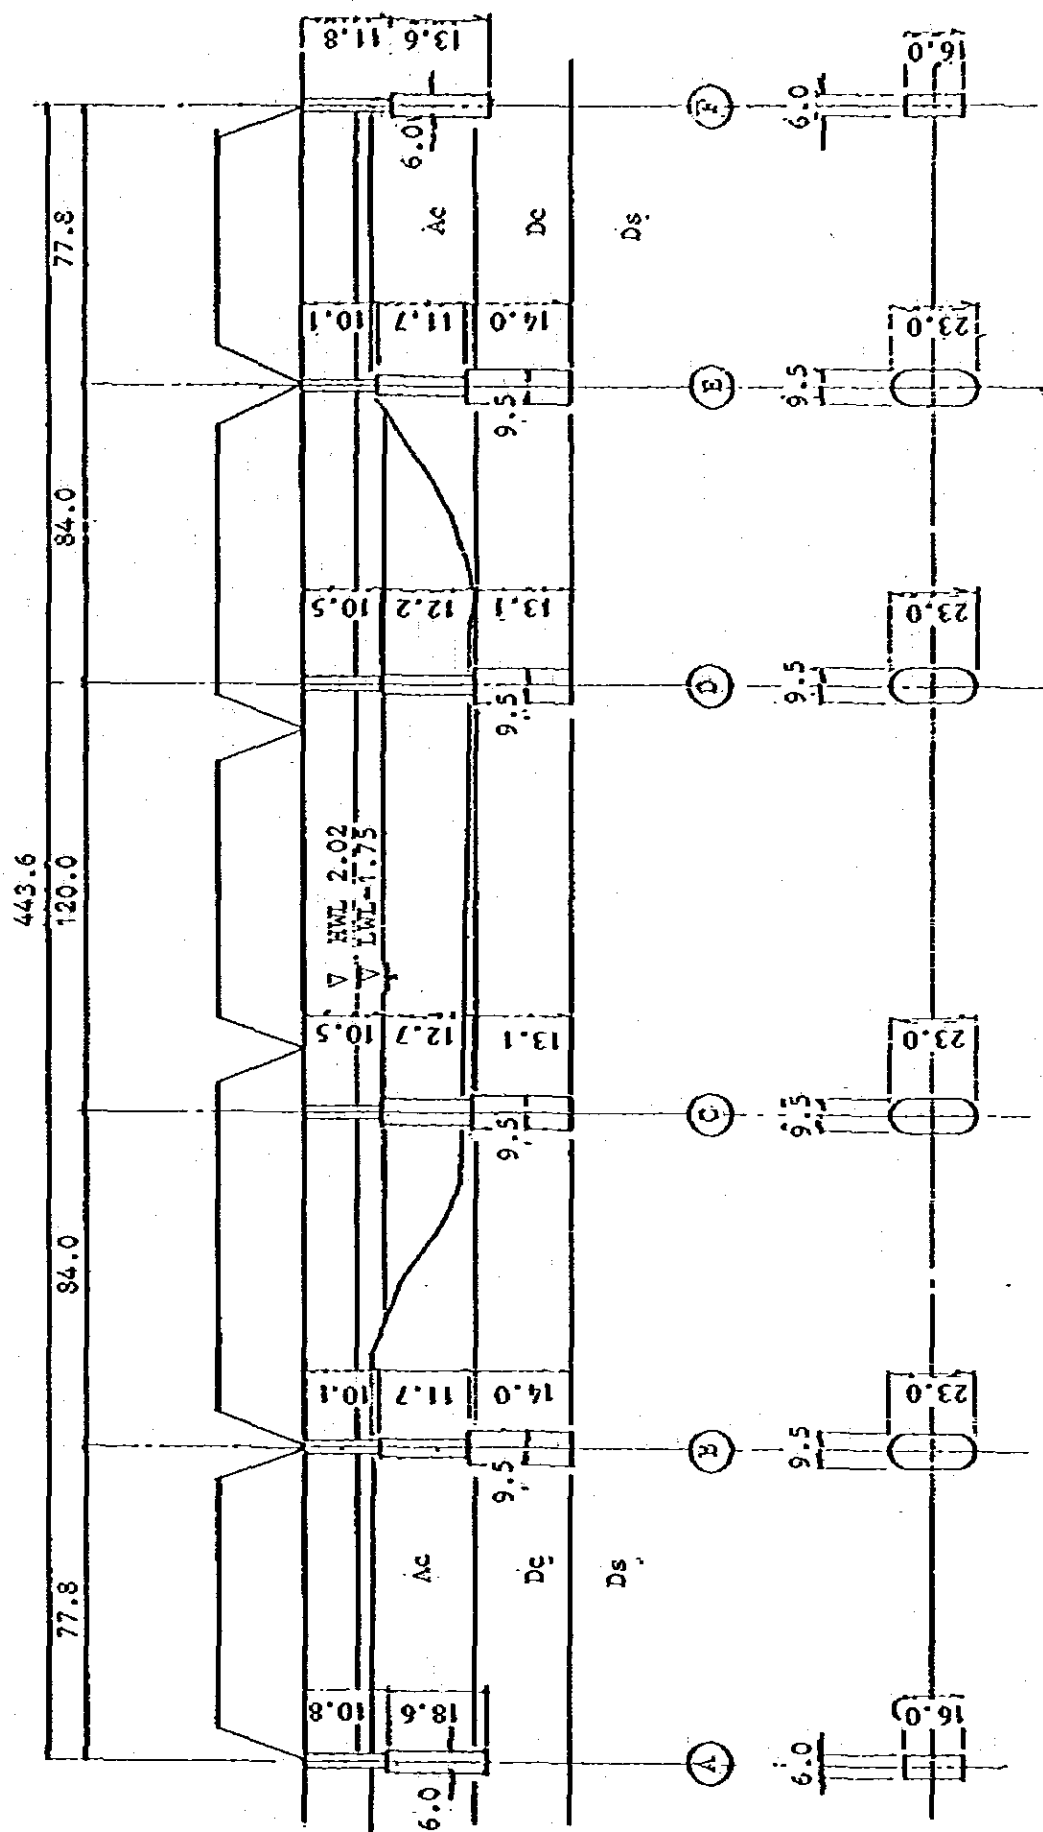
Fig. 2-26 General Arrangement of Rama VI Bridge

Firstly the RAMA VI Bridge shown in Fig. 2-26 will be converted into the calculation model as shown in Fig. 2-27. Then, by substitution of the horizontal displacement factor of Piers A~E in horizontal spring constants  $K_A$  thru  $K_E$  at each crown of piers from the relationship between load and displacement of each crown of piers, the model can be simplified as shown in Fig. 2-28.

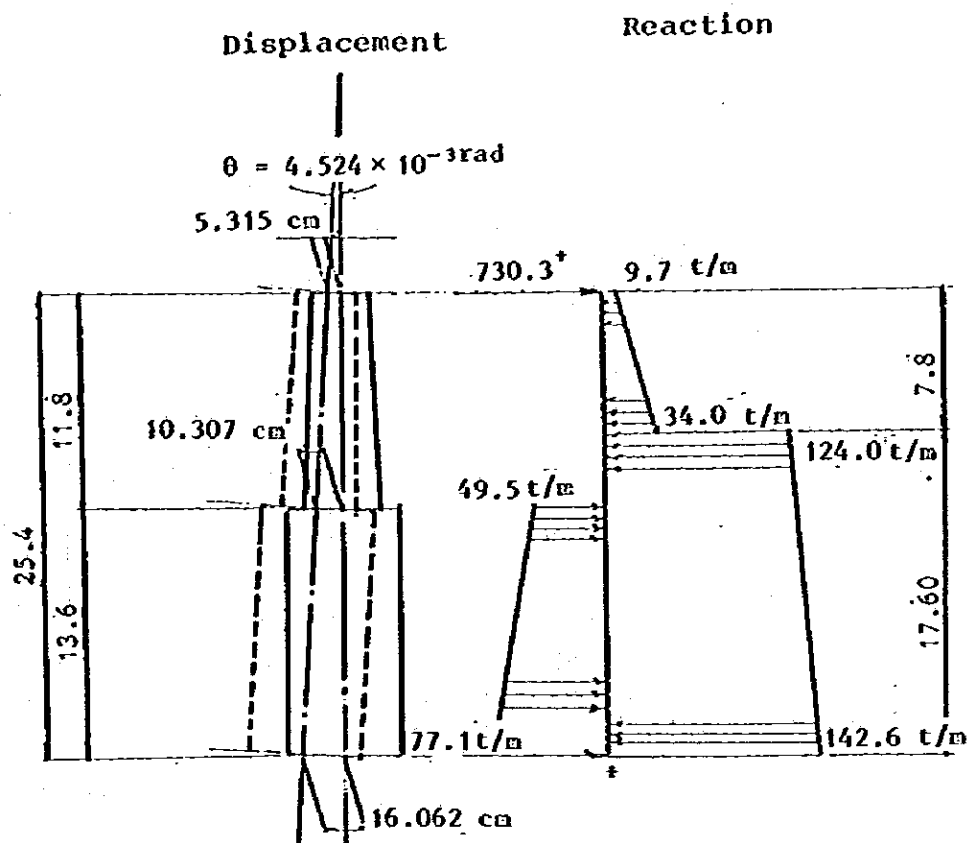
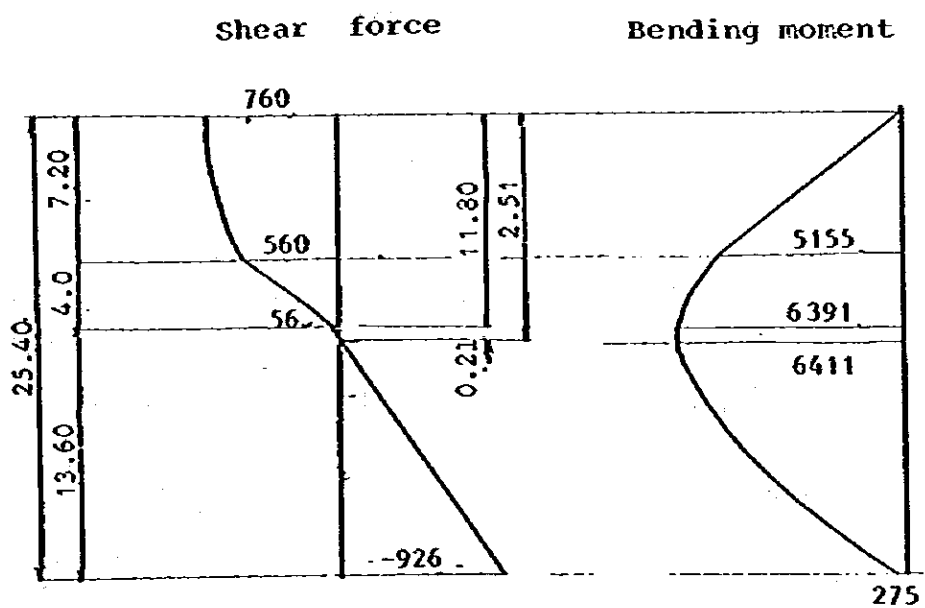
Fig. 2-29 Result of Simulation Analysis (No. 1)

The result is as shown in Fig. 2-29. That is to say, horizontal displacement at Abutment F may be calculated at  $\delta_1 = 5$  cm at the top of pier and  $\delta_2 = 16$  cm at the bottom of caisson.

- (3) Displacement of Abutment F due to unequal earth pressure toward Bangkok as shown in Fig. 2-29 is nearly same as horizontal displacement on assumption that the whole superstructure would

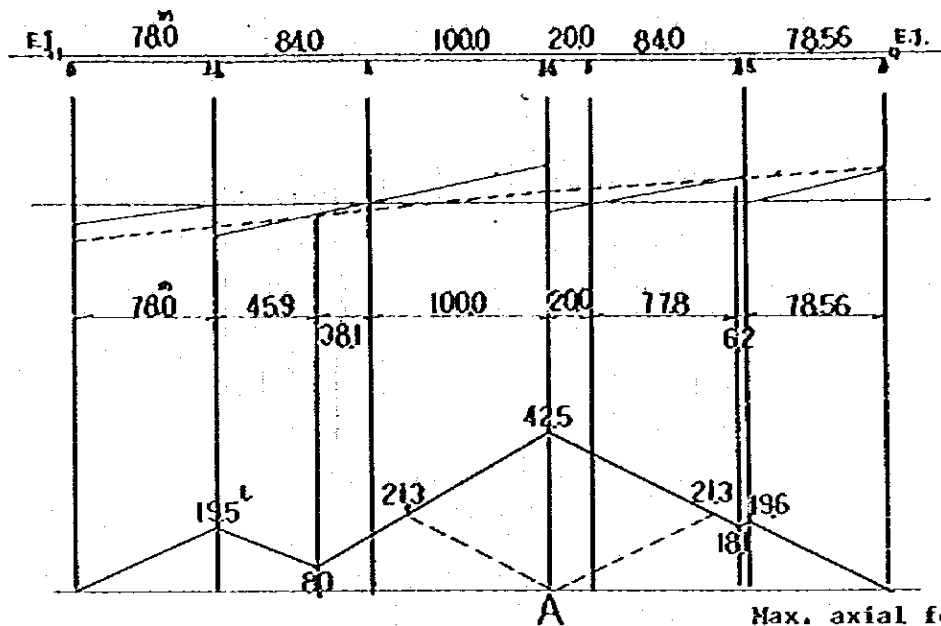
Fig. 2-33 Axial Force Distribution of Long Rail on the Bridge (with insertion of expansion joint to bridge end)

Fig. 2-33 shows distribution of rail axial force.

The calculated size of opening is shown in Figs. 2-33 and 2-34 at long rail breakdown on the bridge.

Max. axial force Pt=42.5t  
Opening at rail SD=2.68cm  
breakdown (Point A)
