REPORT ON  
THE RAMA VI BRIDGE  
REHABILITATION PROJECT

DECEMBER, 1982

JAPAN INTERNATIONAL COOPERATION AGENCY  
(JICA)

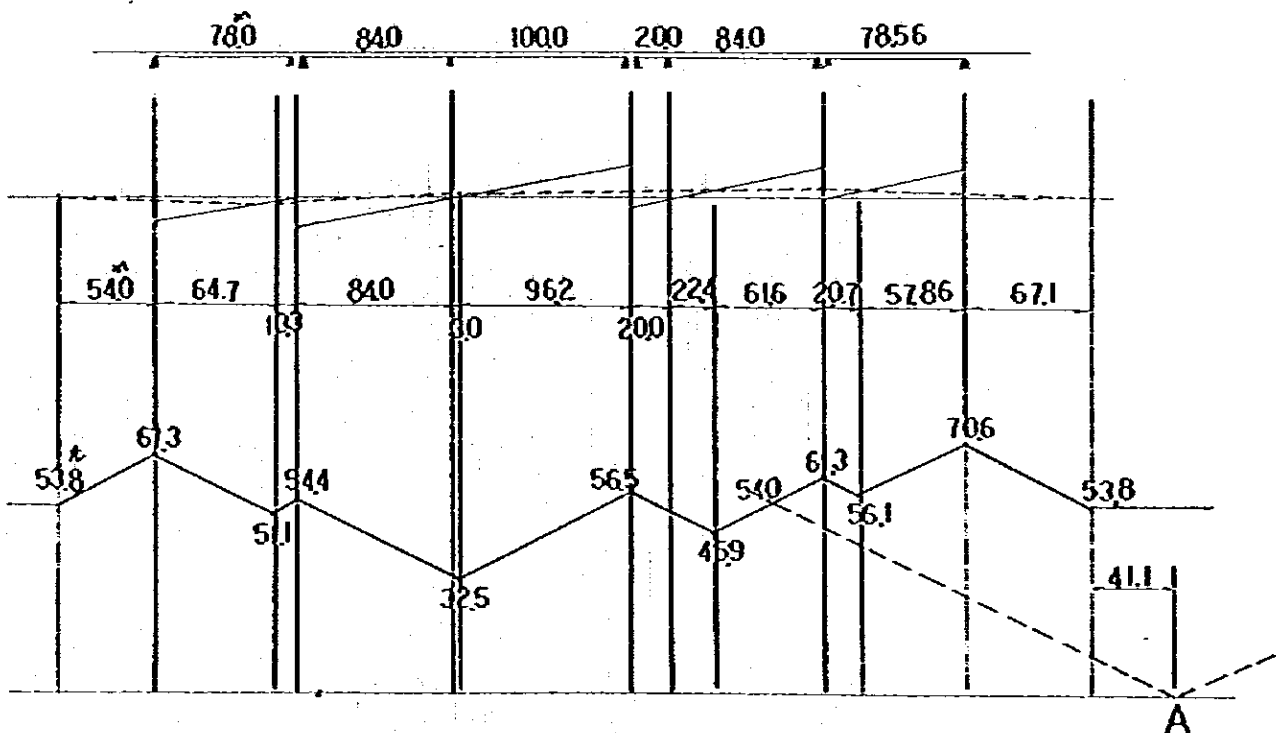
Fig. 2-34 Axial Force Distribution of Long Rail on the Bridge (without insertion of expansion joint to bridge end)

Fig. 2-34 shows distribution of rail axial force.

The calculated size of opening is shown in Figs. 2-33 and 2-34 at long rail breakdown on the bridge.

Max. axial force Pt=70.6t  
Opening at rail SD=9.57cm  
breakdown
