APPENDIX 5.3-2 ROAD DISASTER DIAGRAM

APPENDIX 6.5-1 CONDITION OF DISASTER AND
SELECTED COUNTERMEASURES

CONDITION OF DISASTER AND SELECTED COUNTERMEASURES

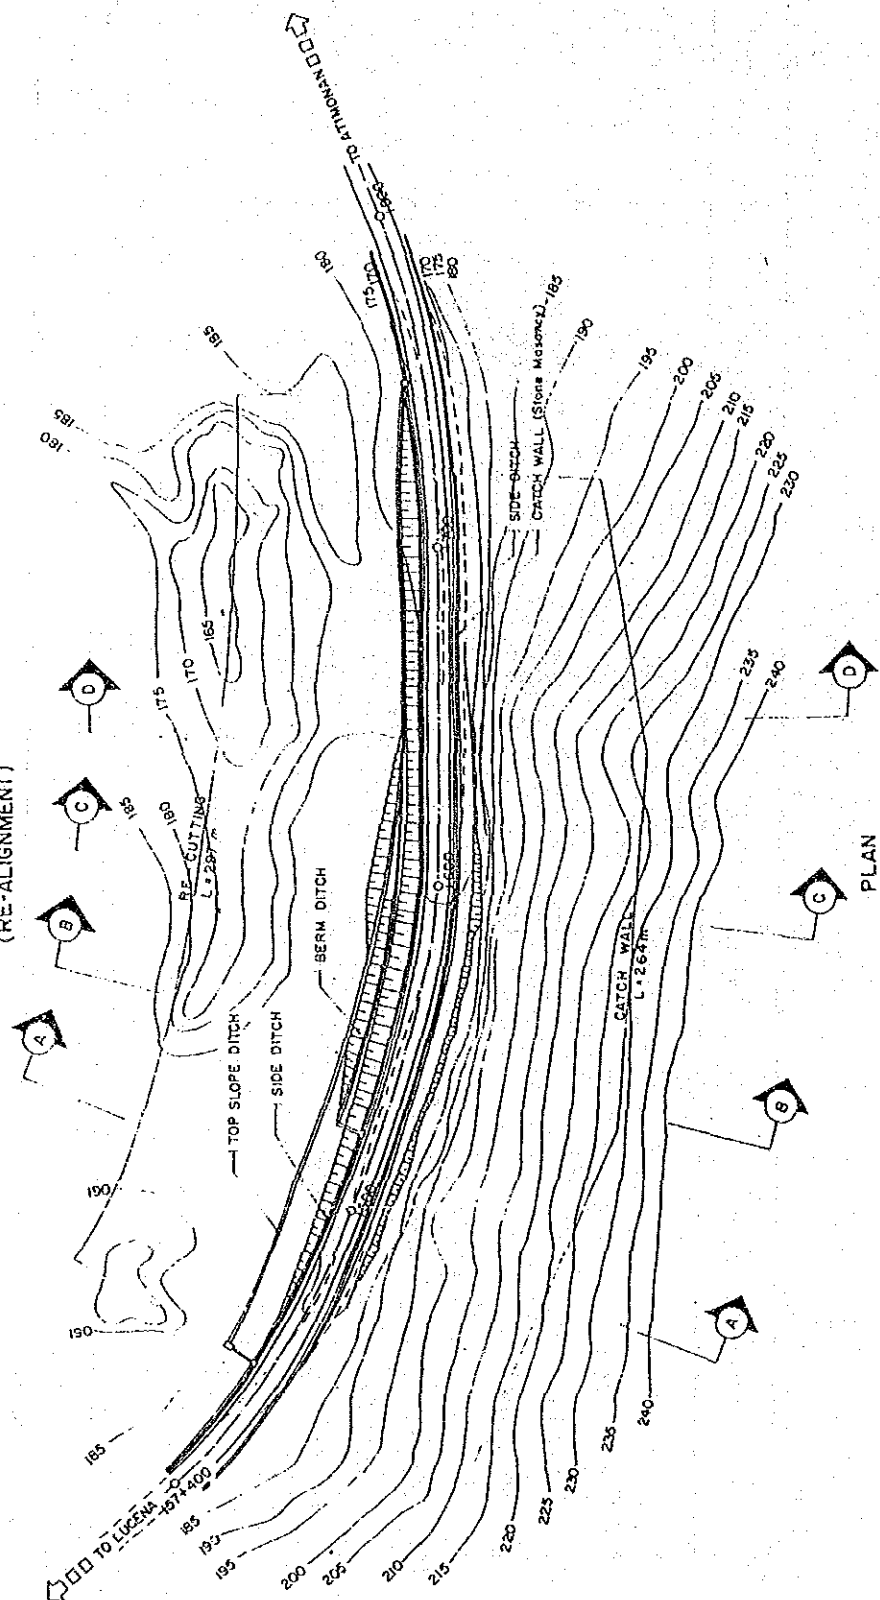
PROPOSED COUNTERMEASURE
OF SPOT NO. IV-A-15 (CASE 1)
(RE-ALIGNMENT)

<ul style="list-style-type: none"> Soft Rock. Limestone. Highly weathered and developed crack. 	<ul style="list-style-type: none"> Surface water flows on the slope and a little concentration of surface water from hinterland. 	<ul style="list-style-type: none"> Slope is steep but not so high. Progress of weathering is anticipated on weak soft rock. Fallen rock size: 0.50~1.00m 	<ul style="list-style-type: none"> Re-alignment. Re-cutting (left portion). Catch wall. Top slope ditch. Berm ditch. Side ditch.
6	IVA-17	158 + 500 C-D.F

SPOT NO. IV-A-15	UNIT	PESOS	
ITEM OF WORK	U N I T	Q U A N T I T Y	A M O U N T
Side Ditch	Lm	598	459,264
Berm Ditch	Lm	374	65,450
Top Slope Ditch	Lm	418	127,490
Catch Wall	Lm	1,215	374,220
Concrete Pavement	m ²	350	518,000
Removal (Soft Rock)	m ³	240.31	448,800
Excavation (Soft Rock)	m ³	261	62,640
Re-cutting (Soft Rock)	m ³	356	2,207,912
T o t a l			4,260,776

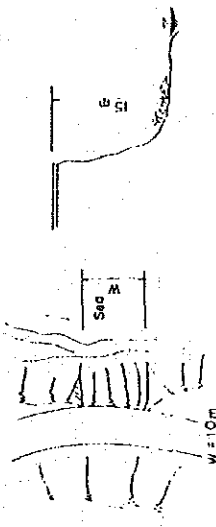
<ul style="list-style-type: none"> Embankment materials. (Gravelly Soil) 		<ul style="list-style-type: none"> Slope gradient is steep and high. No existing slope protection. Scouring by sea waves. Small scale riparian. 	<ul style="list-style-type: none"> Re-filling. Stone masonry retaining wall. Gravity type retaining wall. Gabion foot protection.

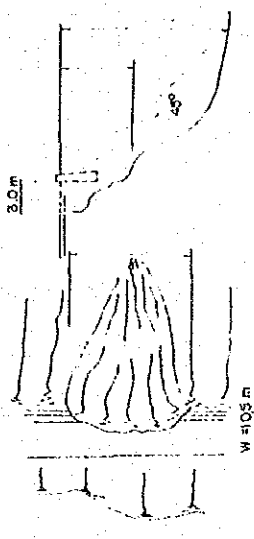
Embankment material. (Gravelly Soil)	Concentration of road surface water. Road surface water saturates into embankment materials.		Under construction.
